Re: Vault Location 4651 on 95 St. Clair Ave W, Toronto

**Fibertop Vault Fire – January 28, 2013**

**Fibertop Network Protector Vault Fire, January 28, 2013**  
**Vault Location 4651 – 95 St. Clair Ave W.**

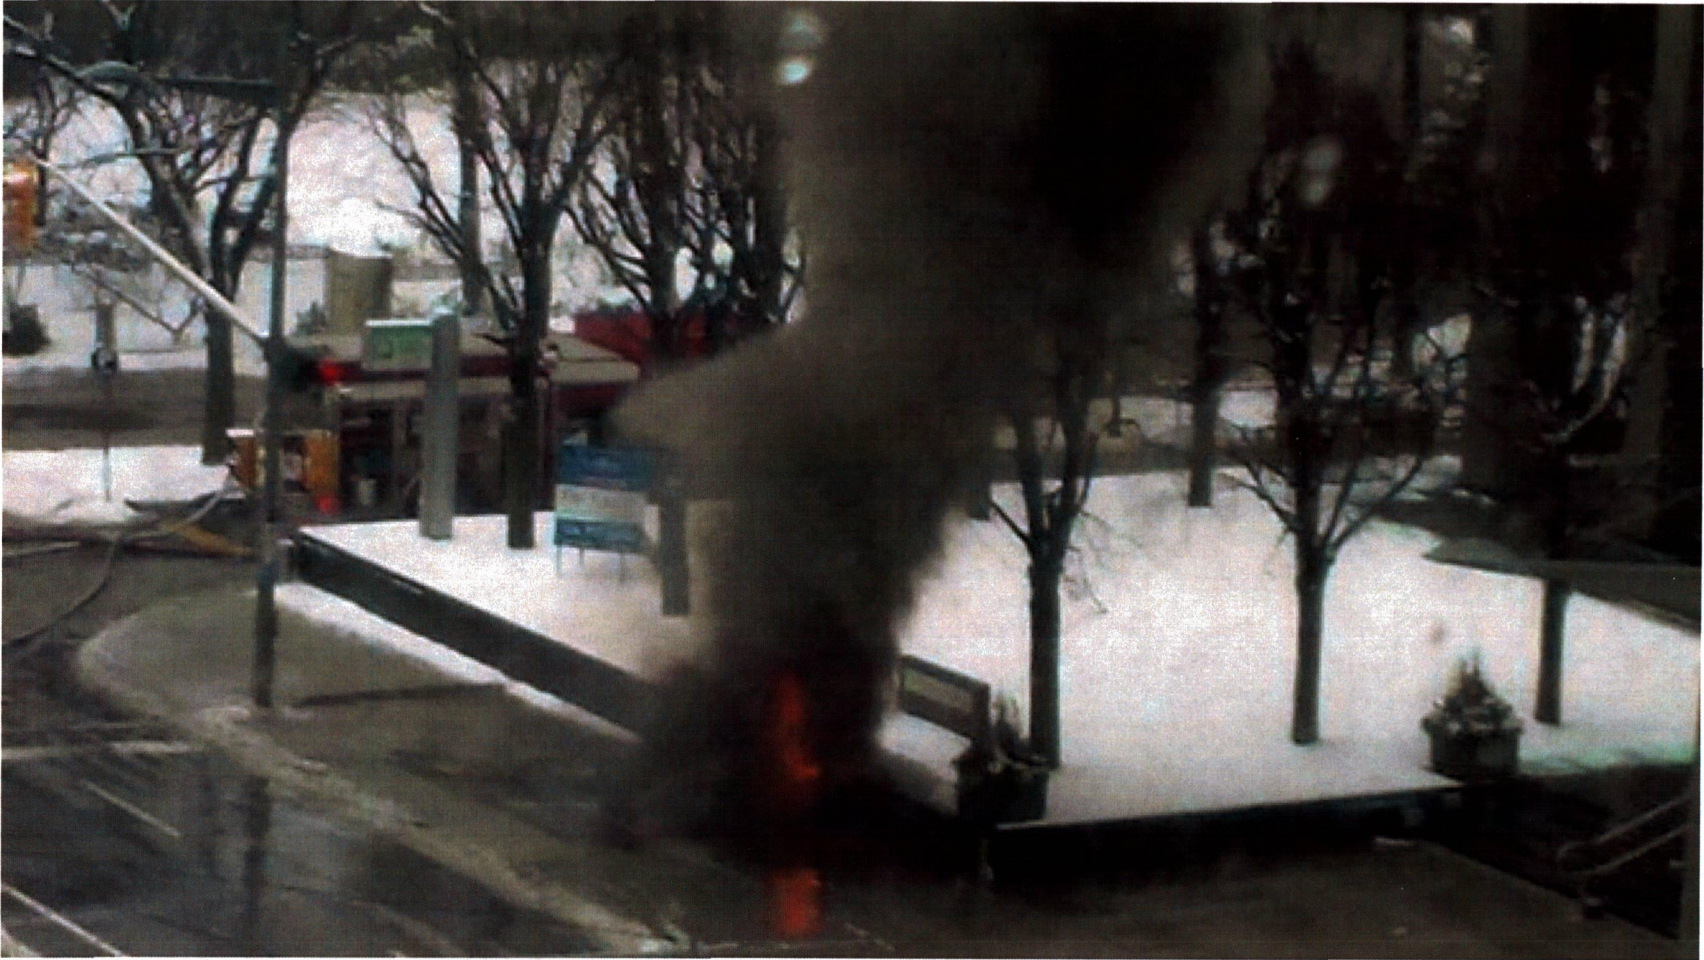
Based on the information we have so far, the fire most likely started on the west side of the customer owned vault. The unit on the west side was fed by the A54H transformer and was equipped with a fibertop protector (as was the unit fed by the A53H transformer).

On the day of the incident, the near freezing weather conditions, resulted in melt water from the snow and the previous day's worth of salt both being present. The accumulation of debris, water and salt on top of the fibertop protector was the most likely cause of the fire.
