Burlington **hydro** inc.

# Appendix L

## Fleet Management Plan

Fleet Management Plan

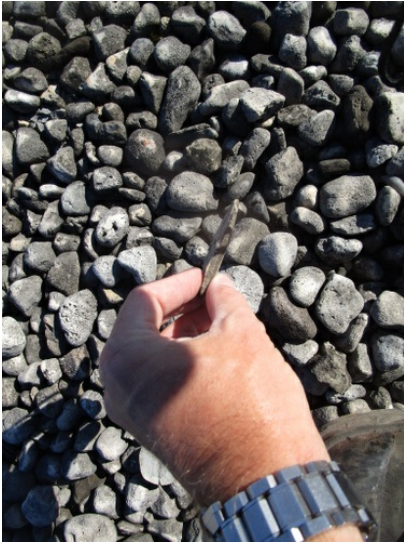
*Photo 14*

The ballast has broken down which can cause punctures from mere foot traffic

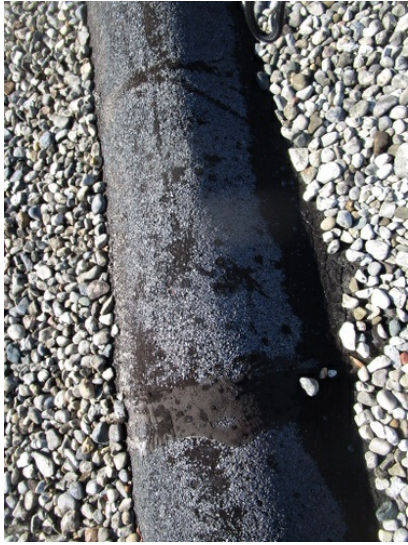
*Photo 10*

Mineral loss along the expansion joint that requires repairs

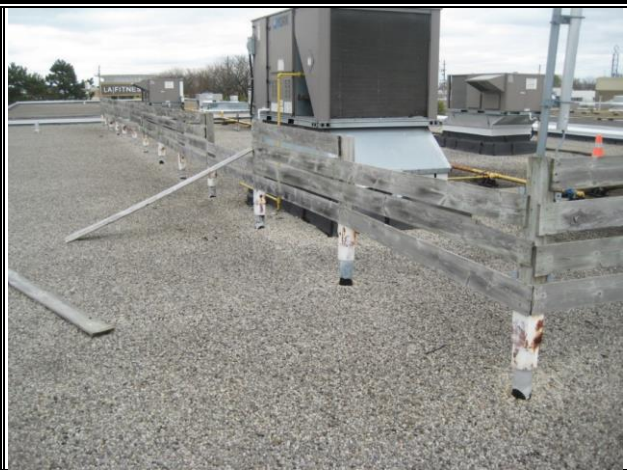
The roof wood screen metal bases are corroded and the wood is deteriorated; some of the boards are detached from the frame. We recommend clean, prime and paint the metal bases and replace the wood screen with a new composite screen. We included an allowance in the Capital Expenditures for replacement.

**Photo #18: Deteriorated Roof Screen**

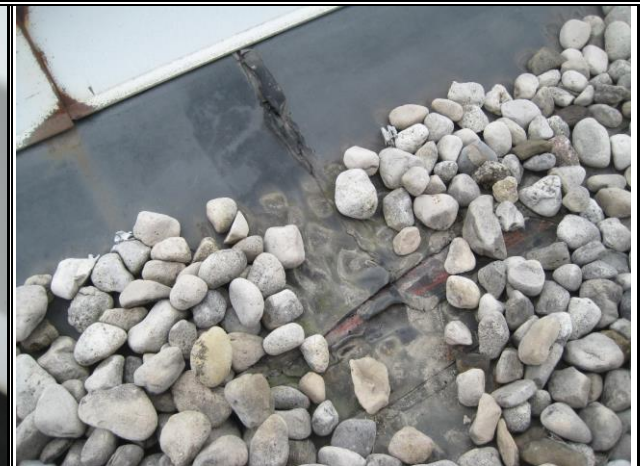
**Photo #30: Corroded Metal Capping and Thorn Seam**

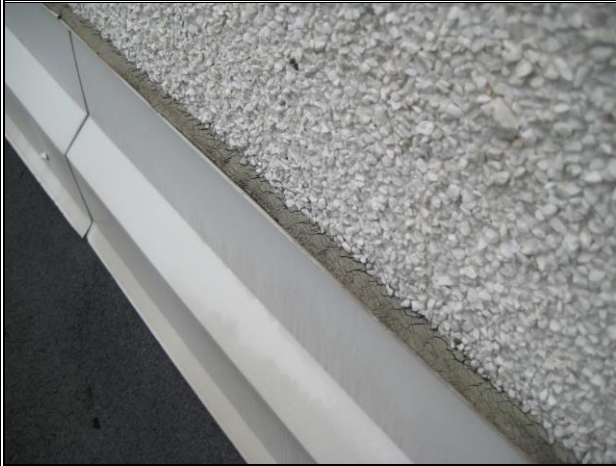
Photo #35: Cracked Caulking at Metal Flashing	Photo #36: Split Caulking at Precast Cladding

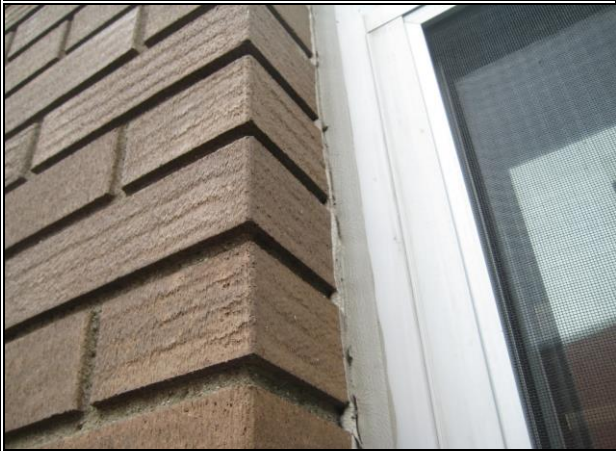
Photo #37: Split Caulking at Window Frame	Photo #38: Cracked Caulking at Precast Panel Joint

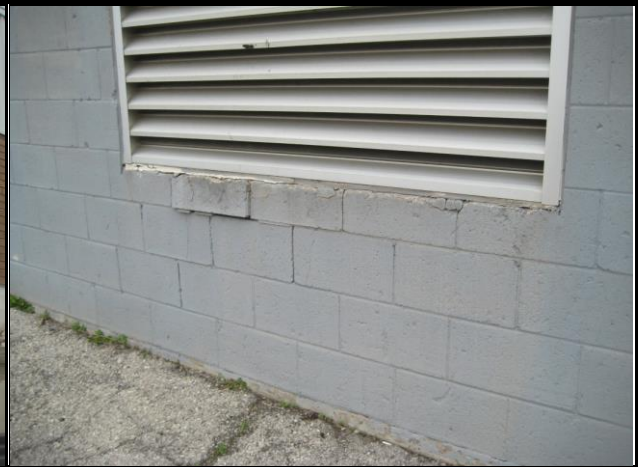
**Photo #44: Loose Concrete Block Units below Mechanical Louvre**

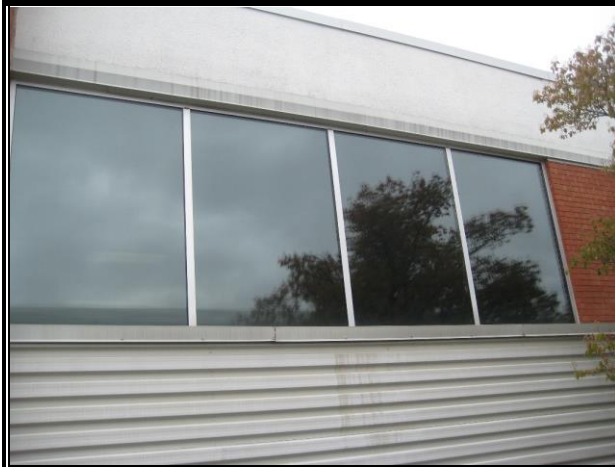
The corrugated metal siding is in good condition. However, we noticed that the paint is starting to fade at the metal cladding in the office building. This is not impacting the cladding structurally at this time as the metal has not started to corrode. You may wish to repaint the metal cladding as the finish continues to age and wear. We included an allowance for painting in the Capital Expenditures.

**Photo #47: Stained Metal Cladding at Office Building**

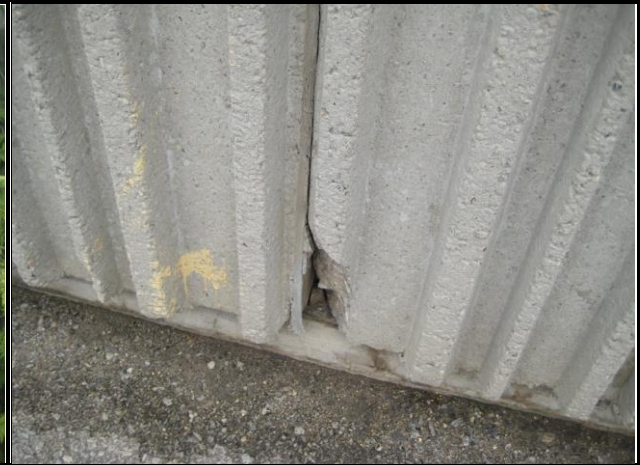
**Photo #52: Damaged Precast Panels**

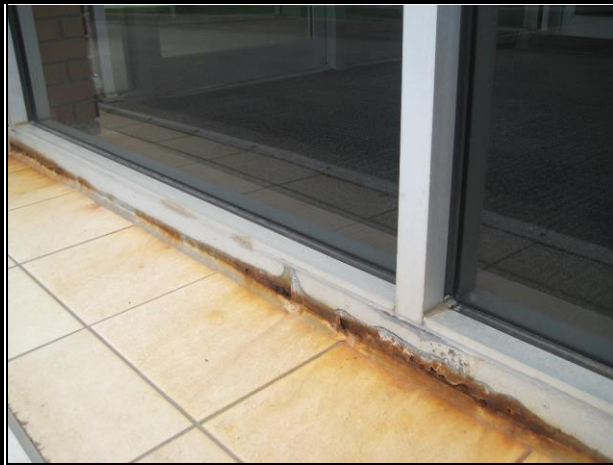
**Photo #57: Corroded Metal Flashing at bottom of Window**

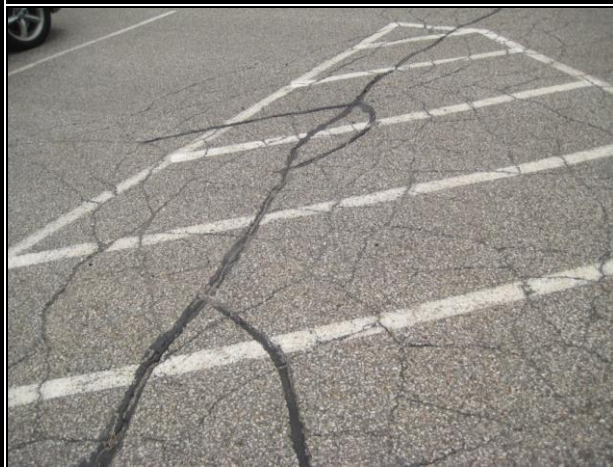
**Photo #101: Cracked Asphalt Pavement**

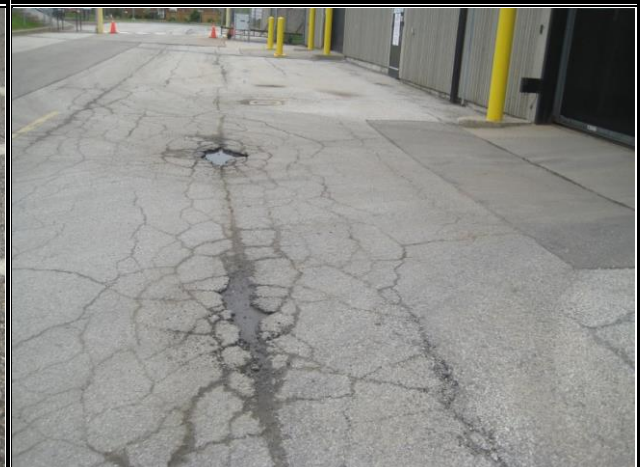
**Photo #102: Potholes**

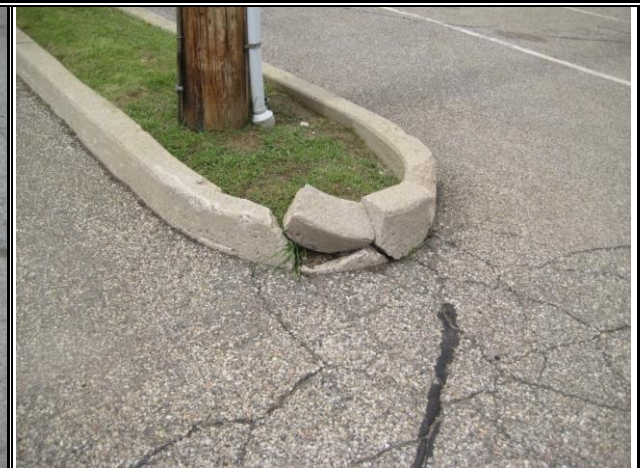
**Photo #104: Damaged Concrete Curb**

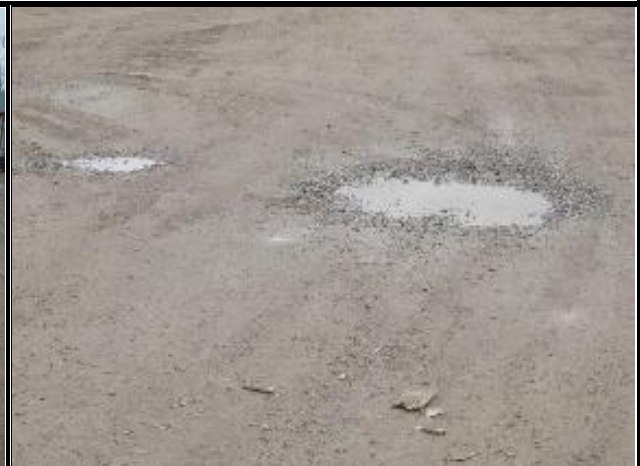
Description	
There is gravel pavement at the rear of the property.	
Observations and Recommendations	
The gravel pavement is in good to fair condition. We noticed localized settlement and pot holes. We recommend local repairs such as fill in pot holes with new gravel, locally re-grade and re-compact. We have carried an allowance in the Capital Expenditures.

<b>Photo #111: Rear Gravel Pavement</b>	<b>Photo #112: Potholes in Gravel Pavement</b>

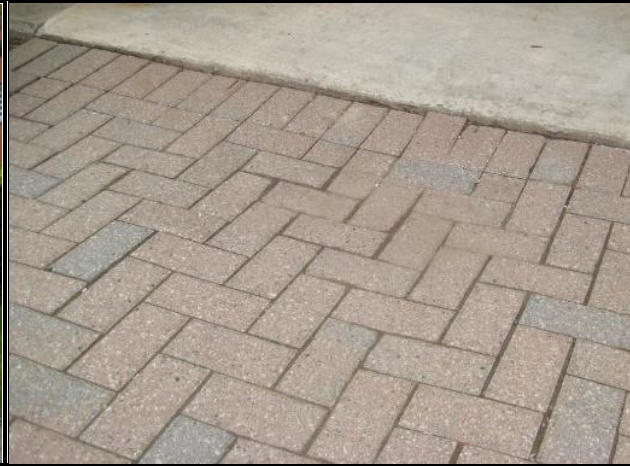
Description	
There are interlocking pavers at the courtyard.	
Observations and Recommendations	
The pavers are in good condition. However, some pavers are unlevelled resulting in tripping hazards. We recommend repairs such as repositioning and replacement of concrete pavers. We included an allowance for this work in the Capital Expenditures.

<b>Photo #113: Concrete Pavers at Courtyard</b>	<b>Photo #114: Settled Concrete Pavers</b>

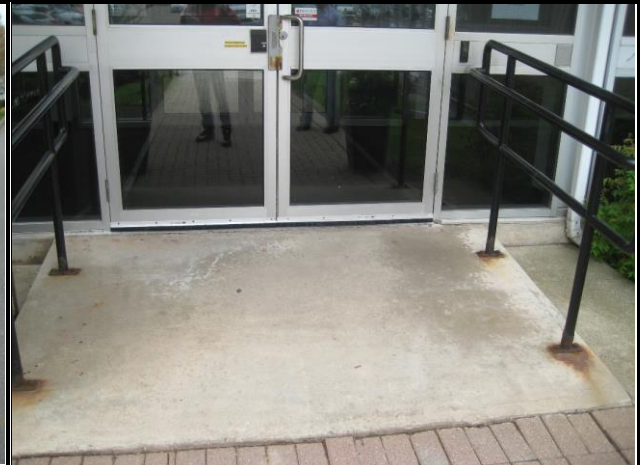
**Photo #116: Corroded Metal Railings at Secondary Entrance**

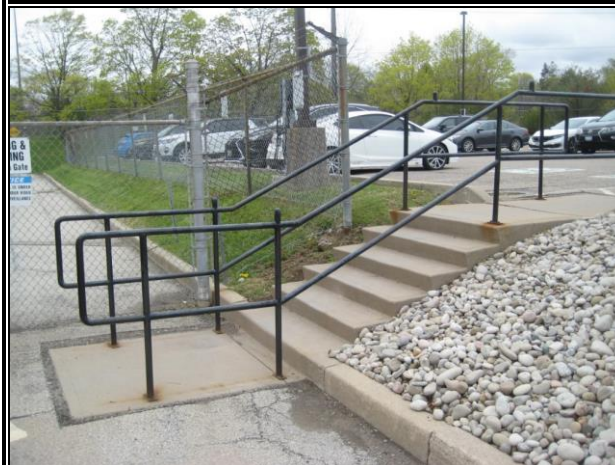
**Photo #117: Corroded Metal Railings at Concrete Stairs**

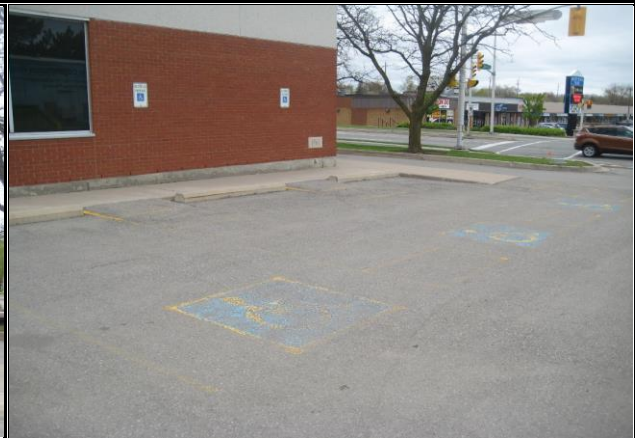
<b>Photo #125: South Accessible Parking Wall Signage</b>	<b>Photo #126: South Accessible Parking Faded Pavement Symbols</b>

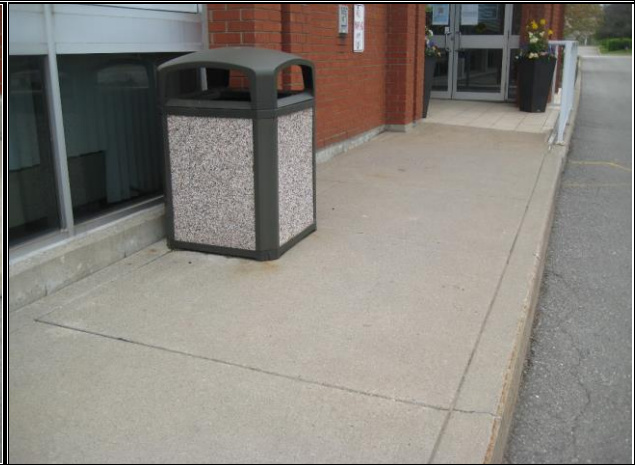
<b>Photo #127: Asphalt Ramp</b>	<b>Photo #128: Sidewalk Width reduced by Garbage Can</b>
