August 29, 2025

**Re: Enbridge Gas Inc. ("Enbridge Gas")  
Ontario Energy Board ("OEB") File No.: EB-2022-0248  
Mohawks of the Bay of Quinte and Shannonville Community Expansion  
Project ("Project")**

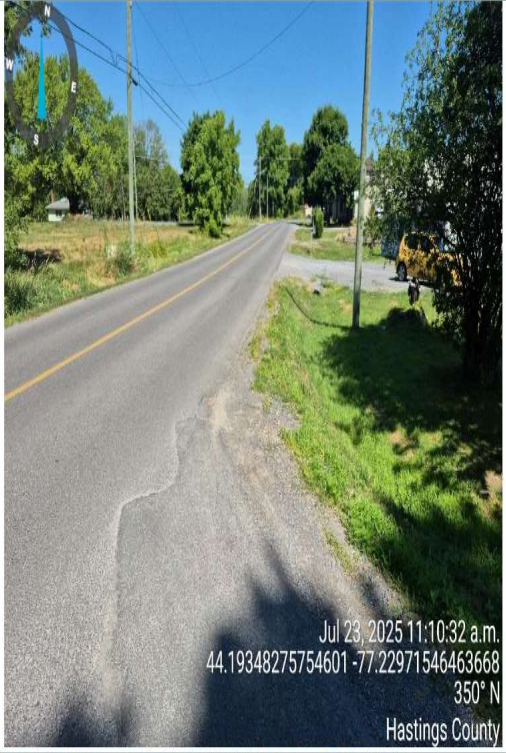
| ID # | Location | Site Condition | Additional Work Recommended (Y/N) | Comments/Recommendations | Representative Photo (July 23, 2025) |
|---|---|---|---|---|---|
| 1 | Intersection of Beach Road and Yonge Street | Road/ asphalt in good condition. | N | No issues to report at time of inspection. | |

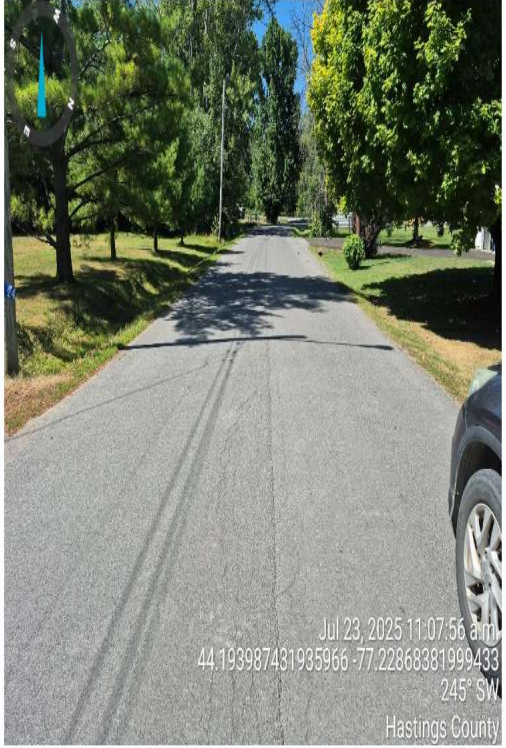
| ID # | Location | Site Condition | Additional Work Recommended (Y/N) | Comments/Recommendations | Representative Photo (July 23, 2025) |
|---|---|---|---|---|---|
| 2 | 23 Young Street | Asphalt has been replaced; roadside is revegetated. | N | No issues to report at time of inspection. | |

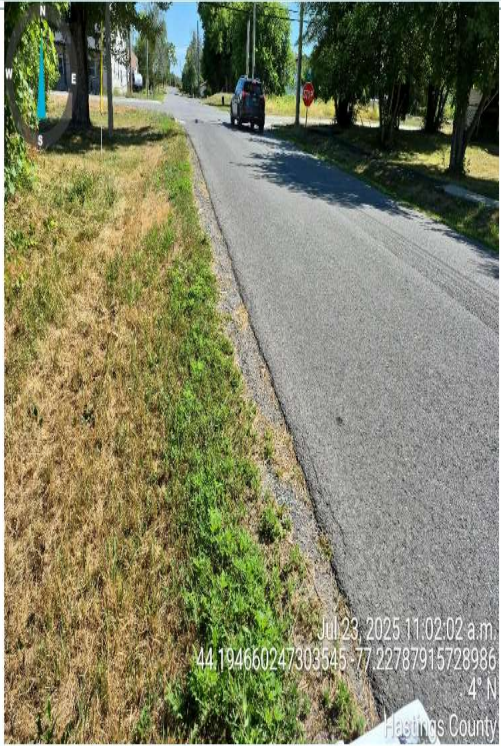
| ID # | Location | Site Condition | Additional Work Recommended (Y/N) | Comments/Recommendations | Representative Photo (July 23, 2025) |
|---|---|---|---|---|---|
| 3 | Intersection of Young Street and York Road (north side) | Road /asphalt is in good condition. Area restored to pre-construction conditions. | N | No issues to report at time of inspection. | <p>Jul 23, 2025 11:02:02 a.m.<br/>44.194660247303545 -77.22787915728986<br/>4° N<br/>Hastings County</p> |

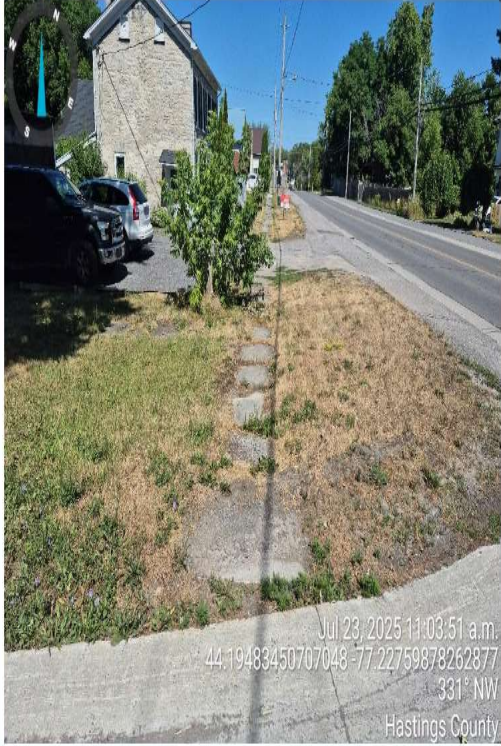
| ID # | Location | Site Condition | Additional Work Recommended (Y/N) | Comments/Recommendations | Representative Photo (July 23, 2025) |
|---|---|---|---|---|---|
| 4 | Intersection of Young Street and York Road (south side) | Some areas of dry grass due to weather conditions. Area restored to pre-construction conditions. | N | No issues to report at time of inspection. | <p>Jul 23, 2025 11:03:51 a.m.<br/>44.19483450707048 -77.22759878262877<br/>331° NW<br/>Hastings County</p> |

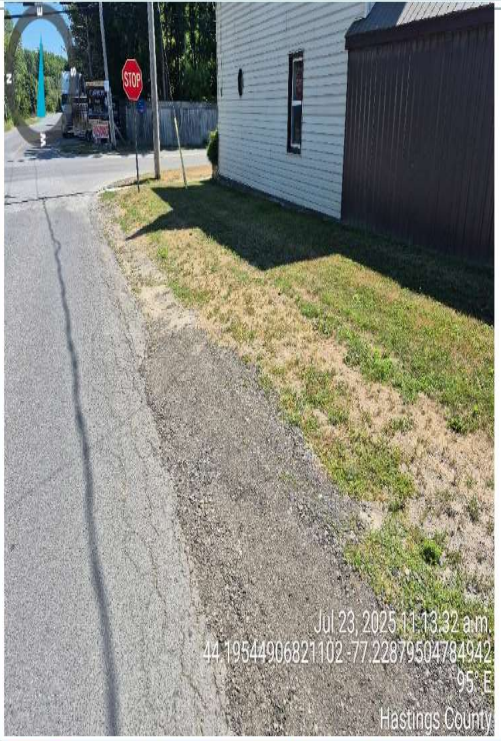
| ID # | Location | Site Condition | Additional Work Recommended (Y/N) | Comments/Recommendations | Representative Photo (July 23, 2025) |
|---|---|---|---|---|---|
| 5 | Intersection of Queen Street and York Road | Some areas of dry grass due to weather conditions. Area restored to pre-construction conditions. | N | No issues to report at time of inspection. | <p>Jul 23, 2025 11:13:32 a.m.<br/>44° 19' 54.4906821102 - 77° 22' 87.9504784942<br/>95° E<br/>Hastings County</p> |

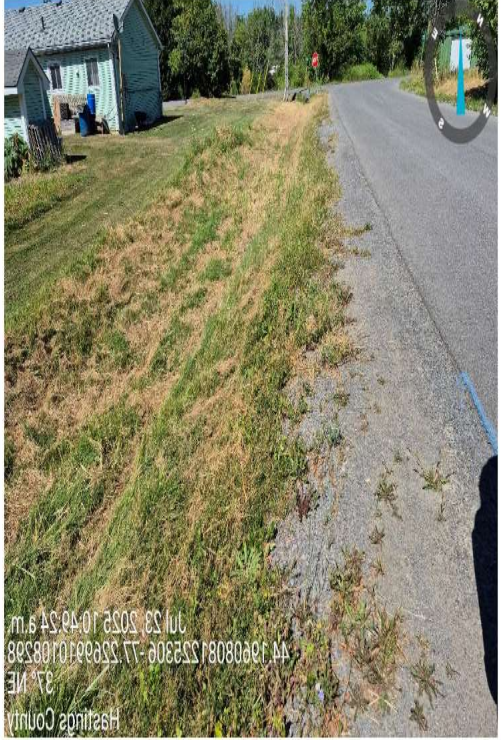
| ID # | Location | Site Condition | Additional Work Recommended (Y/N) | Comments/Recommendations | Representative Photo (July 23, 2025) |
|---|---|---|---|---|---|
| 6 | Gore Street between Young Street and Queen Street | Road/ asphalt in good condition. Some areas of dry grass due to weather conditions. Area restored to pre-construction conditions. | N | No issues to report at time of inspection. | <p>Jul 23, 2025 10:58:54 a.m.<br/>44° 19' 54.4906821102 - 77° 22' 87.9504784942<br/>95° E<br/>Hastings County</p> |

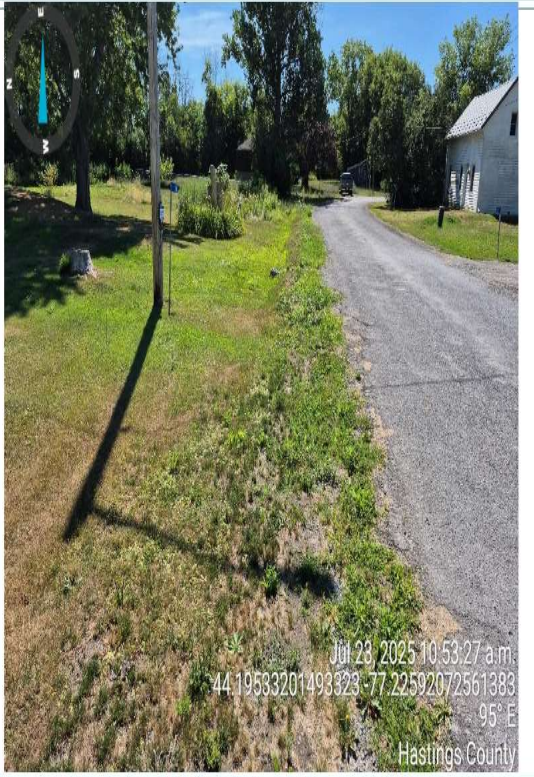
| ID # | Location | Site Condition | Additional Work Recommended (Y/N) | Comments/Recommendations | Representative Photo (July 23, 2025) |
|---|---|---|---|---|---|
| 7 | 13 Gore Street | Road/ asphalt in good condition. Area restored to pre-construction conditions. | N | No issues to report at time of inspection. | <p>Jul 23, 2025 10:53:27 a.m.<br/>44.19533201493323 -77.22592072561383<br/>95° E<br/>Hastings County</p> |

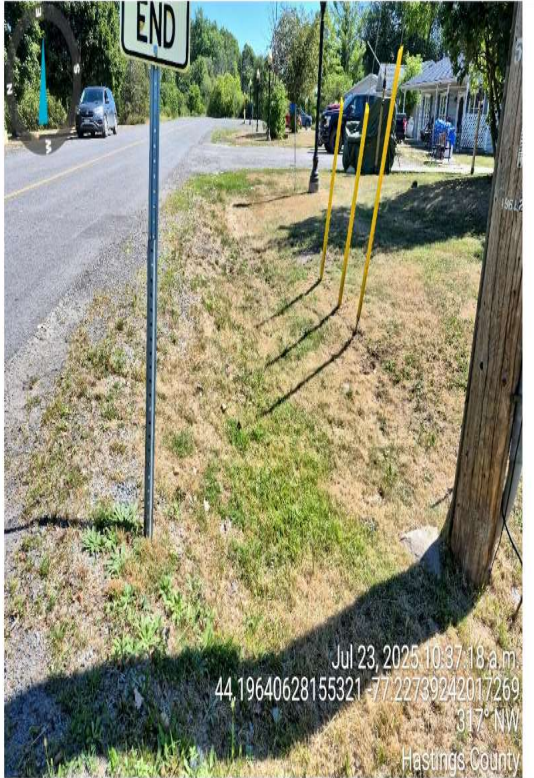
| ID # | Location | Site Condition | Additional Work Recommended (Y/N) | Comments/Recommendations | Representative Photo (July 23, 2025) |
|---|---|---|---|---|---|
| 8 | 5 Atsia Court | Road/ asphalt in good condition. Some areas of dry grass due to weather conditions. Area restored to pre-construction conditions. | N | No issues to report at time of inspection. | <p>Jul 23, 2025 10:37:18 a.m.<br/>44.19640628155321 -77.22739242017269<br/>317° NW<br/>Hastings County</p> |

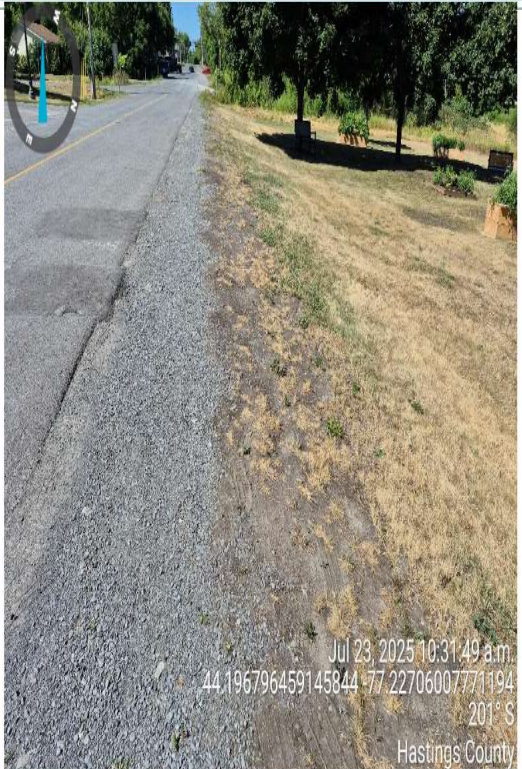
| ID # | Location | Site Condition | Additional Work Recommended (Y/N) | Comments/Recommendations | Representative Photo (July 23, 2025) |
|---|---|---|---|---|---|
| 9 | Atsia Court (north side) | Road/asphalt in good condition. Some areas of bare soil and dry vegetation due to weather conditions. | N | No issues to report at time of inspection. | <p>Jul 23, 2025 10:31:49 a.m.<br/>44.196796459145844 -77.22706007771194<br/>201° S<br/>Hastings County</p> |

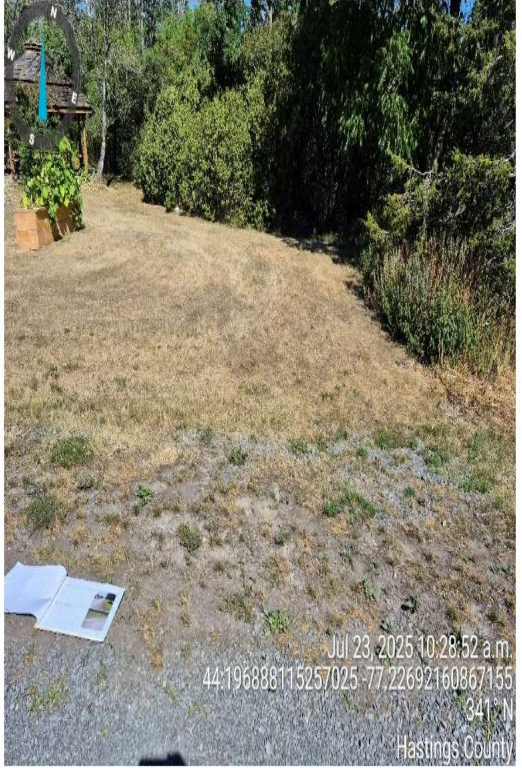
| ID # | Location | Site Condition | Additional Work Recommended (Y/N) | Comments/Recommendations | Representative Photo (July 23, 2025) |
|---|---|---|---|---|---|
| 10 | Atsia Court (north side) before roundabout | Road/asphalt in good condition. Area restored to pre-construction conditions. | N | No issues to report at time of inspection. | <p>Jul 23, 2025 10:28:52 a.m.<br/>44.196888115257025 -77.22692160867155<br/>341° N<br/>Hastings County</p> |

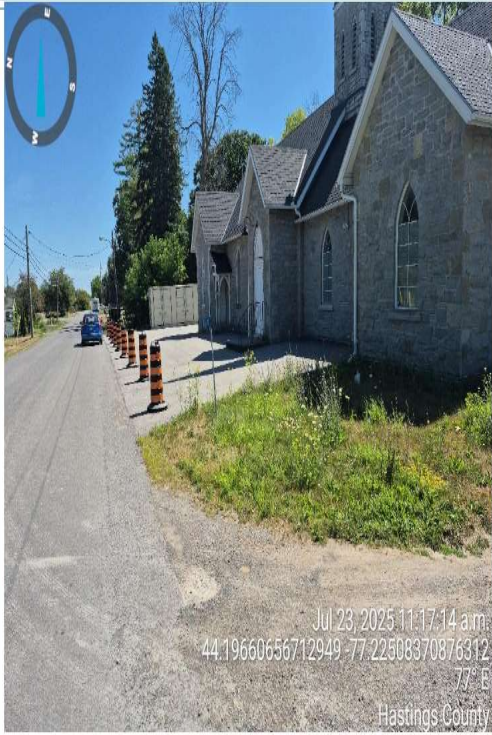
| ID # | Location | Site Condition | Additional Work Recommended (Y/N) | Comments/Recommendations | Representative Photo (July 23, 2025) |
|---|---|---|---|---|---|
| 11 | 104 Young Street | Road/asphalt in good condition. Area restored to pre-construction conditions. | N | No issues to report at time of inspection. | <p>Jul 23, 2025 11:17:14 a.m.<br/>44 19660656712949 -77-22508370876312<br/>77° E<br/>Hastings County</p> |

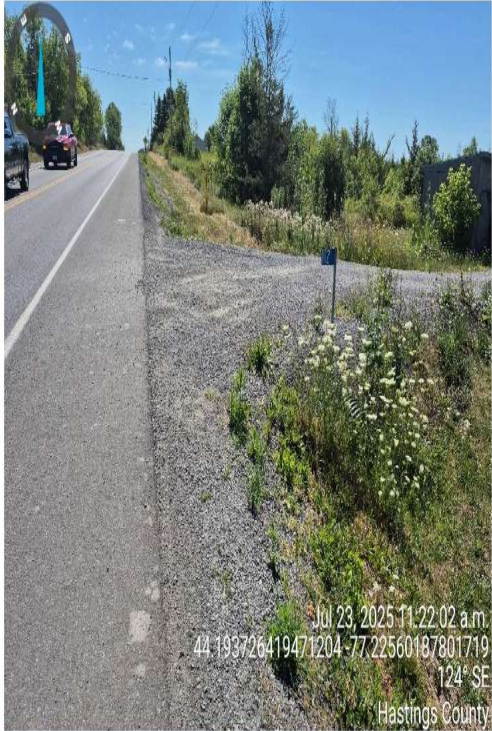
| ID # | Location | Site Condition | Additional Work Recommended (Y/N) | Comments/Recommendations | Representative Photo (July 23, 2025) |
|---|---|---|---|---|---|
| 12 | 112 York Road | Road is in good condition; ROW is gravelled with some vegetation. Area restored to pre-construction conditions. | N | No issues to report at time of inspection. | <p>Jul 23, 2025 11:22:02 a.m.<br/>44 193726419471204 -77-22560187801719<br/>124° SE<br/>Hastings County</p> |

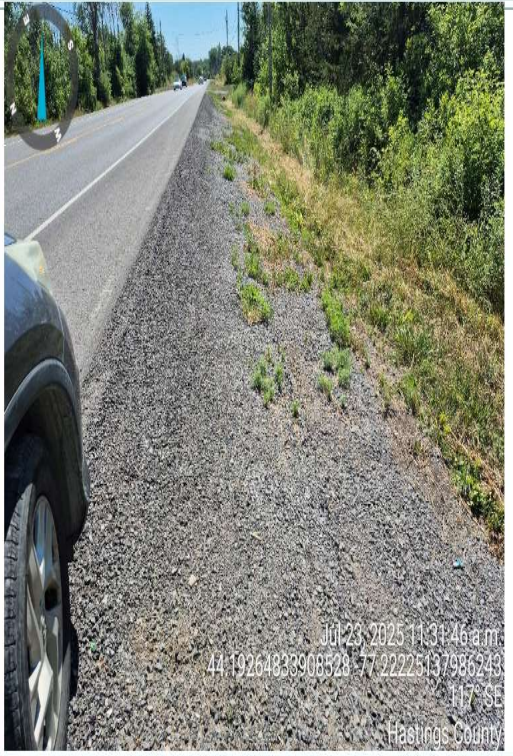
| ID # | Location | Site Condition | Additional Work Recommended (Y/N) | Comments/Recommendations | Representative Photo (July 23, 2025) |
|---|---|---|---|---|---|
| 13 | 192 York Road | Area restored to pre-construction conditions. | N | No issues to report at time of inspection. | <p>Jul 23, 2025 11:34:46 a.m.<br/>44.19264833908528 -77.22225137986243<br/>117° SE<br/>Hastings County</p> |

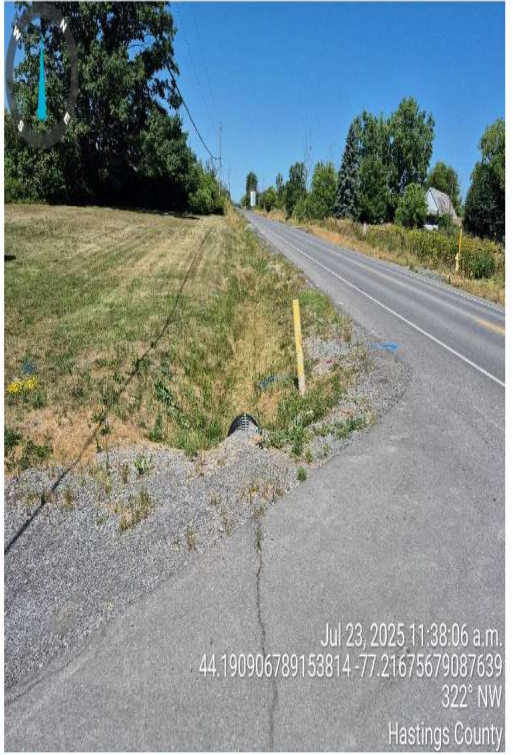
| ID # | Location | Site Condition | Additional Work Recommended (Y/N) | Comments/Recommendations | Representative Photo (July 23, 2025) |
|---|---|---|---|---|---|
| 14 | 266 York Road | Area restored to pre-construction conditions. | N | No issues to report at time of inspection. | <p>Jul 23, 2025 11:38:06 a.m.<br/>44.190906789153814 -77.21675679087639<br/>322° NW<br/>Hastings County</p> |

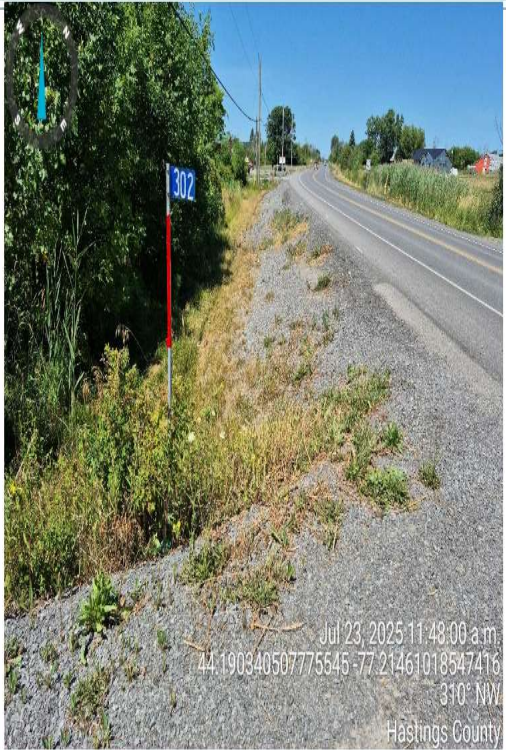
| ID # | Location | Site Condition | Additional Work Recommended (Y/N) | Comments/Recommendations | Representative Photo (July 23, 2025) |
|---|---|---|---|---|---|
| 15 | 302 York Road | Area restored to pre-construction conditions. | N | No issues to report at time of inspection. | |

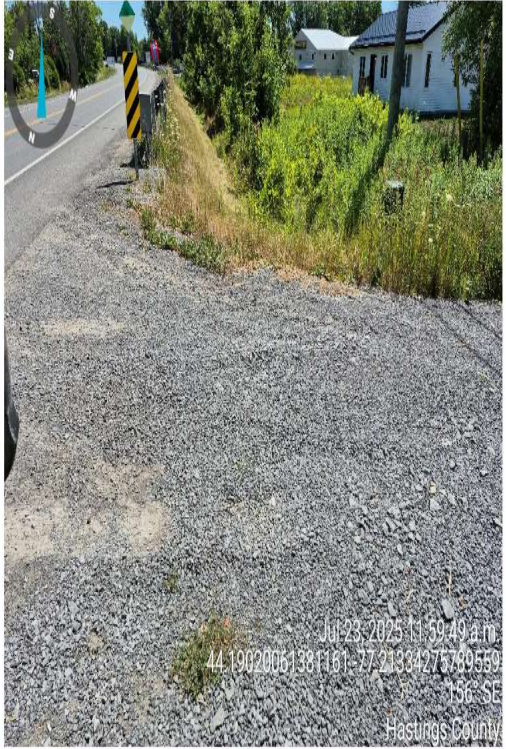
| ID # | Location | Site Condition | Additional Work Recommended (Y/N) | Comments/Recommendations | Representative Photo (July 23, 2025) |
|---|---|---|---|---|---|
| 16 | 329 York Road | Area restored to pre-construction conditions. | N | No issues to report at time of inspection. | |

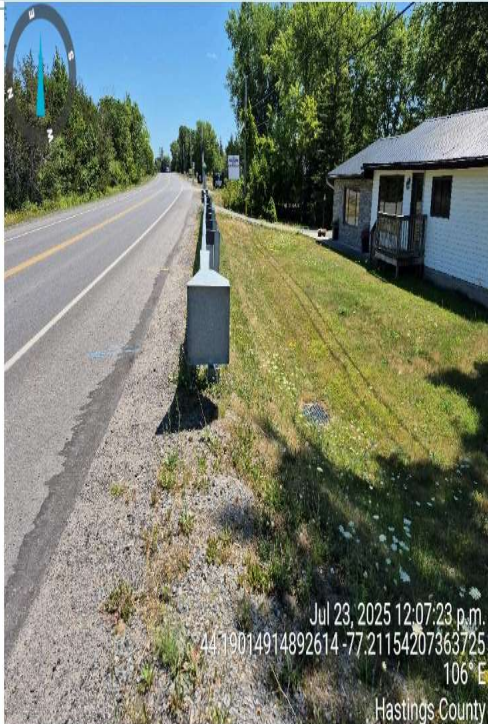
| ID # | Location | Site Condition | Additional Work Recommended (Y/N) | Comments/Recommendations | Representative Photo (July 23, 2025) |
|---|---|---|---|---|---|
| 17 | 346 York Road | Road is in good condition; ROW is gravelled with manicured lawn behind the guardrail. Area restored to pre-construction conditions. | N | No issues to report at time of inspection. | <p>Jul 23, 2025 12:07:23 p.m.<br/>44.19014914892614 -77.21154207363725<br/>106° E<br/>Hastings County</p> |

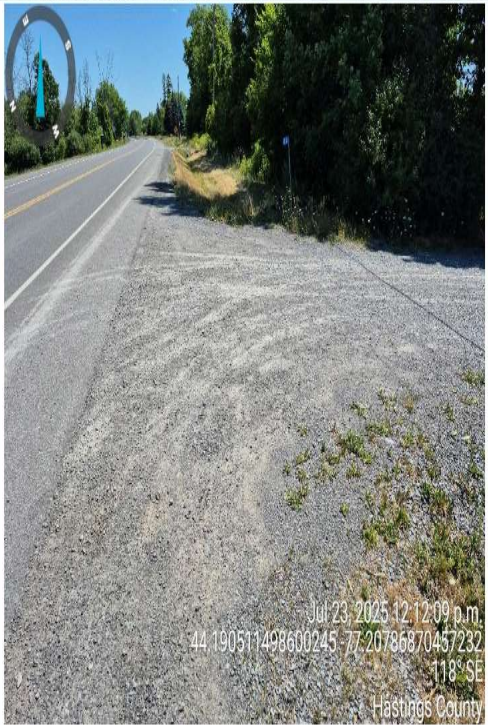
| ID # | Location | Site Condition | Additional Work Recommended (Y/N) | Comments/Recommendations | Representative Photo (July 23, 2025) |
|---|---|---|---|---|---|
| 18 | 414 York Road | Area restored to pre-construction conditions. | N | No issues to report at time of inspection. | <p>Jul 23, 2025 12:12:09 p.m.<br/>44.190511498600245 -77.20786870437232<br/>118° SE<br/>Hastings County</p> |

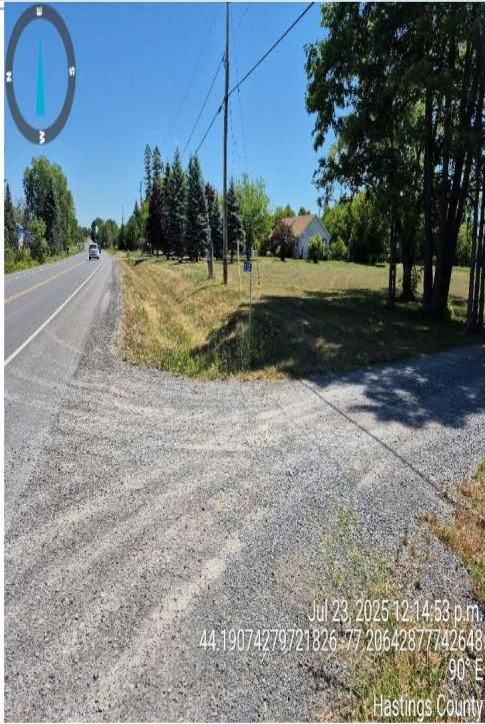
| ID # | Location | Site Condition | Additional Work Recommended (Y/N) | Comments/Recommendations | Representative Photo (July 23, 2025) |
|---|---|---|---|---|---|
| 19 | 438 York Road | Area restored to pre-construction conditions. | N | No issues to report at time of inspection. | <p>Jul 23, 2025 12:14:53 p.m.<br/>44-19074279721826-77-20642877742648<br/>90° E<br/>Hastings County</p> |

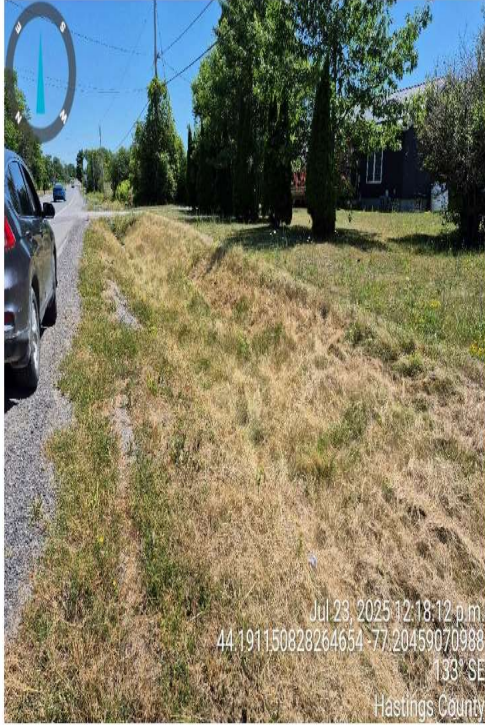
| ID # | Location | Site Condition | Additional Work Recommended (Y/N) | Comments/Recommendations | Representative Photo (July 23, 2025) |
|---|---|---|---|---|---|
| 20 | 474 York Road | Dry grass present due to weather conditions. Area restored to pre-construction conditions. | N | No issues to report at time of inspection. | <p>Jul 23, 2025 12:18:12 p.m.<br/>44-191150828264654-77-20459070988<br/>133° SE<br/>Hastings County</p> |

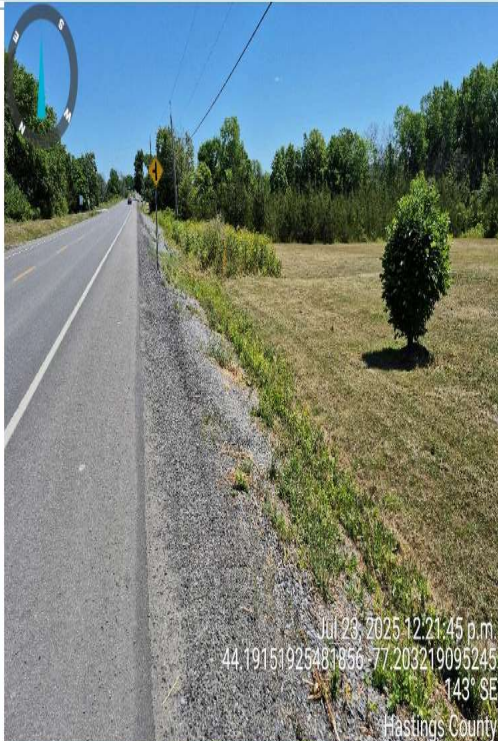
| ID # | Location | Site Condition | Additional Work Recommended (Y/N) | Comments/Recommendations | Representative Photo (July 23, 2025) |
|---|---|---|---|---|---|
| 21 | 490 York Road | Road/ ROW asphalt in good condition. Area restored to pre-construction conditions. | N | No issues to report at time of inspection. | <p>Jul 23, 2025 12:21:45 p.m.<br/>44.19151925481856 -77.203219095245<br/>143° SE<br/>Hastings County</p> |

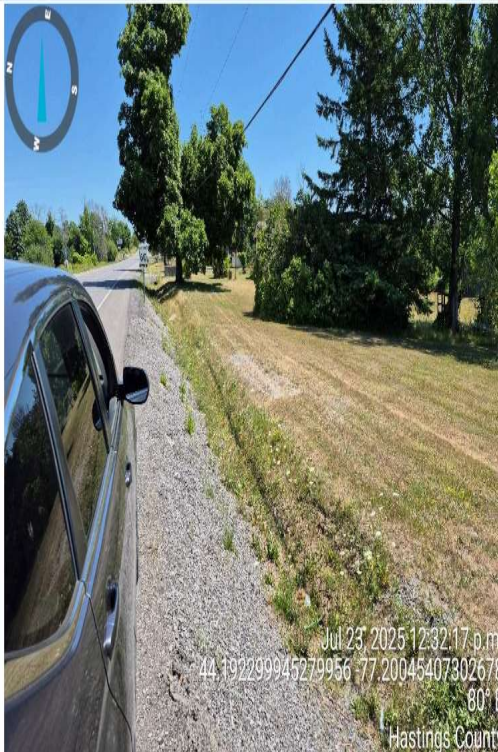
| ID # | Location | Site Condition | Additional Work Recommended (Y/N) | Comments/Recommendations | Representative Photo (July 23, 2025) |
|---|---|---|---|---|---|
| 22 | 538 York Road | ROW is gravelled and in good condition. Previous area of exposed soil is starting to revegetate. | Y | Apply topsoil and reseed as needed. | <p>Jul 23, 2025 12:32:17 p.m.<br/>44.192299945279956 -77.20045407302678<br/>80° E<br/>Hastings County</p> |

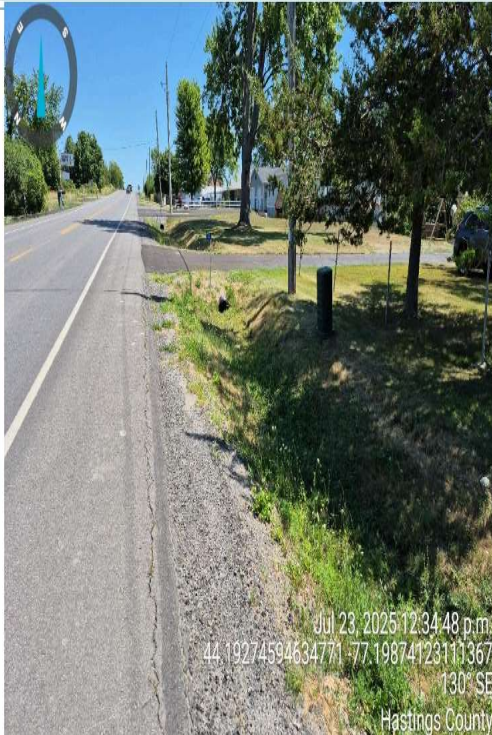
| ID # | Location | Site Condition | Additional Work Recommended (Y/N) | Comments/Recommendations | Representative Photo (July 23, 2025) |
|---|---|---|---|---|---|
| 23 | 572 York Road | Area restored to pre-construction conditions. | N | No issues to report at time of inspection. | <p>Jul 23, 2025 12:34:48 p.m.<br/>44.19274594634771 -77.19874123113367<br/>130° SE<br/>Hastings County</p> |

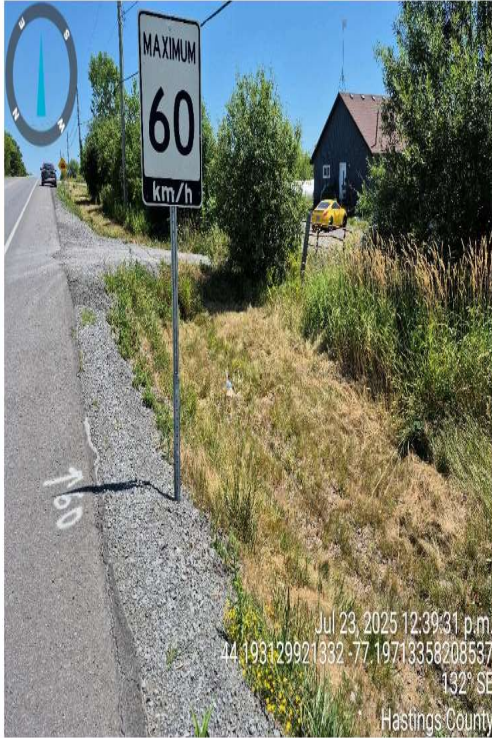
| ID # | Location | Site Condition | Additional Work Recommended (Y/N) | Comments/Recommendations | Representative Photo (July 23, 2025) |
|---|---|---|---|---|---|
| 24 | 588 York Road | Area restored to pre-construction conditions. | N | No issues to report at time of inspection. | <p>Jul 23, 2025 12:39:31 p.m.<br/>44.198129921332 -77.19713358208537<br/>132° SE<br/>Hastings County</p> |

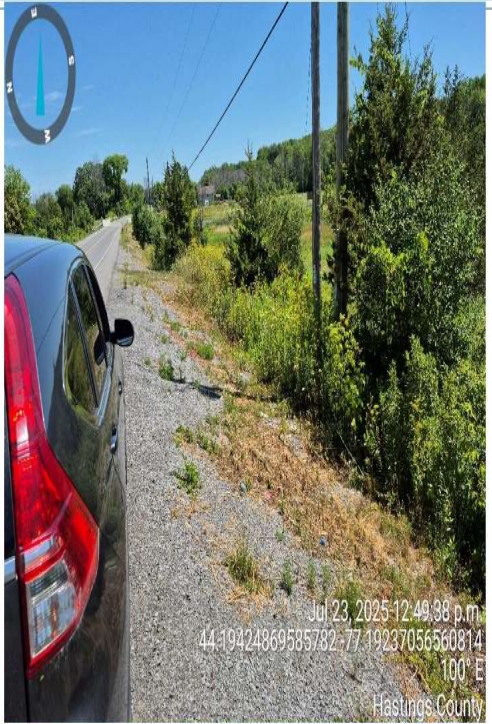
| ID # | Location | Site Condition | Additional Work Recommended (Y/N) | Comments/Recommendations | Representative Photo (July 23, 2025) |
|---|---|---|---|---|---|
| 27 | Across from 683 York Road | Area restored to pre-construction conditions. | N | No issues to report at time of inspection. | |

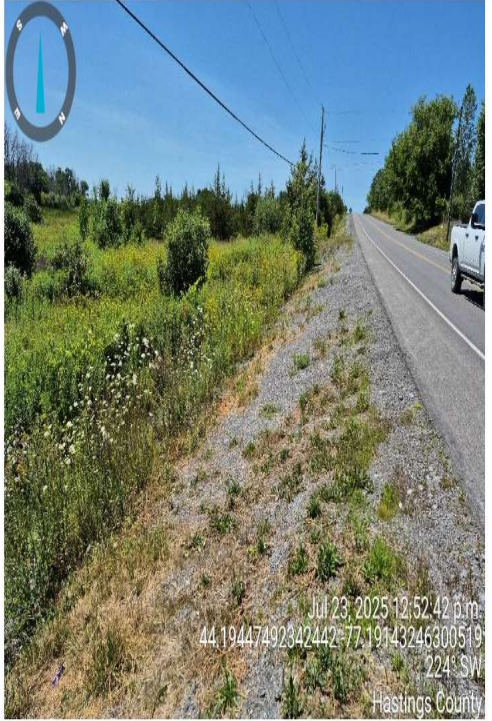
| ID # | Location | Site Condition | Additional Work Recommended (Y/N) | Comments/Recommendations | Representative Photo (July 23, 2025) |
|---|---|---|---|---|---|
| 28 | West of bridge at Marysville Creek | ROW and location of TWS is gravelled with some vegetation beginning to grow at roadside. Area restored to pre-construction conditions. | N | No issues to report at time of inspection. | |

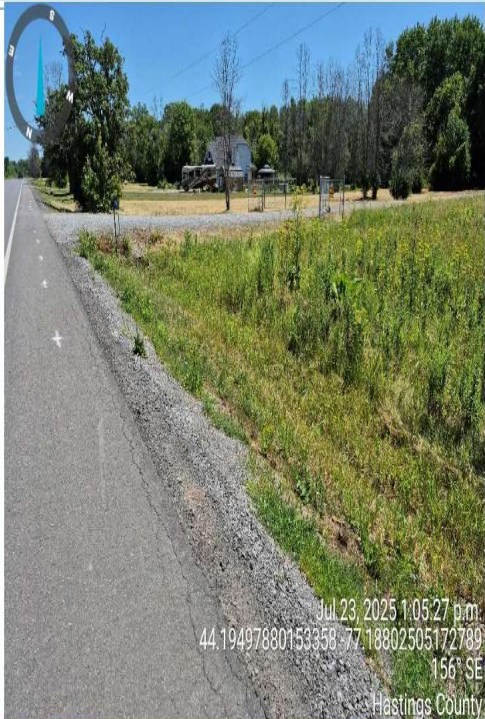
| ID # | Location | Site Condition | Additional Work Recommended (Y/N) | Comments/Recommendations | Representative Photo (July 23, 2025) |
|---|---|---|---|---|---|
| 31 | 756 York Road | Road/ asphalt in good condition; ROW is gravelled, and roadside ditch is vegetated. Area restored to pre-construction conditions. | N | No issues to report at time of inspection. | <p>Jul 23, 2025 1:05:27 p.m.<br/>44.19497880153358 -77.18802505172789<br/>156° SE<br/>Hastings County</p> |

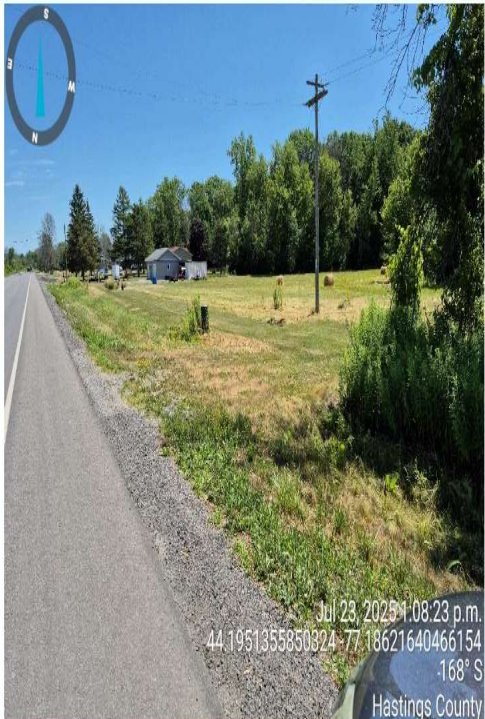
| ID # | Location | Site Condition | Additional Work Recommended (Y/N) | Comments/Recommendations | Representative Photo (July 23, 2025) |
|---|---|---|---|---|---|
| 32 | Across from 781 York Road | Area restored to pre-construction conditions. | N | No issues to report at time of inspection. | <p>Jul 23, 2025 1:08:23 p.m.<br/>44.1951355850324 -77.18621640466154<br/>168° S<br/>Hastings County</p> |

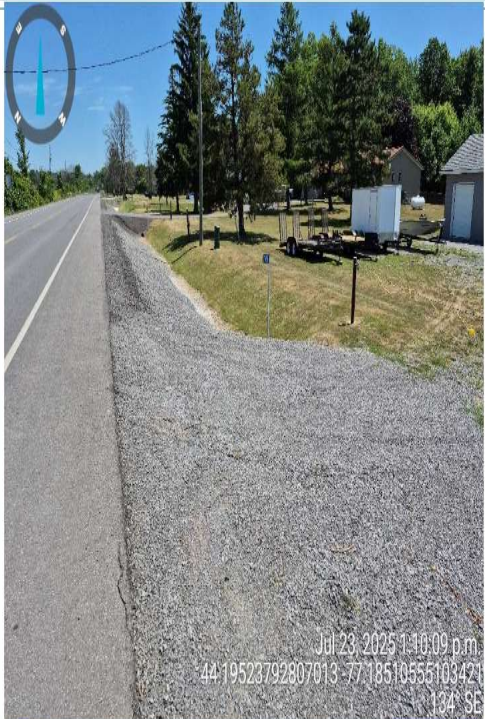
| ID # | Location | Site Condition | Additional Work Recommended (Y/N) | Comments/Recommendations | Representative Photo (July 23, 2025) |
|---|---|---|---|---|---|
| 33 | 796 York Road | Area restored to pre-construction conditions. | N | No issues to report at time of inspection. | |

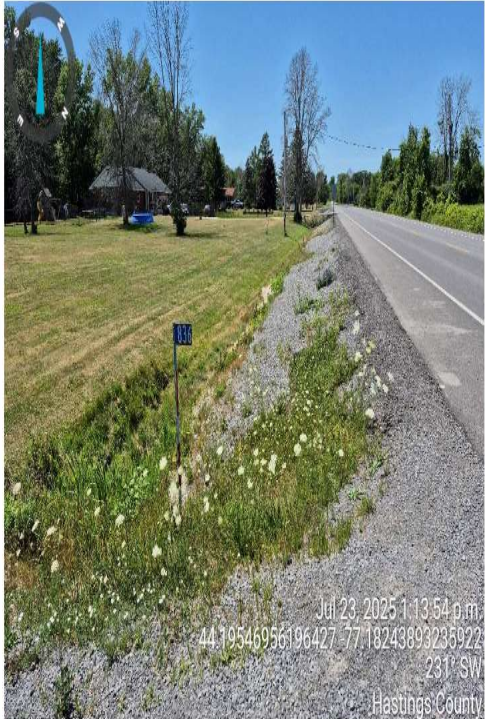
| ID # | Location | Site Condition | Additional Work Recommended (Y/N) | Comments/Recommendations | Representative Photo (July 23, 2025) |
|---|---|---|---|---|---|
| 34 | 836 York Road (west of driveway) | Road / asphalt in good condition; ROW is gravelled up to manicured lawn. Area restored to pre-construction conditions. | N | No issues to report at time of inspection. | |

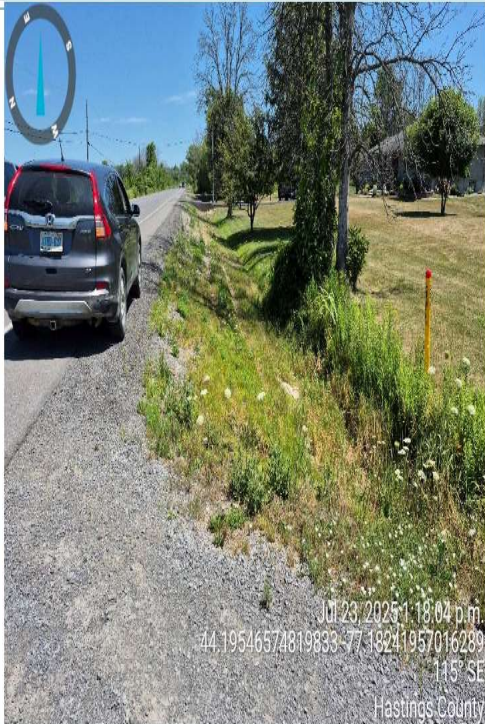
| ID # | Location | Site Condition | Additional Work Recommended (Y/N) | Comments/Recommendations | Representative Photo (July 23, 2025) |
|---|---|---|---|---|---|
| 35 | 836 York Road (east of driveway) | Road /asphalt in good condition; ROW has some vegetation. Area restored to pre-construction conditions. | N | No issues to report at time of inspection. | <p>Jul 23, 2025 1:18:04 p.m.<br/>44.19546574819833 -77.13241957016289<br/>145° SE<br/>Hastings County</p> |

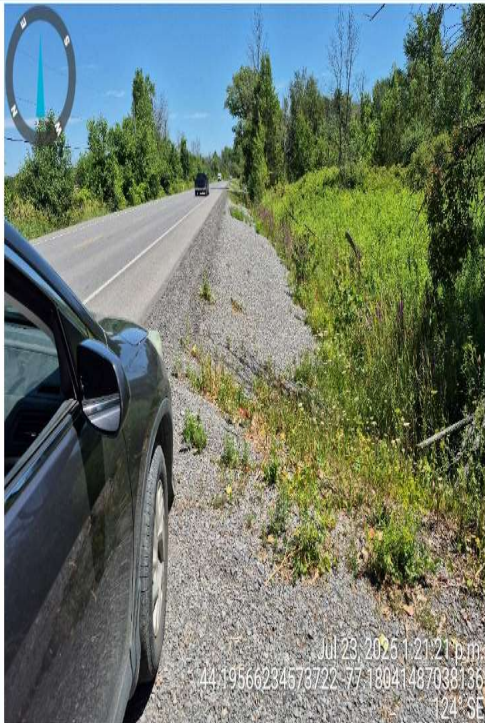
| ID # | Location | Site Condition | Additional Work Recommended (Y/N) | Comments/Recommendations | Representative Photo (July 23, 2025) |
|---|---|---|---|---|---|
| 36 | Between 860 and 888 York Road | ROW is gravelled and in good condition. Area restored to pre-construction conditions. | N | No issues to report at time of inspection. | <p>Jul 23, 2025 1:21:21 p.m.<br/>44.19566234578722 -77.13041487038136<br/>124° SE</p> |

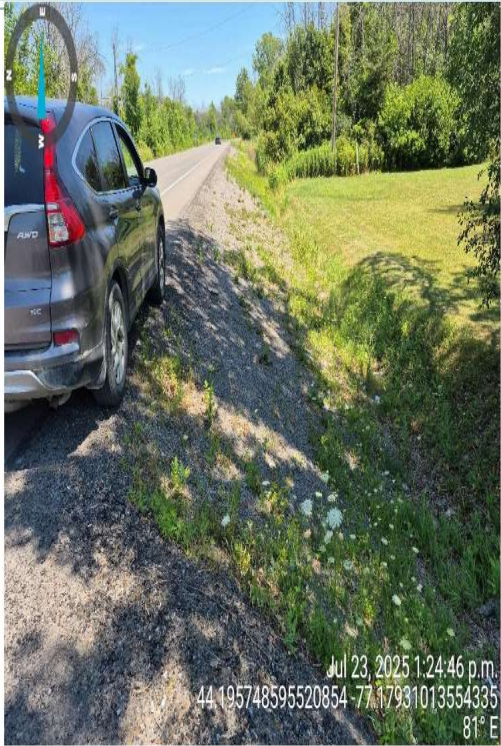
| ID # | Location | Site Condition | Additional Work Recommended (Y/N) | Comments/Recommendations | Representative Photo (July 23, 2025) |
|---|---|---|---|---|---|
| 37 | East of 888 York Road | ROW is gravelled and in good condition. Area restored to pre-construction conditions. | N | No issues to report at time of inspection. | <p>Jul 23, 2025 1:24:46 p.m.<br/>44-195748595520854-77-17931013554335<br/>81° E</p> |

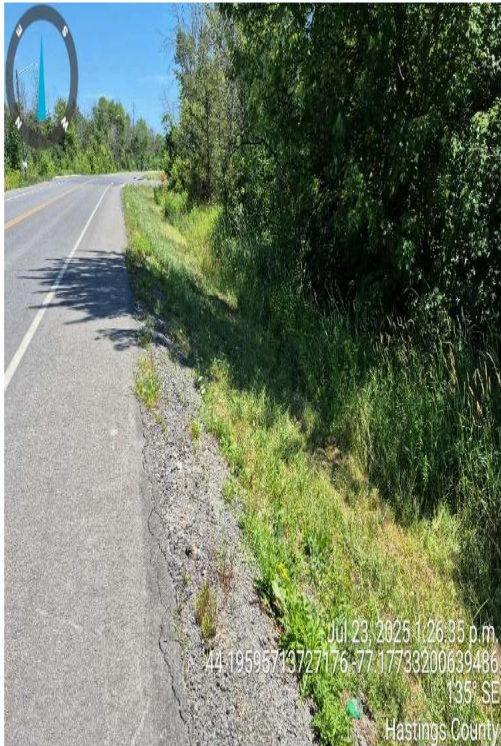
| ID # | Location | Site Condition | Additional Work Recommended (Y/N) | Comments/Recommendations | Representative Photo (July 23, 2025) |
|---|---|---|---|---|---|
| 38 | York Road, west of intersection with Norways Road | Road/ asphalt is in good condition. Area restored to pre-construction conditions. | N | No issues to report at time of inspection. | <p>Jul 23, 2025 1:26:35 p.m.<br/>44-19595713727176-77-17733200639486<br/>135° SE<br/>Hastings County</p> |

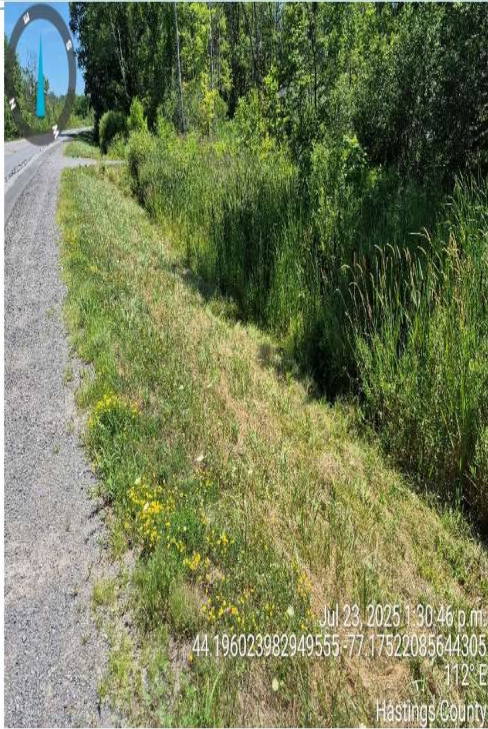
| ID # | Location | Site Condition | Additional Work Recommended (Y/N) | Comments/Recommendations | Representative Photo (July 23, 2025) |
|---|---|---|---|---|---|
| 39 | York Road, east of intersection with Norways Road | Area restored to pre-construction conditions. | N | No issues to report at time of inspection. | <p>Jul 23, 2025 1:30:46 p.m.<br/>44.196023982949555 -77.17522085644305<br/>112° E<br/>Hastings County</p> |

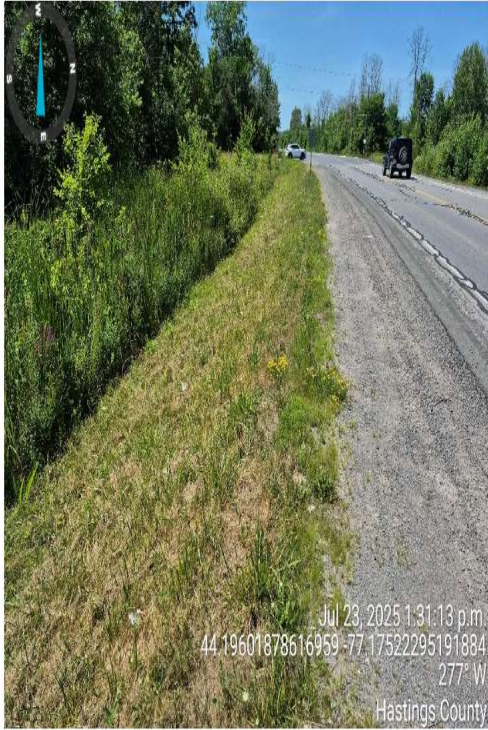
| ID # | Location | Site Condition | Additional Work Recommended (Y/N) | Comments/Recommendations | Representative Photo (July 23, 2025) |
|---|---|---|---|---|---|
| 40 | York Road, east of intersection with Norways Road | Area restored to pre-construction conditions. | N | No issues to report at time of inspection. | <p>Jul 23, 2025 1:31:13 p.m.<br/>44.19601878616959 -77.17522295191884<br/>277° W<br/>Hastings County</p> |

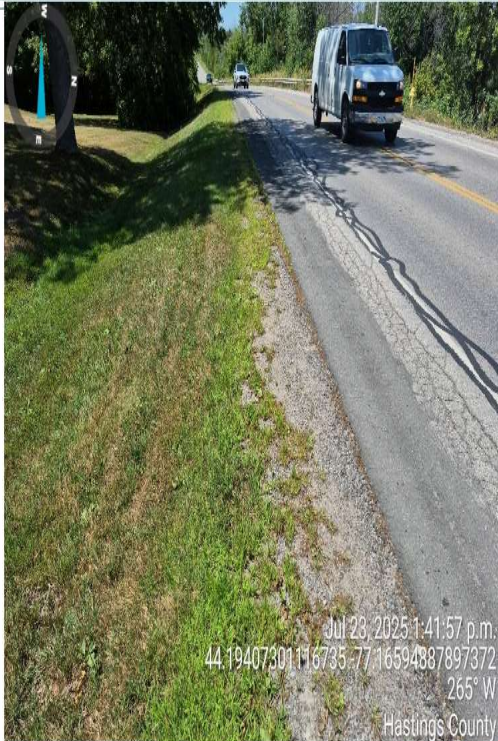
| ID # | Location | Site Condition | Additional Work Recommended (Y/N) | Comments/Recommendations | Representative Photo (July 23, 2025) |
|---|---|---|---|---|---|
| 43 | 1112 York Road | Area restored to pre-construction conditions. | N | No issues to report at time of inspection. | <p>Jul 23, 2025 1:41:57 p.m.<br/>44.19407301196735 -77.16594887897372<br/>265° W<br/>Hastings County</p> |

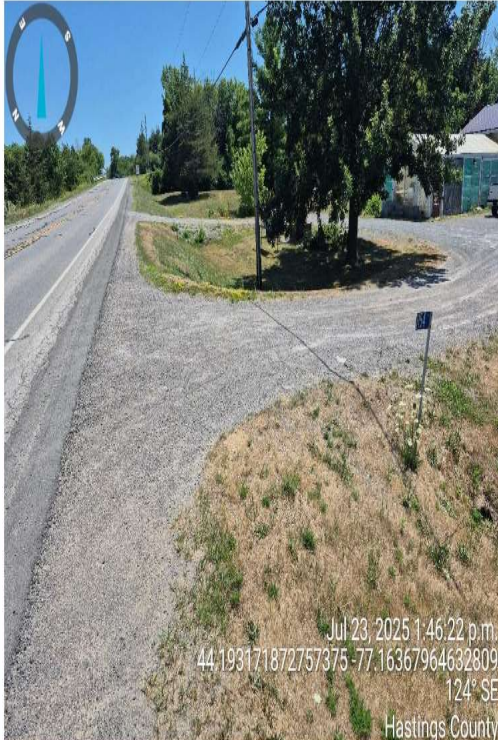
| ID # | Location | Site Condition | Additional Work Recommended (Y/N) | Comments/Recommendations | Representative Photo (July 23, 2025) |
|---|---|---|---|---|---|
| 44 | 1154 York Road | Road/ asphalt in good condition. Area restored to pre-construction conditions. | N | No issues to report at time of inspection. | <p>Jul 23, 2025 1:46:22 p.m.<br/>44.193171872757375 -77.16367964632809<br/>124° SE<br/>Hastings County</p> |

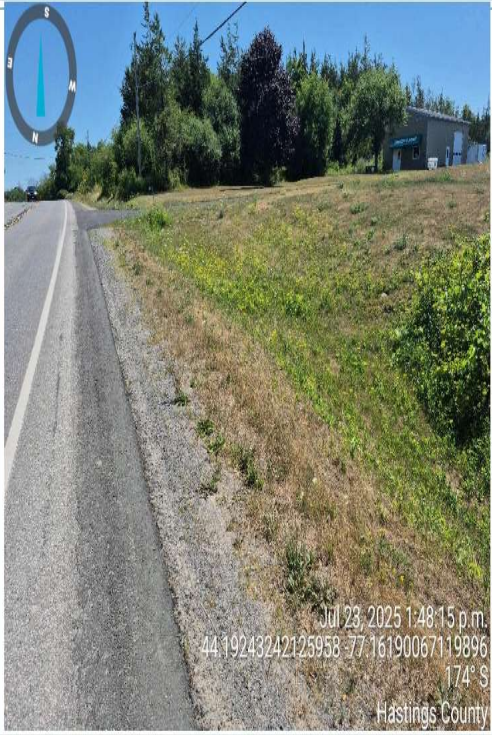
| ID # | Location | Site Condition | Additional Work Recommended (Y/N) | Comments/Recommendations | Representative Photo (July 23, 2025) |
|---|---|---|---|---|---|
| 45 | 1192 York Road | Area restored to pre-construction conditions. | N | No issues to report at time of inspection. | <p>Jul 23, 2025 1:48:15 p.m.<br/>44 19243242125958 -77 16190067119896<br/>174° S<br/>Hastings County</p> |

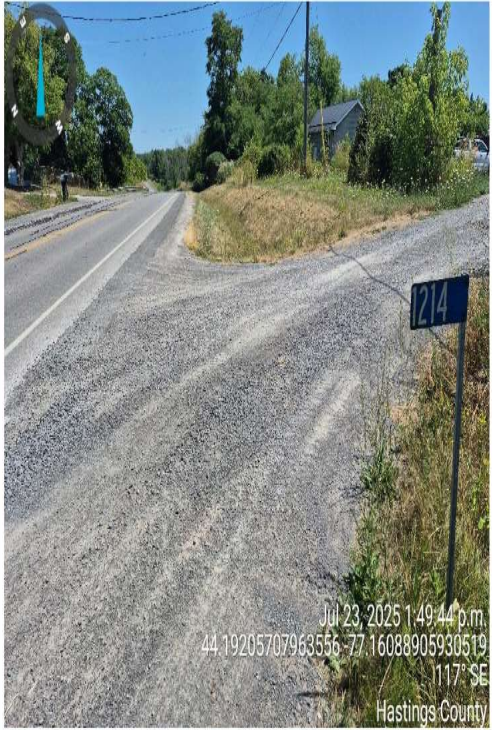
| ID # | Location | Site Condition | Additional Work Recommended (Y/N) | Comments/Recommendations | Representative Photo (July 23, 2025) |
|---|---|---|---|---|---|
| 46 | 1214 York Road | Area restored to pre-construction conditions. | N | No issues to report at time of inspection. | <p>Jul 23, 2025 1:49:44 p.m.<br/>44 19205707963556 -77 16088905930519<br/>117° SE<br/>Hastings County</p> |

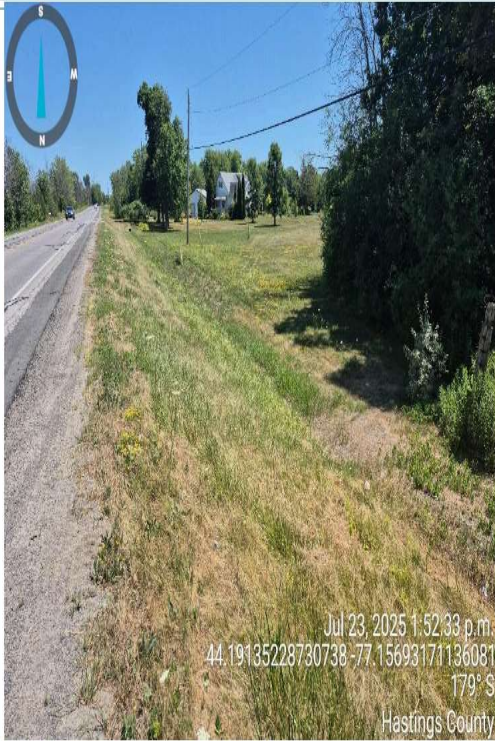
| ID # | Location | Site Condition | Additional Work Recommended (Y/N) | Comments/Recommendations | Representative Photo (July 23, 2025) |
|---|---|---|---|---|---|
| 47 | East of 1286 York Road | Area restored to pre-construction conditions. | N | No issues to report at time of inspection. | <p>Jul 23, 2025 1:52:33 p.m.<br/>44.19135228730738 -77.15693171136081<br/>179° S<br/>Hastings County</p> |

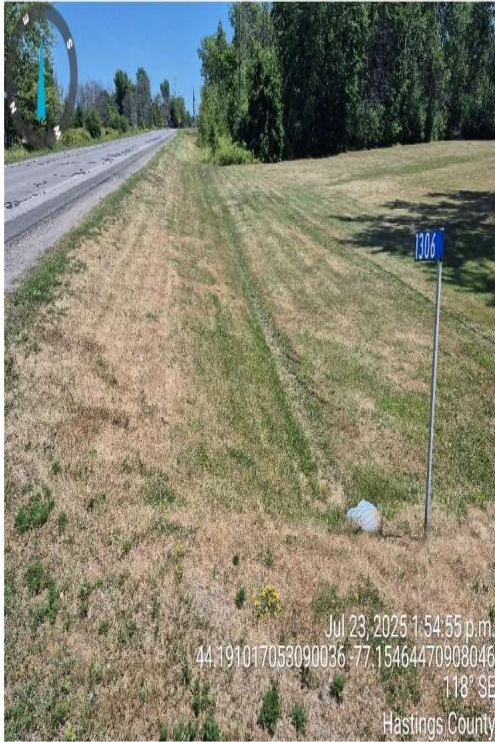
| ID # | Location | Site Condition | Additional Work Recommended (Y/N) | Comments/Recommendations | Representative Photo (July 23, 2025) |
|---|---|---|---|---|---|
| 48 | 1306 York Road | Road and ROW are in good condition. Some areas of dry vegetation due to weather conditions. | N | No issues to report at time of inspection. | <p>Jul 23, 2025 1:54:55 p.m.<br/>44.191017053090036 -77.15464470908046<br/>118° SE<br/>Hastings County</p> |

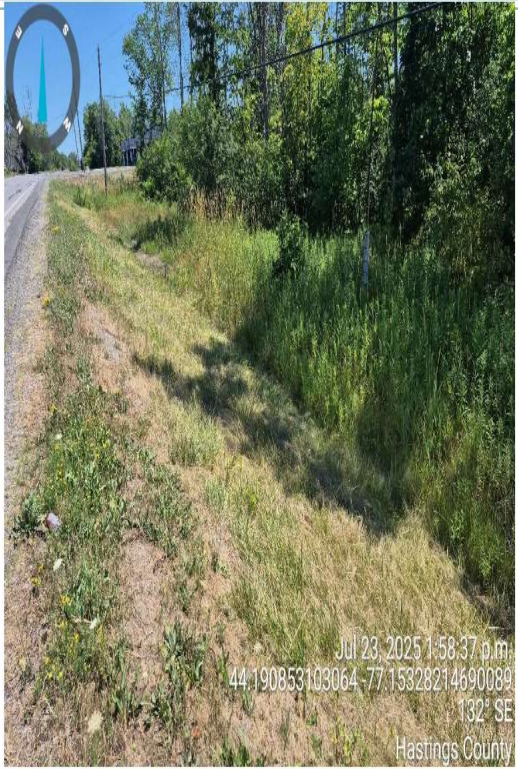
| ID # | Location | Site Condition | Additional Work Recommended (Y/N) | Comments/Recommendations | Representative Photo (July 23, 2025) |
|---|---|---|---|---|---|
| 49 | East of 1306 York Road | Roadside has revegetated; some areas of dry vegetation due to weather conditions. | N | No issues to report at time of inspection. | <p>Jul 23, 2025 1:58:37 p.m.<br/>44.190853103064 -77.15328214690089<br/>132° SE<br/>Hastings County</p> |

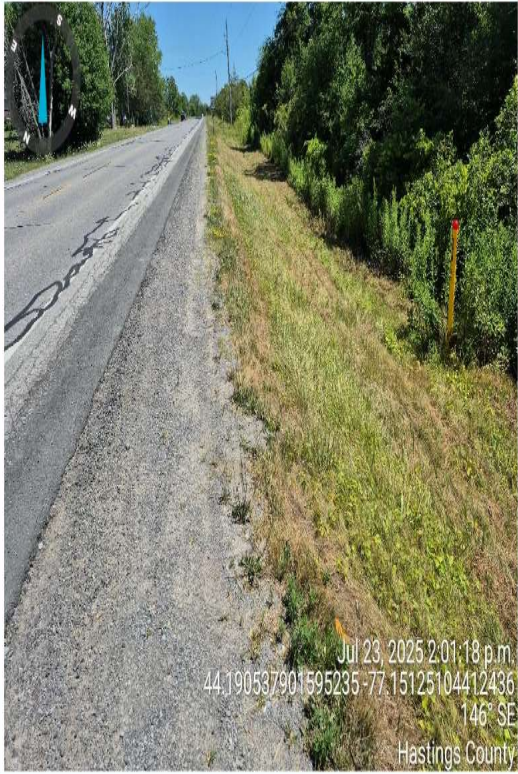
| ID # | Location | Site Condition | Additional Work Recommended (Y/N) | Comments/Recommendations | Representative Photo (July 23, 2025) |
|---|---|---|---|---|---|
| 50 | Across from 1365 York Road | Road and ROW are in good condition. Area restored to pre-construction conditions. | N | No issues to report at time of inspection. | <p>Jul 23, 2025 2:01:18 p.m.<br/>44.190537901595235 -77.15125104412436<br/>146° SE<br/>Hastings County</p> |

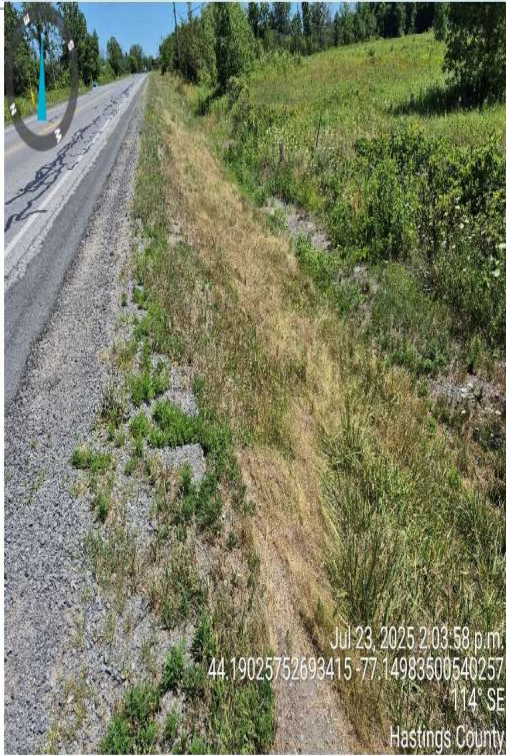
| ID # | Location | Site Condition | Additional Work Recommended (Y/N) | Comments/Recommendations | Representative Photo (July 23, 2025) |
|---|---|---|---|---|---|
| 51 | Across from 1387 York Road | Road and asphalt are in good condition. Roadside has revegetated; some dry vegetation due to weather conditions. | N | No issues to report at time of inspection. | <p>Jul 23, 2025 2:03:58 p.m.<br/>44.19025752693415 -77.14983500548257<br/>114° SE<br/>Hastings County</p> |

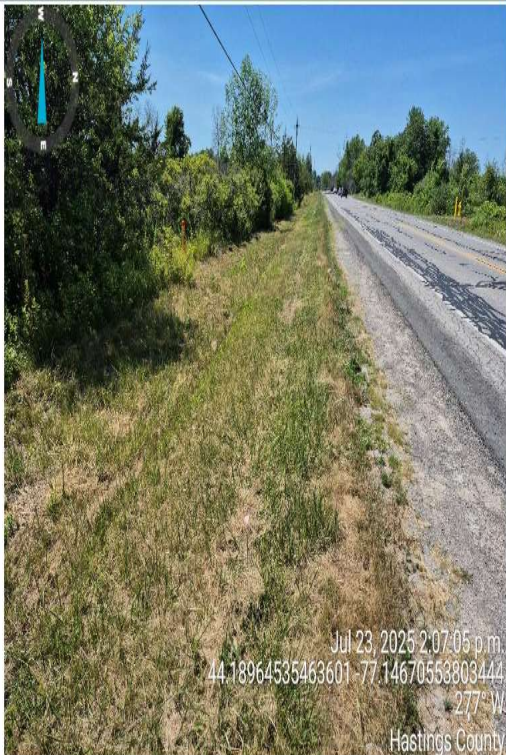
| ID # | Location | Site Condition | Additional Work Recommended (Y/N) | Comments/Recommendations | Representative Photo (July 23, 2025) |
|---|---|---|---|---|---|
| 52 | 1462 York Road | Road and ROW are in good condition. Roadside has revegetated; some dry vegetation due to weather conditions. | N | No issues to report at time of inspection. | <p>Jul 23, 2025 2:07:05 p.m.<br/>44.18964535463601 -77.14670553803444<br/>277° W<br/>Hastings County</p> |
