August 29, 2025

**Re: Enbridge Gas Inc. ("Enbridge Gas")  
Ontario Energy Board ("OEB") File No.: EB-2022-0248  
Mohawks of the Bay of Quinte and Shannonville Community Expansion  
Project ("Project")**

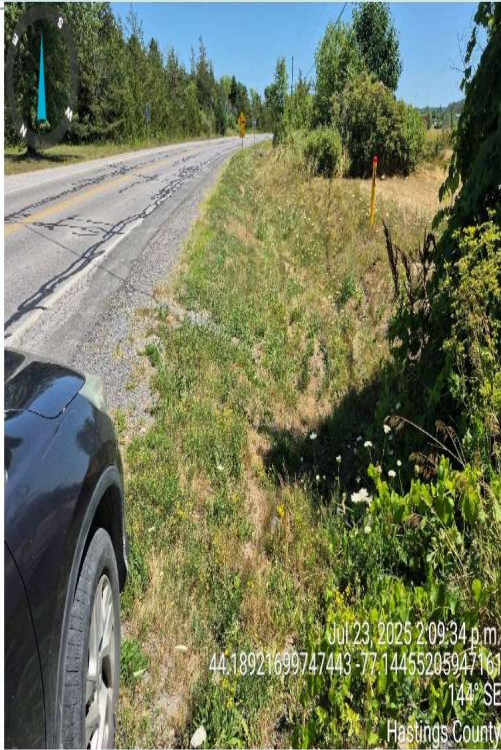
| ID # | Location | Site Condition | Additional Work Recommended (Y/N) | Comments/Recommendations | Representative Photo (July 23, 2025) |
|---|---|---|---|---|---|
| 53 | 1474 York Road | Road and ROW are in good condition. Area restored to pre-construction conditions. | N | No issues to report at time of inspection. | <p>Jul 23, 2025 2:09:34 p.m.<br/>44-18921699747443-77-14455205947161<br/>144° SE<br/>Hastings County</p> |

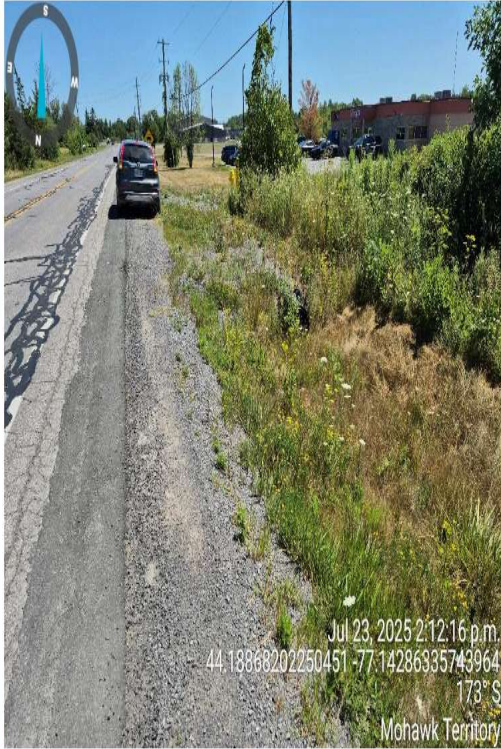
| ID # | Location | Site Condition | Additional Work Recommended (Y/N) | Comments/Recommendations | Representative Photo (July 23, 2025) |
|---|---|---|---|---|---|
| 54 | 1508 York Road | Area restored to pre-construction conditions. | N | No issues to report at time of inspection. | <p>Jul 23, 2025 2:12:16 p.m.<br/>44-18868202250451-77-14286335743964<br/>173° S<br/>Mohawk Territory</p> |

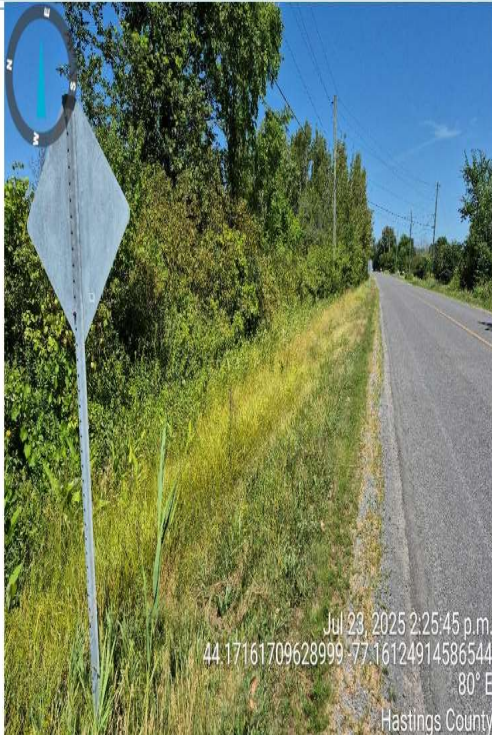
| ID # | Location | Site Condition | Additional Work Recommended (Y/N) | Comments/Recommendations | Representative Photo (July 23, 2025) |
|---|---|---|---|---|---|
| 55 | East of 830 Ridge Road | Area restored to pre-construction conditions. | N | No issues to report at time of inspection. | <p>Jul 23, 2025 2:25:45 p.m.<br/>44.17161709628999 -77.16124914586544<br/>80° E<br/>Hastings County</p> |

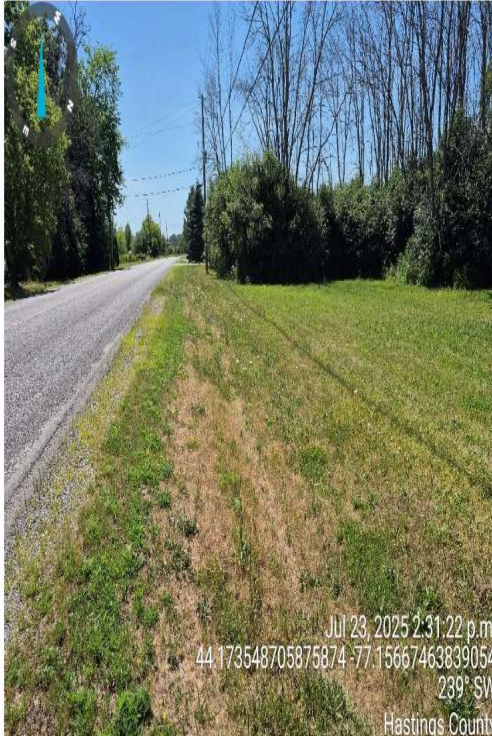
| ID # | Location | Site Condition | Additional Work Recommended (Y/N) | Comments/Recommendations | Representative Photo (July 23, 2025) |
|---|---|---|---|---|---|
| 56 | 962 Ridge Road | Road and ROW are in good condition, some dry vegetation due to weather conditions.<br>Area restored to pre-construction conditions. | N | No issues to report at time of inspection. | <p>Jul 23, 2025 2:31:22 p.m.<br/>44.173548705875874 -77.15667463839054<br/>239° SW<br/>Hastings County</p> |

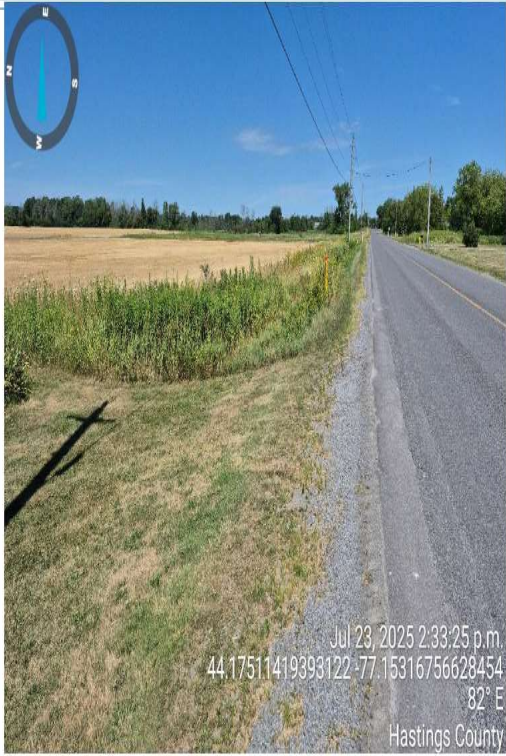
| ID # | Location | Site Condition | Additional Work Recommended (Y/N) | Comments/Recommendations | Representative Photo (July 23, 2025) |
|---|---|---|---|---|---|
| 57 | 1020 Ridge Road | Area restored to pre-construction conditions. | N | No issues to report at time of inspection. | <p>Jul 23, 2025 2:33:25 p.m.<br/>44.17511419393122 -77.15316756628454<br/>82° E<br/>Hastings County</p> |

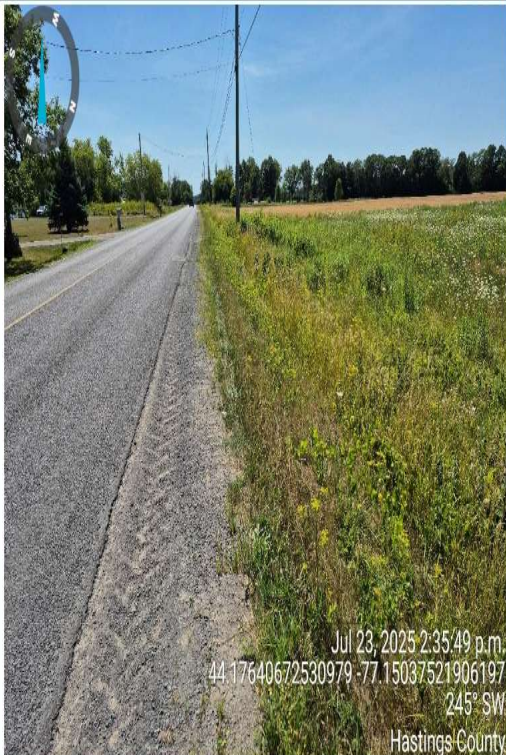
| ID # | Location | Site Condition | Additional Work Recommended (Y/N) | Comments/Recommendations | Representative Photo (July 23, 2025) |
|---|---|---|---|---|---|
| 58 | 1068 Ridge Road | Area restored to pre-construction conditions. | N | No issues to report at time of inspection. | <p>Jul 23, 2025 2:35:49 p.m.<br/>44.17640672530979 -77.15037521906197<br/>245° SW<br/>Hastings County</p> |

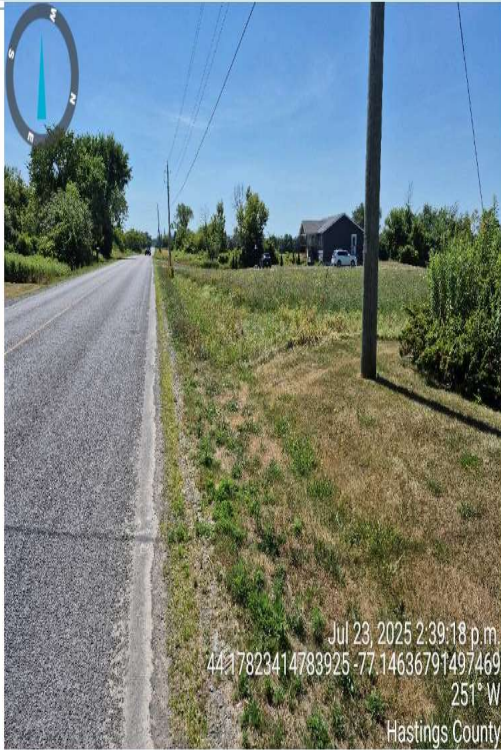
| ID # | Location | Site Condition | Additional Work Recommended (Y/N) | Comments/Recommendations | Representative Photo (July 23, 2025) |
|---|---|---|---|---|---|
| 59 | 1148 Ridge Road | Area restored to pre-construction conditions. | N | No issues to report at time of inspection. | <p>Jul 23, 2025 2:39:18 p.m.<br/>44°17'82.3414783925 -77°14'63.6791497469<br/>251° W<br/>Hastings County</p> |

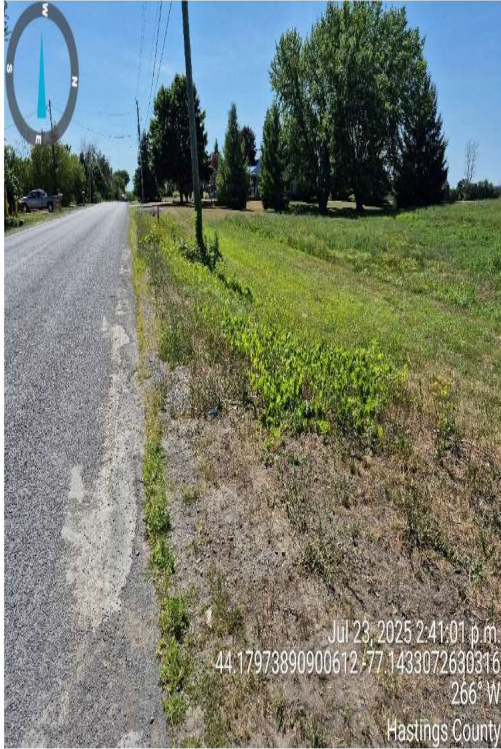
| ID # | Location | Site Condition | Additional Work Recommended (Y/N) | Comments/Recommendations | Representative Photo (July 23, 2025) |
|---|---|---|---|---|---|
| 60 | 1208 Ridge Road | Some areas of exposed soil. | Y | Reseed as needed. | <p>Jul 23, 2025 2:41:01 p.m.<br/>44°17'97.3890900612 -77°14'33.072630316<br/>266° W<br/>Hastings County</p> |

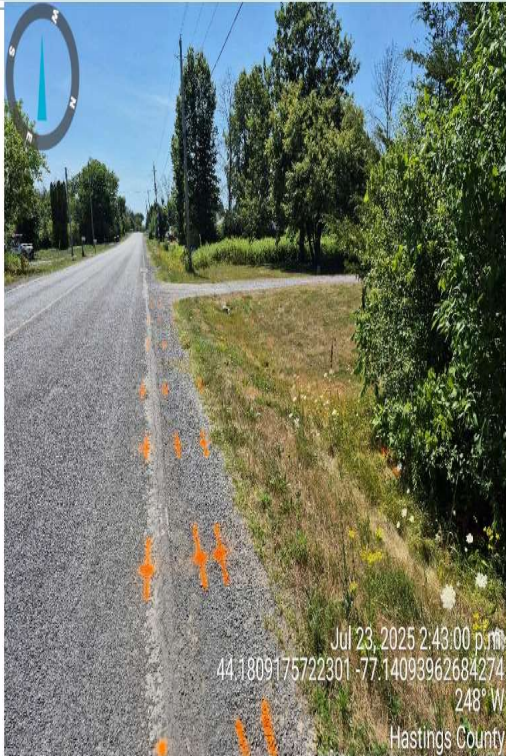
| ID # | Location | Site Condition | Additional Work Recommended (Y/N) | Comments/Recommendations | Representative Photo (July 23, 2025) |
|---|---|---|---|---|---|
| 61 | 1253 Ridge Road | Area restored to pre-construction conditions. | N | No issues to report at time of inspection. | <p>Jul 23, 2025 2:43:00 p.m.<br/>44.1809175722301 -77.14093962684274<br/>248° W<br/>Hastings County</p> |

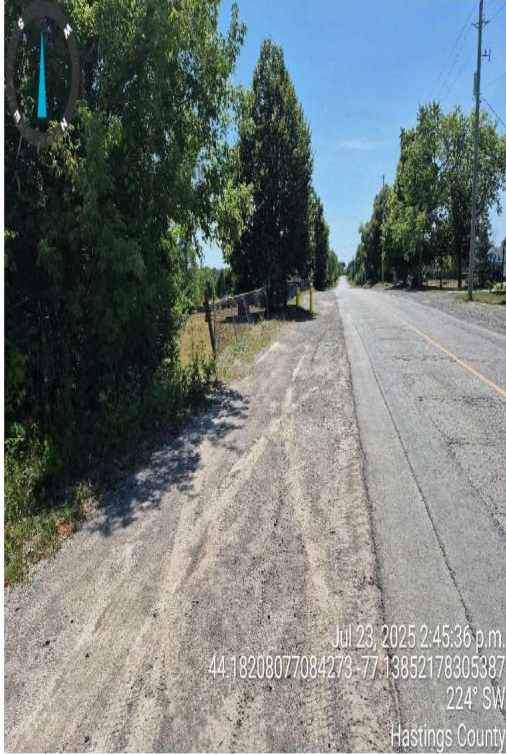
| ID # | Location | Site Condition | Additional Work Recommended (Y/N) | Comments/Recommendations | Representative Photo (July 23, 2025) |
|---|---|---|---|---|---|
| 62 | West of 1310 Ridge Road | Road and ROW are in good condition. Area restored to pre-construction conditions. | N | No issues to report at time of inspection. | <p>Jul 23, 2025 2:45:36 p.m.<br/>44.18208077084273 -77.13852178305387<br/>224° SW<br/>Hastings County</p> |

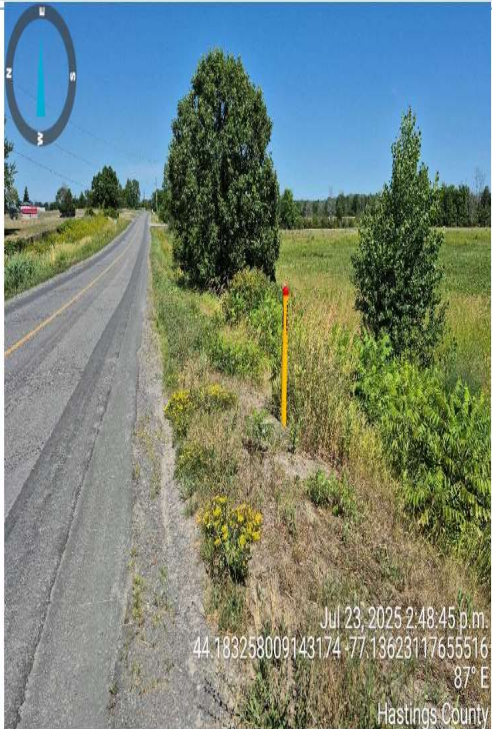
| ID # | Location | Site Condition | Additional Work Recommended (Y/N) | Comments/Recommendations | Representative Photo (July 23, 2025) |
|---|---|---|---|---|---|
| 63 | Ridge Road east of intersection with Sadies Lane | Road and ROW are in good condition. Area restored to pre-construction conditions. | N | No issues to report at time of inspection. | <p>Jul 23, 2025 2:48:45 p.m.<br/>44.183258009143174 -77.13623117655516<br/>87° E<br/>Hastings County</p> |

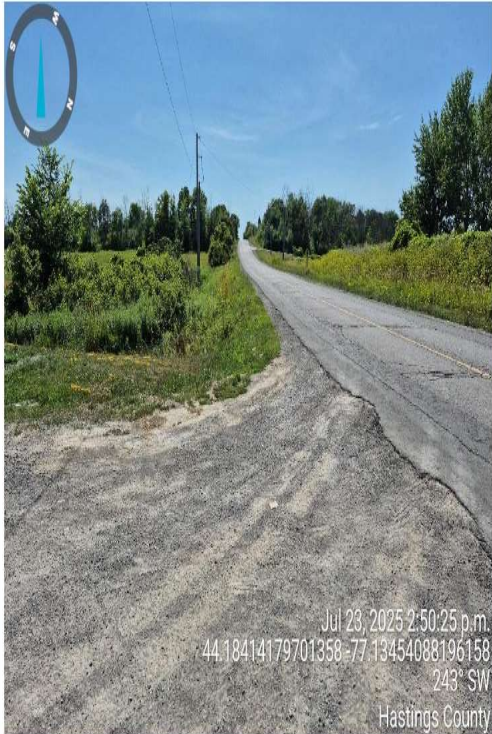
| ID # | Location | Site Condition | Additional Work Recommended (Y/N) | Comments/Recommendations | Representative Photo (July 23, 2025) |
|---|---|---|---|---|---|
| 64 | 1384 Ridge Road | Road and ROW are in good condition. Area restored to pre-construction conditions. | N | No issues to report at time of inspection. | <p>Jul 23, 2025 2:50:25 p.m.<br/>44.18414179701358 -77.13454088196158<br/>243° SW<br/>Hastings County</p> |

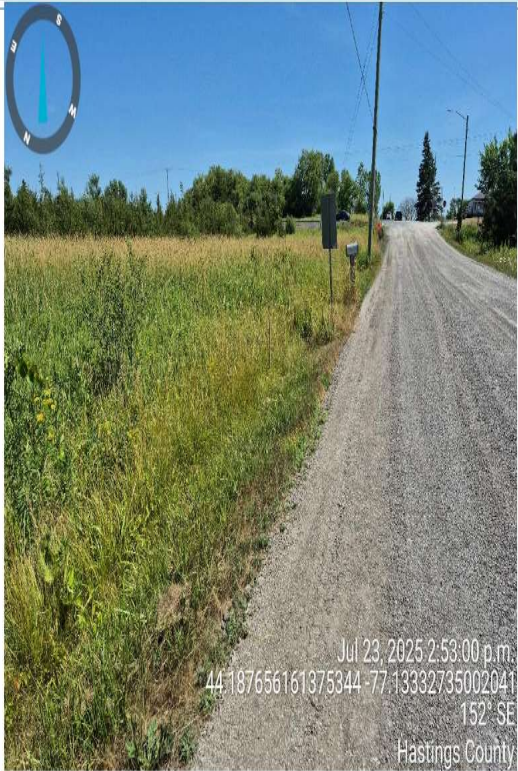
| ID # | Location | Site Condition | Additional Work Recommended (Y/N) | Comments/Recommendations | Representative Photo (July 23, 2025) |
|---|---|---|---|---|---|
| 65 | 15 Wyman Road | Area restored to pre-construction conditions. | N | No issues to report at time of inspection. | <p>Jul 23, 2025 2:53:00 p.m.<br/>44.187656161375344 -77.13332735002041<br/>152° SE<br/>Hastings County</p> |

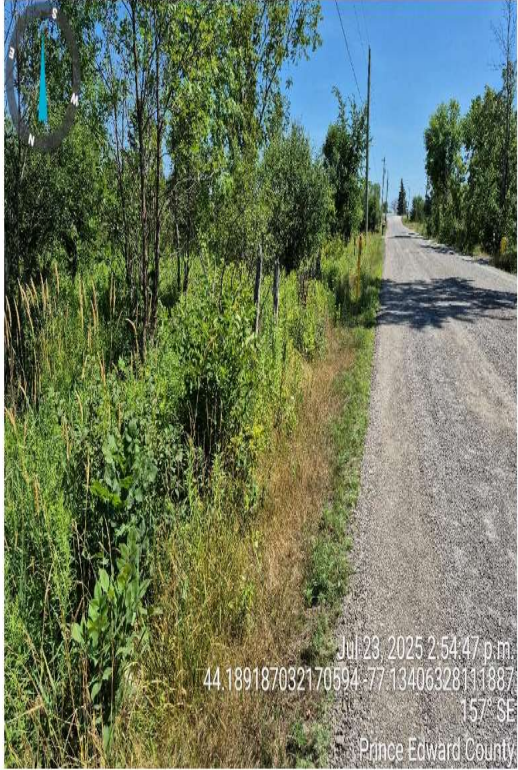
| ID # | Location | Site Condition | Additional Work Recommended (Y/N) | Comments/Recommendations | Representative Photo (July 23, 2025) |
|---|---|---|---|---|---|
| 66 | North of 27 Wyman Road | Area restored to pre-construction conditions. | N | No issues to report at time of inspection. | <p>Jul 23, 2025 2:54:47 p.m.<br/>44.189187032170594 -77.13406328111887<br/>157° SE<br/>Prince Edward County</p> |

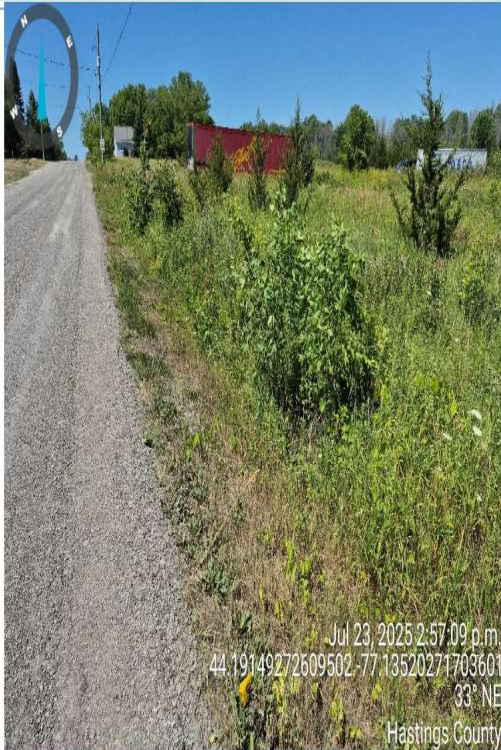
| ID # | Location | Site Condition | Additional Work Recommended (Y/N) | Comments/Recommendations | Representative Photo (July 23, 2025) |
|---|---|---|---|---|---|
| 67 | South of 121 Wyman Road | ROW is gravelled and roadside is vegetated. | N | No issues to report at time of inspection. | <p>Jul 23, 2025 2:57:09 p.m.<br/>44.19149272609502 -77.13520271703601<br/>33° NE<br/>Hastings County</p> |

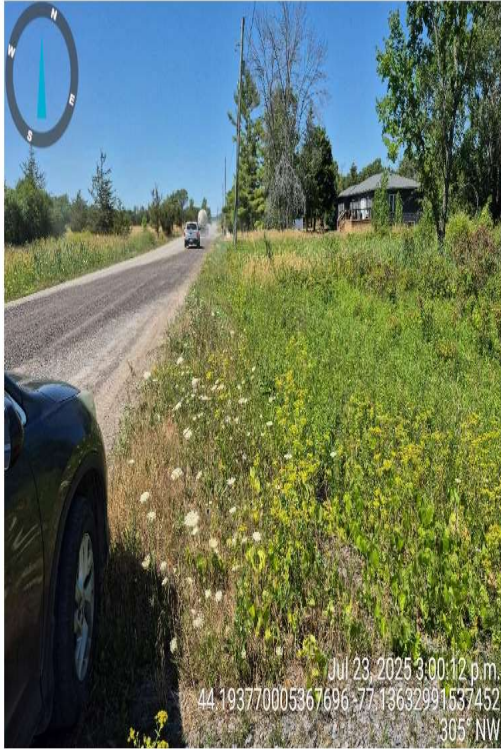
| ID # | Location | Site Condition | Additional Work Recommended (Y/N) | Comments/Recommendations | Representative Photo (July 23, 2025) |
|---|---|---|---|---|---|
| 68 | North of 134 Wyman Road | ROW is gravelled and roadside is vegetated. | N | No issues to report at time of inspection. | <p>Jul 23, 2025 3:00:12 p.m.<br/>44.193770005367696 -77.13632991537452<br/>305° NW</p> |

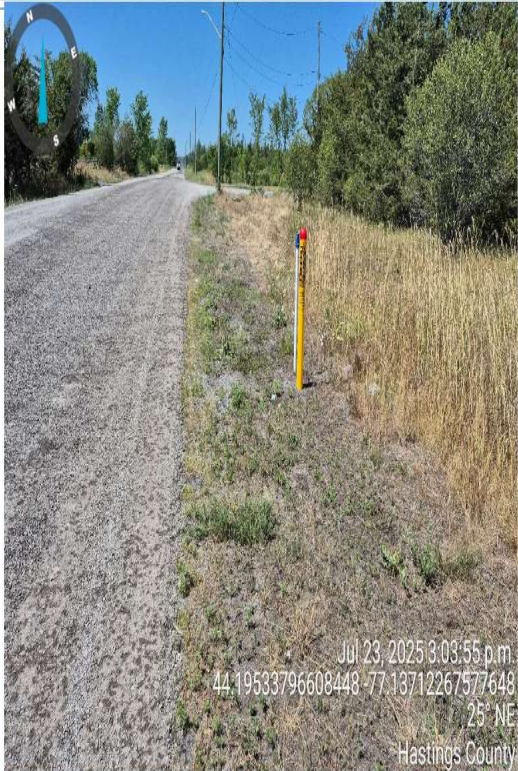
| ID # | Location | Site Condition | Additional Work Recommended (Y/N) | Comments/Recommendations | Representative Photo (July 23, 2025) |
|---|---|---|---|---|---|
| 69 | Wyman Road, south of the intersection of Wyman Road and Lower Slash Road | ROW is gravelled and roadside is vegetated with some areas of exposed soil. | Y | Reseed as needed. | <p>Jul 23, 2025 3:03:55 p.m.<br/>44.19533796608448 -77.13712267577648<br/>25° NE<br/>Hastings County</p> |

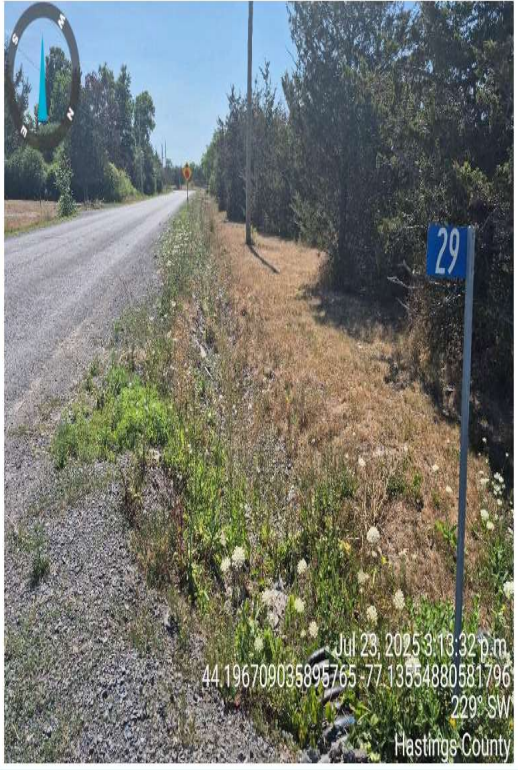
| ID # | Location | Site Condition | Additional Work Recommended (Y/N) | Comments/Recommendations | Representative Photo (July 23, 2025) |
|---|---|---|---|---|---|
| 70 | Lower Slash Road east of the intersection of Lower Slash Road and Wyman Road | Area restored to pre-construction conditions. | N | No issues to report at time of inspection. | <p>Jul 23, 2025 3:13:32 p.m.<br/>44.196709035895765 -77.13554880581796<br/>229° SW<br/>Hastings County</p> |

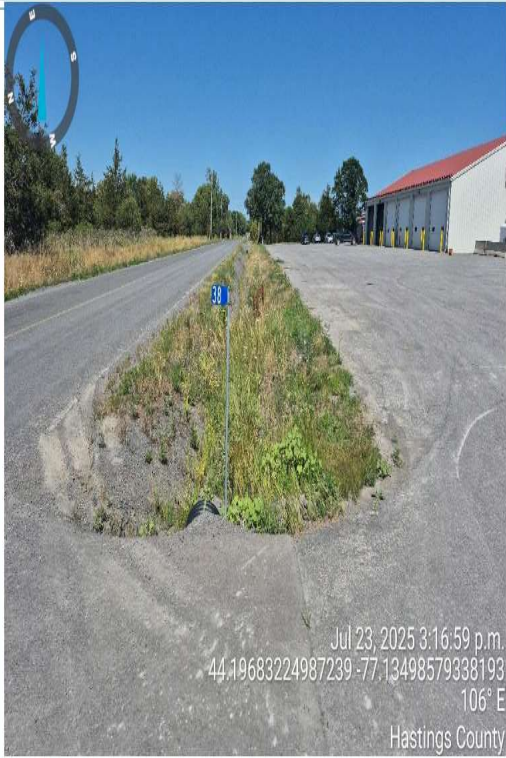
| ID # | Location | Site Condition | Additional Work Recommended (Y/N) | Comments/Recommendations | Representative Photo (July 23, 2025) |
|---|---|---|---|---|---|
| 71 | 38 Lower Slash Road | Area restored to pre-construction conditions. | N | No issues to report at time of inspection. | <p>Jul 23, 2025 3:16:59 p.m.<br/>44.19683224987239 -77.13498579338193<br/>106° E<br/>Hastings County</p> |

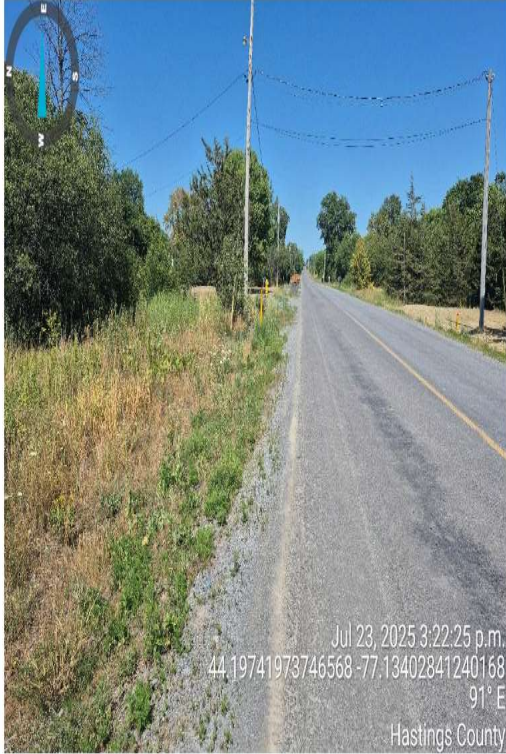
| ID # | Location | Site Condition | Additional Work Recommended (Y/N) | Comments/Recommendations | Representative Photo (July 23, 2025) |
|---|---|---|---|---|---|
| 72 | 38 Lower Slash Road | Area restored to pre-construction conditions. | N | No issues to report at time of inspection. | <p>Jul 23, 2025 3:22:25 p.m.<br/>44.19741973746568 -77.13402841240168<br/>91° E<br/>Hastings County</p> |

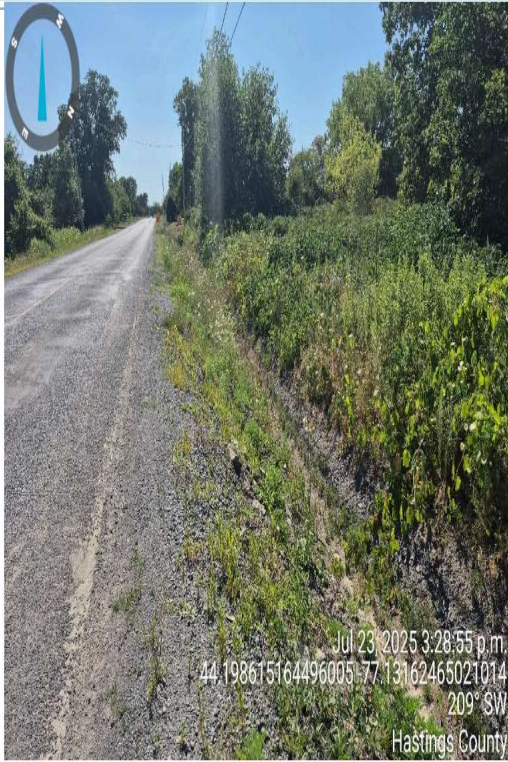
| ID # | Location | Site Condition | Additional Work Recommended (Y/N) | Comments/Recommendations | Representative Photo (July 23, 2025) |
|---|---|---|---|---|---|
| 73 | Across from 110 Lower Slash Road | Area restored to pre-construction conditions. | N | No issues to report at time of inspection. | <p>Jul 23, 2025 3:28:55 p.m.<br/>44.198615164496005 -77.13162465021014<br/>209° SW<br/>Hastings County</p> |

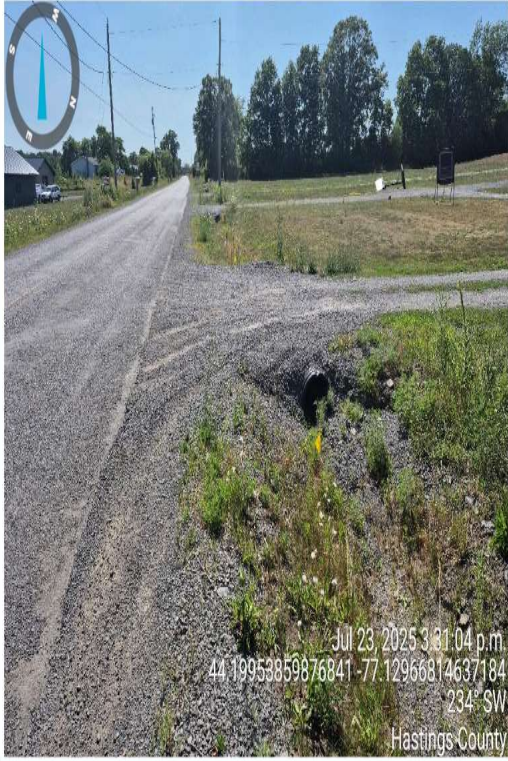
| ID # | Location | Site Condition | Additional Work Recommended (Y/N) | Comments/Recommendations | Representative Photo (July 23, 2025) |
|---|---|---|---|---|---|
| 74 | West of 169 Lower Slash Road | Area restored to pre-construction conditions. | N | No issues to report at time of inspection. | <p>Jul 23, 2025 3:31:04 p.m.<br/>44.19953859876841 -77.12966814637184<br/>234° SW<br/>Hastings County</p> |

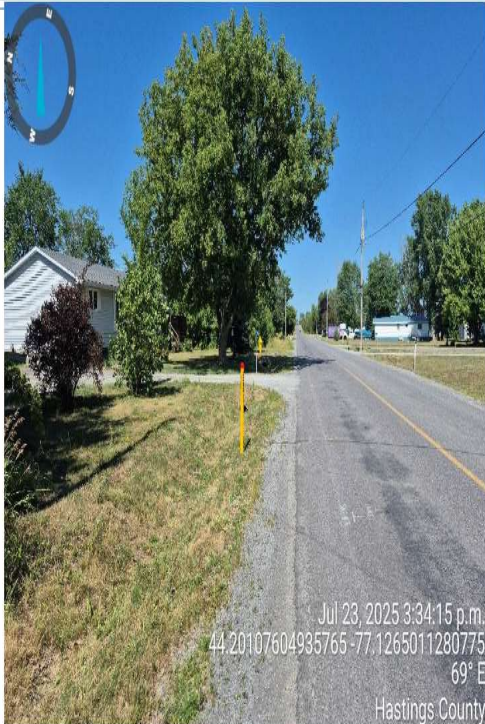
| ID # | Location | Site Condition | Additional Work Recommended (Y/N) | Comments/Recommendations | Representative Photo (July 23, 2025) |
|---|---|---|---|---|---|
| 75 | East of 201 Lower Slash Road | Area restored to preconstruction conditions. | N | No issues to report at time of inspection. | <p>Jul 23, 2025 3:34:15 p.m.<br/>44.20107604935765 -77.1265011280775<br/>69° E<br/>Hastings County</p> |

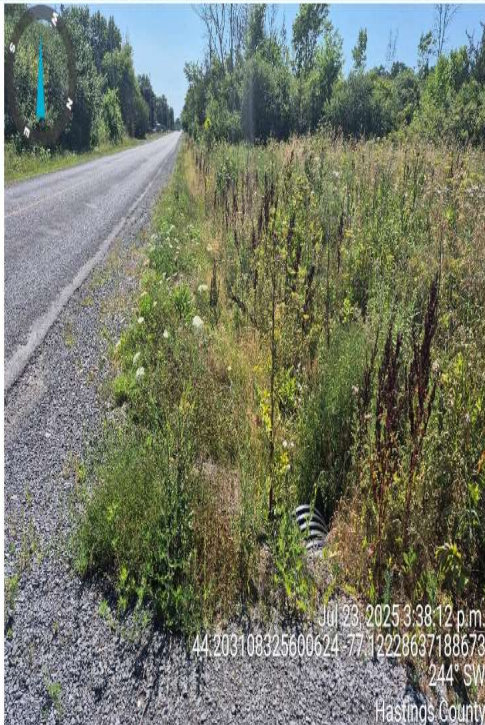
| ID # | Location | Site Condition | Additional Work Recommended (Y/N) | Comments/Recommendations | Representative Photo (July 23, 2025) |
|---|---|---|---|---|---|
| 76 | West of 307 Lower Slash Road | Area restored to preconstruction conditions. | N | No issues to report at time of inspection. | <p>Jul 23, 2025 3:38:12 p.m.<br/>44.203108325600624 -77.12228637188673<br/>244° SW<br/>Hastings County</p> |
