## EXHIBIT 2 – RATE BASE

### 2027 Cost of Service

Rideau St-Lawrence Distribution Inc.  
EB-2026-0069

# **Substation Condition Assessment 2025**

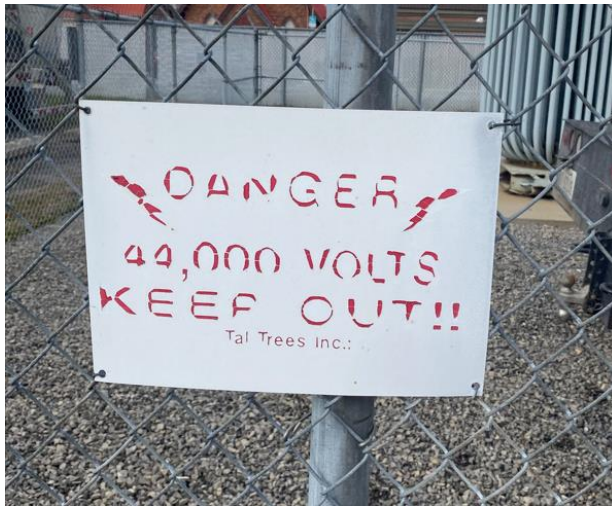
KPC Technicians found that the warning signs are faded and unable to read.

It is our recommendation that new signage is installed to ensure safety of the general public.

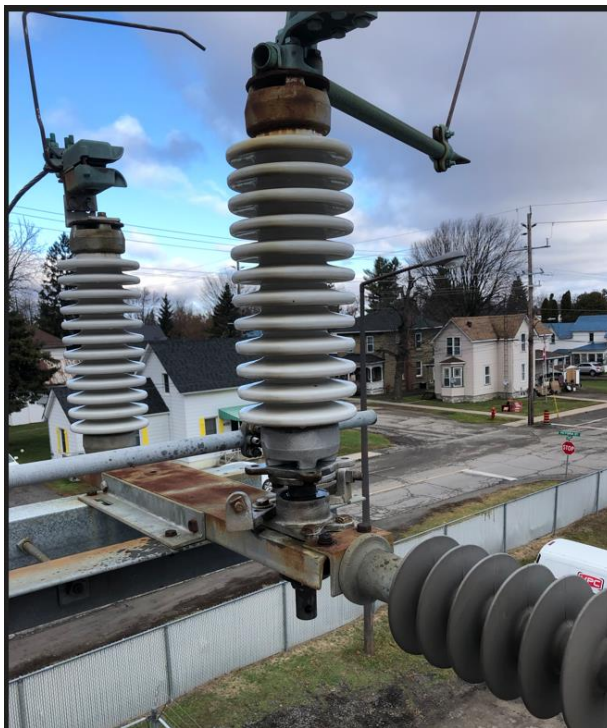
When conducting maintenance on the HV Switch, KPC Technicians found that the B phase blade was not properly aligned.

KPC technicians temporarily fixed the switch while on site.

It is our recommendation that the line to load switch arms are replaced.

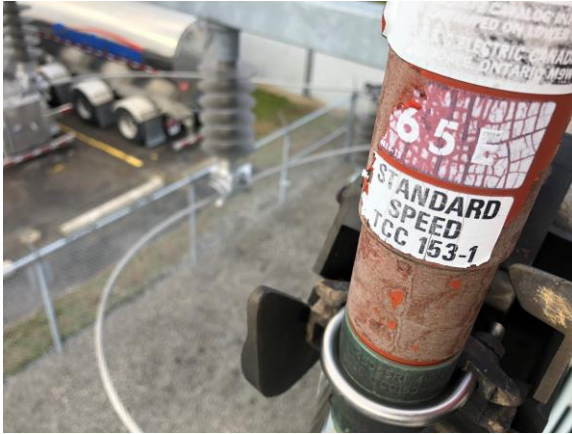
KPC Technicians noted that the Primary Incoming Fuse Barrels were severely weathered. It was also noted that there were no spare fuses available on site.

It is our recommendation that the fuses are repainted. And that 3 spare fuses are available on site at all times in the case of emergencies.

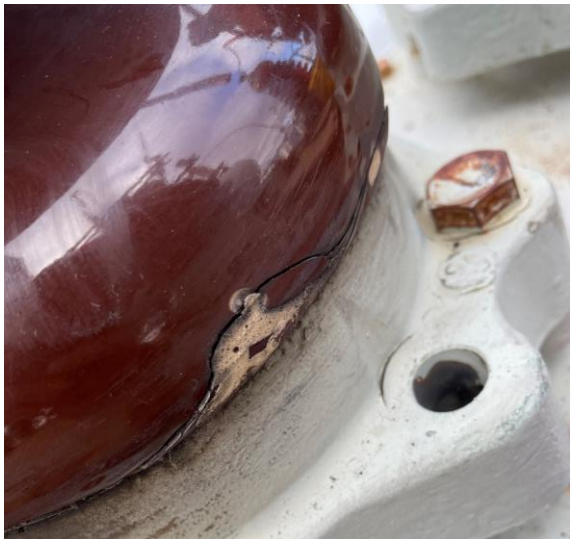
When conducting maintenance on the Primary Transformer, KPC Technicians found that the Secondary Bushings were cracked.

It is our recommendation that the bushings are resealed and recoated to restore the integrity of the insulation.

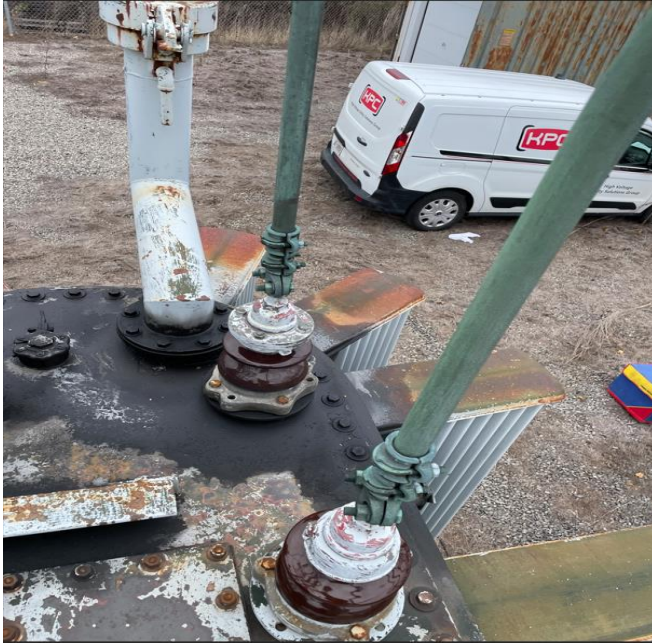
While conducting inspections of Transformer 'T1', KPC Technicians noted an oil leak from the oil level gauge and oil stains on the surface area of transformer. It was also noted that the transformer is running low on oil as shown on the gauge.

It is our recommendation to keep monitoring the oil leak and refill the oil to the appropriate level to ensure sufficient insulation.

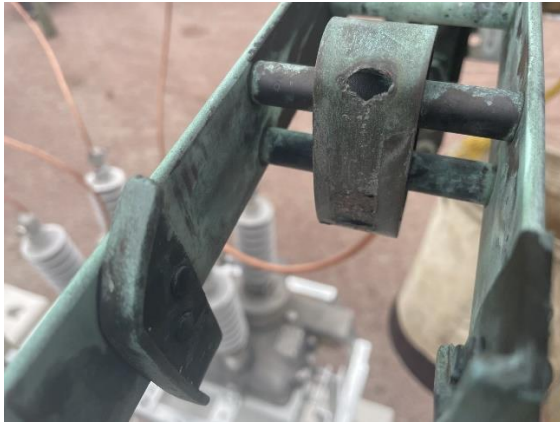
While conducting inspections of the feeder line switches it was noted that the red phase of the 46 F1 switch and the 46 F2 switch has damaged arcing contact surface is poor.

It is recommended to replaced the damaged arcing contact surfaces.

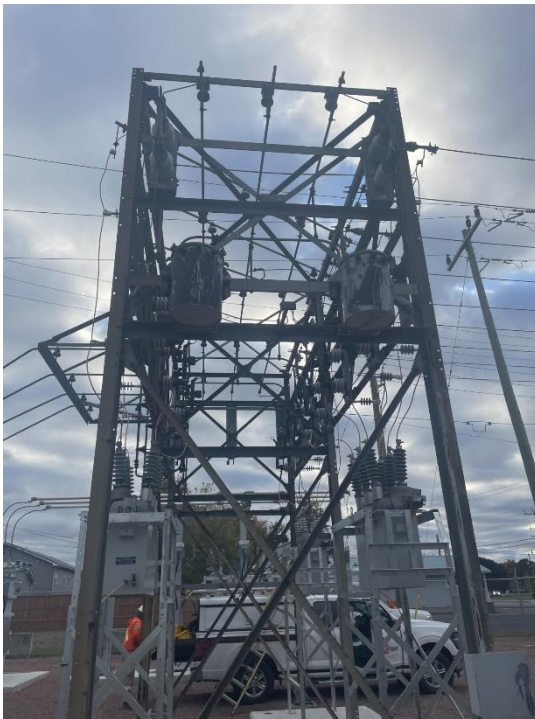
While conducting inspections of the 46 F3 switch, KPC Technicians noted No continuity on 'A', 'B', or 'C' phase arc interrupters.

All arc interrupters on the 46F3 feeder line switches should be replaced.

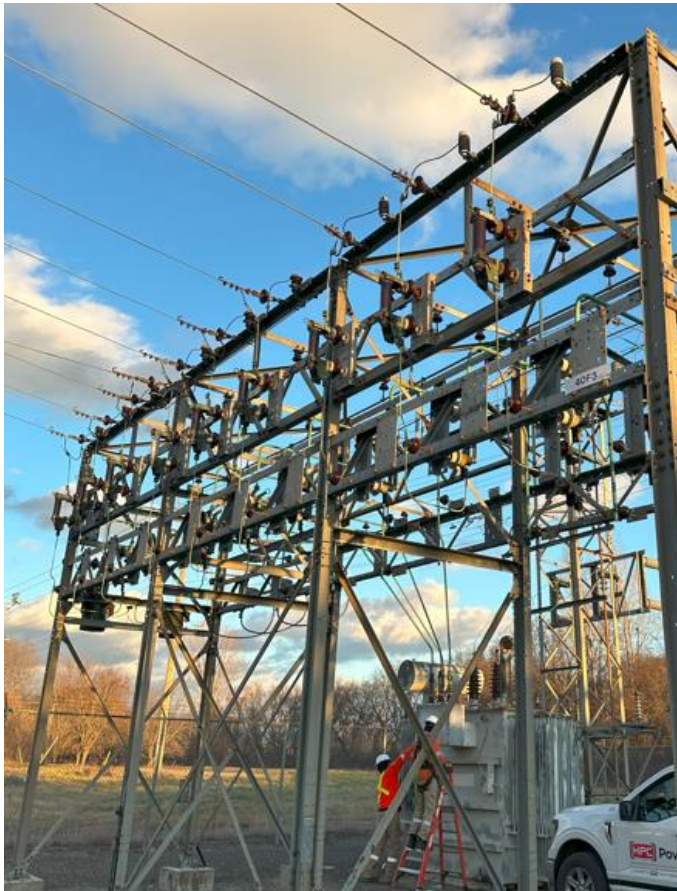
While conducting inspections of the Incoming Tower, KPC Technicians noted no spare fuses on site.

It is our recommendation to acquire a minimum of 3 spare fuses on site for emergency situations.

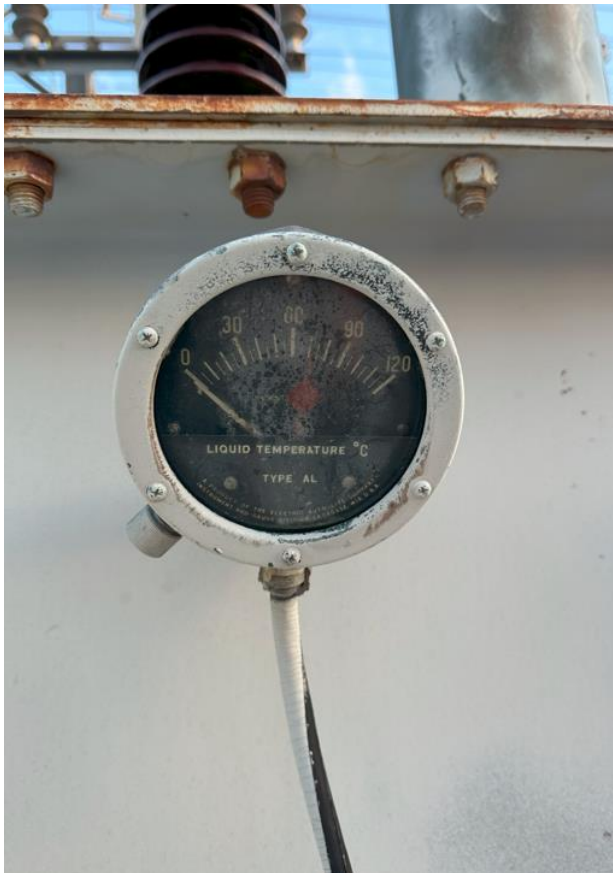
While conducting inspections of the Transformer, KPC Technicians noted that the oil temperature gauge is not working and will not reset.

It is our recommendation to replace the faulty temperature gauge.

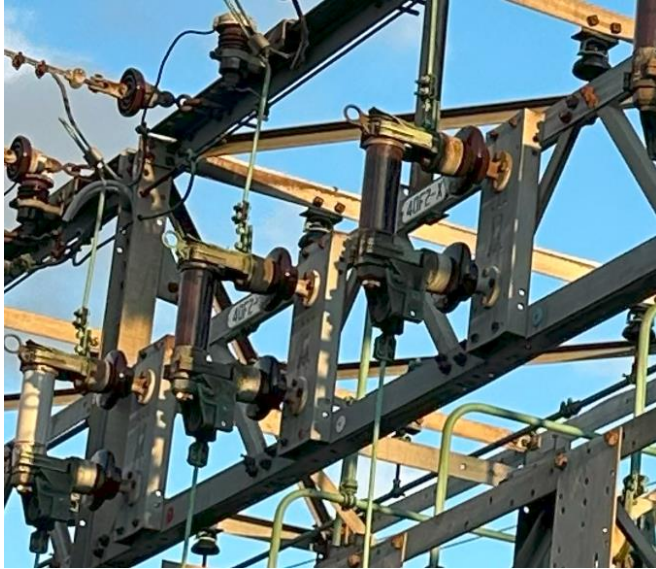
While conducting inspections of the High Voltage Power Fuses, KPC Technicians noted that on 40-FI-X, the phases were labelled incorrectly.

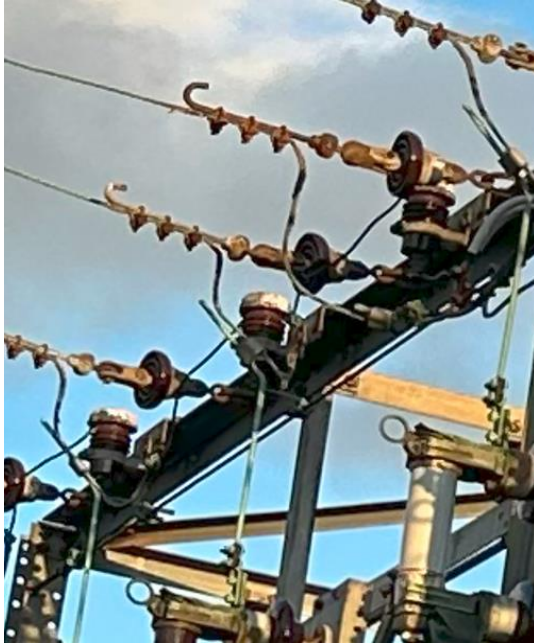
## **40F1 Lightning Arrestors**

While conducting testing of the 40F1 and 40F2 Lightning Arrestors, KPC Technicians noted low insulation resistance results.

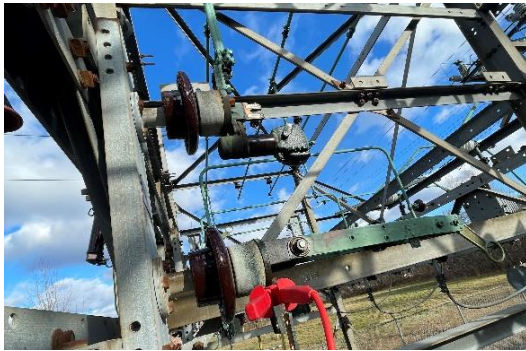
During insulation resistance testing of the secondary bus, it was noted that there was very low insulation resistance on the red phase.

KPC Technicians sectionalized the various insulators on the secondary bus to determine which was the cause of this poor insulation resistance. It was determined that the line side red phase of the 40F2 switch was yielding an insulation resistance value of 4Mohm when isolated from the bus. KPC Technicians removed the problem insulator and replaced it with one of the same voltage class/dimensions, provided by RSL staff. Once installed, the switch was re-tested to confirm satisfactory contact resistance, as well as insulation resistance on the bus, and with this new insulator installed from the bus, insulation resistance results increased from 4Mohm to 10.39Gohm

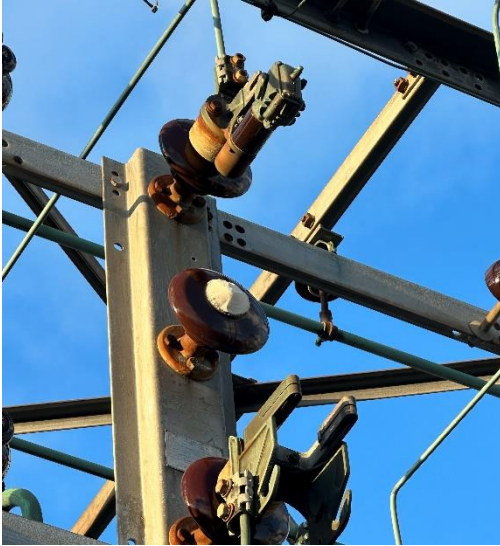
It was noted that the tie switches between MS2/MS1 is presently broken and removed. As a result, KPC Technicians were unable to test this switch

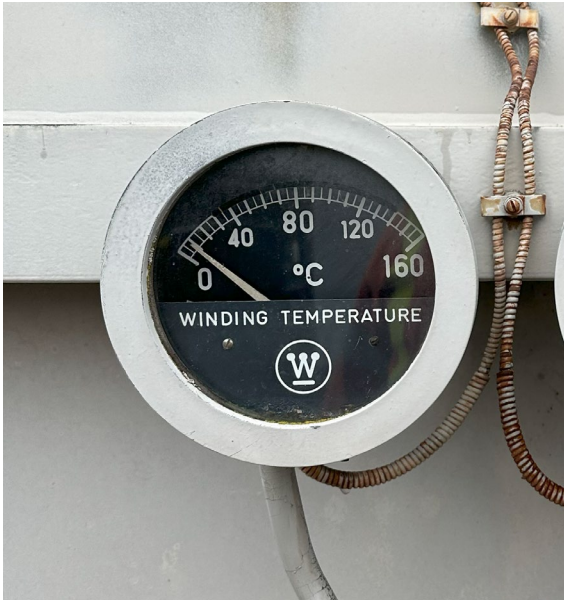
While conducting inspections of the T1-2L30 Transformer, KPC Technicians noted that the Max. needle in winding temperature gauge was missed.

It is our recommendation to replace the faulty winding temperature gauge.

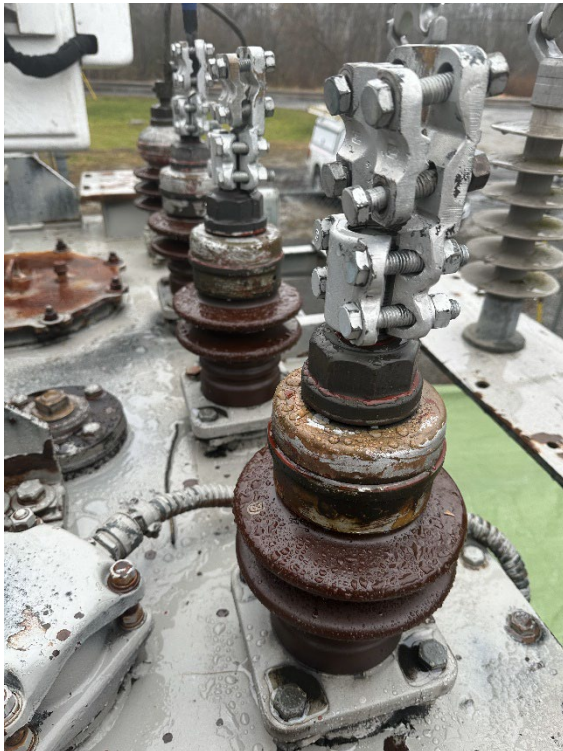
While conducting inspections of the T1-2L30 Transformer, KPC Technicians noted that there were also minor oil leaks from the secondary Red Phase bushings.

It is also our recommendation to continue to monitor for further leaking.
