EXHIBIT 2 – RATE BASE
2027 Cost of Service

Rideau St-Lawrence Distribution Inc.
EB-2026-0069

RSLU SUBSTATION CONDITION ASSESSMENT 2025

Prepared by: Perry Ni, M.A.Sc., EIT
Reviewed by: Rhys Goldman, P.Eng.

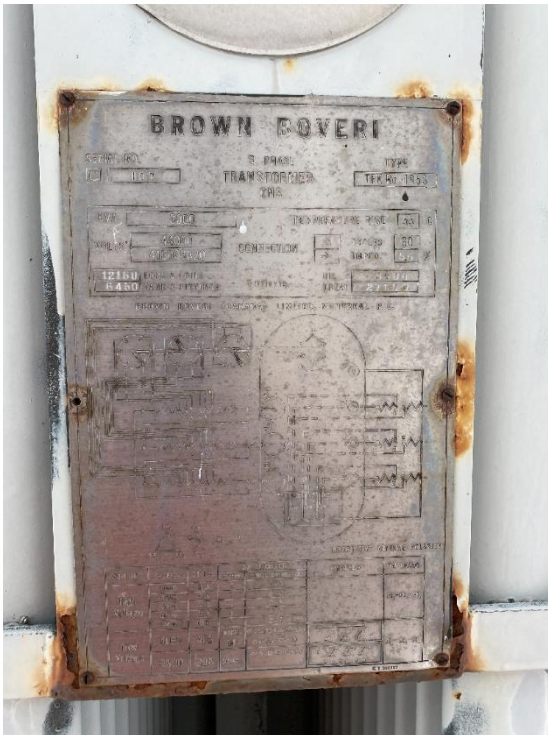
Rideau St. Lawrence - Cardinal DS1

During the maintenance of the main power transformer it was noted that the oil level in the conservator tank was very low. Additionally, there is significant rust present on the surface of the transformer.

It is strongly recommended to top up the oil in the main power transformer and apply paint to the rusted areas to prevent further corrosion.

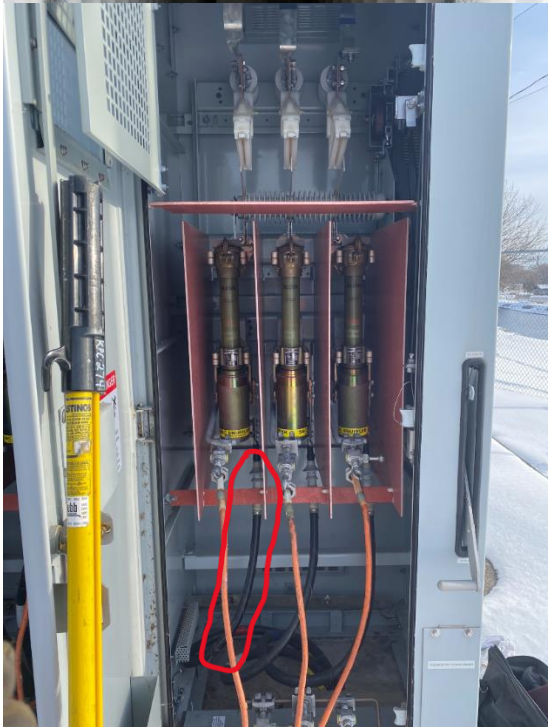
When performing insulation resistance testing of the 23F2 feeder cables, the red phase power cable had a low insulation resistance value of 348m Ω .

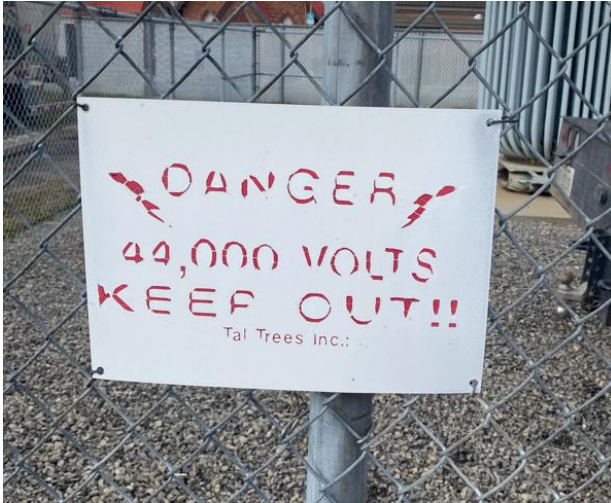
Rideau St. Lawrence

KPC Technicians found that the warning signs are faded and unable to read.

It is our recommendation that new signage is installed to ensure safety of the general public.

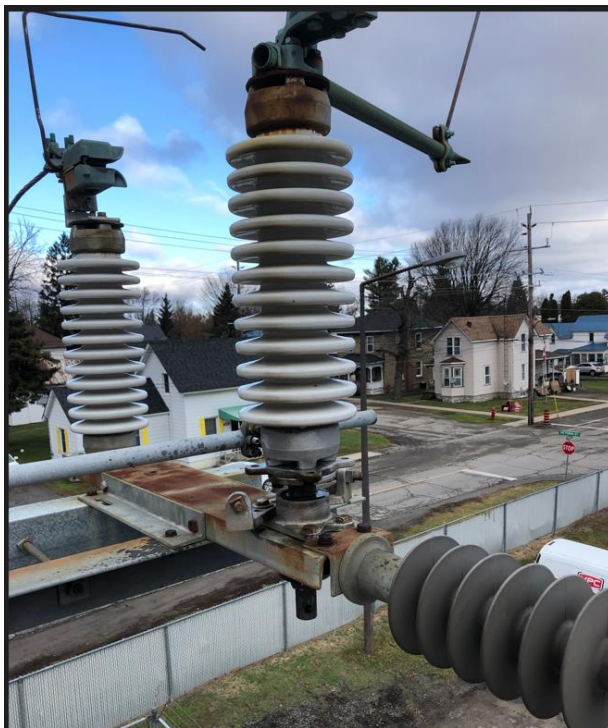
When conducting maintenance on the HV Switch, KPC Technicians found that the B phase blade was not properly aligned.

KPC technicians temporarily fixed the switch while on site.

It is our recommendation that the line to load switch arms are replaced.

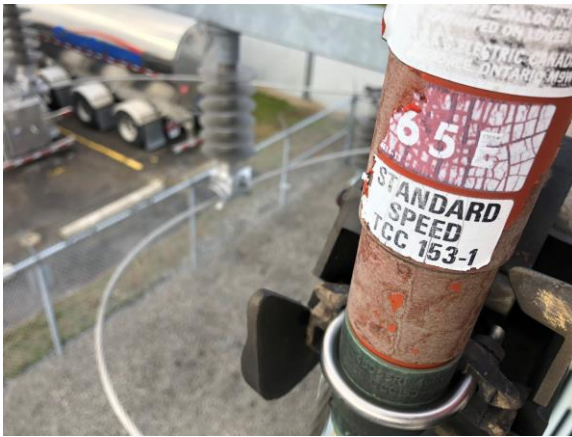
KPC Technicians noted that the Primary Incoming Fuse Barrels were severely weathered. It was also noted that there were no spare fuses available on site.

It is our recommendation that the fuses are repainted. And that 3 spare fuses are available on site at all times in the case of emergencies.

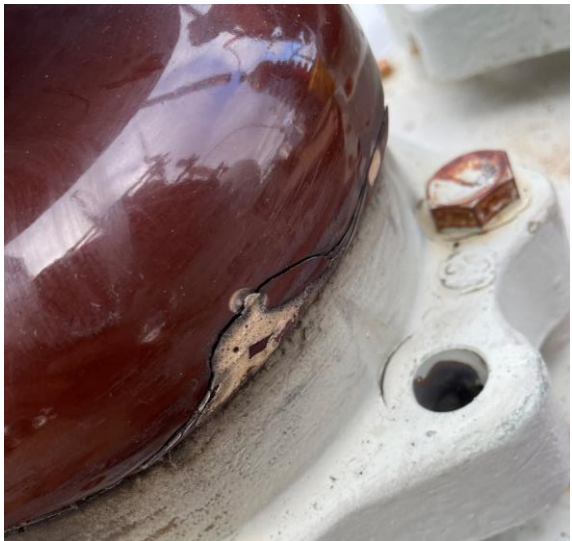
When conducting maintenance on the Primary Transformer, KPC Technicians found that the Secondary Bushings were cracked.

It is our recommendation that the bushings are resealed and recoated to restore the integrity of the insulation.

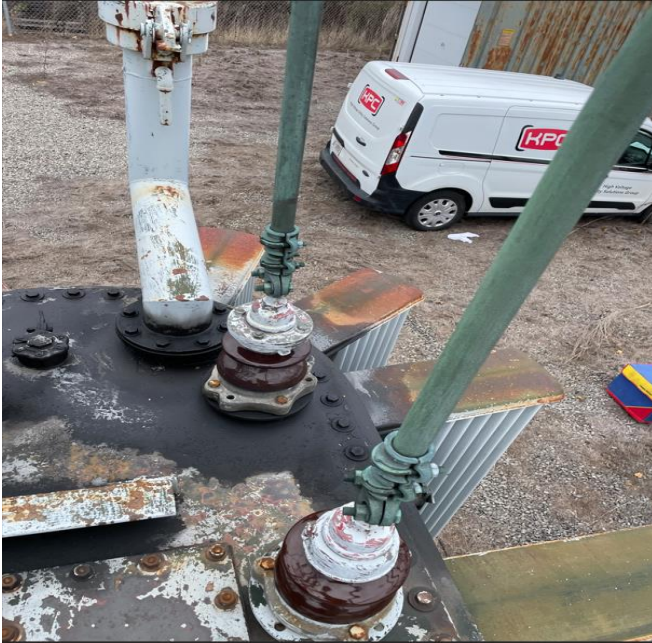
5799 Carman Rd. Prescott

While conducting inspections of Transformer 'T1', KPC Technicians noted an oil leak from the oil level gauge and oil stains on the surface area of transformer. It was also noted that the transformer is running low on oil as shown on the gauge.

It is our recommendation to keep monitoring the oil leak and refill the oil to the appropriate level to ensure sufficient insulation.

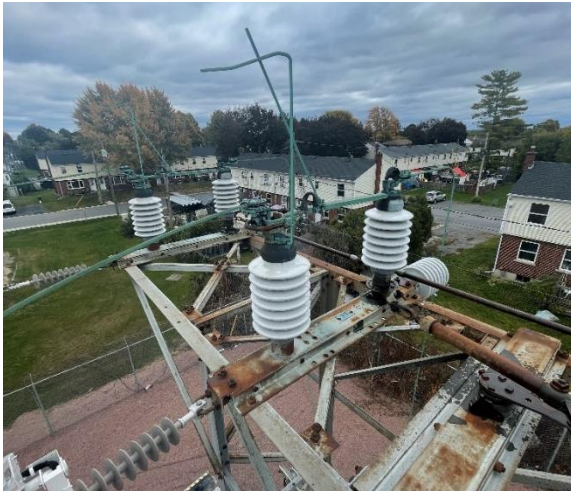
11 Fifth St E, Morrisburg, ON

While conducting inspections of the Primary Switch, KPC Technicians noted that the contact resistances on 'A' and 'B' Phases were higher.

Continue to monitor/perform infrared scanning of the main load break switch to ensure there is no hot spots present on the switch contacts.

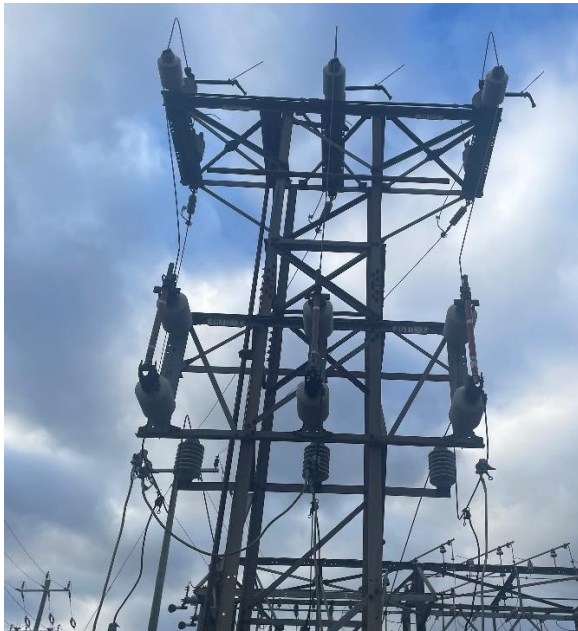
When performing contact resistance testing of the 46kV primary fusing, it was noted that the 'C' phase fuse had a contact resistance that was 50x higher than the other 2 phases.

KPC Technicians changed out the fuse link with a spare provided by RSL staff during the maintenance.

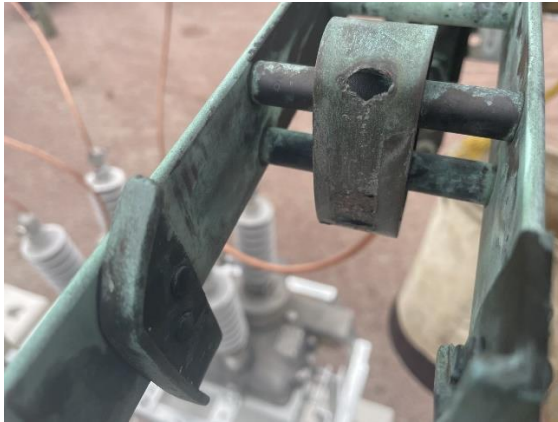
While conducting inspections of the feeder line switches it was noted that the red phase of the 46 F1 switch and the 46 F2 switch has damaged arcing contact surface is poor.

It is recommended to replaced the damaged arcing contact surfaces.

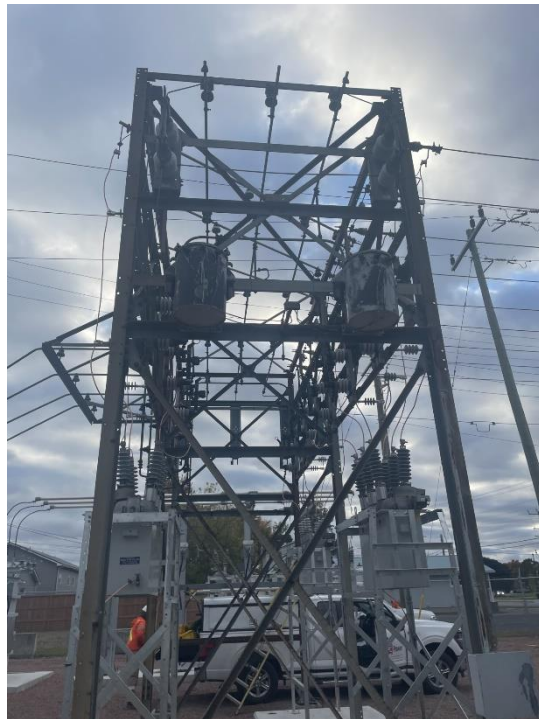
While conducting inspections of the 46 F3 switch, KPC Technicians noted No continuity on 'A', 'B', or 'C' phase arc interrupters.

All arc interrupters on the 46F3 feeder line switches should be replaced.

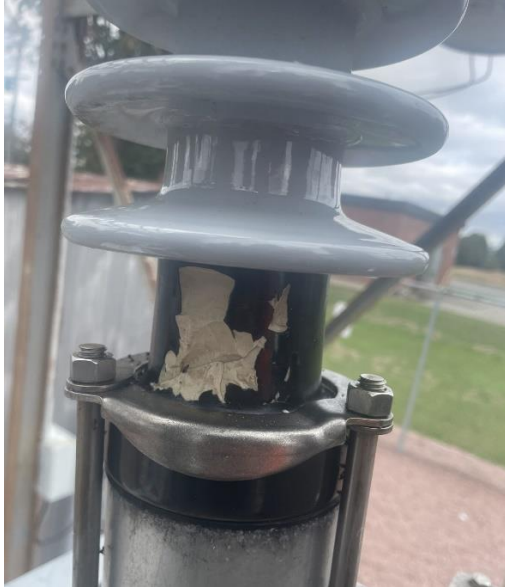
While conducting inspections of the 46-F3 reclosure, KPC Technicians noted the bushing on 'C' phase load side is cracked/damaged. During the time of the maintenance, insulation resistance was found to be satisfactory.

To prevent moisture intrusion in the cracked portion of the bushing, it is recommended to seal the crack with an insulating paint until the damaged bushing can be replaced.

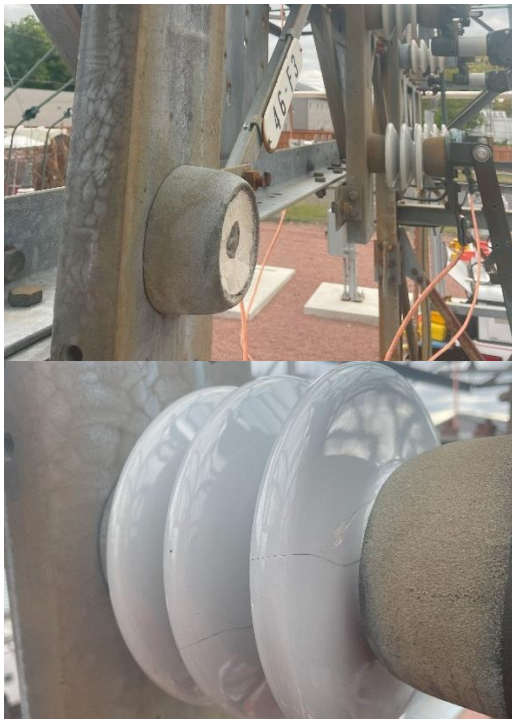
When performing maintenance on the 46-F3 line switches, it was noted that the line side of the red phase switch was completely broken, and the load side had a very large crack in the insulator.

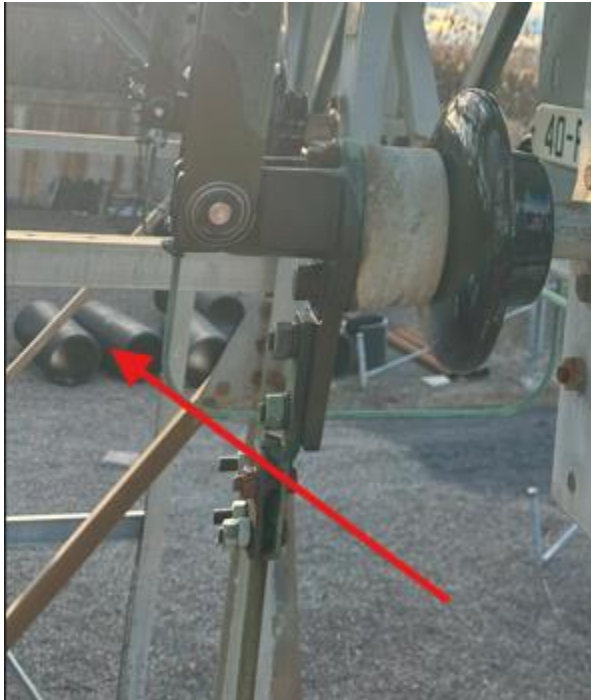
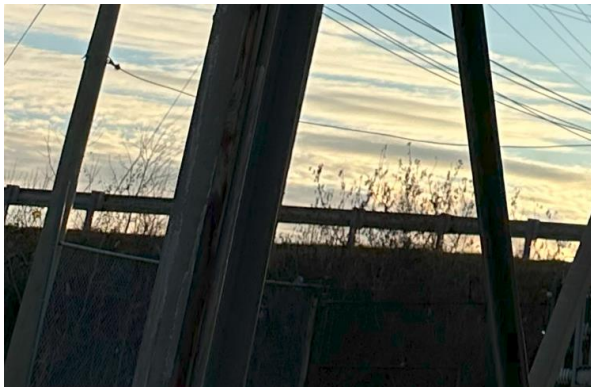
101 Churchill Rd. Prescott

While conducting inspections of the Substation Yard, KPC Technicians noted that there was foreign material stored on site and part of the barbed wire was missing.

It is our recommendation to replace the missing barbed wire.

It is also our recommendation to remove any foreign materials for safety.

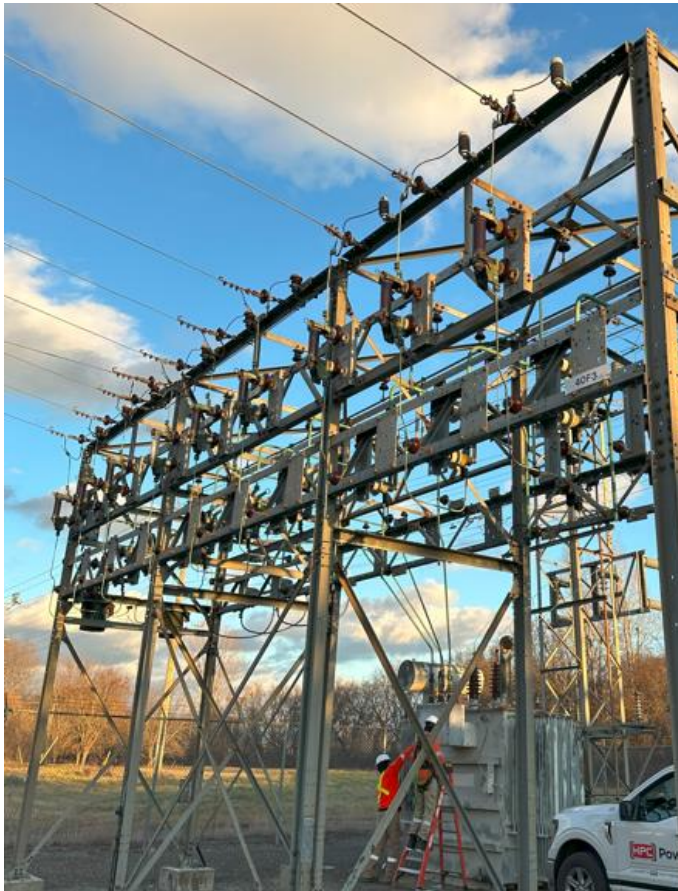
While conducting inspections of the Incoming Tower, KPC Technicians noted no spare fuses on site.

It is our recommendation to acquire a minimum of 3 spare fuses on site for emergency situations.

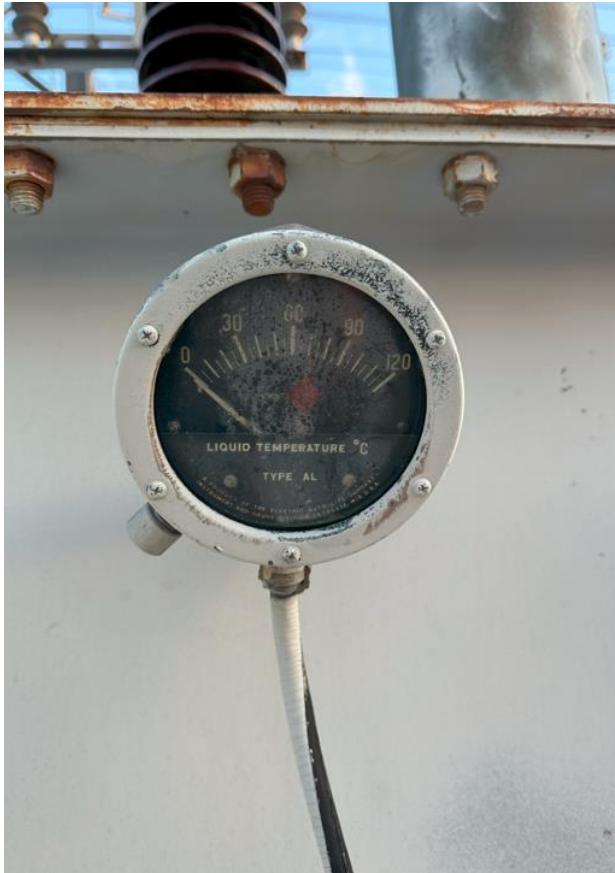
While conducting inspections of the Transformer, KPC Technicians noted that the oil temperature gauge is not working and will not reset.

It is our recommendation to replace the faulty temperature gauge.

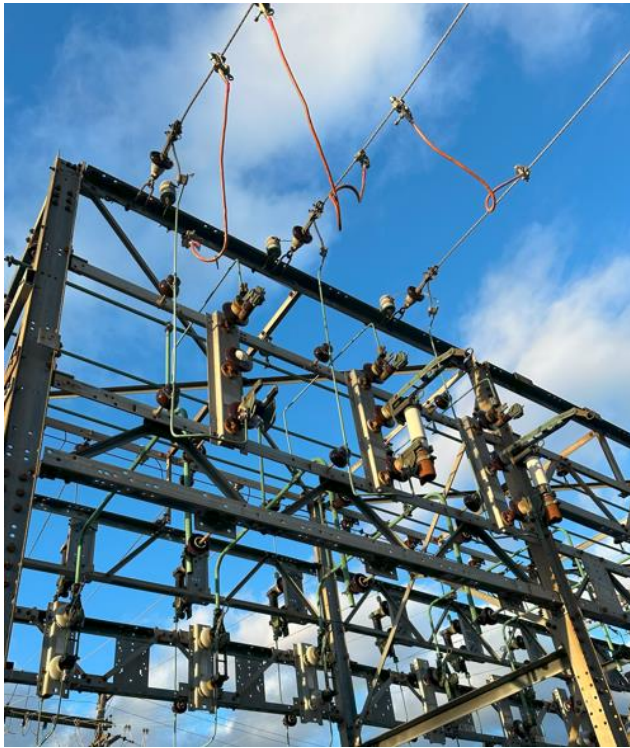
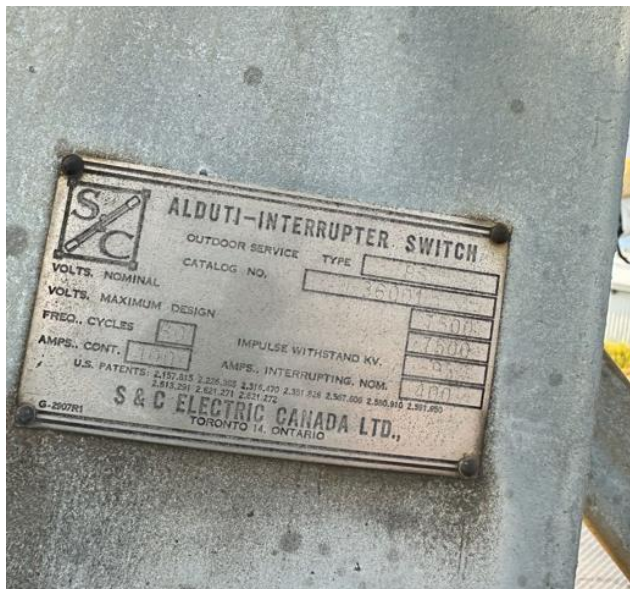
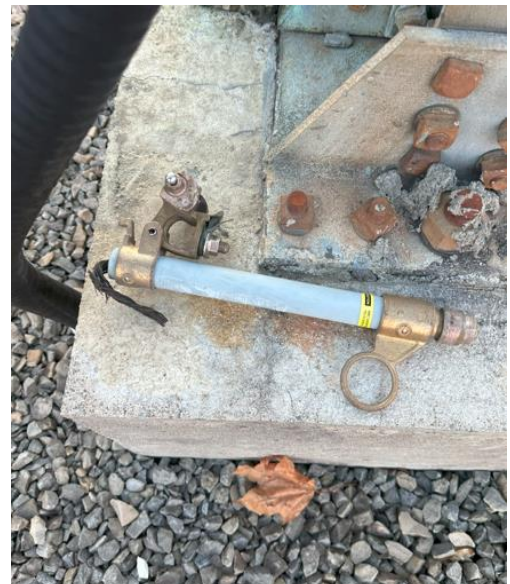
While conducting inspections of the High Voltage Switches, KPC Technicians noted issues on all 3 Switches (40-F3, 40-F2, 40-F1).

It is our recommendation to replace the faulty Arcing Interrupters.

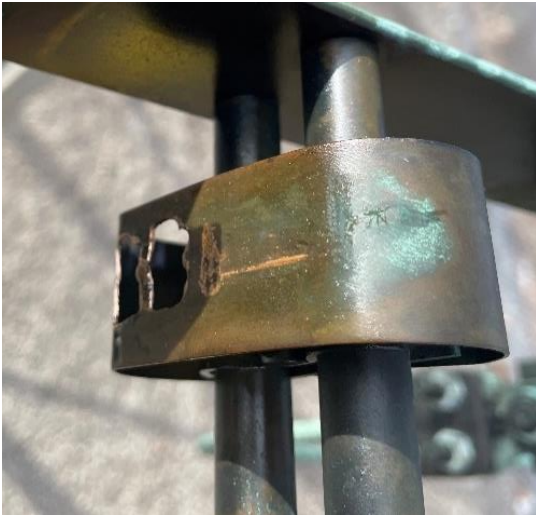
While conducting inspections of the High Voltage Break Switches, KPC Technicians noted the contact surfaces on 40-F1 are deteriorating.

It is our recommendation to replace the faulty contact surfaces on the one effected area.

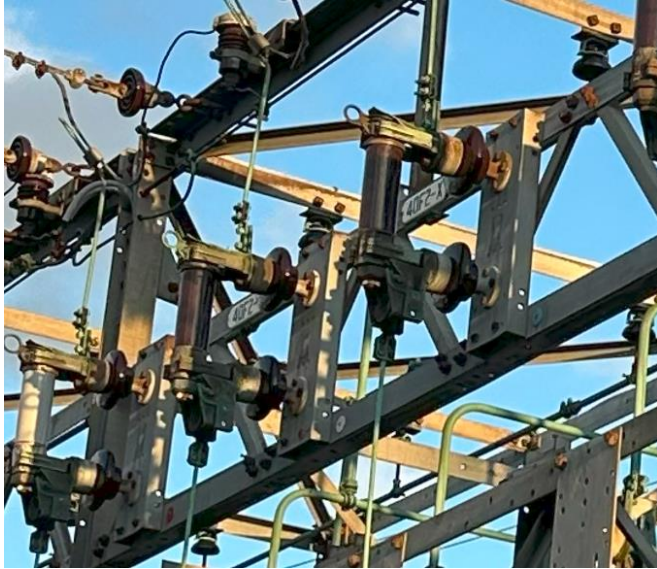
While conducting inspections of the High Voltage Power Fuses, KPC Technicians noted that on 40-F1-X, the phases were labelled incorrectly.

It is our recommendation to Label the phases correctly.

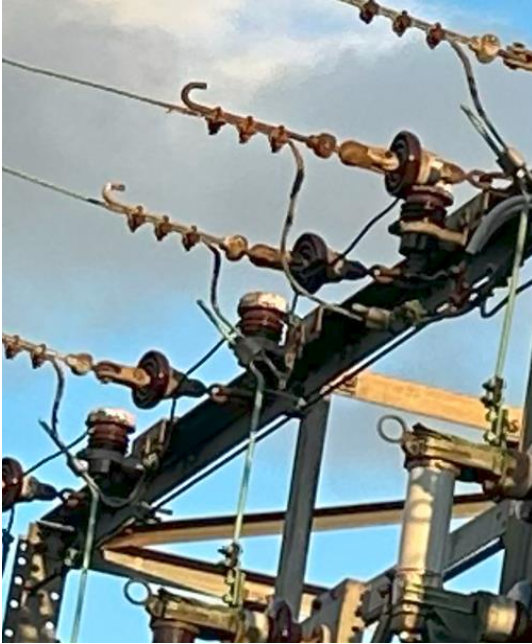
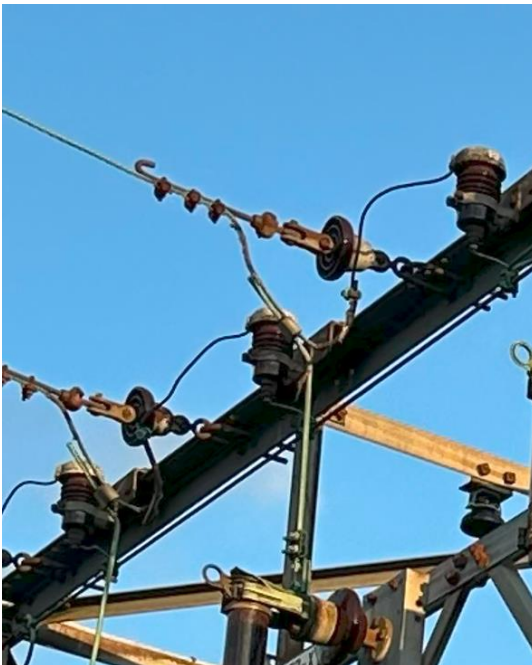
While conducting testing of the 40F1 and 40F2 Lightning Arrestors, KPC Technicians noted low insulation resistance results.

It is our recommendation to replace the 6 old porcelain Lightning Arrestors with new non-fragmenting polymer arrestors.

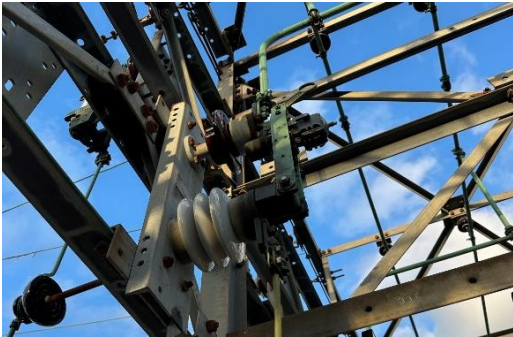
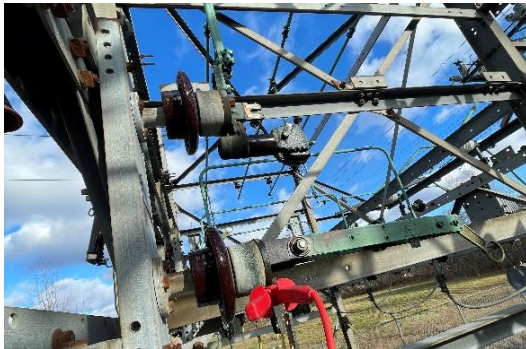
During insulation resistance testing of the secondary bus, it was noted that there was very low insulation resistance on the red phase.

KPC Technicians sectionalized the various insulators on the secondary bus to determine which was the cause of this poor insulation resistance. It was determined that the line side red phase of the 40F2 switch was yielding an insulation resistance value of 4Mohm when isolated from the bus. KPC Technicians removed the problem insulator and replaced it with one of the same voltage class/dimensions, provided by RSL staff. Once installed, the switch was re-tested to confirm satisfactory contact resistance, as well as insulation resistance on the bus, and with this new insulator installed from the bus, insulation resistance results increased from 4Mohm to 10.39Gohm

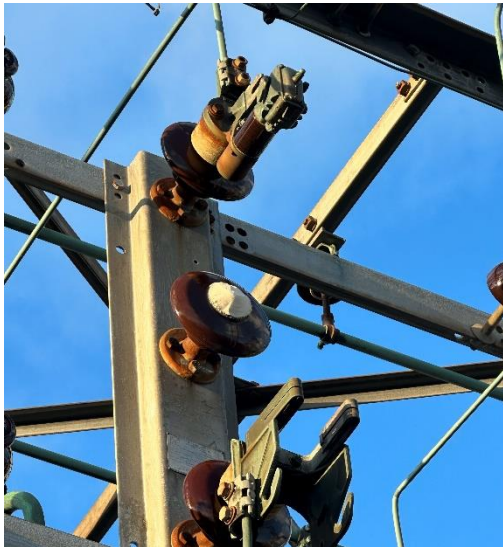
It was noted that the tie switches between MS2/MS1 is presently broken and removed. As a result, KPC Technicians were unable to test this switch

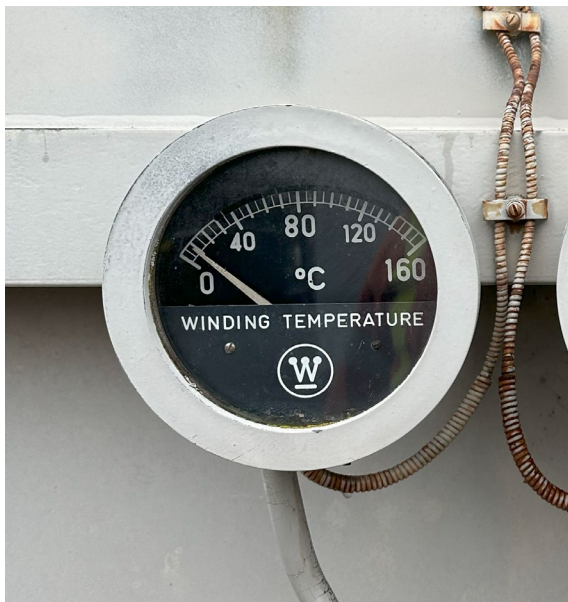
898 Boundary St. Prescott

While conducting inspections of the T1-2L30 Transformer, KPC Technicians noted that the Max. needle in winding temperature gauge was missed.

It is our recommendation to replace the faulty winding temperature gauge.

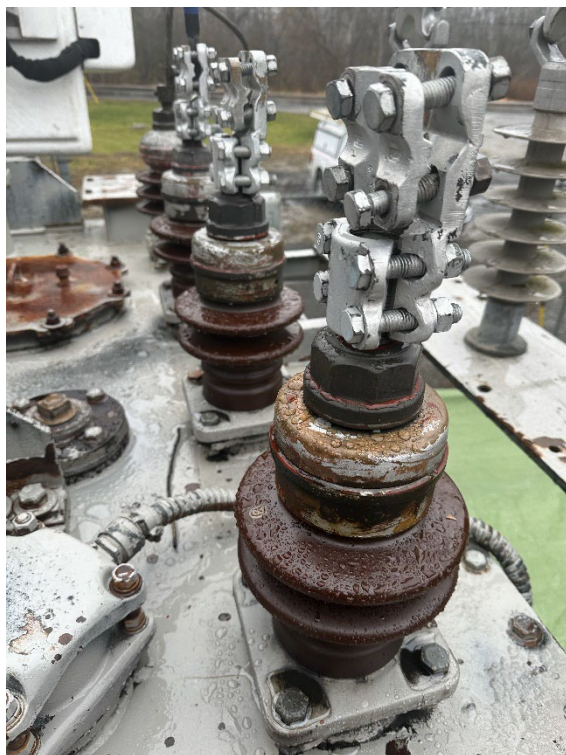
While conducting inspections of the T1-2L30 Transformer, KPC Technicians noted that there were also minor oil leaks from the secondary Red Phase bushings.

It is also our recommendation to continue to monitor for further leaking.

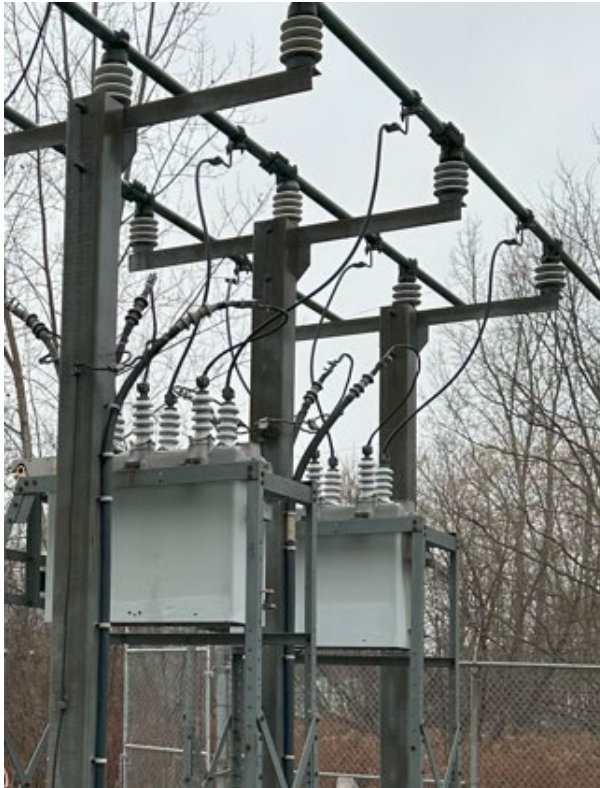
While conducting inspections of the Feeder Cables, KPC Technicians noted low insulation resistance on 'C' Phase of 30F2.
