Overview of Rate Base

Ex.2/Tab 1/Sch.1 - Rate Base Overview

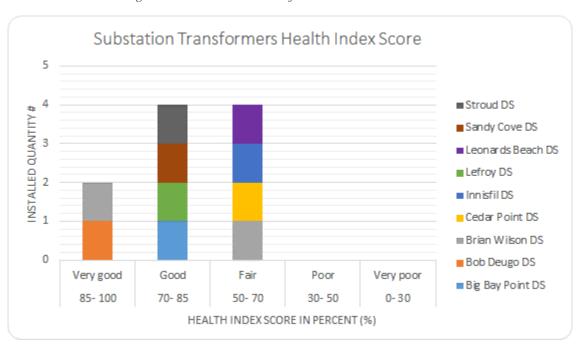
Figure 3-7: Substation transformers Health Index scores

The results of the ACA for substation transformers are summarized in Figure 3-7. The ACA result indicates that there are three (3) power transformers that are in "fair" condition, while the remaining seven (7) transformers are in "good" or "very good" condition.

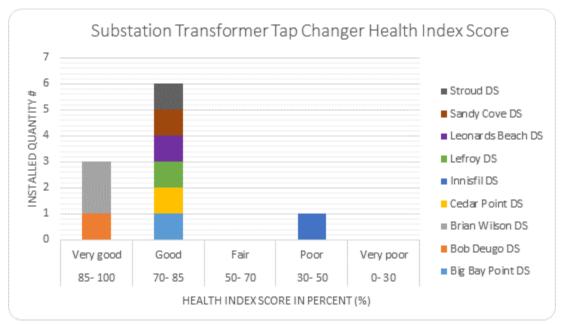
Figure 3-9: Substation transformer tap changer Health Index score

The results of the ACA for transformer tap changers are summarized in Figure 3-9. The ACA result indicates that one (1) tap changer is in "poor" condition, while the remaining nine (9) are in "good" or "very good" condition. Of the six (6) tap changers in "good" condition, five (5) of them have already passed the typical useful life and are likely to degrade to worse condition in the next five to ten years.

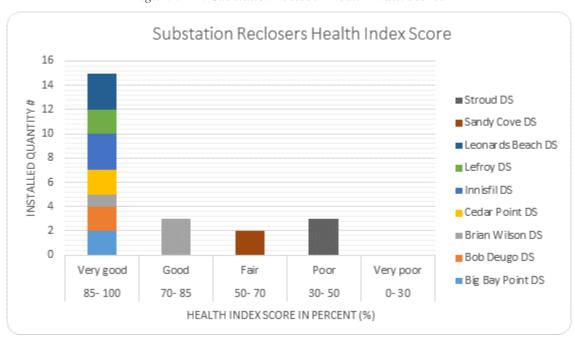
Figure 3-11: Substation recloser Health Index scores

Based on the service age of substation reclosers, visual inspections, and maintenance test reports (where available), a Health Index score has been calculated for all reclosers, and the results are summarized in Figure 3-11. As indicated by the results, the five (5) aged reclosers are determined in "fair" or "poor" health while the remaining eighteen (18) reclosers are in "good" or "very good" condition.

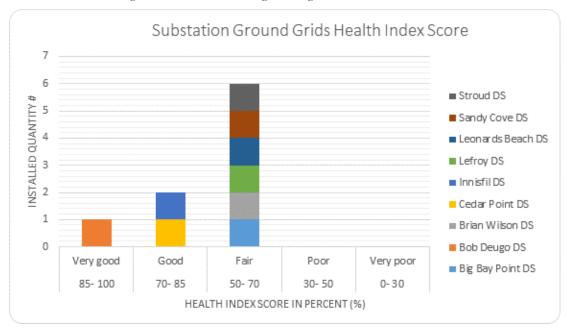
Figure 3-12: Substation ground grid Health Index scores

Based on the service age of ground grids, the results of visual inspections, and grounding tests, the Health Index score for ground grids was calculated and the results have been summarized in Figure 3-12. As indicated, the ground grids for three (3) substations, Bob Deugo DS, Cedar Point DS, and Innisfil DS, are determined to be in "very good" or "good" condition. The rest are in "fair" condition, mostly due to the fact that substations are aging and the gravel has sunk into the earth below.

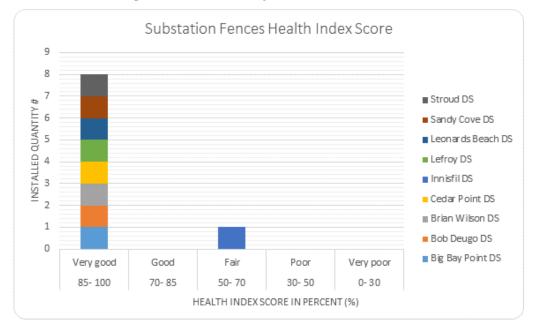
Figure 3-13: Substation fence Health Index scores

The Health Index score as summarized in Figure 3-13, was calculated for substation perimeter fences. The fences are in "very good" condition for all substations, except Innisfil DS, which received a "fair" rating.

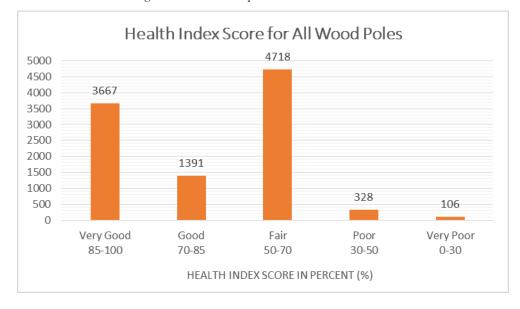
Figure 3-16: Wood pole Health Index scores

Using a Health Index algorithm based on service age and testing results, the sampled pole population has been ranked into "very good", "good", "fair", "poor", and "very poor" categories. The results of this analysis were then projected to the entire pole population, as shown in Figure 3-16. Almost 36% of wood pole population are in "very good" condition and 434 poles are in "poor" or "very poor" condition.

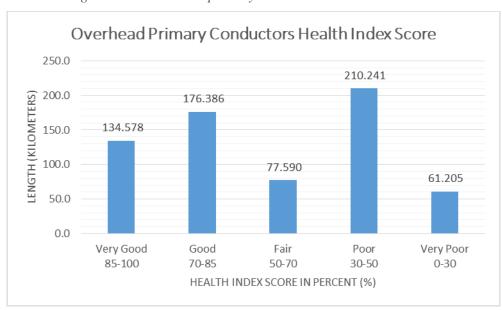
Figure 3-18: Overhead primary conductor Health Index scores

The overall Health Index for the overhead conductors, derived from age information, is summarized in Figure 3-18. It is determined that all the conductors in "poor" and "very poor" condition constitute 41% of the entire population. 20.4% of the lines are in "very good" condition and 26.7% are in "good" condition.

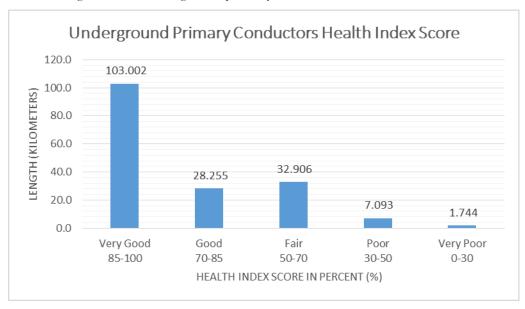
Figure 3-20: Underground primary conductors Health Index scores

The overall health index for the underground conductors, derived from age information, is summarized in Figure 3-20. It is determined that all the conductors in poor and very poor condition only constitute 5% of the entire population. 59.5% of the cables are in very good condition and 16.3% are in good condition.

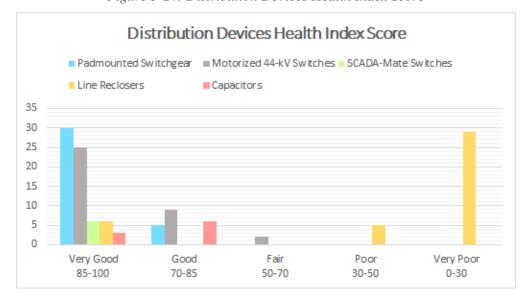
Figure 3-24: Distribution Devices Health Index Score

As shown, line reclosers make up the vast majority of the aged assets in this class. Derived from age information and IR inspection results, where available, the Health Index result for distribution devices is presented in Figure 3-24. It is observed that all the assets ranked at "very poor" or "poor" condition assets are line reclosers. Approximately 27% of InnPower owned distribution devices are approaching the end of their service life.

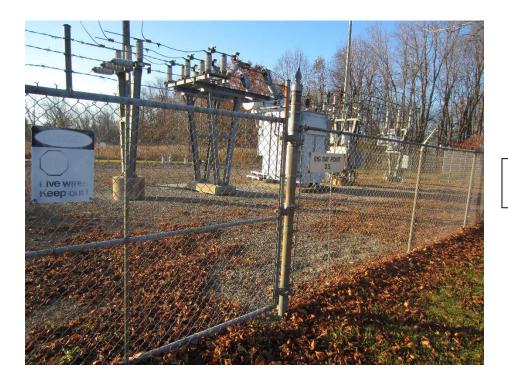
A.1 Big Bay Point DS

There is no gravel outside of the station.

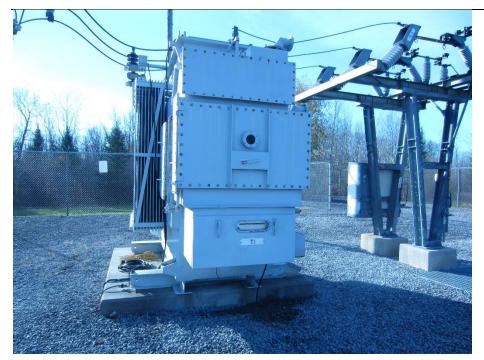
Oil leakage spotted.

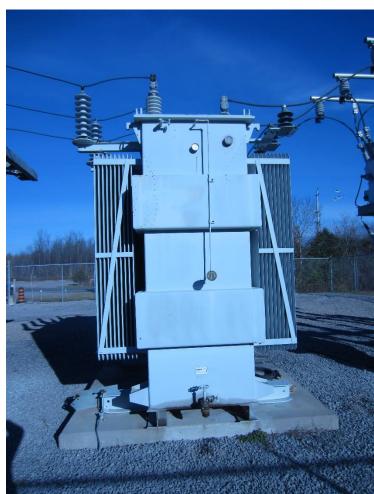
Transformer has no oil containment.

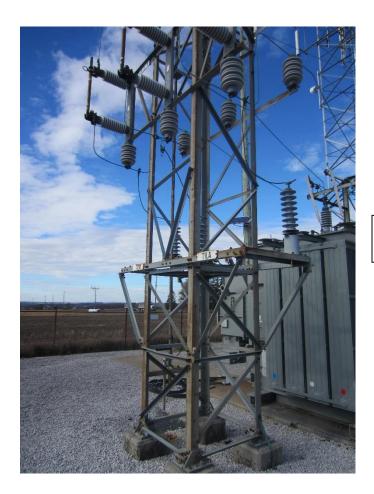
The operating rods and handles are badly rusted.

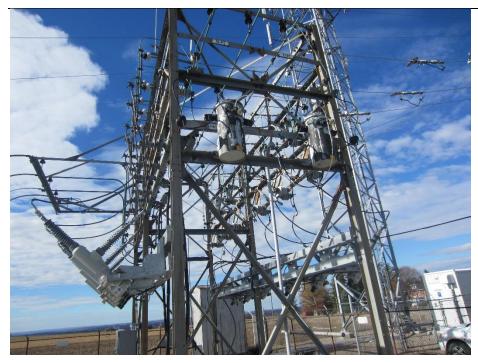
Jumpers are not properly supported from the reclosers to the bus bar.

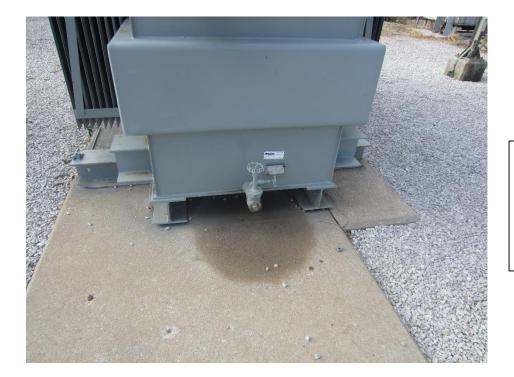
The foundation of transformer has sunk to a very low level. Transformer has no oil containment; leakage observed.

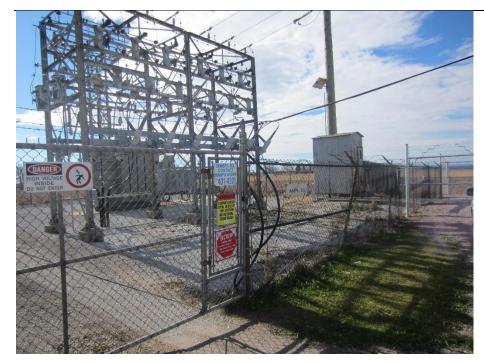
There is no gravel outside of the station.

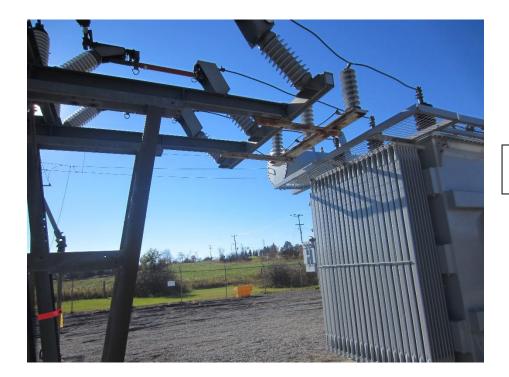
Rust observed from the structure.

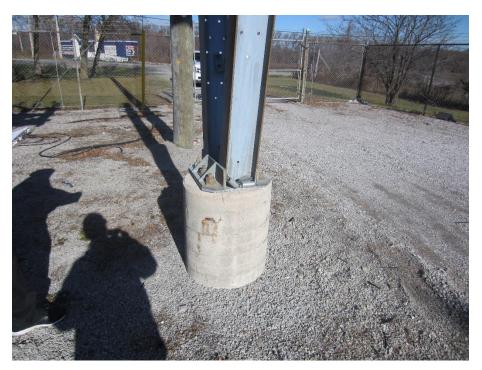
Cracked foundation of the 44kV primary switch.

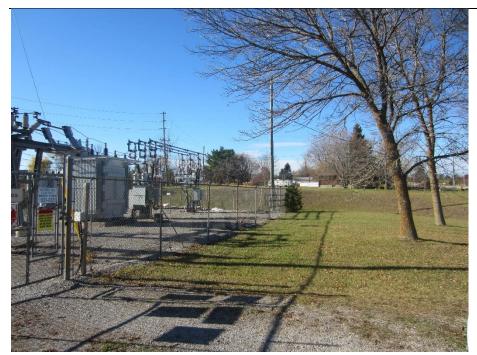
There is no gravel outside of the station.

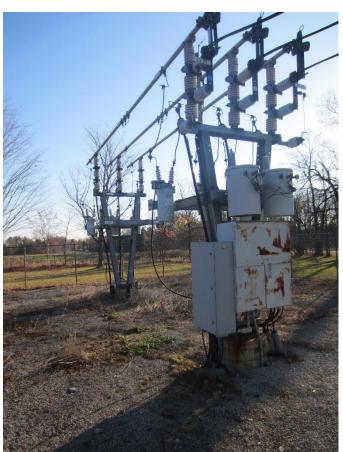
There is rust seen on the structure and cabinet.

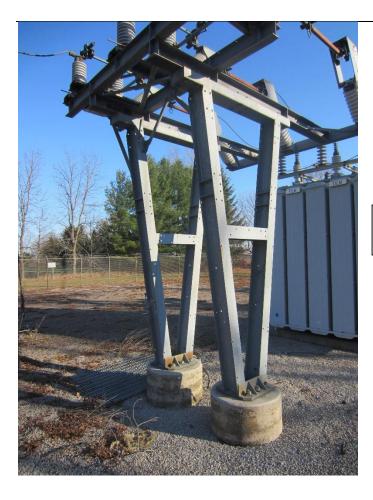
Water drains towards the foundation of the structure.

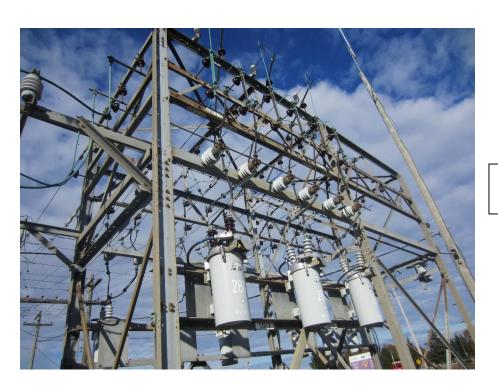
Rust observed on the structure.

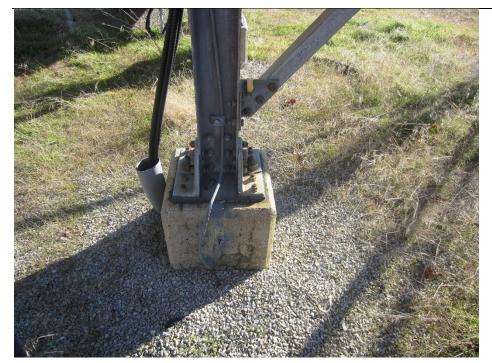
The foundation of the structure is deteriorating.

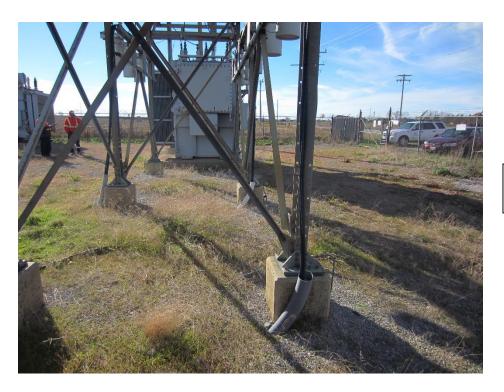
Cable ducts are not properly sealed.
