RE: EB-2016-0160 Hydro One Networks Inc. ("Hydro One") Transmission Rates Application – Additional Evidence

HYDRO ONE NETWORKS INC.

ADDITIONAL EVIDENCE

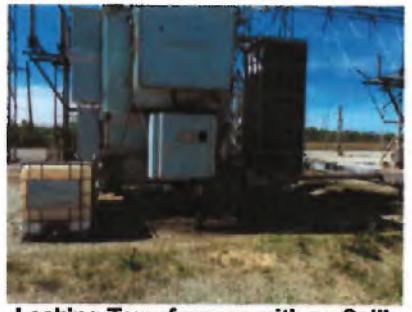
Leaking Transformers with no Spill Containment

This investment will result in the complete rebuild and reconfiguration of Wanstead Transformer Station in a greenfield location. The scope of the work will include replacement of the three non-standard transformers and associated deteriorated infrastructure with two new standard 50/83 MVA transformers, construction of the medium voltage gas insulated indoor switchgear, and protection, control and teleprotection facilities that adhere to the current standards. To address environmental issues and to meet current Ministry of Environment and Climate Change requirements, spill containment, drainage and oil/water separator facilities will be also installed on the new transformers.

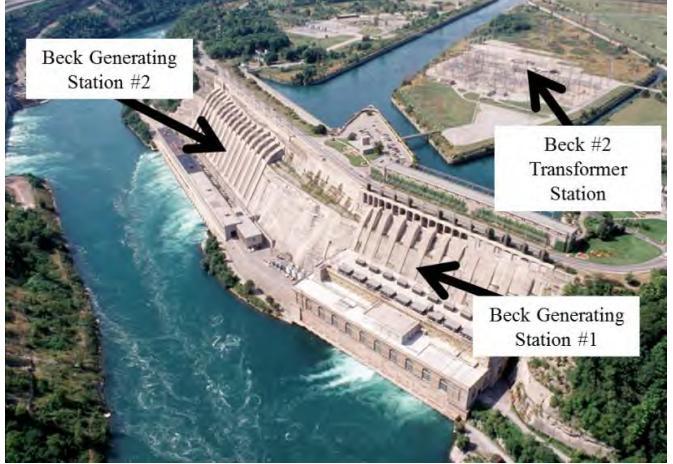
The condition of the assets at Beck has resulted in 68 air blast circuit breaker failures in the last 7 years, resulting in corrective and emergency work to address equipment deficiencies. Current annual sustainment cost of Beck #2 Transformer Station is \$1 million, which is 2.5% of Hydro One Transmission's 2016 total power equipment preventative and corrective maintenance budget. This cost is forecasted to increase due to lack of spare parts and technical knowledge for maintaining this

obsolete equipment. With this investment, we estimate that maintenance and corrective costs will be lowered by \$600,000 per annum, and will further reduce incremental and indirect costs that the failures have caused for both Hydro One and our customers.

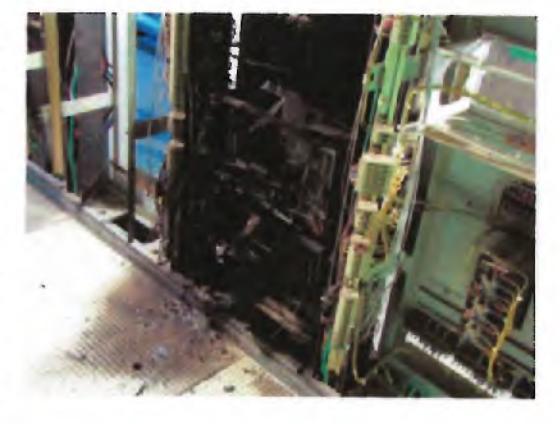
The existing six 115kV oil circuit breakers, its disconnect switches, protection, control and teleprotection equipment and other associated facilities are at end of life due to their poor condition, obsolescence and declining performance as verified through visual inspection, diagnostic testing and recent major interruption of October 27, 2015 which impacted 62MW of load in the City of Kingston as a result of failed equipment at the station. The asset event investigation recommended the earliest

Fire damage as a result of failed equipment at Barrett Chute SS

replacement of the oil circuit breakers and upgrades to the protection, control and teleprotection equipment in order to prevent this failure from reoccurring.

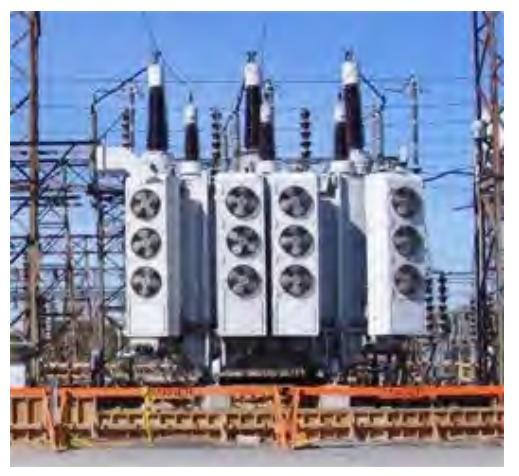
T21 autotransformer - 60 years old, end of life unit with no self cooling rating

two 230-115 kV, 75/100/125 MVA autotransformers (T21 and T23) that are at end of life, in poor condition, limited capacity and require noise mitigation; In-service: December 13, 2021

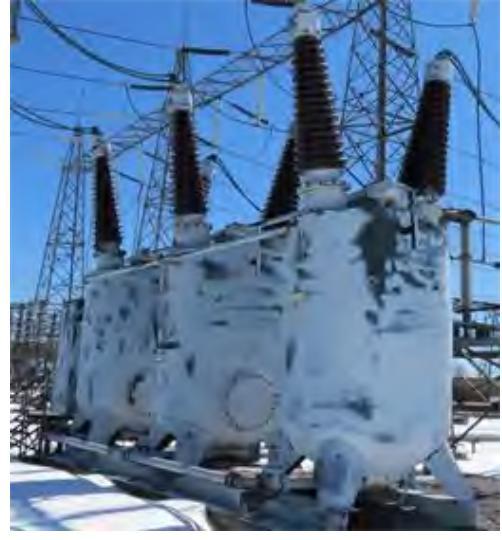
64 year old, end of life 230kV oil circuit breaker

- (ii) five 230kV Canadian Westinghouse GW oil circuit breakers that do not meet the required interrupting time for high voltage circuit breakers;
- (iii) three 230 kV bus sections that are inadequate for withstanding the existing short circuit levels at the station;
- (iv) four 115 kV line disconnect switches and two breaker disconnect switches;
- (v) replacement of the 1960's vintage design 44kV switchyard equipped with eleven oil circuit breakers and four feeder tie switches that pose safety risks to field maintenance personnel due to electrical safety clearance issues;
- (vi) upgrades to the DC Station service, protections, controls and telecom facilities to meet Northeast Power

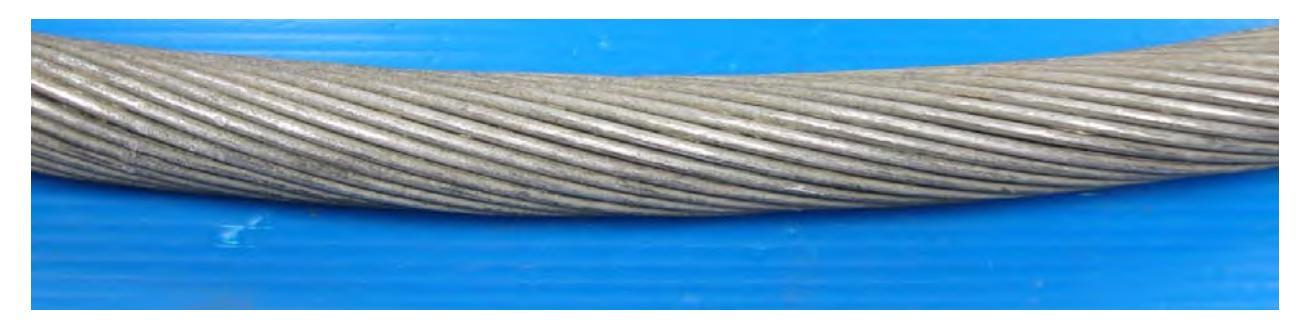
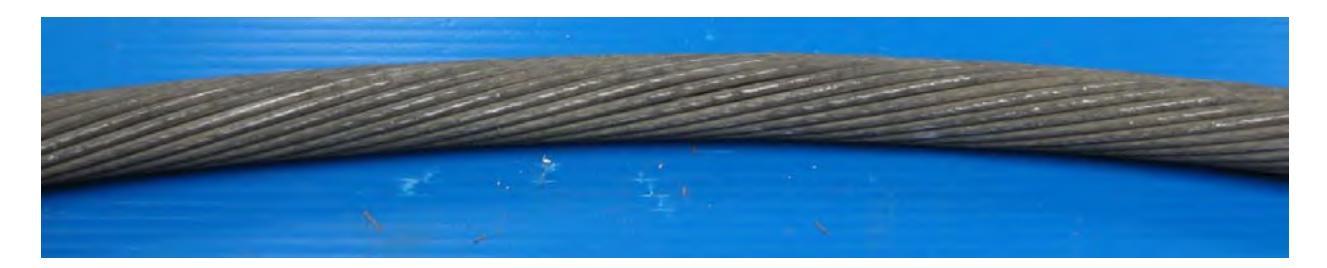
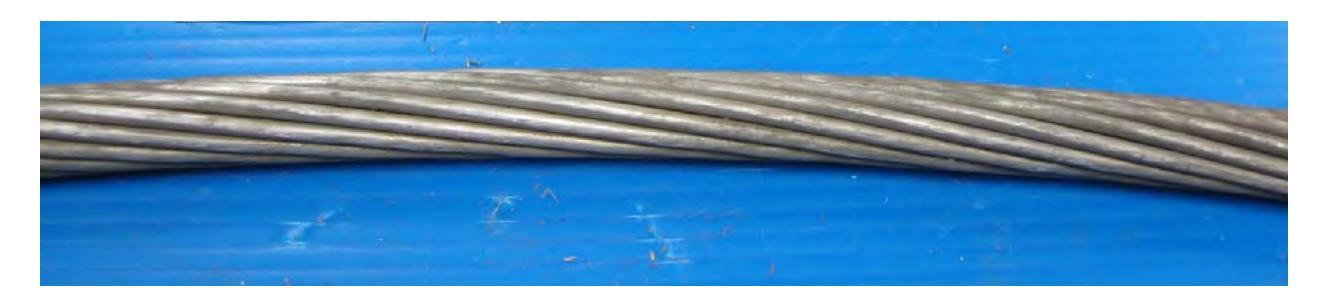
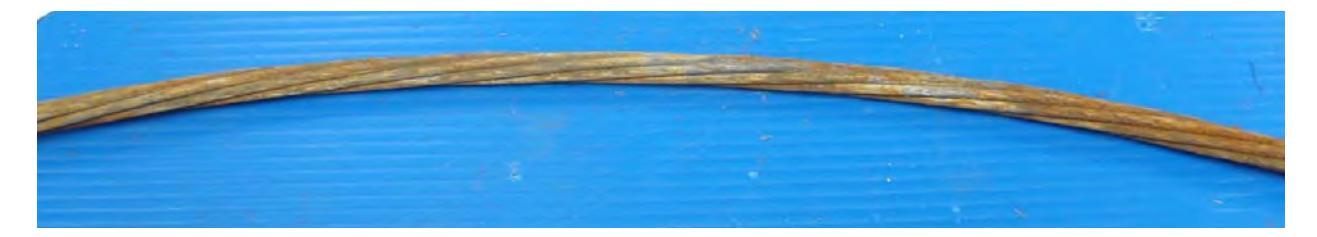
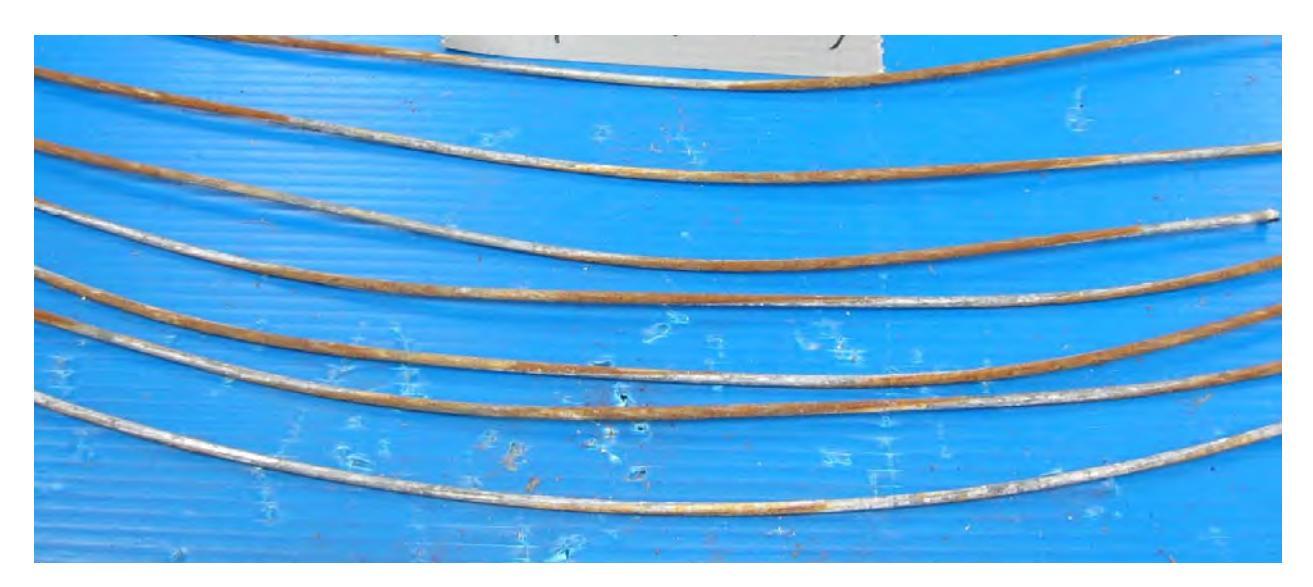
The degradation of the conductor has started to be noticeable. The amount of rust and contamination shows that the conductor is in the early stages of deterioration.

Figure 2 Outer Aluminum Wires Circuit D1A, Conductor Structure 5 – 16

Figure 3 Middle Layer Aluminum Wires Circuit D1A, Conductor Structure 5 – 16

Figure 4 Inner Layer Aluminum Wires Circuit D1A, Conductor Structure 5 – 16

Figure 5a Steel Core Wires – Outer Surface Circuit D1A, Conductor Structure 5 – 16

Figure 5b Steel Core Wires – Dissected Circuit D1A, Conductor Structure 5 – 16

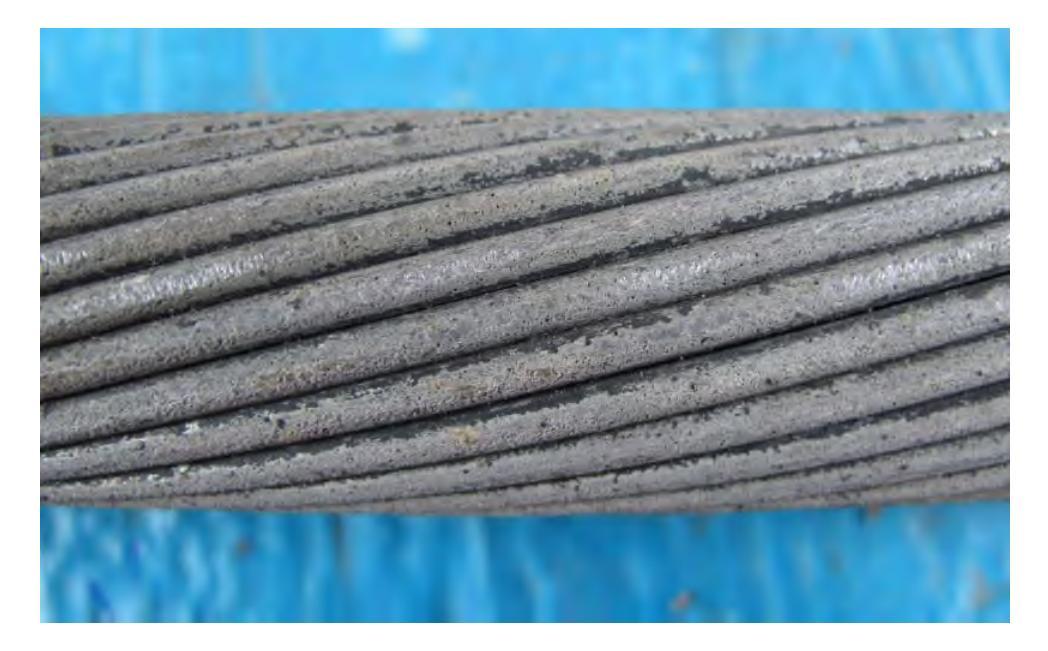
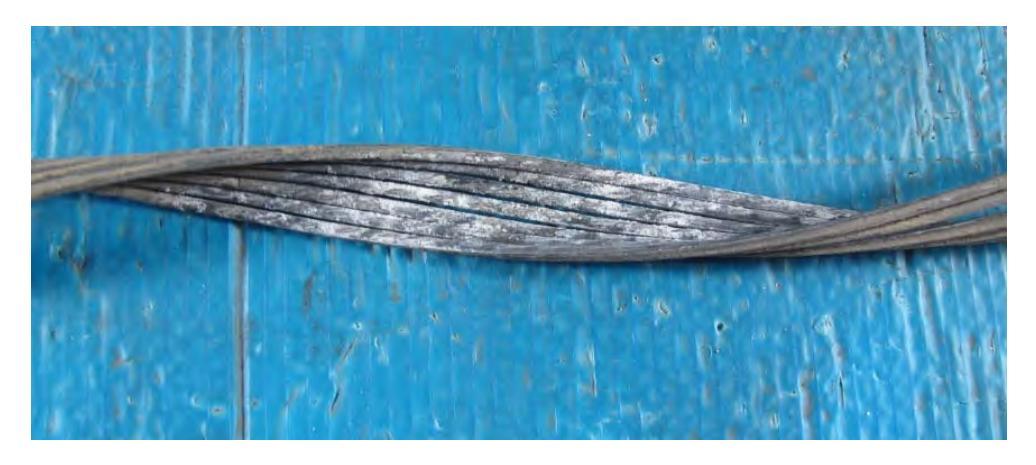
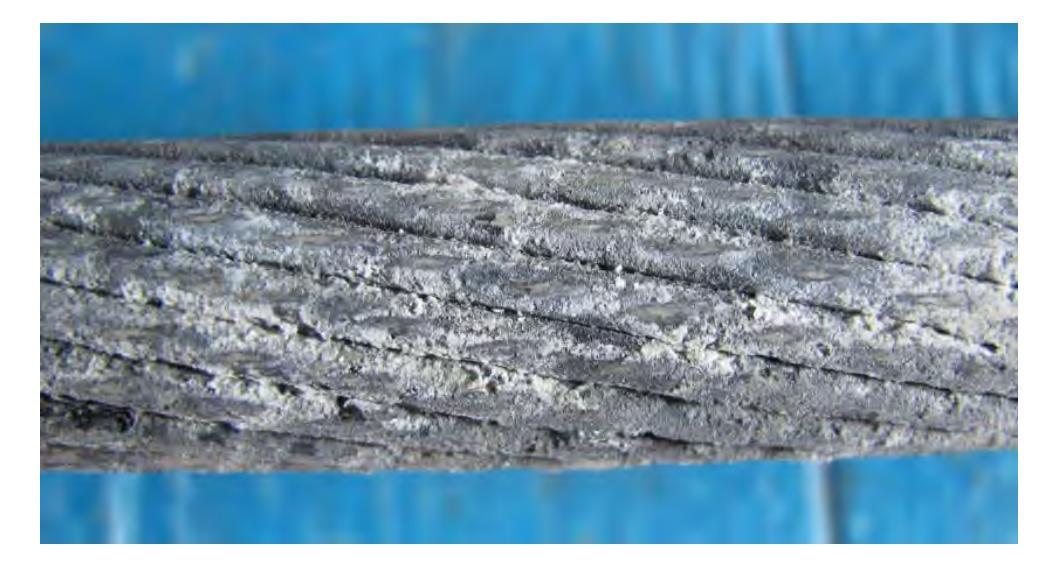
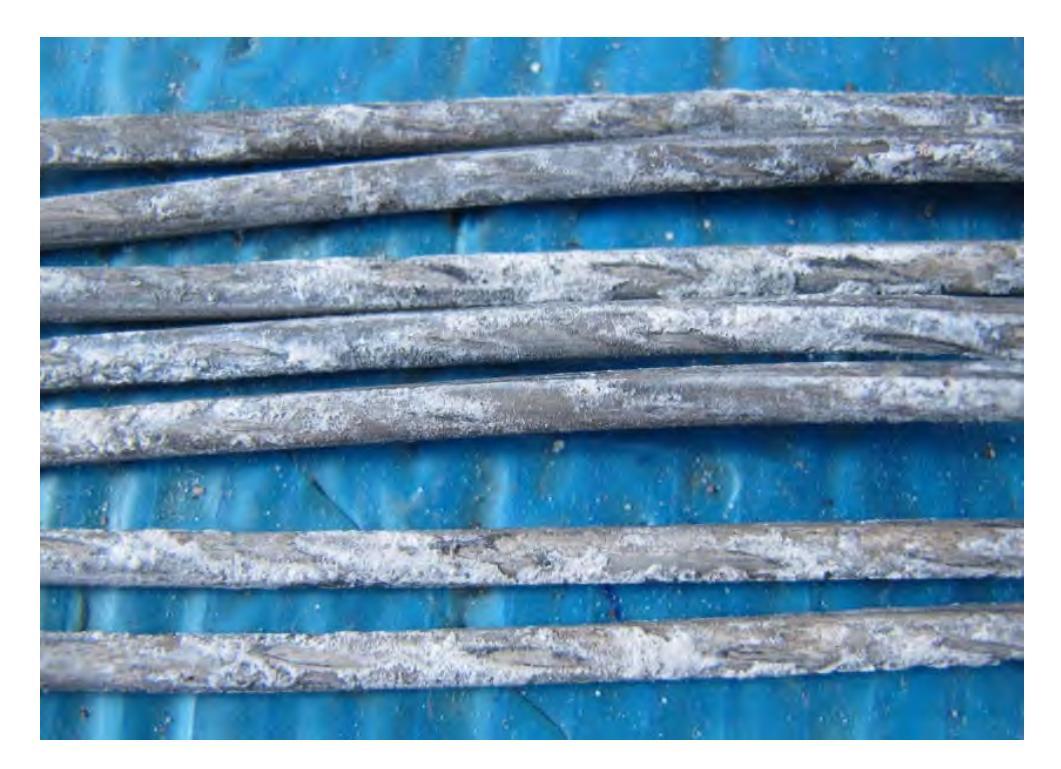
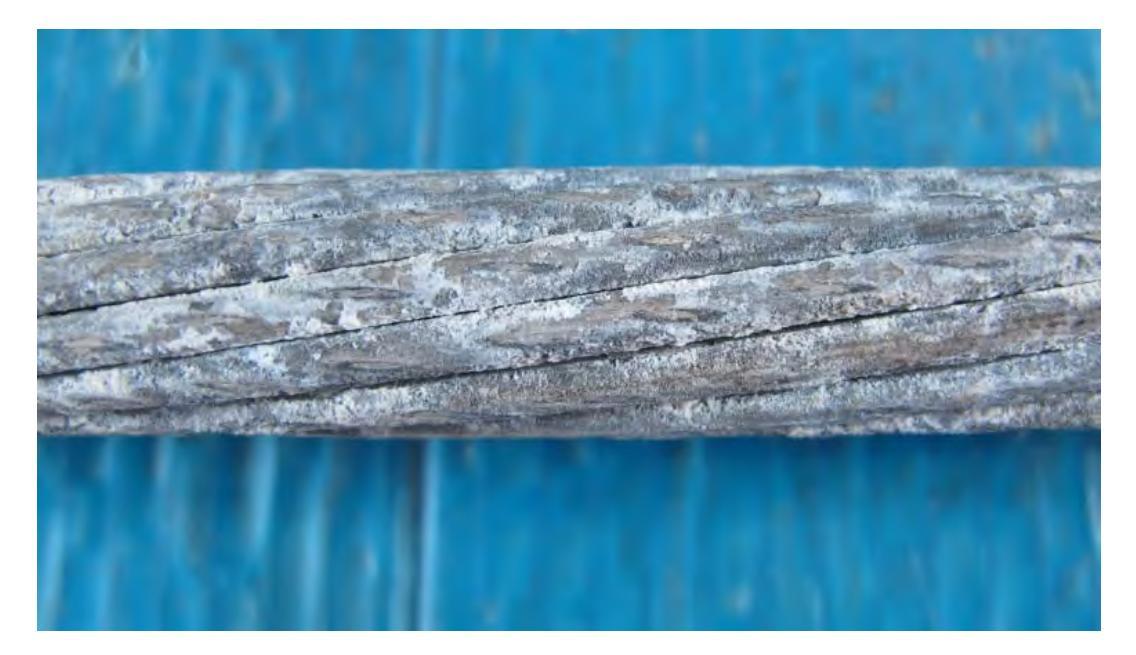
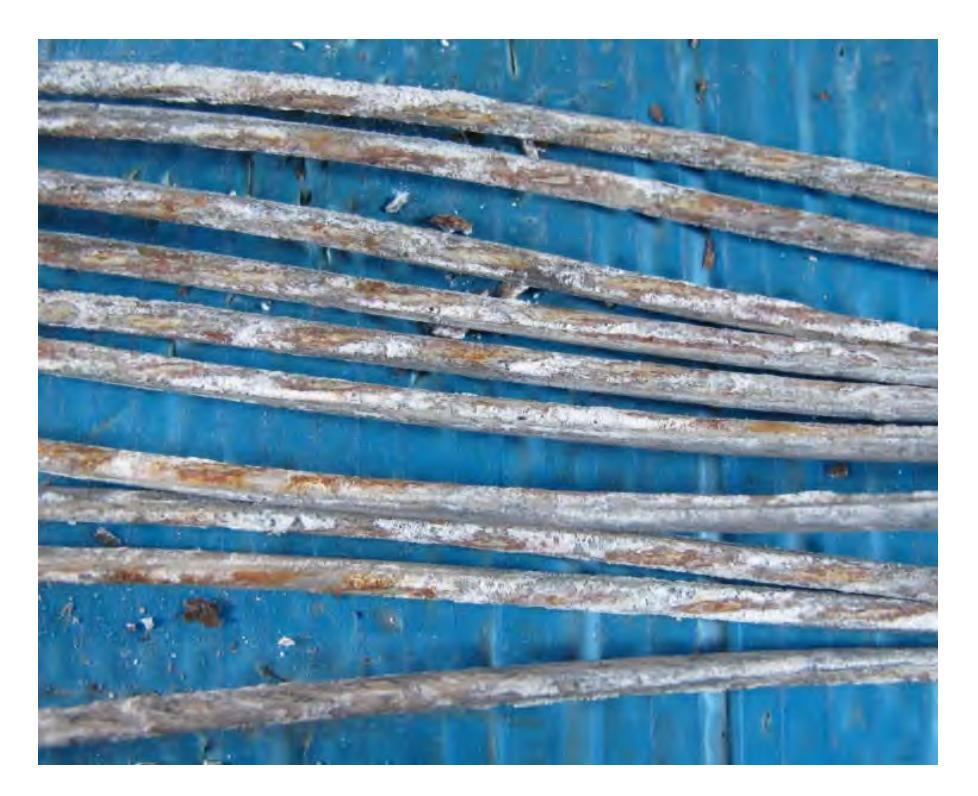
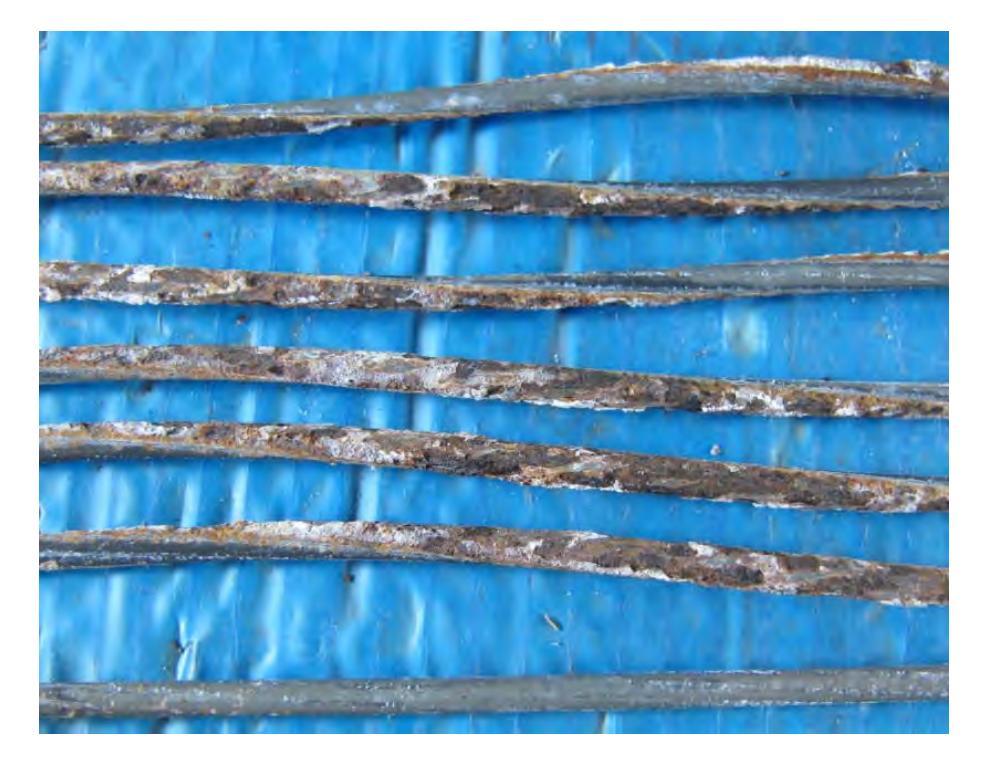
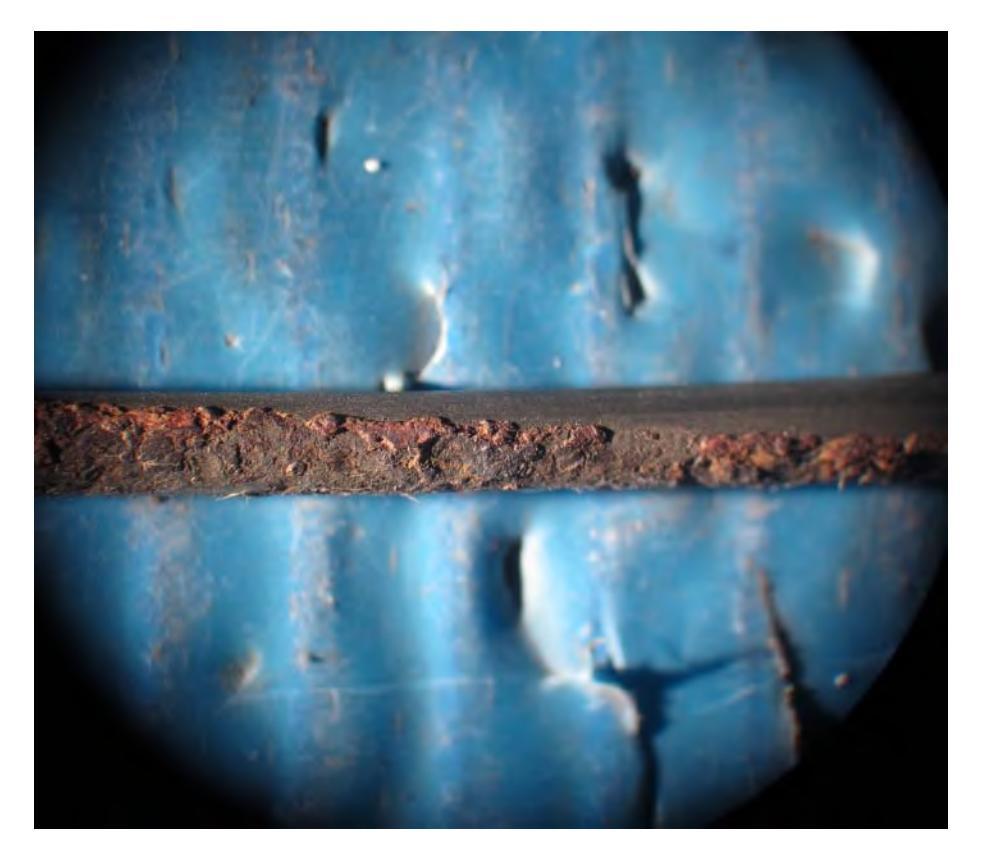
The observations indicate that most layers of the conductor are in advanced stage of deterioration. The conclusion of the visual examination is based on the worst condition found in the sample provided.

Figure 1a Outer Layer Aluminum Wires - Outside Surface Circuit Q12S

Figure 1b Outer Layer Aluminum Wires - Inner Surface Circuit Q12S

Figure 2a 2nd (Middle) Layer Aluminum Wires - Outside Surface Circuit Q12S

Figure 2b 2nd (Middle) Layer Aluminum Wires - Inside Surface Circuit Q12S

Figure 3a 3rd (Inner) Layer Aluminum Wires - Outside Surface Circuit Q12S

Figure 3b 3rd (Inner) Layer Aluminum Wires - Inside Surface Circuit Q12S

Figure 4a Steel Layer Wires - Outside Surface Circuit Q12S

Figure 4b Steel layer Wires - Magnified View of Area with Severe Corrosion Circuit Q12S

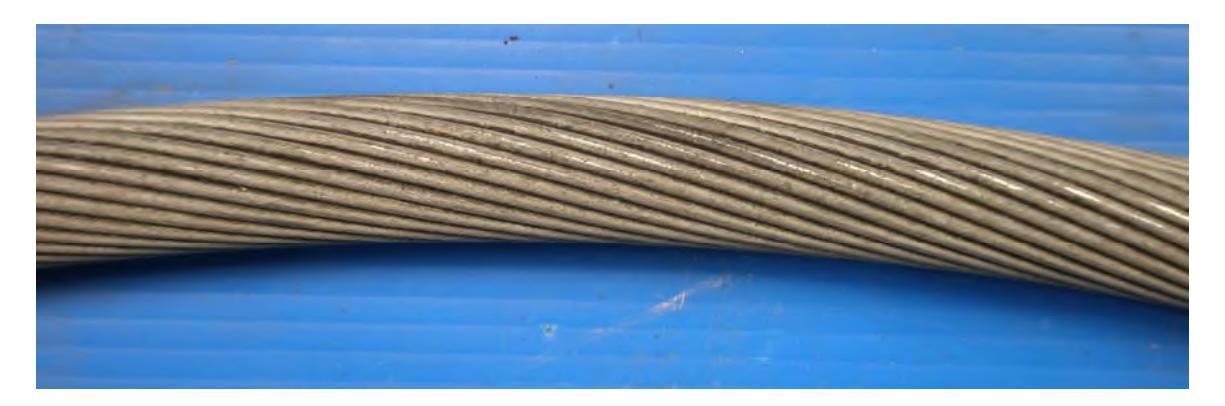
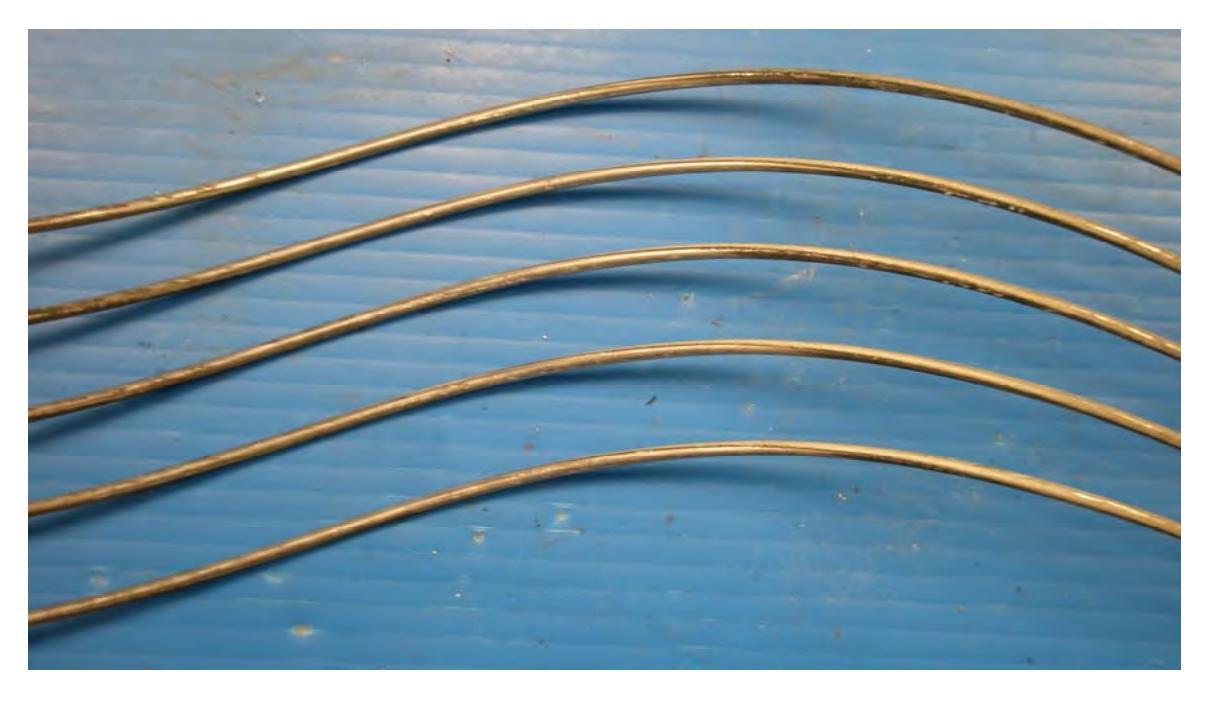
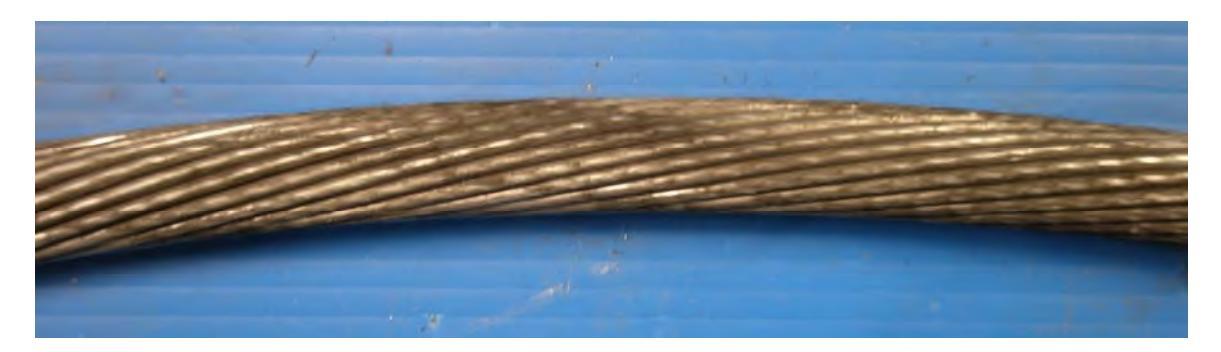
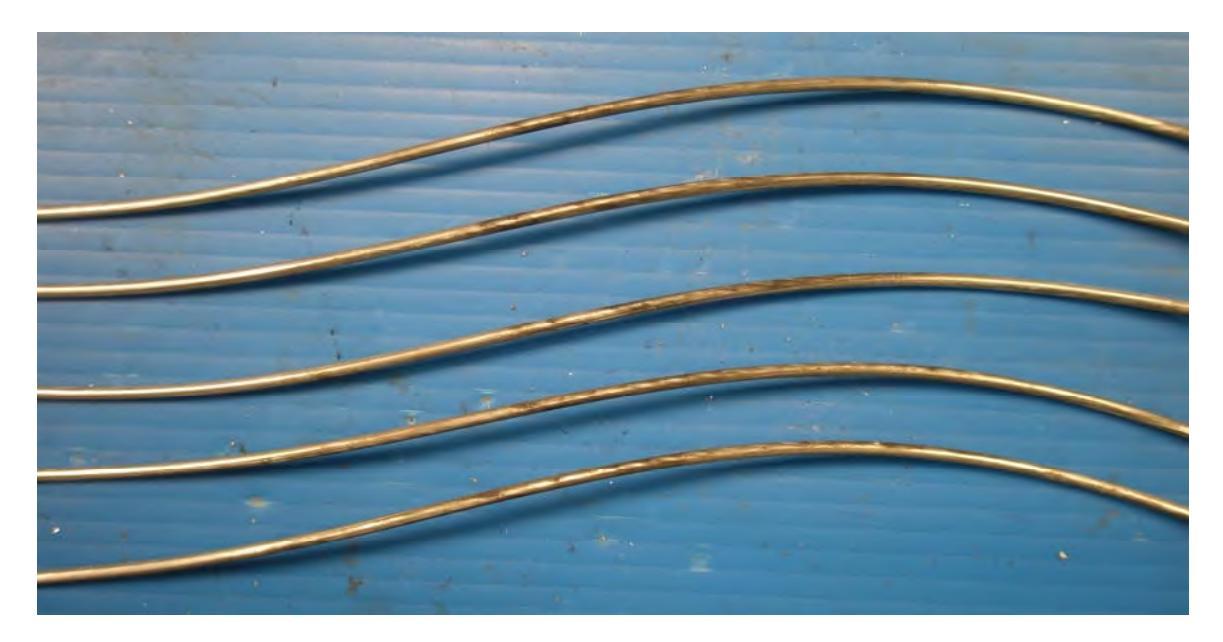
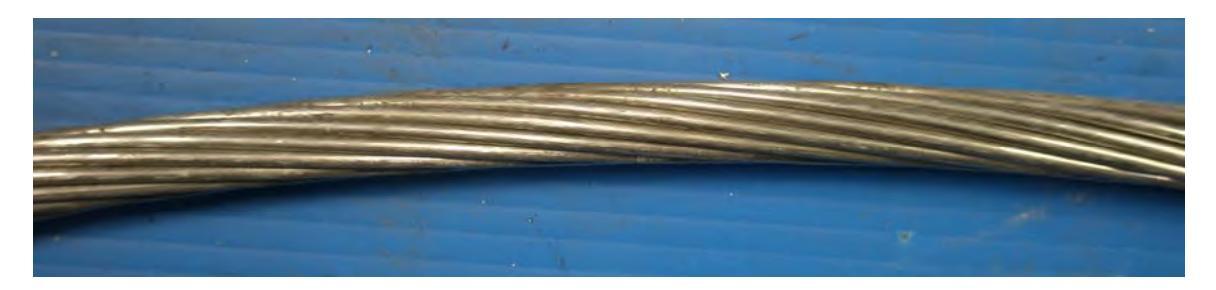
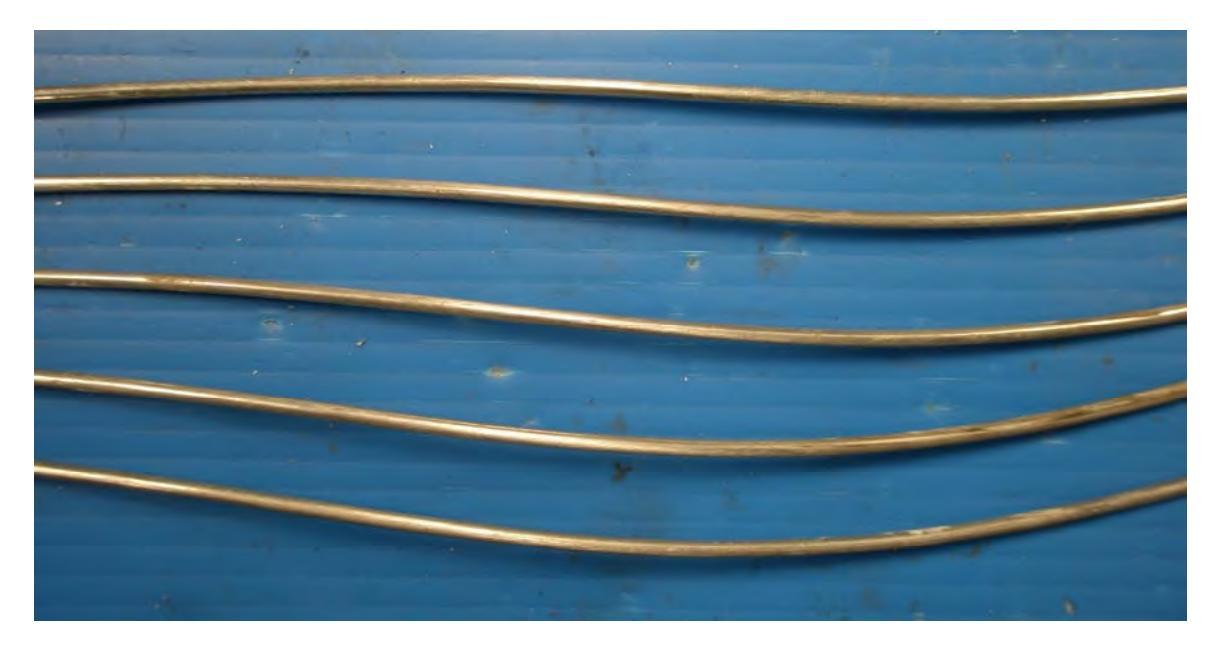
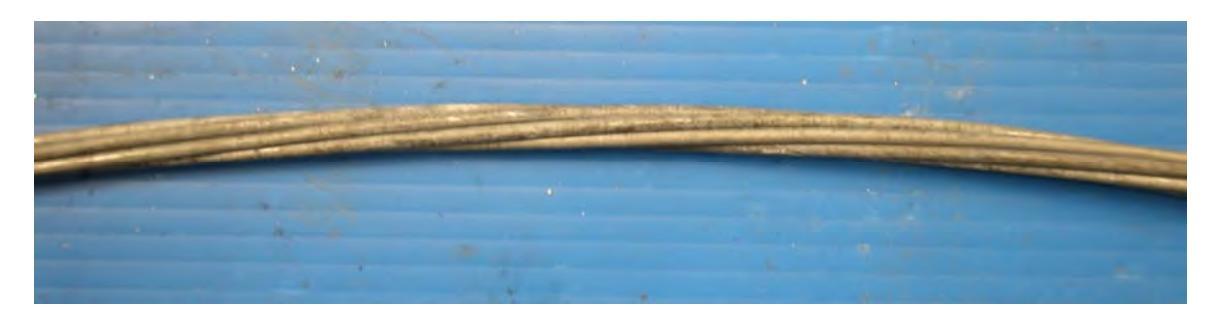
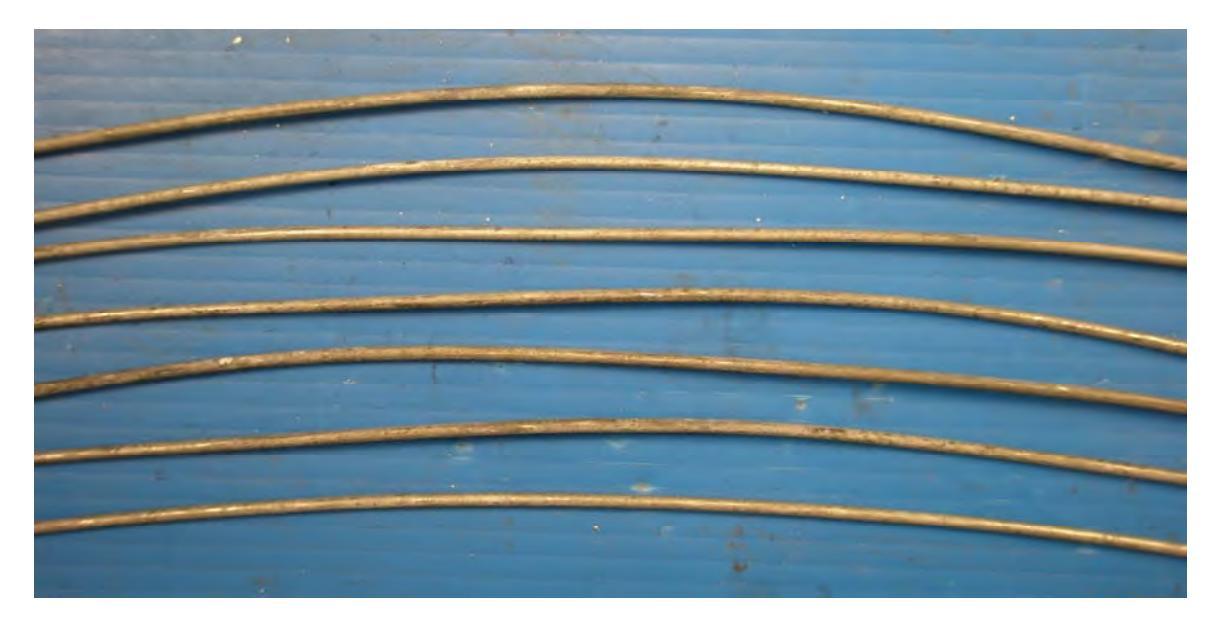
There is light signs of corrosion activity of the steel core. The amount and extent of rust and contamination show that the conductor is in the early stages of deterioration.

There is contamination and scale build up in the inner layers of aluminum wires. In addition, there was light-to-medium severity of wear and fretting. The broken wires found during the ½ span dissection, after the breaking load test, indicate that there may have been vibration related wear at or near the suspension assembly. Because the as-received suspension assembly was loose, the exact location at the time of installation is unknown.

Figure 1a Outer Aluminum Wires Circuit H24C, Conductor Tower 700 – 720

Figure 1b Outer Aluminum Wires – Inner and Outer Surfaces Circuit H24C, Conductor Tower 700 – 720

Figure 2a Middle Layer Aluminum Wires Circuit H24C, Conductor Tower 700 – 720

Figure 2b Middle Layer Aluminum Wires – Dissected Wires Circuit H24C, Conductor Tower 700 – 720

Figure 3a Inner Layer Aluminum Wires Circuit H24C, Conductor Tower 700 – 720

Figure 3b Inner Layer Aluminum Wires – Dissected Wires Circuit H24C, Conductor Tower 700 – 720

Figure 4a Steel Core Wires Circuit H24C, Conductor Tower 700 – 720

Figure 4b Steel Core Wires – Dissected Wires Circuit H24C, Conductor Tower 700 – 720

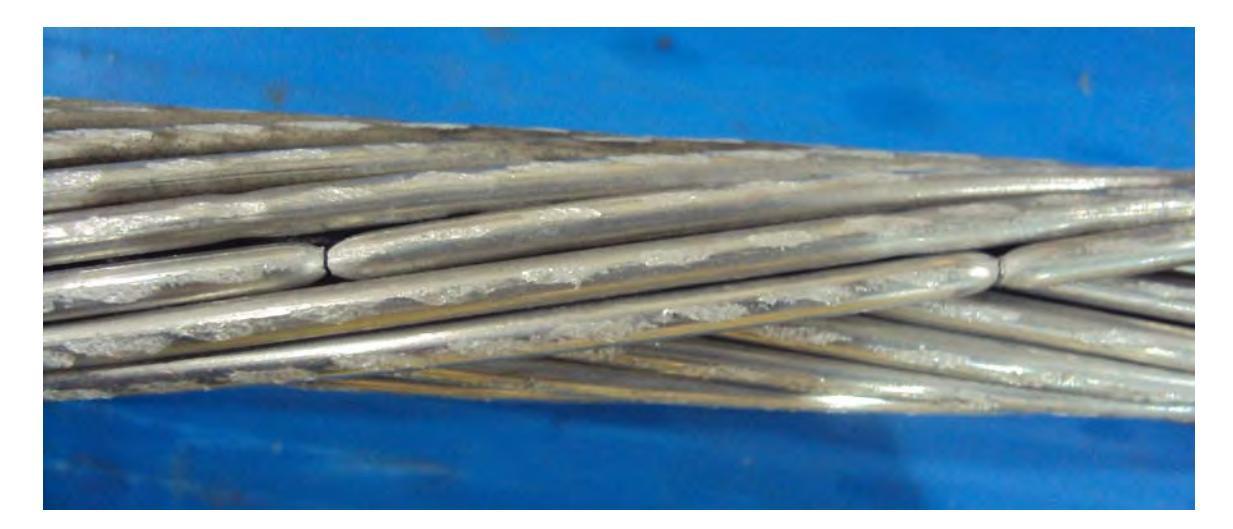
Figure 5 Broken Aluminum Wires Found in 2^{nd} Layer, From 0 to 2.5 m from Suspension $\frac{1}{2}$ Span Dissection – After Breaking Load

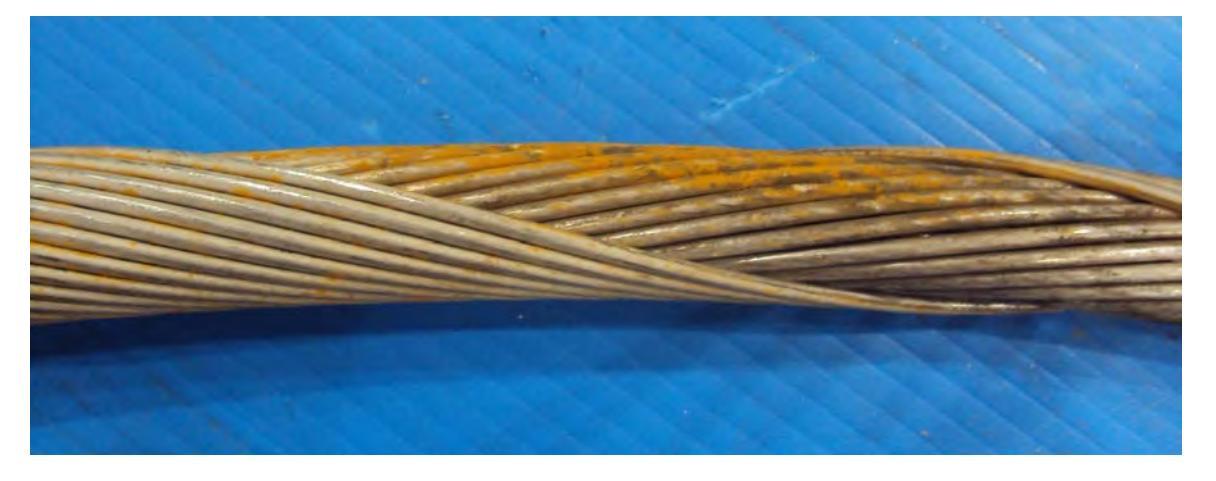
Figure 6 Localized Contamination Found in 2^{nd} Layer, From 10 to 12.5 m from Suspension $\frac{1}{2}$ Span Dissection – After Breaking Load
