City Hall Hydro Vault Fire

Date:	August 27, 2015
To:	Government Management Committee
From:	Chief Corporate Officer
Wards:	All Wards
Reference Number:	P:\2015\Internal Services\FAC\Gm15020fac (AFS 21337)

Hydro Vaults and Heat Detectors

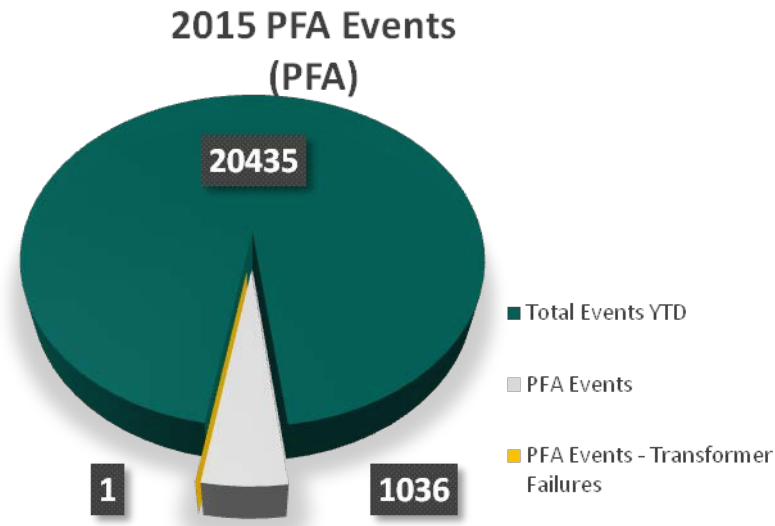
As of September 2015, Toronto Hydro has responded to a total of 20,435 events of which Police, Fire and Ambulance (PFA) events total of 1036 events, or 5 % of the total year to date volume. Of the 1036 PFA events received, only 1 was attributed to a building transformer vault. Upon arrival, TFS did not find an active fire in progress but only smoke arising from overheated polyethylene cable insulation.

This equates to 0.09% of the total PFA events YTD, or 0.004% of the total for all events YTD.

There is no evidence of a systemic distribution system failure mode that is causing fire in electric building vaults.
