**Impact, Torsion, and Crush Tests for
477 kcmil and 795 kcmil 3M Brand Composite
Conductor**

**3M Company
Purchase Order 0000620410**

NEETRAC Project Number: 02-229

October, 2002

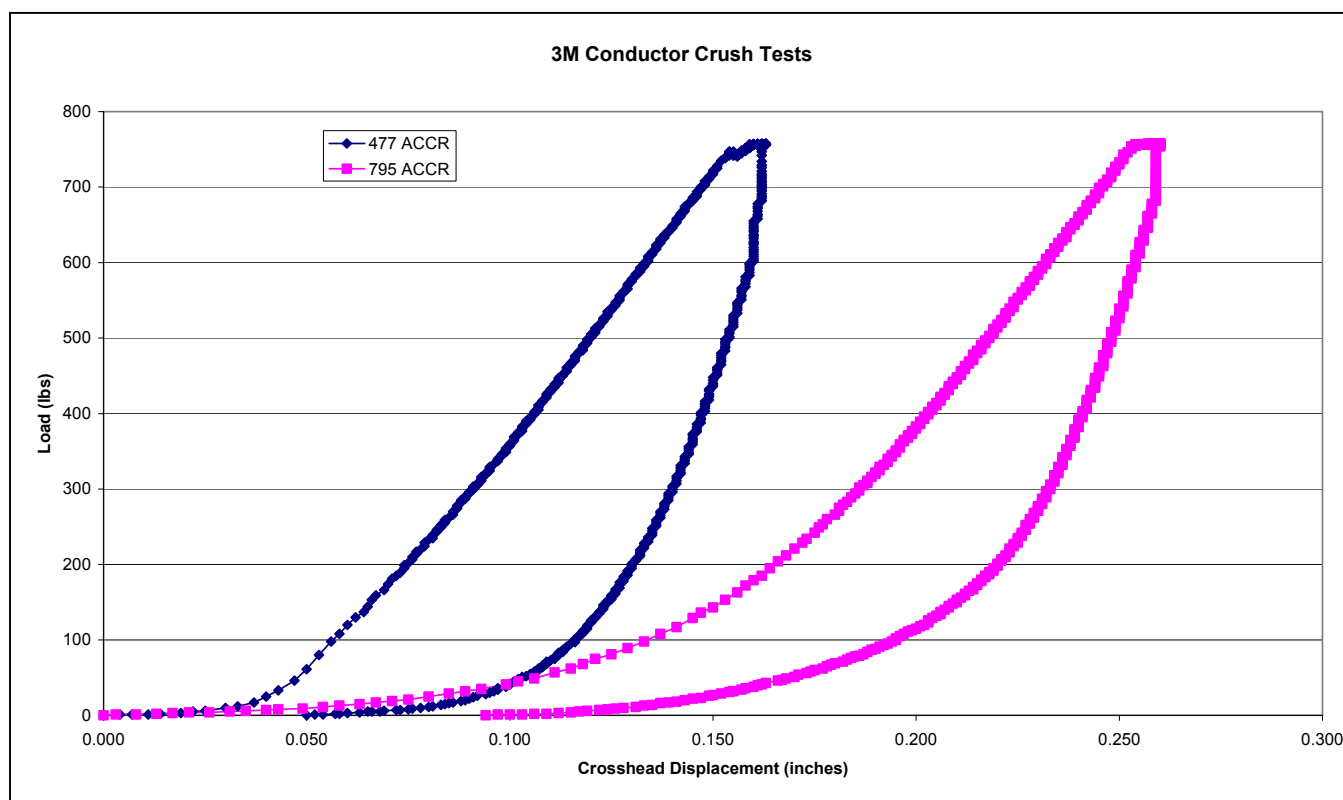
Following the crush tests, the conductor samples were returned to 3M for dissection and evaluation of the condition of the core strands. 3M's Colin McCullough reported that the tensile test evaluation showed full strength retention of the strands. Figure 1 shows load versus anvil displacement for the crush tests.

Figure 1, Load versus force for MMC conductor crush tests

The crush test is designed to simulate damage to a cable during shipping and installation. A line truck running over the conductor applies loads similar to the crush test load stipulated in IEEE 1138 (optical cable testing). A value of 126 lb/linear inch was used for testing. A 6-inch diameter hardened steel platen was used to support the center section of a 2-ft long sample. A second hardened platen was used to apply the crush load. Load was increased at a rate of 600 lb/min. Load was held at 756 lbs (126 lb/inch) for one minute, and then released. Following the test, there were surface marks where the platens applied pressure, but no detectable deformation or other damage to the sample.

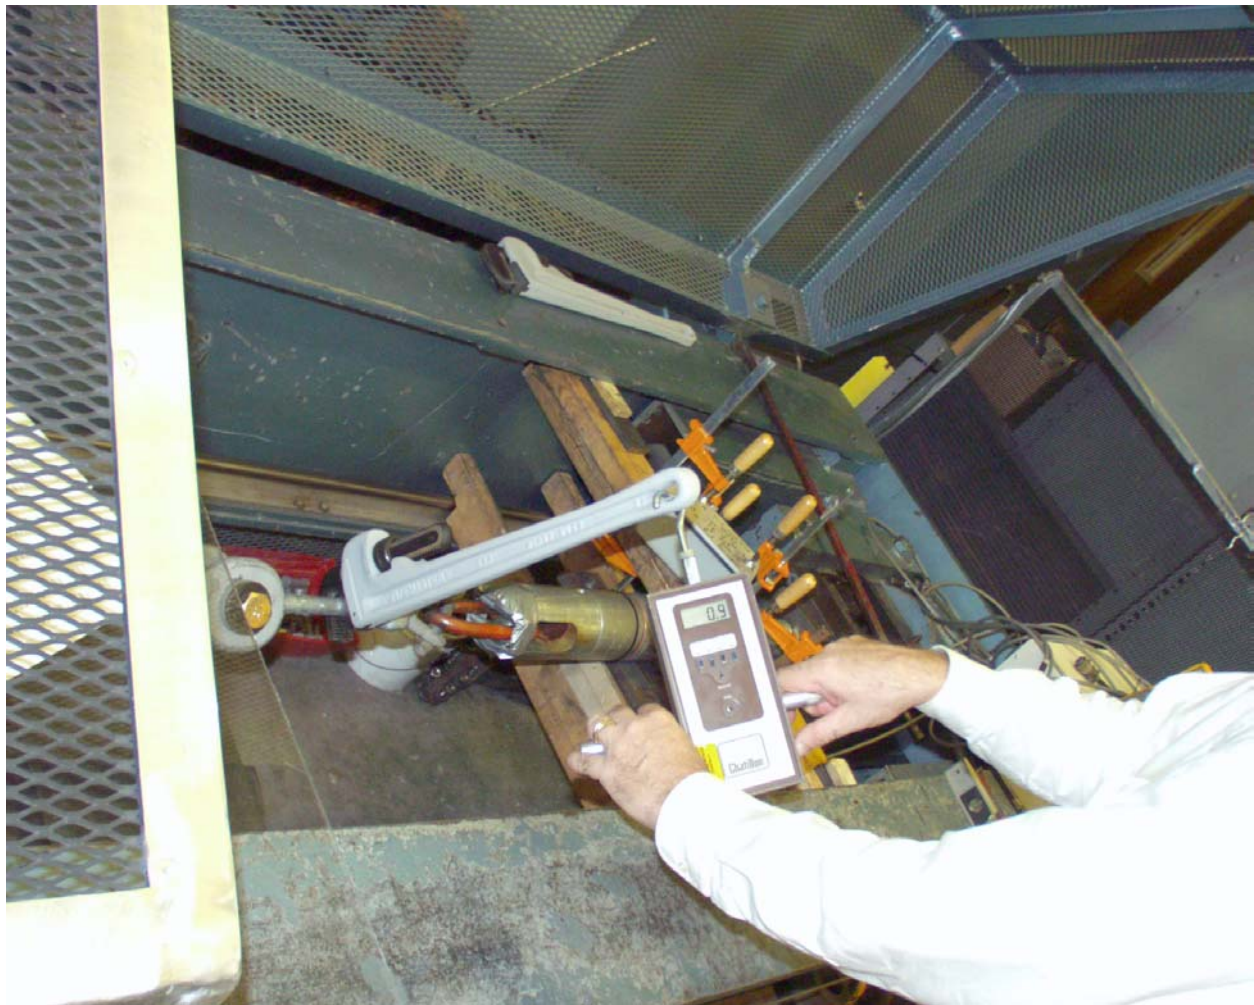
Photograph 1, sample rotation and torque measurement (note second pipe wrench)

of a pipe wrench used to rotate the sample. The pipe wrench was applied to a steel link, and did not contact the sample. The twist angle was increased in 180 degree steps, with the expectation that the conductor would fail within two or three turns. The exposed conductor measured 195.5 inches.

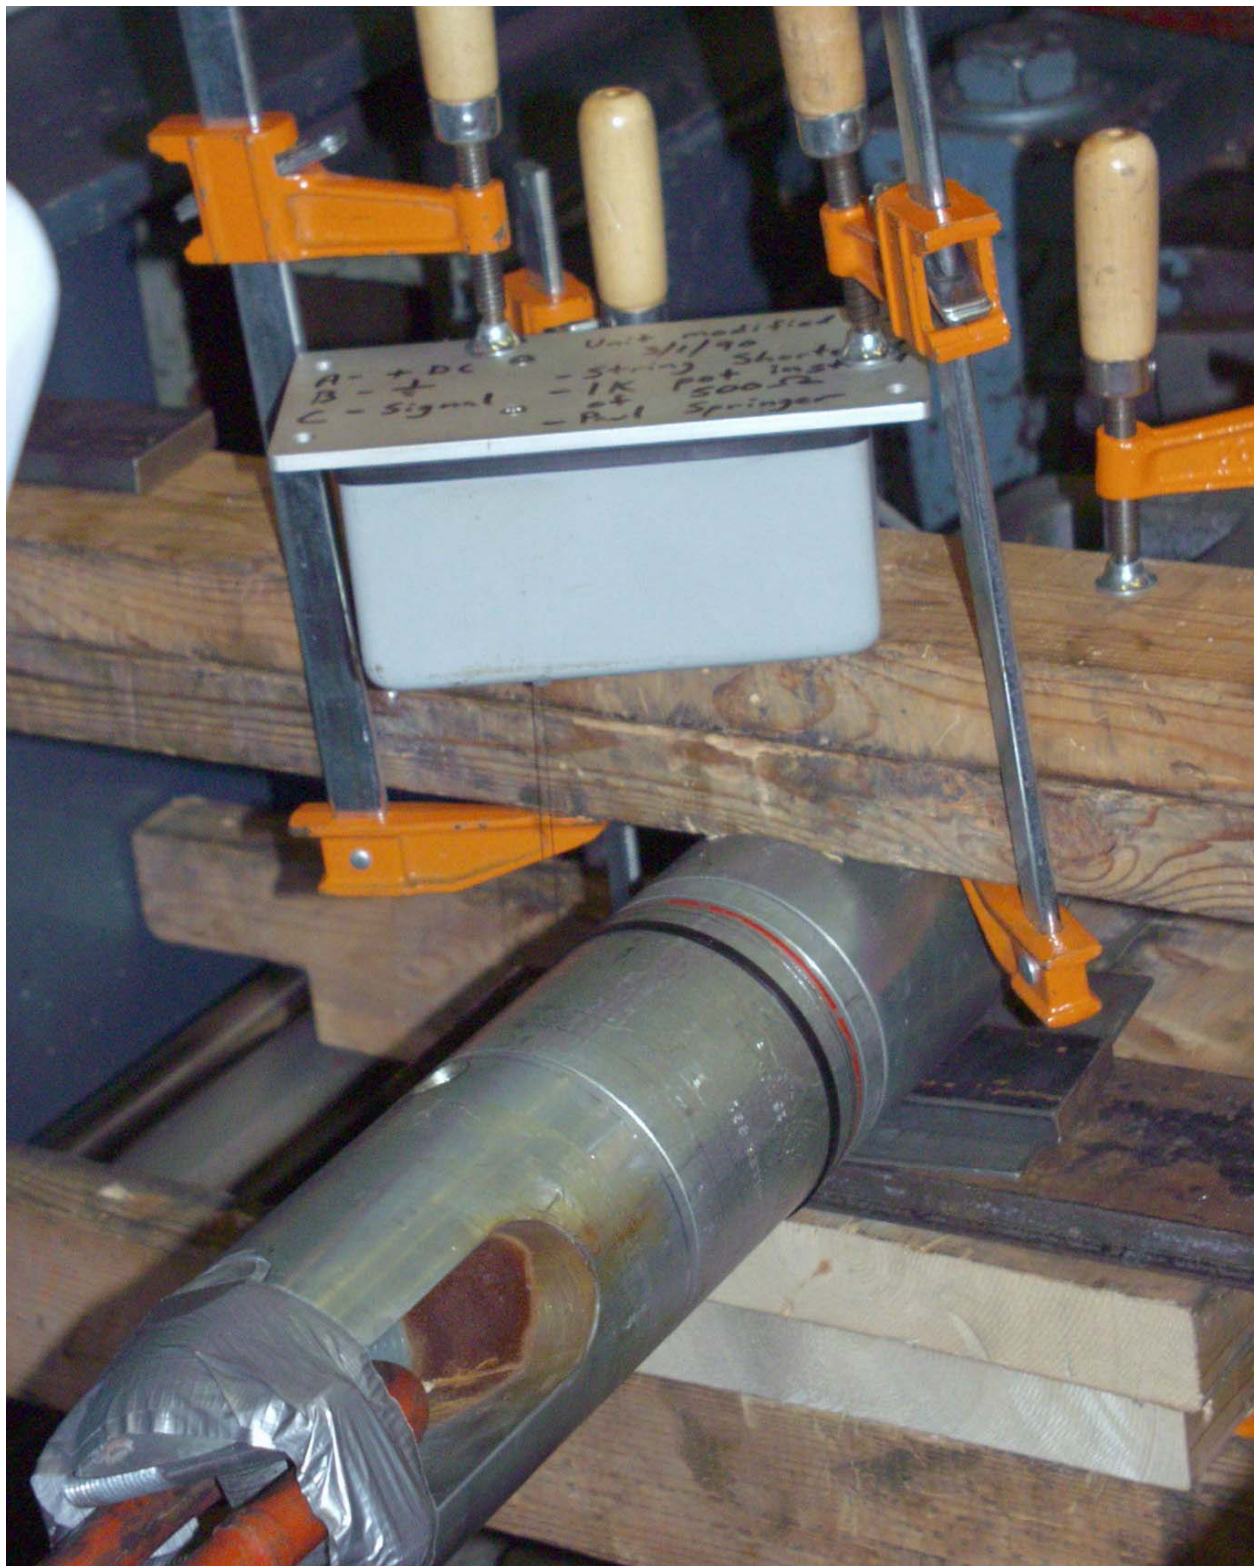
Photograph 2, rotation angle measured using string potentiometer on rotation bearing

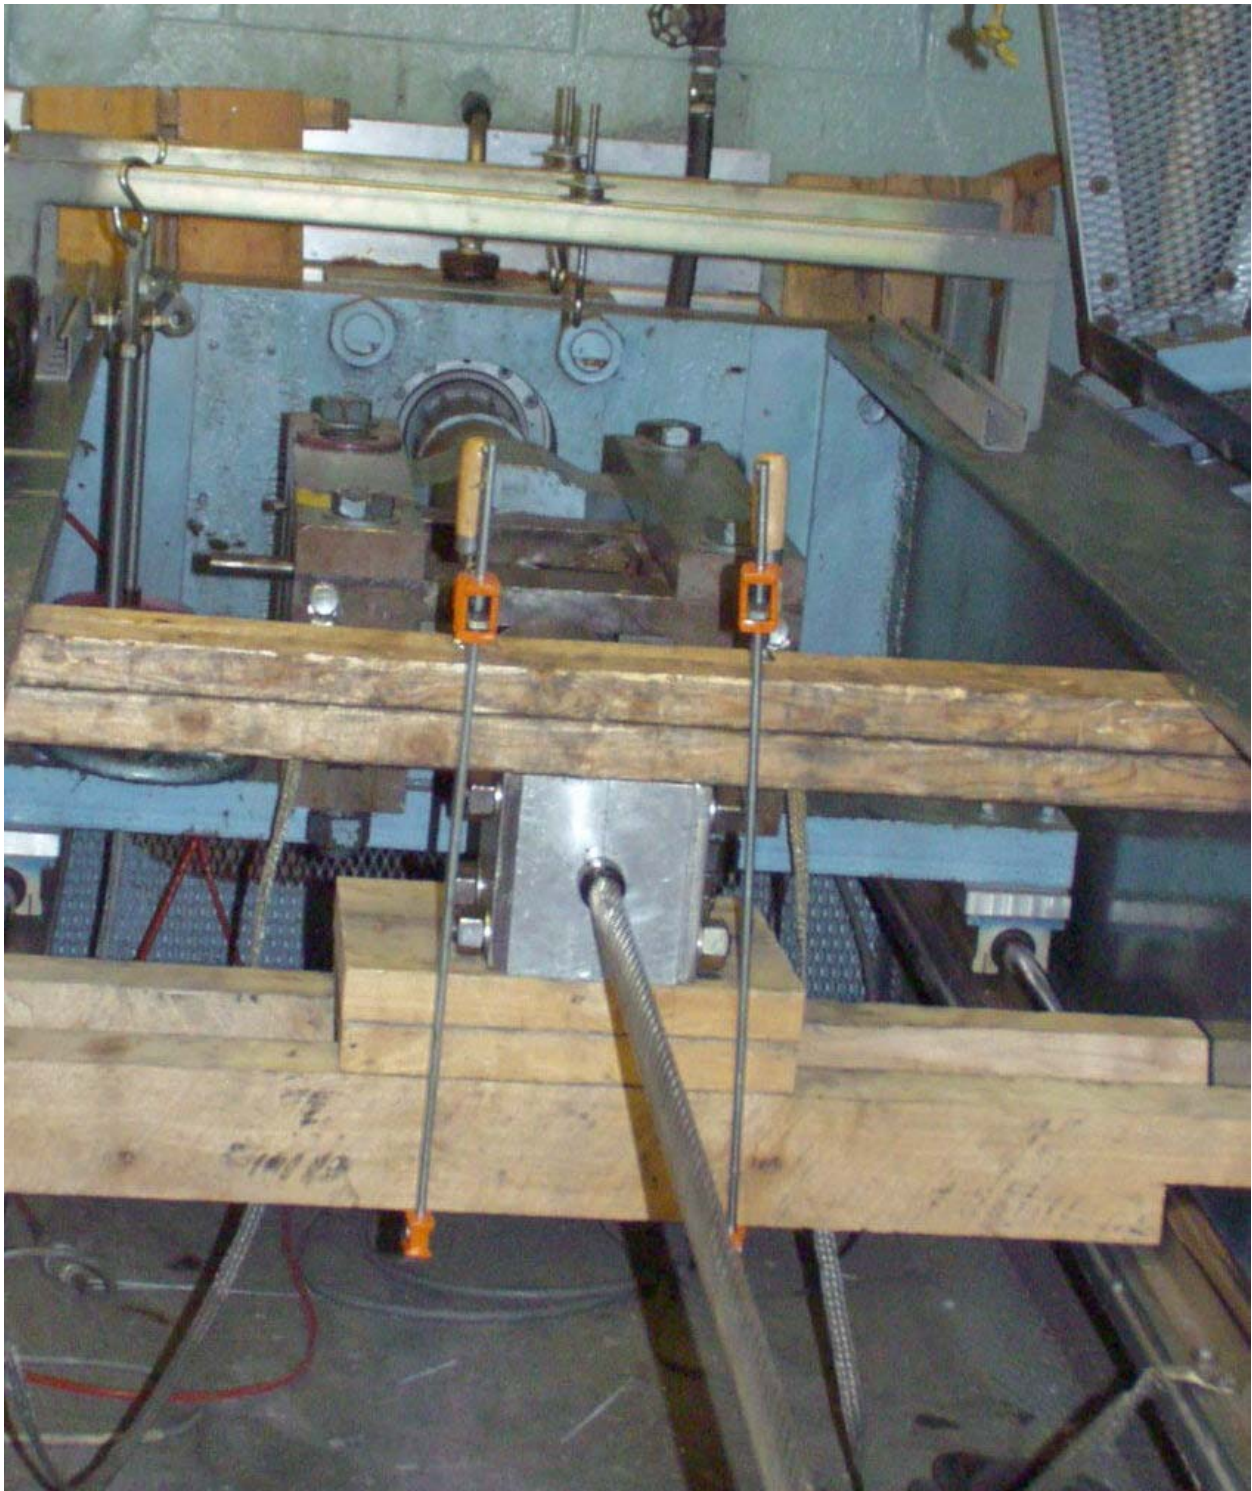
Photograph 3, cribbing used to prevent sample rotation

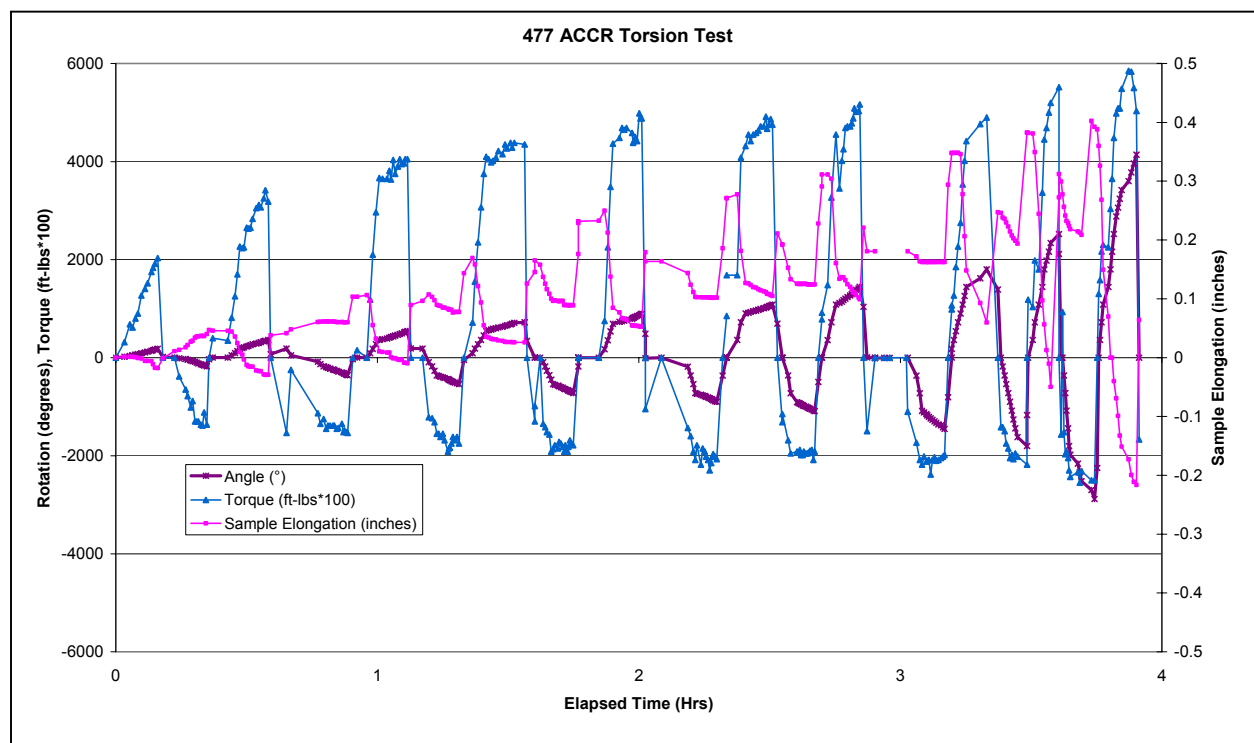
The conductor exceeded expectations by turning past 11 full rotations (3976 degrees), before an outer-layer aluminum strand broke. The rotation counter range was +/- 4 turns (+/- 1440 degrees). The instrument had to be removed and the zero point reset each time the limit was exceeded. The action of rotating the conductor proved to be quite strenuous for the pipe wrench operator. After the first aluminum strand broke, a request was made and granted to revise the procedure to permit removal of the outer aluminum strands to make it easier to continue rotating the sample to core failure. This was done. With the outer layer removed, the inner aluminum layer was extremely slack due to rotation opposite its lay direction. Therefore, all tensile load was on the core. Rotation continued in the positive direction (tighten the core outer layer). An additional five (5) turns were accomplished before the first core strand broke. Sixteen (16) turns from the neutral position were required to fail the core. The test demonstrated that the outer aluminum layer will fail before the MMC core in the event the conductor is twisted. The core fails at twist of one (1) rotation per foot. The outer aluminum layer fails at 0.68 rotations per foot. We were not able to cause the inner aluminum layer to fail. Figure 2 shows the torque, tension, and rotation angle during the 477 ACCR torsional ductility test.

Figure 2, Composite of manual and automatically recorded data during 477 ACCR torsion test

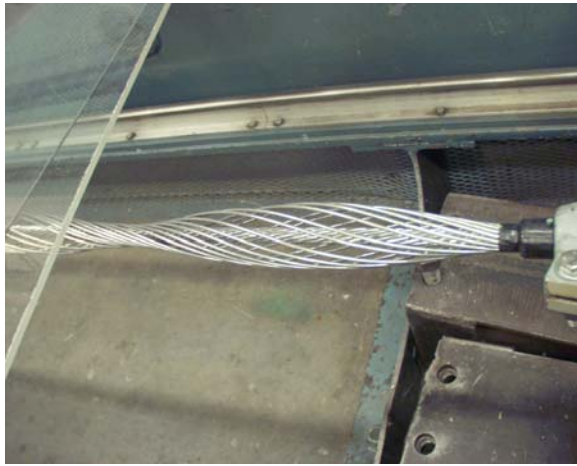
Photographs 4, and 5 document the condition of the conductor prior to any strand breaks. There was significant birdcaging before any strand breaks occurred.

Photograph 4, outer layer birdcaging

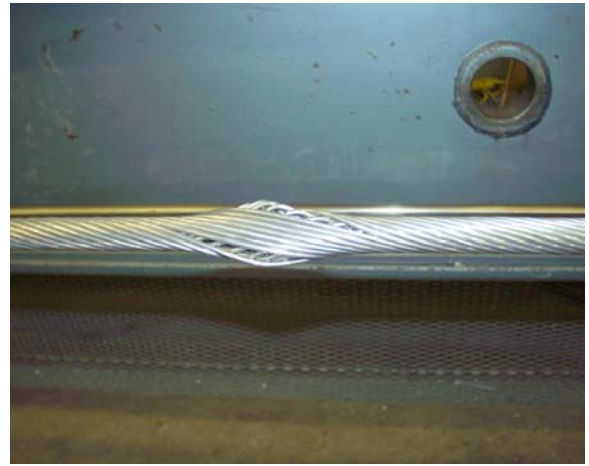
Photograph 5, inner layer birdcage

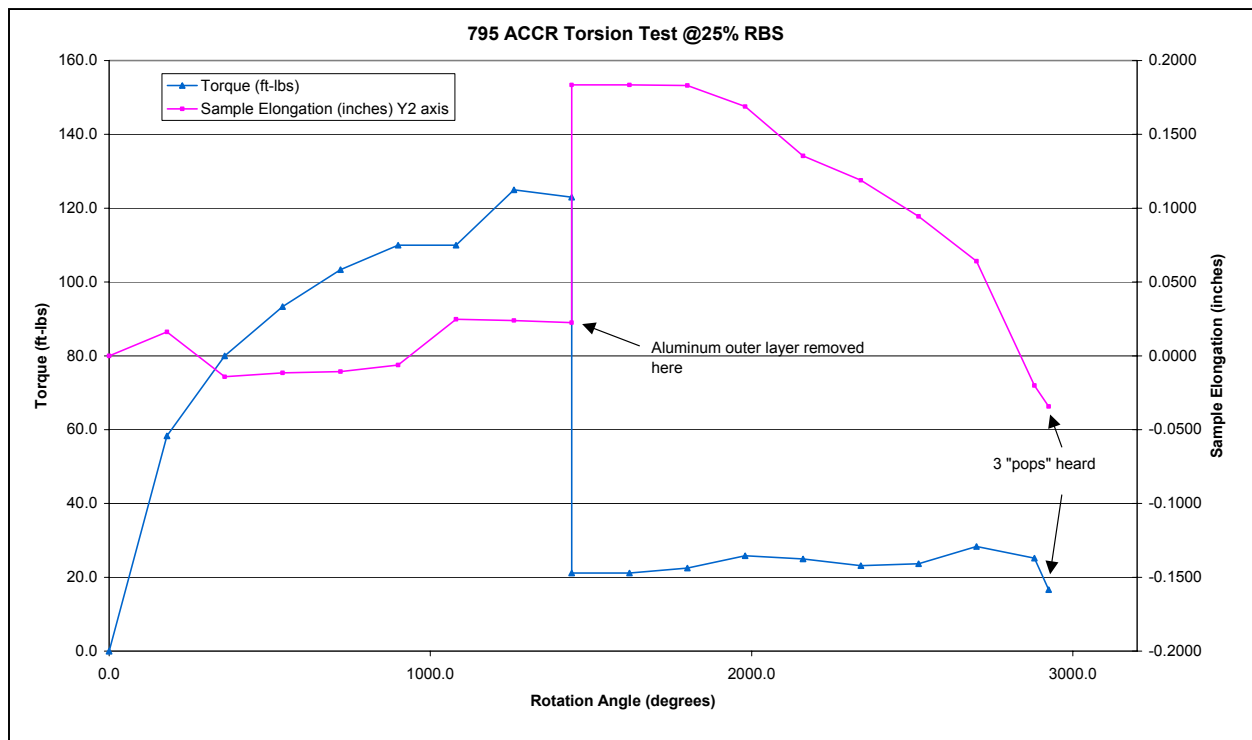
The conductor behaved as expected. It was difficult to turn with the two 24” pipe wrenches. At 1440 degrees (4.0 turns), the torque measured 123 ft-lbs (167 Nt-meters). Handle force on the pipe wrenches was 75 lbs, and we were developing gripping problems as the jaws chewed up the steel link. A decision was made to remove the outer aluminum layer at 4 turns to facilitate completing the torsion test on the core. The twist angle was held while all strands in the outer layer were cut using a tubing cutter. The outer aluminum layer pulled back 1.0 inches. The inner aluminum strands were birdcaged, so all tensile load was on the core. The first break in a core strand occurred at 2925 degrees (8.125 rotations). This establishes the torsion limit for the conductor at greater than 88 degrees/ft (0.24 rotations per foot). The limit for core damage is 180 degrees/ft (1/2 rotation per foot). Figure 3 shows the data recorded during the test:

Figure 3, Composite of manual and automatically recorded data during 795 ACCR torsion test

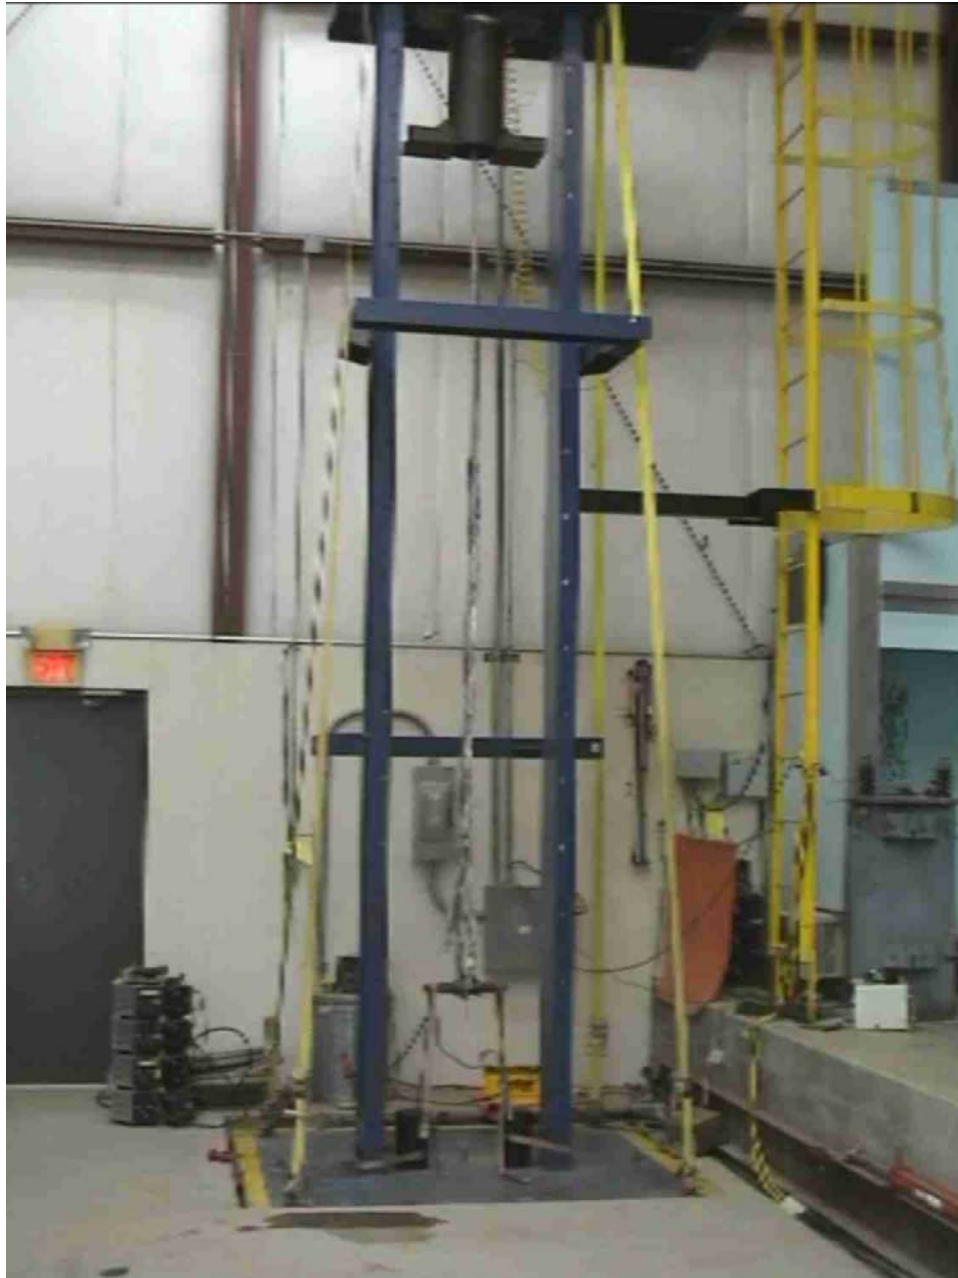
The sample is pulled to nominal tension using fabric straps fitted to a steel bar through the eye at the end of the formed wire grip. See Photograph 6, which shows the sample with the 1,300-lb drop weight ready to drop. A latch releases to put the weight in guided free fall. Rollers on the drop weight ensure that anvils contact the steel bar and load the sample in tension. The top of the sample is fitted to an impact-rated load cell, which is conditioned by a high-speed amplifier. The output of the load cell is recorded and stored using two Fluke ScopeMeters. One meter is set to record 50,000 samples per second, and will capture the fast transient if the sample ruptures at impact. The second meter is set to capture 5,000 samples per second. That instrument captures data in the event of a long transient due to slipping of the connector. Figure 4 shows the impact load versus time for the 477 sample. Figure 5 shows an estimate of load versus displacement for the 477 ACCR test. Displacement is estimated by making the assumption that drop weight velocity is constant during the impact event. This assumption is valid in

Photograph 6, Impact test machine

An impact test is performed in the same manner as a standard tensile test, except that load is applied by dropping a 1,300 lb weight from an elevation of 12 feet above the sample. The sample is placed in a vertical configuration, and the impact is in the axial (downward) direction. Impact velocity is 24 ft/sec. The sample is pre-tensioned to 400 lbs. The shock load is comparable to loading rate experienced during ice jumps, galloping events, and impact from storm-blown objects.

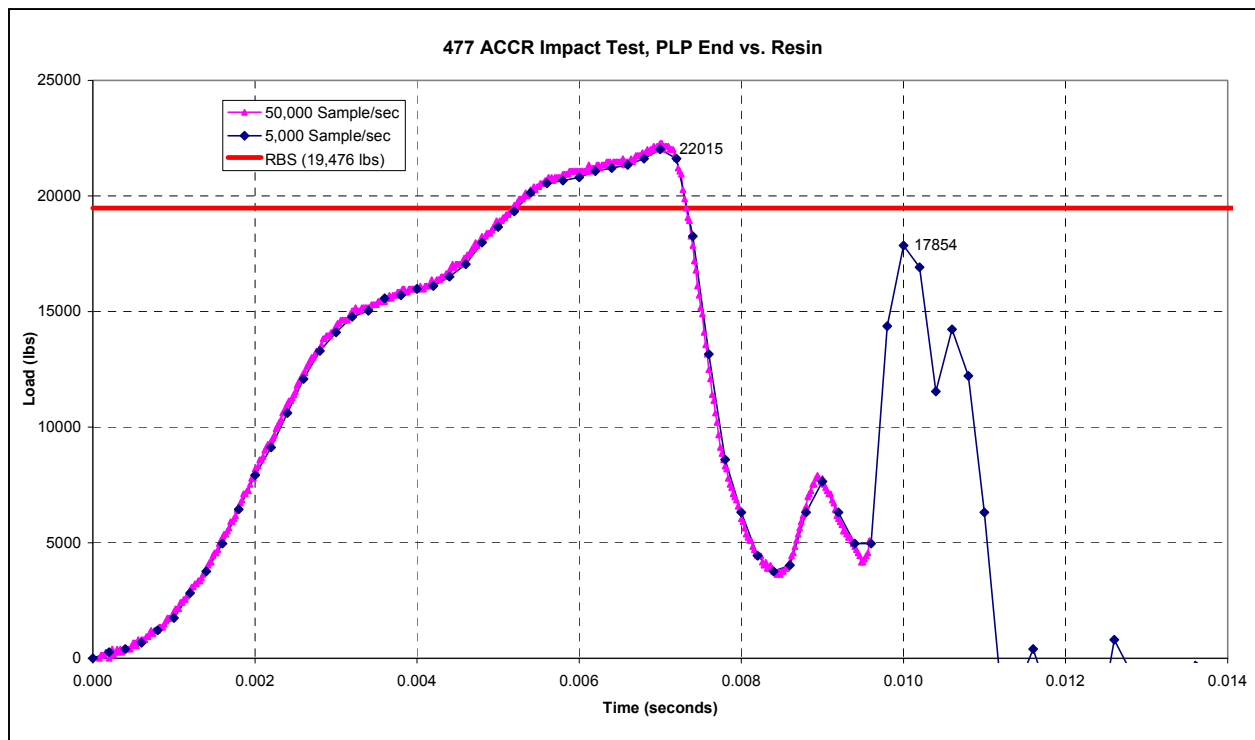
Figure 4, load versus time data for 477 ACCR impact test

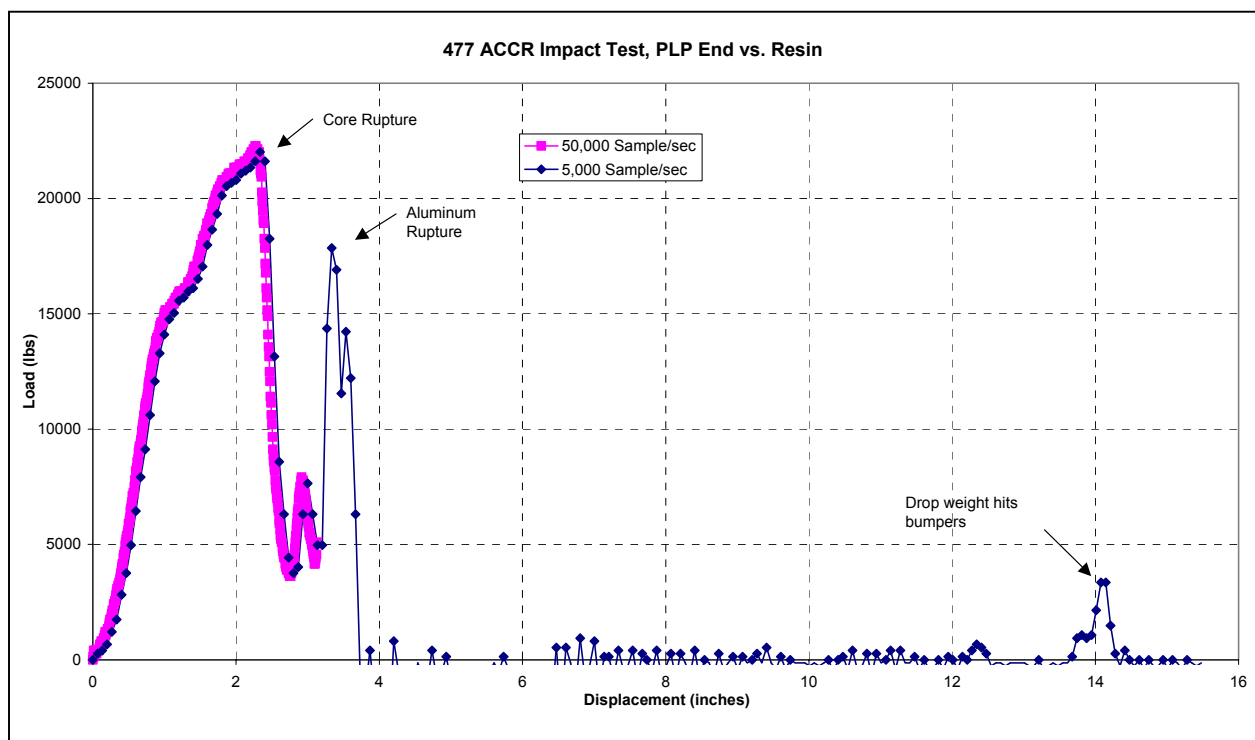
Figure 5, data from Figure 4 formatted or load versus estimated displacement, with range extended to show impact of drop weight on bumpers

Figure 5 permits an estimate of energy absorbed to rupture the 477 sample. The high-speed record missed the second peak, which is believed to be the rupture of the aluminum layers. The first peak is likely the load at first break, which is assumed to be the core strand rupture. Energy absorbed during the

high-speed record is 3185 ft-lbs. Energy absorbed based on the slow speed record is 3695 ft lbs. The reason for the larger value in the longer record is that the aluminum rupture is captured in the longer record. Peak load for the 477 ACCR sample is 22,015 lbs (113% RBS).

The x-axis on Figure 5 is extended to show the peak at 14 inches. The stop bumpers for the drop weight are located 14 inches below the end of the sample. That peak is the response of the load cell to the shock of the drop weight hitting the bumpers. The location of that peak confirms that the estimate of drop weight displacement is accurate.

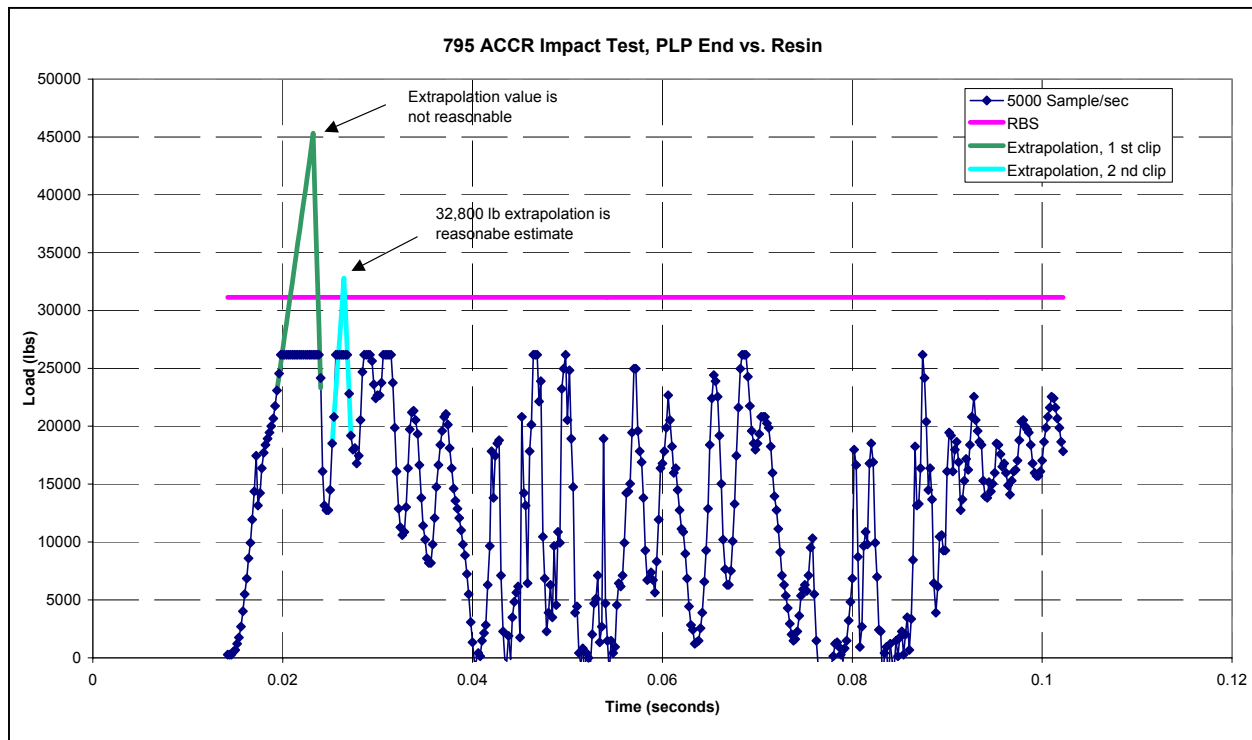
The 795 ACCR test data was inadvertently clipped due to errors setting the voltage range and offset on the ScopeMeters. It was agreed that the test was acceptable provided that the peak load could be estimated, and shown to be greater than RBS. Analysis of the video record shows deceleration of the drop weight to nearly a stop before the sample separated. Separation appears to occur at 6 inches after impact, which means the average load during deceleration is 30,000 lbs (total energy is 15,000 ft-lbs). Unclipped data shows peaks well above the average value, which means that the peak load almost certainly exceeded the 31,134 lb RBS by a comfortable margin. A more precise estimate is possible by extrapolation of valid (non-clipped) data. Figure 6 shows the impact test data for the 795 ACCR sample. Also shown is the extrapolation of the data. The first clip likely contains two stick-slip events, both exceeding the conductor RBS. The third stick-slip was a single event, and extrapolation permits estimation of the peak load at greater than 32,800 lbs (105% RBS).

Figure 6, impact test data for 795 ACCR conductor
