Testing of THERMOLIGN® Suspension Assembly

For

1272-kcmil 3M Brand Composite Conductor

Robert Whapham
Preformed Line Products, Principal Investigator

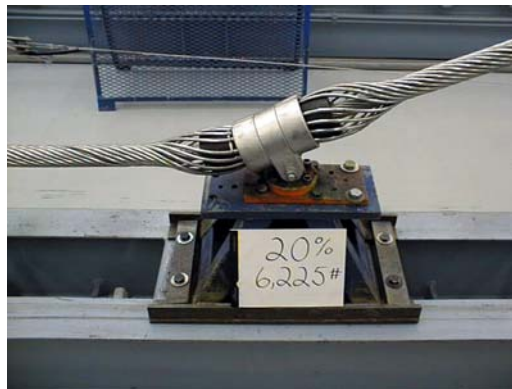
Figure 2 – Unbalanced Load Test Arrangement

To simulate the effects of unbalanced loading in the laboratory, a 30 ft. span of 1272 ACCR was terminated at one end with a PLP Dead-End Assembly and attached to the hydraulic ram of the 55K Tensile Equipment. The Suspension Assembly was installed near the far end of the span in an inverted position, and secured to a short tower on the tensile equipment test frame (Figure 2).

The unbalanced load is applied to the conductor in increments of 5% of the RBS , until a continuous slip at the Suspension assembly occurs. Each load increment is held for 5 minutes. As the unbalanced load increases, the angle of rotation of the Suspension Assembly on the attachment plate also increases. Specifically, the tilt angle was 14 degrees for a 5% load, and 18 degrees for a 10% load.

Continuous slipping of the conductor relative to the Suspension Assembly occurred at 10% RBS. Afterward, the conductor and Suspension Assembly were dissected, and no damage was observed on any of the conductor or Suspension Assembly components.

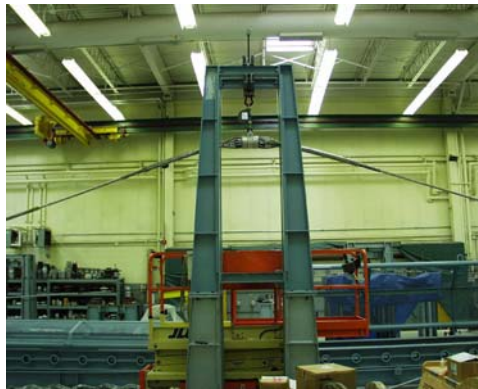
Figure 3 – Turning Angle Test

In the laboratory, the turning angle is simulated in the 55K Tensile Equipment. The Suspension Assembly is attached to a tall tower, which is secured to the tensile equipment test frame (see Figure 3).

For the laboratory turning angle test on the 795 Suspension Assembly for the ACCR conductor, the sample was subjected to a balanced turning angle of 32° , at a conductor tension of 12,460# (40% RBS). The load and angle was held for 5 minutes.

At the completion of the test, the Suspension Assembly and the conductor were dissected, and no damage or distortion was observed on any of the components.

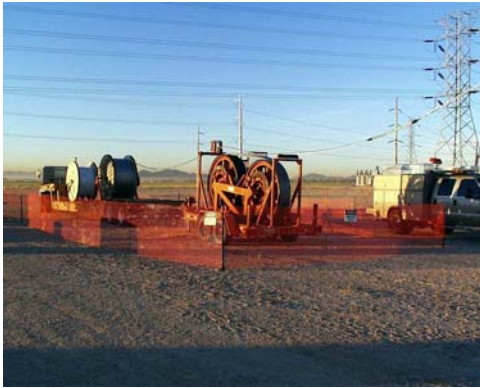
Figure 4 – Bull Wheel

To verify that the equipment and procedures used during the WAPA Phoenix installation did not affect the strength of the conductor, conductor samples were removed from the bottom phase. The first sample was cut out between the Bull Wheel and the first dead-end structure (Figure 4). The second sample was removed from the section of conductor at the second dead-end structure between the Sheave Wheel and the Puller (Figure 5). There was a steep break over angle at the stringing block at this location. The ends of the conductor samples were secured with clamps prior to cutting, and carefully loaded onto a reel for shipping back to PLP for testing.

The maximum load for the conductor adjacent to the Bull Wheel was 44,959# (103% RBS). For the conductor adjacent to the Puller, the maximum load was 45,233# (103% RBS).
