Variability of Conductor Temperature in a Two Span Test Line

Tapani O. Seppa
The Valley Group, Inc.

Powerline Conductor Accelerated Testing Facility (PCAT)

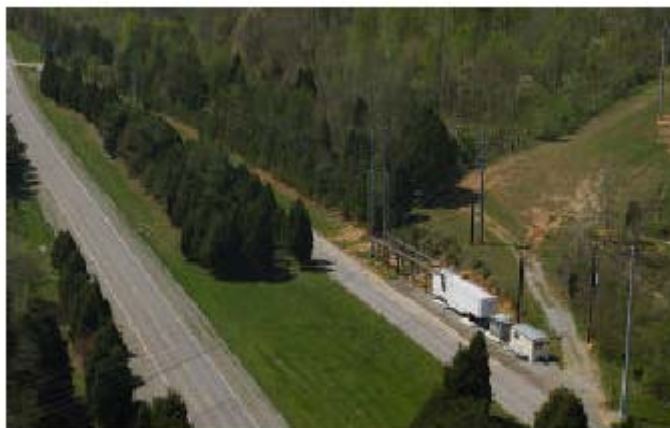
Figure 1: Aerial view of PCAT facility

The Powerline Conductor Accelerated Testing facility (PCAT) at Oak Ridge National Laboratory (ORNL) in Oak Ridge, Tennessee is an outdoor facility for thermal stress and age characterization tests of power line conductors, [1,2]. The facility includes a 2MW DC power supply fed by a 13.8kV/4160V transformer which can vary the loading of the conductor under test up to 400 Vdc and 5000 Adc.

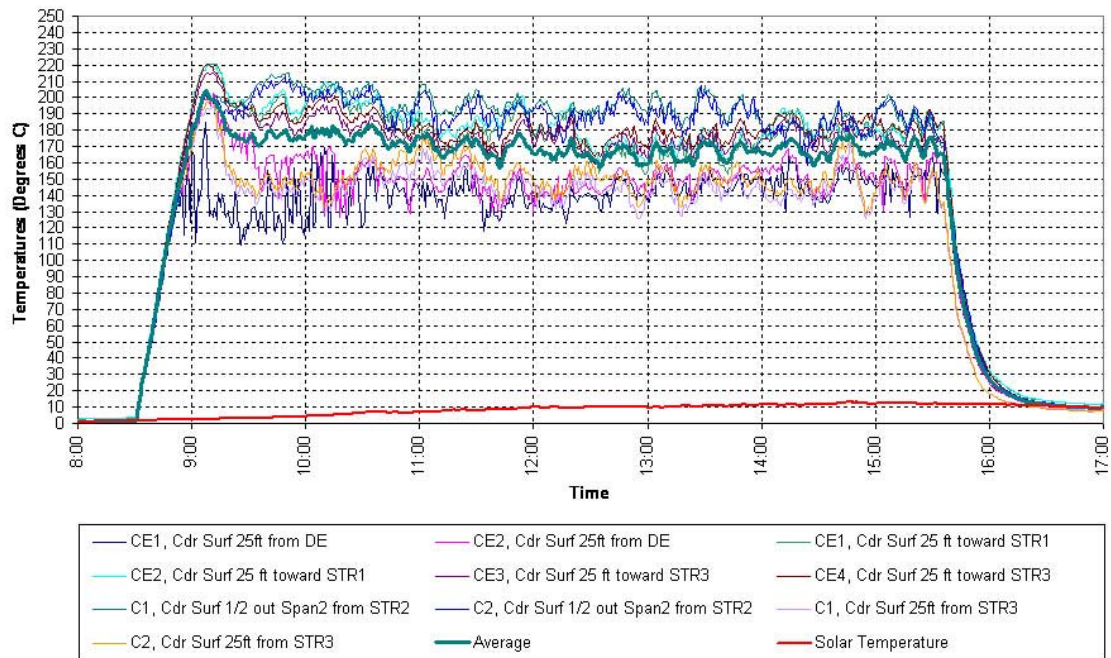
**Figure 4. Thermocouple Temperatures- Road Side
February 27, 2004**

During this test the ambient temperature averaged 6°C and the solar temperature 10°C. The record of the individual thermocouple temperatures is shown in Figures 3 and 4. The standard deviations of the individual simultaneous conductor temperatures were 23°C in Figure 3 and 27°C in Figure 4, which is +/- 15%. For each minute, the standard deviation of the conductor

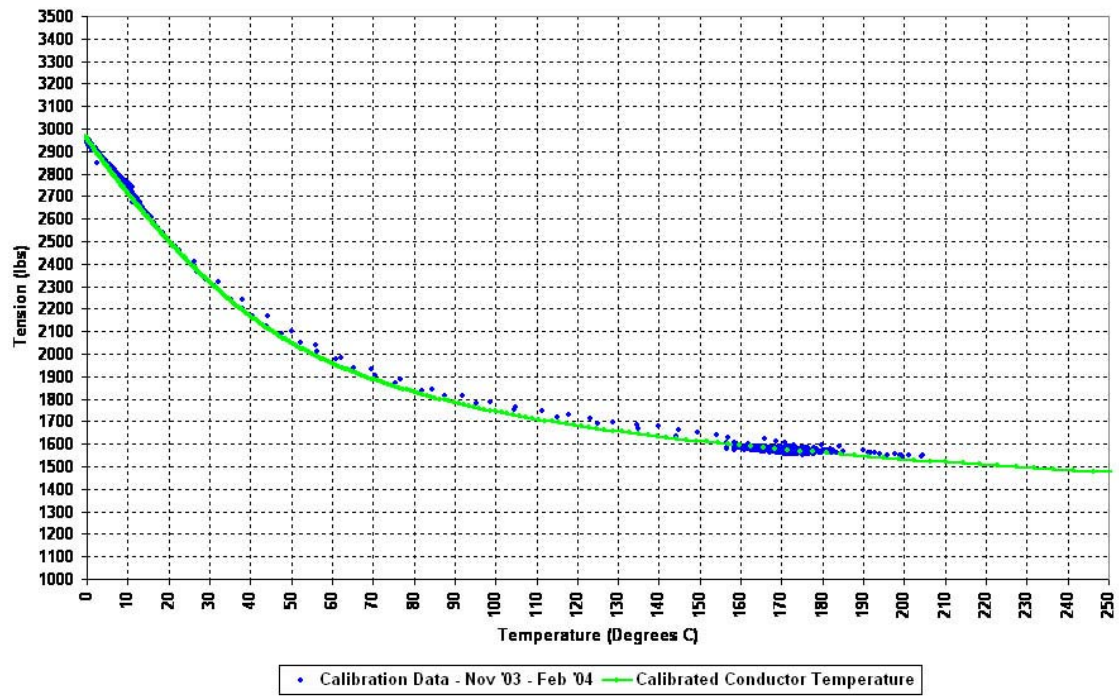
Figure 8. Road Side Conductor Temperature Calibration Curve

The calibrated relationship between the conductor tension measurements and the average temperature are shown in the calibration curves of Figures 7 and 8. Note that the measured tension/temperature relationship shows a certain amount of hysteresis. This can be explained by a combination of two processes:

1. The knee point of a layered conductor is actually a range of temperatures. The knee point of the 675 kcmil ACCR conductor falls between 95-110°C. Manufacturing tolerances make it impossible for all the wires in the outside layers to reach zero tensile stress simultaneously. When passing through the knee point range, each strand must settle in relationship to the others.
2. There is substantial longitudinal variability in the conductor temperature. This means that there are compressive and tensile stresses in the outside layers which will try to move the outside wires longitudinally. Such stresses are constrained by the friction between the core and the outside layers.

As a result, the tension-temperature equilibrium shown in Figures 6 and 7 will exhibit a clear, albeit minor, hysteretic behavior.

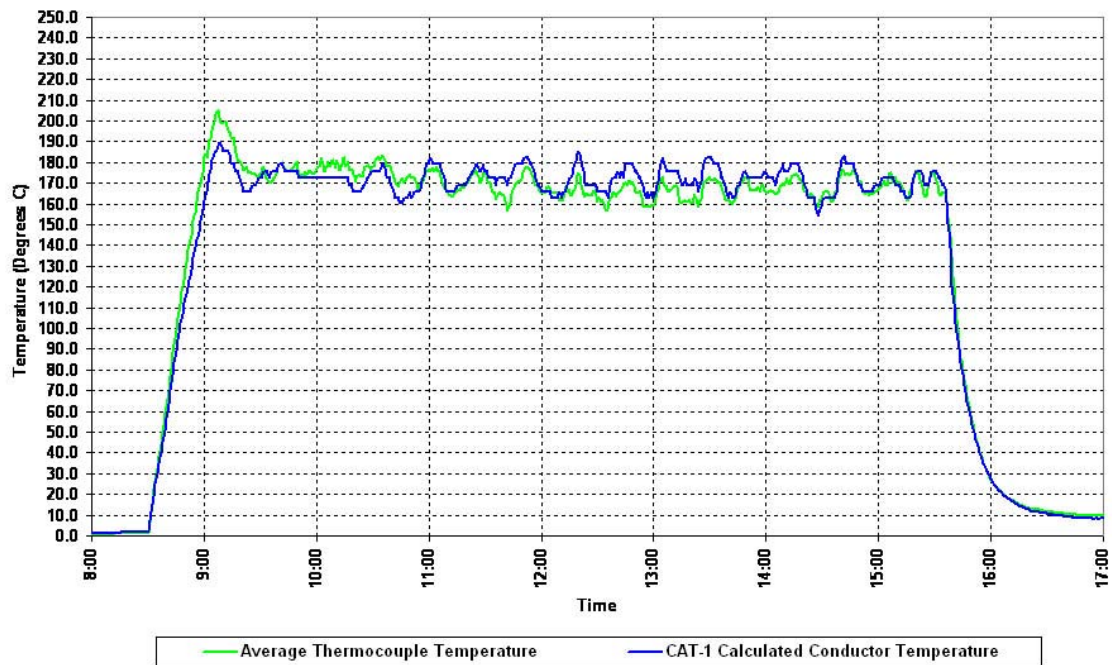
Figure 10. Conductor Temperature Comparison
Road Side (Port 2) - 2/27/04

Figures 9 and 10 show the relationship between the measured average temperature of the two circuits and the conductor temperatures derived based on tension measurements. The close correlation between the measurements proves conclusively that the conductor tension is a function of the average temperature of the line section.
