Testing of THERMOLIGN® Full Tension Splice

For

477-kcmil 3M Brand Composite Conductor

Prepared by:

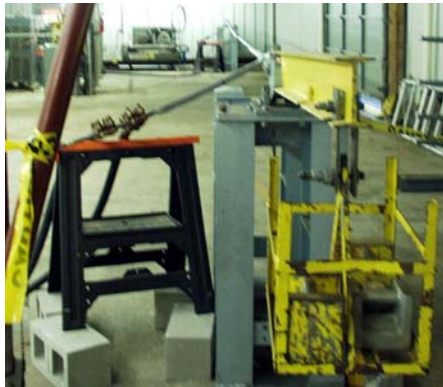
The test span consisted of a 65 ft (19.8 m) length of 477 ACCR Conductor, terminated at both ends with a PLP Dead-End Assembly and cut and spliced at mid-span with a PLP Splice Assembly. A tension of 15% RBS (2915 lbs) was maintained throughout the test using a tension beam/weight basket (see Figure 3). The conductor was heated by applying approximately 1,000 Amps of AC current, supplied by a pair of heavy duty power supplies (see Figure 4). Thermo-couples were mounted to the conductor and to locations along one dead-end to monitor temperature.

Figure 3 – Sustained Heat Test Arrangement

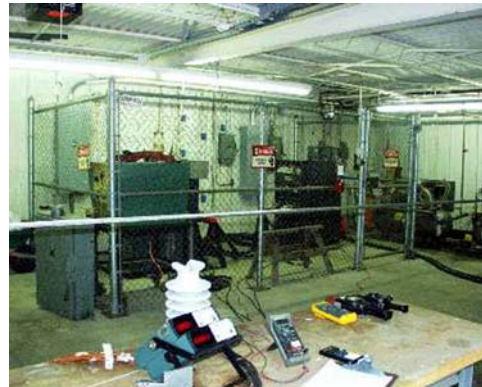
Figure 4 – Dual Power Source

The Splice temperature was monitored at four (4) locations (Figure 11) on both the inner rods and the outer ones (Figure 4). The inner rod temperatures (PS1, 2) were slightly higher than those measured on the outer rods (PS3) and the inner center of the splice (PS4) where conductor segments come together (because of its proximity to the conductor).

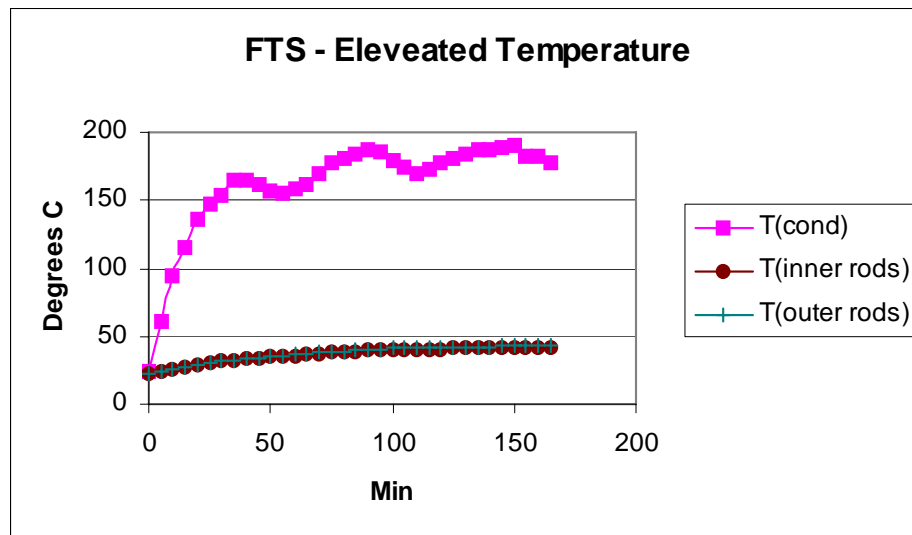
The running temperature of the splice was measured in a separate experiment in which a 20ft (6.1 m) length of the spliced conductor, was tensioned to 4870 lbs (25% RBS) and then heated by applying AC current. Thermocouples recorded the temperature on the conductor and at the splice. When the temperature of the conductor reached 195°C, the splice remained cool, with the maximum measured temperature below 50°C (Figure 6).

Figure 6. Splice Temperature (°C) vs. Time (min.) showing the temperature at the inner and outer rods remains less than 50°C when the conductor is heated to 195°C.

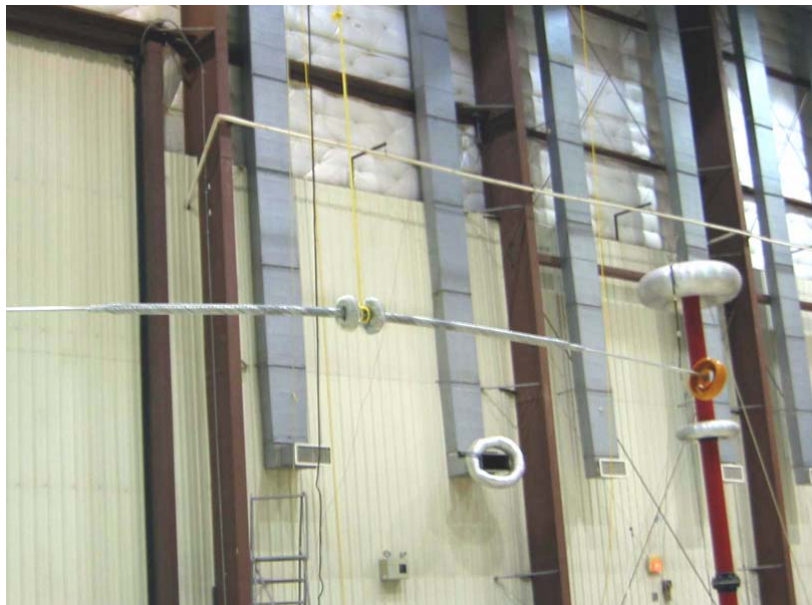
The 477 ACCR Splice Assembly was installed on a 20' length of 0.840" diameter tubing to simulate the conductor (see Figure 7). The Splice Assembly and tubing were positioned at 12 feet above the ground plane.

Figure 7 –Splice Arrangement in the Corona Test

Based on both visual observations and radio interference voltage (RIV) measurements, corona onset voltage for the Splice assembly was recorded at 267 KV (phase to phase).
