**KINECTRICS NORTH AMERICA INC. TEST REPORT  
FOR 3M TO DETERMINE THE SHEAVE CRITERIA FOR  
774 KCMIL 3M™ COMPOSITE CONDUCTOR**

**Kinectrics North America Inc. Report No.: K-422132-RC-0006-R00**

March 29, 2006

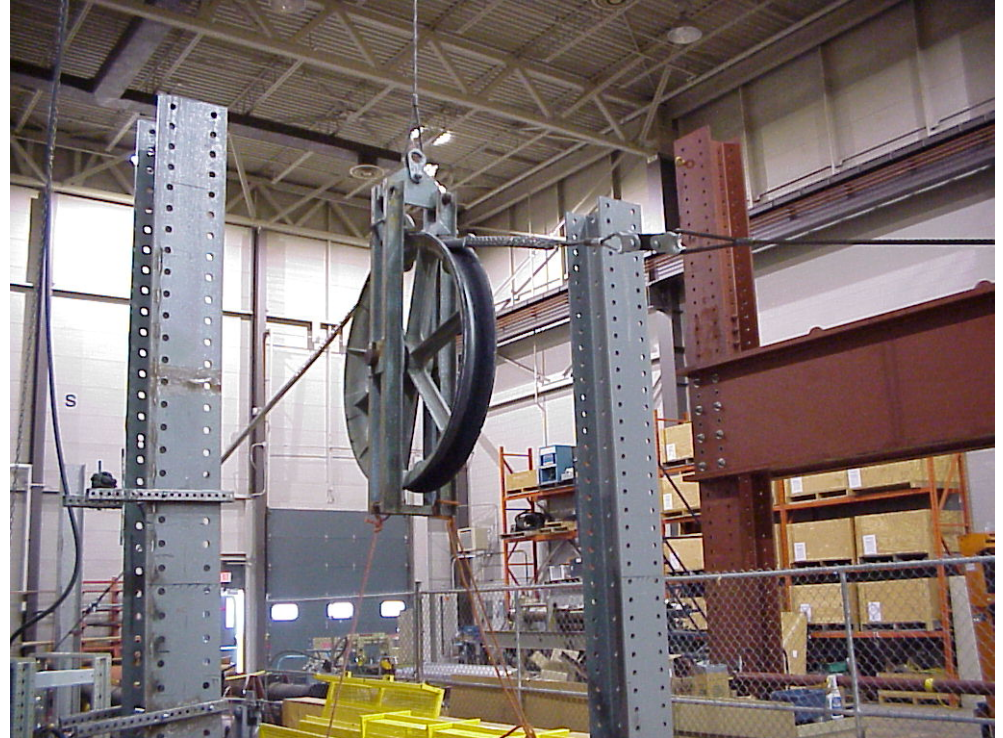
**Figure 1b Typical Set-up for 36" Sheave Test**

**Figure 1c Typical Set-up for 36" Sheave Test**

A schematic of the set-up for the Double and Multi-Pass Sheave Tests is shown in Figure 1a. Typical photos of the set-up for the 36 inch sheave are shown in Figures 1b and 1c. Typical photos of the set-up for the 7x7 inch Roller Array sheave are shown in Figures 1d, and 1e.

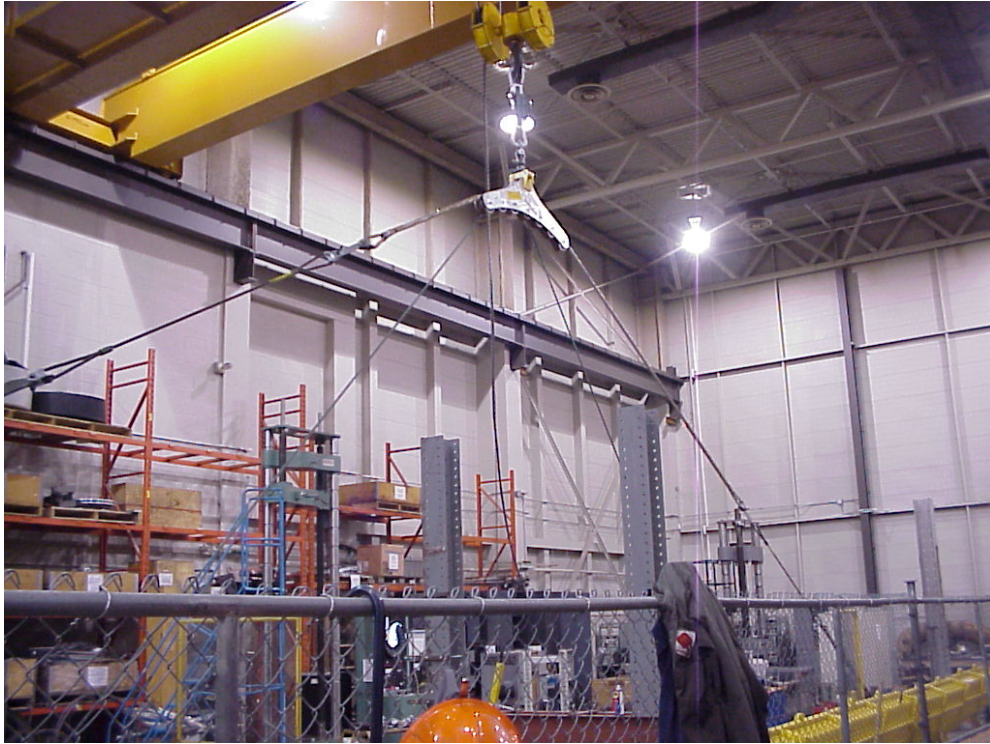
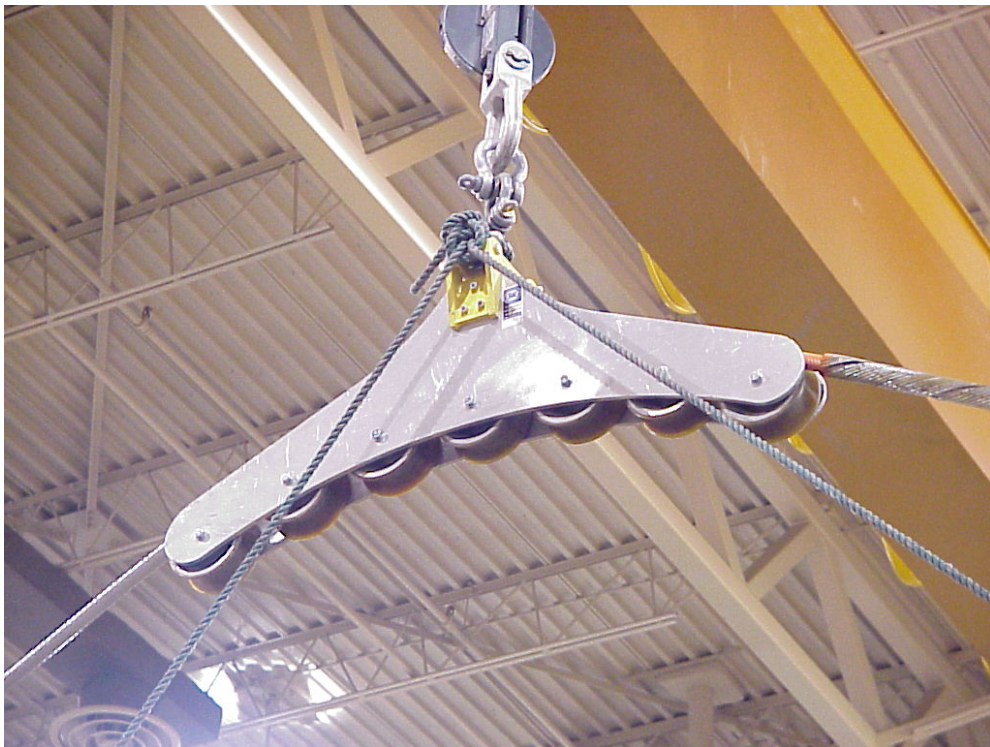
**Figure 1d Typical Set-up for 7x7" Roller Array Sheave Test  
(60 degree break-over angle shown in photo)**

**Figure 1e Typical Set-up for 7x7" Roller Array Sheave Test**

The Roller Array consists of 7 small sheaves each 7 inches in diameter with a 1 inch bottom groove radius. They are arrayed along an arc that sweeps a 60° angle and maintains a 60 inch radius. The Roller Array was built and supplied by Sherman & Reilly Inc. of Chattanooga, TN.

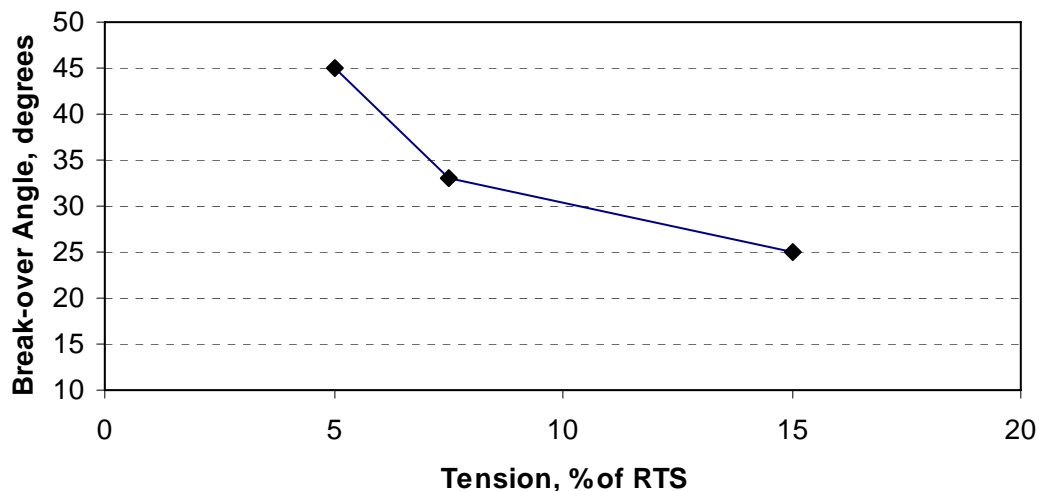
**Figure 2 Threshold Curves for the 36 Inch Root Diameter Sheave  
Double Pass Test, May 9-18, 2005  
(Results from Table 1 – based on a double pass with no broken core wires)**

The results for the various combinations of break-over angles and tensions are summarized in Table 1. Figure 2 shows a graph plotting break-over angle versus tension. This provides a double-pass threshold curve for the 36 inch sheave. The curve is based on the test results from Table 1 that had no broken wires after a double-pass.

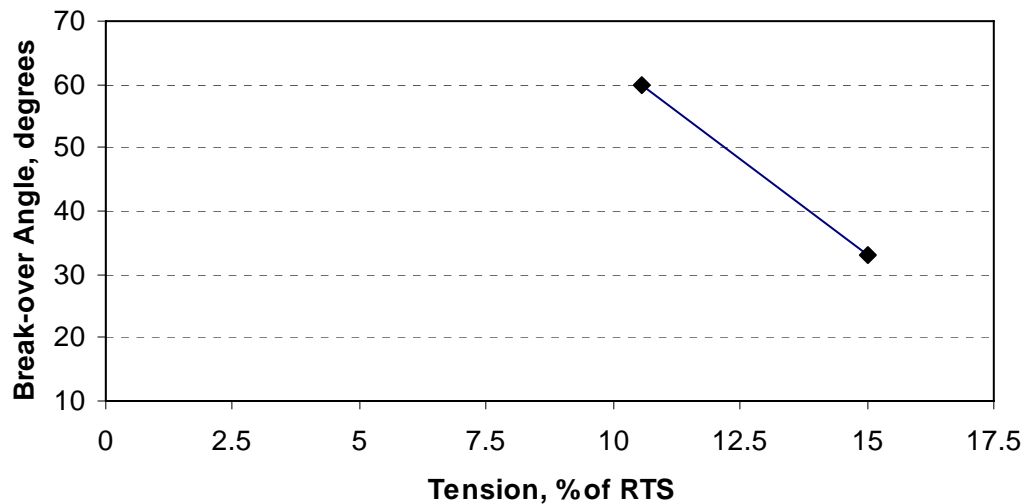
**Figure 4 Threshold Curves for the 7x7 Inch Roller Array Sheave  
Multi Pass Test, October 6 & 11, 2005  
(Results from Table 3 – based on a 20 passes with no broken core wires)**

The results for the two break-over angles and tensions are summarized in Table 3. Figure 4 shows a graph plotting break-over angle versus tension. This provides a multi-pass threshold curve for the 7x7 inch roller array sheave. The curve is based on the test results from Table 3 that had no broken wires after a 20 passes.

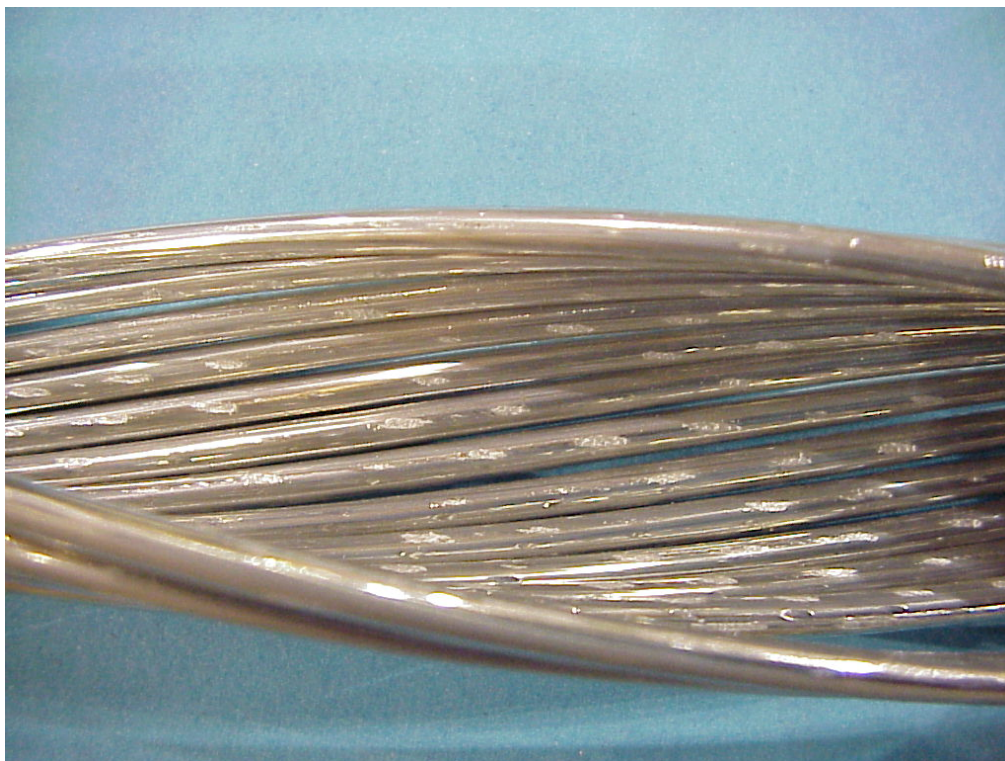
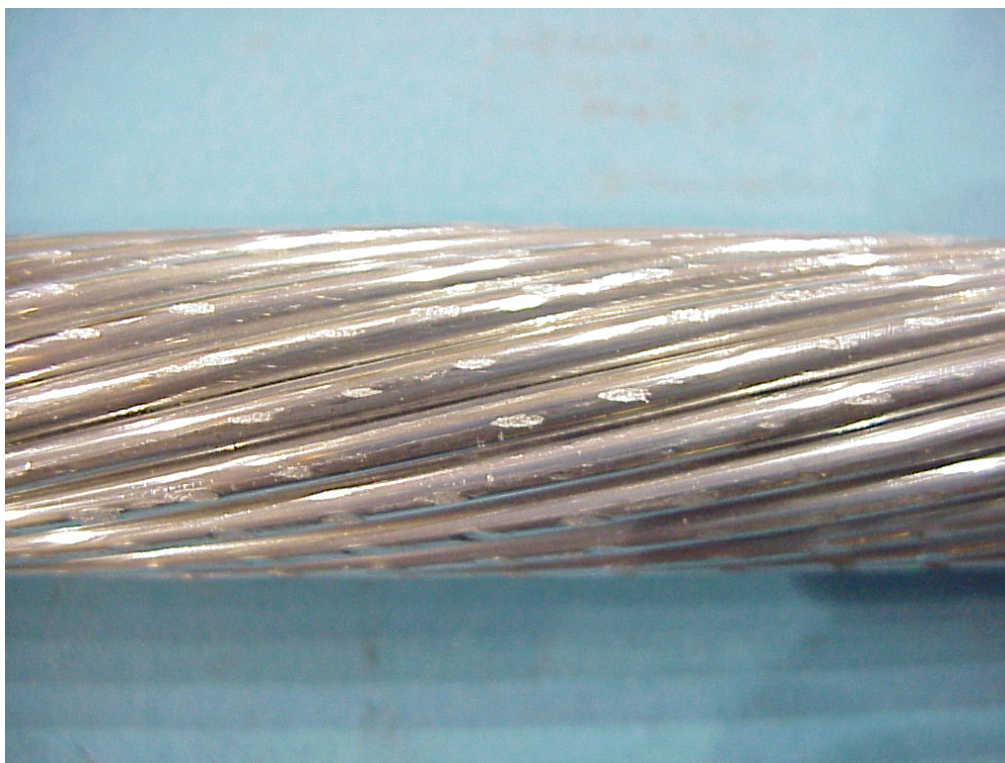
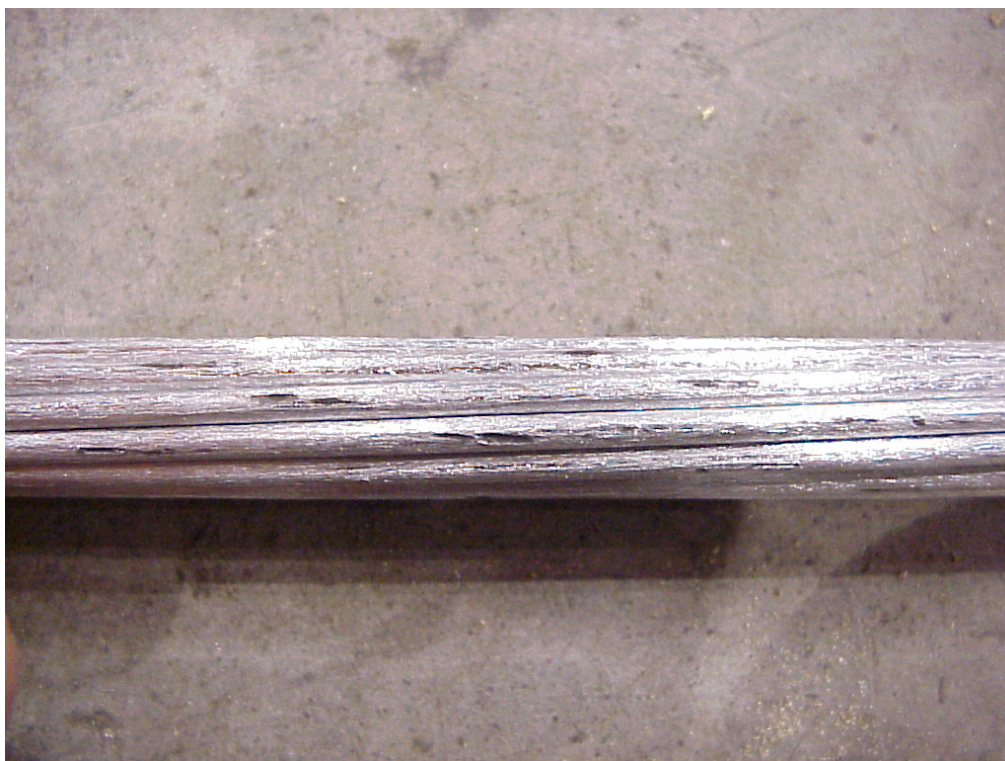
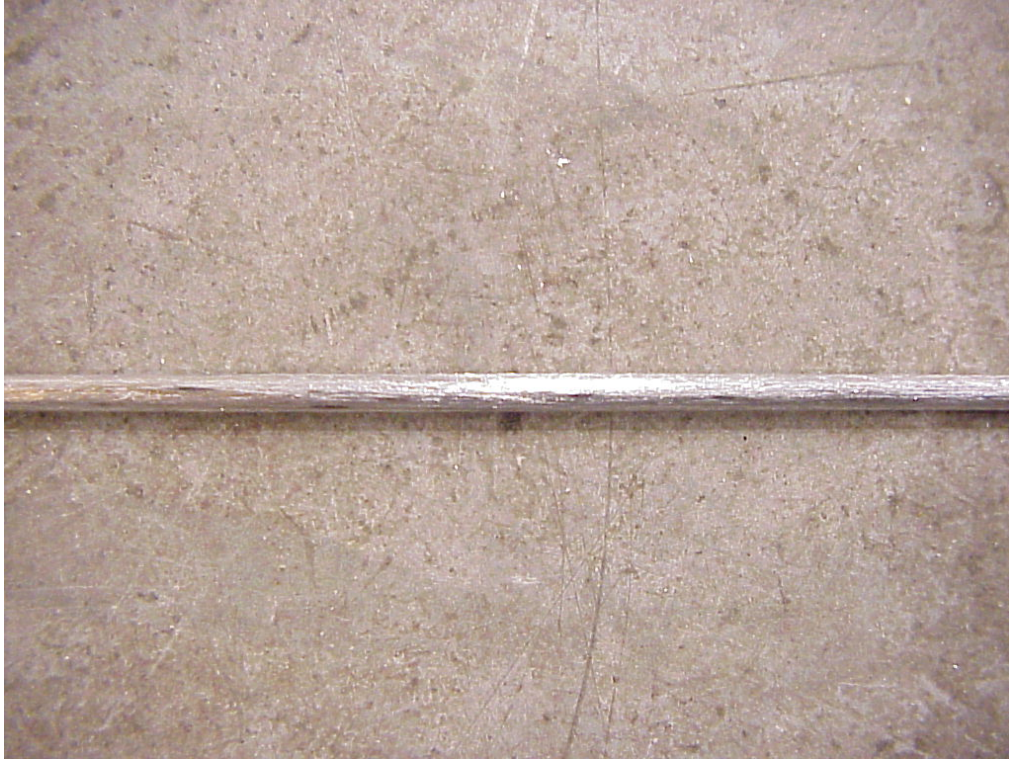
**Photo 1a 1<sup>st</sup> Layer Aluminum – inner surface**

**Photo 1b 2<sup>nd</sup> Layer Aluminum – outer surface**

**Photo 1c 2<sup>nd</sup> Layer Aluminum – inner surface**

**Photo 1d 3<sup>rd</sup> Layer Core – outer surface**

**Photo 1e 2<sup>nd</sup> Layer Core – outer surface**

**Photo 1f 1<sup>st</sup> Layer Core – outer surface**

**Photo 1g Center Core Wire**

**Photo 1h 1<sup>st</sup> Layer Aluminum – side to side fretting**

1 <sup>st</sup> Layer Aluminum (26)	–	inner surface had fret marks – see photo 1a.
2 <sup>nd</sup> Layer Aluminum (20)	–	outer surface had fret marks – see photo 1b.
2 <sup>nd</sup> Layer Aluminum (20)	–	inner surface had fret marks – see photo 1c.
3 <sup>rd</sup> Layer Core Wires (18)	–	outer surface had fret marks – see photo 1d.
2 <sup>nd</sup> Layer Core Wire (12)	–	outer surface had fret marks – see photo 1e.
1 <sup>st</sup> Layer Core Wire (6)	–	outer surface had fret marks – see photo 1f.
Center Core Wire	–	had fret marks – see photo 1g.

1<sup>st</sup> Layer Aluminum (26) – noticed some fretting between adjacent wires (side to side), see photo 1h.

All fret marks were more noticeable (larger or deeper) on the bottom side of the conductor. i.e. the side in contact with the sheave wheel. Unless otherwise labelled, all the photos taken were the most severe fretting observed, generally on the bottom side of the conductor.

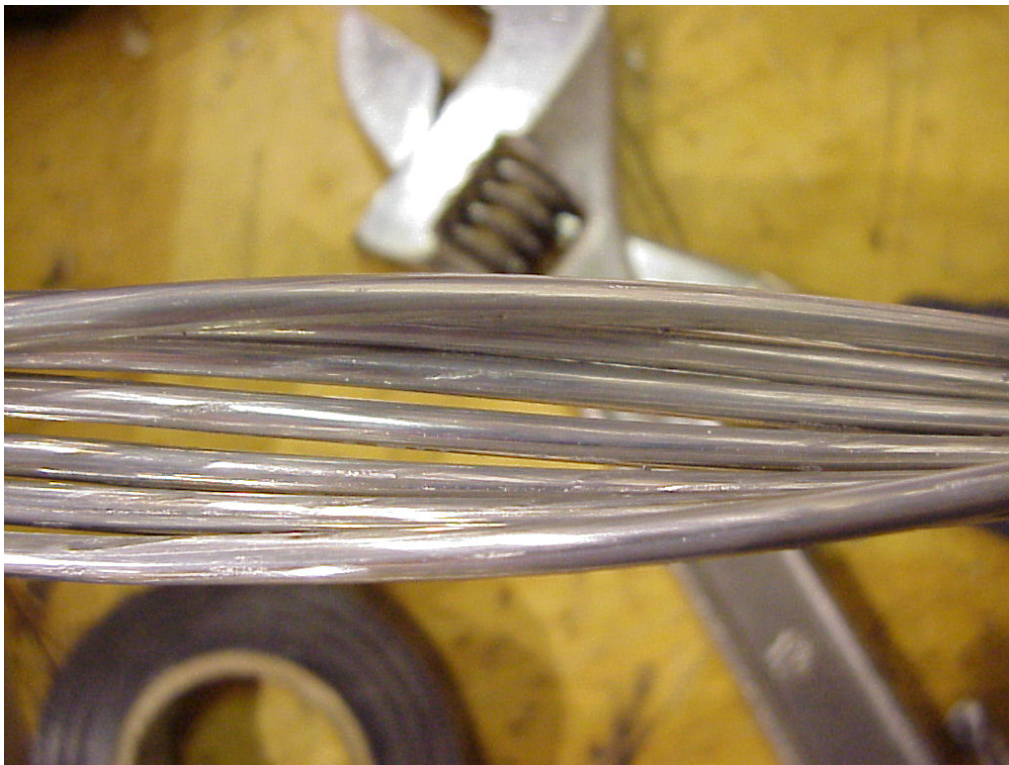
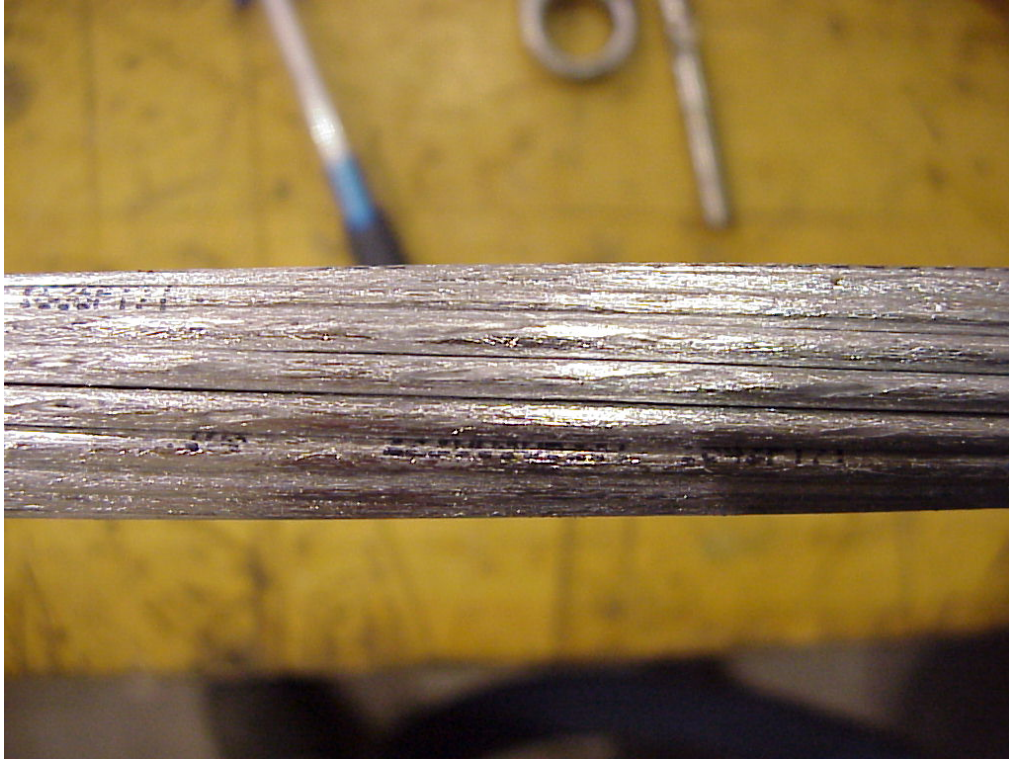
**Photo 2a 1<sup>st</sup> Layer Aluminum – inner surface**

**Photo 2b 2<sup>nd</sup> Layer Aluminum – outer surface, top side**

**Photo 2c 2<sup>nd</sup> Layer Aluminum – outer surface, bottom side**

**Photo 2d 2<sup>nd</sup> Layer Aluminum – inner surface**

**Photo 2e 3<sup>rd</sup> Layer Core – outer surface**

**Photo 2f 1<sup>st</sup> Layer Aluminum – side to side fretting**

- 1<sup>st</sup> Layer Aluminum (26) – inner surface had fret marks – see photo 2a.
  - 2<sup>nd</sup> Layer Aluminum (20) – outer surface, top side had fret marks – see photo 2b.
  - 2<sup>nd</sup> Layer Aluminum (20) – outer surface, bottom side had fret marks – see photo 2c.
  - 2<sup>nd</sup> Layer Aluminum (20) – inner surface had fret marks – see photo 2d.
  - 3<sup>rd</sup> Layer Core Wires (18) – outer surface had fret marks – see photo 2e.
  - 2<sup>nd</sup> Layer Core Wire (12) – outer surface had fret marks.
  - 1<sup>st</sup> Layer Core Wire (6) – had fret marks.
  - Center Core Wire – had fret marks.
- 
- 1<sup>st</sup> Layer Aluminum (26) – noticed some fretting between adjacent wires (side to side), see photo 2f.

All fret marks were more noticeable (larger or deeper) on the bottom side of the conductor. i.e. the side in contact with the sheave wheel. Unless otherwise labelled, all the photos taken were the most severe fretting observed, generally on the bottom side of the conductor.

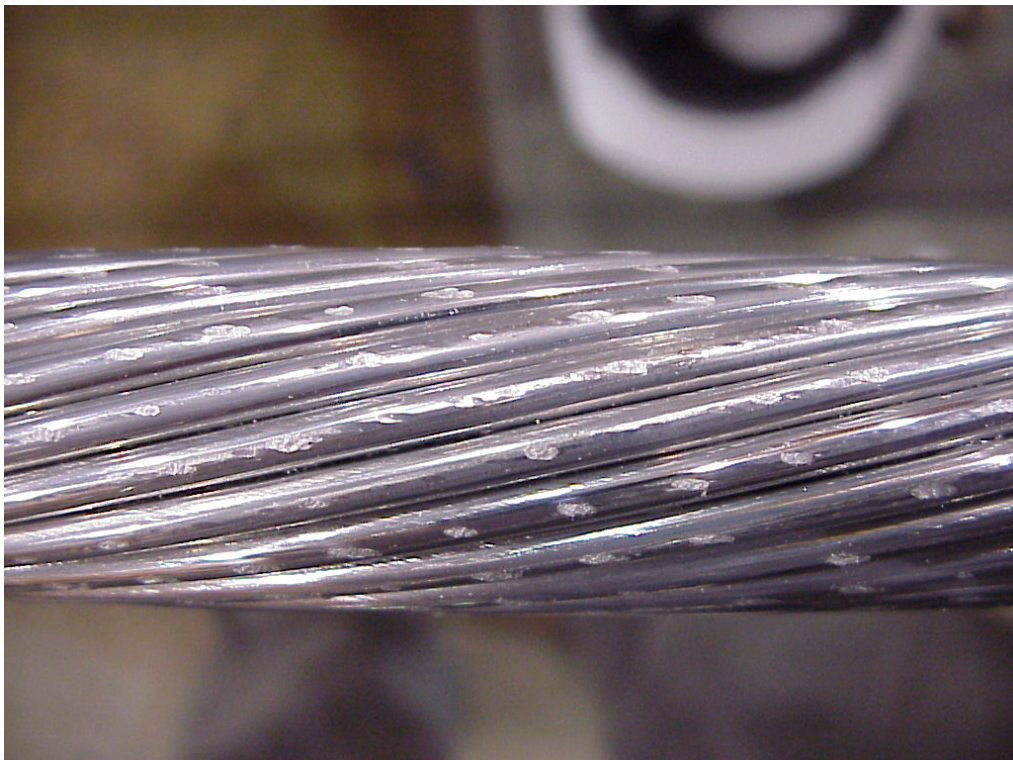
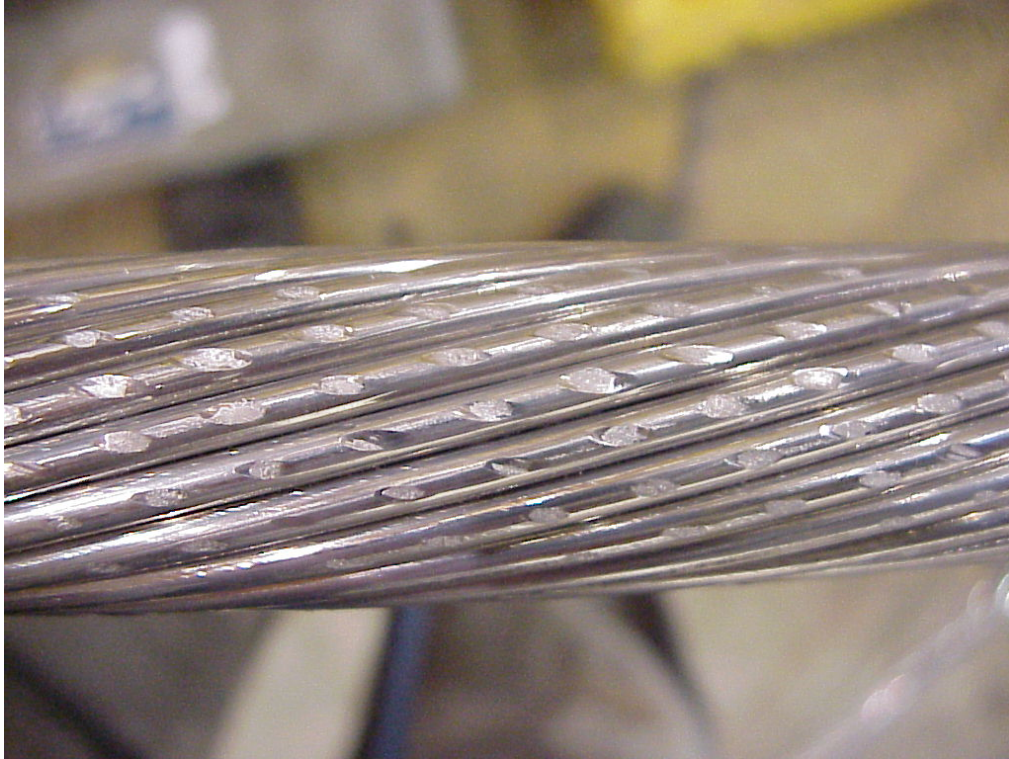
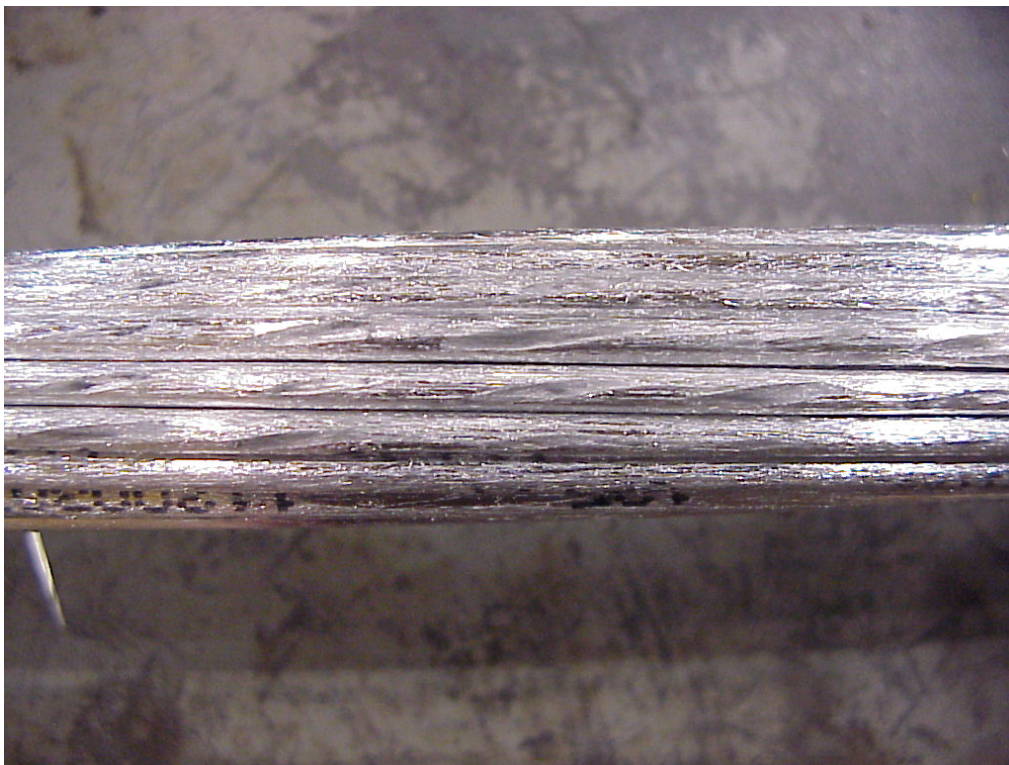
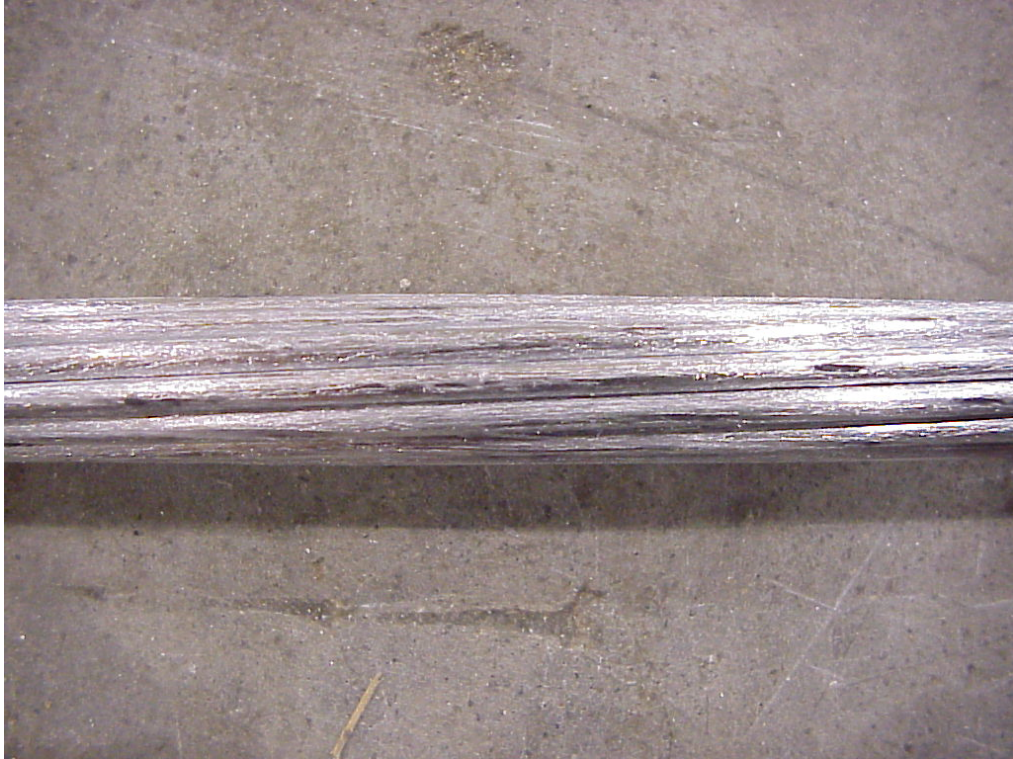
**Photo 3a 1<sup>st</sup> Layer Aluminum – inner surface**

**Photo 3b 2<sup>nd</sup> Layer Aluminum – outer surface, top side**

**Photo 3c 2<sup>nd</sup> Layer Aluminum – outer surface, bottom side**

**Photo 3d 3<sup>rd</sup> Layer Core – outer surface**

**Photo 3e 2<sup>nd</sup> Layer Core – outer surface**

**Photo 3f 1<sup>st</sup> Layer Core – outer surface**

- 1<sup>st</sup> Layer Aluminum (26) – inner surface had fret marks – see photo 3a.
- 2<sup>nd</sup> Layer Aluminum (20) – outer surface, top side had fret marks – see photo 3b.
- 2<sup>nd</sup> Layer Aluminum (20) – outer surface, bottom side had fret marks – see photo 3c.
- 2<sup>nd</sup> Layer Aluminum (20) – inner surface had fret marks.
- 3<sup>rd</sup> Layer Core Wires (18) – outer surface had fret marks – see photo 3d.
- 2<sup>nd</sup> Layer Core Wire (12) – outer surface had fret marks – see photo 3e.
- 1<sup>st</sup> Layer Core Wire (6) – outer surface had fret marks – see photo 3f.
- Center Core Wire – had fret marks.

All fret marks were more noticeable (larger or deeper) on the bottom side of the conductor. i.e. the side in contact with the sheave wheel. Unless otherwise labelled, all the photos taken were the most severe fretting observed, generally on the bottom side of the conductor.

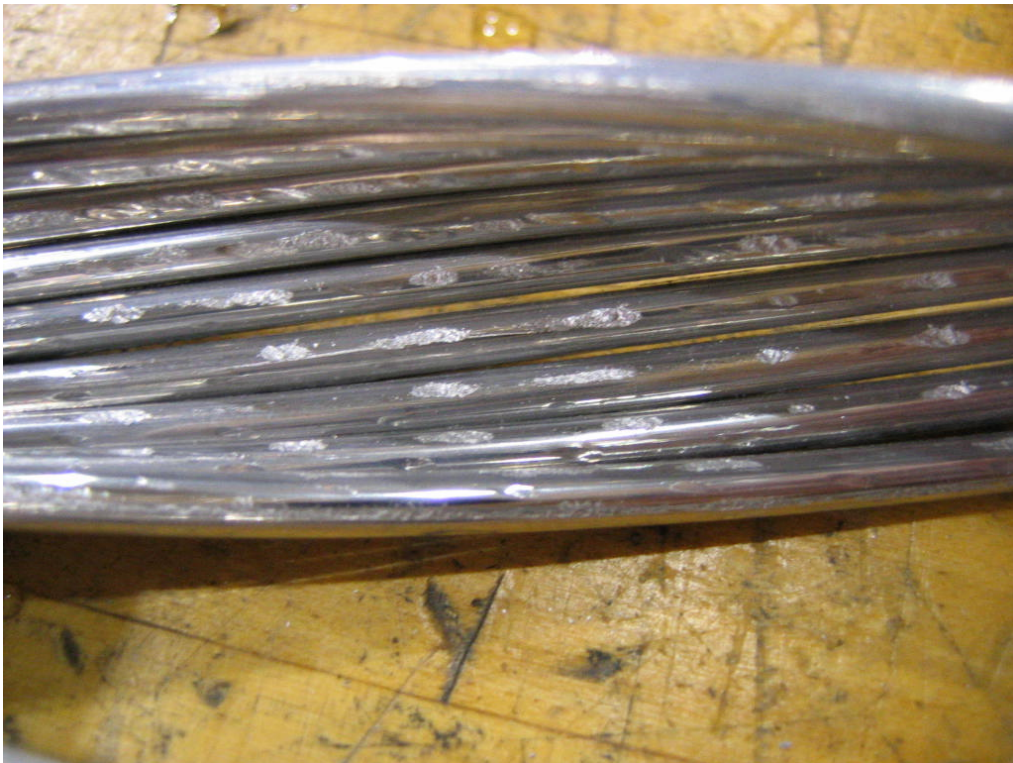
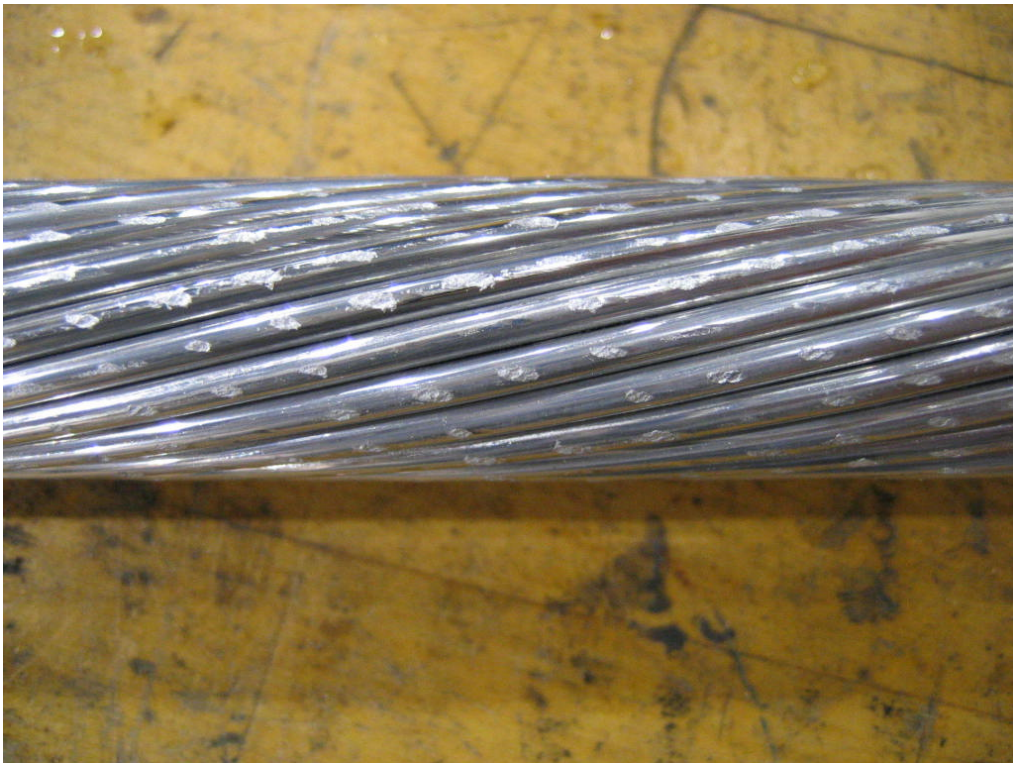
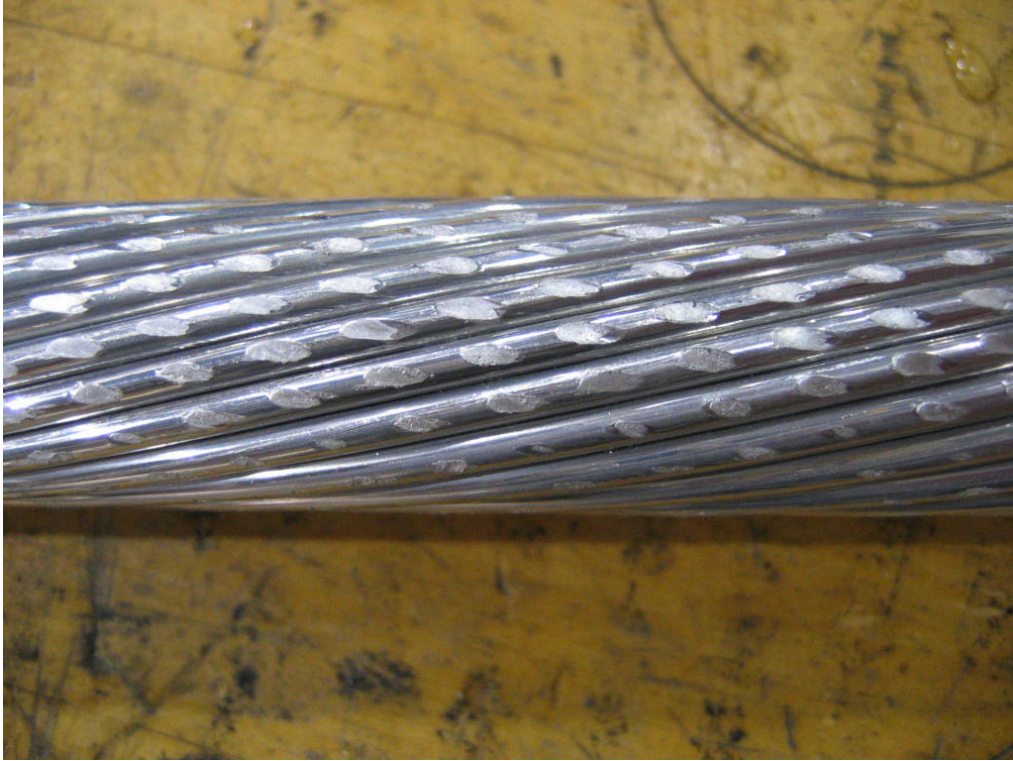
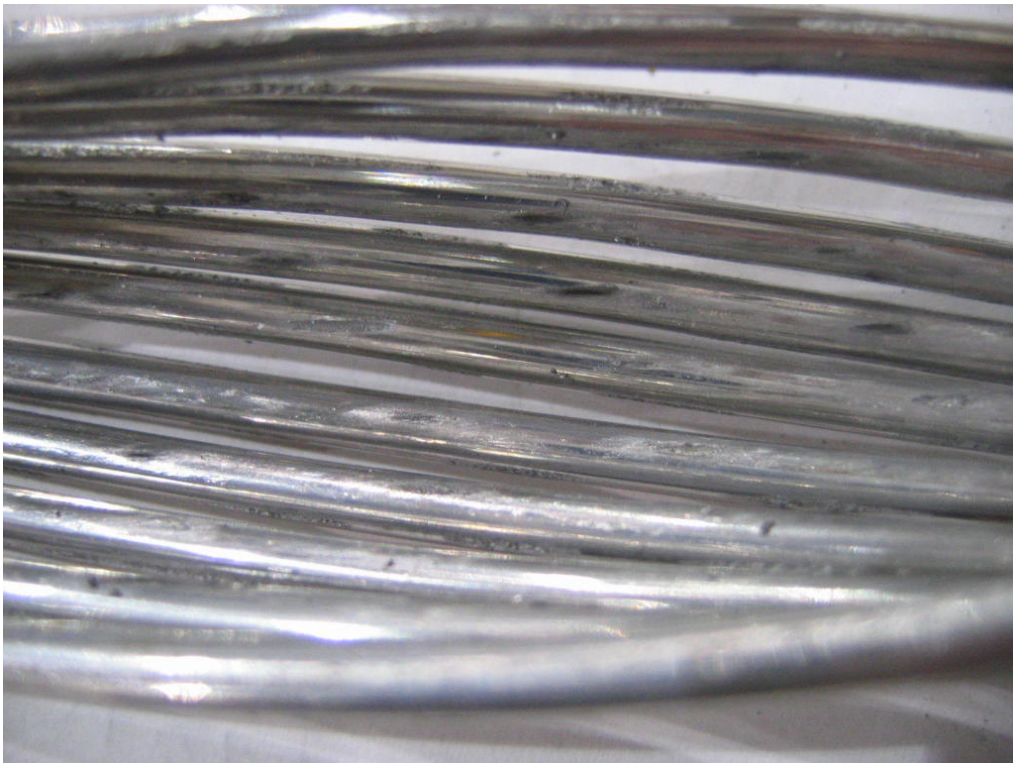
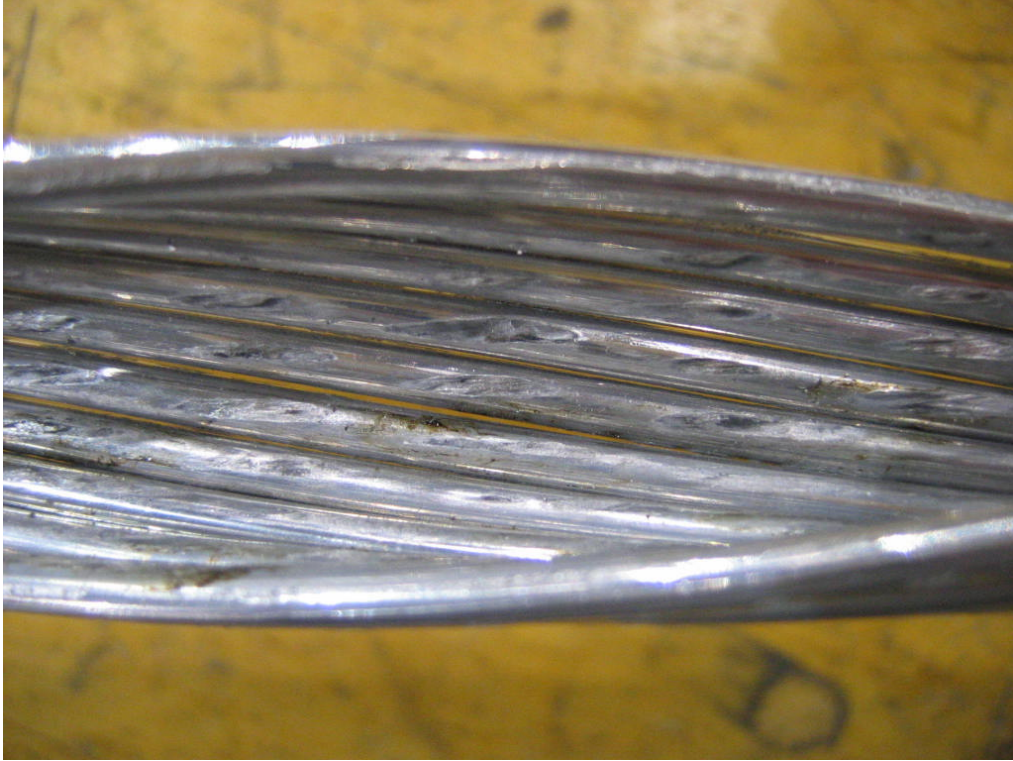
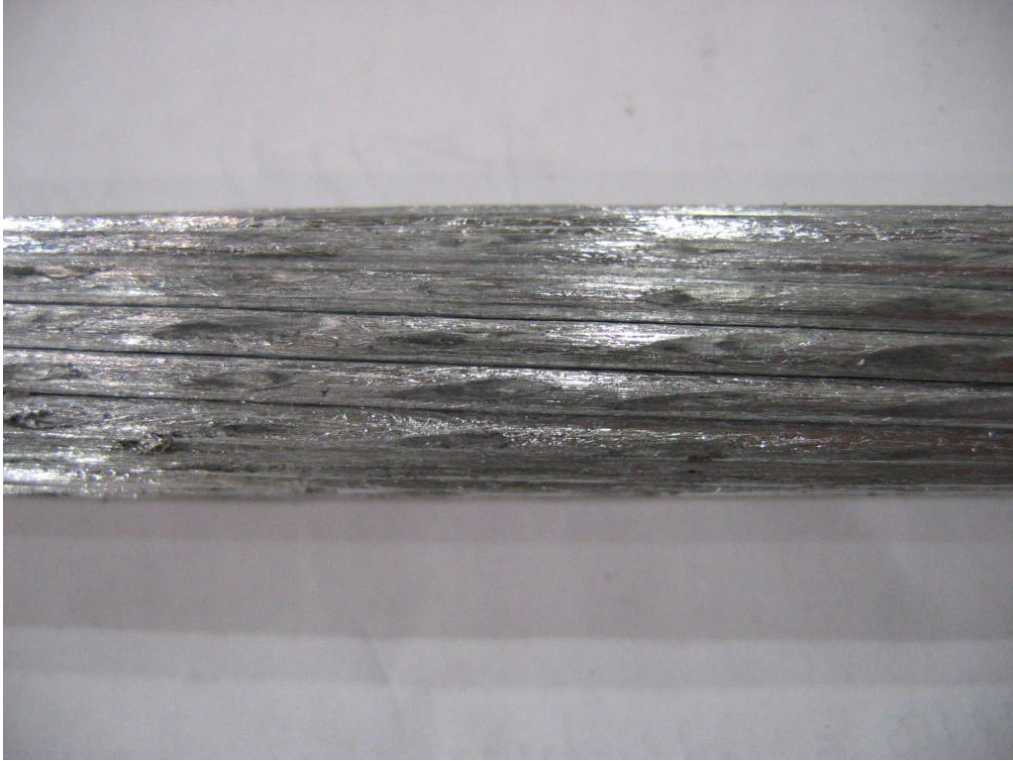
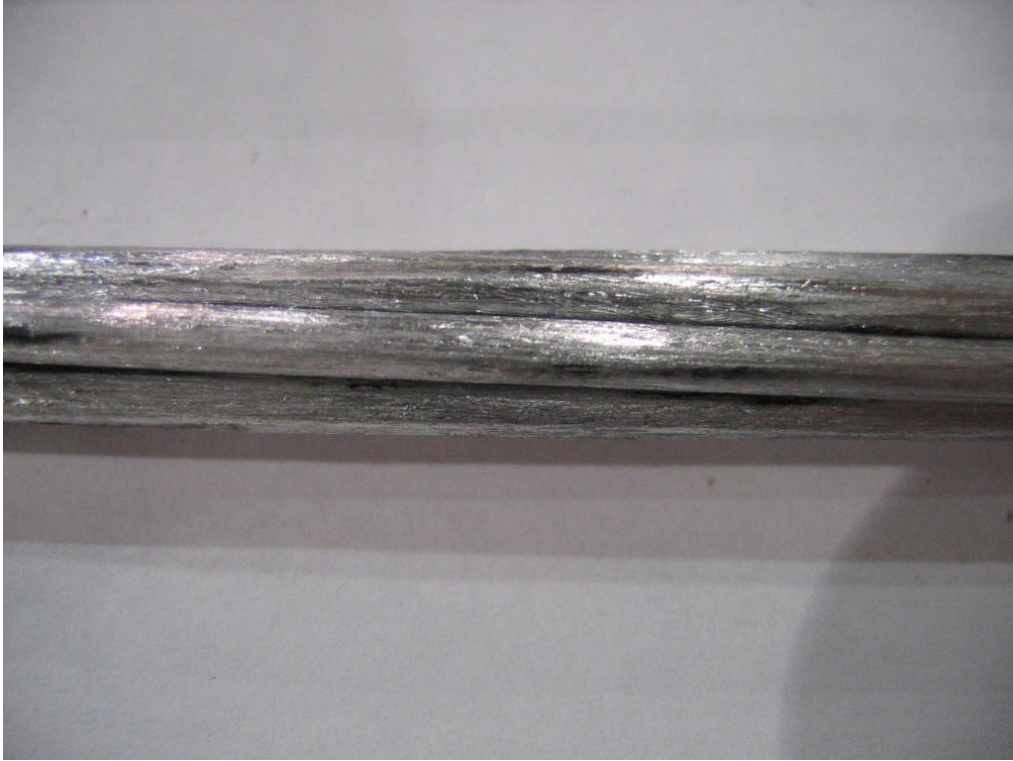
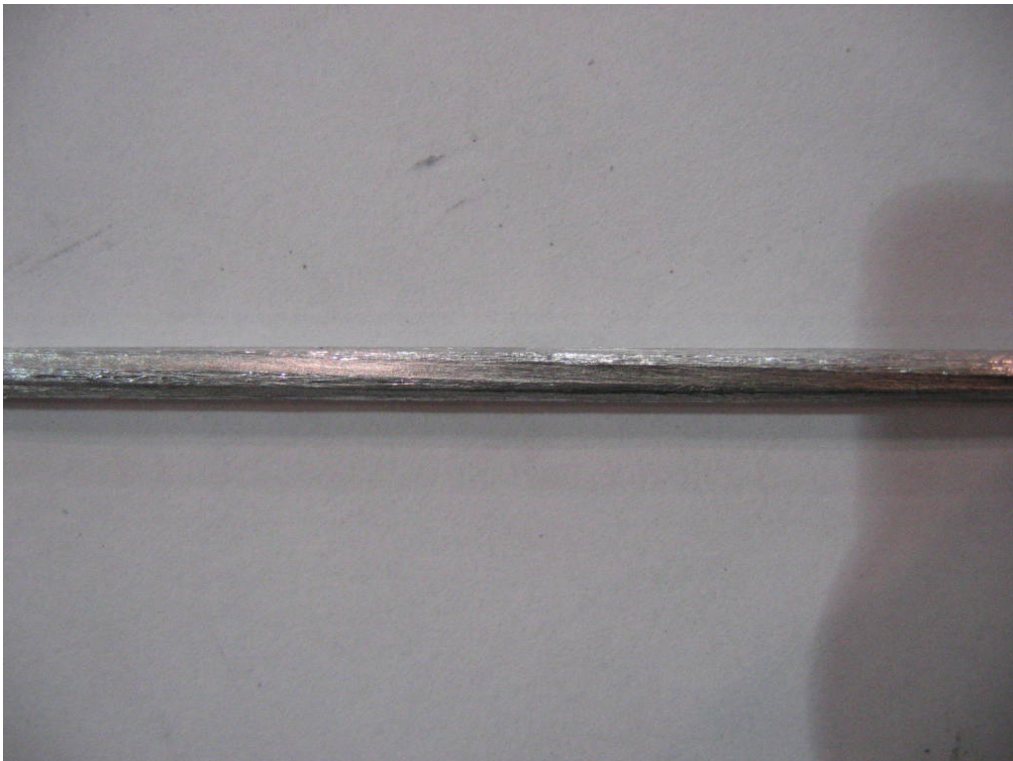
**Photo 5a 1<sup>st</sup> Layer Aluminum – outer surface**

**Photo 5b 1<sup>st</sup> Layer Aluminum – inner surface, top side**

**Photo 5c 1<sup>st</sup> Layer Aluminum – inner surface, bottom side**

**Photo 5d 2<sup>nd</sup> Layer Aluminum – outer surface, top side**

**Photo 5e 2<sup>nd</sup> Layer Aluminum – outer surface, bottom side**

**Photo 5f 2<sup>nd</sup> Layer Aluminum – inner surface, top side**

**Photo 5g 2<sup>nd</sup> Layer Aluminum – inner surface, bottom side**

**Photo 5h 3<sup>rd</sup> Layer Core – outer surface, top side**

**Photo 5j 3<sup>rd</sup> Layer Core – outer surface, bottom side**

**Photo 5k 2<sup>nd</sup> Layer Core – outer surface**

**Photo 5m 1<sup>st</sup> Layer Core – outer surface**

**Photo 5n Center Core Wire**

1 <sup>st</sup> Layer Aluminum (26)	– outer surface, no fret marks – see photo 5a.
1 <sup>st</sup> Layer Aluminum (26)	– inner surface, top side had fret marks – see photo 5b.
1 <sup>st</sup> Layer Aluminum (26)	– inner surface, bottom side had fret marks – see photo 5c.
2 <sup>nd</sup> Layer Aluminum (20)	– outer surface, top side had fret marks – see photo 5d.
2 <sup>nd</sup> Layer Aluminum (20)	– outer surface, bottom side had fret marks – see photo 5e.
2 <sup>nd</sup> Layer Aluminum (20)	– inner surface, top side had fret marks – see photo 5f.
2 <sup>nd</sup> Layer Aluminum (20)	– inner surface, bottom side had fret marks – see photo 5g.
3 <sup>rd</sup> Layer Core Wires (18)	– outer surface, top side had fret marks – see photo 5h.
3 <sup>rd</sup> Layer Core Wires (18)	– outer surface, bottom side had fret marks – see photo 5j.
2 <sup>nd</sup> Layer Core Wire (12)	– outer surface, had fret marks – see photo 5k.

1 <sup>st</sup> Layer Core Wire (6)	– outer surface, had fret marks – see photo 5m.
Center Core Wire	– had fret marks – see photo 5n.

All fret marks were more noticeable (larger or deeper) on the bottom side of the conductor. i.e. the side in contact with the sheave wheel. Unless otherwise labelled, all the photos taken were the most severe fretting observed, generally on the bottom side of the conductor.

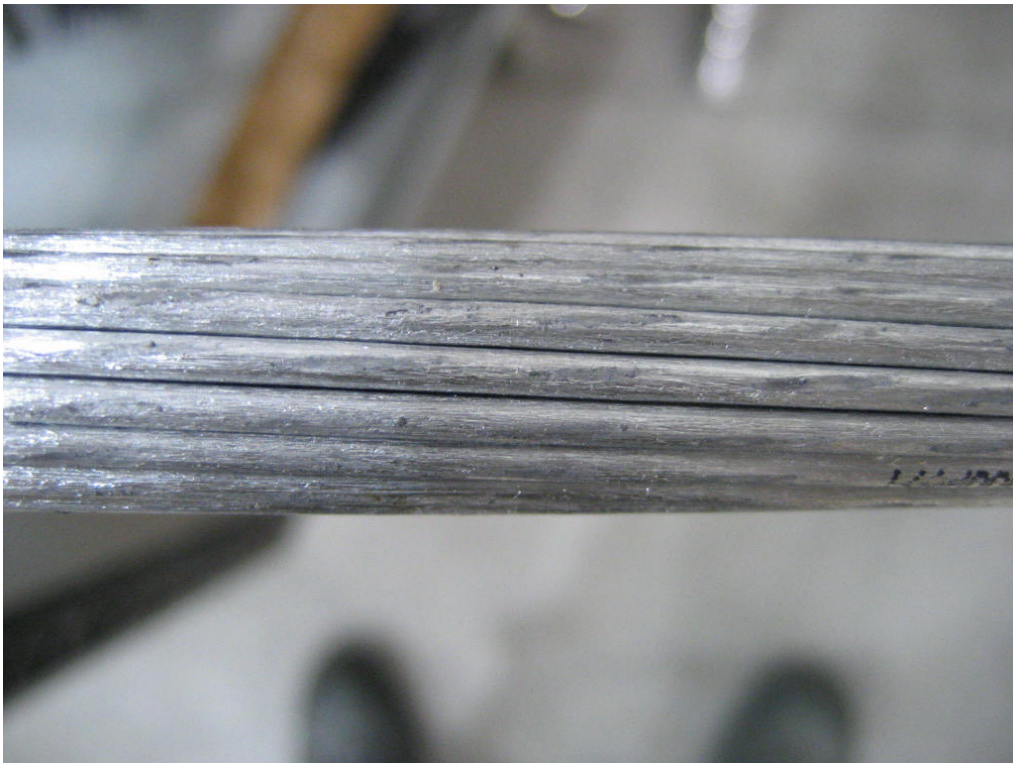
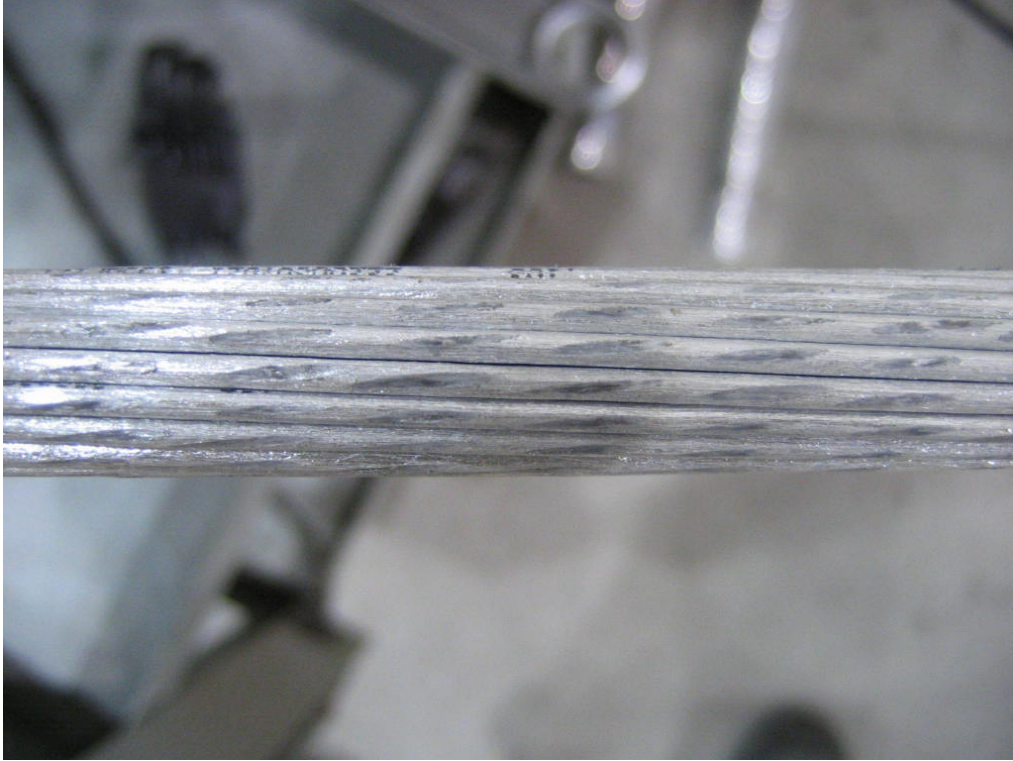
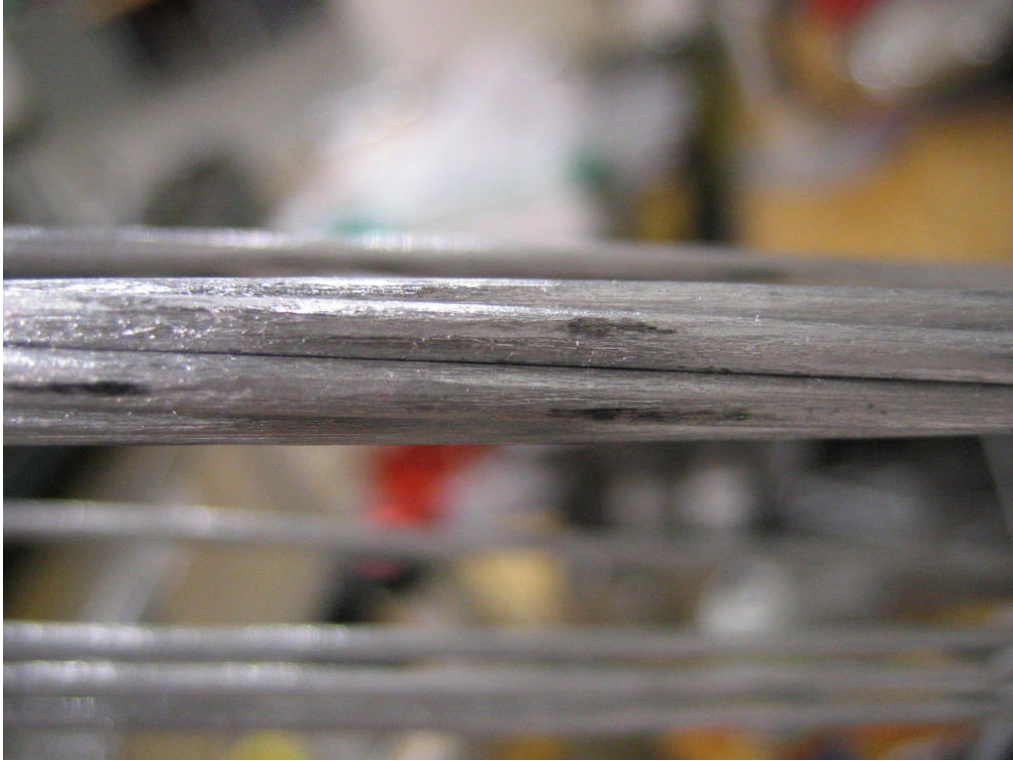
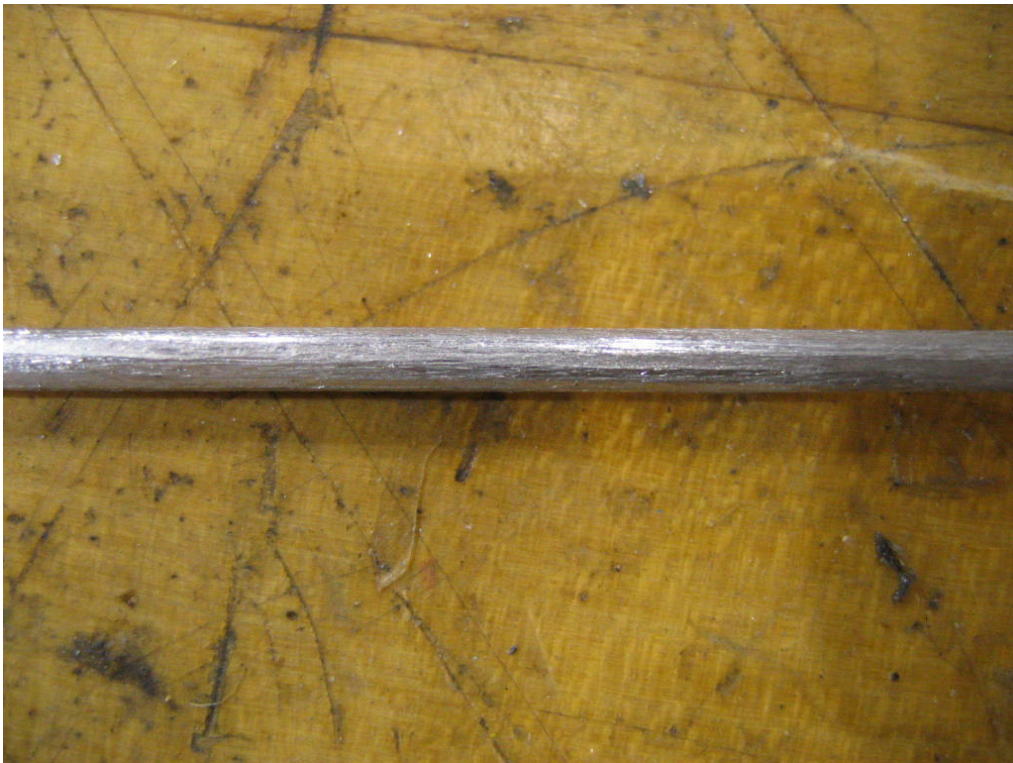
**Photo 6a 1<sup>st</sup> Layer Aluminum – outer surface**

**Photo 6b 1<sup>st</sup> Layer Aluminum – inner surface, bottom side**

**Photo 6c 2<sup>nd</sup> Layer Aluminum – outer surface, top side**

**Photo 6d 2<sup>nd</sup> Layer Aluminum – outer surface, bottom side**

**Photo 6e 2<sup>nd</sup> Layer Aluminum – inner surface, bottom side**

**Photo 6f 3<sup>rd</sup> Layer Core – outer surface, top side**

**Photo 6g 3<sup>rd</sup> Layer Core – outer surface, bottom side**

**Photo 6h 2<sup>nd</sup> Layer Core – outer surface**

**Photo 6j 1<sup>st</sup> Layer Core – outer surface**

**Photo 6k Center Core Wire**

- 1<sup>st</sup> Layer Aluminum (26) – outer surface, no fret marks – see photo 6a.
- 1<sup>st</sup> Layer Aluminum (26) – inner surface, bottom side had fret marks – see photo 6b.
- 2<sup>nd</sup> Layer Aluminum (20) – outer surface, bottom side had fret marks – see photo 6c.
- 2<sup>nd</sup> Layer Aluminum (20) – outer surface, bottom side had fret marks – see photo 6d.
- 2<sup>nd</sup> Layer Aluminum (20) – inner surface, bottom side had fret marks – see photo 6e.
- 3<sup>rd</sup> Layer Core Wires (18) – outer surface, top side had fret marks – see photo 6f.
- 3<sup>rd</sup> Layer Core Wires (18) – outer surface, bottom side had fret marks – see photo 6g.
- 2<sup>nd</sup> Layer Core Wire (12) – outer surface, had fret marks – see photo 6h.
- 1<sup>st</sup> Layer Core Wire (6) – outer surface, had fret marks – see photo 6j.
- Center Core Wire – had fret marks – see photo 6k.

All fret marks were more noticeable (larger or deeper) on the bottom side of the conductor. i.e. the side in contact with the sheave wheel. Unless otherwise labelled, all the photos taken were the most severe fretting observed, generally on the bottom side of the conductor.
