**3MTM Composite Conductor
795-kcmil ACCR Conductor Repair Sleeve Tensile Tests**

3M Company

NEETRAC Project Number: 04-180, Release 3

June, 2006

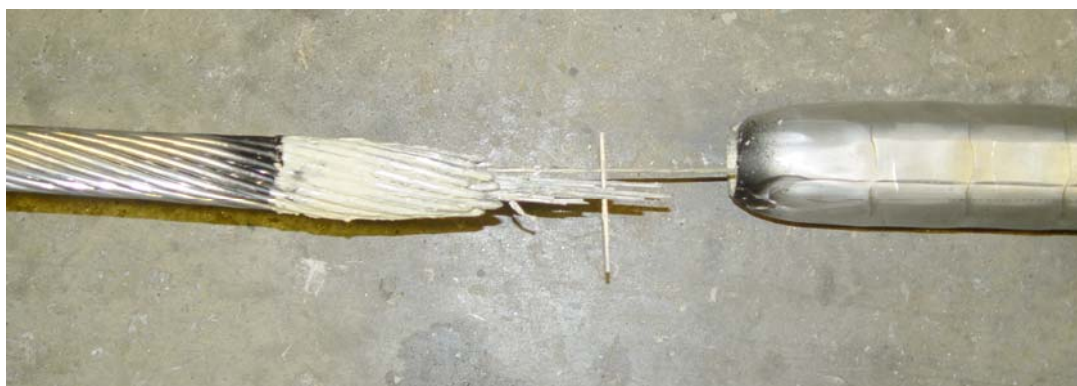
Figure 3: typical tensile overload failure

After the resin cured, the samples were loaded in the tensile machine and pulled to destruction at a rate of 15,000 lbs/min. Figure 1 shows a typical sample during installation of the repair sleeve. Figure 2 shows the sample immediately prior to test. Figure 3 shows the typical failure pattern. Figure 4 shows the load and actuator position data.

<u>Sample #</u>	<u>Breaking Load</u>	<u>% RBS</u>	<u>Failure Description</u>
RS1	31,820	102	Break 3 1/2" inside repair sleeve
RS2	30,850	99	Break 5" inside repair sleeve
RS3	31,080	100	Break 5" inside repair sleeve

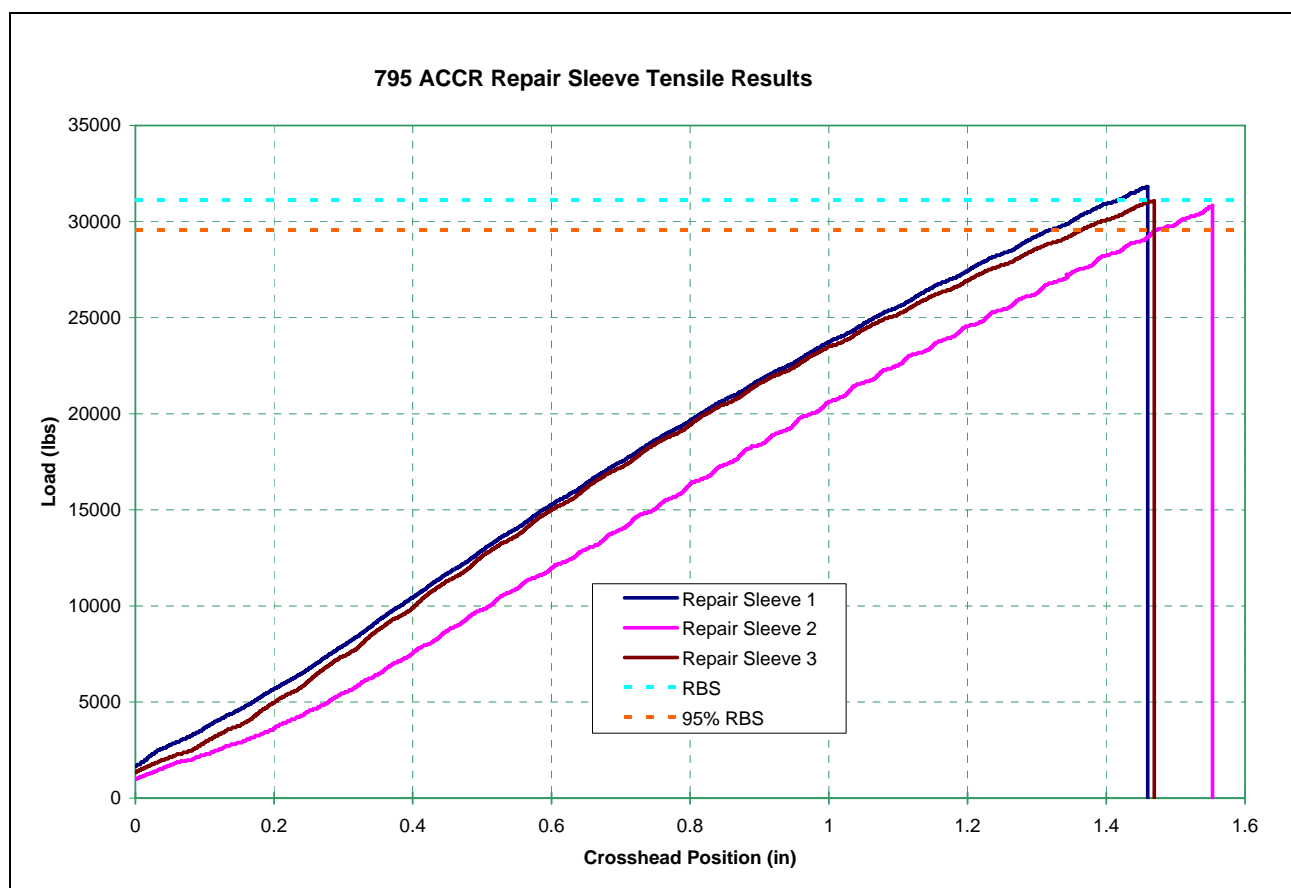
Figure 4: load and actuator position data
