**KINETRICS NORTH AMERICA INC. TEST REPORT
FOR 3M COMPANY TO COMPARE THE LIGHTNING PERFORMANCE
OF ACCR TO ACSR CONDUCTORS**

Kinectrics North America Inc. Report No.: 9513-004-RC-0002-R00

September 26, 2003

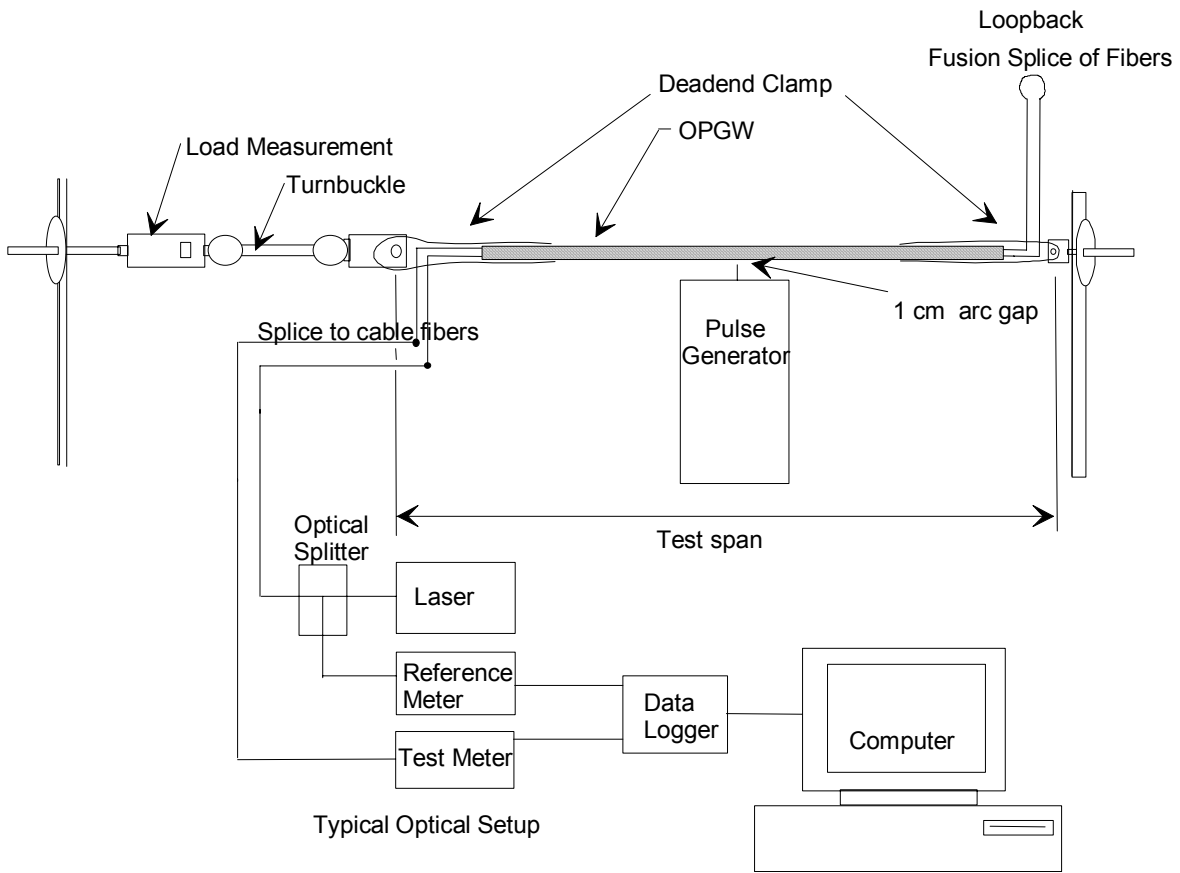
Figure 1 Set-up of Lightning Arc Test

Figure 1 shows a schematic diagram of the configuration for this test. The setup for this test involves a conductor sample approximately 12 m long. The test sample was supported by suitable deadend clamps. A turnbuckle was used to tension the conductor to the desired tension and a load cell was used to measure the tension.

The arc head, which is the electrode and return-current clamp assembly that supports the arc, is mounted on the sample part way along the span. A battery bank was used to provide the current to produce a continuing current waveform. A 5 cm fuse wire was used to initiate the arc. The magnetically-balanced arc head was designed to withstand both the heating and mechanical forces imposed by the current.

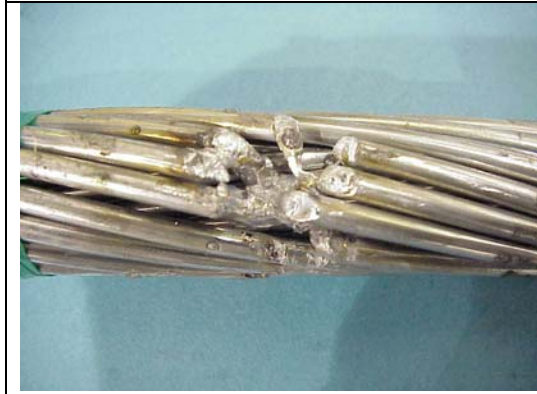
Figure A10aa – ACCR 477 kcmil, 191 C, Hit 5

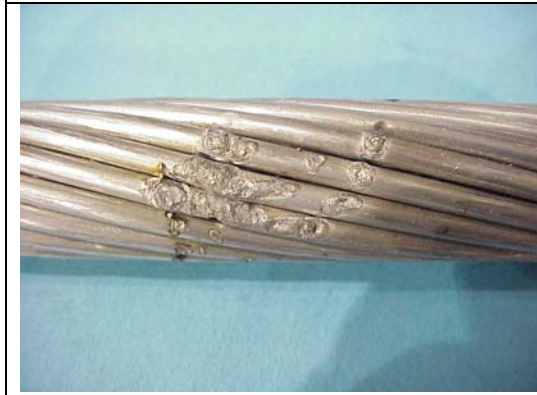
Figure A11aa – ACCR 477 kcmil, 192 C, Hit 8

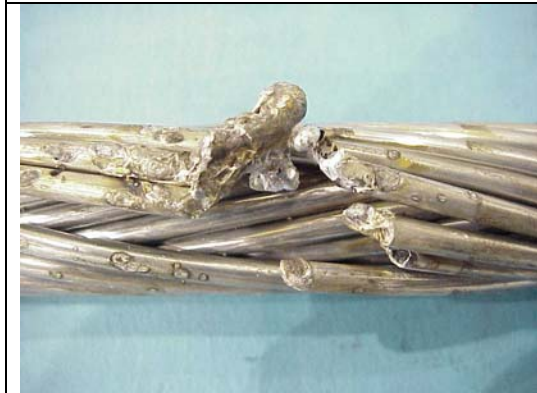
Figure A12aa – ACCR 477 kcmil, 208 C, Hit 12

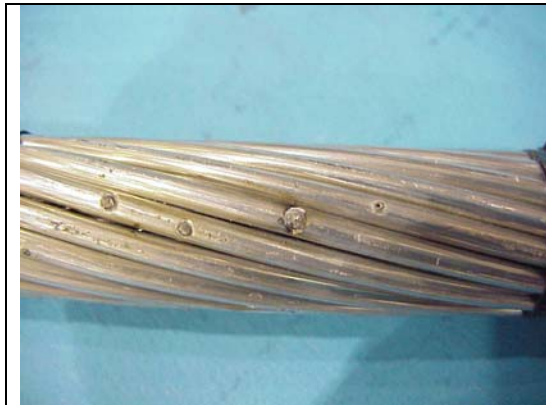
Figure A13aa – ACSR 477 kcmil, 48 C, Hit 14

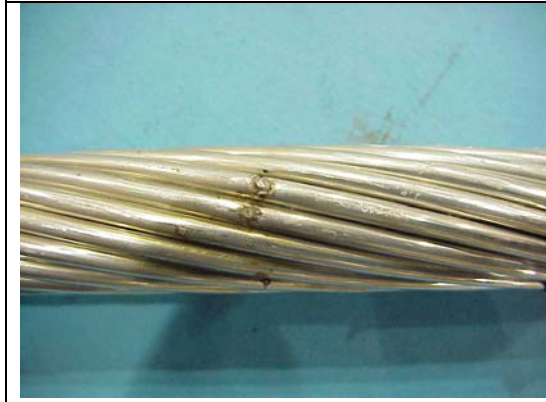
Figure A14aa – ACSR 477 kcmil, 52 C, Hit 13

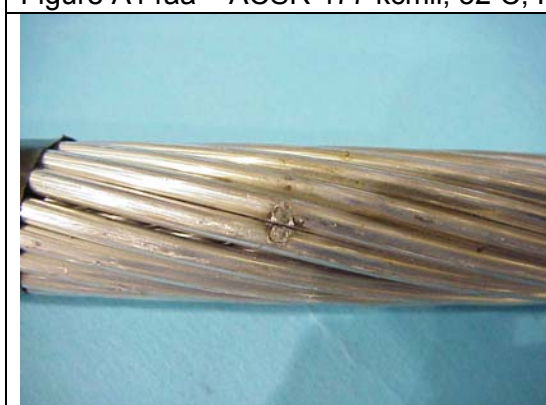
Figure A15aa – ACSR 477 kcmil, 53 C, Hit 15

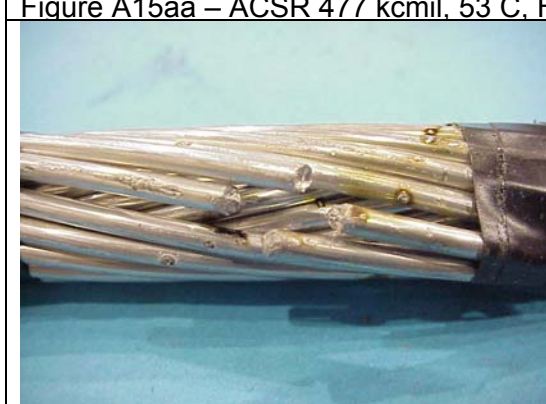
Figure A16aa – ACSR 477 kcmil, 102 C, Hit 20

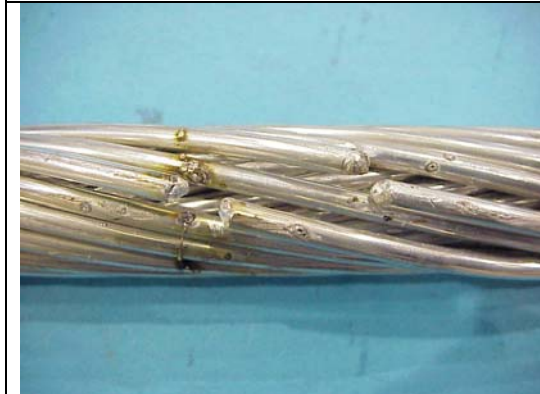
Figure A18aa – ACSR 477 kcmil, 110 C, Hit 19

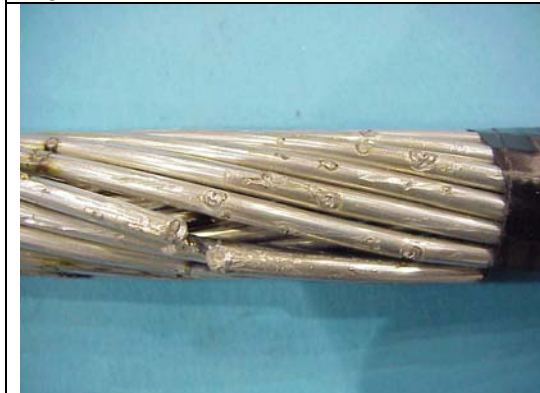
Figure A20aa – ACSR 477 kcmil, 183 C, Hit 17

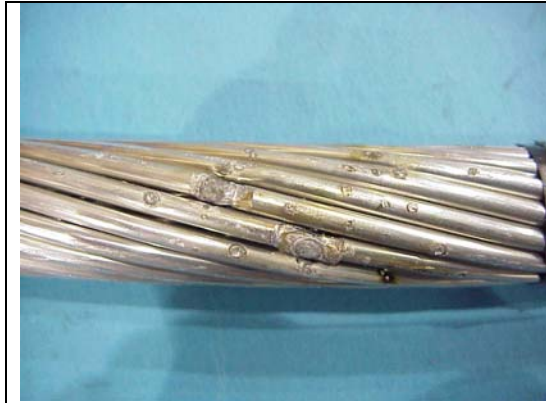
Figure A21aa – ACSR 477 kcmil, 189 C, Hit 23

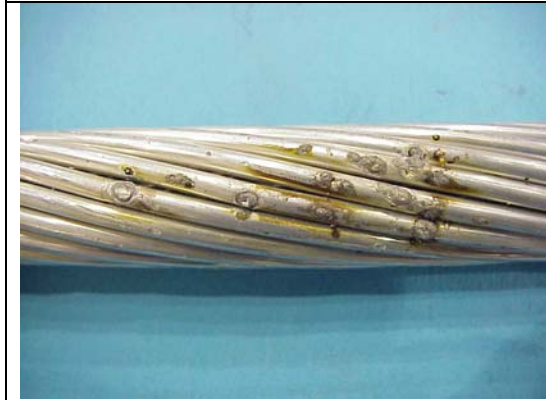
Figure A22aa – ACSR 477 kcmil, 198 C, Hit 18

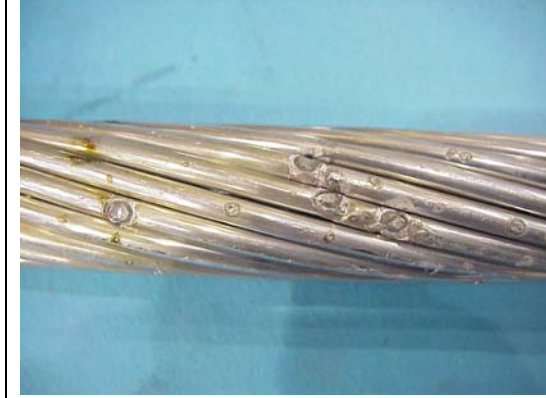
Figure A23aa – ACSR 477 kcmil, 198 C, Hit 22

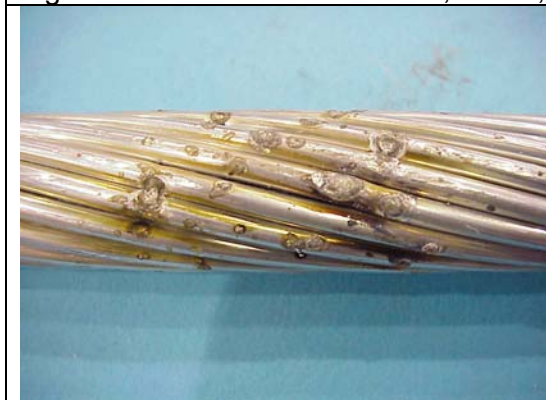
Figure A24aa – ACSR 477 kcmil, 199 C, Hit 24

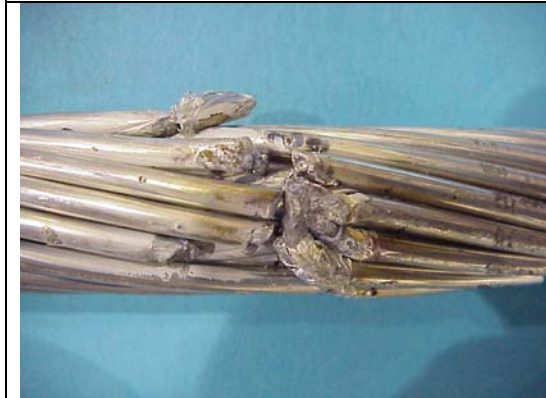
Figure A25aa – ACSR 477 kcmil, 214 C, Hit 15

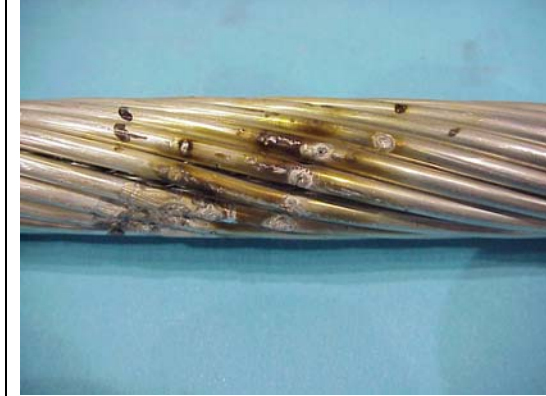
Figure A26aa – ACSR 477 kcmil, 220 C, Hit 14

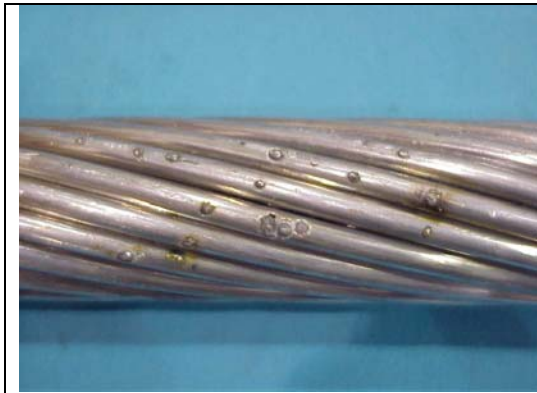
Figure B4aa – ACCR 795 kcmil, 108 C, Hit 7

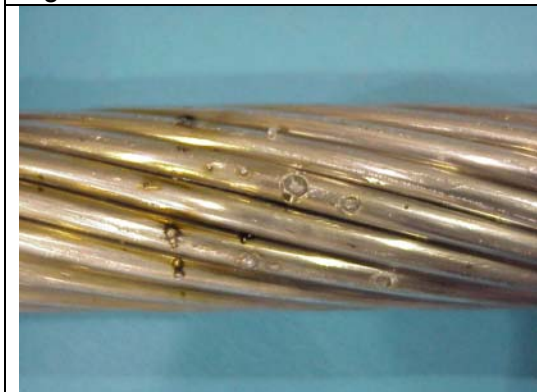
Figure B5aa – ACCR 795 kcmil, 109 C, Hit 6

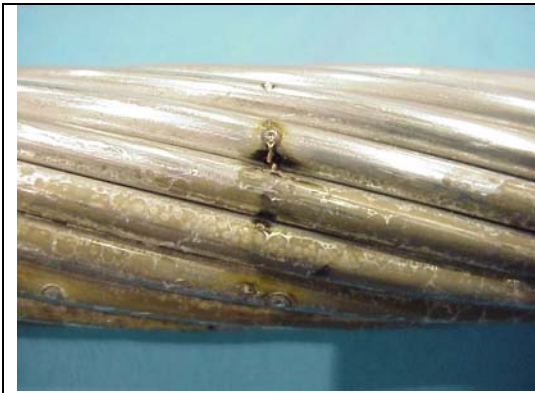
Figure B14aa – ACSR 795 kcmil, 49 C, Hit 4

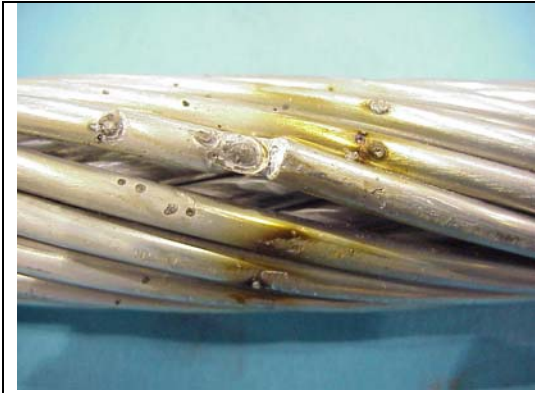
Figure B18aa – ACSR 795 kcmil, 107 C, Hit 1

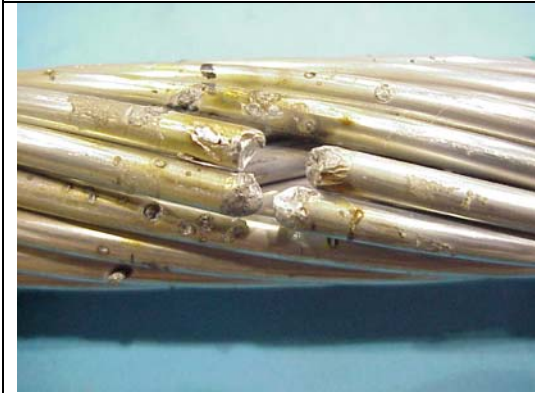
Figure B20aa – ACSR 795 kcmil, 189 C, Hit 7
