Testing of THERMOLIGN® Suspension Assembly

795-kcmil 3M Brand Composite Conductor

Robert Whapham  
Preformed Line Products, Principal Investigator

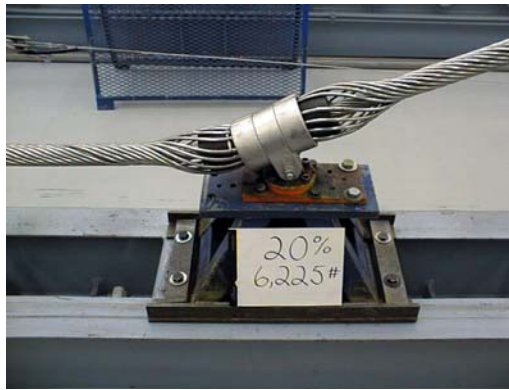
Figure 2 – Unbalanced Load Test Arrangement

To simulate the effects of unbalanced loading in the laboratory, a 30 ft. span of 795 ACCR was terminated at one end with a PLP Dead-End Assembly and attached to the hydraulic ram of the 55K Tensile Equipment. The Suspension Assembly was installed near the far end of the span in an inverted position, and secured to a short tower on the tensile equipment test frame (see Figure 2).

The unbalanced load is applied to the conductor in increments of 5% of the RBS (1,557#), until a continuous slip at the Suspension assembly occurs. Each load increment is held for 5 minutes. As the unbalanced load increases, the angle of rotation of the Suspension Assembly on the attachment plate also increases. Specifically, the tilt angle was 14 degrees for a 5% load, 18 degrees for a 10% load, 22 degrees for a 15% load and 28 degrees for a 20% load.

Two tests were conducted. For the first test, the Suspension Assembly that was subjected to 240° C for 168 hours was used. The second test utilized a new Suspension Assembly.

For both tests, continuous slipping of the conductor relative to the Suspension Assembly occurred at 20% RBS (6,225#). Afterward, the conductor and Suspension Assembly were dissected, and no damage was observed on any of the conductor or Suspension Assembly components.

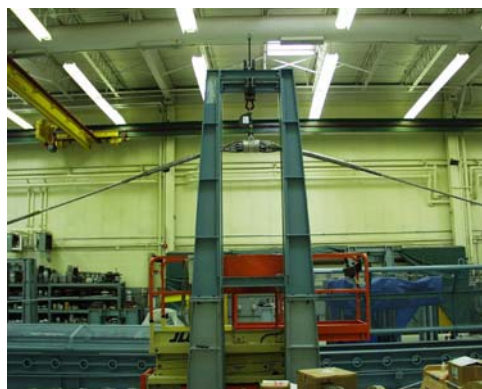
Figure 3 – Turning Angle Test

In the laboratory, the turning angle is simulated in the 55K Tensile Equipment. The Suspension Assembly is attached to a tall tower, which is secured to the tensile equipment test frame (see Figure 3).

For the laboratory turning angle test on the 795 Suspension Assembly for the ACCR conductor, the sample was subjected to a balanced turning angle of 32°, at a conductor tension of 12,460# (40% RBS). The load and angle was held for 5 minutes.

At the completion of the test, the Suspension Assembly and the conductor were dissected, and no damage or distortion was observed on any of the components.

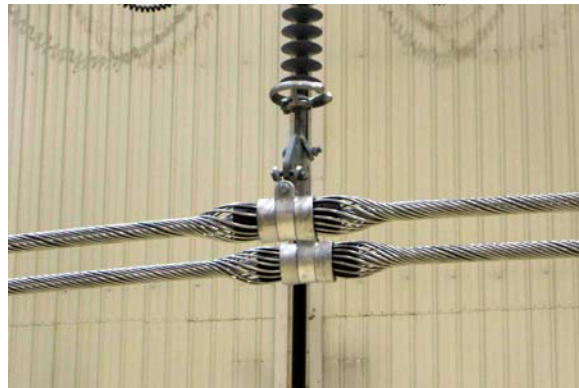
Figure 4 – Corona Test Arrangement

The 795 Suspension Assembly was installed on a single 20' length of 1.125" tubing for one test. On the second test two Suspension Assemblies were tested, each attached to a 20' length of 1.125" tubing, spaced 18" apart (See Figure 4). For both tests the Suspension assemblies were positioned 12 feet above the ground plane.

Corona onset (based on visual and RIV measurements) occurred at 289 KV (phase-to-phase) for the single conductor configuration, and at 510 KV (phase-to-phase) for the twin configuration.

For a single conductor configuration, it may be possible to use a 795 conductor on lines operating at voltages up to 230 KV. The twin 795 configuration would commonly be used on 345 KV lines (400 KV internationally). The results of these tests clearly show that the Suspension Assembly will meet these electrical performance requirements.

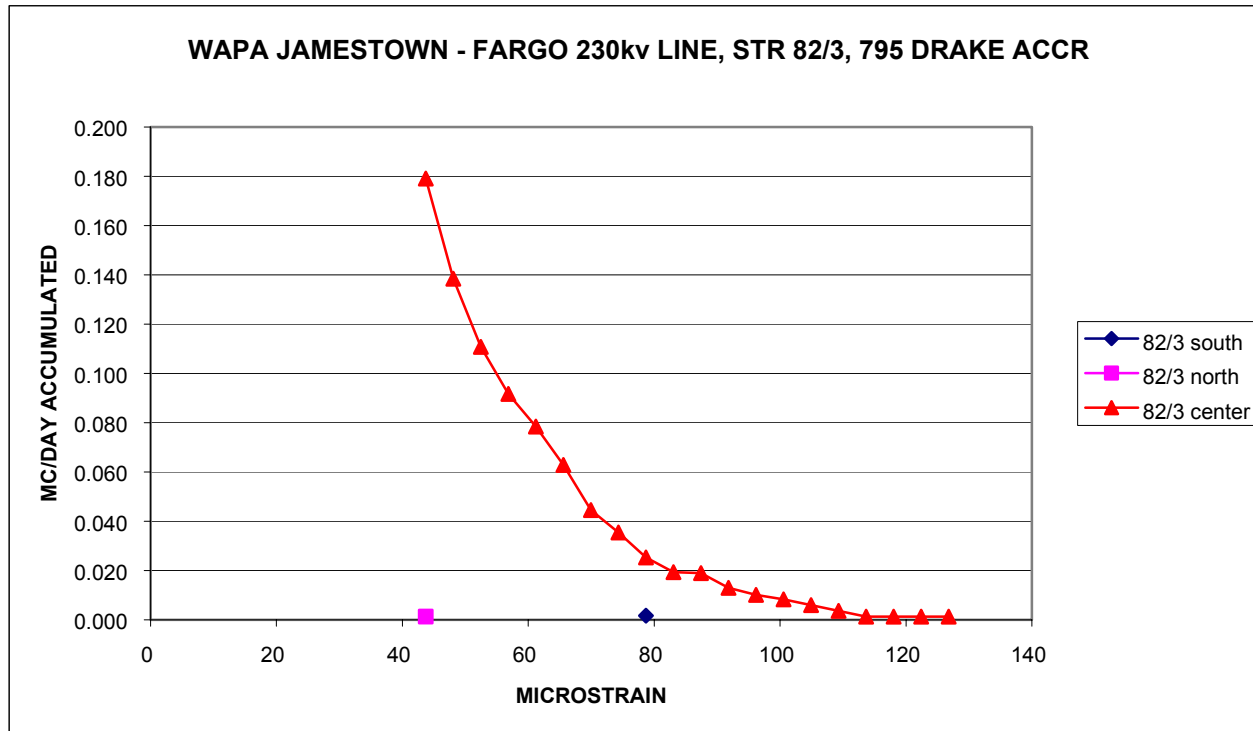
The graph in Figure 8 shows the results for all three phases of the 795 ACCR conductor at Tower #82/3. The two dots near the bottom of the y-axis are the phases with the vibration dampers. Figure 9 shows the activity of the 954 ACSR conductor at Tower #81/4. The South phase with the dampers had no recorded amplitudes above the minimum value.

Figure 8. Plot of mega-cycles per day (MC/Day) vs. micro-strain for all three phases of the 795 ACCR conductor at Tower #82/3

It is also clear from the results shown in Figures 8-10 that the vibration dampers are effective in reducing the levels of vibration on both the ACSR and ACCR conductors.

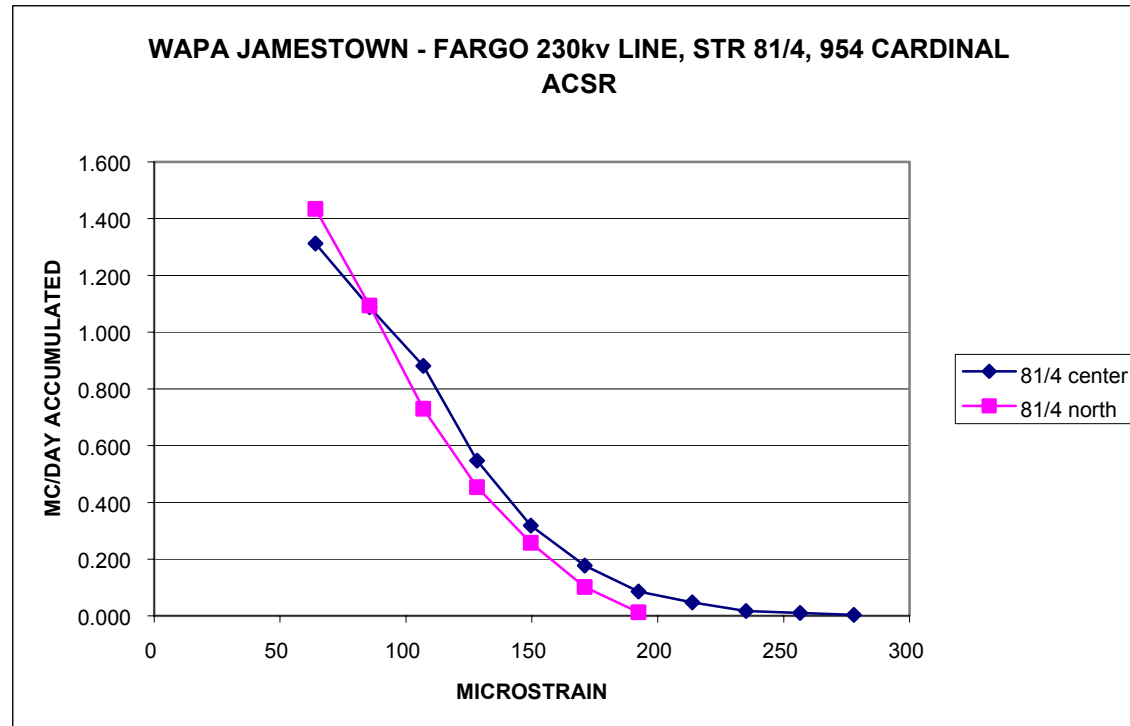
Figure 9. Plot of mega-cycles per day (MC/Day) vs. micro-strain for undamped phases of the 954 ACSR conductor at Tower #81/4

The amount of bending strain on the 954 ACSR conductor, without dampers, is in the moderate range (280 micro-strain). This value is somewhat below the fatigue endurance limit for ACSR conductors. The fatigue endurance limit is a value (micro-strain) at which the conductor can handle, regardless of the accumulated number of cycles. Above the endurance limit, there is a finite number of cycles, after which the conductor will begin to experience fatigue failures in the outer strands. ACSR conductors in the field that have been subjected to micro-strain levels above 400 have been known to experience fatigue breaks in as little as one or two years.

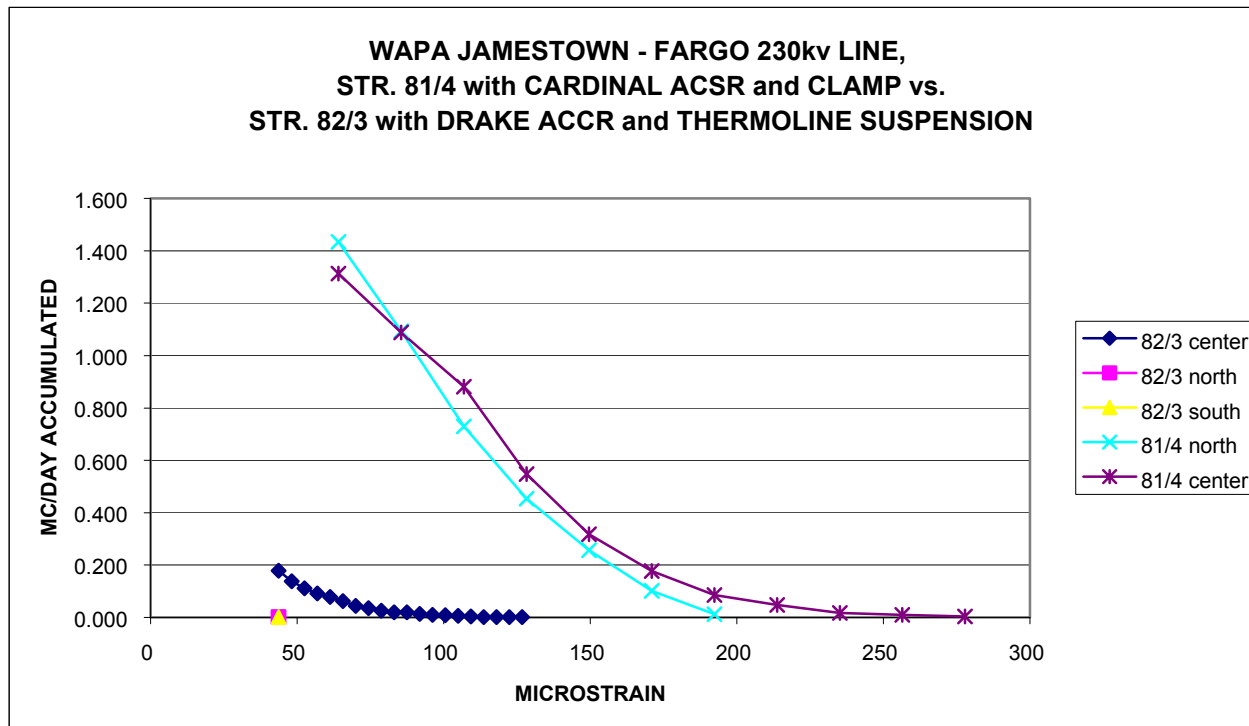
The graph in Figure 10 is a summary of all the study results on the same graph. It is clear from this graph that the bending strain (micro-strain) on the 795 ACCR conductor is, for the worst case, 40% to 50% below that of the 954 ACSR for the same study period. This is mainly due to the protection provided by the PLP Suspension Assembly. The inner and outer rods of the PLP Suspension Assembly take a large percentage of the bending stress, thus reducing the stress on the conductor by 40% or more.

Figure 8. Plot of mega-cycles per day (MC/Day) vs. micro-strain, comparing ACCR (tower 82/3) with ACSR (tower 81/4). The bending micro-strain on the 795 ACCR conductor is, in the worst case, 40% to 50% below that of the 954 ACSR for the same study period. This is mainly due to the protection provided by the PLP Suspension Assembly.
