Sheave Testing of 795 ACCR Conductor with Helical-Rod Full-tension Splices

June, 2006

**Colin McCullough & Todd Staffaroni, 3M
Rob Parker, Sherman & Reilly**

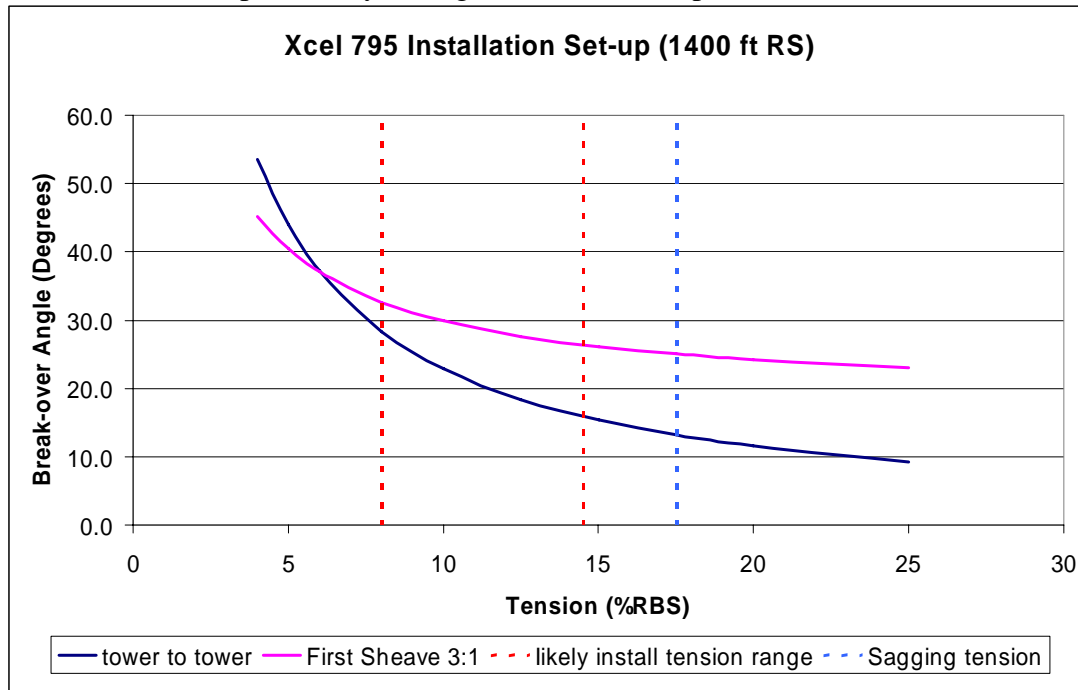
first tower). The expected typical angles and tensions are characterized in Figure 1. The final sag was at ~5500 lbs (17.5% RBS tension), and it was predicted to take ~2500 lbs (8% RBS tension) just to prevent sag onto the ground. Pulling tensions were 10-12% RBS tension which may climb to 14.5% RBS with frictional drag from the sheaves. The angles produced from these tensions are in the range of 15-22 degrees at the suspension towers, and 25-30 degrees at the first sheave assuming a 1:3 ratio in set-up from the tower. If the set-up distance shrinks to 1:2, then the first tower angles increase by 8 degrees. Thus, these are the conditions that the splice and spliced conductor has to endure in order to pass safely through the installation process.

Figure 1. Calculated expected angles and tensions for the installation.

Figure 6. Test Data plotted with expected installation conditions.

The round symbols represent data from the roller array and pair with the curve for the first sheave (first tower). The splice & conductor assembly can endure higher angles and

tensions than will be anticipated. If the field set-up was constrained at 2:1 then the angles would increase 8 degrees, but the test data suggests this would be tolerable. The square symbol is data from the 36-inch sheave used at suspension towers. This suggests the expected angles and tensions would be fine for safe passage of the splice & conductor assembly.

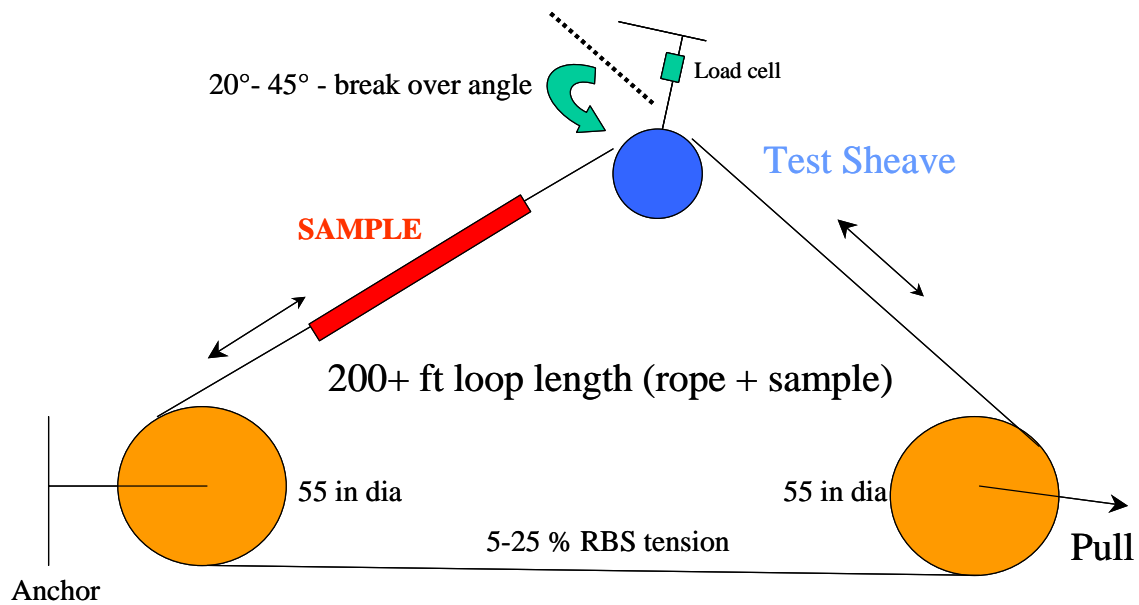
The field installation arrangement at Sherman & Reilly, Chattanooga, TN, uses a loop defined by three sheaves (Figure 2). The 55-inch diameter Anchor sheave is actually the drive sheave that drives the loop in a single direction. The 55-inch diameter Pull sheave is connected to a puller that applies tension to the loop. The test sheave is selected as desired. Break-over angles are set either by changing the position of the Pull sheave or by adjusting the loop length, which has the net effect of moving the Pull anchor in the horizontal plane. Nominal angles were set in the field but then actual angles were accurately measured later by image processing of digital photographs.

Figure 2. Sheave Test Configuration

Resultant tension (R) on the test sheave is monitored through a load cell and the line tension (T) is then computed from this using the equation:

$$T = R/2\sin(\Theta/2)$$

where Θ is the break-over angle.

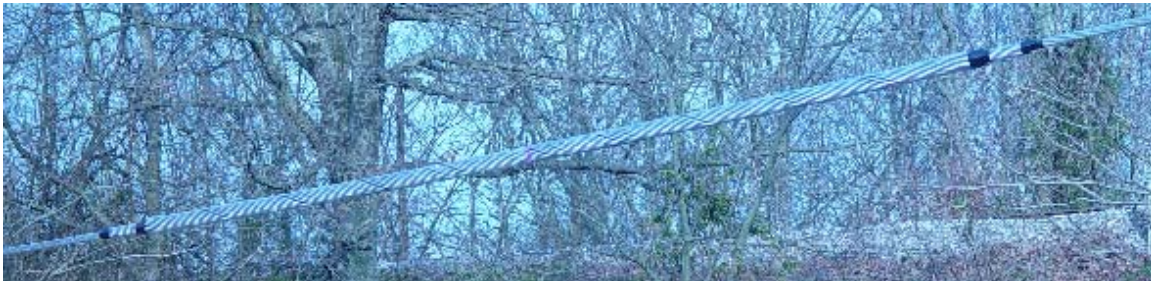
The length of the loop is nominally 200 ft but is adjusted by removing or splicing in length as needed. Most of the loop is strung with a Uniline pulling line (low stretch rope), and the sample is spliced into the loop using pulling grips. Each end of the pulling line is terminated with wire-mesh pulling grips and each end of a 40 ft long conductor piece is terminated with a wire-mesh pulling grip. The conductor piece was further cut into two 20 ft sections and then re-connected using a two layer PLP Thermolign™ full-tension splice, part number TLSP-795 (Figure 3). Two splices were available for testing, each of which was used twice. The ends of the rods were taped to prevent catching on the sheaves.

Figure 3. Fully configured splice in the test loop

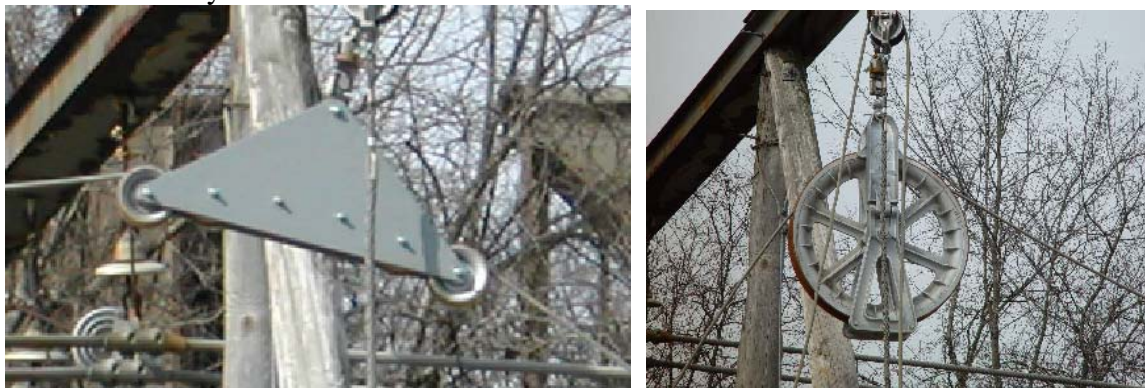
Two Sheaves were tested (Figure 4). Firstly a Roller Array was used consisting of 6 small 7-inch diameter sheaves that laid out an arc of 45 degrees having a radius of 60 inches. Secondly a 36-inch sheave block was tried.

Figure 4. (a) roller array (b) single 36-inch sheave

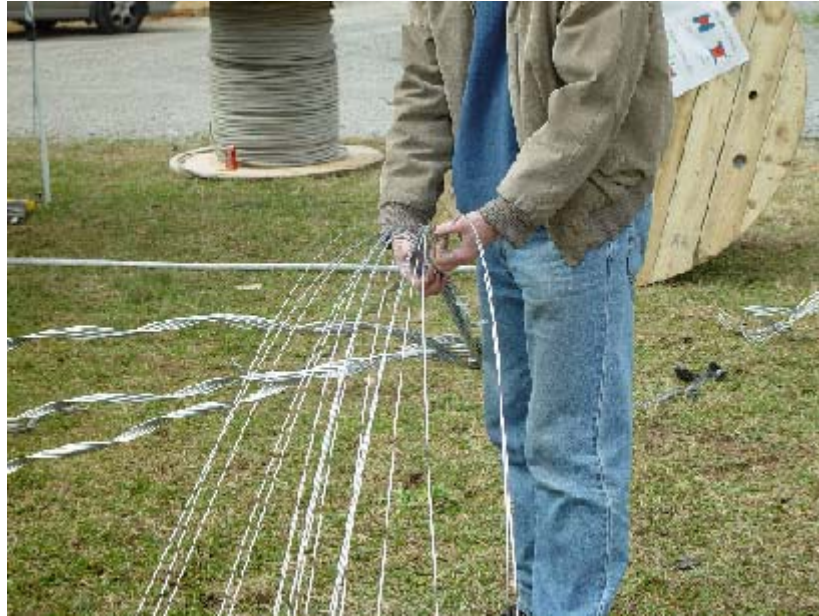
In all cases, a good result was achieved. There was no damage to the core wires or the splice upon dissection (Figure 5). The splices were surprisingly flexible and suffered no signs of distortion.

Figure 5. Undamaged Conductor core wires after sheave testing.

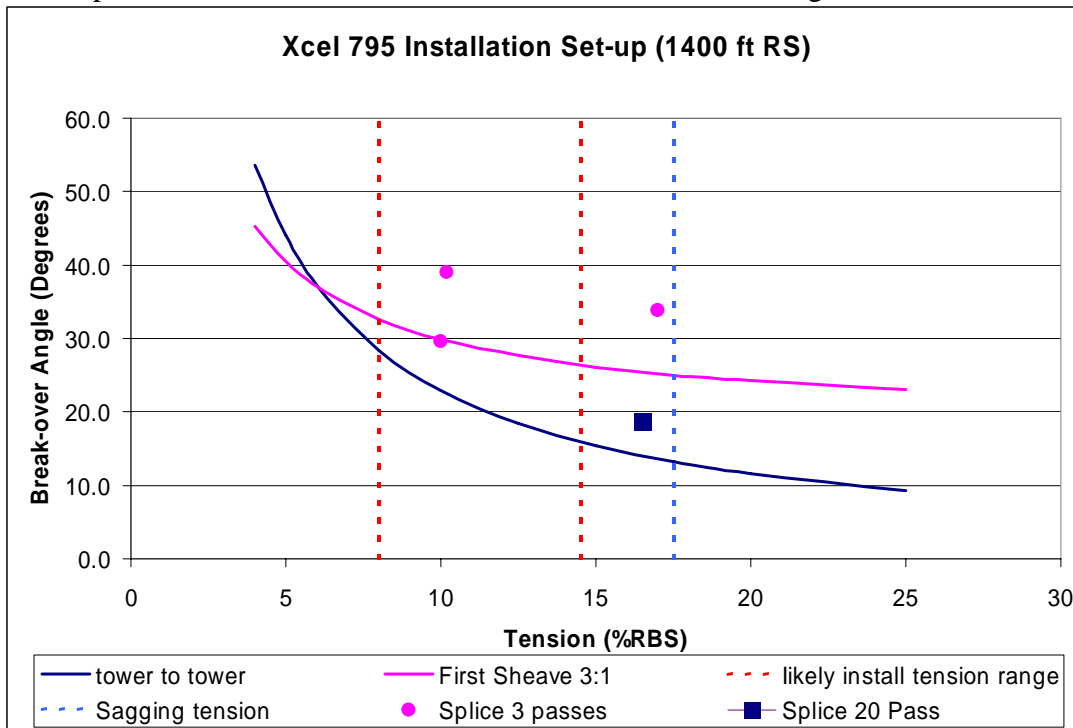
The implications for the installation conditions are shown in Figure 6.
