**KINETRICS NORTH AMERICA INC. TEST REPORT
FOR 3M 1272 kcmil ACCR CONDUCTOR**

Test Name: TENSION TESTS ON FULL TENSION SPLICES FOR 1272 kcmil
ACCR CONDUCTOR AT ROOM TEMPERATURE

Standard: Based on ANSI C119.4-2003, Paragraph 7.3.4

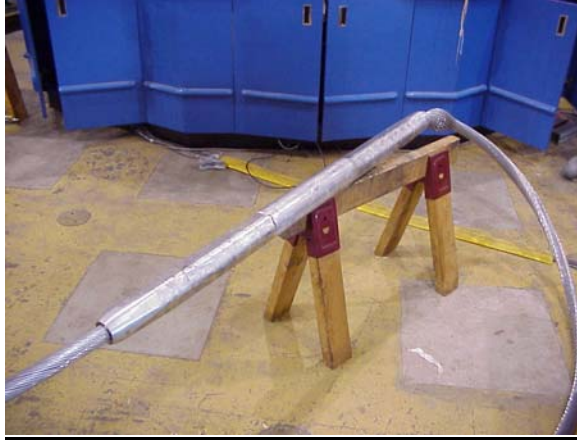
Figure 1a: 1272 kcmil Full Tension Splice after Tension Test at Room Temperature (Sample #1)

Sample #1 – 43,927 lbf (100.6% RTS) at north epoxy-resin clamp. The splice remained intact at failure.

Photographs of the splices after the tension tests for Samples #1, #2 and #3 are shown in Figures 1a-c, 2a-c and 3a-c, respectively.

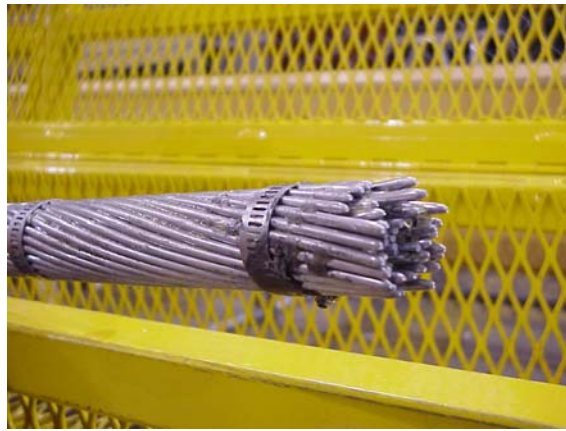
Figure 1b: Failed 1272 kcmil Conductor after Tension Test at Room Temperature (Sample #1)

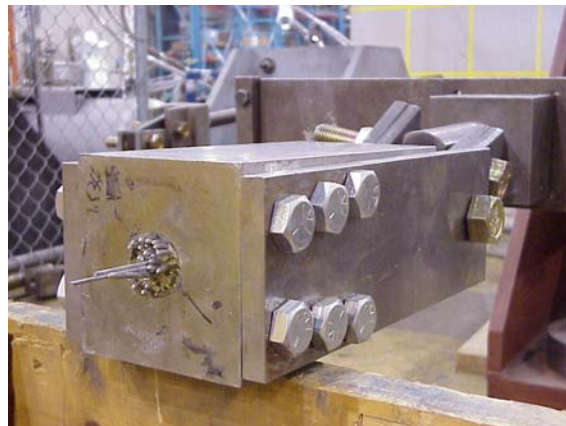
Figure 1c: 1272 kcmil Conductor at North Epoxy-Resin Clamp Location after Tension to Failure Test at Room Temperature (Sample #1)

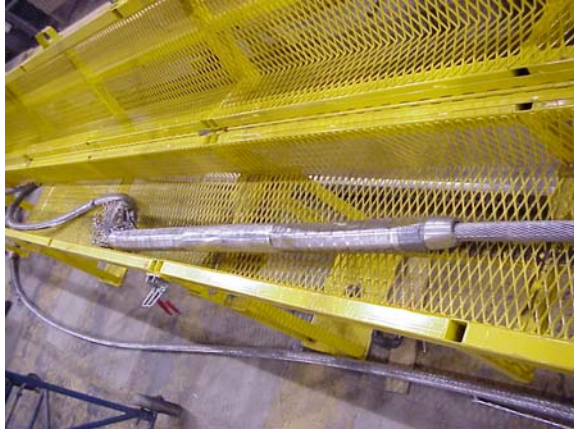
Figure 2a: 1272 kcmil Full Tension Splice after Tension Test at Room Temperature (Sample #2)

Sample #2 – 43,732 lbf (100.1% RTS) at north epoxy-resin clamp. The splice remained intact at failure.

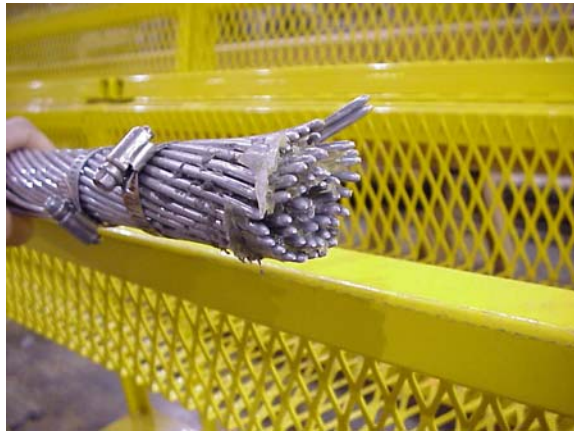
Figure 2a: Failed 1272 kcmil Conductor after Tension Test at Room Temperature (Sample #2)

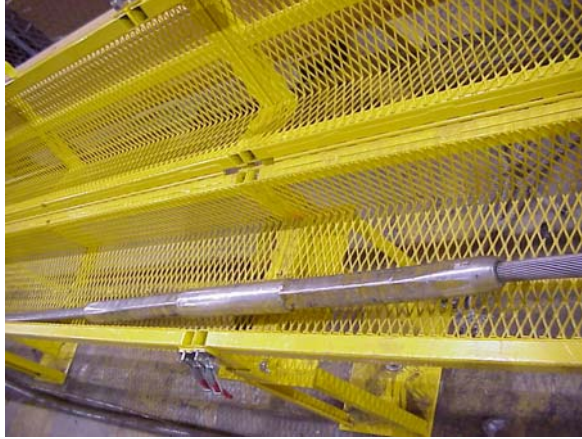
Figure 3a: 1272 kcmil Full Tension Splice after Tension Test at Room Temperature (Sample #3)

Sample #3 – 38,212 lbf (87.5% RTS) at south epoxy-resin clamp. The splice remained intact at failure. The failure was a premature break at the epoxy-resin clamp, and thus for the purposes of qualifying the splices, this test may be discarded.

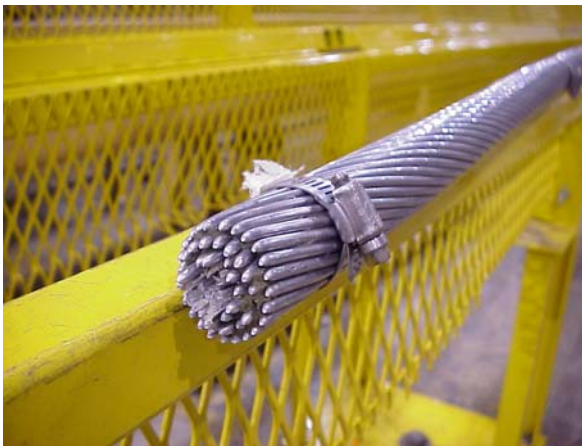
Figure 3a: Failed 1272 kcmil Conductor after Tension Test at Room Temperature (Sample #3)
