July 2011

## **McLean's Mountain Wind Farm**

### *Water Assessment Site Investigation Report*

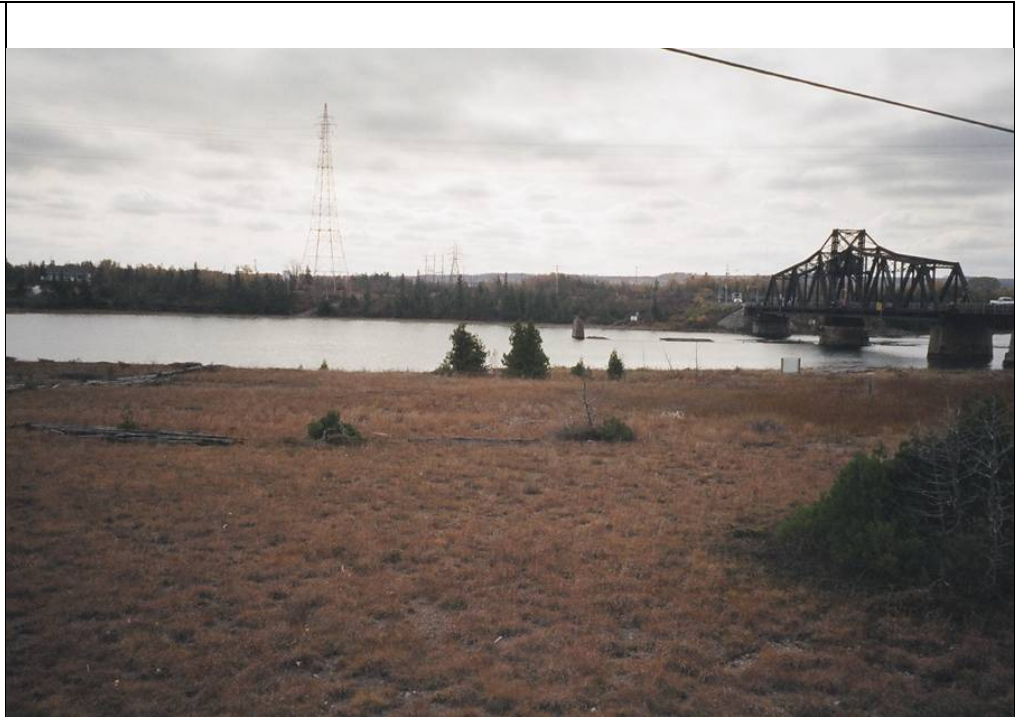
**Photo 3**

October 26, 2004  
North Channel of  
Lake Huron  
Station #11

Photo taken from  
the north side of the  
channel, looking  
south at the shore  
area and channel.

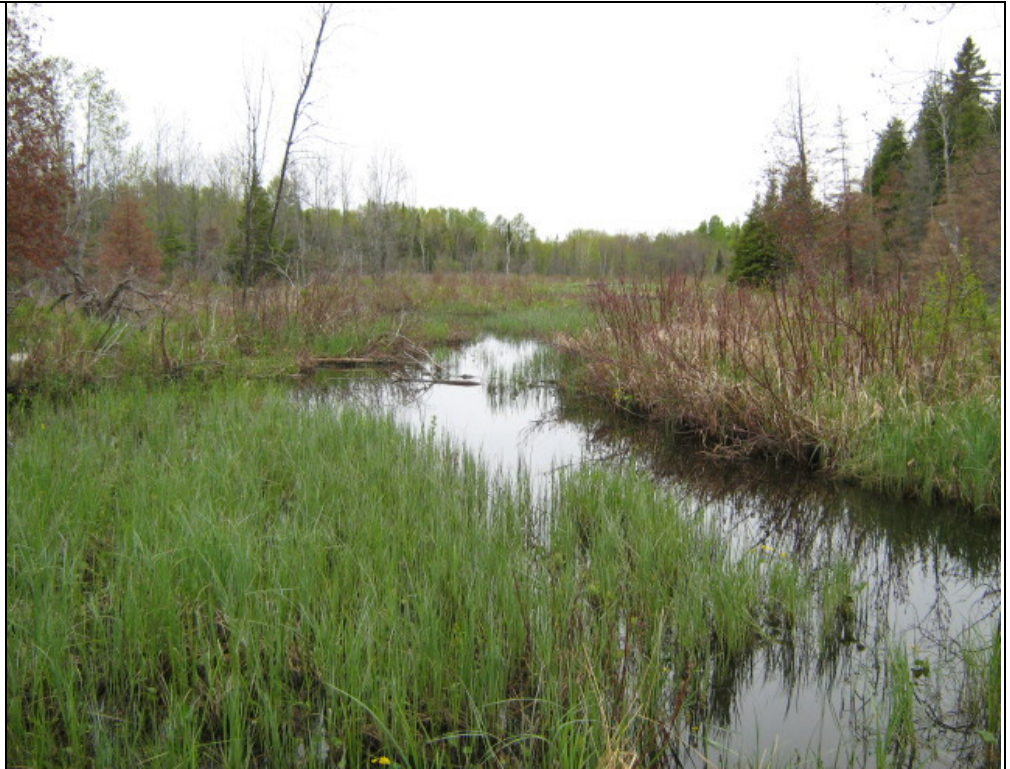
**Photo 5**

Marsh area at  
downstream end of  
Perch Creek

Looking downstream

This new crossing location falls along a section of Perch Creek which flows southwest through a wetland area (Photo 5, Appendix C) and over a waterfall as it moves to its discharge point at Lake Huron. This waterfall is a barrier to fish migration to this section of the creek. Flow at the time of field investigations was fairly low with moderate velocity. Aquatic conditions are best characterized by dominant run habitat with some riffle and flats downstream of the crossing and riffle habitat dominating upstream of

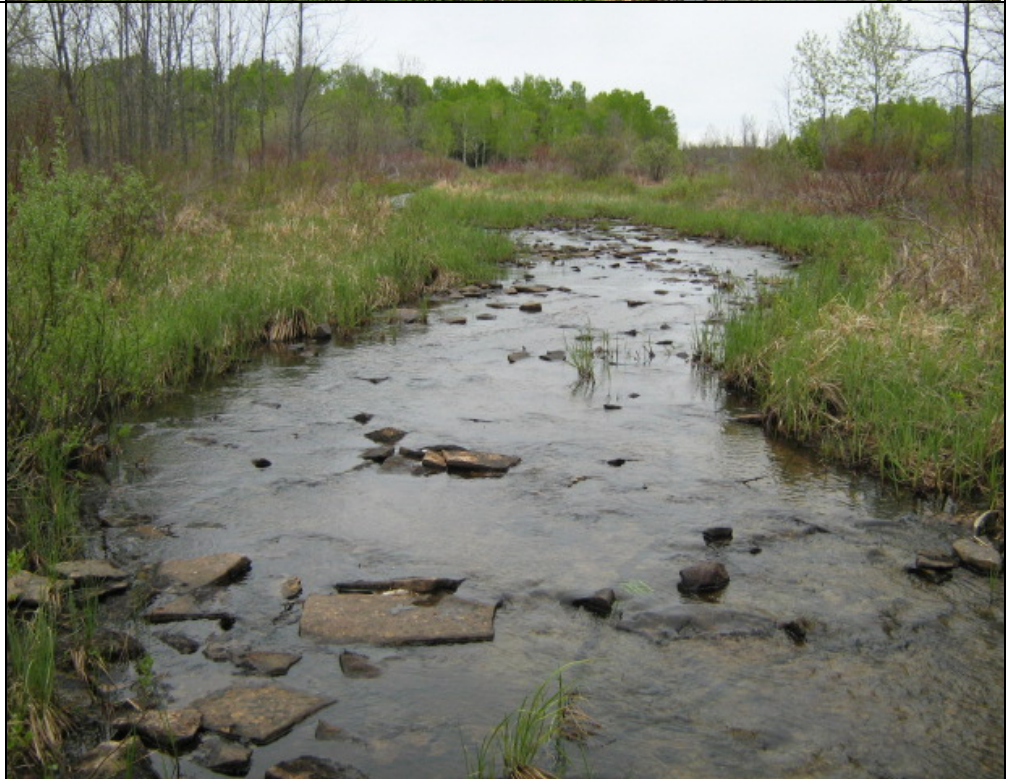
**Photo 6**

Perch Creek  
Station #1

Looking upstream

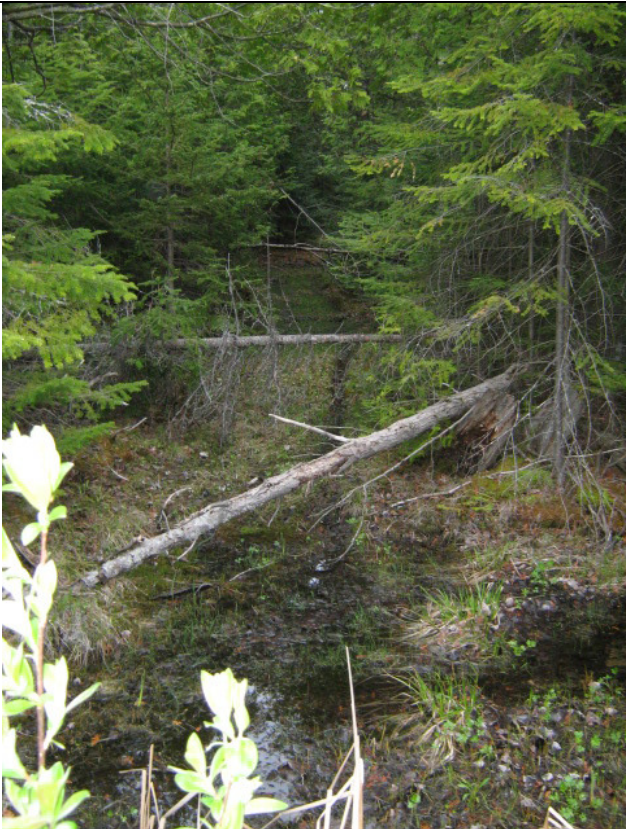
| <p><b>Photo 7</b></p> <p>McLean's Mountain<br/>Wind Farm</p> <p>May 7, 2010</p> <p>Tributary of Perch<br/>Creek<br/>Station #2</p> <p>Upstream grass<br/>channel with minimal<br/>flow</p> <p>Looking upstream</p> | |

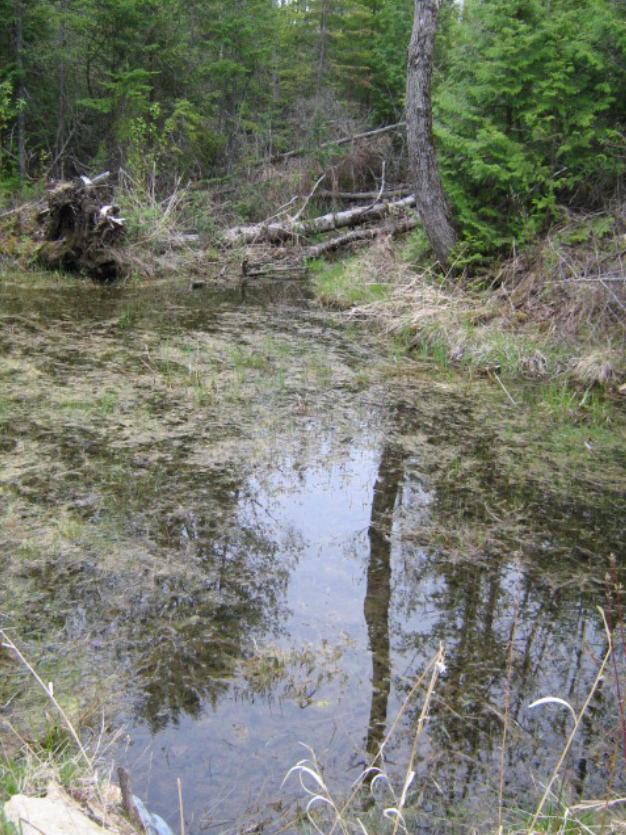
| <p><b>Photo 8</b></p> <p>McLean's Mountain<br/>Wind Farm</p> <p>May 7, 2010</p> <p>Tributary of Perch<br/>Creek<br/>Station #2</p> <p>Downstream culvert<br/>and open water<br/>wetland with small<br/>channel</p> <p>Looking downstream</p> | |

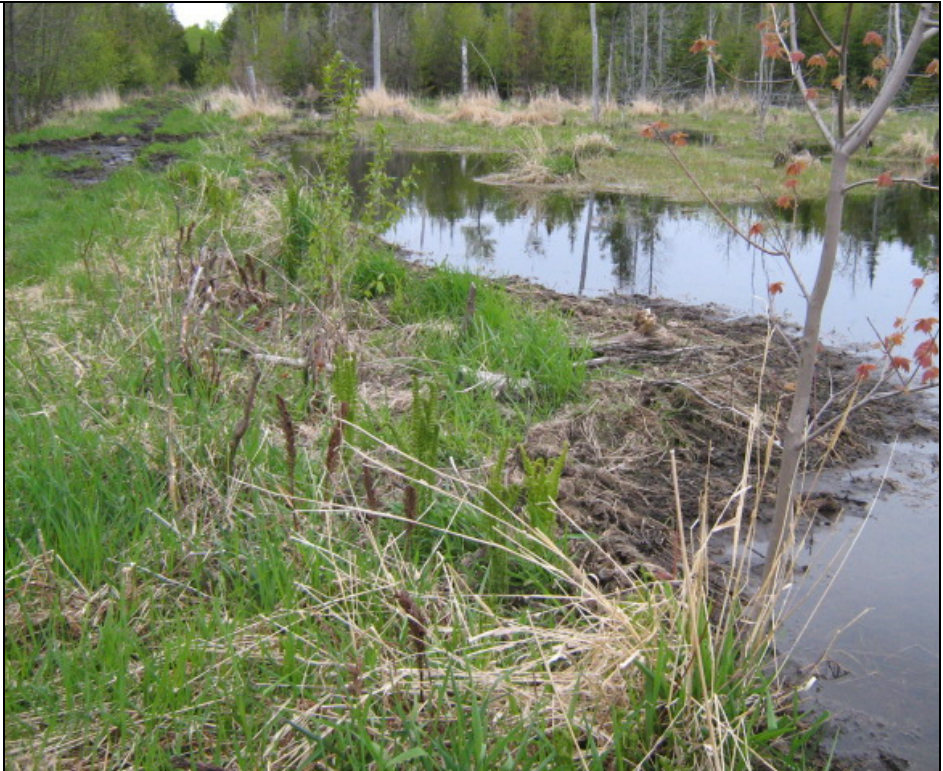
**Photo 9**

Blocked upstream  
double CSP culvert  
preventing flow  
downstream

Looking upstream

This crossing conveys flow between two wetland areas; a large open water marsh with many grass mat islands (Photo 9, Appendix C) to a mixed forest with braided channels (Photo 10, Appendix C). A double culvert is located at this crossing but is blocked by built up woody debris at the upstream end (Photo 11 and 12, Appendix C). A small flow has formed across the road. This crossing represents permanent flow and fish habitat. Substrate near the shore of the open water consists of muck and detritus. No fish were observed during field investigations. The surrounding vegetation community consists of MASM1-14: Reed Canary Grass Mineral Shallow Marsh and SWMM1-1: White Cedar-Hardwood Mixed Swamp (Figure 4). Significant wildlife habitat associated with this crossing includes a Turtle Overwintering Area (TOA 2; Figure 6), Woodland Amphibian Breeding Area (WABH 3 and 4; Figure 7) and Sites Supporting Area-sensitive Species: Forest Birds (FB 2; Figure 8). A beaver dam is also located upstream of this crossing.

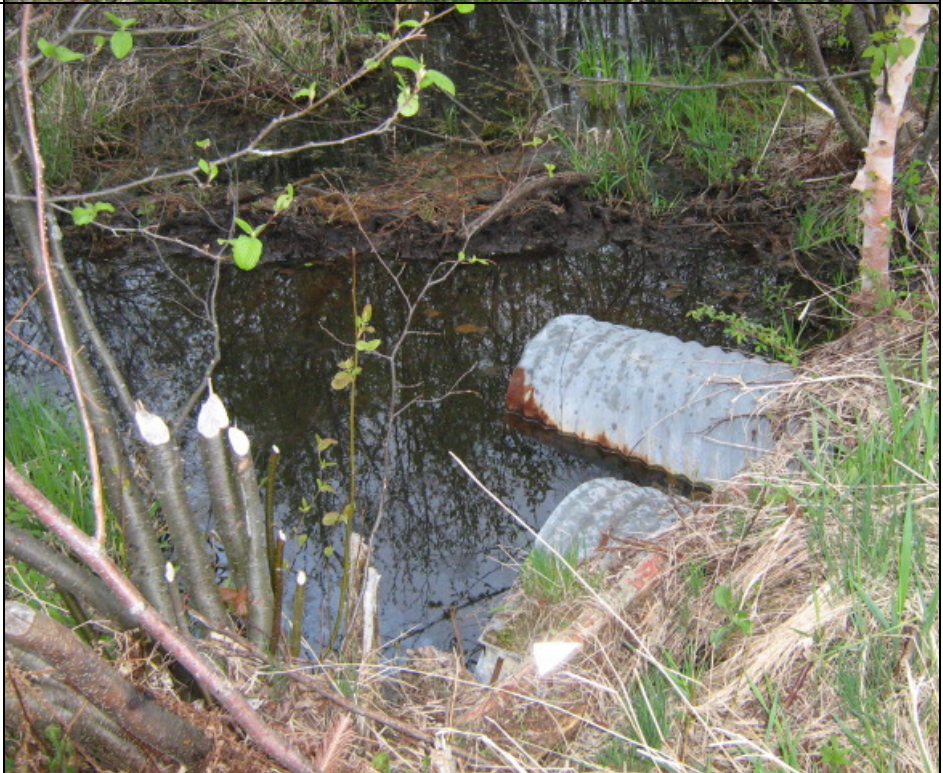
**Photo 10**

Double CSP culvert  
downstream

Looking downstream

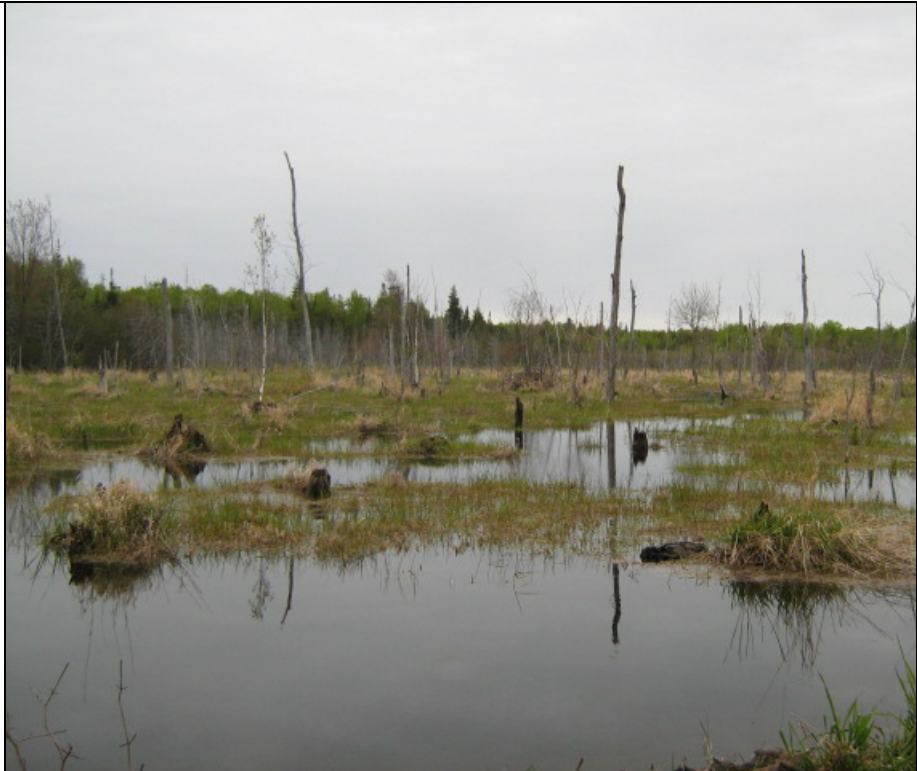
**Photo 11**

Wetland area upstream  
of back road (extension  
of Guida's Sideroad)

Looking upstream

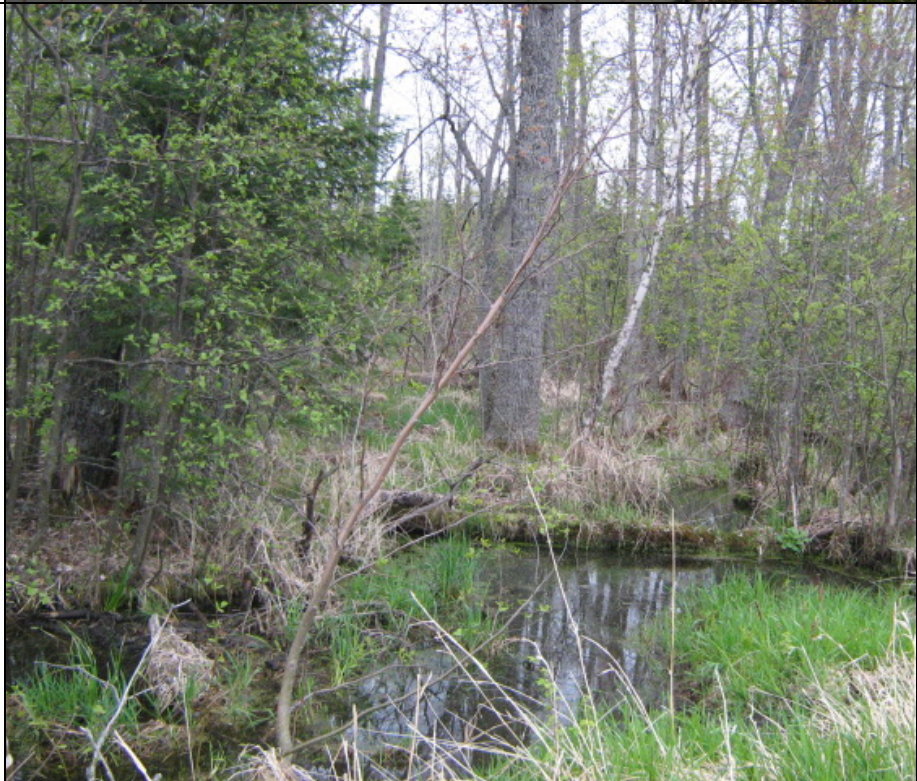
**Photo 12**

Wetland area with  
braided channels  
downstream of back  
road (extension of  
Guida's Sideroad)

Looking downstream

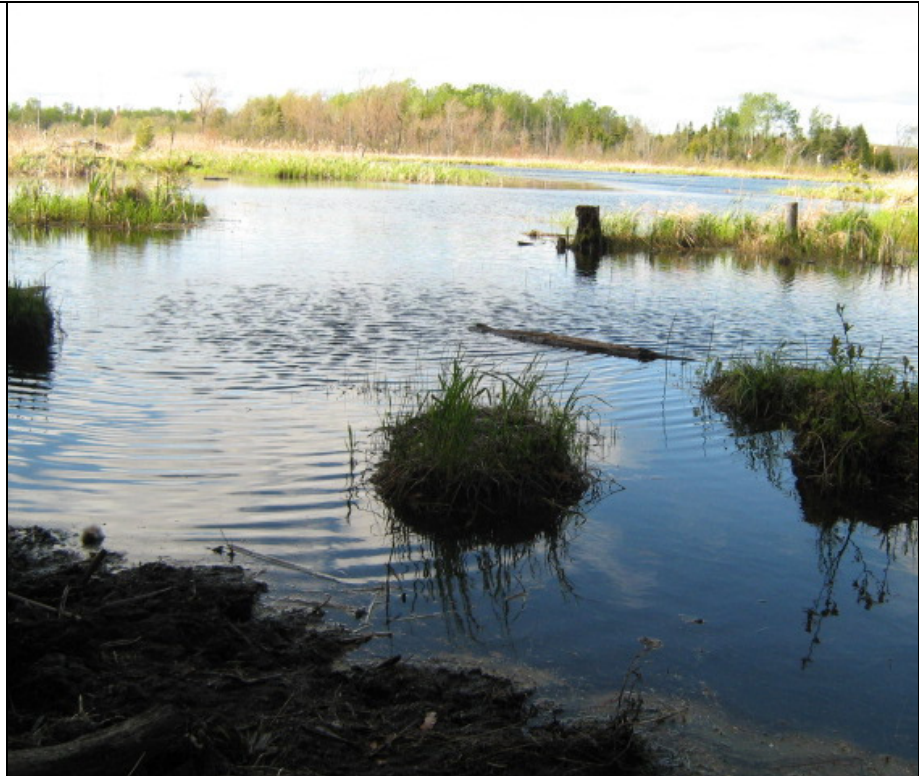
**Photo 13**

Open marsh wetland  
upstream of dry  
channel

Facing upstream

This crossing conveys flow between two open marsh wetland areas (Photo 13, Appendix C). The southern wetland falls along the northeast tip of Perch Lake. A defined channel exists at the upstream end of the Perch Lake tributary for approximately 6 m, opening into a wet forested area (Photo 14, Appendix C) where an ATV trail crosses. Only standing water was observed at the time of field investigations; therefore, this crossing represents intermittent flow and contributes to fish habitat. Substrate consists solely of mud and detritus. No fish were observed during field investigations. The surrounding vegetation community consists of SWCM1-2: White Cedar-Conifer Coniferous Swamp, SWDM2: Ash Mineral Deciduous Swamp, SWTM3: Willow Mineral Deciduous Thicket Swamp and TAGM4: Treed Pasture (Figure 4). Significant wildlife habitat associated with this crossing includes a Waterfowl Nesting Area (WNA 4; Figure 5), Turtle Overwintering Areas (TOA 5 and 6; Figure 6) and Woodland Amphibian Breeding Habitat (WABH 7 and 8; Figure 7). A beaver dam is also located upstream of this crossing.

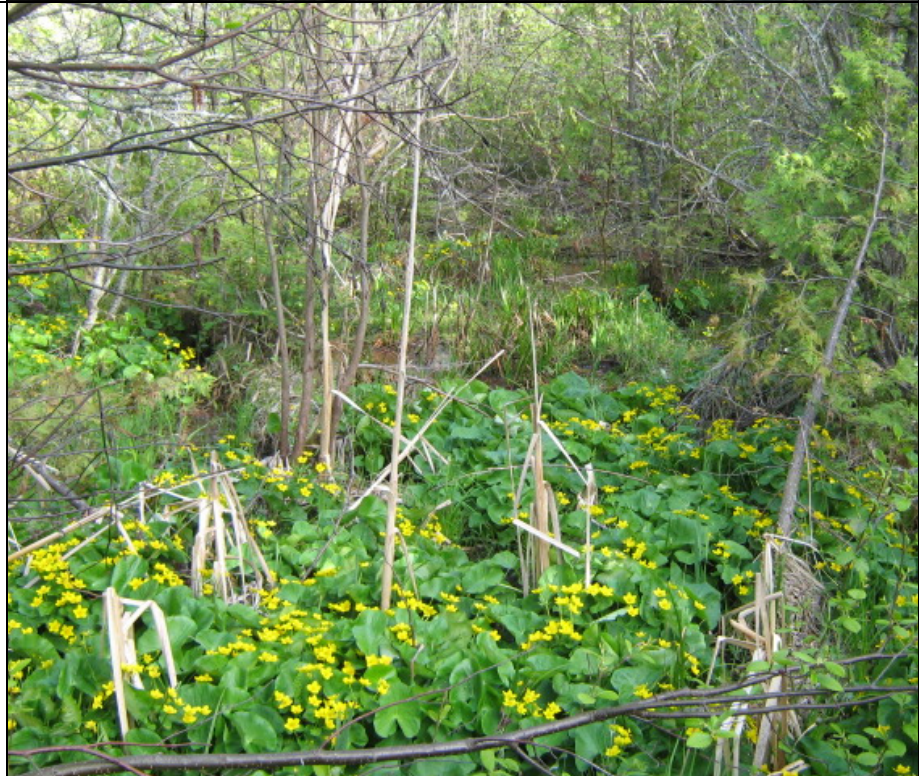
**Photo 14**

Wet low lying area  
with standing water  
downstream of open  
wetland; no defined  
channel

Facing downstream

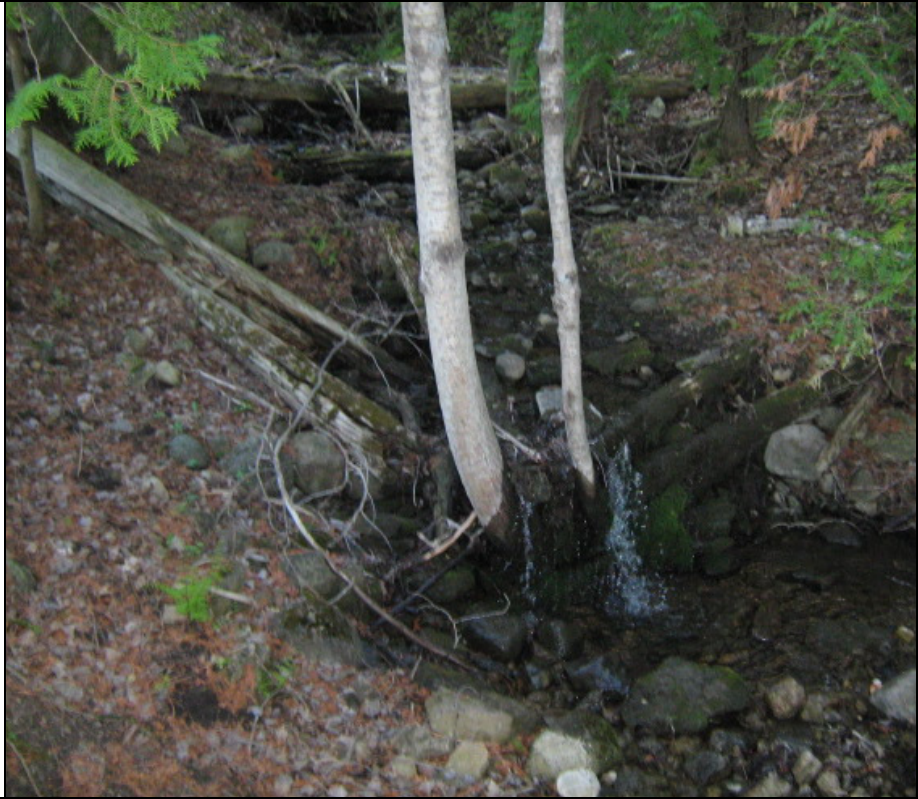
**Photo 15**

High gradient stream  
with multiple  
waterfall barriers

Looking upstream

consisting of multiple waterfalls and drops over the McLean's Mountain escarpment (Photo 15, Appendix C). Flow is conveyed from a cattail marsh (Photo 16, Appendix C) southeast to Bass Lake. Channel width averages from 0.5 – 0.8 m with undercut banks, cobble, woody debris and organic debris as in-stream cover (20%, 30%, 5%, and 5% respectively). Muck, cobble and gravel compose the channel's substrate with minimal submergent vegetation. Flow was moderate at the time of field investigations. No fish were observed and numerous barriers to fish migration are found along the high gradient channel; therefore, limited habitat potential exists. The surrounding vegetation community consists of FODM8-1: Fresh-Moist Poplar Deciduous Forest and OAGM4: Open Pasture (Figure 4). Significant wildlife habitat associated with this crossing includes a Raptor Winter Feeding and Roosting Area (RWFR 3; Figure 9) and Sites Supporting Area-sensitive Species: Open Country Breeding Birds (OCBB 3; Figure 10).

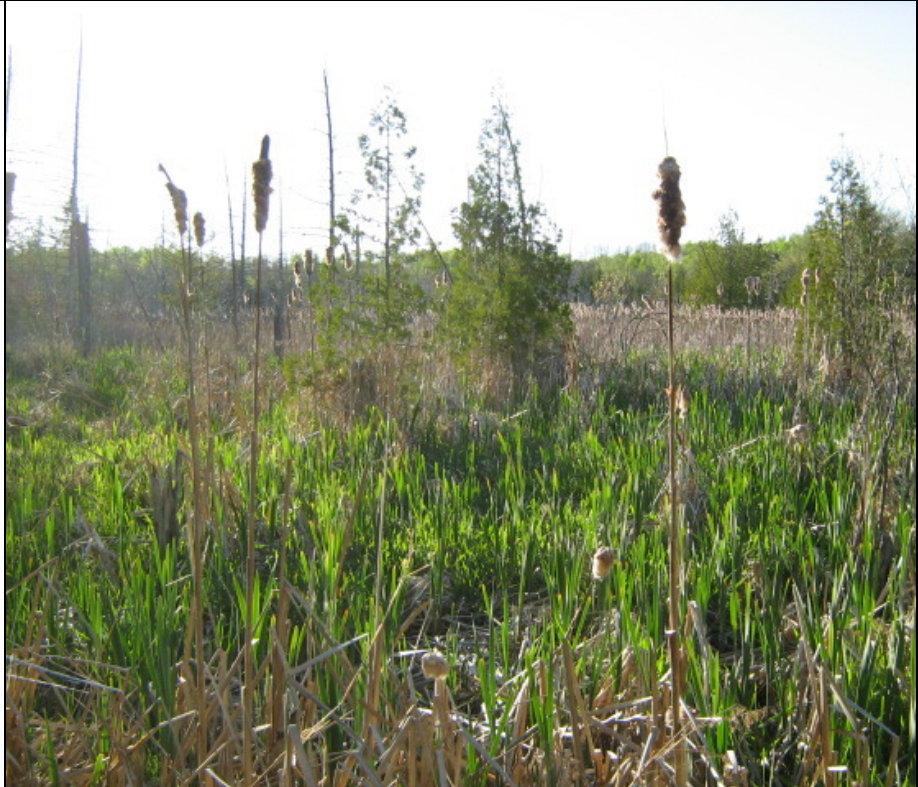
**Photo 16**

Cattail wetland area  
upstream

Looking upstream

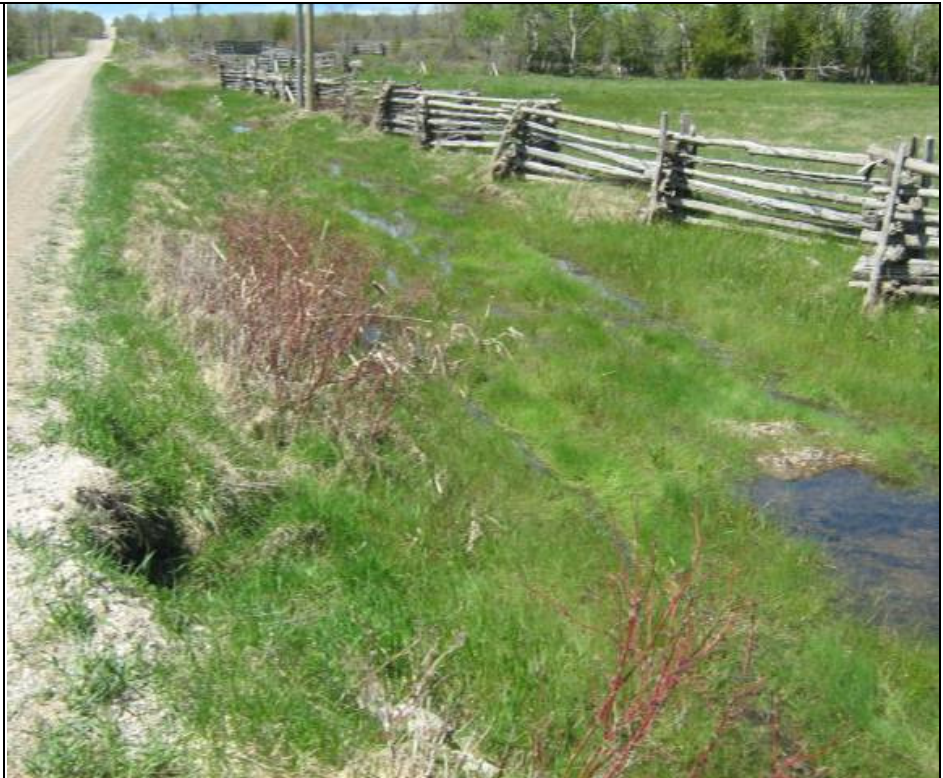
**Photo 17**

Channel formed by  
depressed tire marks  
with small flow  
through culvert north  
of Green Bush Rd.

Looking upstream

This existing crossing location conveys flow from a depressed tire track channel through a culvert to a grass channel in open meadow (Photo 17, Appendix C) which eventually drains into Bass Lake. The upstream channel width averages 3.5 m with in-stream woody debris, in-stream vascular macrophytes and overhanging vascular macrophytes as in-stream cover (5%, 80% and 5% respectively). The downstream channel width averages 2.0 m. In-stream cover consists of in-stream vascular macrophytes (90%). Gravel, sand, detritus and muck compose the channel's substrate. Three fish were observed on the north side of Green Bush Rd; two northern redbelly dace and a central mudminnow. This depressed, grassy channel (Photo 18, Appendix C) showed minimal flow at the time of field investigations which slowed in the open meadow farm fields. As with most of the culverts along Green Bush Rd, flow tends to be intermittent. The surrounding vegetation community consists of FODM1: Dry-Fresh Oak Deciduous Forest and OAGM4: Open Pasture (Figure 4). Significant wildlife habitat associated with this crossing includes a Raptor Winter Feeding and Roosting Area (RWFR 4; Figure 9) and Sites Supporting Area-sensitive Species: Open Country Breeding Birds (OCBB 4; Figure 10).

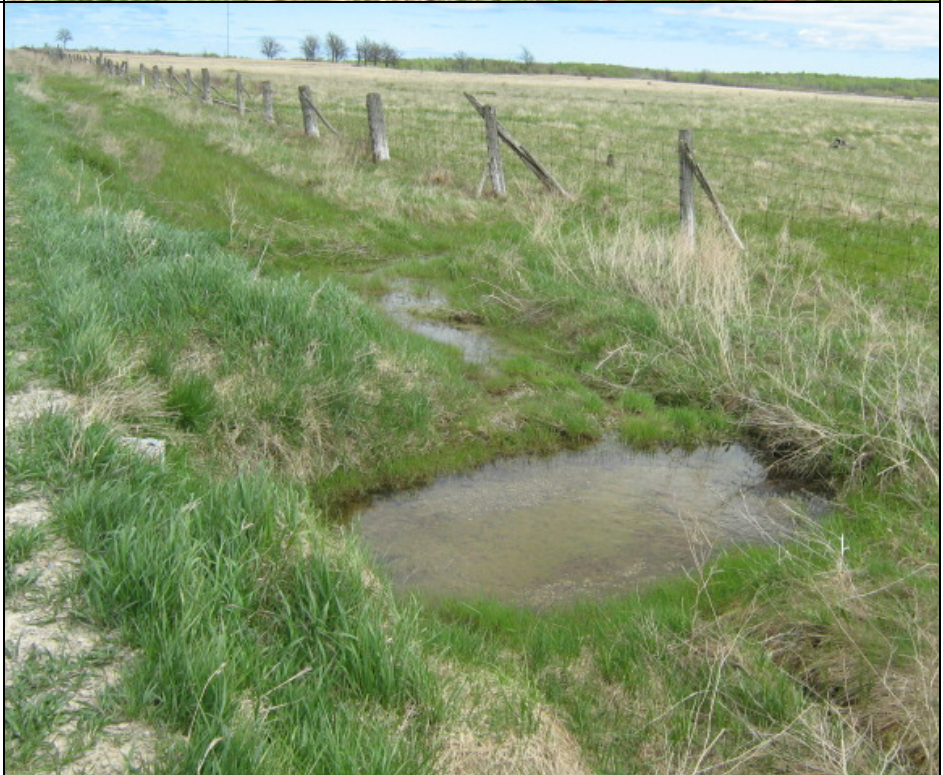
**Photo 18**

Pool and small  
channel flowing into  
farm field south of  
Green Bush Rd.

Looking downstream

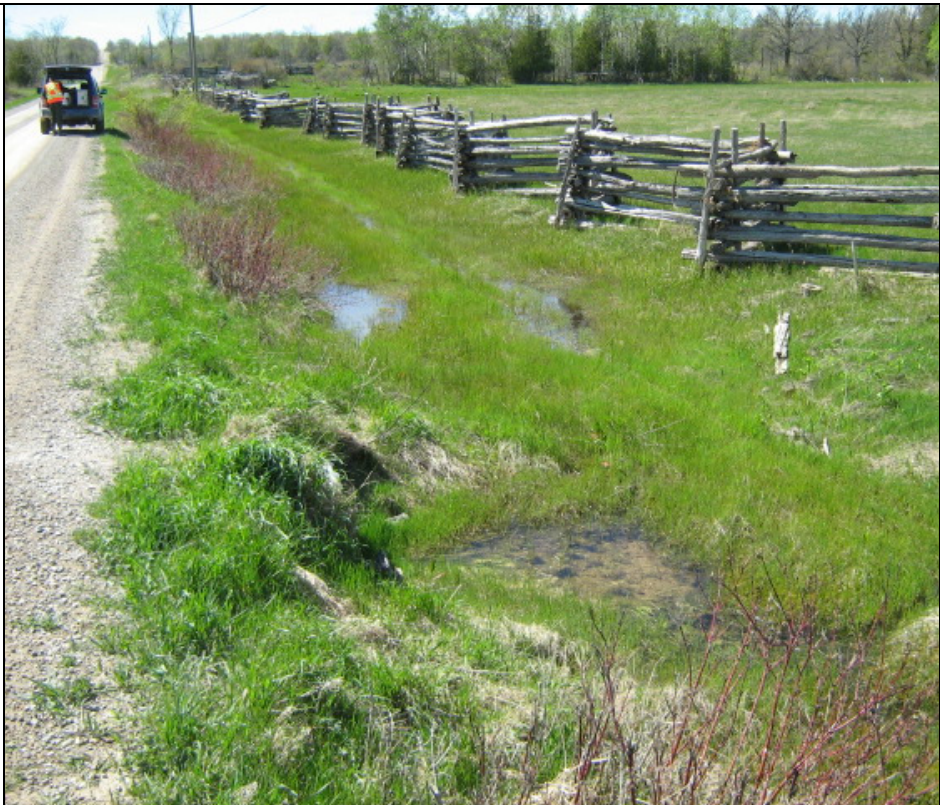
**Photo 19**

Channel formed by  
depressed tire marks  
with small flow  
through culvert north  
of Green Bush Rd.

Looking upstream

stream cover (85% and 5% respectively), as shown in Photo 19, Appendix C. Gravel, sand, muck and detritus compose the upstream channel substrate. The downstream channel width averages 2.0 m with cobble, organic debris, as well as in-stream and overhanging vascular macrophytes for in-stream cover (15%, 10%, 60%, and 10% respectively). Gravel, cobble, sand and detritus compose the downstream channel substrate. Low to no flow was observed during field investigations along this tributary (see Photo 20, Appendix C). The surrounding vegetation community consists of OAGM4: Open Pasture (Figure 4). Significant wildlife habitat associated with this crossing includes a Raptor Winter Feeding and Roosting Area (RWFR 4; Figure 9) and Sites Supporting Area-sensitive Species: Open Country Breeding Birds (OCBB 4; Figure 10).

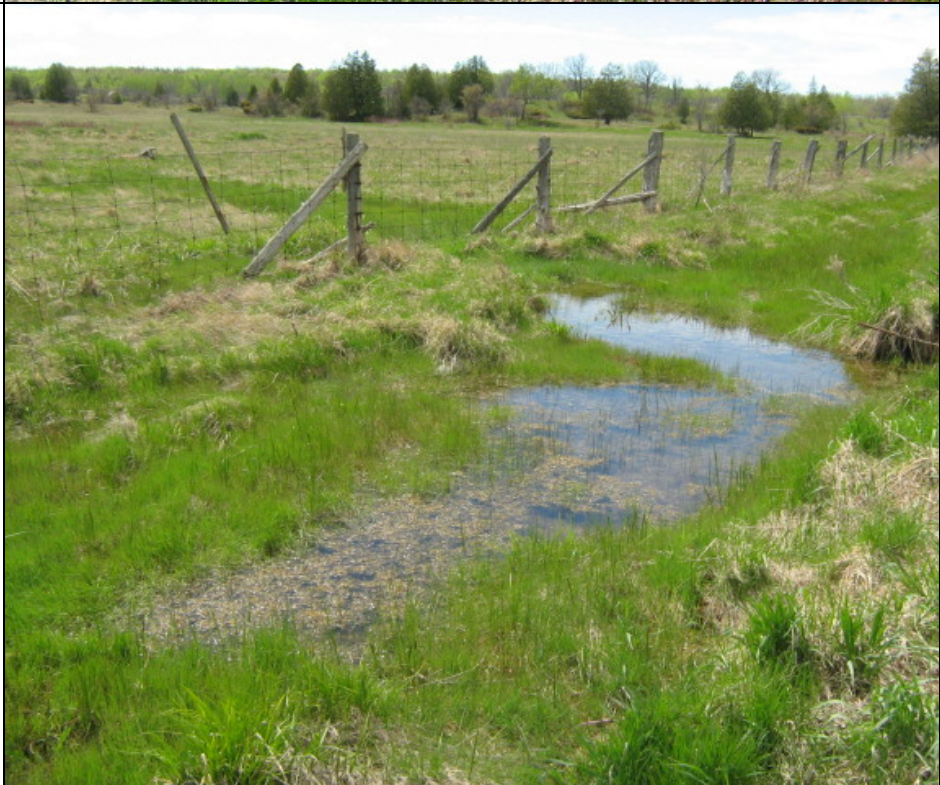
**Photo 20**

Pool and small  
channel flowing into  
farm field south of  
Green Bush Rd.

Looking downstream
