Pipeline to Serve York Energy Centre LP Final Post Construction Environmental Monitoring Report

EB-2009-0187

May 28, 2013

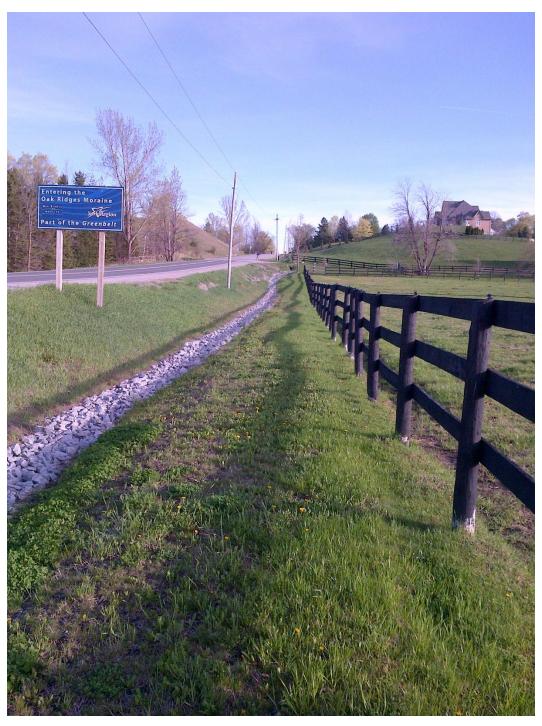
Photo 1 Steep Drainage Channel Stabilized with Rip-Rap on West Ditch of Jane St, Approaching Davis Drive (May 6, 2013)

rerim Monitoring Report Reclamation Resolution commendation Location		Success
1.	Steep slope on the west ditch of Jane St, immediately south of Davis Drive	Enbridge installed rip-rap within the ditch-line and placed a seeded mulch mix on the sides of the ditch to promote vegetation establishment.	The rip-rap was successful in stopping ongoing erosion on the bottom of the ditch-line and vegetation became well established on the sides of the ditch. Area appears to be well stabilized and should not continue to actively erode. (Photo 1; Appendix C)

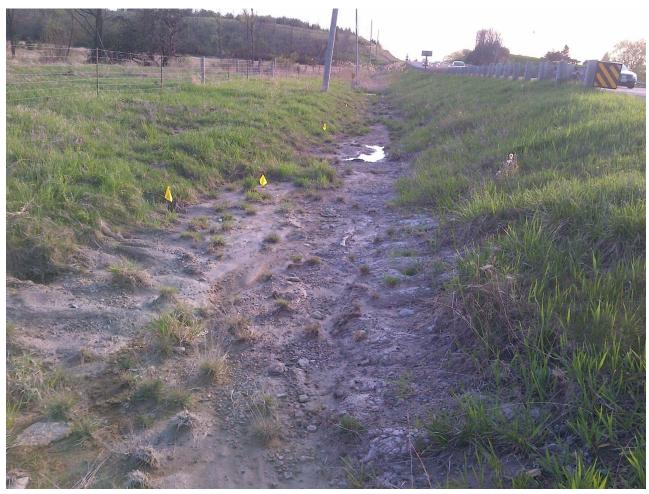
Photo 2 Drainage Ditches Leading into WC6 Remains without Full Vegetation Reestablishment (May 6, 2013)

2.	Drainage ditches into Watercourse ("WC")6	Drainage ditches leading into WC6 hydro-seeded and/or supplemented with a seeded mulch blend to promote adequate vegetation establishment.	Vegetation in the drainage ditch has not fully re-established itself; however, there was no evidence of active erosion. The drainage ditch should continue to re-seed itself with the rich seed-bank in the adjacent field. (Photos 2 and 3; Appendix C)

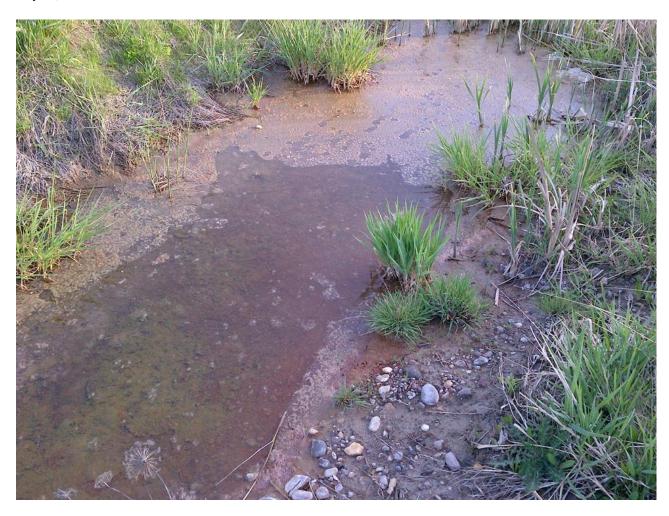
Photo 3 Standing Water in Drainage Ditch Leading into WC6 (May 6, 2013)

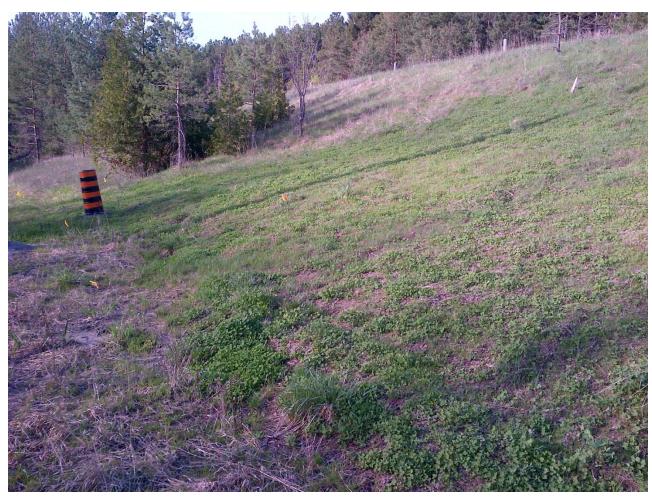
Photo 4 Vegetation Establishment on the Steep Slope on the West Side of Dufferin Street at the Open-Cut Area, Directly North of Davis Drive (May 6, 2013)

3.	Steep slope on west side of Dufferin Street at the open-cut area, directly north of Davis Drive	The site was re-seeded using a hydro-seed mixture to stabilize the slope in spring 2012.	The slope has moderate vegetation establishment with limited indications of erosion at the site. The site should continue to re-seed itself and establish an appropriate level of vegetation to prohibit any active erosion. (Photo 4; Appendix C)

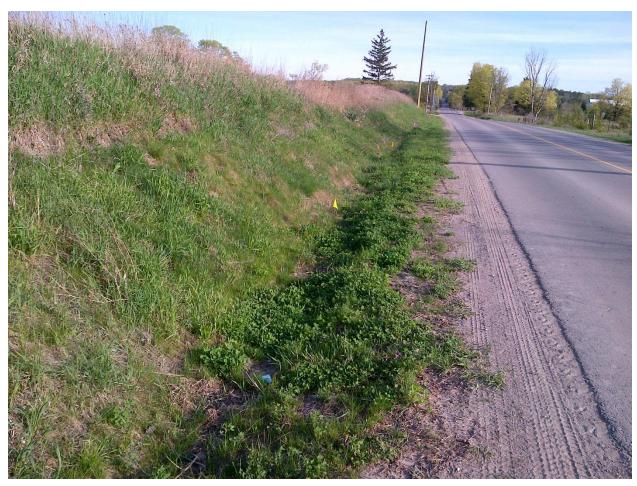
Photo 5 Slope Stability of a Former Sloughing/Soil Creep Area South of Miller's Side Road on Dufferin Street (May 6, 2013)

terim Monitoring Report Reclamation commendation Location	Resolution	Success	
4.	Sloughing/soil creep on small area of exposed backslope south of Miller's Side Road on Dufferin Street should be investigated and seeded as appropriate.	The area was stabilized using an erosion control blanket and re-seeded in 2012.	Vegetation establishment was good and appropriate for the conditions with no active erosion occurring. (Photo 5; Appendix C)

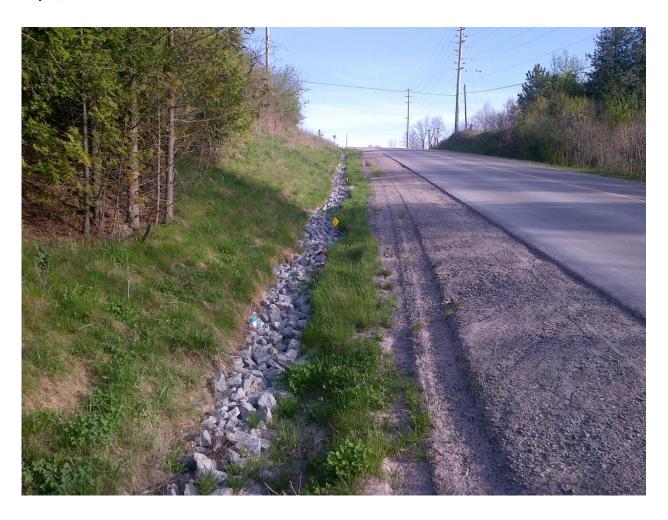
Photo 6 Rip-Rap Installed within the Drainage Ditch in 2012 on the East side of Dufferin Street, Directly North of Miller's Side Road (May 6, 2013)

5.	East side of Dufferin Street directly north of Miller's Side Road	Rip-rap was installed in the drainage ditch to reduce erosion potential and the sides of the ditches were hydro-seeded to promote the appropriate vegetation establishment.	The ditch has been stabilized as appropriate to reduce the potential for erosion and any potential supplemental deposition of sediment downslope into the adjacent Provincially Significant Wetland. (Photo 6; Appendix C)

6.	Stantec recommends that all previously disturbed areas be appropriately vegetated and meet preconstruction conditions.	Hydroseed with appropriate vegetation seed mix to promote establishment on slopes.	Generally the site is well vegetated and stabilized to limit erosion on previously disturbed sites. (Photo 6; Appendix C)
