**Re: Union Gas Limited (“Union”)
Red Lake Pipeline Project
Board File # EB-2011-0040/0041/0042**

RED LAKE PIPELINE PROJECT

INTERIM MONITORING REPORT

Prepared by: Union Gas Limited
Environmental Planning
April 2013

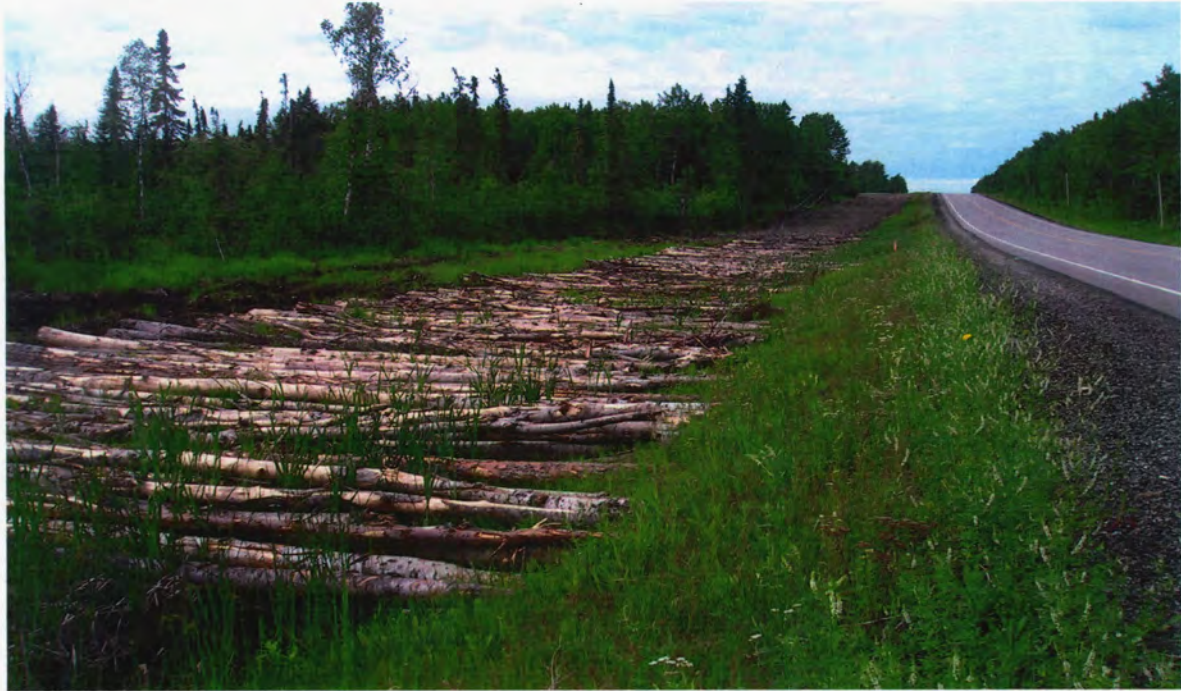
Wet areas along the right-of-way were either horizontally directional drilled or corduroy roads like the one pictured in the photo above were used. Following construction the roads were removed.

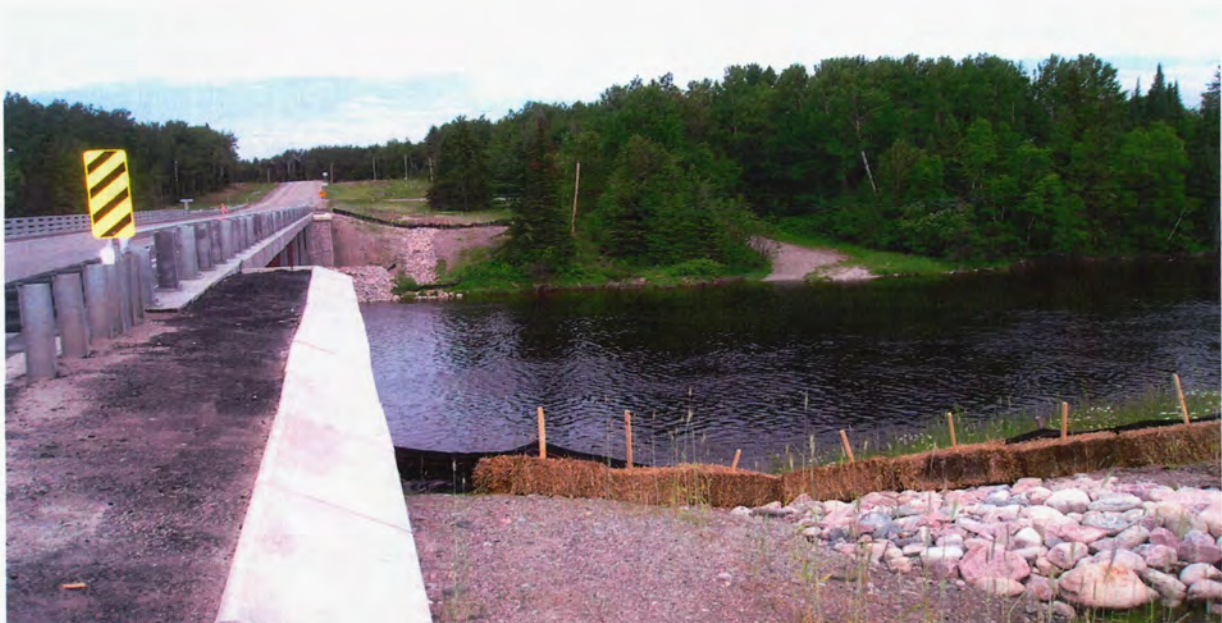
The pipeline at all large watercourses including the Trout River, Caribou Creek, Chukuni River at Hwy 105 (pictured above), Stone River, Bug River and the Chukuni River at Hwy 125 were installed by horizontal directional drill.

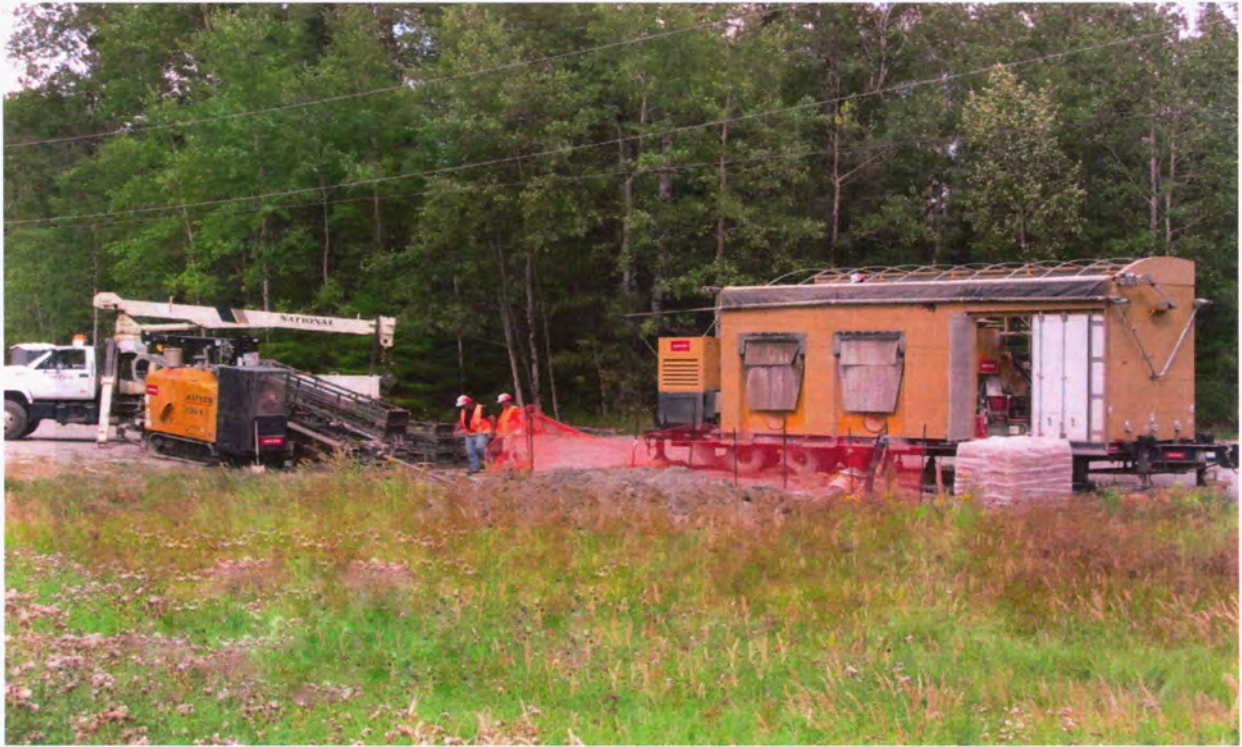
The horizontal directional drill unit, pictured to the left and the drilling mud reclaimer, pictured to the right, successfully installed 338 metres of pipe across the Chukuni River along Hwy 105. The same unit successfully installed 263 metres of pipe through solid rock at the Chukuni River located along Hwy 125.

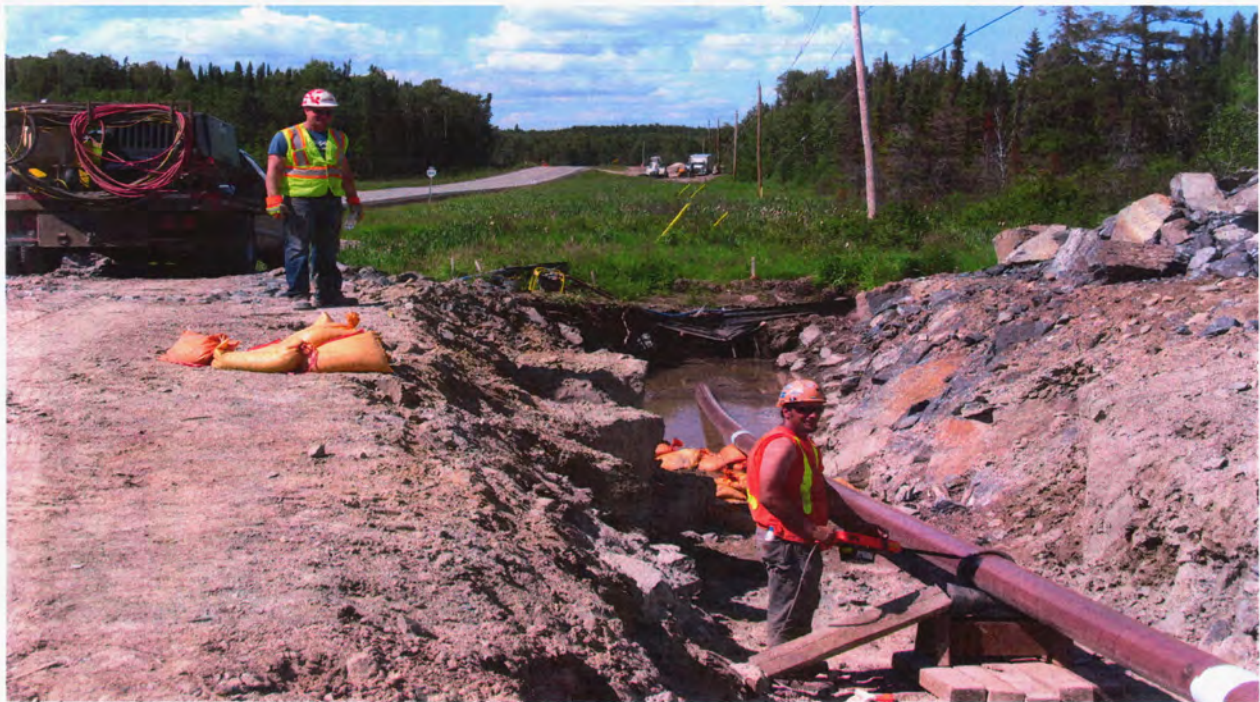
Many wet areas along the right-of-way were installed by drilling under the wetland.

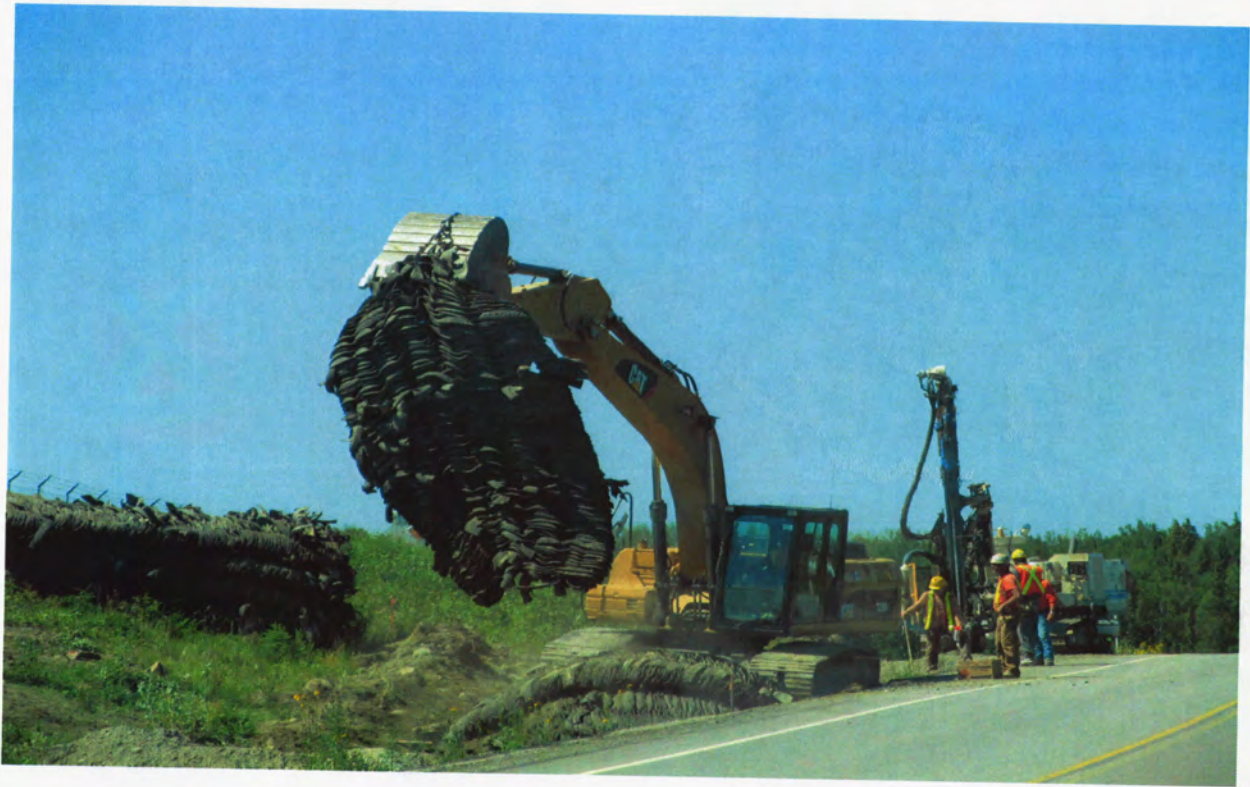
Blasting was necessary along several sections of the right-of-way. Holes are drilled into the rock, charges are set inside the holes and the area is covered with blasting mats as shown above. The blasting mats help control the spread of fly rock. Traffic was stopped in both directions and kept well back during this operation.

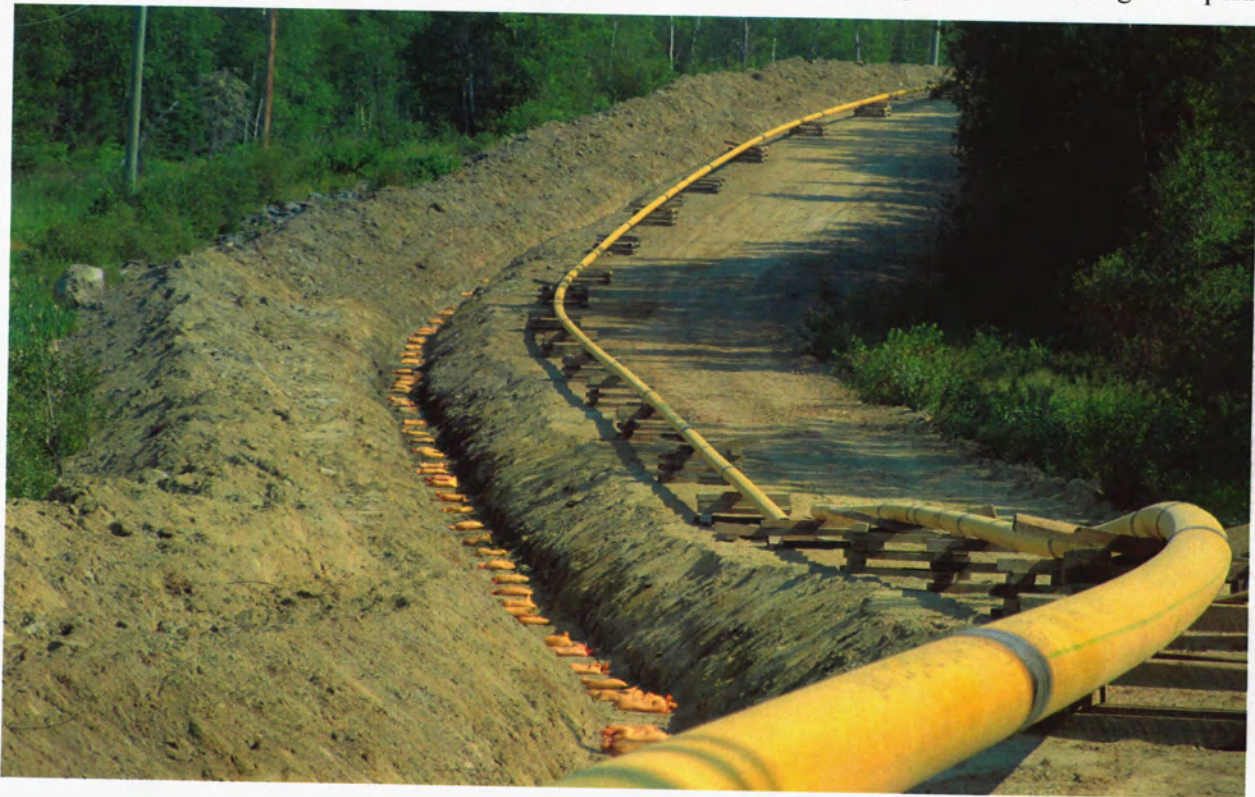
This section of pipeline along the former MTO road allowance has been strung, welded and is ready for all welds to be coated and x-rayed prior to installation.

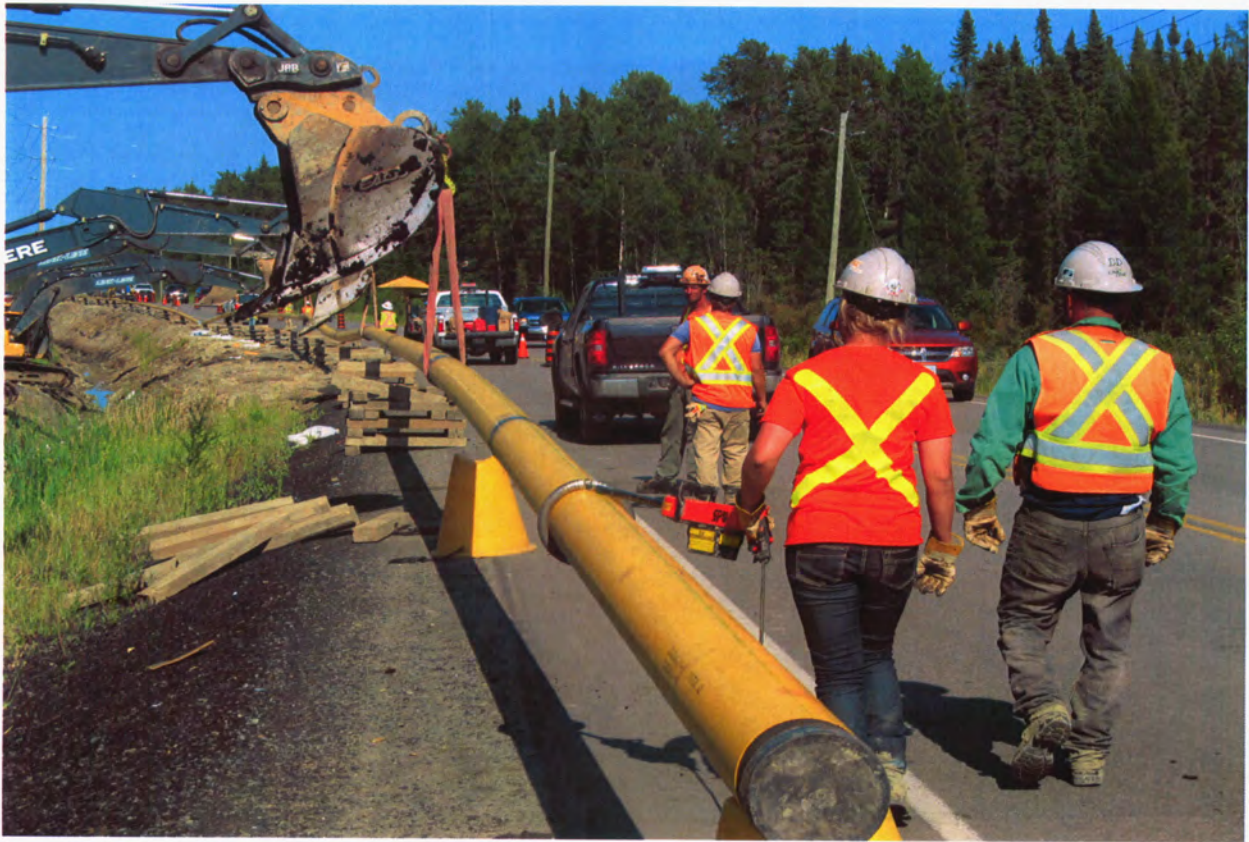
During construction it was necessary at times to close one lane of traffic in order to prepare the pipeline for installation. One lane of traffic was maintained at all times. In the foreground the worker jeeps the pipe looking for any damage to the pipe coating before it is lowered into the trench.

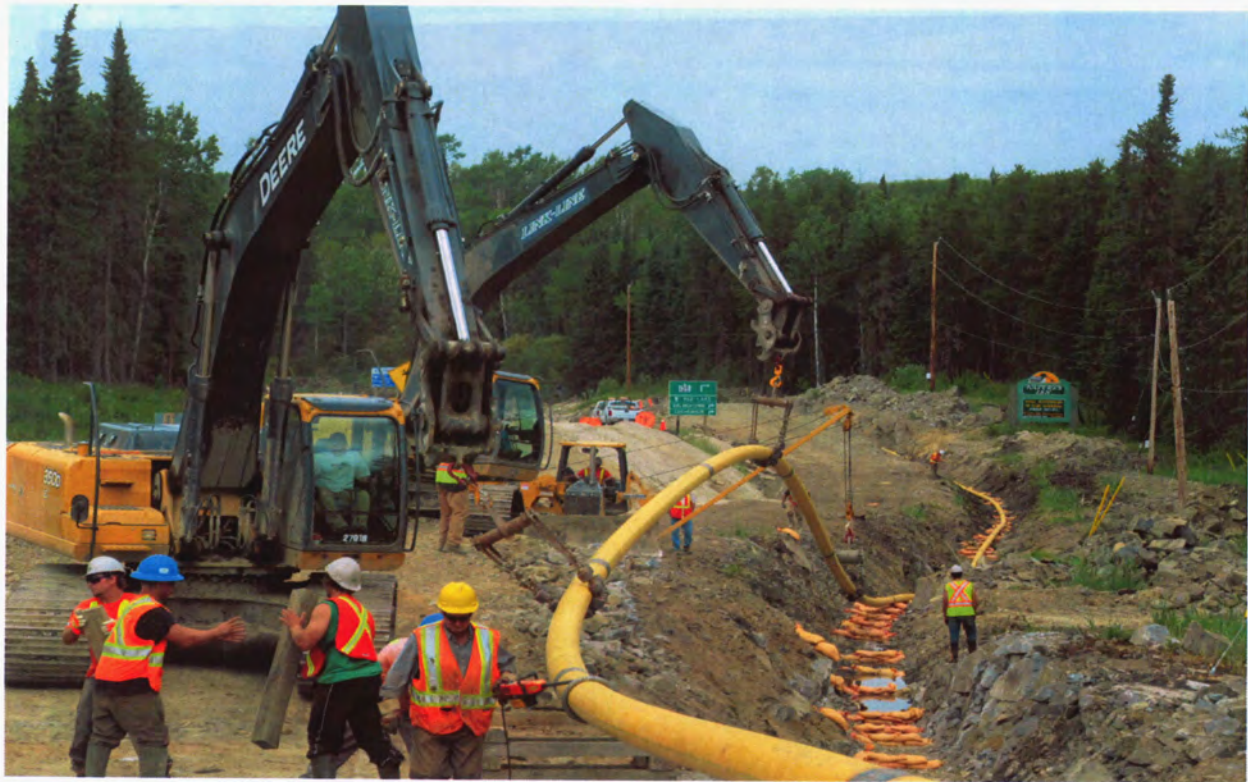
The pipeline is lowered into the trench along Hwy 105 just outside of Red Lake.

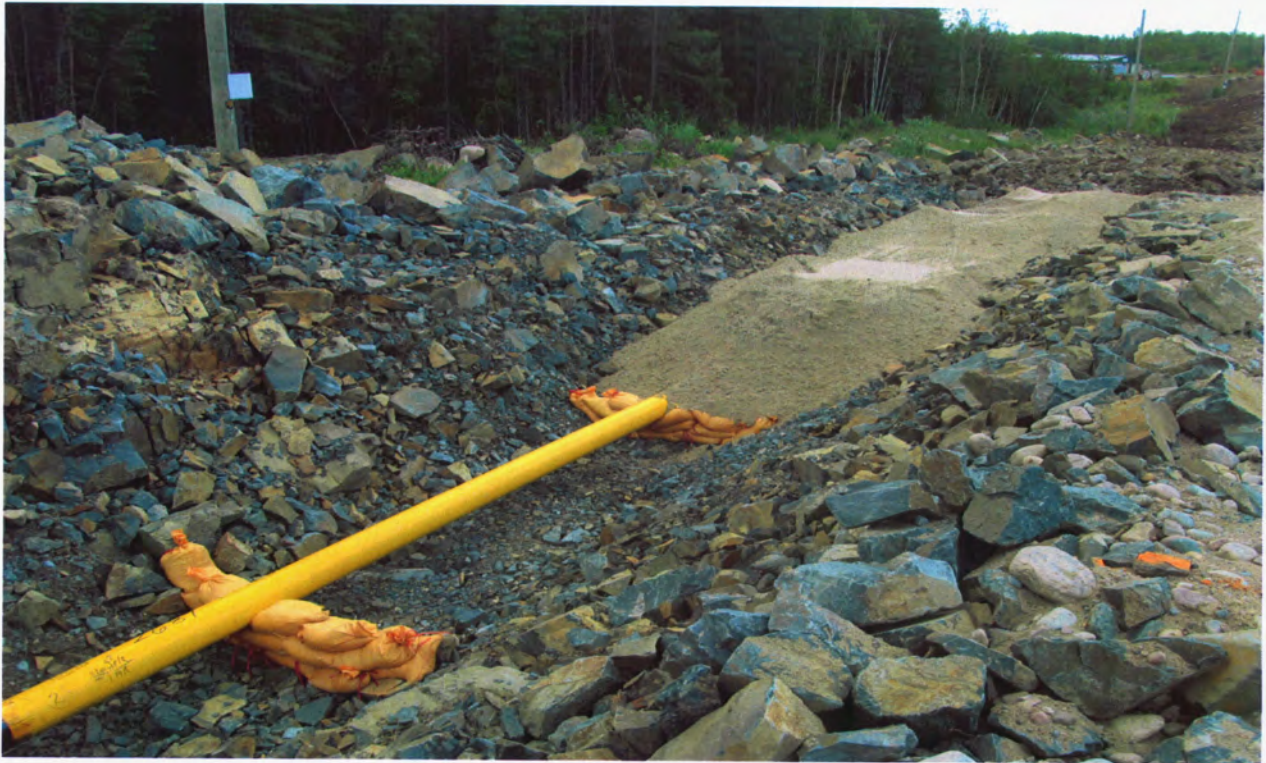
In areas of rock where it was necessary to blast, the pipe is first lowered in and placed on sandbag supports. The trench is then backfilled with sand to ensure that there are no open pockets around the pipe and that the pipe is properly padded before backfilling the rock material.

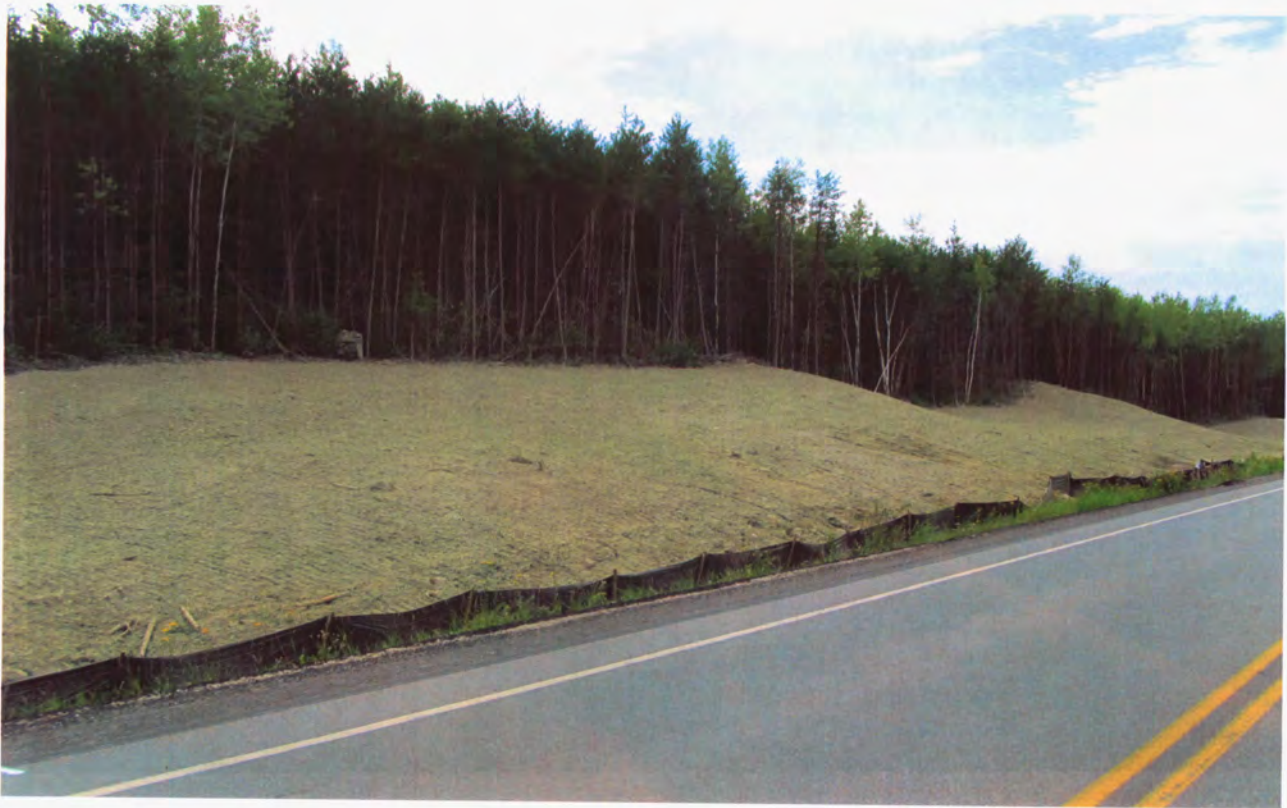
Following the installation of the pipeline and re-establishing the grade, areas prone to erosion were hydro seeded (combination of water, mulch and grass seed) to encourage revegetation.

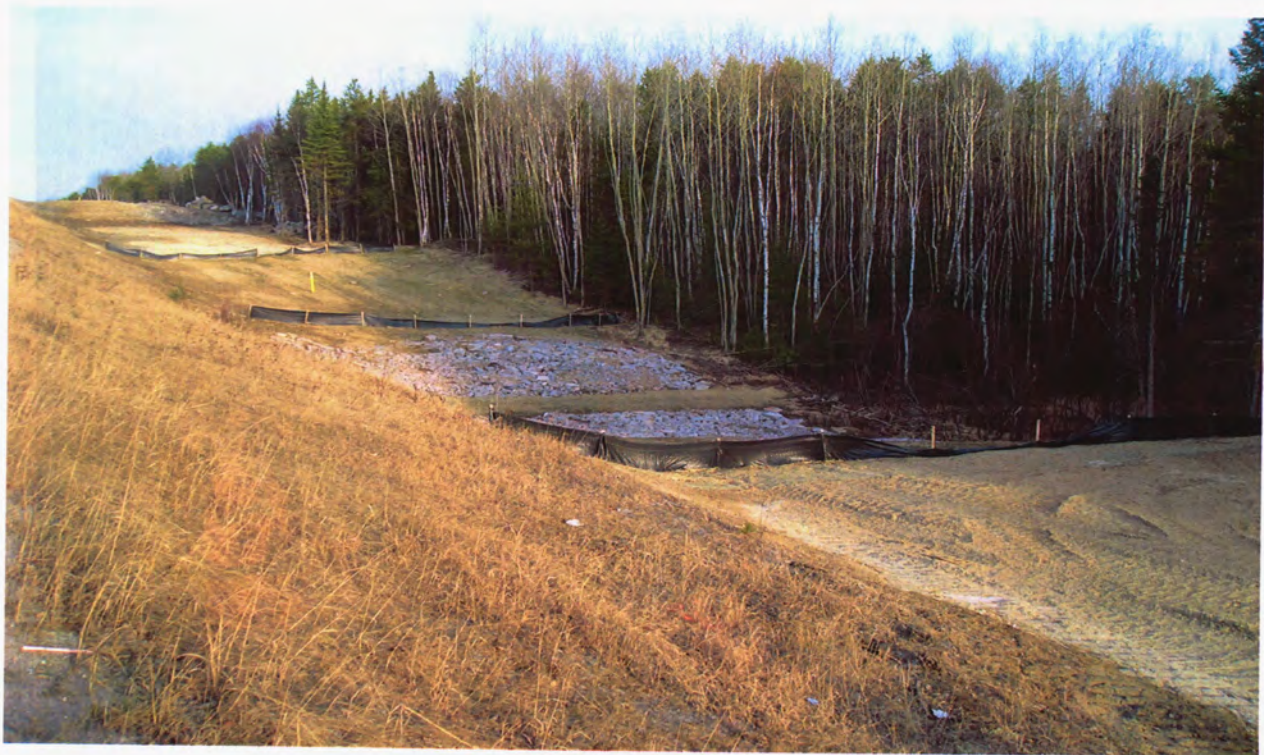
Sediment control fencing was installed at each watercourse crossing to protect them from potential erosion along the right-of-way. Unfortunately, winter grooming machines and all terrain vehicles caused damage to the fencing and was a constant concern throughout the project to maintain their integrity. The right-of-way will be re-visited in the spring and assessed for stability.

Union will return to the area in spring 2013 to complete the following activities: repair any subsidence on the right-of-way, ensure there is adequate stability and re-vegetation at all watercourse crossings, tree/shrub replacement, perform a general overview of the right-of-way and complete any additional clean-up or work that may be required.

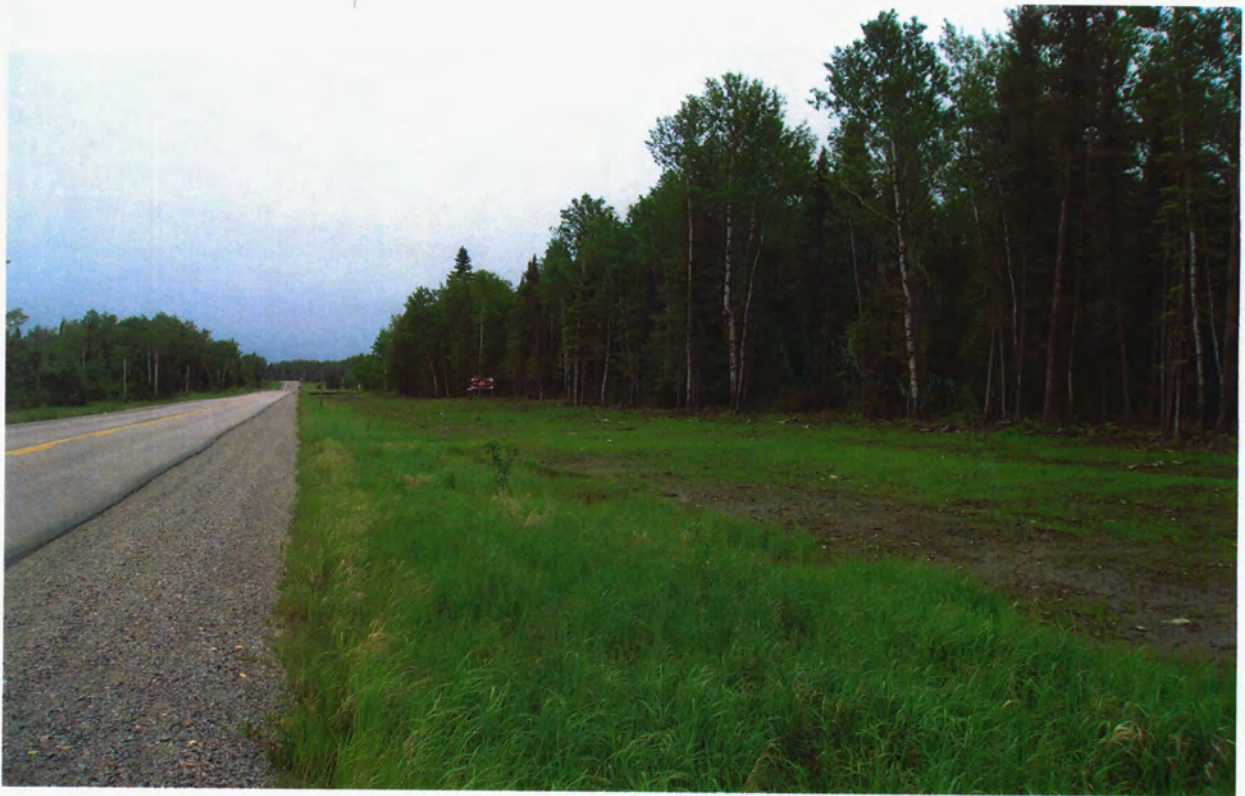
Approximately half the Red Lake lateral pipeline was installed in 2011 with the remainder being installed in 2012. The above photo is of an area installed in 2011 and was taken in late spring 2012.

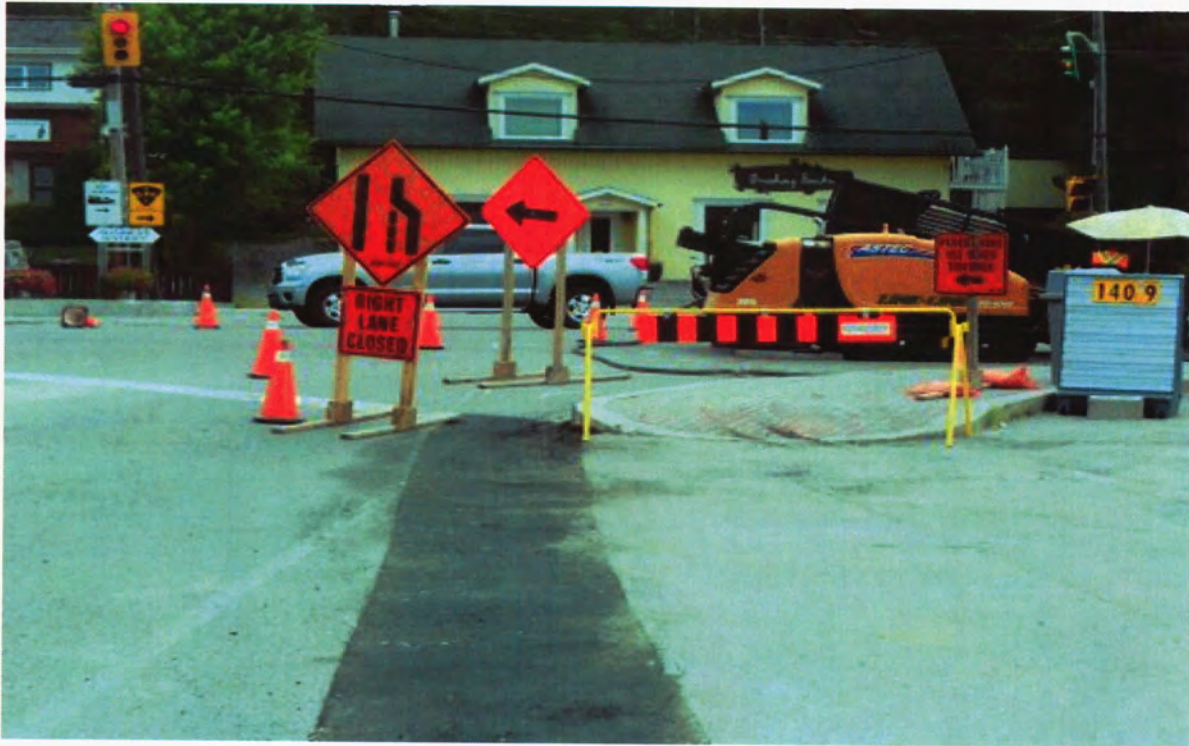
Pipelines were installed by excavation (trench backfilled and pavement patched in foreground) and by trenchless technology (horizontal directional drill in background).

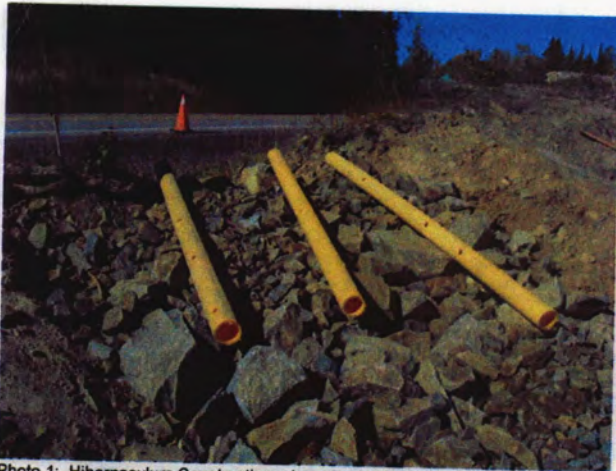
Photo 1: Hibernaculum Construction – base layer of blast rock installed with 8' – 10' sections of crush resistant piping with random holes drilled in it placed on top. The blast rock will form the void spaces of the hibernaculum with the piping providing access points to the hibernaculum.

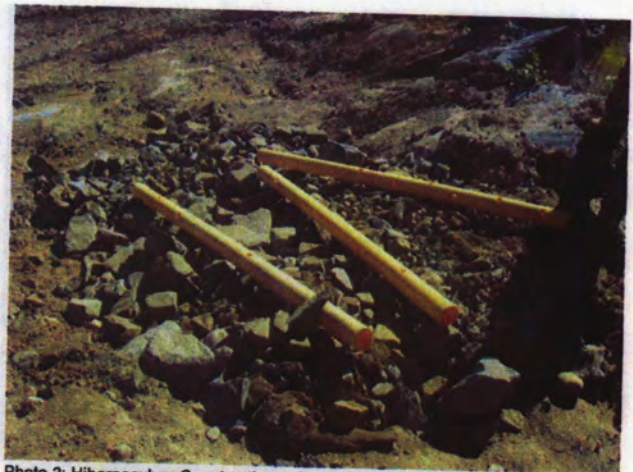
Photo 2: Hibernaculum Construction – Crush resistant piping arranged for placement of the top layer of crush rock, which will finish the interior construction of the hibernaculum.

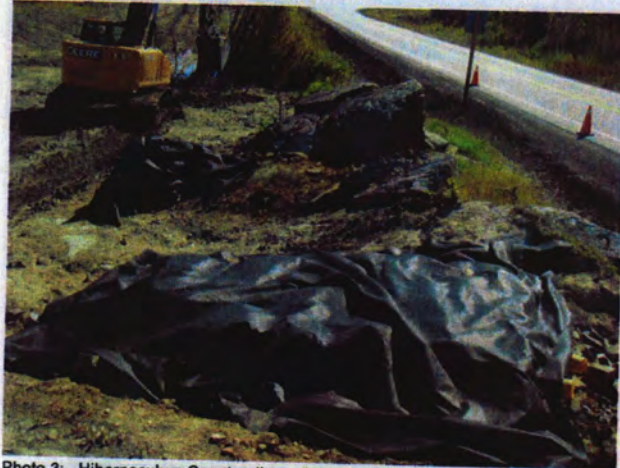
Photo 3: Hibernaculum Construction – Access piping completely encased with blast rock and covered with geotextile ready for the placement of soil. The geotextile will prevent the void spaces from infilling with soil.

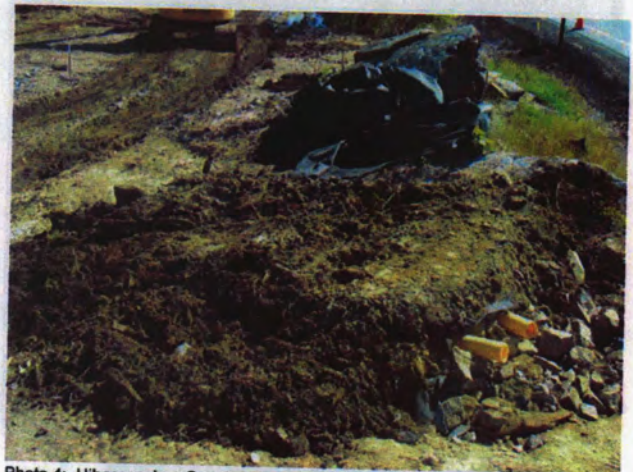
Photo 4: Hibernaculum Construction – Initial placement of soil over the hibernaculum. The soil placement is required to provide insulation to the hibernaculum to prevent complete freezing though the winter. A layer of soil approximately 1.3 m (4') is required.

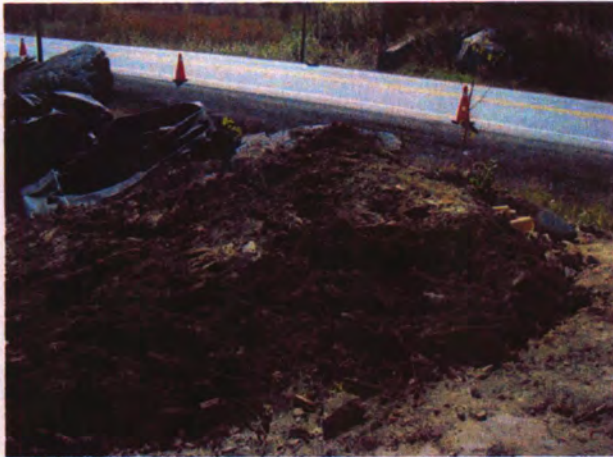
Photo 5: Hibernaculum Construction – Another photo of the soil layering process.

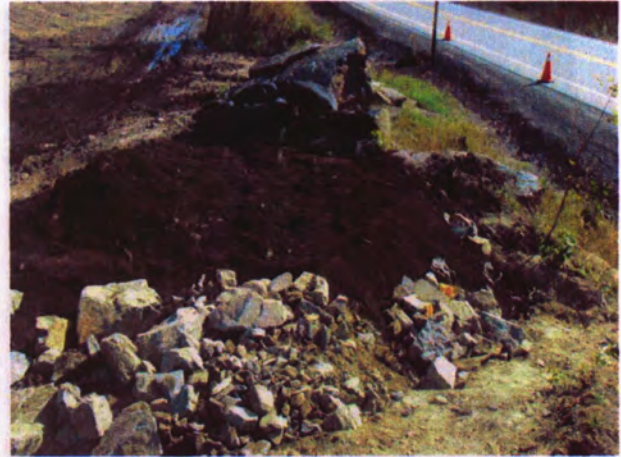
Photo 6: Hibernaculum Construction – Placement of top soil over the hibernaculum to add to the insulating layer and provide a suitable base for plant growth of the future seeding and plantings.

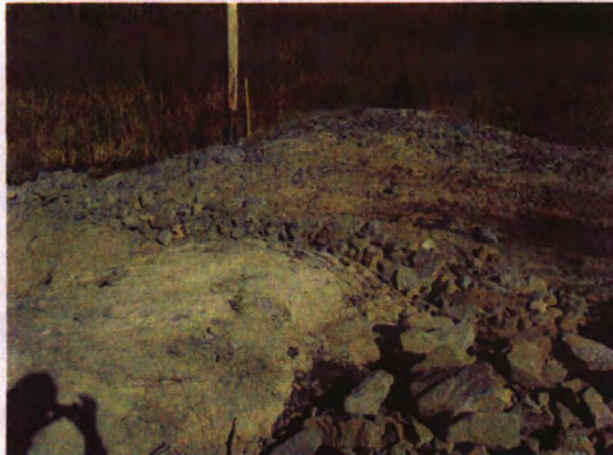
Photo 7: Migration Corridor - Installation of the blast rock which forms the structure of the migration corridor for snakes moving to and from the hibernaculum. The corridor will provide cover for snake movement prior to the re-vegetation of the gas line corridor.

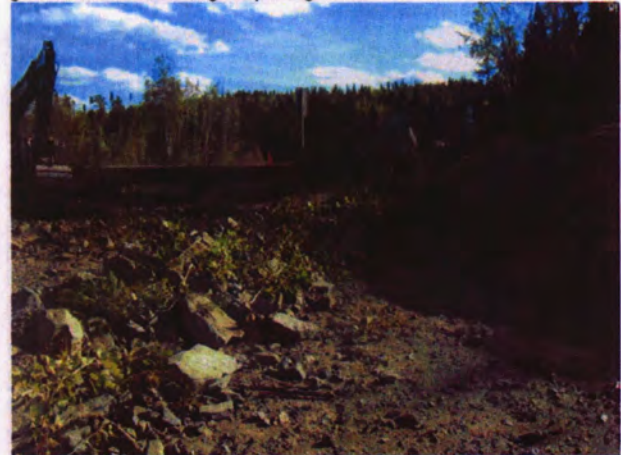
Photo 8: Migration Corridor - Woody debris was placed on the migration corridor to provide added cover. The corridor could have been constructed using any natural material, blast rock and woody debris was chosen for its availability.

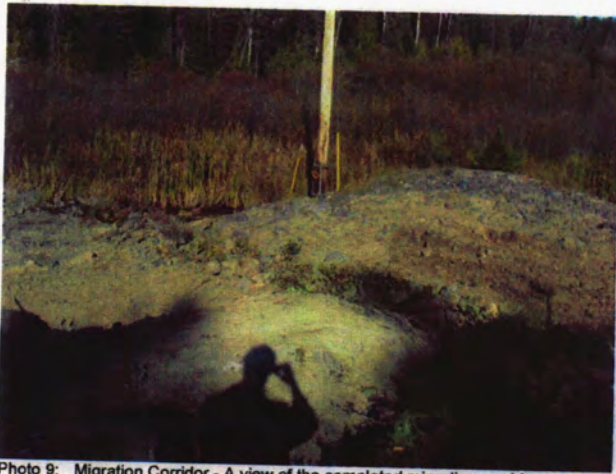
Photo 9: Migration Corridor - A view of the completed migration corridor.

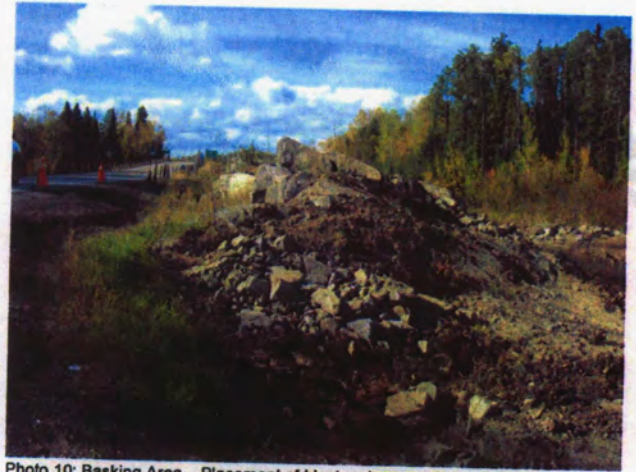
Photo 10: Basking Area - Placement of blast rock on south facing slope will provide a basking area and cover for basking snakes after emergence in the spring

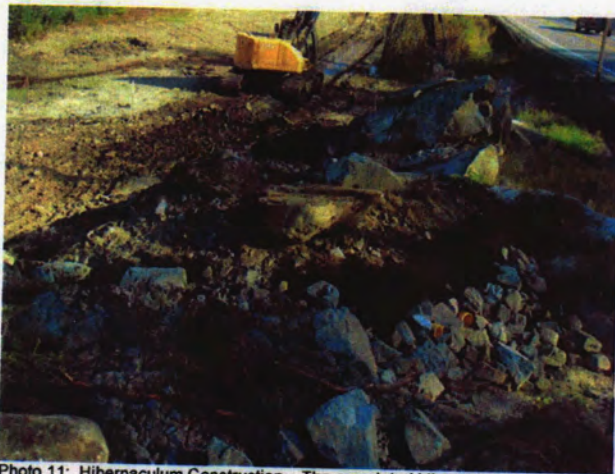
Photo 11: Hibernaculum Construction - The completed hibernaculum with boulder placements on top for add basking area, cover and visual improvement. Entrance pipes can be covered by blast rock to improve visual aspects but must remain clear of smaller debris which could block access to the hibernaculum.
