Water & Natural Features Gray Road Allowance

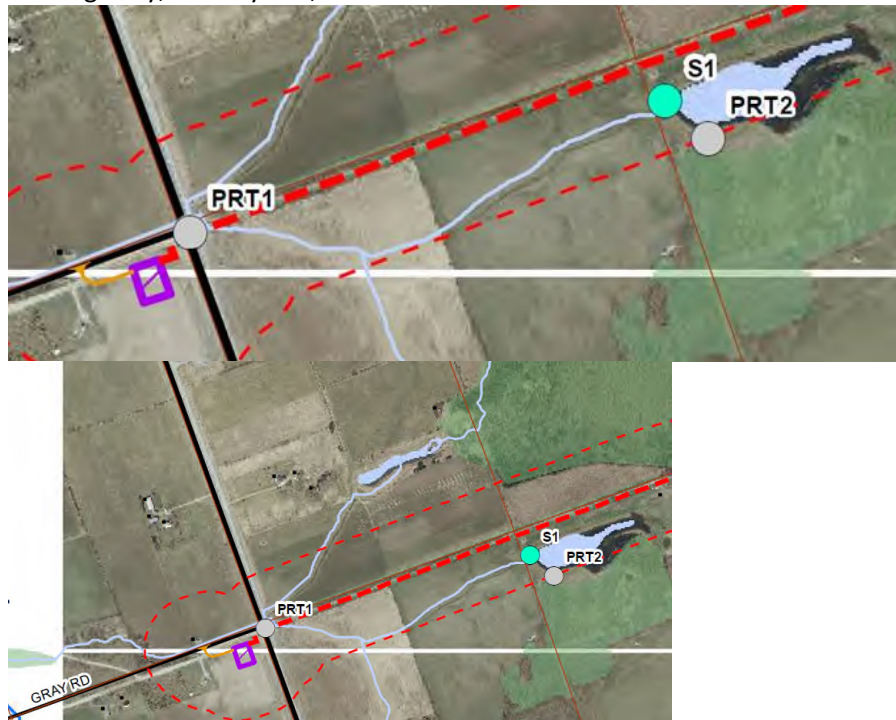
Close-up Location Drawing provided by Applicant Hwy 35 and Gray Road Allowance in reply to OEB interrogatory, January 21st, 2015.

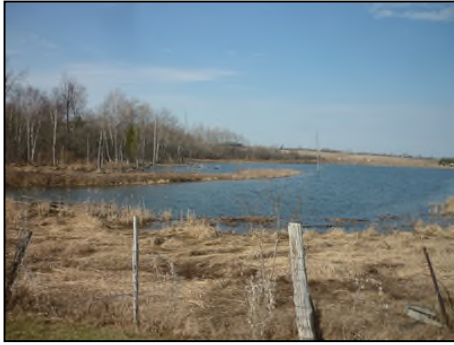
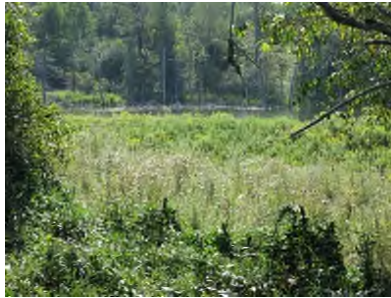
The pond along Gray Road that provides stopover habitat for waterfowl.

Within a hundred metres of Gray Road from Hwy 35 eastward, the water table is at the ground level. There is a permanent seep within the road allowance that the Applicant did not account for in its REA application or in this application before the board. This seep within the road allowance expands and contracts but never goes dry even in the time of severe drought.

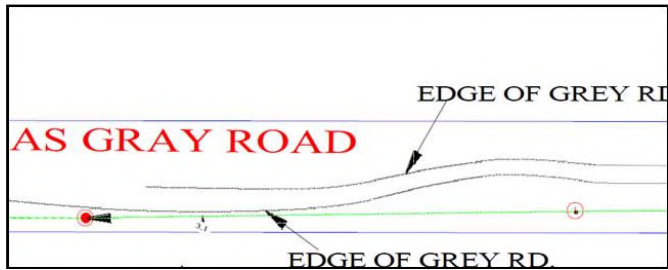
Close-up Location Drawing provided by Applicant Hwy 35 and Gray Road Allowance in reply to OEB interrogatory, January 21st, 2015. Still incorrectly labelled as a 'carniferous' forest, this close-up indicates there is a 3.1 m clearance at the narrowest point. This point was measured on January 24th, 2015 from the edge to the fenceline. It is 2.69 m in width.

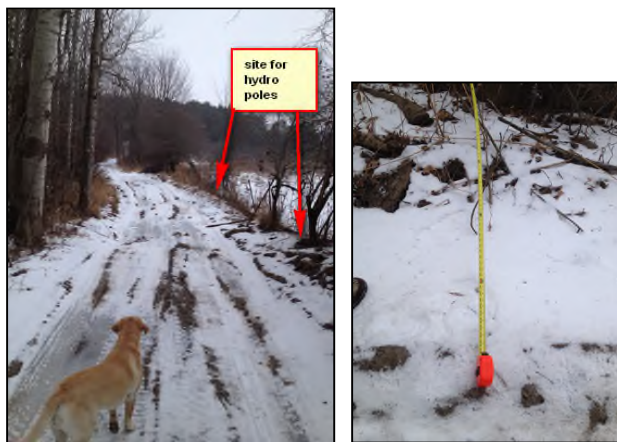
N 44°09'05.350 W 78°38'38.387 Photos taken January 24th, 2015 by the Intervenor.

The buffer zone between road allowance and fenceline is too narrow to accommodate hydro poles. This is area where the allowance Gray Road deviates south almost to the fenceline in order to try and avoid the seep and trees. ATVs and snowmobiles are the only motorized vehicles that can get through this area.

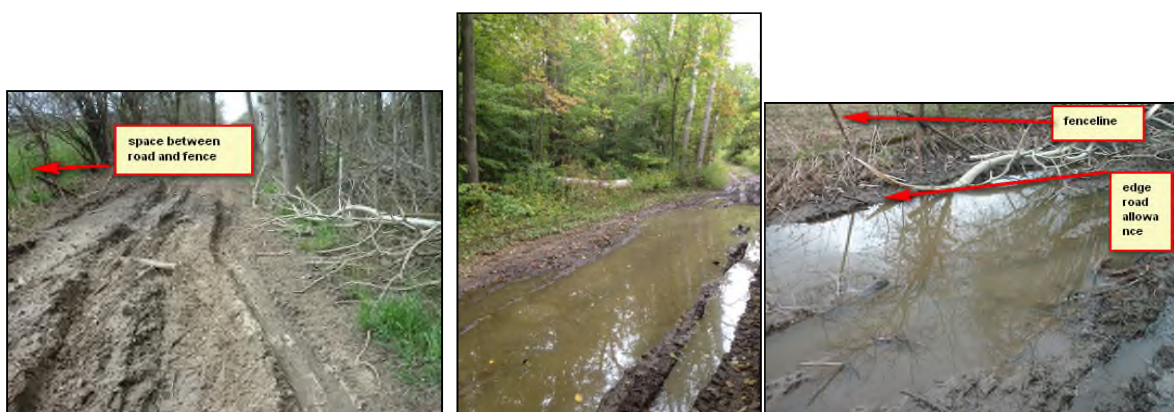
The 2.69 m area between the allowance where and the fenceline measured in the winter is even narrower in the spring and summer. This is also the area where it is stated in the Water Assessment report there are no mitigation strategies to deal with the flow that comes out of the Moraine hill and flows across the road allowance into the wetland located on the north side, indicating only that work

will have to be completed as quickly as possible without specifying a timeline that must be met in order to avoid serious interference with this hydrologic feature.

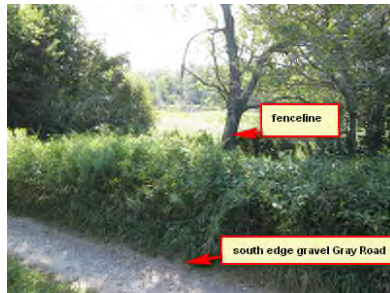
The Intervenor also contends that the 5 m setback from the edge of the road allowance to the property line along the majority of the allowance is also inaccurate. There needs to be a ground truth survey.

Road allowance buffer zone between fenceline and edge of road allowance is less than 5 m.

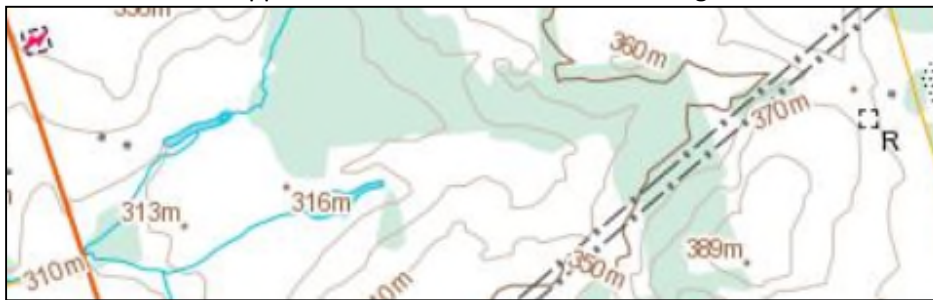
Cal Topo map NRC

The Applicant states in its reply on January 21st, 2015 (page 9) that topographic detail was not supplied because there is no appreciable difference in elevation along the road allowance.

Elevation levels along and surrounding the road allowance Gray Road vary dramatically from 313 m to 389 m.

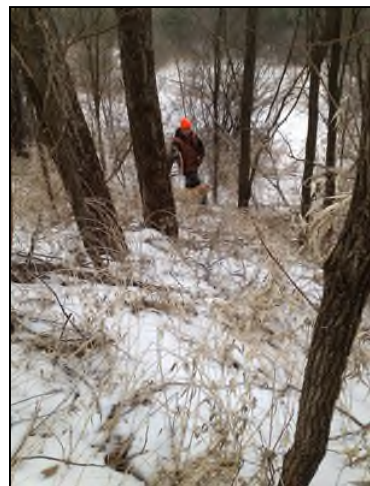
N 44°09'11.100 W 78°38'13.289 Photo taken by Intervenor January 24th, 2015.

Looking down southwards from the gravel edge road allowance where trees are to be removed to erect hydro poles.

Slope stability will be compromised. The Applicant has stated that soil sampling is not necessary. The soils in this particular slope area to be cleared of vegetation are sand.

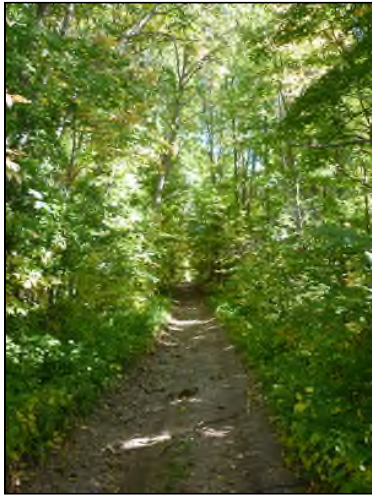
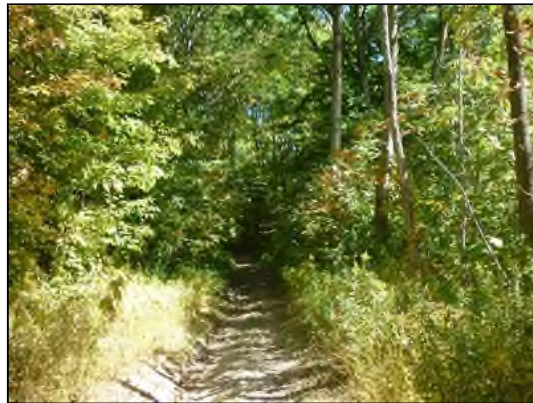
Gray Road (above) will look like the scene below. The Applicant plans to clear a 3 m area around each pole. The recreational value of Gray Road will be lost.
