**Comments of Concern: Re: EBR 011-8756 – Sumac Ridge Project – Gray Road – Proposed Transmission Line Corridor**

Gray Road is an unassumed road within the Township of Manvers that has its roots in pioneer days dating back to the mid-1850s. This 1.9 km unassumed road is the proposed route for the transmission line to connect from the turbine locations westward to the switching station to be built on the west hand side of Hwy 35. This narrow road/pathway is owned by the City of Kawartha Lakes.

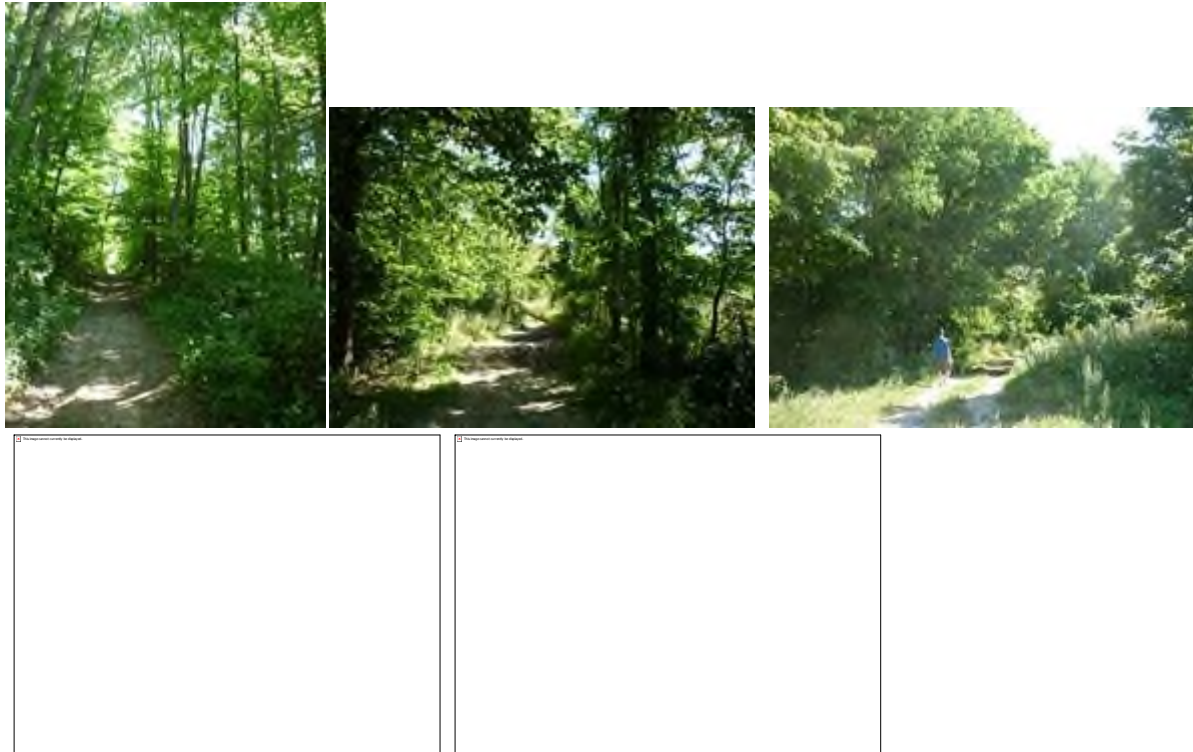
Gray Road is not a 'road'. Note: three photos are from August 22-25, 2012 to demonstrate to full measure and scale of vegetation coverage along Gray Road.

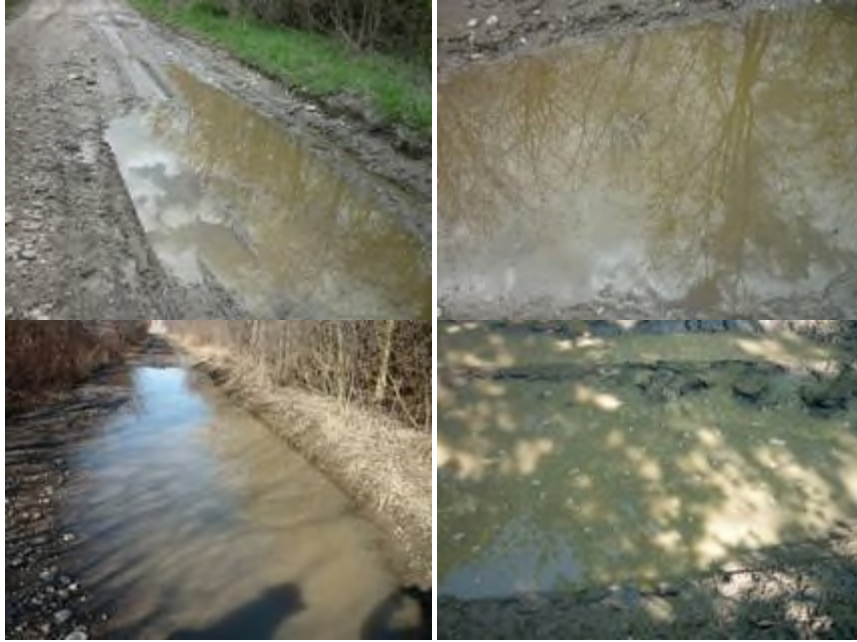
The water assessment report acknowledges the presence of one seep along Gray Road as S3 on the *Project Area & Aquatic Features* map. Onsite investigation indicates that Seep # 3 (S3) is actually not a seep but a watercourse. Seep #1 (labelled S1 on the Aquatic features map) is located at the western end of the pond as part of water feature PRT2. However, there is also another seep along Gray Road that has **NOT** been identified either in the assessment reports or on the maps. It is located directly in the centre of Gray Road approximately 100 metres in from Highway 35. A second seep, also not identified by the proponent is approximately 5 metres further eastward. Both of these seeps have created depressions which are water filled at all times of the year. On August 25th, 2012, during a regional drought event, a visit to Gray Road found these two seeps to be filled with water. Green frogs inhabit these seeps.

Permanent seep in the middle of Gray Road – not identified in the water report. Green groggs inhabit the seep from spring until fall.

The seep needs to be assessed.

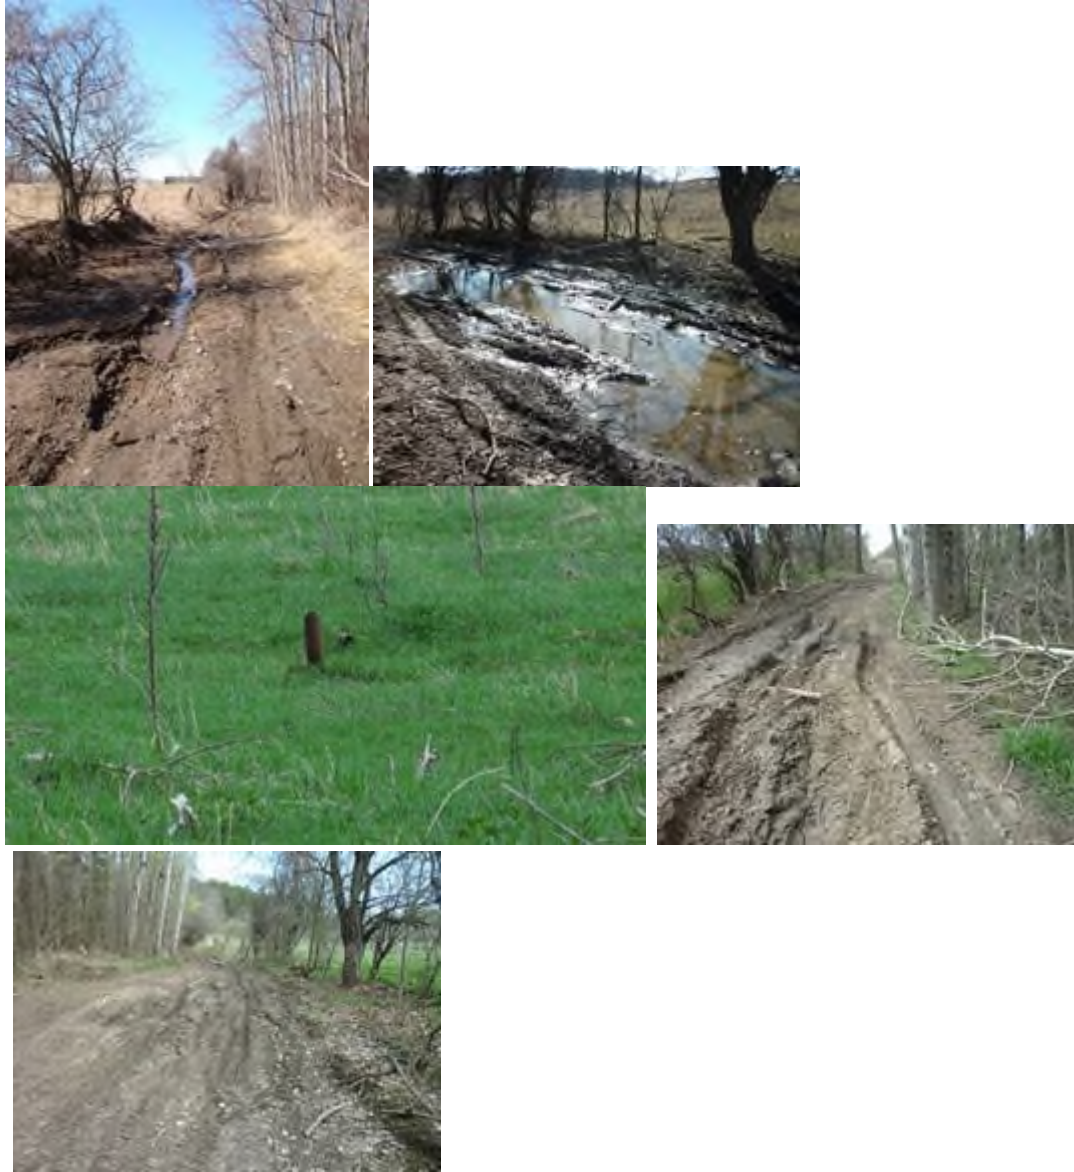
The roadway was also flooded with water in one section - part of a more complex unrecorded watercourse approximately 60 metres east of the pond location on Gray Road. This water feature was identified as S3 (Seep 3) in the wpd Canada water assessment report. There is an approximately 20 cm diameter pipe inserted into the side of the hill of the Moraine. Visual observations indicate that water flows out this standpipe on a continual basis down the hillside north and across Gray Road. There is also indication of supplemental seasonal flow by run-off flow from the east. This site, as one can see in the included photos has created a 5 metre pool of water along the roadway. This area is wet year-round. The water flow is directed into mixed woodland (identified by wpd as FODM5-1). Remnants of a broken concrete culvert were found on the north side of Gray Road indicating that at some point, an attempt was made to provide some form of cross road drainage. The banks of the stream are approximately 40 cm deep; an indicator that this waterway has been in existence for an extended period of time. The Water Assessment report states that S3 does **not** connect to any aquatic features (pg. 23 section 7.4 Seepage Areas of the *Sumac Ridge Draft Water Report*). This water feature S3 needs reassessment since it is clearly part of a more complex water system and **does** connect to other aquatic features. Fish habitat has been identified by the proponent as being downstream of PRT1 of which this watercourse empties into. The need to reassess this water feature is made more pressing since the Water Report prepared for wpd Canada Corporation indicates that it will not be possible to mitigate damage caused by interference with the seep (spring) along Gray Road - **“It will not be feasible to mitigate sediment entrainment into the seep using standard methods.”.... The mitigation strategy is “to complete work as quickly as possible”.**

Water flows out of the pipe in the rise of the hill across Gray Road into a deep cut stream. The flow causes deep muddy conditions across the roadway.

Considering that the proponent may wish to construct the transmission line at a depth of one metre below ground along Gray Road, there needs to be a precise and accurate

mitigation strategy. Measures to protect possible fish habitat when carrying out a stream crossing under DFO regulations must be adhered to.

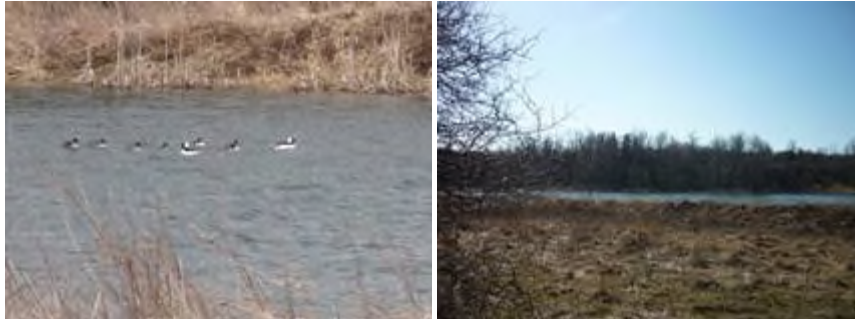
It is admitted in the field notes as well as the natural heritage assessment that the pond is fed by Moraine based groundwater to the south and east. During the field survey of April 19<sup>th</sup>, 2013, eight Buffleheads (*Bucephala albeola*) – two males and six females were spotted on the pond. There were also four Common Mergansers (*Mergus merganser*) all males. Numerous spring peepers could be heard. The wooded area along the south side of the pond contains trees with several good sized cavities that

Buffleheads on pond – the far side contains a mixed forest. The far side of the pond also includes several half-submerged dead trees – habitat for many wildlife species.

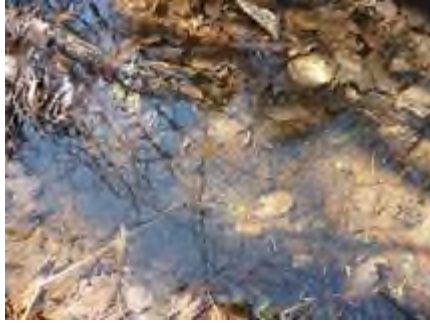
A salamander survey was not conducted by wpd, but several vernal pools and wetlands located on the north side of Gray Road in WOD-007 would support salamander breeding grounds. There is no indication that proper salamander surveys were undertaken as part of a Natural Heritage Assessment along the length of Gray Road. These surveys would need to be undertaken in late March/early April. The pond along the south side of Gray Road has been identified by Ortech as snapping turtle habitat. Egg remnants have been found along the roadside.

Section of one of the many vernal pools found within WOD-007 within 120 metres of Gray Road.

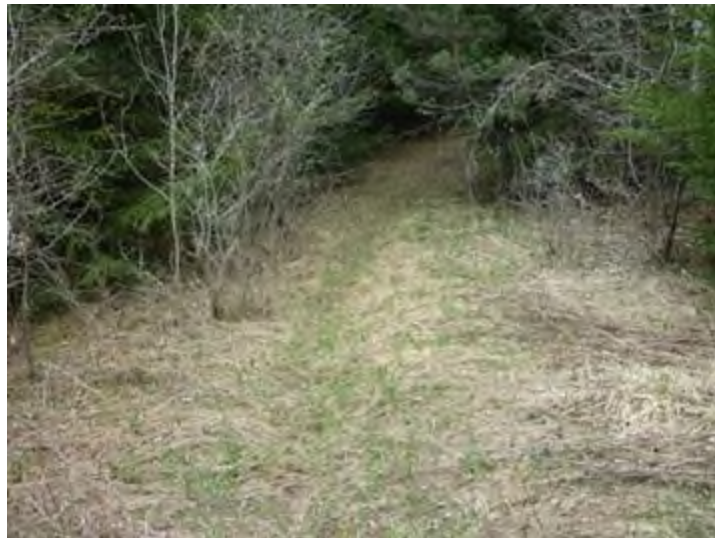
Survey visits on all three occasions saw evidence of deer tracks and droppings along Gray Road. There was also evidence of multiple white tailed deer runs crossing Gray Road, as well as coyote scat along the length of the path/roadway. An extensive and multiple branching deer corridor was located in woodland - WOD-007, of which an acre is to be removed next to a wetland in order to accommodate the construction of Turbine # One. This trail system included deer rubs. Fresh droppings were evident along the trail system. There was evidence of multiple laydown areas in the field adjacent and west of WOD-007 and north of Gray Road. The extensive deer trail system in this woodland extended into the proposed site for Turbines # 1 and 3. Deer tracks and a trail crossing were noted across PRT3 – Pigeon River Tributary # 3. The proponent did not conduct a deer movement corridor investigation.

Deer corridor in WOD-007. This corridor wound its way from Gray Road through a mixed mature deciduous forest (white and red oak, beech, maple) through a coniferous plantation of white spruce and tamaracks (as noted in the photo) and on into another mature mixed forest and valleylands at the site of Turbine # 1.

In light of this information, it is paramount that further investigations into deer movement corridors be undertaken.

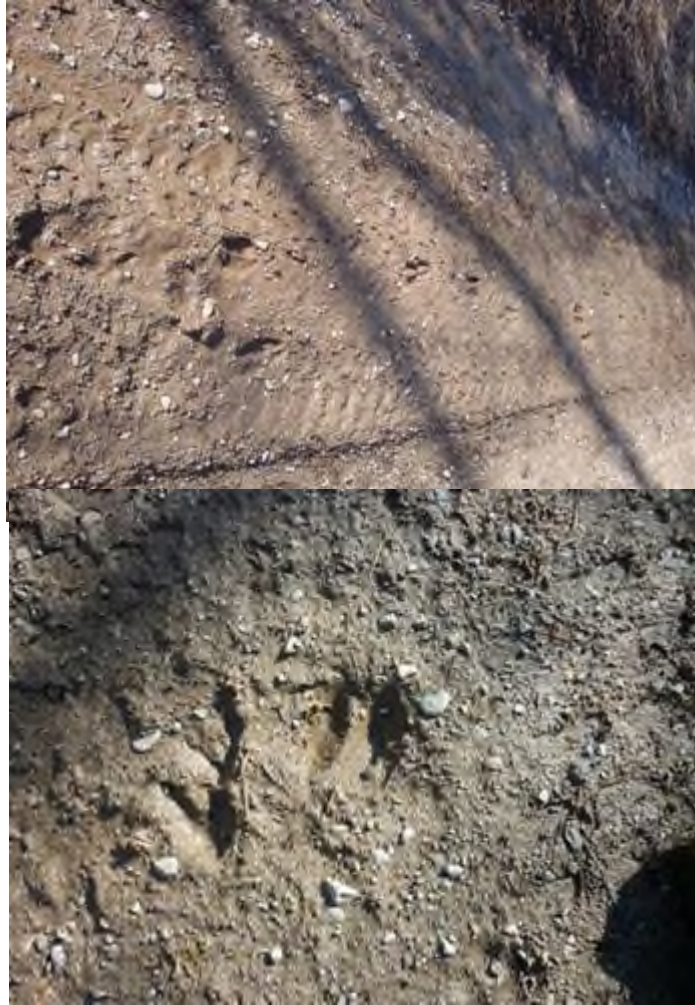
Deer tracks along Gray Road. Tracks were observed on each of the site investigations.

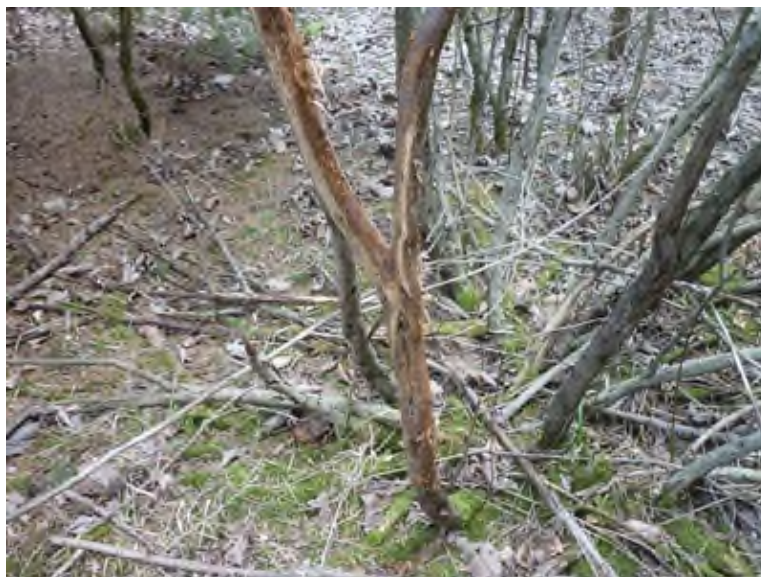
Deer rub along one of the deer corridors in WOD-007. The corridor can be seen as the bare worn ground on the left hand side contrasts to the leaf covered ground on the right.

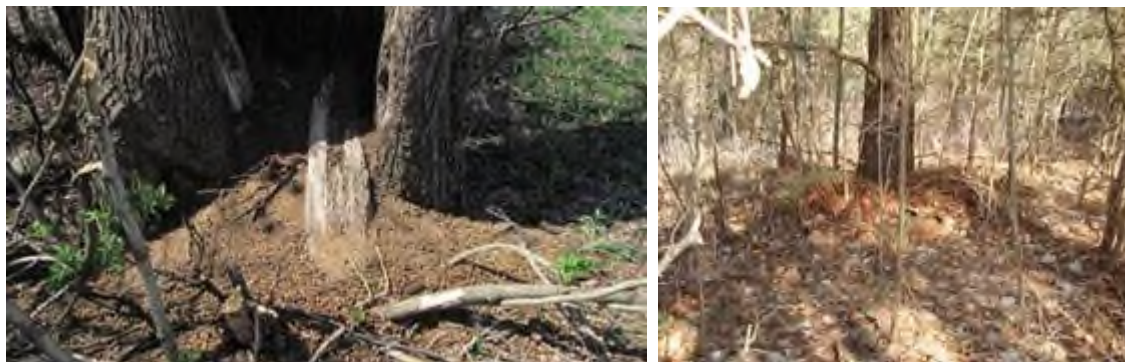
Porcupine scat and habitat with 120 m of Gray Road. Several red squirrel midden piles were spotted along the roadside.

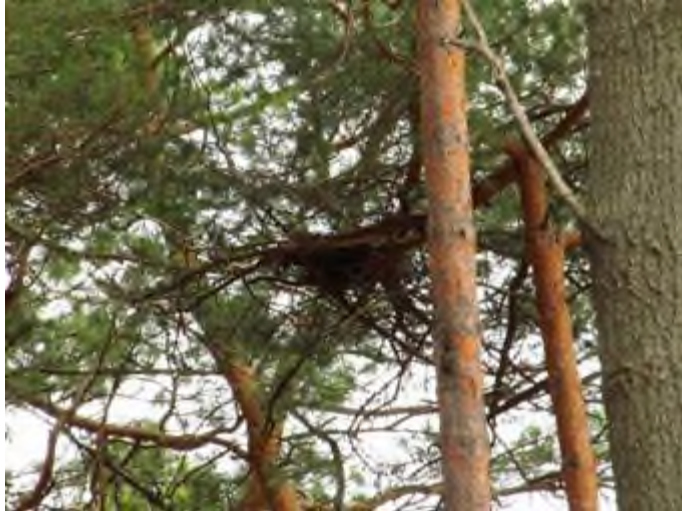
The Natural Features indicate that winter raptor monitoring occurred at three stations along Gray Road. Gray Road is not maintained in the winter. According to the field notes, winter raptor monitoring took seven minutes. It would take longer than seven minutes on snowshoes to reach the mapped monitoring stations. At the second public meeting, it was indicated by a representative of NRSI that the seven minute raptor surveys were conducted from a vehicle. This would be nearly impossible to do along Gray Road at the designated monitoring stations at the best of times due to the road conditions. Gray Road is an unmaintained narrow roadway with no possible turning area for vehicles and no alternative exit to another roadway to the east of Hwy 35. It is interesting to note and of concern that on the Sumac Ridge Wind Project Natural Features with Project Locations map, that one RWA – Raptor Wintering Area Monitoring Station is in the approximate location where a stick nest in a Scots pine was spotted directly south of Gray Road at (UTM 0688598 4891461). This stick nest was not noted or investigated as part of the Natural Heritage assessment.

This nest along Gray Road is located within 20 metres of the proposed transmission line and in the designated RWA area.

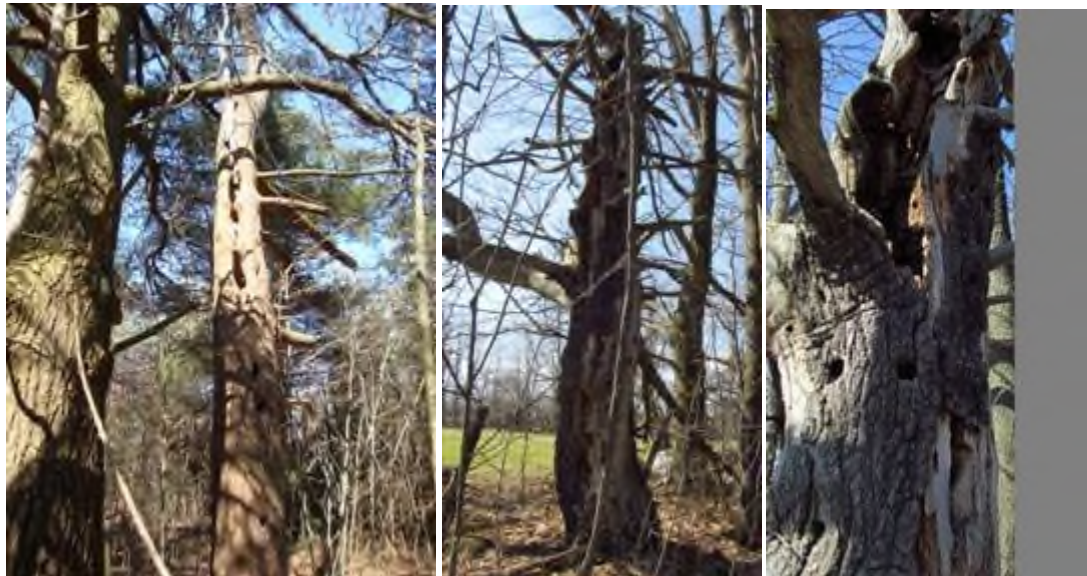
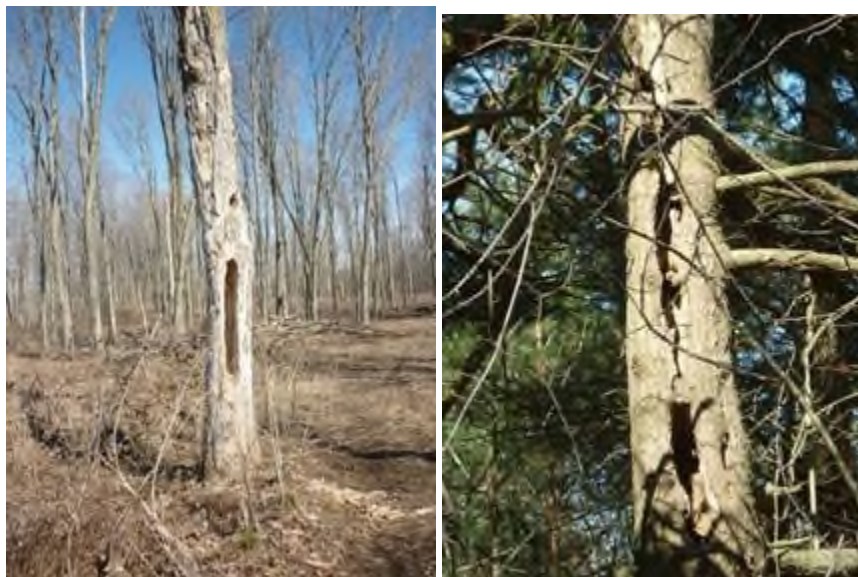
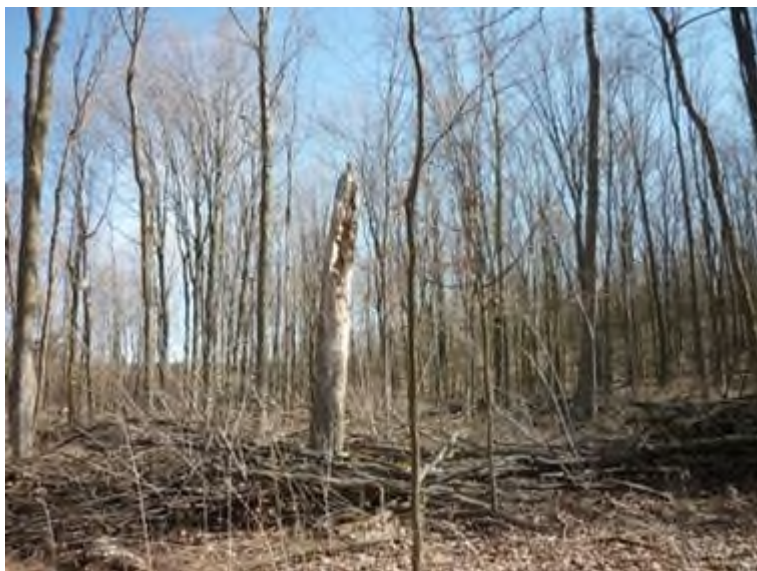
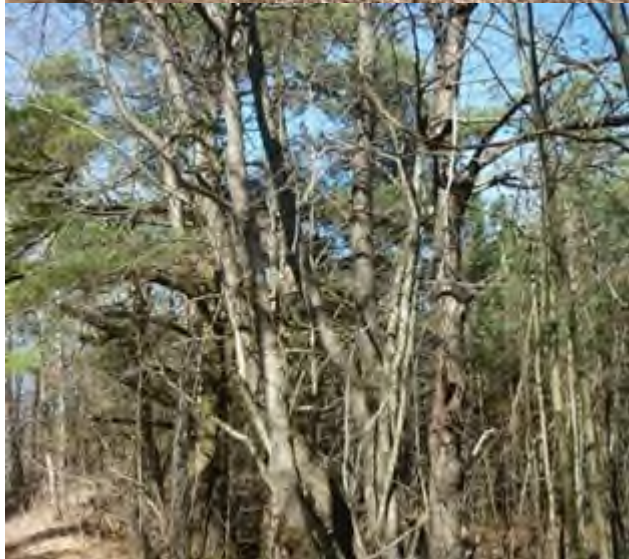
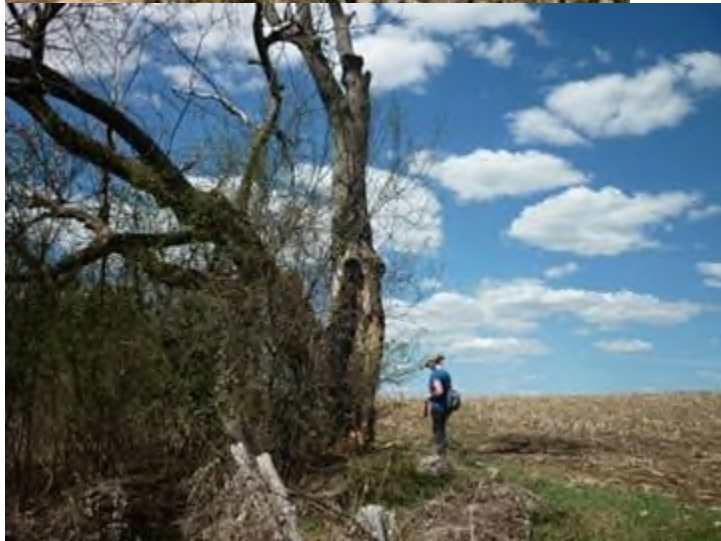
WOD-007.

The following photos taken within 120 metres of the proposed transmission line along Gray Road and within the sites of Turbines Numbers 1 and 3 indicates a need for further bat habitat assessment surveys. These are just a few snags photographed in

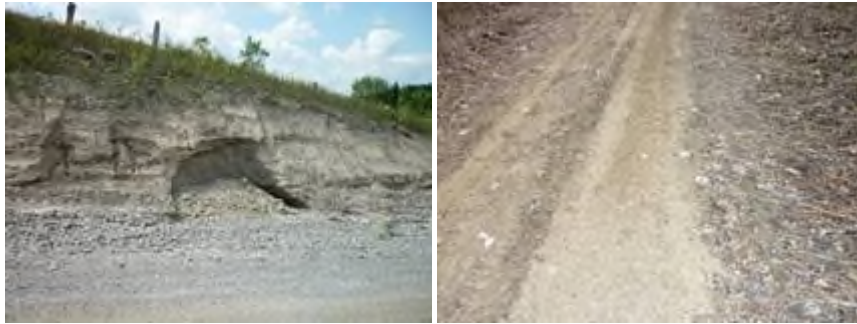
A great variety of vegetation was present along the length of Gray Road, likely due to the varying saturation levels and composition of the soils. From the entrance to the pathway known as the unassumed Gray Road the soil is clay loam over gravel till until approximately 20 metres past the area designated Seep 3 (which is appears actually to be a continual stream originating within the Moraine). At this point it becomes very sandy (UTM 0688572 4891455) and the change in vegetation reflects this. Some sections of silt loam were also found.

Pontypool sand conditions that are prone to erosion – section of Gray Road is pure sand.

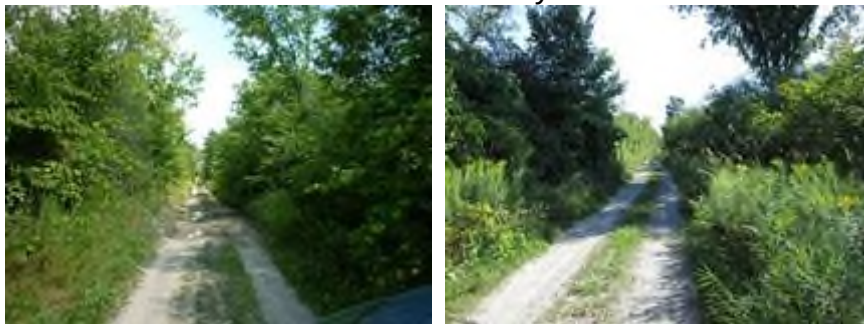
Photos of Gray Road taken between August 22 and 25, 2012 showing sections of the hedgerow and that Gray Road is not a road in the commonly understood sense of the word.

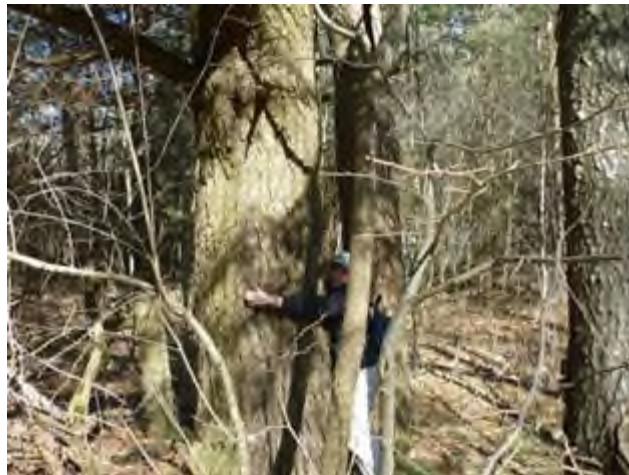
1. A hundred year old plus *Pinus strobus* is located at the edge of Gray Road on the north side (UTM 0688641 4891493). The trunk circumference is approximately 260 cm at a height of 1.2 meters off of the ground. Whether the line is constructed underground or aboveground, the removal of this ancient tree might be necessary. Construction practices will interfere with the tree's extensive root system.
