**EB-2009-0078 – Hydro One Networks' Section 92 Lower Mattagami Transmission Reinforcement Project – Hydro One's Construction Activities Monitoring Report**

## **LOWER MATTAGAMI RIVER PROJECT**

### **Monitoring Report**

August 31, 2015

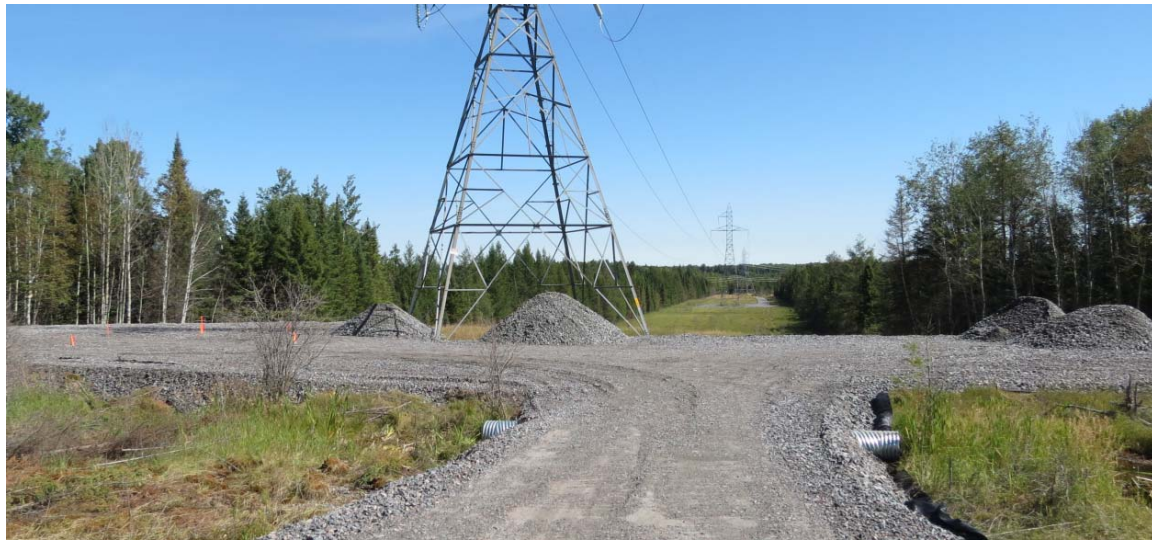
New rock roads and tower pads were constructed off of the existing service road between Harmon and Kipling GS to accommodate the heavy equipment needed for the existing tower upgrade and new tower construction work. Specifically the work involved:

Figure 2 - Building Rock Construction Pads on circuit L20D Tower 12 (in foreground) and 13 and 14 (in background)<sup>5</sup>

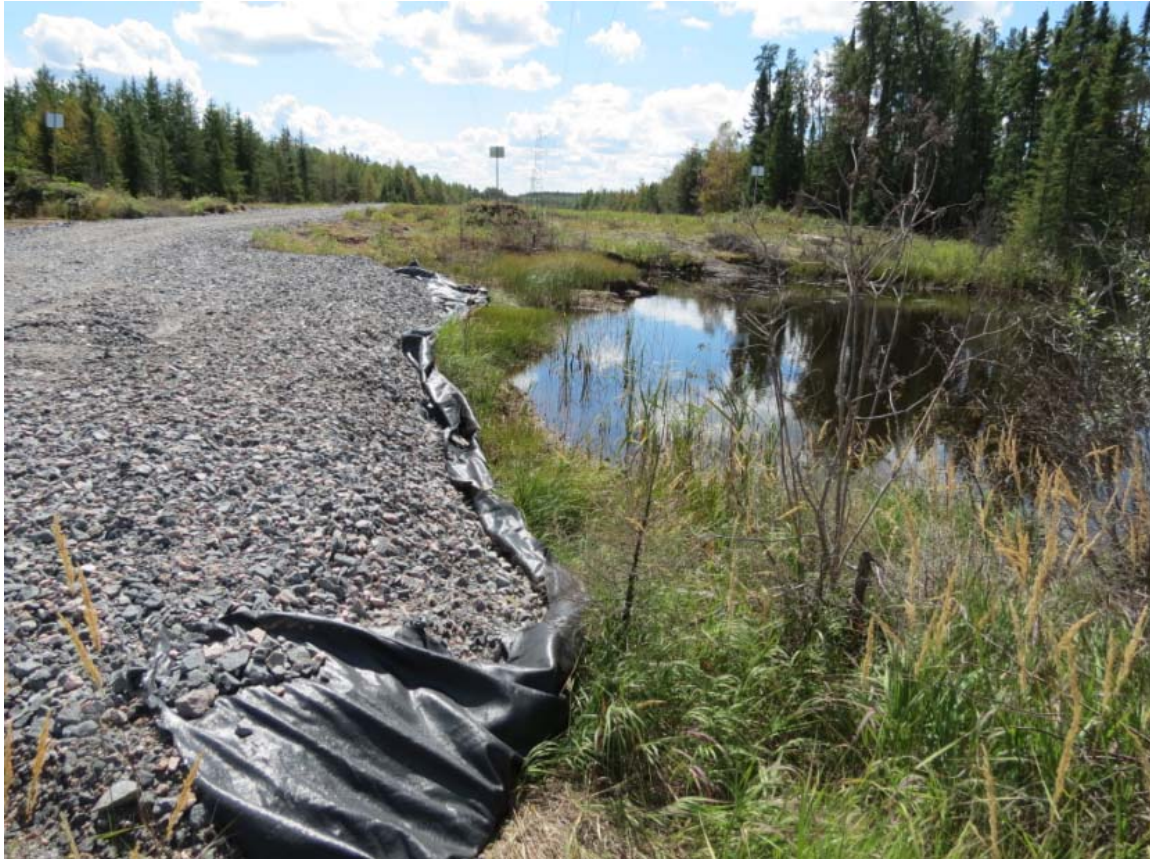
Figure 3 - Avoiding wetlands with new rock road construction

While there was already existing access on the H22D/L20D transmission line, additional crushed aggregate was added to the roads and around the towers in order to allow for the safe travel and use of the heavy equipment needed to complete this work. All Hydro One travel and work was contained to the rock areas including tower pads, roads and yards. As shown in Figure 4, barriers were established wherever there was concern about inadvertent entry into natural areas.

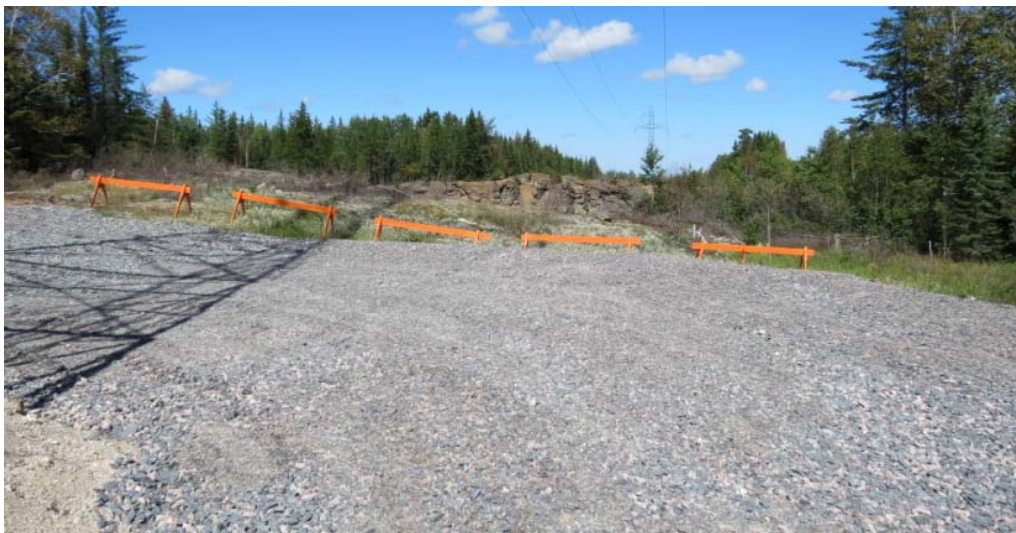
Figure 4 - Barriers installed to prevent entry into natural areas

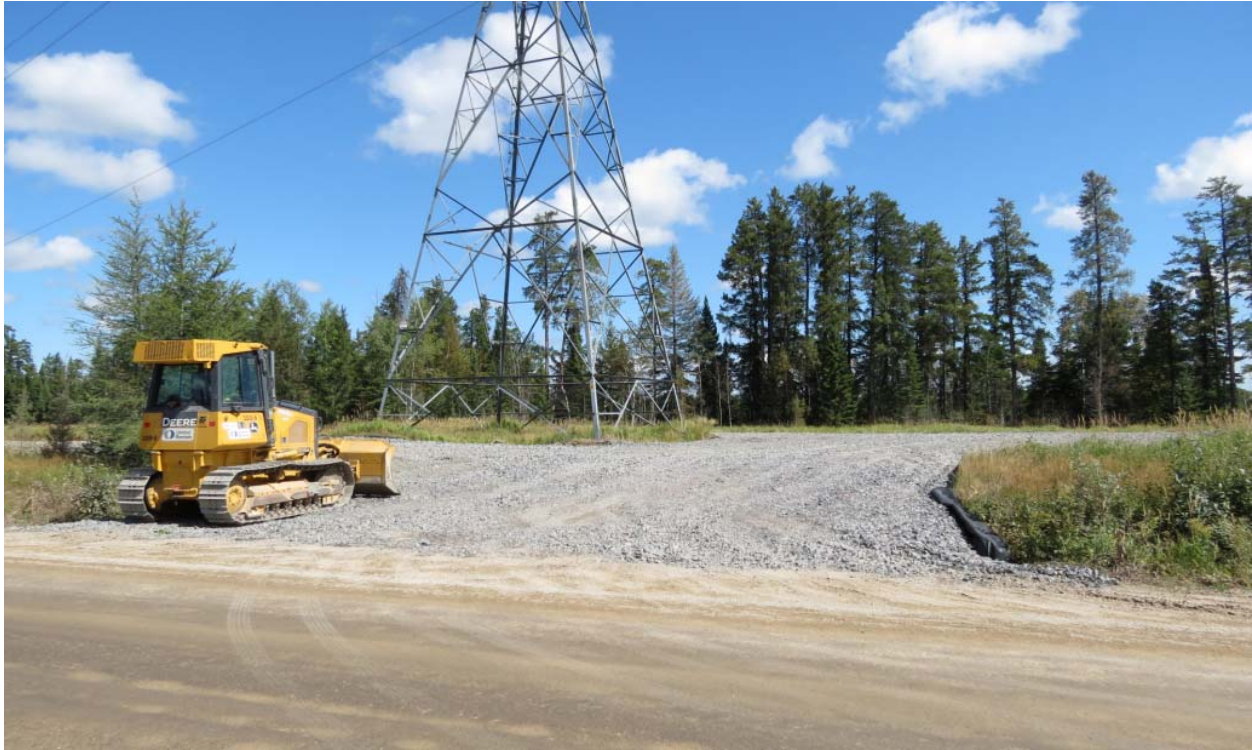
Figure 5 - Tower Pad Construction on Tower 4 on Circuit L20D

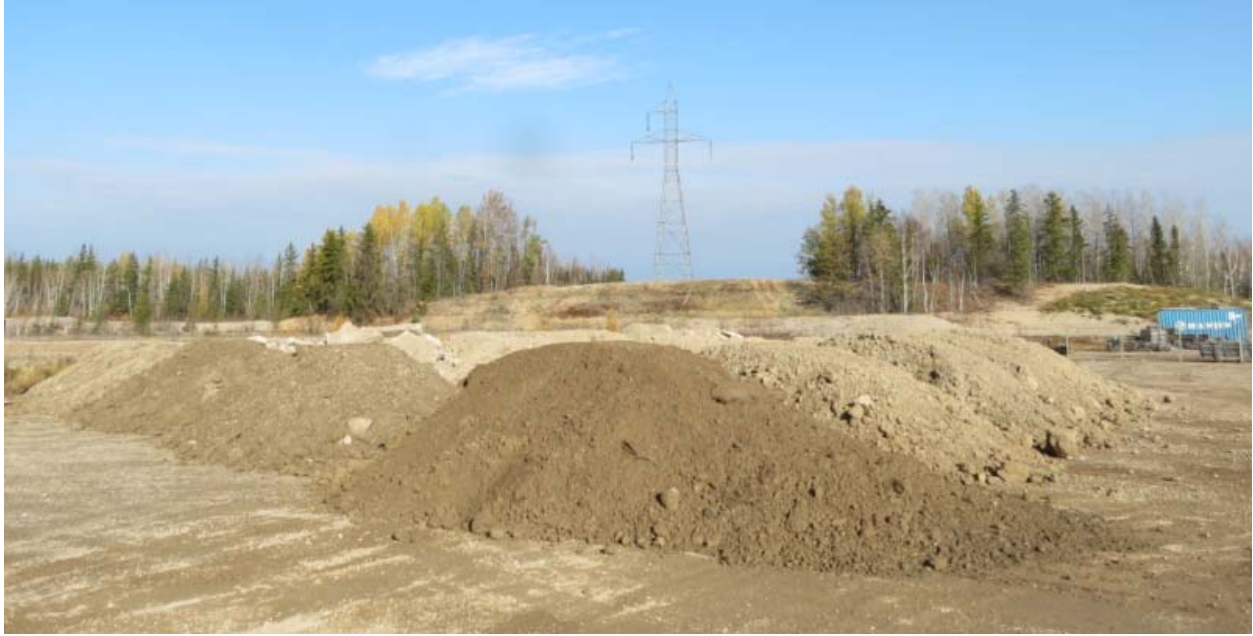
There was station refurbishment work at Little Long Switching Station (SS) involving the installation of a new protection, control and telecom building, station service voltage transformers, new footings, a wave trap, fiber optic cabling, fuse boxes and associated cable trenches. As a result of this station work, there were fifteen dump truck loads of spoil and broken concrete that needed to be removed. This material was sampled prior to it leaving the site using Waste Disposal Bulk and Toxicity Characteristic Leaching Procedure (TCLP) testing parameters. As this material tested clean, it was disposed of on the nearby Hydro One transmission corridor under circuit L20D between Towers 7 and 8 as shown in Figure 6. This area was “high and dry” with no conflicting land uses. This excavated material was spread so that there was minimal change to the overhead electrical clearances as shown in Figure 7 below.

Figure 6 - Clean excavated fill piled on Hydro One transmission corridor for disposal on site

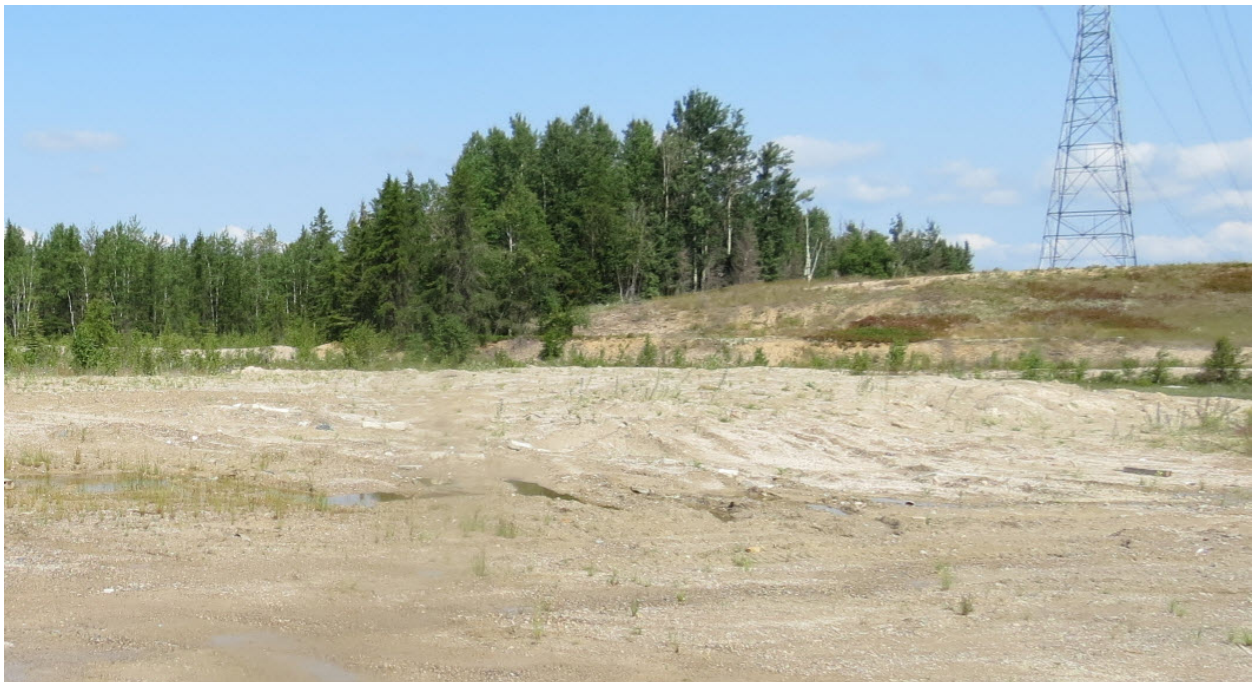
Figure 7 - Clean excavated fill spread out on Hydro One corridor for disposal on site

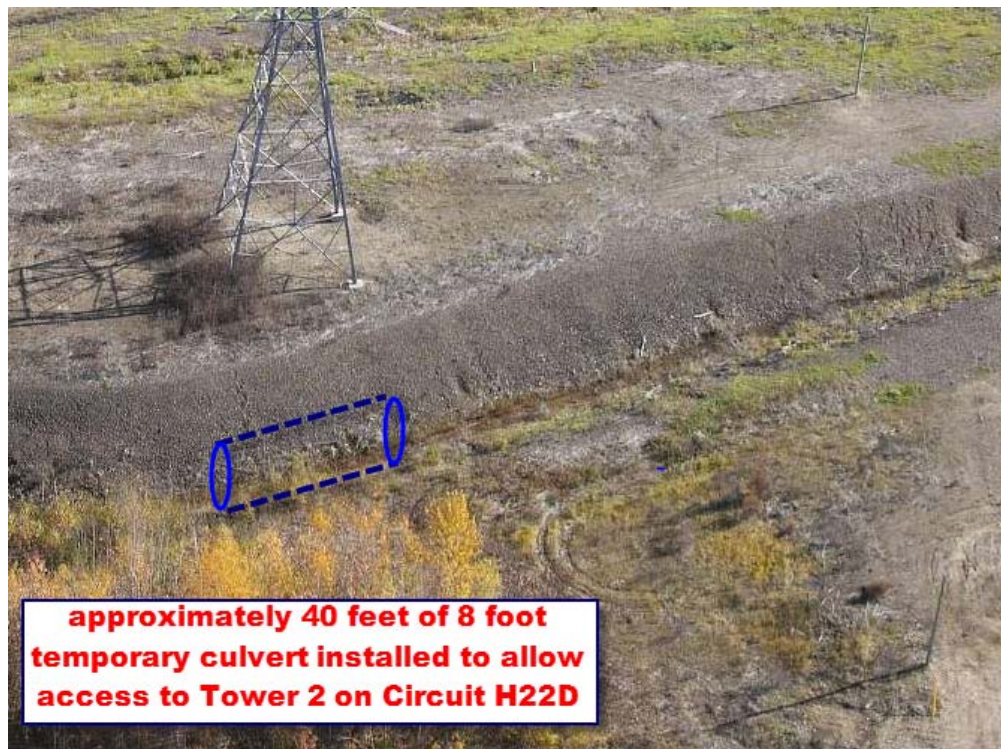
In order to access Tower 2 of circuit H22D as part of the Harmon GS new connection, a large ditch had to be crossed approximately 50 metres from the structure. This 8 foot culvert was installed in July of 2012 and was removed in October of 2012. After removal the site was restored to its previous condition and was seeded. The photos in Figures 9 and 10 show the site just after the culvert had been removed and 2 years after removal, respectively. There is very little evidence of this culvert installation in the latter photo as the site is re-established with vegetation.

Figure 8 - Pre-Construction Site photo Showing Location of Temporary Culvert Installation

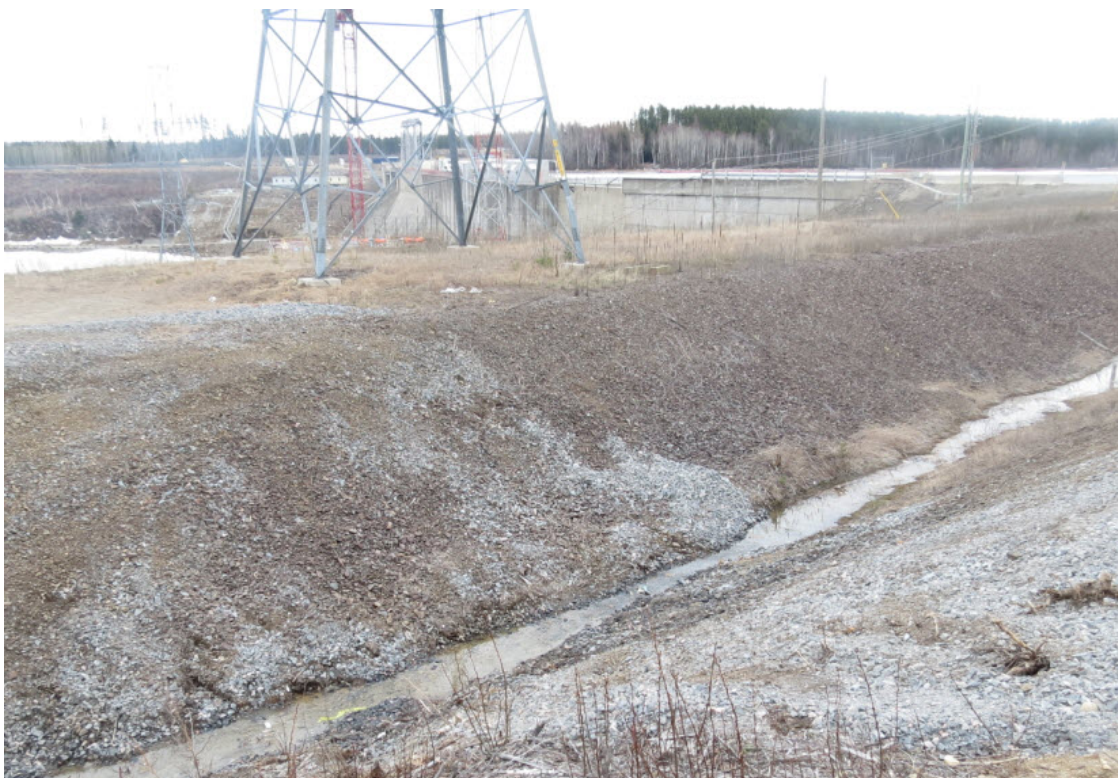
Figure 9 - Restored Site after the Removal of the Temporary Culvert

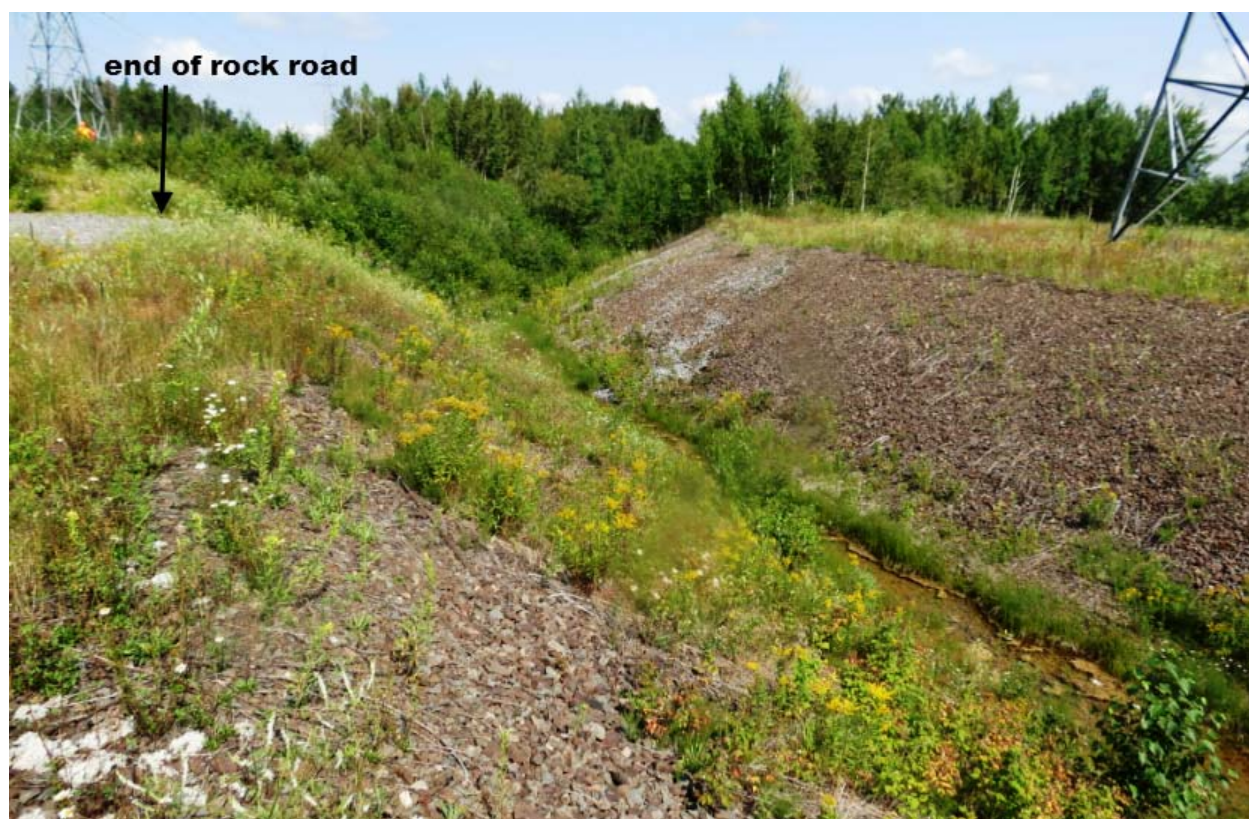
Figure 10 - Restored Site Two Years after the Removal of the Temporary Culvert

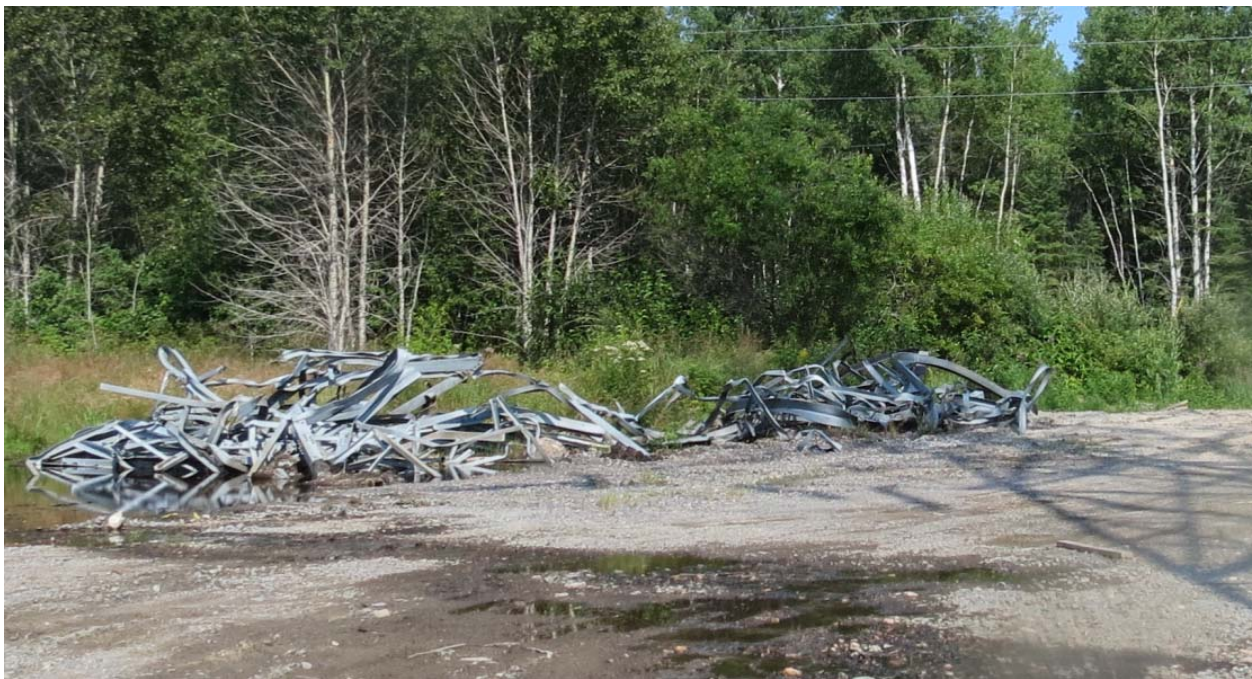
On the August 6, 2014 monitoring visit, the only outstanding environmental issue related to the Section 92 approvals area is two locations where scrap steel from previously removed lattice towers were still piled on site waiting for contractor pickup. This will be scheduled for removal in the Fall of 2015.

Figure 11 - Scrap steel from old tower removal still on site waiting for pickup

This project has had minimal environmental impact beyond adding a significant layer of crushed aggregate to the existing access and work areas which was required in order to accommodate the heavy equipment needed. The only outstanding environmental issue is the scrap steel which is scheduled to be picked up in the Fall of 2015. Overall the construction activities were in compliance with the Conditions of Approval set out for this Project. It is unlikely that there will be any long term environmental impacts resulting from this Hydro One project. The site has been left in a stable condition that should pose no safety or environmental risk to anyone or anything in the area. There are no outstanding concerns and for the foreseeable future this site will form part of Hydro One's normal routine high voltage transmission line maintenance program.

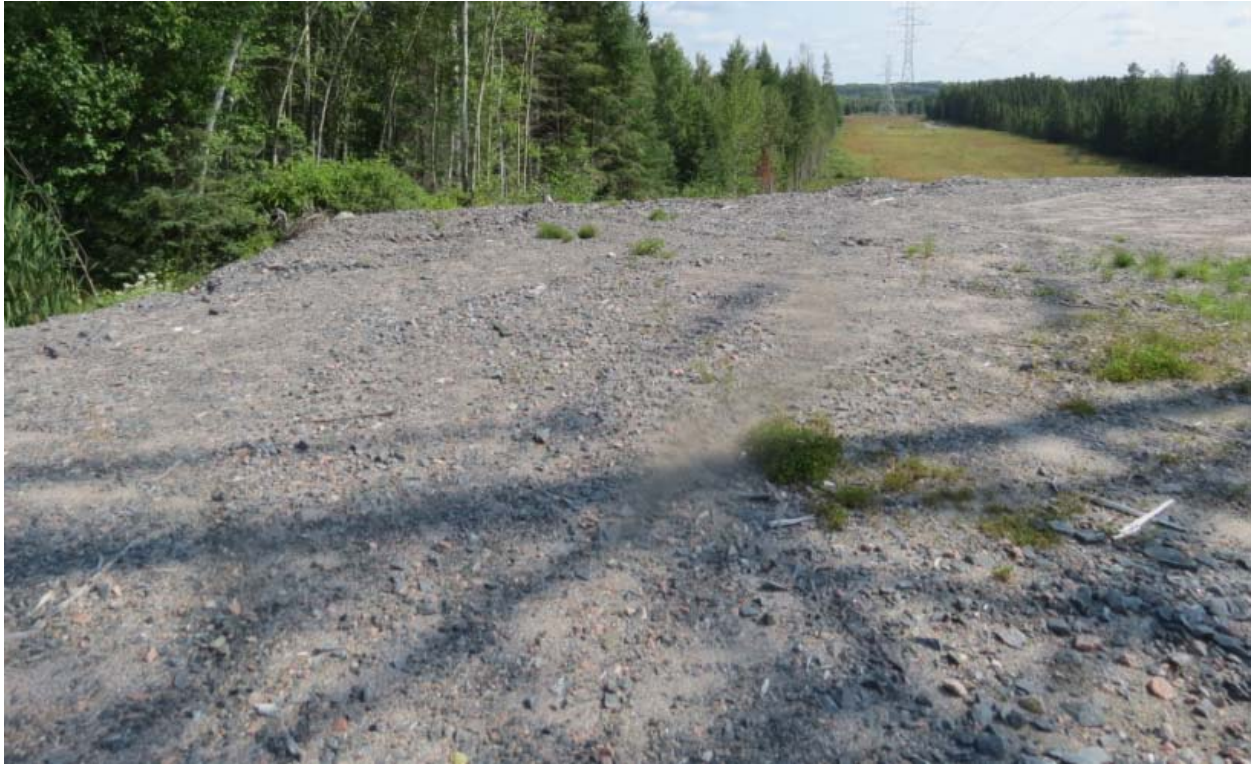
To complete this Project, there was only a small amount of new corridor required. As shown in Fig 12 much of this new area was covered in rock as required for the construction of the new Tower 12<sup>6</sup>.

Figure 12 - Photo showing the only new corridor needed for this project (west of Structure 12 on Circuit L20D with much of it covered with rock)
