**Re: Union Gas Limited
Brantford-Kirkwall Project
Board File # EB-2013-0074**

**TRAFALGAR FACILITIES EXPANSION PROGRAM
2015**

**BRANTFORD TO KIRKWALL PIPELINE PROJECT
INTERIM MONITORING REPORT**

**Prepared by: Union Gas Limited
Environmental Planning
May 2016**

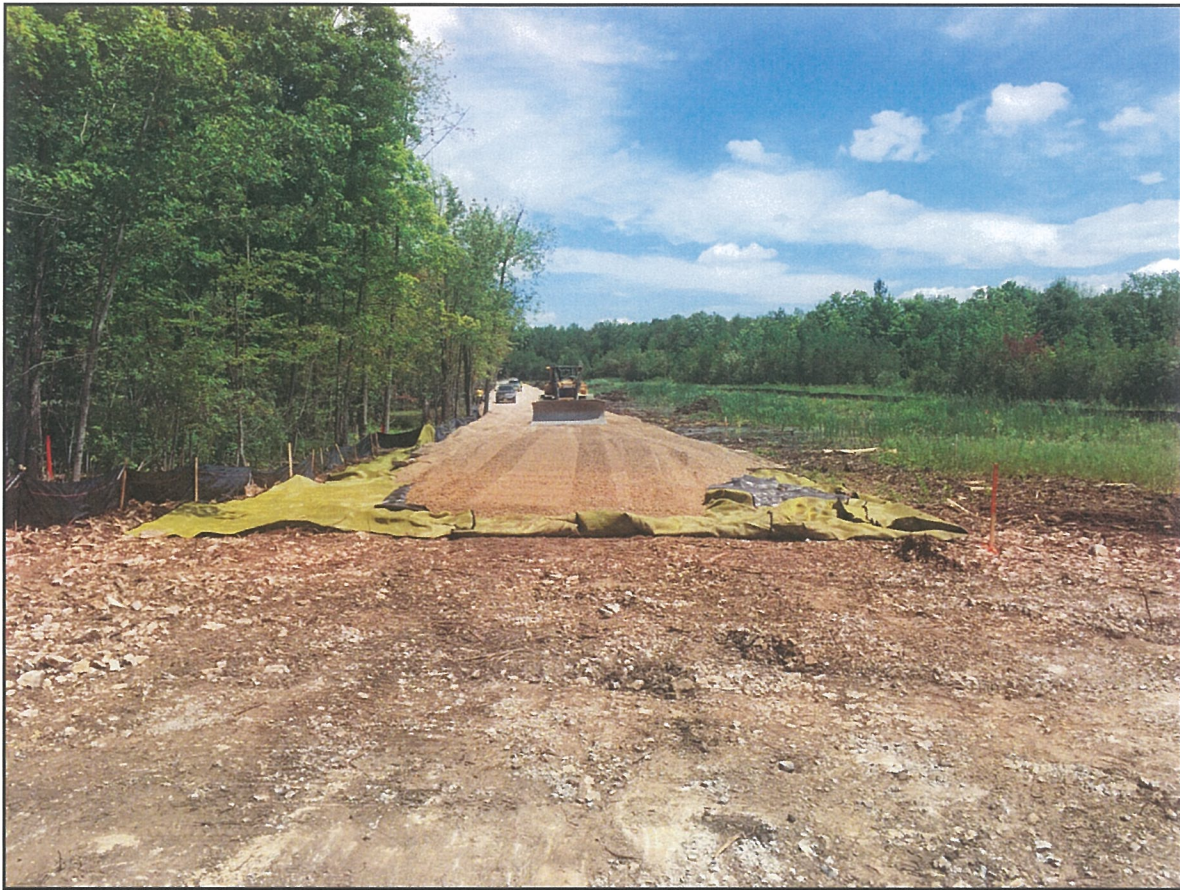
A temporary access road was installed through the wetland west of Valens Road (Beverly Swamp) to minimize impacts to the area from construction equipment. Wildlife exclusion fencing was also installed on either side of the right-of-way to ensure the protection of potential Eastern Milksnakes and other vulnerable species.

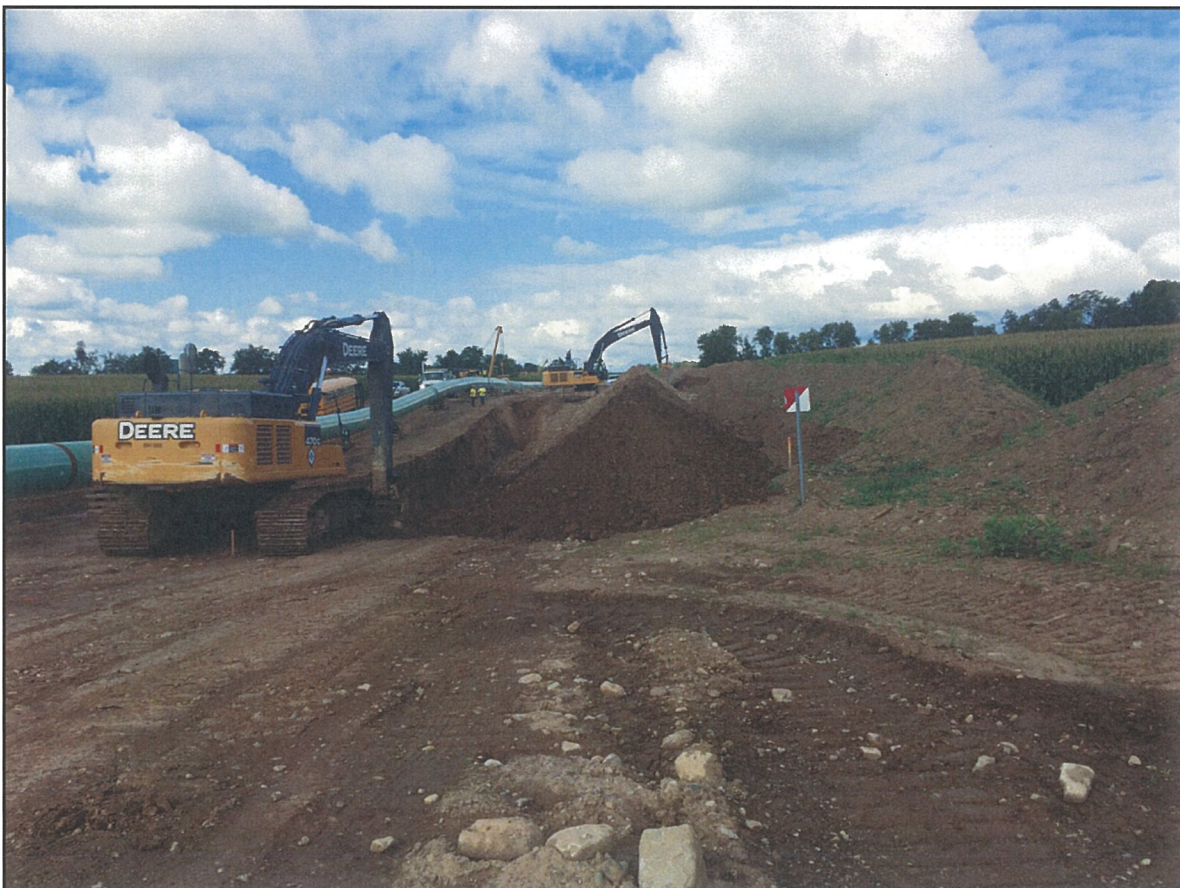
Separation between topsoil and subsoil was maintained during construction to ensure topsoil fertility is maintained.

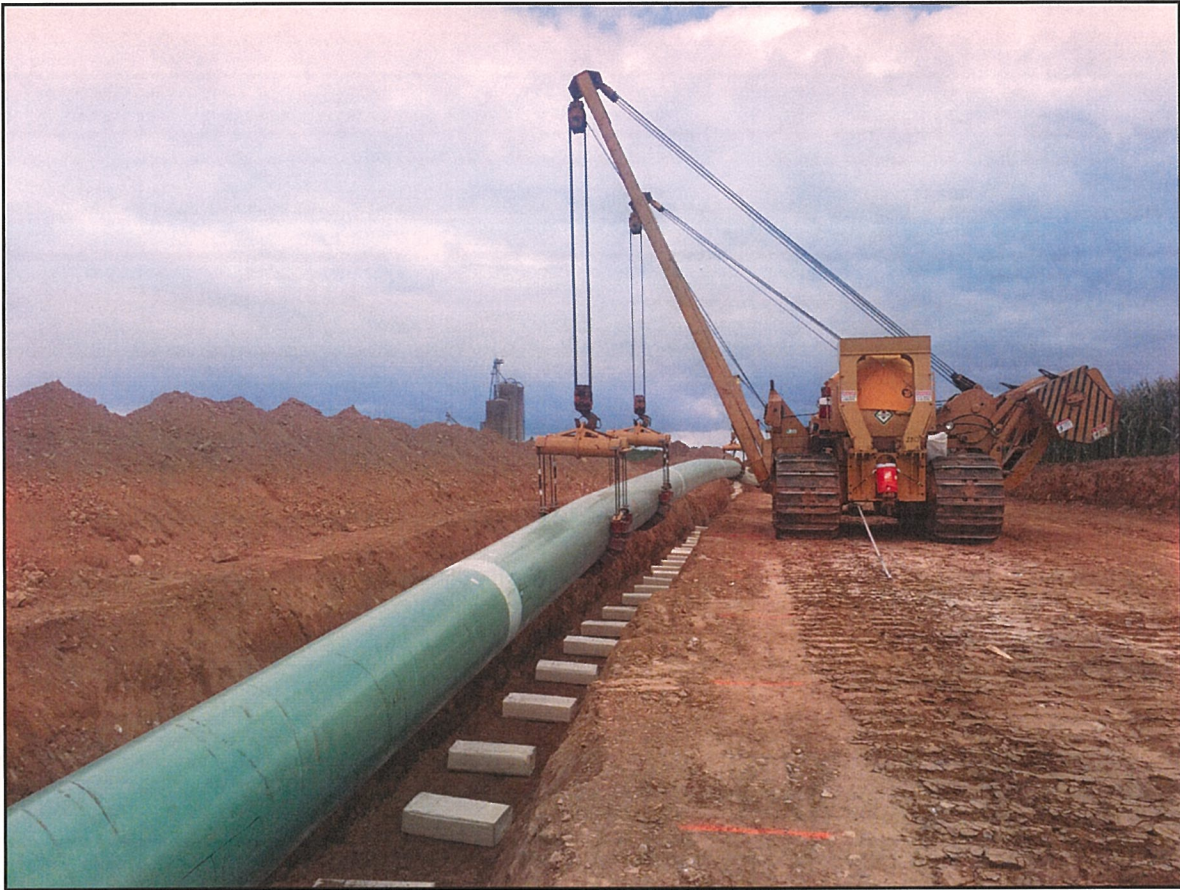
Foam pillows were installed at the bottom of the trench the entire length of the pipeline to protect the pipe from possible damage from stones.

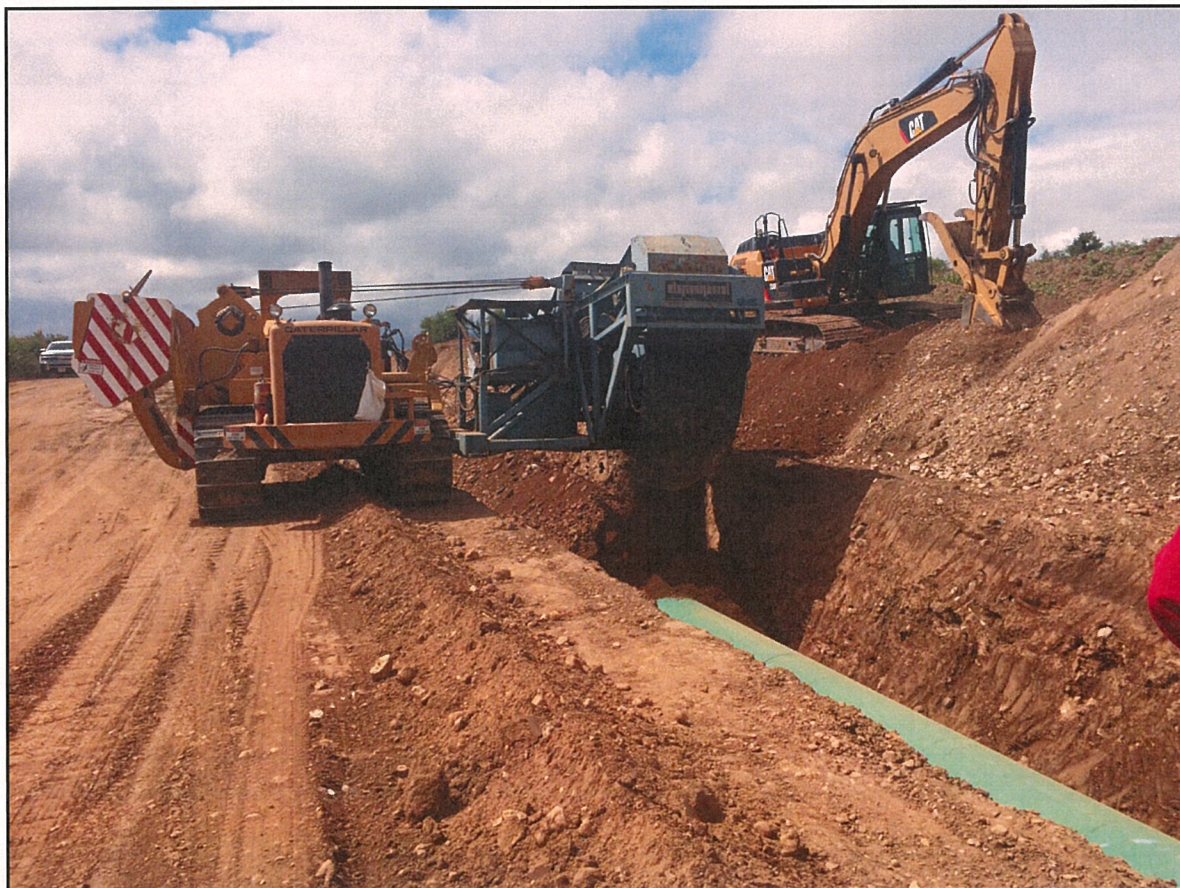
Subsoil is screened during initial backfilling operations using a padding machine to ensure stones do not damage the pipe.

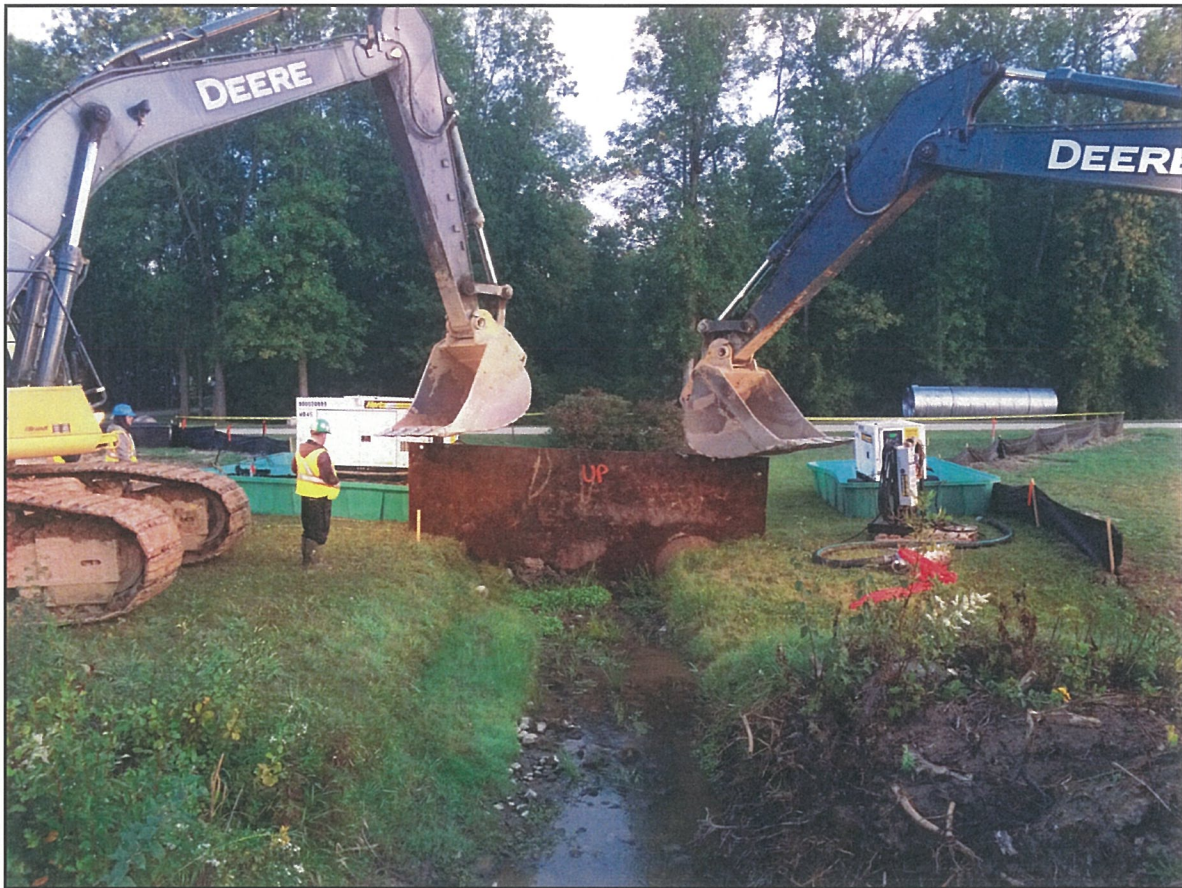
Steel plate dams are installed in watercourses to isolate the pipeline crossing area. Water is pumped from the upstream portion of the watercourse around the work to maintain flow downstream. Extra pumps and generators are kept onsite in the event of primary pump and/or generator failure.

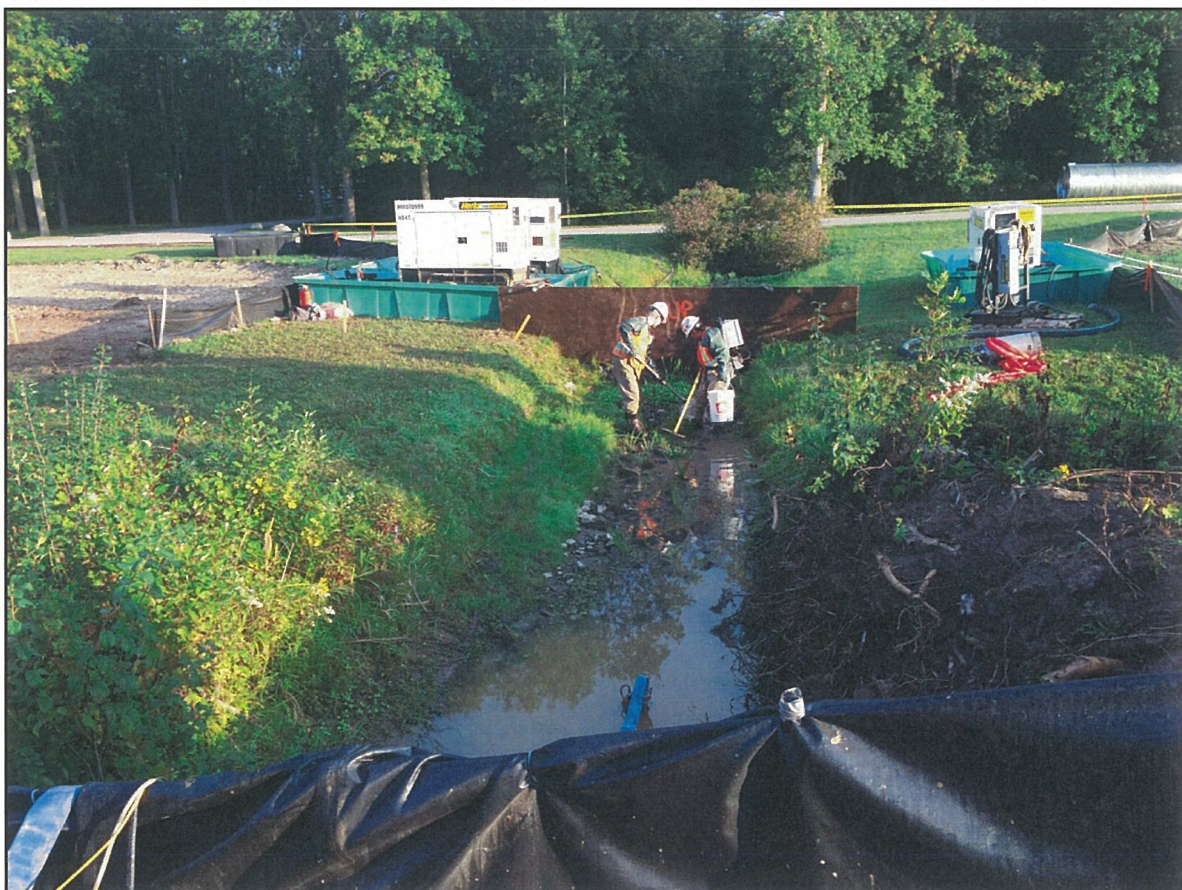
A fish/wildlife rescue is conducted by qualified biologists once the area is isolated. Digging cannot begin until all fish/wildlife are relocated downstream of the crossing location.

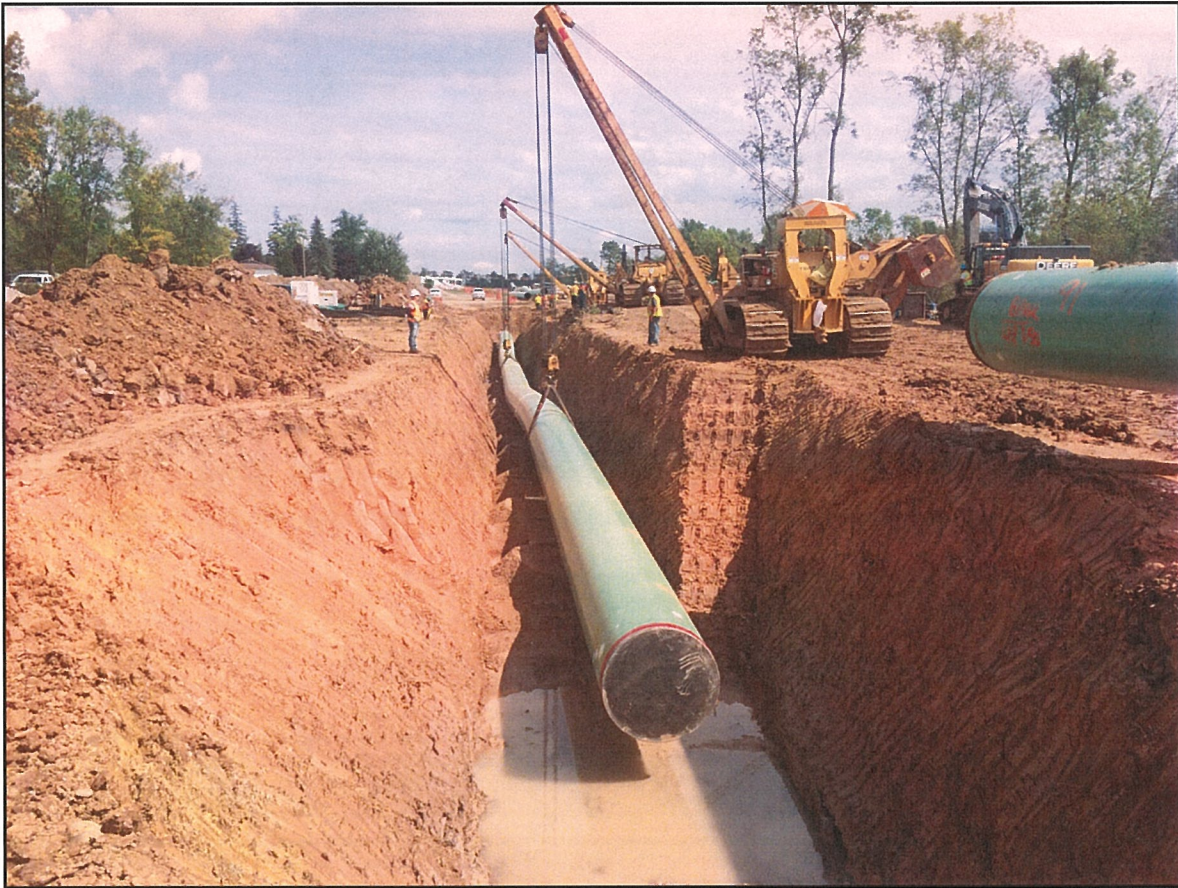
A shorter “creek section” of pipe is lowered in during watercourse crossings to help ensure watercourse crossings are completed within 24 hours.

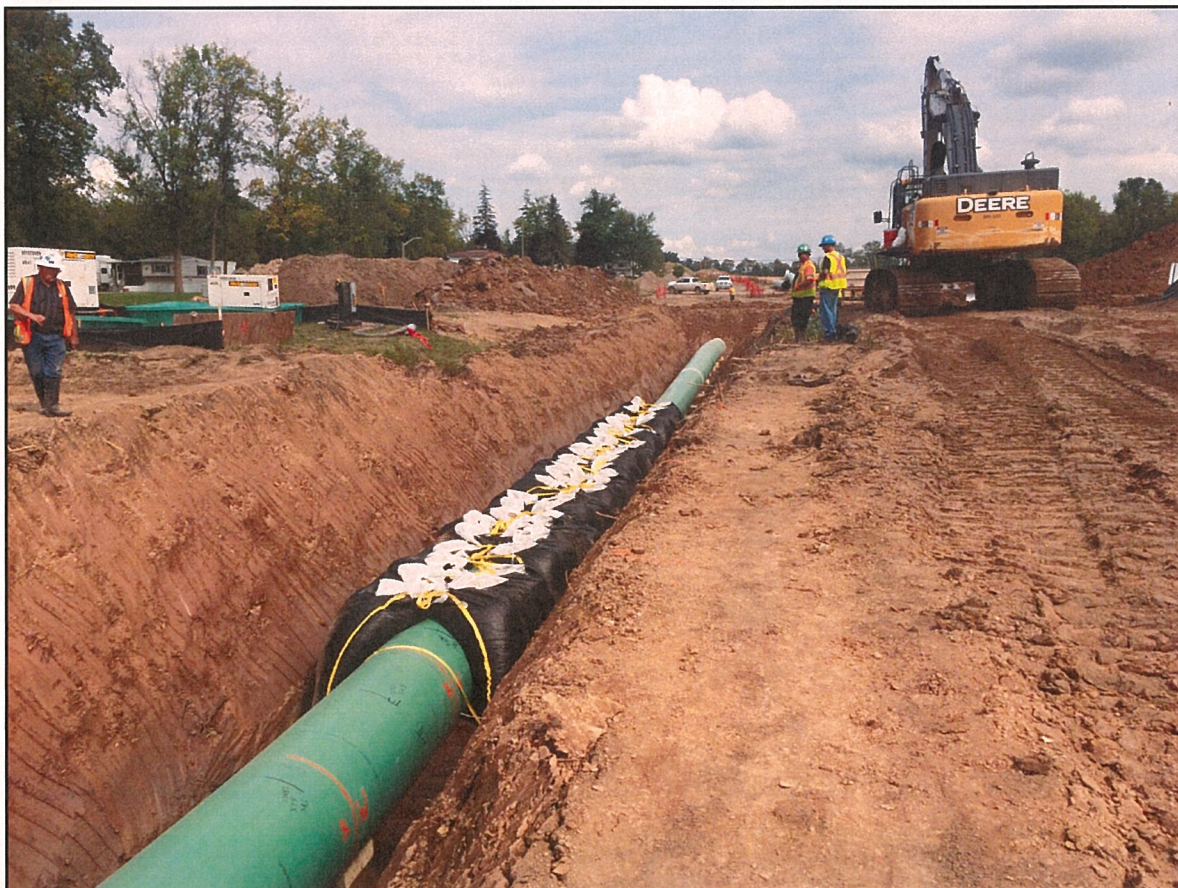
In sections of the right-of-way where the water table is higher, geotextile pipeline weights (PipeSaks) are installed to prevent the pipe from floating to the surface.

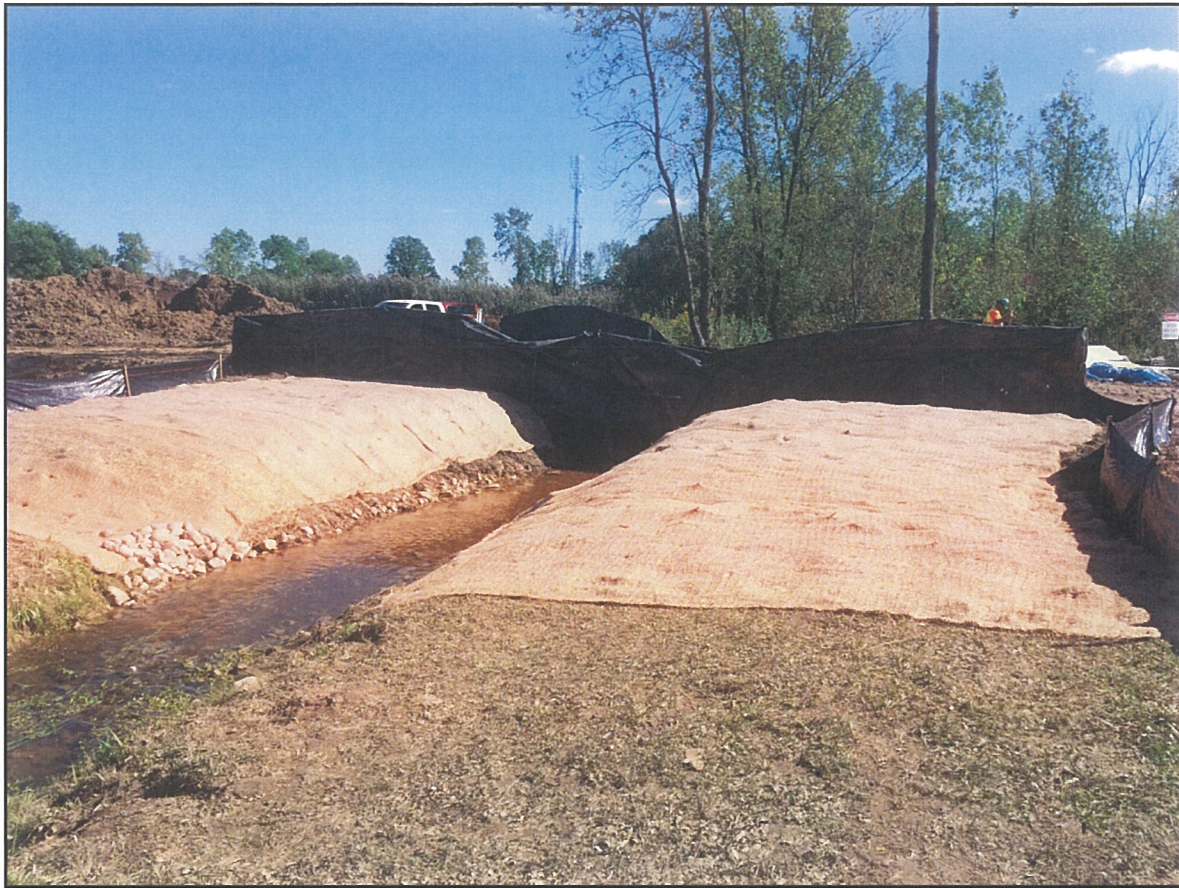
After the watercourse crossing is completed, the watercourse is restored back to pre-construction conditions or better and all disturbed areas are seeded with a creek restoration mix and protected by erosion control blanket and silt fence.

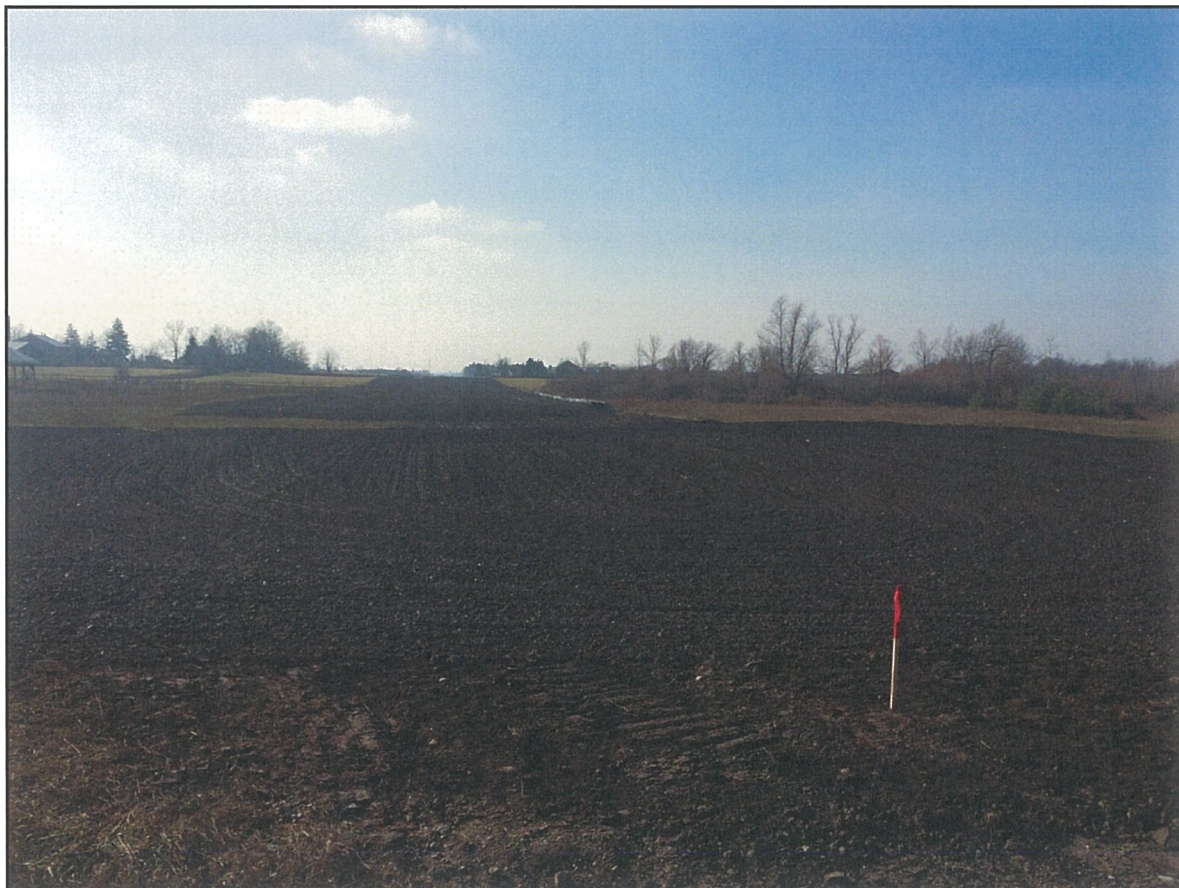
Topsoil soil was spread and returned back to original grade at the end of 2015. Union will perform additional cleanup along the right-of-way as required in spring 2016.
