Re: Dubreuil Lumber Inc.

Status of Electricity Distribution System in the Town of Dubreuilville, 60-day

Algoma Power Inc. EB-2017-0153 Dubreuilville Status Report Page 1 of 14 Filed: June 6, 2017

Costello Utility Consultants - Electrical Distribution Status Report and Technical Review for the Township of Dubreuilville

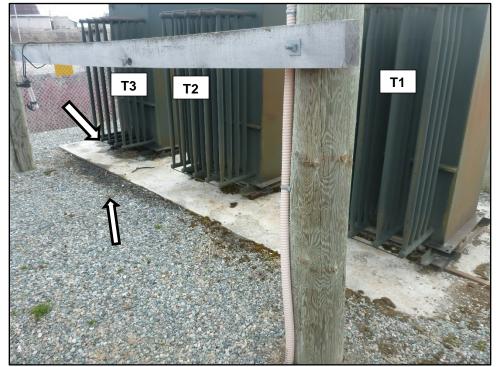
- The fill tap on the side of transformer T3 shows evidence of leaking and has staining on the side of the transformer, on the concrete pad below and on the gravel adjacent to the concrete pad.
- There is potential subsurface contamination due to the Gas bar retail station adjacent the substation.

Photo 4: North side of transformers and concrete pad. Staining around the third (T3) transformer and on gravel outside concrete pad.

• A Phase Two Environmental Site Assessment should be completed to establish baseline conditions at this location.

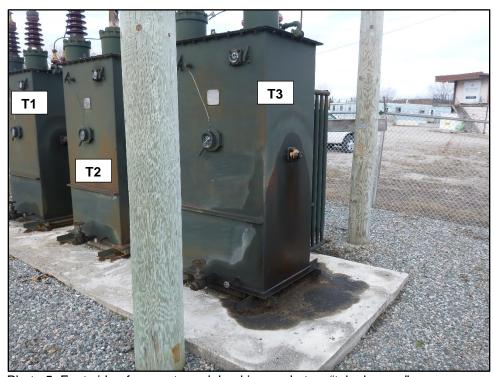
Photo 5: East side of concrete pad. Leaking gasket on "tab changer".

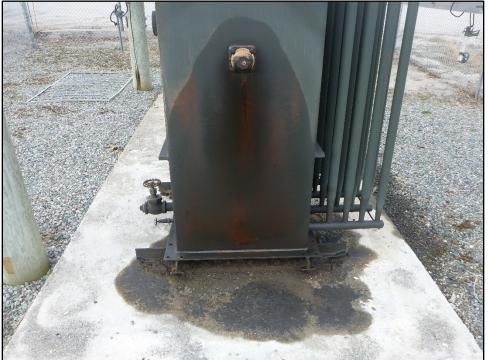
Photo 6: Leak on East side of transformer T3.

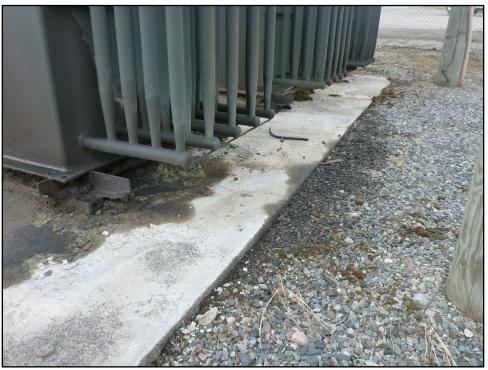
Photo 7: Oil staining on gravel surface on the north side of the concrete pad.

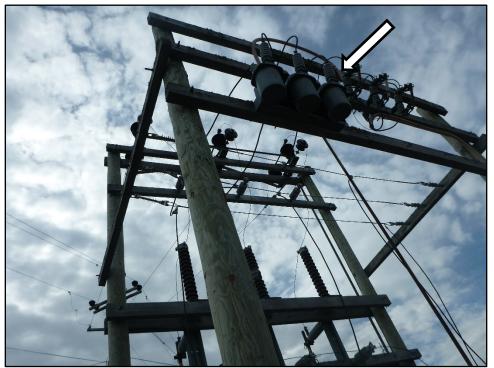
Photo 8: Three oil-filled breakers on the North side.

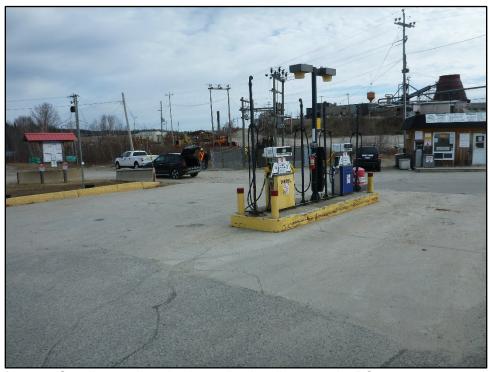
Photo 9: Gasoline retail station immediately adjacent to the DS.

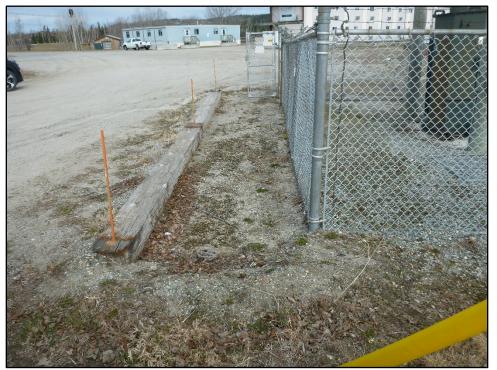
Photo 10: Retaining wall installed approximately 2 years ago to avoid pooling of rainwater run off.

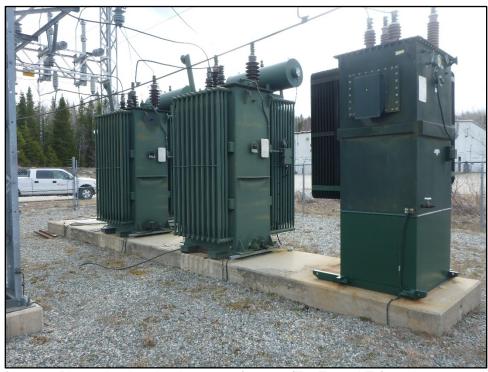
Photo 3: Photo showing the three transformers (T2, T3 and T4) on the concrete pad with no significant oil staining on concrete or gravel.

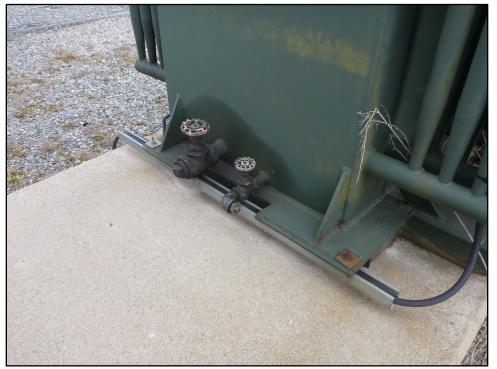
Photo 4: T3 oil staining on side of transformer by valves.

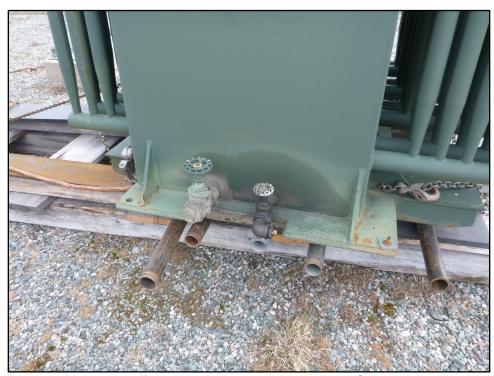
Photo 5: T1 located off the concrete pad awaiting repair. Some oily staining on side by valves.

• T1 should be taken out of service to be repaired and T4 should be put into service. DLI has completed the work associated with this recommendation.

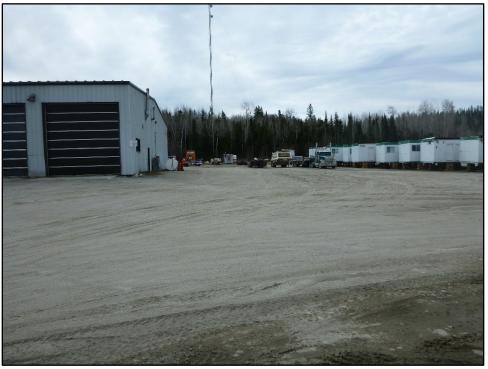
• Adjacent properties with fuel storage may be cause for environmental concern.

Photo 7: Keith Spencer Trucking adjacent to the substation. Fuel tanks visible on the side of the building.

• A Phase Two Environmental Site Assessment should be completed to establish baseline conditions at this location.

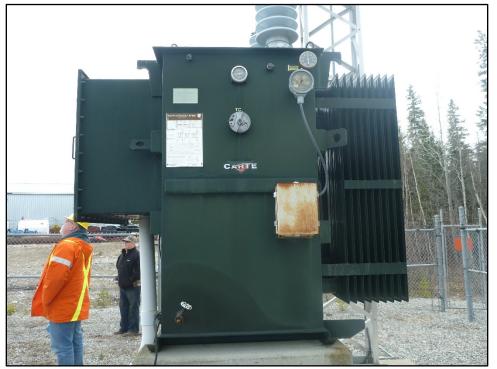
Photo 4: West side of the transformer. Wet staining around the valve.

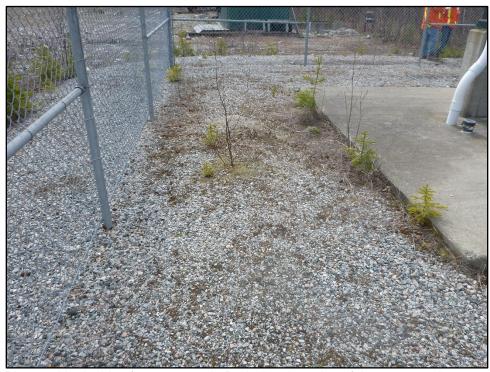
Photo 5: North side of concrete pad. Dark discolouration of the concrete does not appear oily.

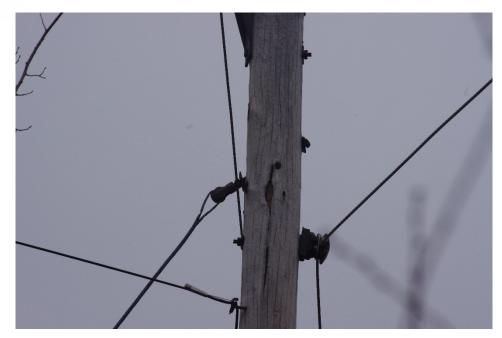
Figure 6 – Pole guys

The method with which some of the pole guys have been installed is antiquated, (a bolt installed through the pole at an angle with no guy hook attachment), and is not up to current industry standards. Please refer to Figure 6 below. Although this poses no immediate concern, it has been noted for the records.

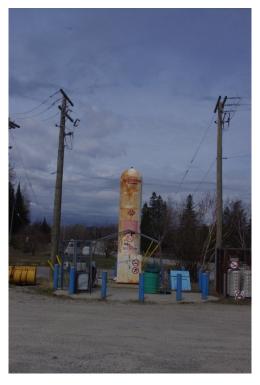
Figure 9 – Propane Filling Station

One issue was found during the inspections related to the proximity of overhead electrical plant to a propane filling station near the restaurant. See Figure 9 below.

Although a cursory review of the clearance requirements between the electrical and propane components yields no obvious transgressions, the proximity of expulsion-type fuses to the propane cylinder is cause for a more detailed review.

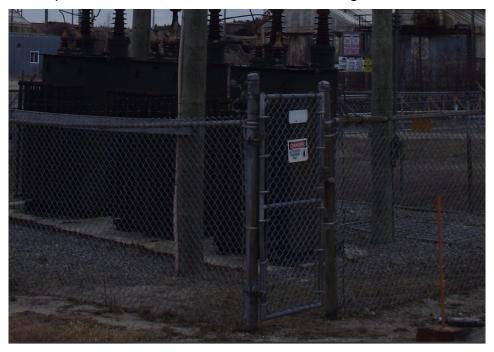
Figure 10 – Substation #1

Although the station fence is intact, structurally sound, and appears to be properly grounded, the total height of the fence is only about 7' (2.1m) to the top of the barbed wire. Current industry practices call for 8' (2.4m) of fence fabric with three strands of barbed wire for a total height of 9' (2.74m). In addition, the current barbed wire is turned into the station, rather than outward toward the public side of the fence. Please refer to Figure 10 below.

Although it meets the minimum safety code requirements, the low station fence poses a risk to public safety and the security of the station equipment. Keeping the public, specifically children, out of the station is paramount. A taller fence also provides less opportunity for damage due to objects being thrown at the porcelain transformer bushings and insulators.

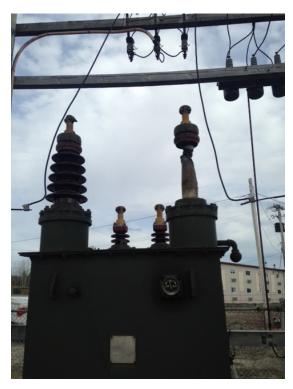
Figure 11 – Transformer at Substation #1

The station transformer (three single-phase units) were originally connected in a 2400V Delta configuration, however, a unit failure due to a lightning strike within the last few years forced the reconfiguration into a 2400V Open Delta. Please refer to Figure 11 below.

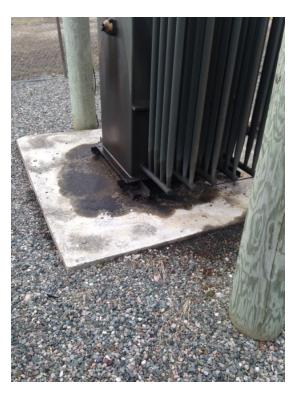
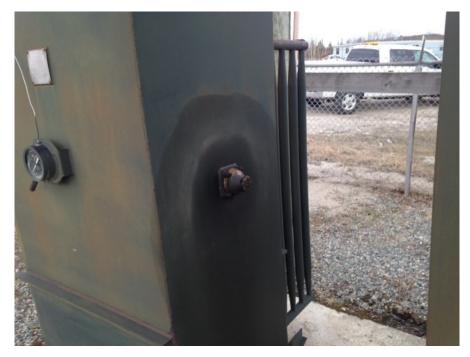
In addition to the failure of one single phase unit, all three transformers are leaking oil, and the concrete pad and ground around the units show signs of long-term leakage. The tap changer operators and the lower tank valve appear to be the main source of the oil leaks on all three units. Please refer to Figures 12 and 13 below.

Figure 12 – Transformer leakage at Substation #1, first example

Figure 13 – Transformer leakage at Substation #1, second example

Such leaks pose operations reliability concerns as well as safety and environmental concerns. Although the grade of the concrete foundation slopes away from the nearby water course, the direction of the general drainage is toward the adjacent creek.

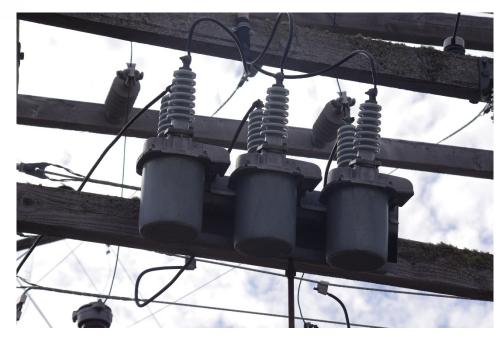
Figure 14 – Single-phase, oil-filled switch units

The 2400V load break device is currently three single-phase oil-filled switch units mounted on the wooden structure. (See Figure 14 below.) The manual operator for these units is mounted directly below the oil-filled unit, and although the switch operator appears to be properly grounded, the location of the operator relative to the devices above is less than optimal for general staff safety.

The feeder protection is provided by fused disconnects on the load side of the oil-immersed switch units. The size of the current fuses is not known.

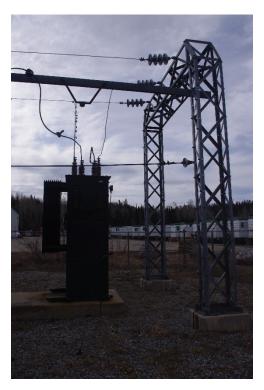
Figure 15 – Substation #2

Also, the tap changer controllers on all three transformers were found to be unlocked. Operation of the tap changer controllers while energized would result in sever equipment damage and personal injury to staff.

The fence appears to be properly grounded in all respects, but shares the same low height issues as the fence at Substation #1. There are also some gaps at the bottom of the fence that could allow pests and wildlife to enter the enclosure. Current practice is to have the fence fabric extend 6" (150mm) below the stone to deter animals and children from crawling under the fences.

- Install crushed stone around the outside fences at Substation #2 and #3.
- Install control padlocks on the transformer tap changers within Substation #2 and #3 (currently being addressed).
- Implement a semi-annual herbicide treatment plan to address the vegetation growth inside and immediately adjacent to Substation #2 and #3.
- Investigate contingency options for Substation #2.
- Perform a dissolved gas analysis for each station transformer.
- Perform soil resistivity and ground grid tests to determine the state of the grounding systems.
- Replace the broken porcelain insulators identified at Substation #2 and #3.

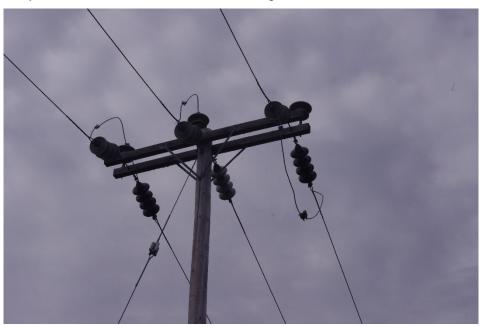
Figure 16 – Broken insulator at Substation #3

There is some vegetation growth within the substation yard that requires maintenance attention, as a potential tripping hazard. The vegetation around the 44kV line leading into the station has not been trimmed in several years. A broken 44kV insulator was also noted on the incoming pole adjacent to the station fence. See Figure 16 below.

- It is recommended that the fence be upgraded to meet current industry best practices and that crushed stone be installed around the outside of the station fence.
- The broken and cracked insulators should be replaced.
- Soil resistivity and ground grid tests should be performed to assess the state of the buried grounding system.
