**CHATHAM EAST REINFORCEMENT
PROJECT**

ENVIRONMENTAL PROTECTION PLAN

Prepared By: Union Gas Limited
Environmental Permitting

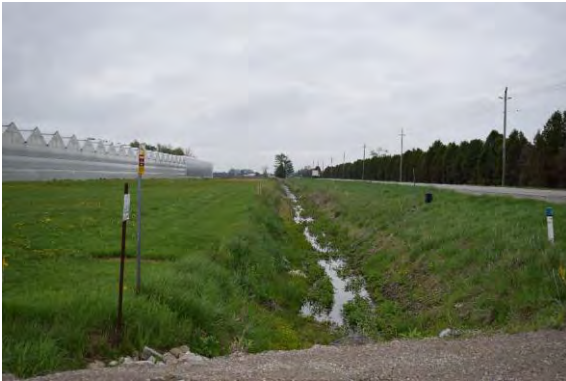
Plate 1: Drainage ditch at the intersection of Base Line and Connection Road

The majority of the region has a history of poor drainage, which required the installation of dredged ditches and tile underdrains to have satisfactory conditions for crop growth and tillage (Chapman and Putnam 1984: 149). The issue of drainage was addressed beginning in 1869 with the first *Ontario Drainage Act*. The act provided municipal and provincial funding to landowners for the construction of drains in southwestern Ontario (Burr 2006: 22). Throughout the late 19th to the early 20th century new innovations established effective drainage throughout the county to facilitate improved agriculture. Still seen on the landscape today within the Study Area are deep ditches and several drains (Plate 1 to Plate 4).

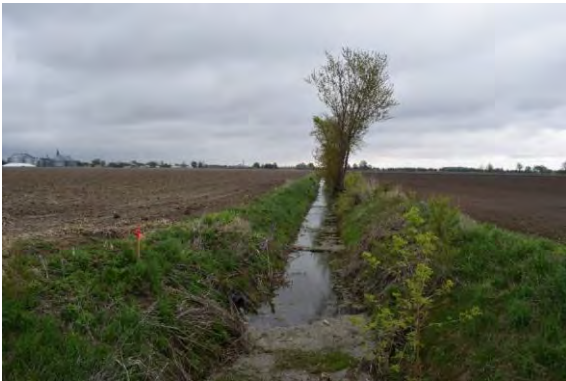
Plate 2: Drain west of Simpson Road north of Base Line

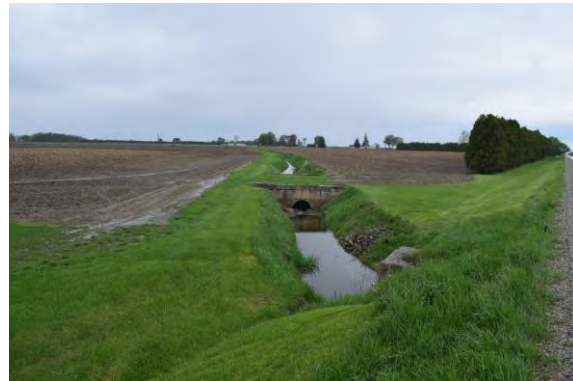
Plate 3: Drain east of Simpson Road north of Base Line

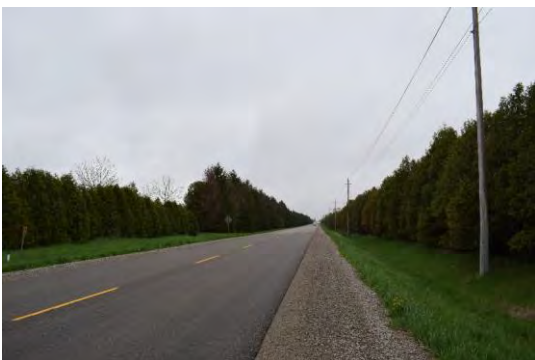
Plate 10: Base Line east of Bush Line looking east

Adjacent to Base Line in the Study Area between Oldfield Line and Lindsay Road for an approximately four kilometre stretch are tree lines of eastern white cedar and Norway spruce trees (Plate 10 and Plate 11). The cedar trees are about 30 years old, while the spruce trees are 40 to 50 years old.

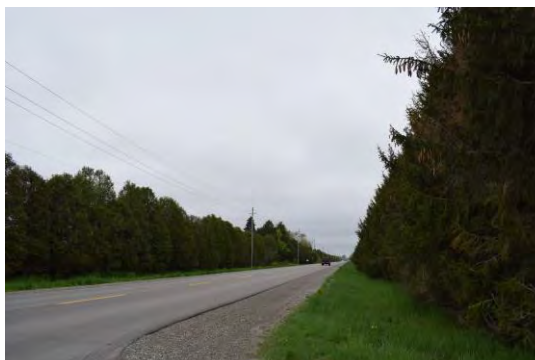
Plate 11: Base Line at King's Ferry Road looking west

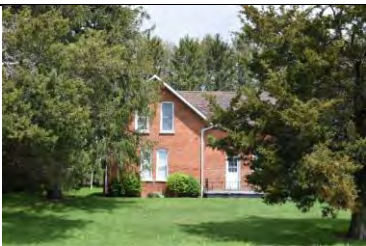
Residence: One and a half storey structure, and medium-pitched cross gable roof, brick exterior, segmental window frames, and brick voussoirs.	Yes	CHR-16	Outside Project Location
Outside Project Location 10211 Base Line	No	Residence

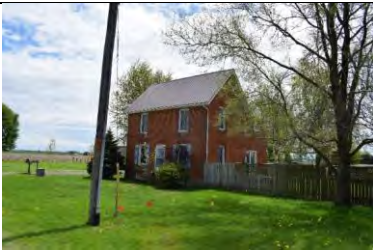
Residence: Two storey structure, high-pitched cross gable roof, brick exterior, brick voussoirs, three-bay front façade, semi-circular wood window, and L-shaped plan.	Yes	CHR-21	Outside Project Location

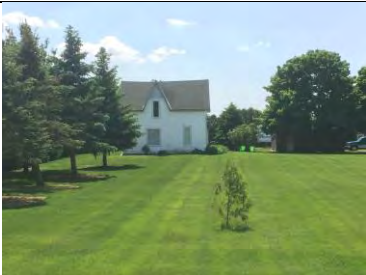
Residence: One and a half storey structure, medium-pitched cross gable roof, high-pitched gable dormer, and L-shaped plan.	Yes	CHR-27	Outside the Project Location
25406 Kent Bridge Road	No	Residence

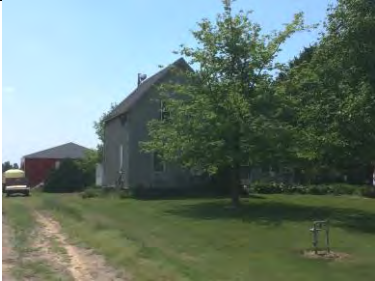
<p>Residence: One and a half storey structure, medium-pitched front facing gable roof, one storey side gable roof section, L-shaped plan, and stone foundation.</p> <p>Landscape: Laneway, mature spruce tree line, and surrounding agricultural fields.</p>	Yes	CHR-29	Outside the Project Location

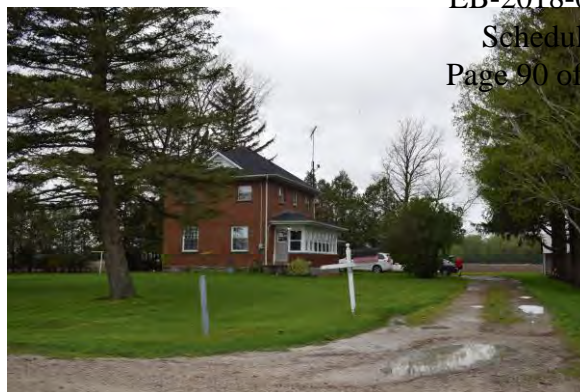
The residence is a two storey structure with a high-pitched hip roof with asphalt shingles. The east elevation has a gabled dormer. The red brick exterior has modern windows. The north elevation has an enclosed porch with a wood paneled entrance door. The residence has a rusticated concrete foundation.

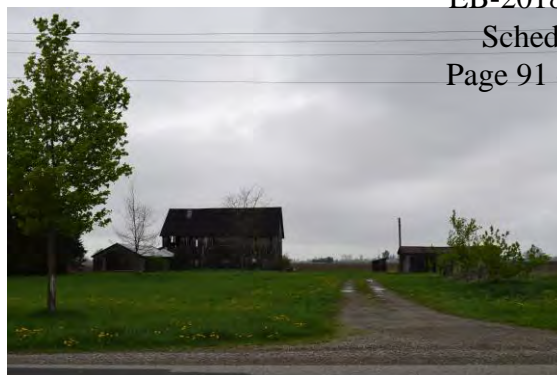
Description: The property contains a laneway that leads to four outbuildings.

The largest outbuilding is a timber frame barn with a side gable roof that is clad in metal. It has an attached smaller timber frame structure with a side gable roof that is clad in metal. To the east of the barn is a small pumphouse and a side gable outbuilding that has a metal clad roof, and metal clad exterior.

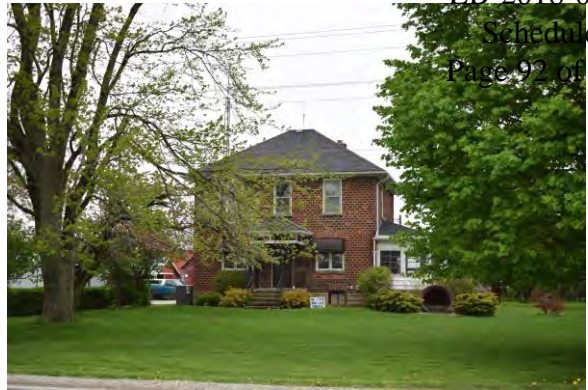
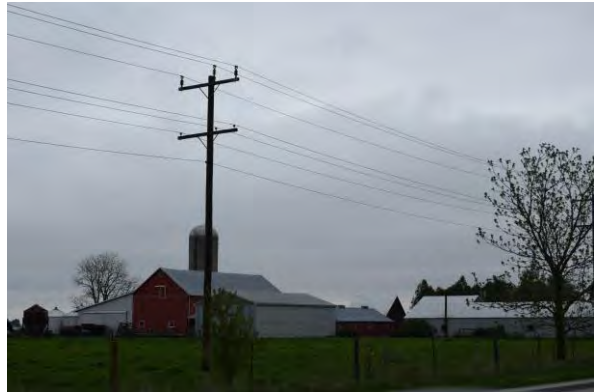
The largest farm outbuilding is a side gable barn with a metal clad roof. Its exterior is clad in vertical wood boards and it has a concrete foundation. The barn has a salt box side. Attached to the barn are smaller side gabled outbuildings. Adjacent to the barn is a cast-in-place concrete silo, and two metal clad silos, as well as two to three more side gable outbuildings that are clad in metal.

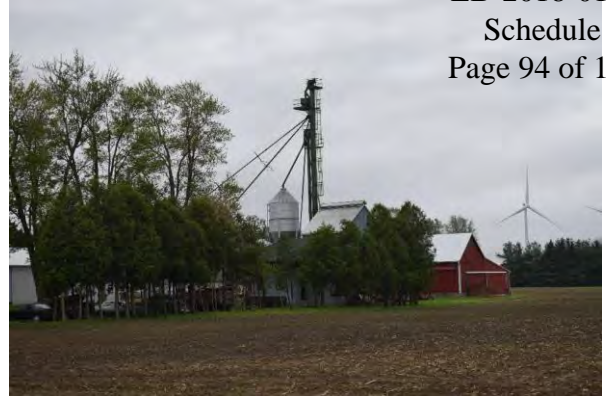
The largest outbuilding is a timber frame barn with a side gable roof that is clad in metal. The structure has a salt box addition and a concrete foundation. Adjacent to the barn is a tall side gable outbuilding that is clad with metal and has an attached grain elevator with metal silos.

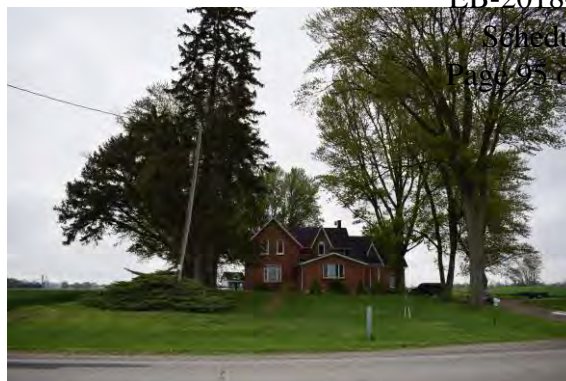
The residence is a one and a half storey structure with a medium-pitched cross gable roof, with asphalt shingles and a brick chimney. The structure has a modern addition on its east and south elevations. The red brick exterior has mostly modern windows, except for a flat fixed window on the lower storey with side 1/1 wood windows and a fixed wood transom. The windows on the original portion of the residence have brick voussoirs. The residence has a concrete foundation.

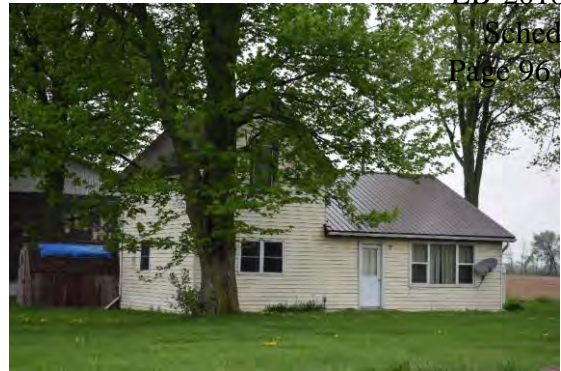
Description: The property contains a residence and modern outbuilding. The property has mature maple trees.

The residence is a one and a half storey structure with a medium-pitched front facing gable roof, with metal cladding. Its east elevation has an attached one storey side gable roof section, with a metal clad roof. The exterior of the residence is clad in vinyl siding and has modern windows and doors. The foundation is undetermined. The residence has been heavily altered with modern materials.

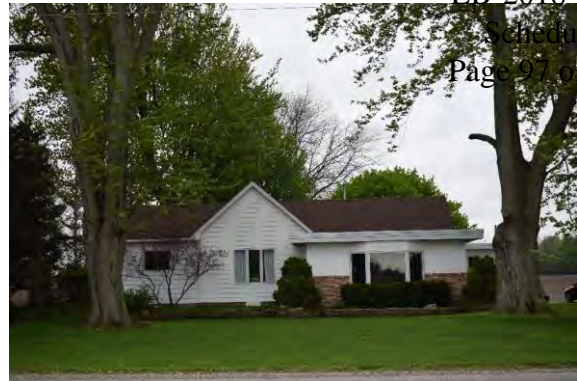
Description: The property contains a residence, a cast-in-place concrete silo, two metal silos, a timber frame outbuilding, and a small horizontal wood outbuilding. The front yard has mature deciduous trees.

The residence is a one storey structure with a medium-pitched side gable roof with asphalt shingles. The front (north) elevation has a front facing gable peak. The residence is clad in vinyl siding and brick and has modern windows and doors. The structure has a concrete foundation.

At the rear of the residence is the timber frame outbuilding with a side gable roof that is clad in metal. The view to the outbuilding is obstructed by the residence and vegetation.

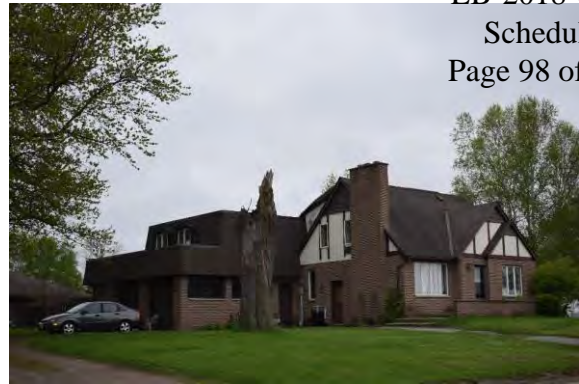
Description: The property contains a residence and modern garage.

The residence is a one and a half storey structure with a high-pitched side gable roof with asphalt shingles and a brick chimney. The structure has an attached modern addition with a flat roof on its south elevation. The lower storey of the residence is clad in brick, while the upper storey is clad in stucco with half timbering. The residence has modern windows and doors. The front (north) elevation has two front facing gable peaks. The structure has a concrete foundation.

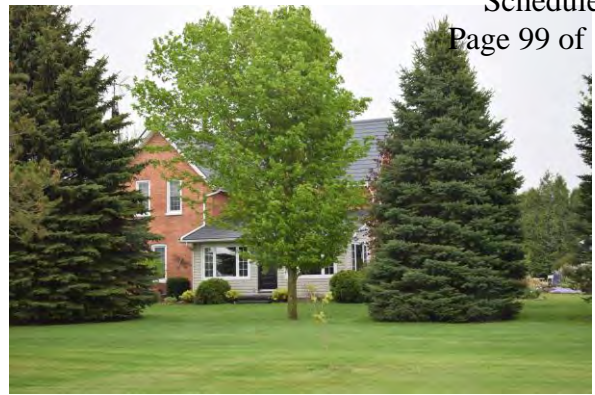
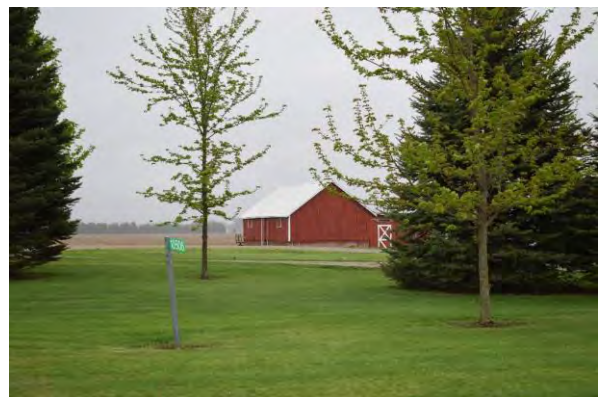
The residence is a one and a half storey structure with a medium-pitched cross gable roof that is clad with metal. The structure has a modern rear addition. The roofline has high-pitched gabled dormers on the north and west elevations. The red brick exterior has modern windows and doors. The front (west) elevation has an enclosed porch.

The vertical wood outbuilding has a side gable roof that is clad in metal. The structure has a concrete foundation.

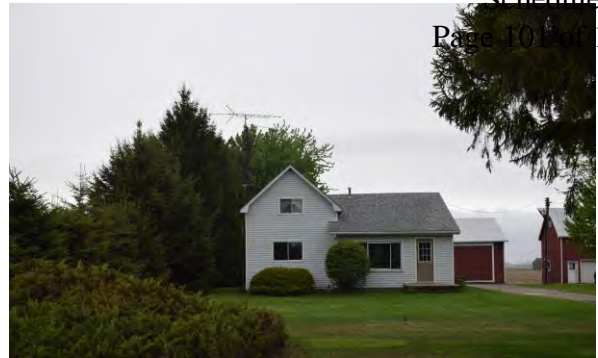
Description: The property contains a residence, barn, and outbuilding. The south and north of the residence are mature spruce tree lines. The farmstead is surrounded by agricultural fields.

The residence is a one and a half storey structure with a medium-pitched cross gable roof with asphalt shingles. The structure is clad in vinyl siding and has modern windows and doors. The residence has a concrete foundation. The residence has been heavily altered with modern materials.

The barn has a side gable roof that is clad in metal and has a hay hood. The barn is clad in vertical wood boards and has modern doors. The outbuilding is a similar side gable roof structure, with a metal clad roof, and vertical wood board exterior.

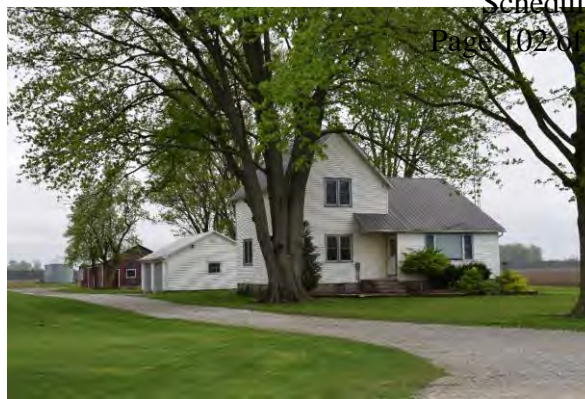
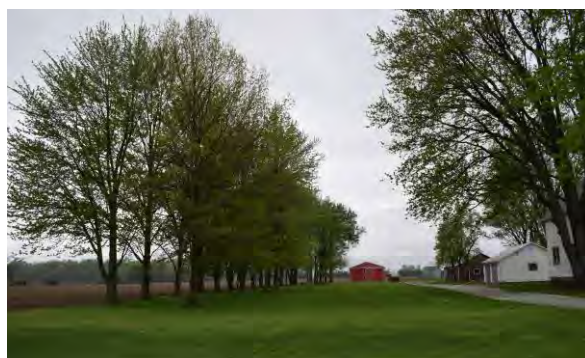
The residence is a one and a half storey structure with a medium-pitched front facing gable roof, with metal cladding. The structure has a one storey addition on its north elevation with a high-pitched side gable roof that is clad in metal. The residence is clad in vinyl siding and has modern windows within wood surrounds. The structure has a rusticated concrete foundation.

To the rear of the residence is a wood outbuilding with a side gable roof that is clad with metal. Southwest of the outbuilding is another outbuilding with a side gable roof that is clad in metal. Its exterior is clad in vertical wood boards.

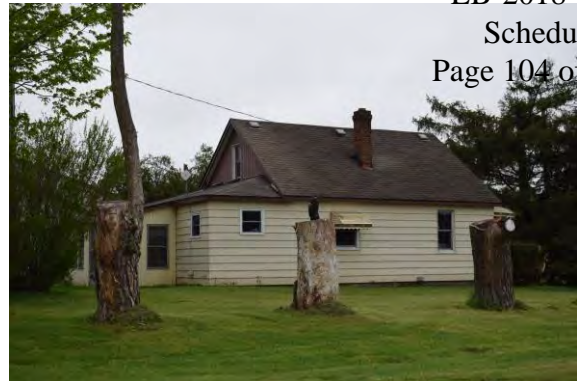
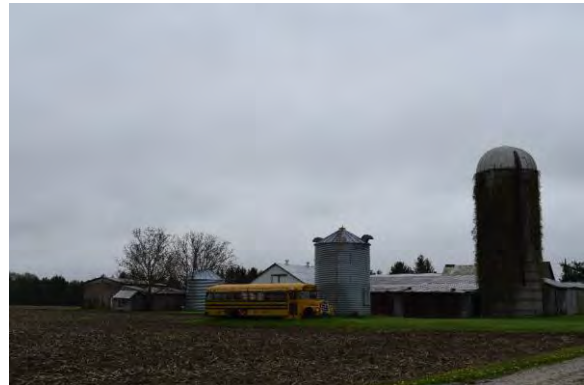
The residence is a one and a half storey structure with a medium-pitched front facing gable roof with asphalt shingles and a brick chimney. The structure is clad in aluminum siding and has modern windows. The residence has a concrete foundation.

To the rear of the residence are multiple farm associated outbuildings. This includes a timber frame outbuilding with a high-pitched side gable roof that is clad in metal, a long side gable roof outbuilding, that has a metal clad roof, and a small wood outbuilding with a side gable roof that is clad in metal. Adjacent to these outbuildings is a cast-in-place concrete silo, and metal clad silo.

To the northeast of the residence is a wood outbuilding with a side gable roof that is clad in metal. It has a shed roof addition. Adjacent to this outbuilding, are two smaller wood outbuildings with gable roofs that are clad in metal. The outbuildings have wood doors and one has wood windows.

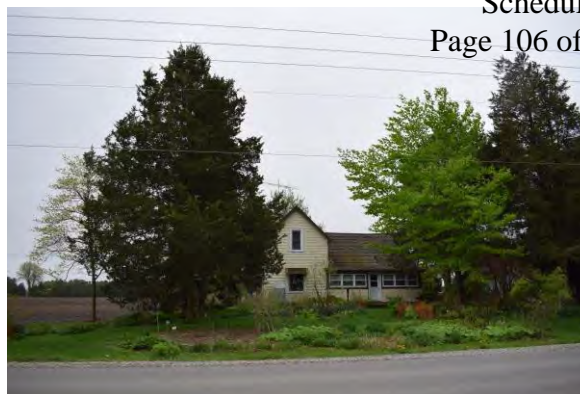
Description: The property contains a residence and outbuildings. The property has cedar trees and an ornamental garden.

The residence is a one and a half storey structure with a medium-pitched cross gable roof with asphalt shingles. The structure is clad in vinyl siding and has modern windows and doors. The front (north) elevation has an enclosed porch. The structure has a concrete foundation.

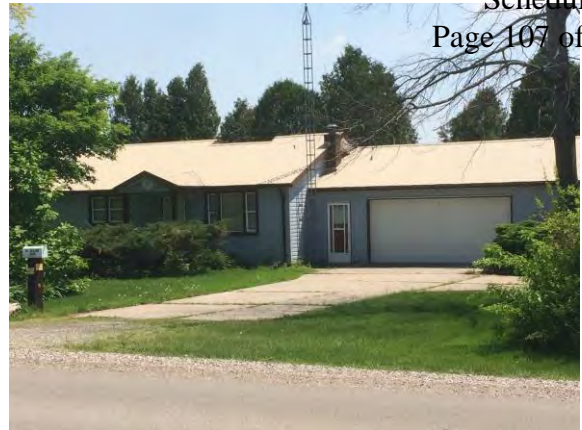
Description: The property contains a residence.

The residence is a one storey structure with a medium-pitched side gable roof that is clad in metal and has a brick chimney. The exterior is clad in vinyl siding and has modern windows and doors. The structure has an attached single-car garage. The residence has a concrete foundation.

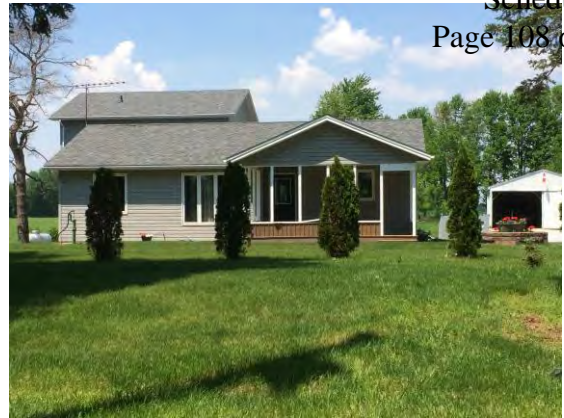
Description: The property contains a residence and outbuildings. The outbuildings adjacent to the residence are modern. The view of the outbuildings at the rear of the property is obstructed by vegetation. The property has mature spruce and cedar trees.

The residence is a one storey structure with a side gable roof that has asphalt shingles. The structure is clad in vinyl siding and has modern windows and doors. The front (south) elevation has an enclosed partial porch. The residence has a concrete foundation and a rear addition.

A structure is shown on the property on the 1913 topographic map of Wallaceburg, but the current structure appears to date from the mid-20th century.

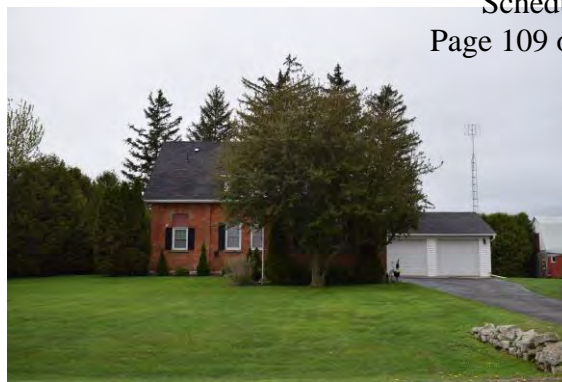
Description: The property contains a residence and modern outbuilding. The residence is a former schoolhouse. The front (south) elevation of the property is bordered in a cedar hedge, while the west elevation has mature spruce trees.

The residence is a one storey structure with a high-pitched front facing gable roof, with asphalt shingles. The east elevation has a shed dormer. The red brick exterior has decorative vertical and horizontal brick banding. The residence has modern windows, with brick voussoirs that have a central keystone and label stops. The structure has a rear modern addition with an attached double-car garage. The residence has a rusticated stone foundation.

Identified Heritage Attributes: Residence: One storey structure, high-pitched front facing gable roof, red brick exterior, shed dormer, decorative vertical and horizontal brick banding, brick voussoirs with central keystone and label stops, and rusticated stone foundation. Landscape: Mature spruce trees.

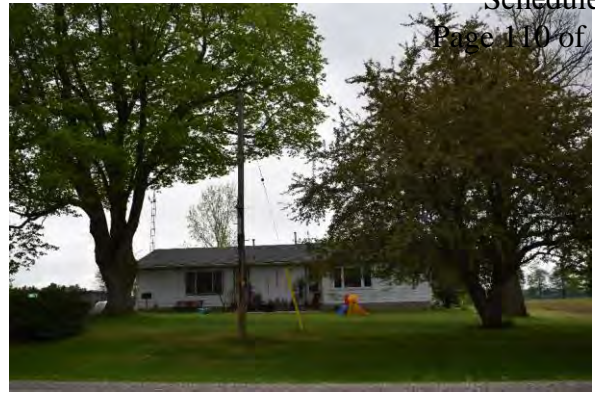
Description: The property contains a residence and outbuildings. The property has mature maple trees.

The residence is a one storey structure with a medium-pitched side gable roof with asphalt shingles. The exterior is clad in vinyl siding and has modern windows and doors. The structure has a concrete block foundation.

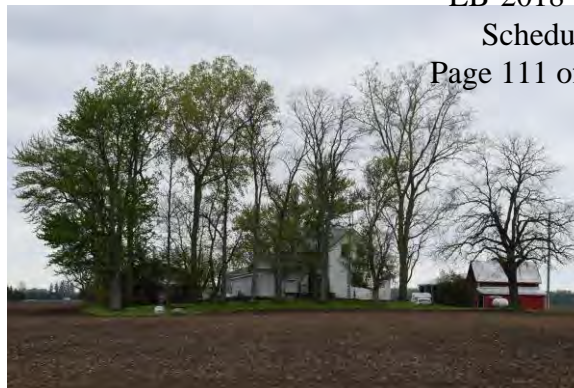
Description: The property contains a residence and outbuildings. The structures are set back from the roadway off a long laneway. The view of the residence and outbuildings is obstructed by distance and surrounding vegetation. The residence and outbuildings are surrounded by agricultural fields.

The residence is a one and a half storey structure with a medium-pitched cross gable roof, that is clad in metal. The structure is clad in vinyl siding and has a mixture of modern windows and 2/1 windows. The foundation is undetermined.

North of the residence is a wood outbuilding with high-pitched side gable roof that is clad in metal. The structure has an attached shed roof addition and attached side gable addition. West of the residence is a modern outbuilding, and south of the residence is a wood outbuilding with side gable roof that is clad in metal. The outbuilding has a three-bay front (east) façade with wood windows.

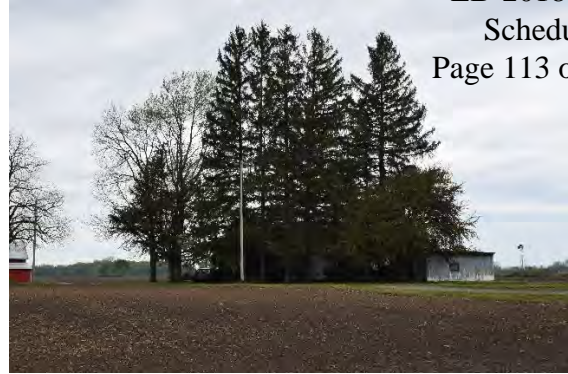
Description: The property contains a residence and outbuilding. The view of the residence is obstructed by surrounding vegetation, that includes mature spruce trees. The residence is set back from the roadway and is reached by a long laneway associated with 29076 Uncle Toms Road.

The residence has a gable roof and is clad in horizontal wood siding.

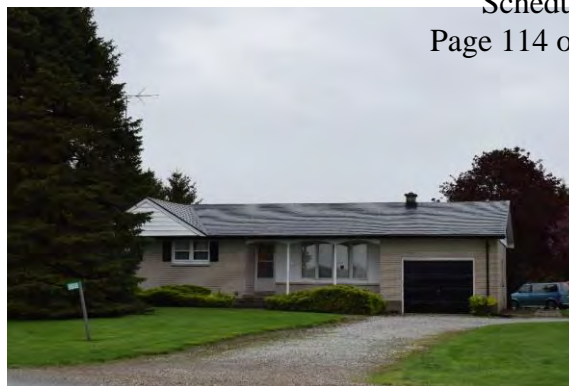
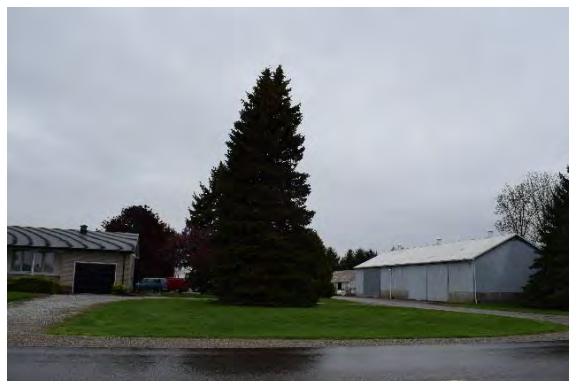
The residence is a one storey structure with a medium-pitched side gable roof that is clad with metal shingles and has a brick chimney. The structure is clad in brick and has modern windows and doors. The residence has an attached single-car garage and a concrete foundation.

The largest outbuilding has a side gable roof that is clad in metal and has ventilators. Its exterior is clad in vertical wood boards and has a concrete foundation. Behind the outbuilding is a smaller wood outbuilding with side gable roof that is clad in metal. To the rear of the property are four silos.

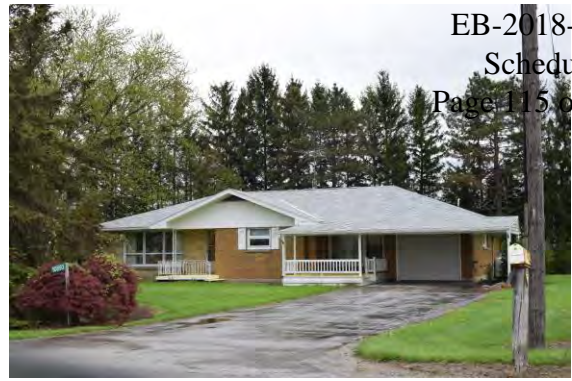
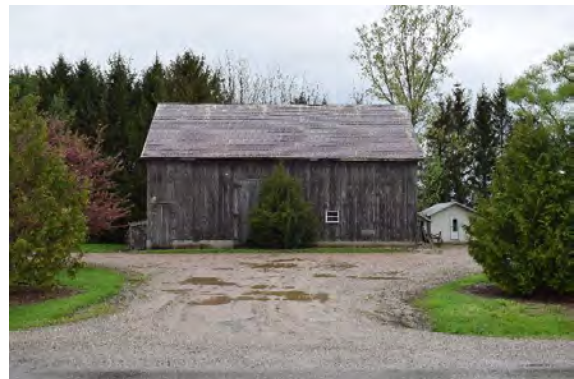
The residence is a one storey structure with a medium-pitched hip roof with asphalt shingles. The structure has a brick exterior with stone cladding and modern windows and doors. The front (east) elevation has two partial concrete porches. The structure has an attached single-car garage and a concrete foundation.

South of the residence is a timber frame barn with a side gable roof that is clad in metal. The structure has a concrete foundation.

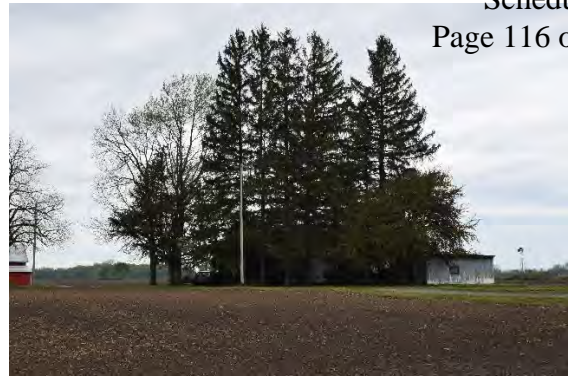
Description: The property contains a laneway that leads to a residence and a modern outbuilding. The view of the residence is obstructed from the roadway by distance and vegetation. The residence is surrounded by mature coniferous trees.

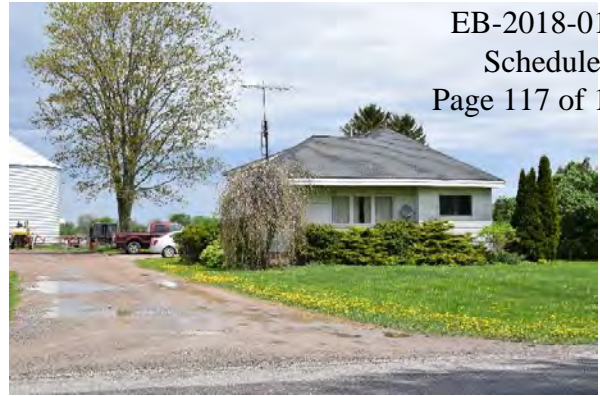
Description: The property contains a residence and modern outbuildings and silos.

The residence is a one storey structure with a medium-pitched hip roof that has asphalt shingles. The exterior is clad in vinyl siding and has modern windows and doors.

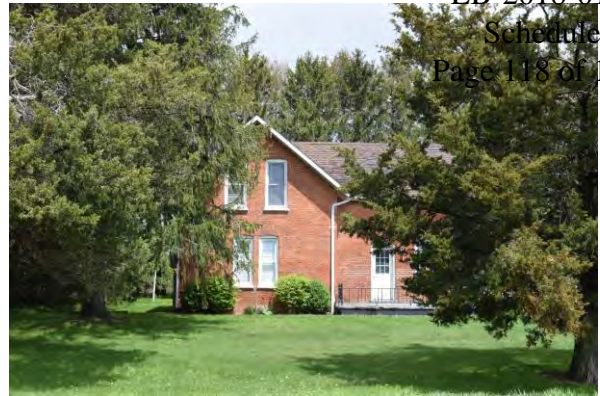
Description: The property contains a residence and modern outbuilding. The property has mature spruce and cedar trees.

The residence is a one and a half storey structure with a medium-pitched cross gable roof with asphalt shingles. The red brick exterior has modern windows and doors. Exterior windows have segmental frames and brick voussoirs. The front (south) elevation has a partial concrete porch with metal railings. The structure has an undetermined foundation.

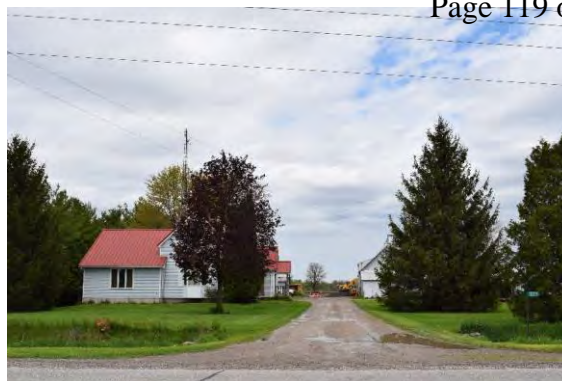
The residence is a one and a half storey structure with a medium-pitched front facing gable roof with metal cladding. The structure has a one storey addition on its west elevation with a side gable roof that is clad in metal.

The exterior is clad in vinyl siding and has modern windows and doors. The original portion of the residence has a rusticated concrete foundation, while the addition has a concrete foundation. The residence has been heavily altered with modern materials.

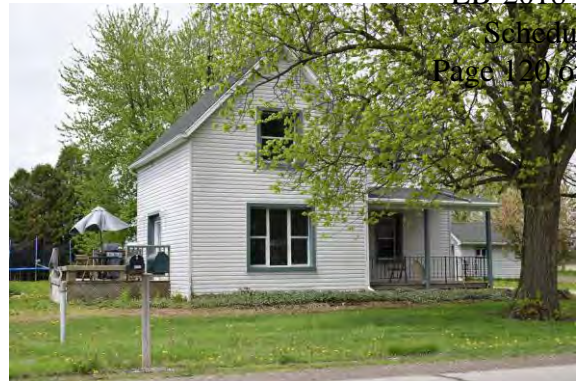
Description: The property contains a residence and two modern outbuildings. The front yard has a mature maple tree.

The residence is a one and a half storey structure with a medium-pitched cross gable roof with asphalt shingles. The residence has an L-shaped plan. The exterior is clad in vinyl siding and has modern windows and doors. The front (east) elevation has a covered partial wood porch. The foundation is undetermined.

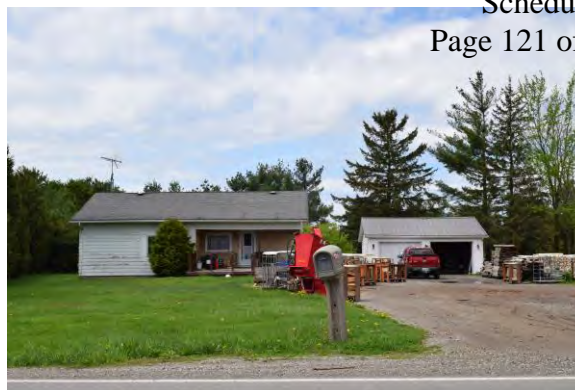
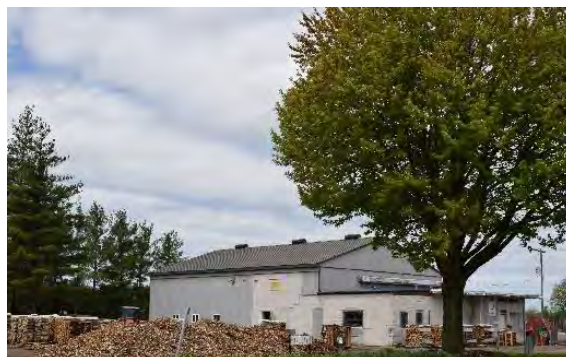
The residence is a one storey structure with a medium-pitched side gable roof with asphalt shingles. The exterior is clad in aluminum siding and stone. The front (east) has a partial wood porch. The structure has a concrete block foundation.

The large outbuilding has a side gable roof that is clad in metal. Its exterior is composed of concrete block and it is clad in metal.

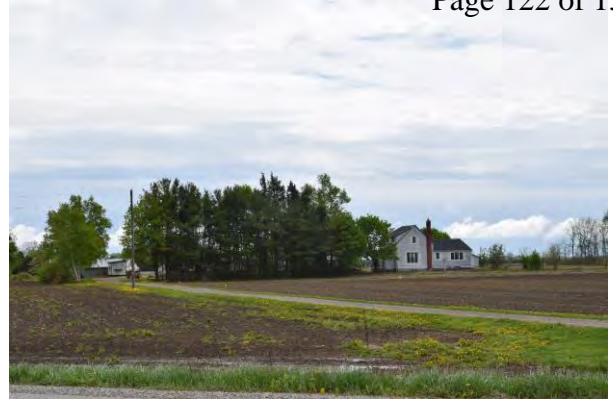
Description: The property contains a long laneway that leads to residence and outbuildings.

The residence is a one and a half storey structure with a medium-pitched side gable roof with asphalt shingles and a brick chimney. The east elevation has a shed dormer. The structure has a one storey rear addition with a side gable roof. The exterior is clad in aluminum siding and has modern windows and doors. The front (east) elevation has a partial concrete porch. The structure has a rusticated concrete foundation.

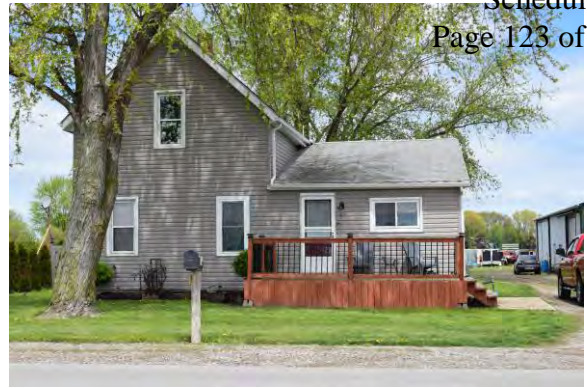
Description: The property contains a residence and two modern outbuildings. The front yard has a mature deciduous tree.

The residence is a one and a half storey structure with medium-pitched front facing gable roof. The structure has a one storey addition on its east elevation with a side gable roof. The residence is clad in vinyl siding and has modern windows and doors. The front (south) elevation has a partial wood porch. The structure has a concrete foundation. The residence has been heavily altered with modern materials.

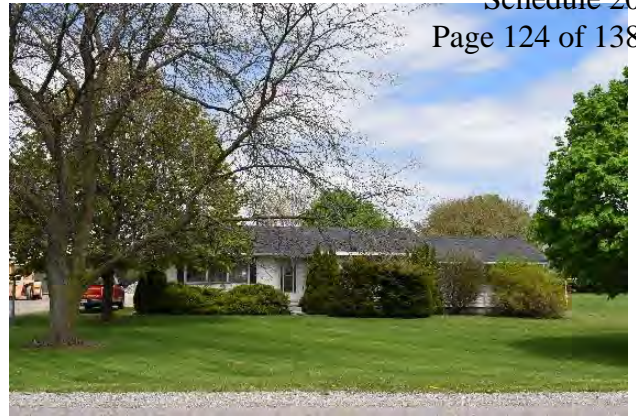
Description: The property contains a residence and modern outbuildings.

The residence is a one storey structure with a medium-pitched side gable roof with asphalt shingles. The exterior is clad in vinyl siding and has modern windows and doors. The residence has a concrete foundation.

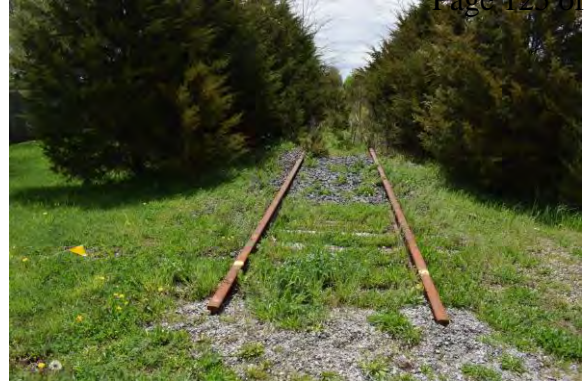
Description: The property contains the former railway corridor of the Erie & Huron Railway line. Railway components have been removed, except for the steel tracks. The line is grown over with vegetation.

The railway line is depicted on the 1881 Township of Chatham and Township of Camden maps in the Illustrated Atlas of the Counties of Essex and Kent (Figure 4).

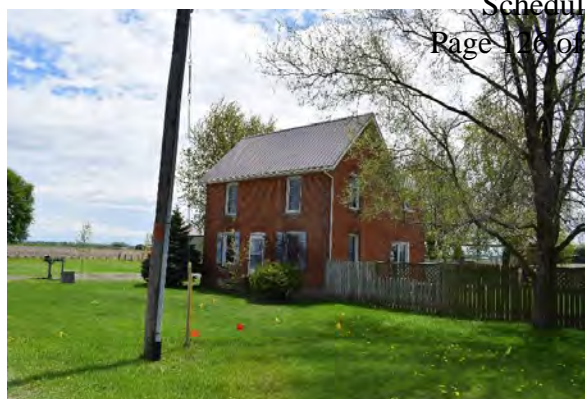
Description: The property contains a residence and two modern outbuildings.

The residence is a two storey structure with high-pitched cross gable roof with metal cladding. The red brick structure has an L-shaped plan. The three-bay front (north) façade has a central entrance. The modern windows are set within segmental frames with concrete sills and brick voussoirs. The east elevation has a wood semi-circular window. The structure has a concrete foundation.

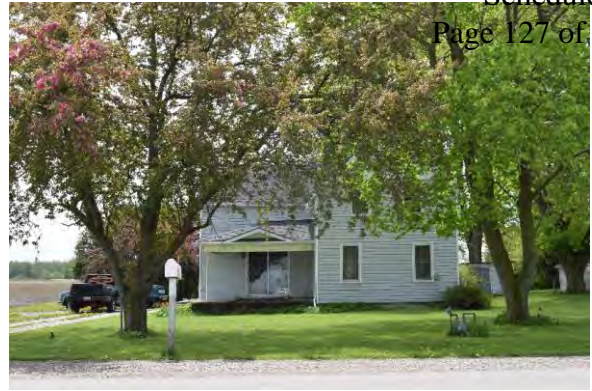
Description: The property contains a residence.

The residence is a one and a half storey structure with a medium-pitched front facing gable roof with asphalt shingles and concrete chimney. The structure has a lower side gable section, that forms an L-shaped plan. The residence is clad in vinyl siding and has modern windows and doors. The front (north) elevation has a covered partial porch with a gable peak. The structure has a rear shed roof addition and a stone foundation.

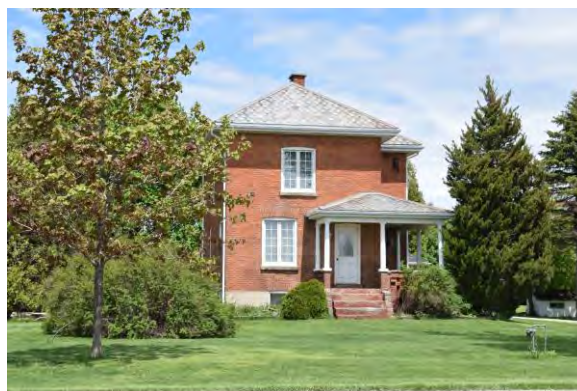
Description: The property contains a residence and two modern outbuildings. The property has a laneway and mature cedar and spruce trees.

The residence is a two storey structure with a medium-pitched hip roof with metal fish-scale shingles and a brick chimney. The structure has an L-shaped plan. The brick exterior has modern windows and doors. Windows have brick voussoirs and concrete sills. The front (south) elevation has a covered partial brick porch with wood columns and metal fish-scale shingles. The structure has a concrete foundation.

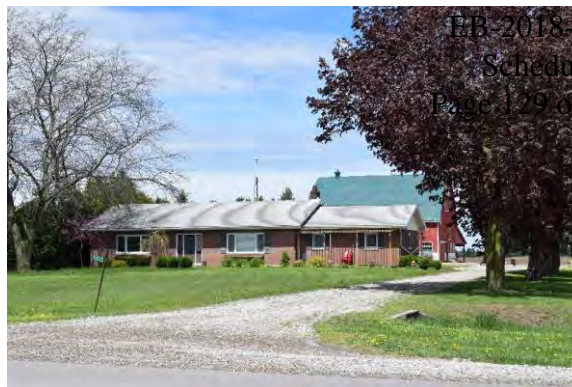
Description: The property contains a residence, and a mixture of early 20th century and modern outbuildings. The residence and outbuildings are surrounded by agricultural fields.

The residence is a one storey structure with a medium-pitched side gable roof with asphalt shingles and a brick chimney. The residence is clad in brick and has modern windows and doors. The structure has a concrete foundation.

To the rear of the residence is a timber frame barn with a gambrel roof that is clad with metal, has two ventilators, and a hay hood. The structure has wood windows and doors, and a concrete foundation. Next to the barn are two wood outbuildings with side gable roofs that are clad in metal with ventilators. The structures have wood windows and doors, and concrete foundations.

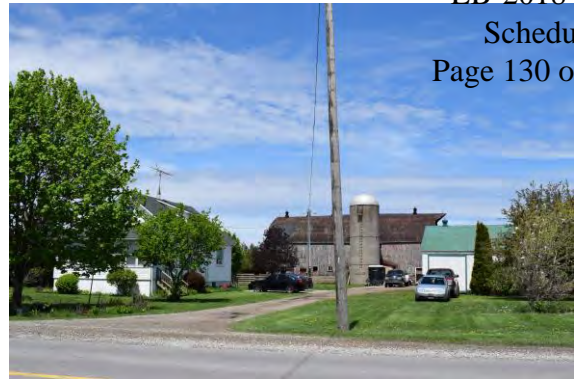
Description: The property contains a laneway that leads to a residence and a mixture of early 20th century and modern outbuildings including three metal silos and one cast-in-place concrete silo. The residence and outbuildings are surrounded by agricultural fields.

The residence is a one and a half storey structure with a medium-pitched front facing gable roof with asphalt shingles. The east elevation has a shed dormer. The residence is clad in vinyl siding and has modern windows and doors. The front (south) elevation has an enclosed porch. The structure has a rusticated concrete foundation.

To the rear of the residence is a timber frame barn with a gambrel roof that is clad in metal, with four ventilators, and a hay hood. The structure has a rusticated concrete foundation. East of the barn is a vertical wood outbuilding with a side gable roof that is clad in metal with two ventilators. The property also has a smaller wood outbuilding with a side gable roof that is clad in metal.

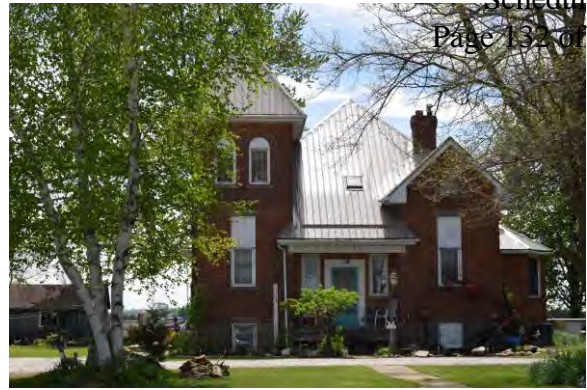
Description: The property contains a residence and an outbuilding. The residence is a former schoolhouse. The structure is depicted on the 1913 topographic map of the study area as a schoolhouse. The property has a gravel semi-circular driveway and mature cedar trees.

The residence is a one and a half storey structure with a high-pitched pyramidal roof that is clad in metal and has a brick chimney. The northeast corner has a two storey tower with a pyramidal roof that is clad in metal. The front (north) elevation has a front facing gable peak. The structure has a red brick exterior with modern windows. The windows have concrete sills and lintels. The modern windows replaced tall windows, as above the current windows is wood cladding. The tower has two windows set in semi-circular frames with brick voussoirs. The front elevation has a central entrance with a covered partial wood porch. The modern entrance door has a wood surround with pilasters. The structure has a rusticated stone foundation.

To the rear of the residence is a wood outbuilding with a side gable roof that has asphalt shingles.

Identified Heritage Attributes: Residence: One and a half storey structure, high-pitched pyramidal roof, brick chimney, two storey tower with pyramidal roof, brick exterior, front facing gable peak, wood door surround with pilasters, and rusticated stone foundation.

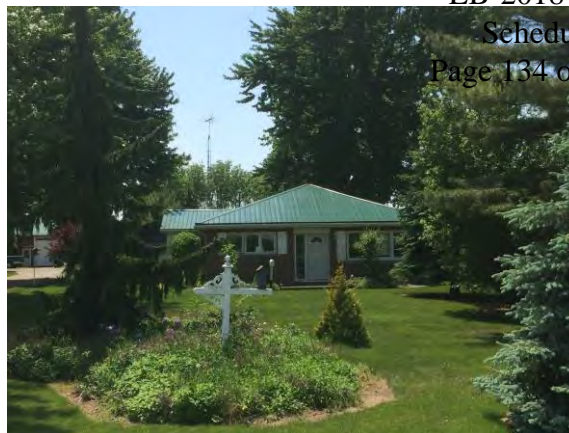
Description: The property contains a residence and three modern outbuildings. The property is bordered with a cedar hedge with the adjacent property 25428 Kent Bridge Road. The two properties share a central driveway.

The residence is a one storey structure with a medium-pitched hip roof that is clad in metal. The exterior is clad in brick and has modern windows and doors. The residence has a concrete foundation.

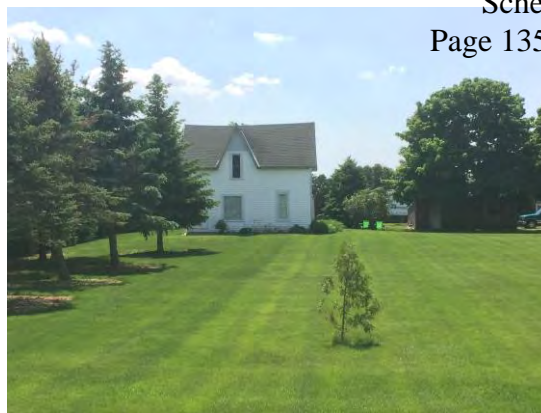
Description: The property contains a residence and outbuildings. The residence is set back from the roadway. The property is bordered with a cedar hedge with the adjacent property 25430 Kent Bridge Road. The two properties share a central driveway.

The residence is a one and a half storey structure with a medium-pitched cross gable roof with asphalt shingles. The east elevation has a high-pitched gable door. The residence has an L-shaped plan. The north elevation has an enclosed porch. The structure is clad in vinyl siding and has modern windows and doors. The foundation was not determined.

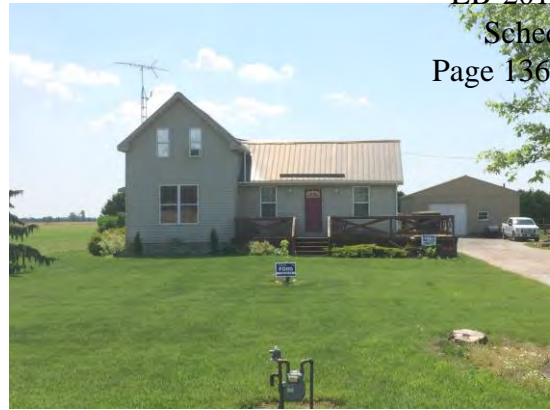
Description: The property contains a residence and outbuildings.

The residence is a one and a half storey structure with a medium-pitched front facing gable roof with metal cladding. The structure has attached one storey section with a side gable roof that is clad in metal. The exterior is clad in vinyl siding and has modern windows and doors. The front (east) elevation has a partial wood porch. The residence has an undetermined foundation and a modern rear addition.

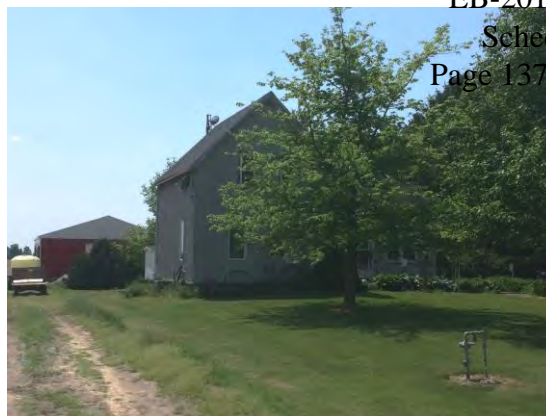
Description: The property contains a laneway that leads to a residence and outbuildings. The laneway has a mature spruce tree line on its north elevation. The property is surrounded by agricultural fields.

The residence is a one and a half storey structure with a medium-pitched front facing gable roof with asphalt shingles. The structure has attached one storey section with a side gable roof with asphalt shingles. The residence has an L-shaped plan. The exterior is clad in aluminum siding and has modern windows and doors. The front (east) elevation has a partial wood porch. The residence has a stone foundation.

The outbuilding is a one storey structure with a gable roof. The structure is clad in metal. The other outbuildings on the property are modern.

Identified Heritage Attributes: Residence: One and a half storey structure, medium-pitched front facing gable roof, one storey side gable roof section, L-shaped plan, and stone foundation. Landscape: Laneway, mature spruce tree line, and surrounding agricultural fields.
