**Re: Enbridge Gas Inc. ("Enbridge Gas")
Ontario Energy Board ("OEB") File No. EB-2019-0294
Low Carbon Energy Project ("Project")**

Post-Construction (Interim) Report

Low-Carbon Energy Project (EB-2019-0294)

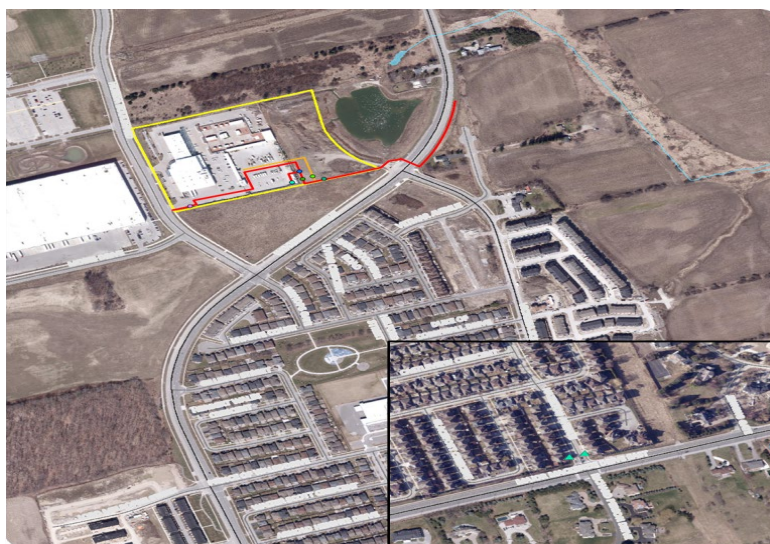
Figure 1: Project Overview

The Project included the installation of new pipelines and facilities. An overview of the Project is provided on **Figure 1**.

A total of 685¹ m of pipeline was installed including:

- 380 m of nominal pipe size (NPS) 6-inch extra-high pressure steel pipeline;
- 295 m of the NPS 6-inch high pressure steel pipeline; and,
- 10 m of NPS 8-inch intermediate pressure polyethylene pipeline.

Approximately 257 m of NPS 6 extra-high pressure steel natural gas pipeline was constructed along the municipal road right-of-way on Woodbine Avenue. The remaining pipeline was constructed on Enbridge Gas-owned property.

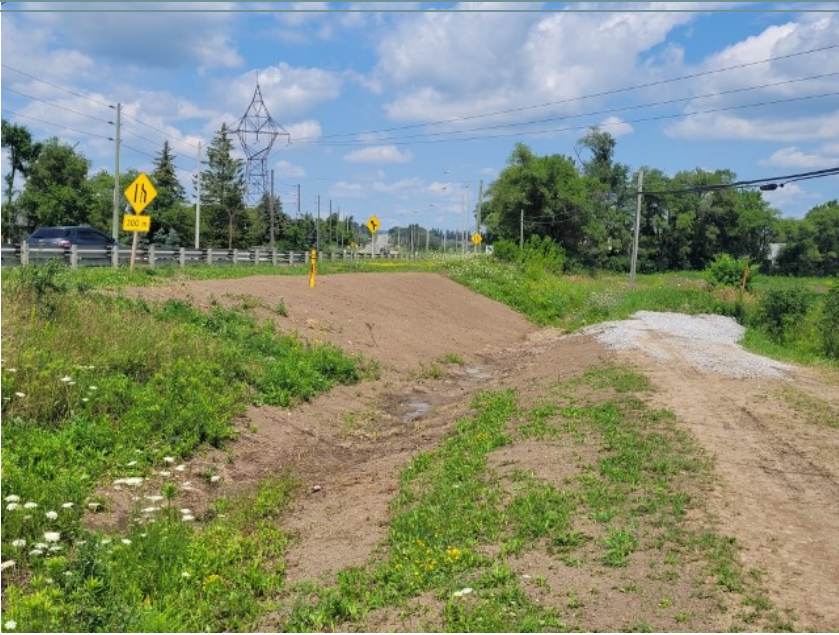
Location	Site Condition	Additional Work Recommended (Y/N)	Comments/Recommendations	Representative Photo (September 8, 2021)
Woodbine Avenue tie-in location, east side	Regraded and seeded. No slope erosion observed at time of inspection.	N	Area to be assessed during post-construction environmental monitoring.

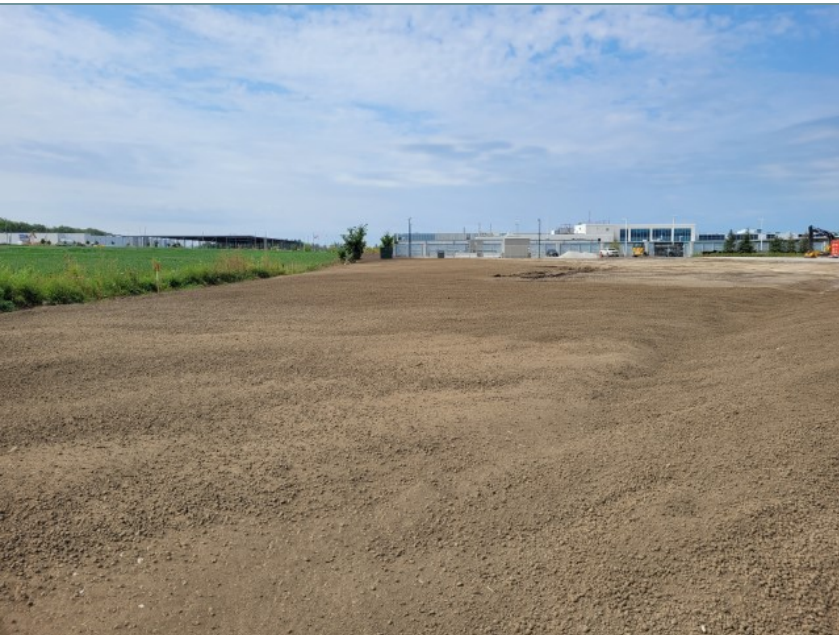
Southern portion of Enbridge Gas property site	Topsoil application completed.	N	Topsoil evenly distributed across Project lands. Area to be assessed during post-construction environmental monitoring.

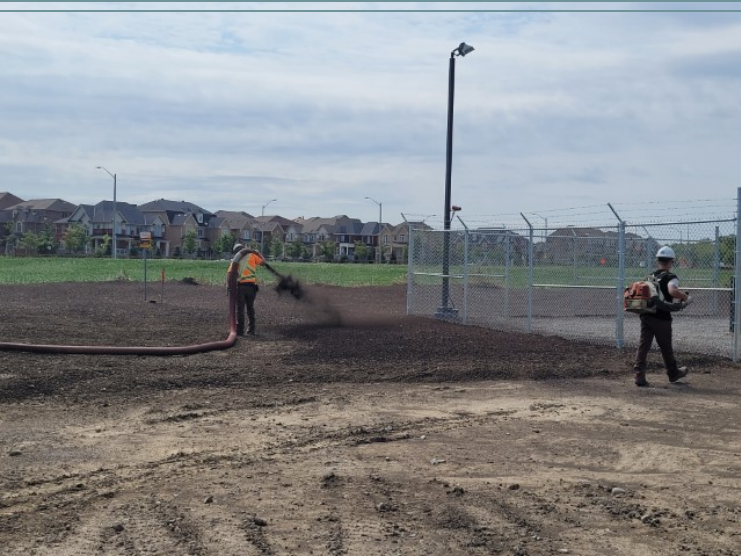
Location	Site Condition	Additional Work Recommended (Y/N)	Comments/Recommendations	Representative Photo (September 8, 2021)	
Southern area of Enbridge Gas lands Project site	Seed application by Hermann’s landscaping.	N	Seed application was evenly distributed.

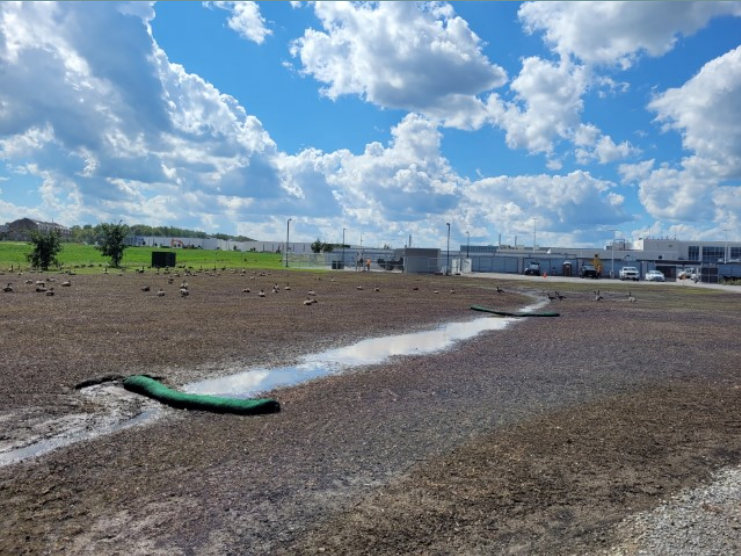
Excavated swale on southern area of Enbridge Gas lands Project site	ESC in place and site in good condition.	N	Area to be assessed during post-construction environmental monitoring.
