Rideau St. Lawrence Distribution  
9 Substations in Prescott, ON; Morrisburg, ON;  
Iroquois, ON and Cardinal, ON

# **D-001 Rev. 1**

## **Substation Condition Assessment**

Project Name:	Substation Condition Assessment	Project Sites:	Cardinal MS1 Cardinal MS2 Iroquois MS Morrisburg MS1 Morrisburg MS2 Prescott MS1 Prescott MS2 Prescott MS3 Prescott MS4
Project #:	30934		
Report Title:	Substation Condition Assessment		
Customer:	Rideau St. Lawrence Distribution		
Document:	D-001

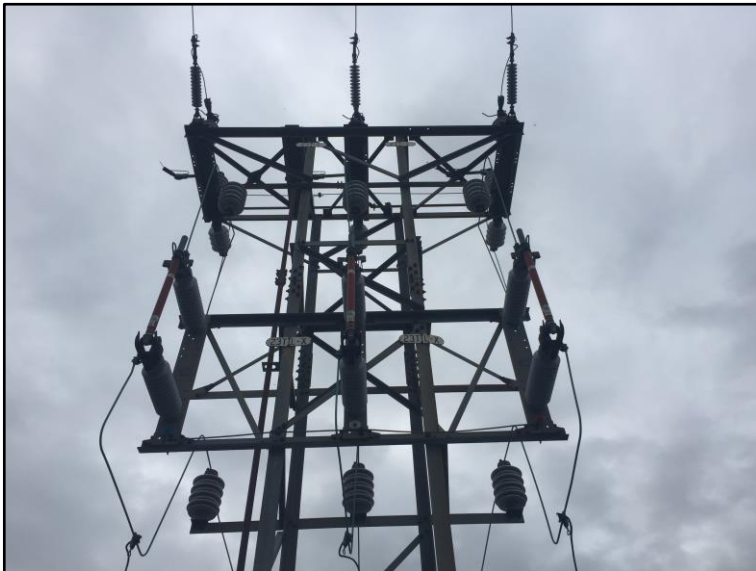
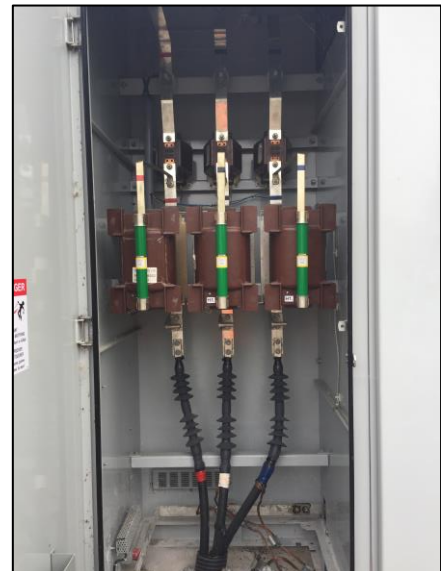
**Load Break Switch & Secondary Switch gear:**

- Switch Contact alignment, toggles, stops, linkage and general ease of operation were inspected and serviced.
- The contacts were closely inspected for burning, wear contact pressure, and simultaneous closure. The integrity of the silver plating was inspected, cleaned and lubricated with electrical grease.
- All insulators were inspected and cleaned, As well tightness and condition of pole ground including the switch matt checked.
- Fusing contacts were checked for burning, wear, and contact pressure as well cleaned and lubricated with electrical grease.
- Fuse holders were cleaned and inspected for excessive wear, fatigue and alignment, as well all insulators were inspected and cleaned.

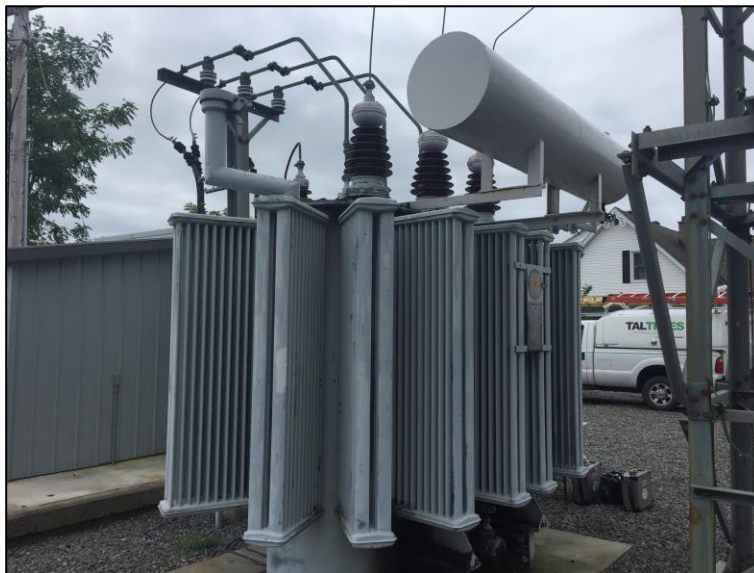
#### **Power Transformer:**

- Transformer tank was inspected for oil leaks, rust and visual damage.
- Primary connections were inspected for tightness and indications of overheating and reinstalled with anti-oxidant grease.
- Primary bushings inspected for damage and cleaned.
- Full transformer test was completed on the transformer.

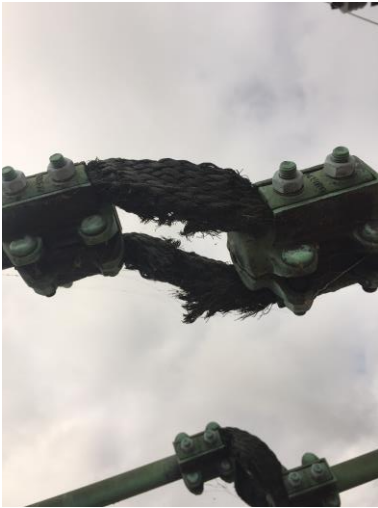
- *Power transformer currently only has one connection to ground, it requires a second connection on opposite corner to comply with OESC.*

- *There are braided bus connections between the secondary bus on transformer and cables on dip pole. These braided connections are fraying and deteriorated and should be replaced. (Connections are approx. 4" in length)*
- *All transformer test results were satisfactory with the exception of the capacitance dissipation factor and dielectric absorption test (insulation resistance). These test results might be an indication that the transformer has low oil levels. This is further supported by the oil results and should be followed up with Tal Trees for further recommendations.*

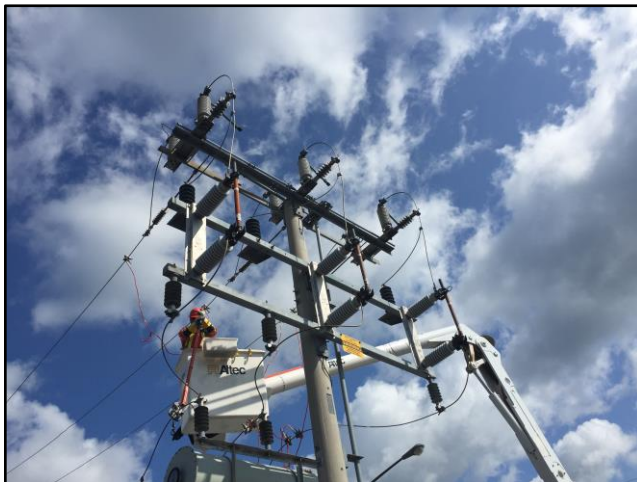
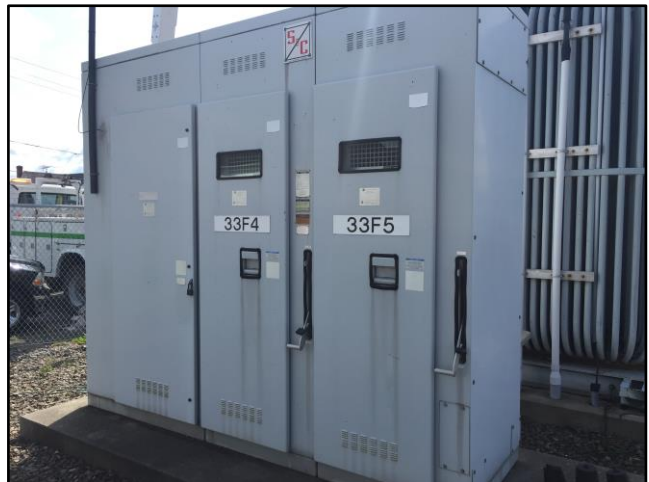
**Load Break Switch & Secondary Switch gear:**

- Switch Contact alignment, toggles, stops, linkage and general ease of operation were inspected and serviced.
- The contacts were closely inspected for burning, wear contact pressure, and simultaneous closure. The integrity of the silver plating was inspected, cleaned and lubricated with electrical grease.
- All insulators were inspected and cleaned, As well tightness and condition of pole ground including the switch matt checked.
- Fusing contacts were checked for burning, wear, and contact pressure as well cleaned and lubricated with electrical grease.
- Fuse holders were cleaned and inspected for excessive wear, fatigue and alignment, as well all insulators were inspected and cleaned.

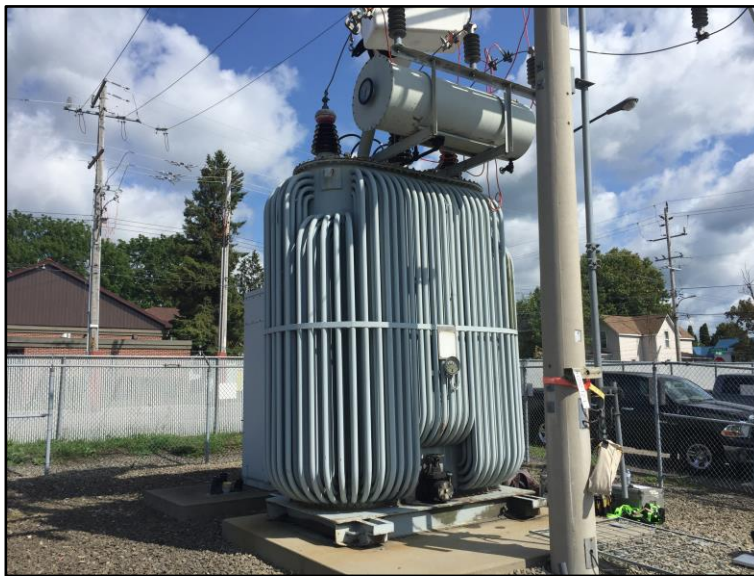
### **Power Transformer:**

- Transformer tank was inspected for oil leaks, rust and visual damage.
- Primary connections were inspected for tightness and indications of overheating and reinstalled with anti-oxidant grease.
- Primary bushings inspected for damage and cleaned.
- Full transformer test was completed on the transformer.

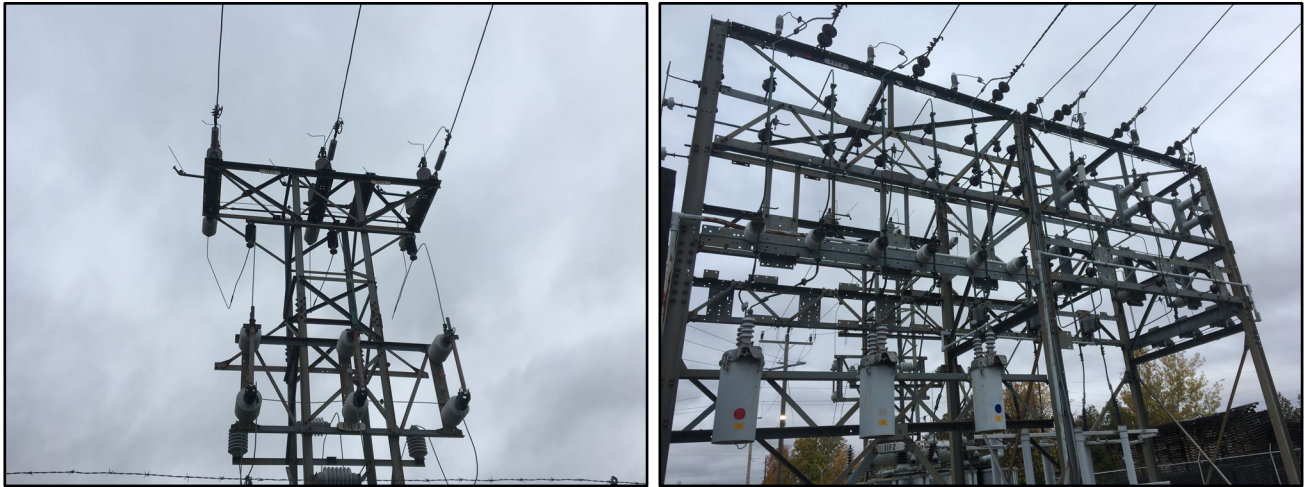
### Air Break / Load Break Switches:

- Switch Contact alignment, toggles, stops, linkage and general ease of operation were inspected and serviced.
- The contacts were closely inspected for burning, wear contact pressure, and simultaneous closure. The integrity of the silver plating was inspected, cleaned and lubricated with electrical grease.
- All insulators were inspected and cleaned, as well tightness and condition of pole ground including the switch matt checked.
- Fusing contacts were checked for burning, wear, and contact pressure as well cleaned and lubricated with electrical grease.
- Fuse holders were cleaned and inspected for excessive wear, fatigue and alignment, as well all insulators were inspected and cleaned.

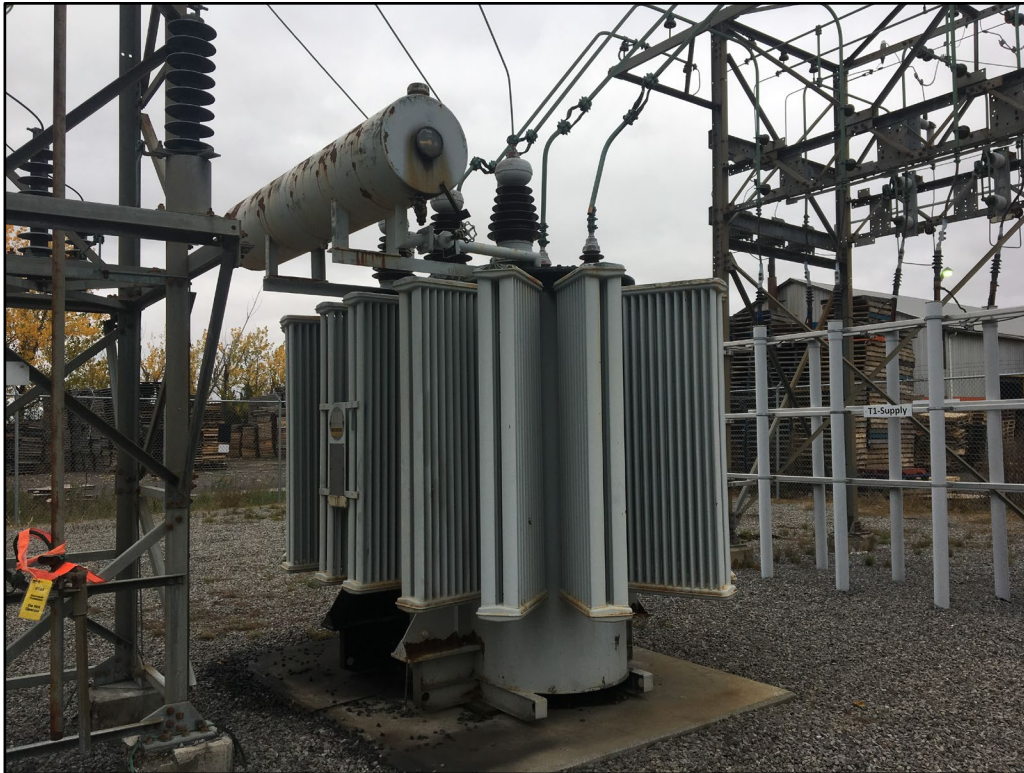
## Power Transformer:

- Transformer tank was inspected for oil leaks, rust and visual damage.
- Primary connections were inspected for tightness and indications of overheating and reinstalled with antioxidant grease.
- Primary bushings inspected for damage and cleaned.
- Full transformer tests were completed on the transformer including turn ratio test, winding resistance, capacitance test and dielectric absorption test (insulation resistance).
- An oil sample was obtained for fluid analysis and DGA.

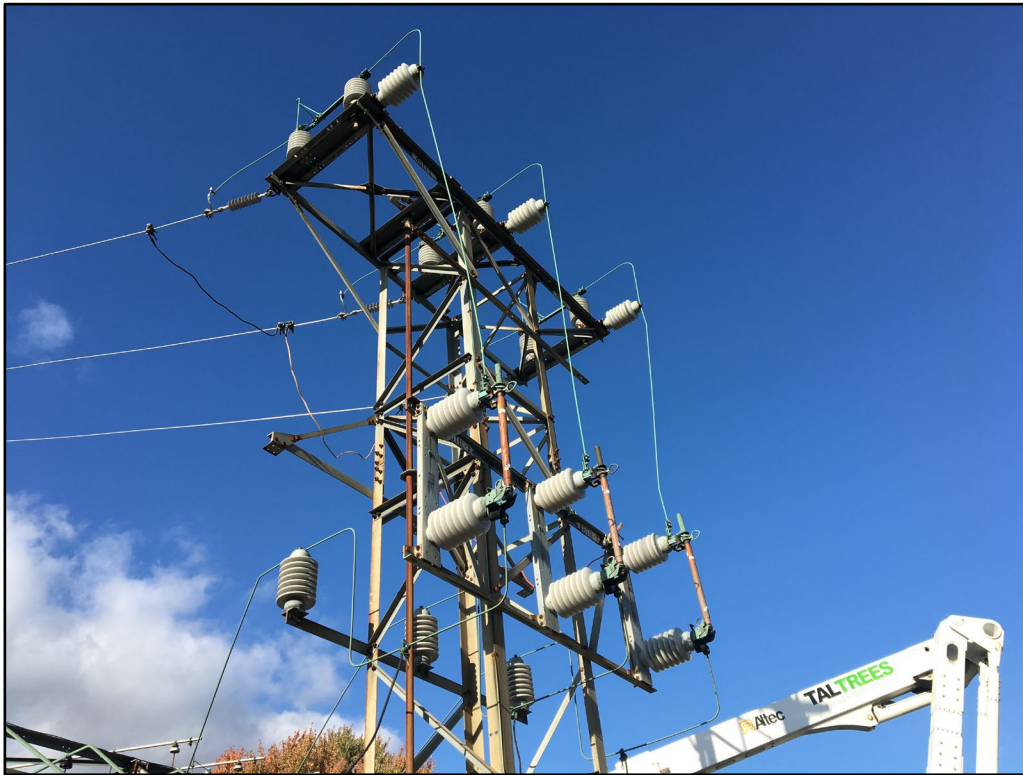
### Air Break / Load Break Switches:

- Switch Contact alignment, toggles, stops, linkage and general ease of operation were inspected and serviced.
- The contacts were closely inspected for burning, wear contact pressure, and simultaneous closure. The integrity of the silver plating was inspected, cleaned and lubricated with electrical grease.
- All insulators were inspected and cleaned, as well tightness and condition of pole ground including the switch matt checked.
- Fusing contacts were checked for burning, wear, and contact pressure as well cleaned and lubricated with electrical grease.
- Fuse holders were cleaned and inspected for excessive wear, fatigue and alignment, as well all insulators were inspected and cleaned.

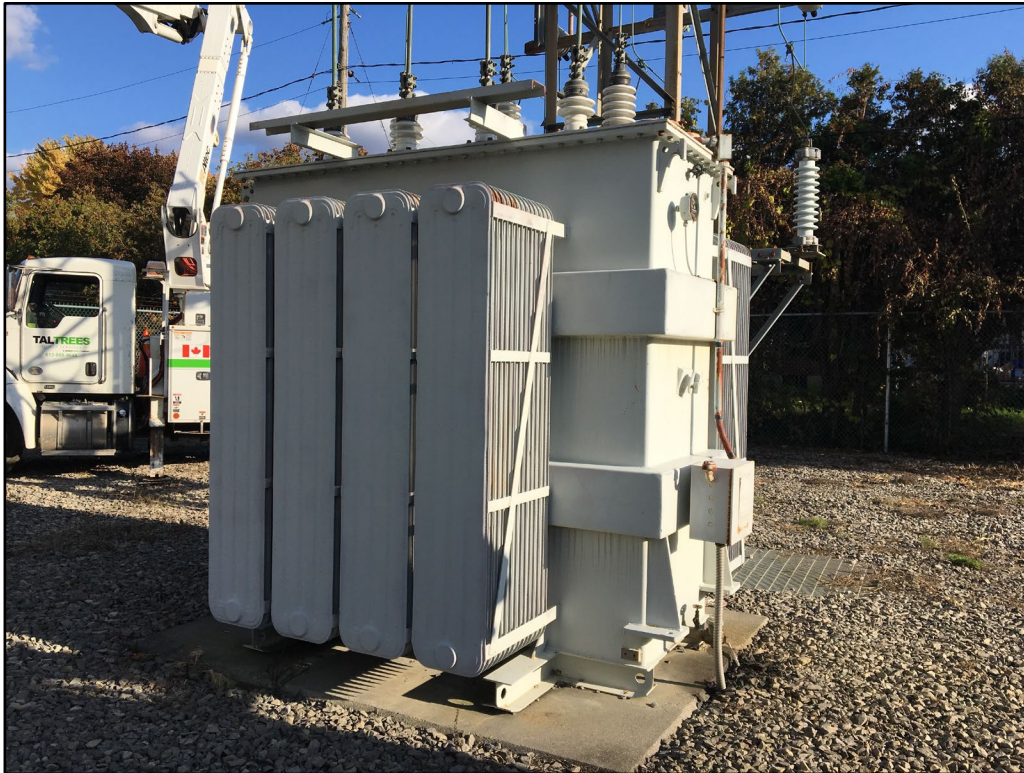
## Power Transformer:

- Transformer tank was inspected for oil leaks, rust and visual damage.
- Primary connections were inspected for tightness and indications of overheating and reinstalled with antioxidant grease.
- Primary bushings inspected for damage and cleaned.
- Full transformer tests were completed on the transformer including turn ratio test, winding resistance, capacitance test and dielectric absorption test (insulation resistance).
- An oil sample was obtained for fluid analysis and DGA.

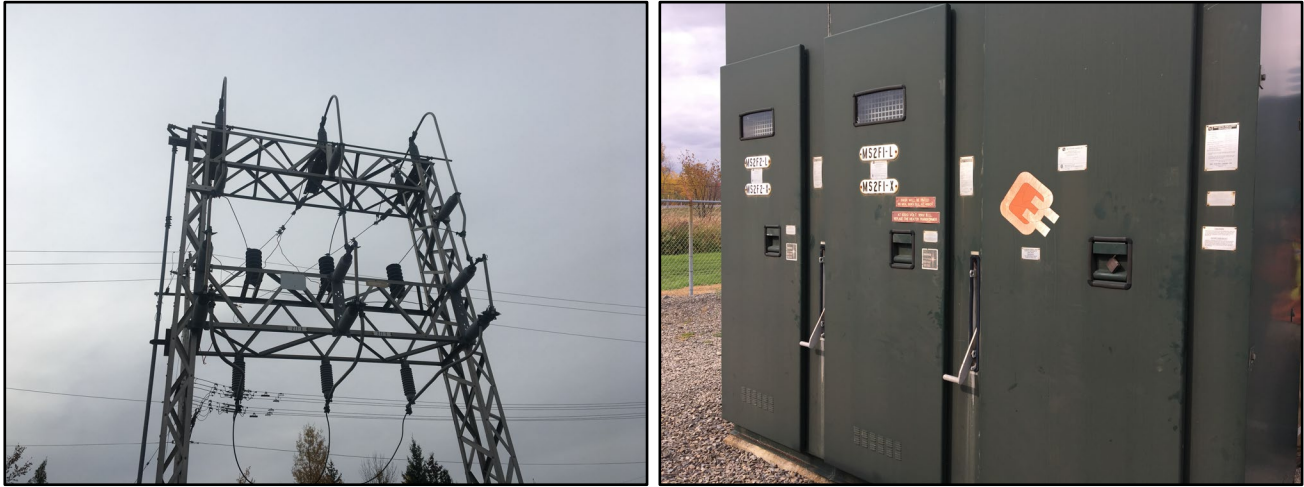
### Air Break / Load Break Switches:

- Switch Contact alignment, toggles, stops, linkage and general ease of operation were inspected and serviced.
- The contacts were closely inspected for burning, wear contact pressure, and simultaneous closure. The integrity of the silver plating was inspected, cleaned and lubricated with electrical grease.
- All insulators were inspected and cleaned, as well tightness and condition of pole ground including the switch matt checked.
- Fusing contacts were checked for burning, wear, and contact pressure as well cleaned and lubricated with electrical grease.
- Fuse holders were cleaned and inspected for excessive wear, fatigue and alignment, as well all insulators were inspected and cleaned.

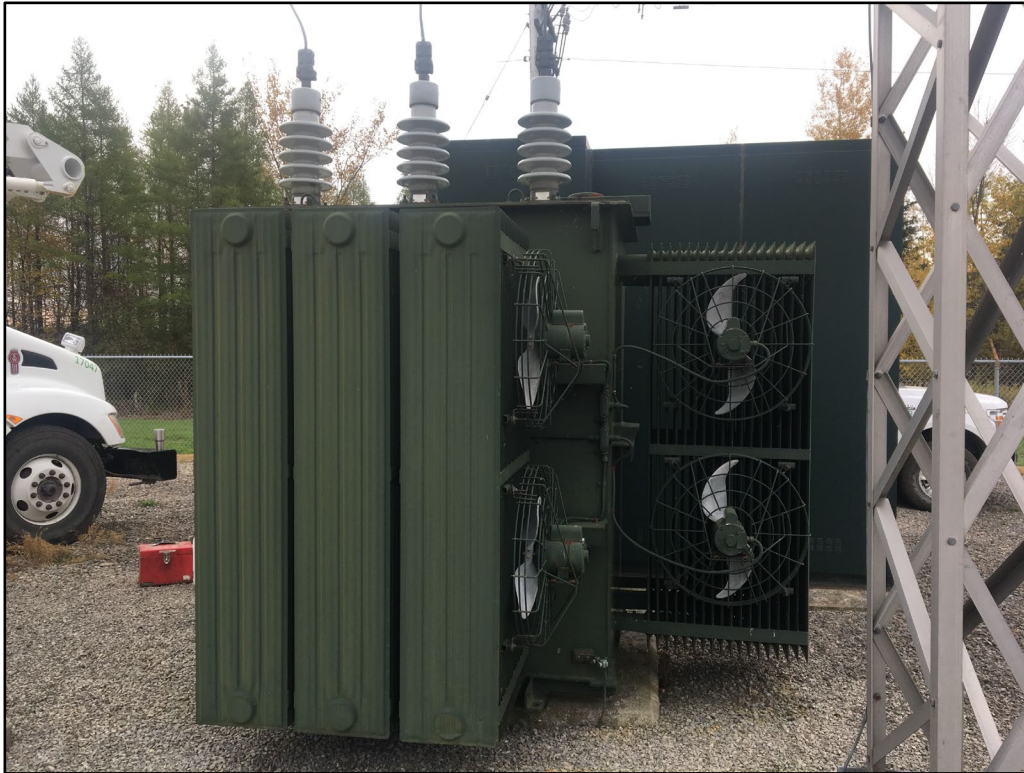
## Power Transformer:

- Transformer tank was inspected for oil leaks, rust and visual damage.
- Primary connections were inspected for tightness and indications of overheating and reinstalled with antioxidant grease.
- Primary bushings inspected for damage and cleaned.
- Full transformer tests were completed on the transformer including turn ratio test, winding resistance, capacitance test and dielectric absorption test (insulation resistance).
- An oil sample was obtained for fluid analysis and DGA.

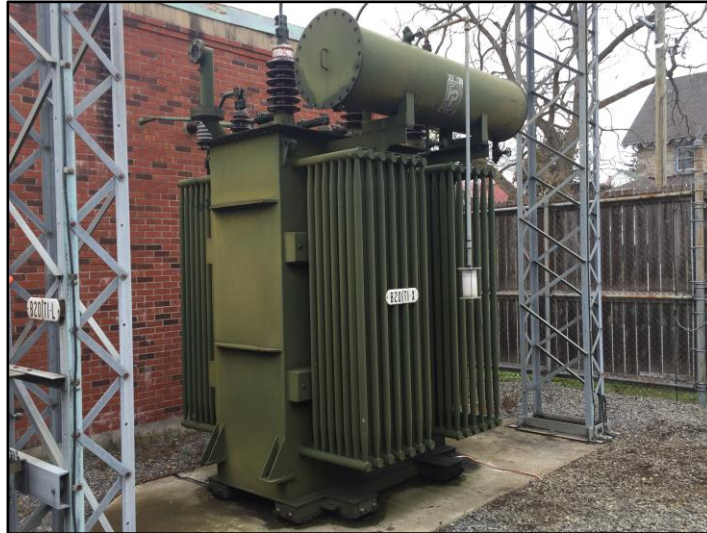
### **Power Transformer:**

- Transformer tank was inspected for oil leaks, rust and visual damage.
- Primary & secondary connections were inspected for tightness and indications of overheating and reinstalled with anti-oxidant grease.
- Primary & secondary bushings inspected for damage and cleaned.
- Transformers was tested electrically (Turn ratio test, winding resistance, capacitance bridge & dielectric absorption test).

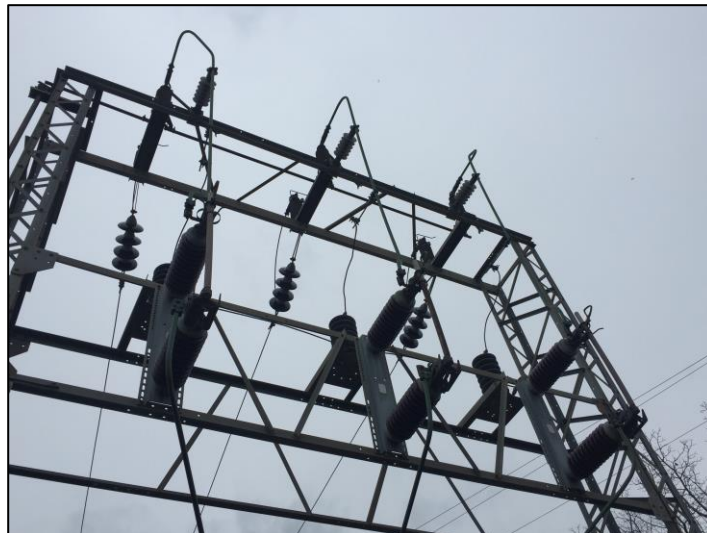
### **Air Break Switch:**

- Switch Contact alignment, toggles, stops, linkage and general ease of operation were inspected and serviced.
- The contacts were closely inspected for burning, wear contact pressure, and simultaneous closure. The integrity of the silver plating was inspected, cleaned and lubricated with electrical grease.
- All insulators were inspected and cleaned, As well tightness and condition of pole ground including the switch matt checked.
- Fusing contacts were checked for burning, wear, and contact pressure as well cleaned and lubricated with electrical grease.
- Fuse holders were cleaned and inspected for excessive wear, fatigue and alignment, as well all insulators were inspected and cleaned.

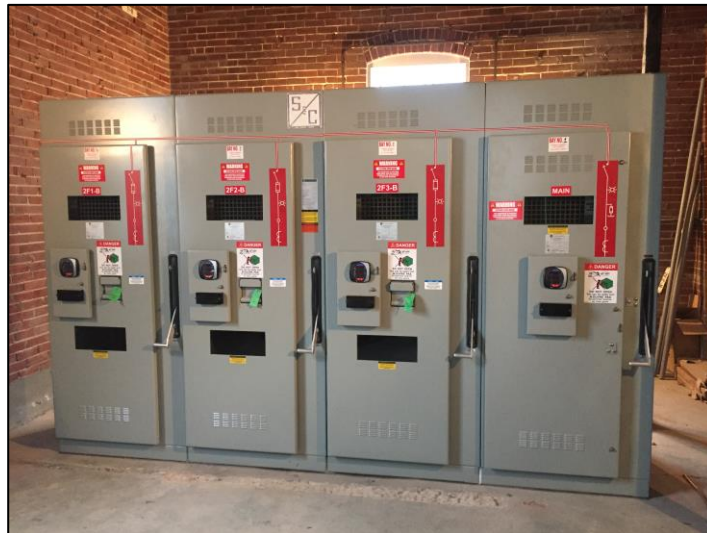
**S&C Switchgear:**

- S&C Switchgear was installed and while contact alignment, toggles, stops, linkage and general ease of operation were inspected.
- The contacts were inspected for contact pressure, and simultaneous closure. Fusing contacts were checked for contact pressure as well as lubricated with electrical grease.
- Bus bar was bolted and torqued to manufacturers recommended specifications.
- Switchgear & fuses were tested electrically for insulation resistance and with a micro ohm meter for contact resistance.
- All 28KV cables were installed in compliance with OESC regulations, terminated and tested for insulation resistance.

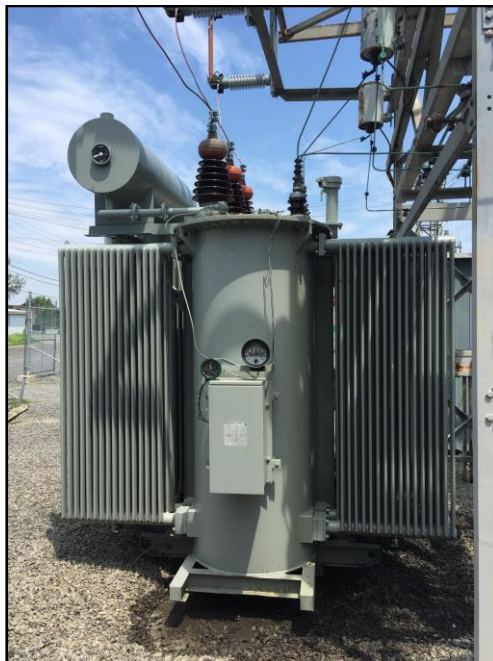
**Power Transformer:**

- Transformers were inspected for oil leaks, and visual damage from transportation.
- All grounding of transformers was performed according to OESC standards.
- Primary conductors were replaced to accommodate positioning and dimensions of new transformer.
- Transformers were tested electrically (Turn ratio test, winding resistance, capacitance bridge & dielectric absorption test).

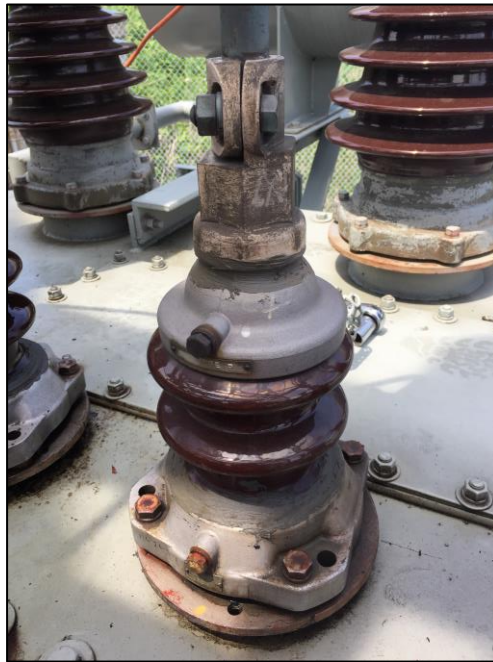
- Gaskets were replaced on all secondary bushings (4) to repair leaks.
- All transformer test results were satisfactory.

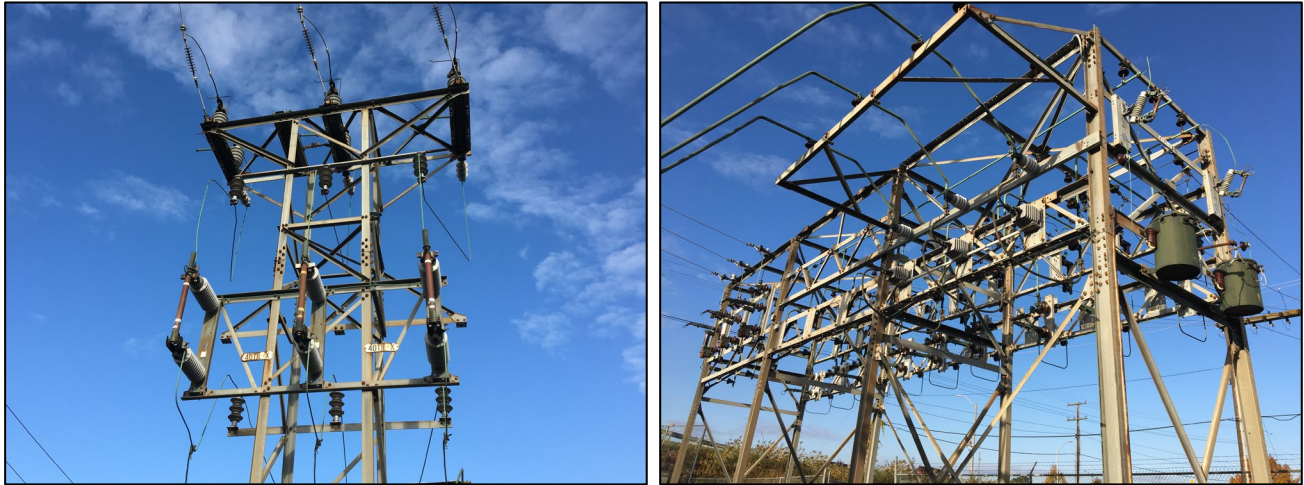
### Air Break / Load Break Switches:

- Switch Contact alignment, toggles, stops, linkage and general ease of operation were inspected and serviced.
- The contacts were closely inspected for burning, wear contact pressure, and simultaneous closure. The integrity of the silver plating was inspected, cleaned and lubricated with electrical grease.
- All insulators were inspected and cleaned, as well tightness and condition of pole ground including the switch matt checked.
- Fusing contacts were checked for burning, wear, and contact pressure as well cleaned and lubricated with electrical grease.
- Fuse holders were cleaned and inspected for excessive wear, fatigue and alignment, as well all insulators were inspected and cleaned.

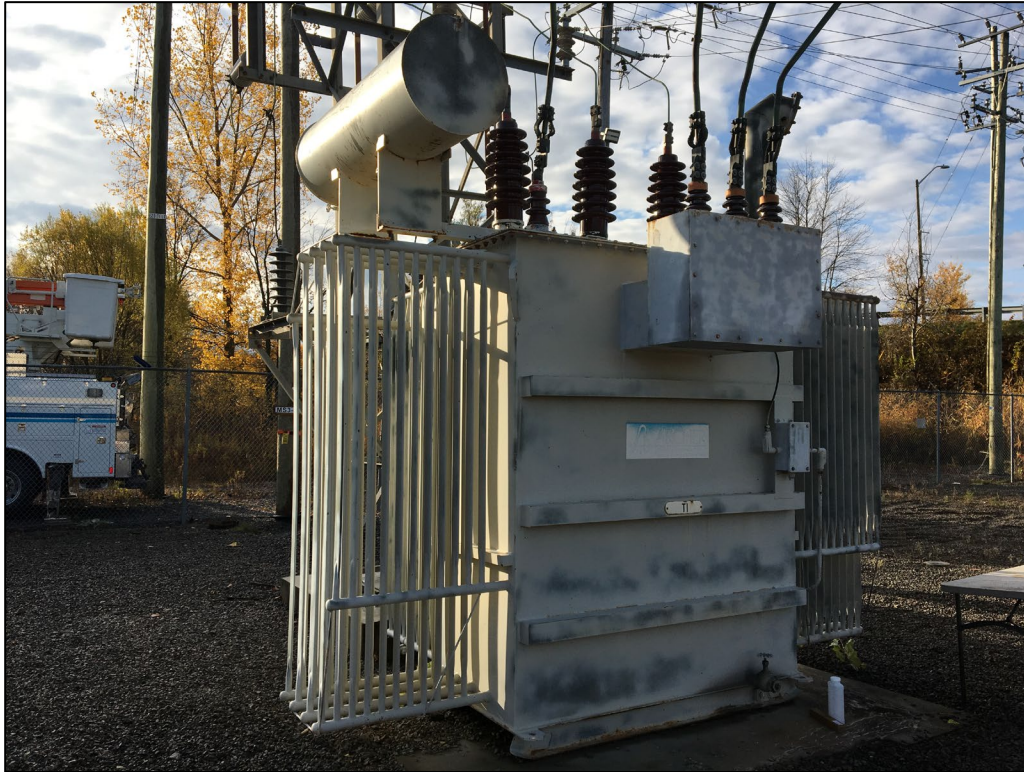
## Power Transformer:

- Transformer tank was inspected for oil leaks, rust and visual damage.
- Primary connections were inspected for tightness and indications of overheating and reinstalled with antioxidant grease.
- Primary bushings inspected for damage and cleaned.
- Full transformer tests were completed on the transformer including turn ratio test, winding resistance, capacitance test and dielectric absorption test (insulation resistance).
- An oil sample was obtained for fluid analysis and DGA.

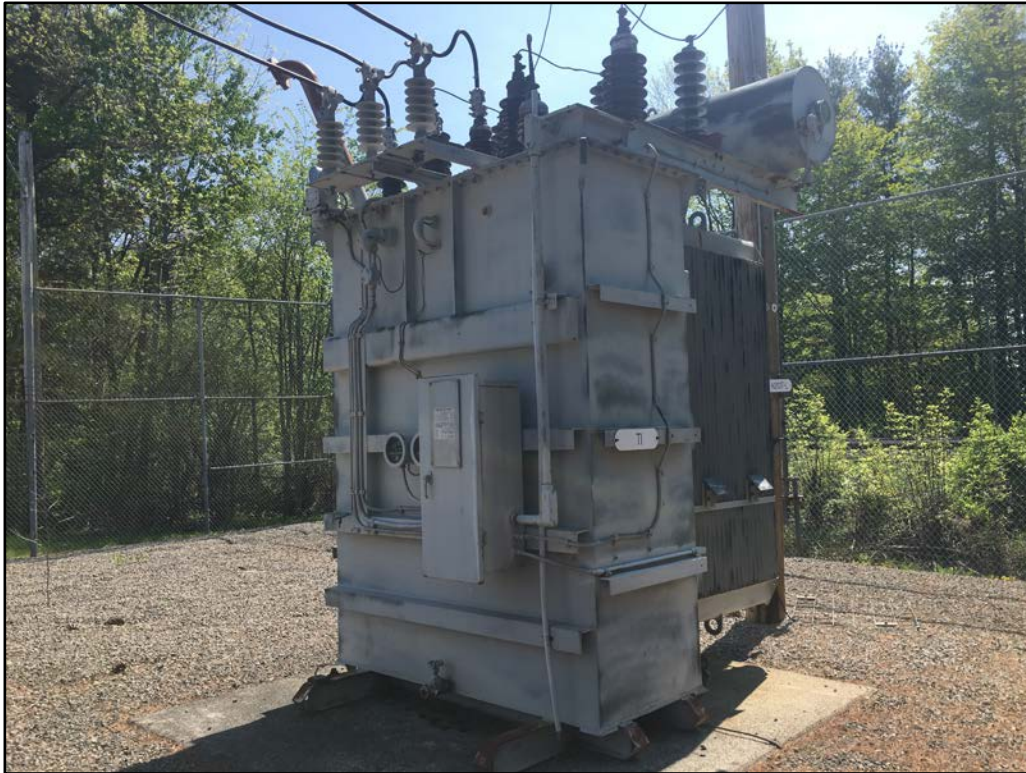
## Power Transformer:

- Transformer tank was inspected for oil leaks, rust and visual damage.
- Primary connections were inspected for tightness and indications of overheating and reinstalled with anti-oxidant grease.
- Primary bushings inspected for damage and cleaned.
- Full transformer tests were completed on the transformer including: turn ratio test, winding resistance, capacitance test and dielectric absorption test (insulation resistance).
- An oil sample was obtained for fluid analysis and DGA.
