**Re: Enbridge Gas Inc. ("Enbridge Gas")
Ontario Energy Board ("OEB") File No.: EB-2017-0147
Fenelon Falls Project
Final Monitoring Report**

**Fenelon Falls Project (EB-2017-0147)
Final Monitoring Report**

FINAL REPORT

June 1, 2022

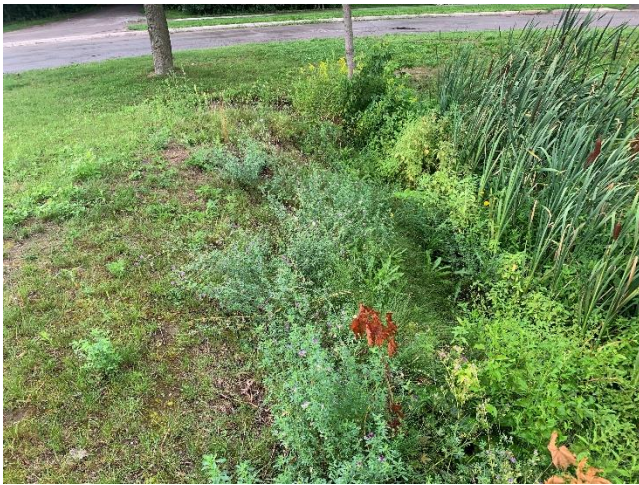
Photo 1: Restored vegetation at previously disturbed area along municipal drainage ditch at 101 Bond Street, looking north (July 2021)

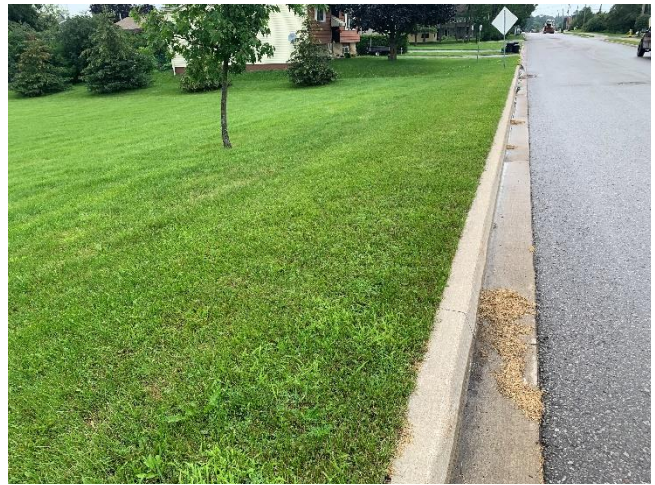
Photo 2: Restored road embankment on North Street adjacent to the Fenelon Falls Community Centre, looking northeast (July 2021)

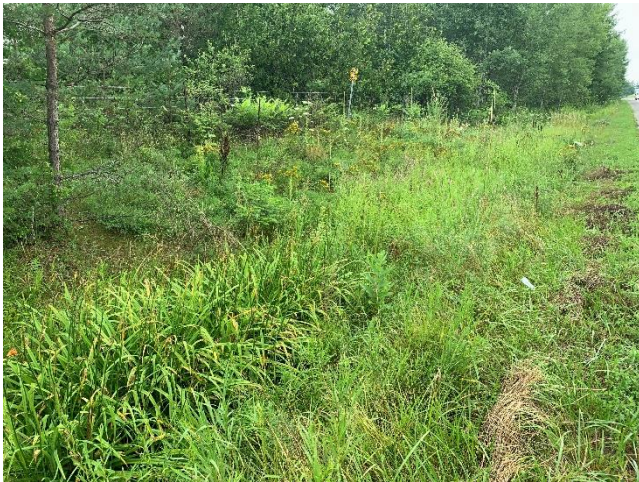
Photo 3: Well-vegetated previously disturbed area for HDD entrance pit at 360 County Road, looking north (July 2021)

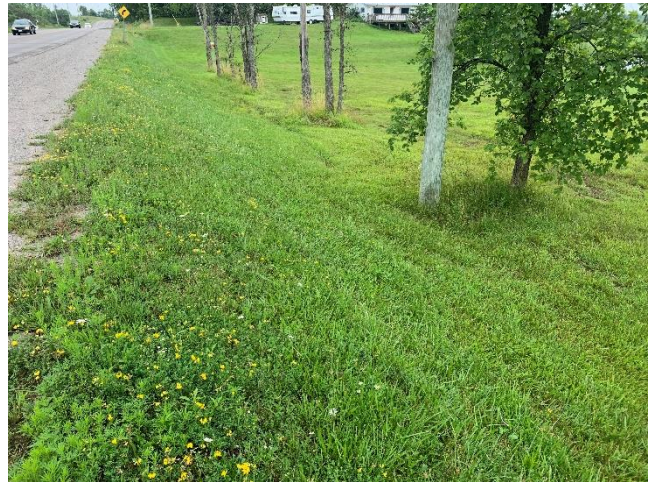
Photo 4: Well-vegetated previously disturbed tie-in pit at 320 County Road 121, looking south (July 2021)

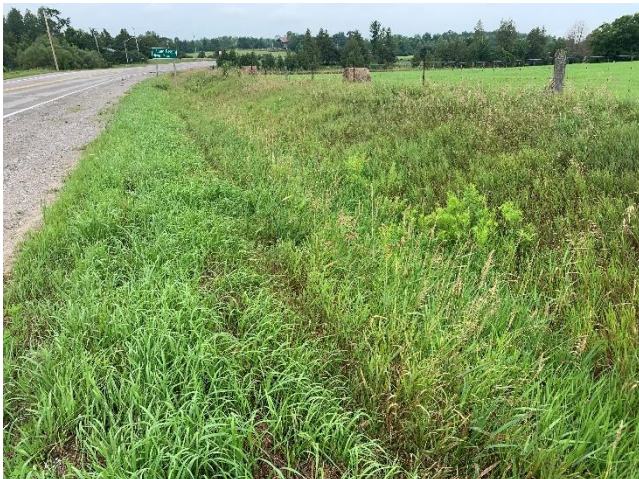
Photo 5: Well-vegetated previously disturbed area at 180 County Road 121, looking south (July 2021)

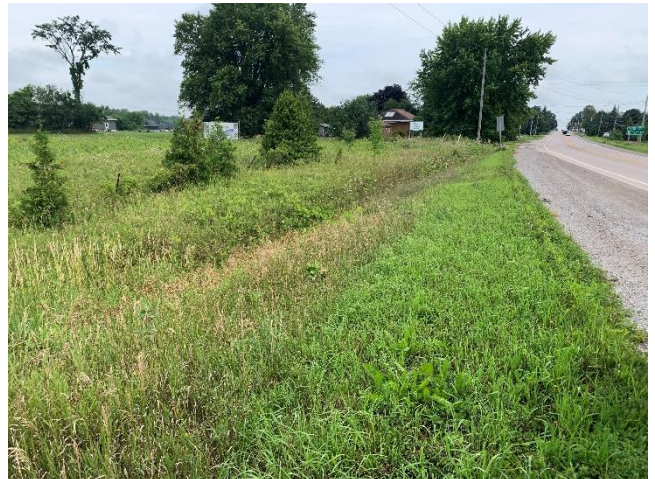
Photo 6: Well-vegetated previously disturbed area south of the Community of Cameron on Hwy 35 (July 2021)

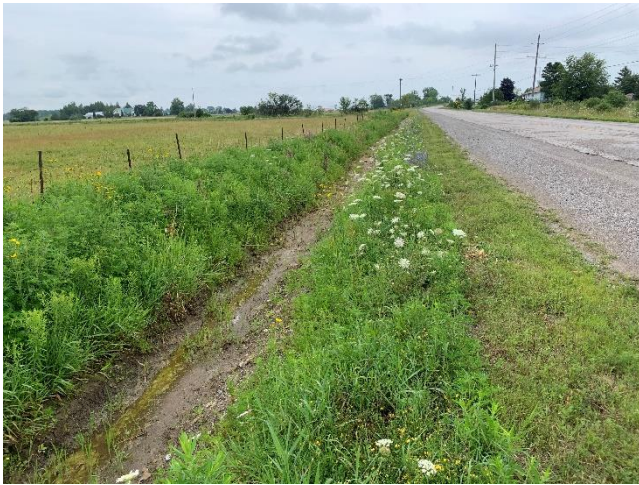
Some encroachment into Conservation Authority (CA) regulated areas occurred at three locations (see Photos 7, 12 and 14 in Appendix B); this was documented in the *Post Construction Report* (Stantec 2021). Subsequent cleaning of ditches by the municipality/region occurred within one of the encroachments (Photo 7). The CA was notified of the encroachments and accepted the mitigation measures as proposed by Enbridge. Otherwise, the encroachments are well stabilized with excellent vegetation establishment and no outstanding concerns.

Photo 7: Reclaimed and stabilized KCA Disturbance Area #1 (60 Cambray Road). Disturbed by municipality/region to clean ditches after restoration, looking east (July 2021)

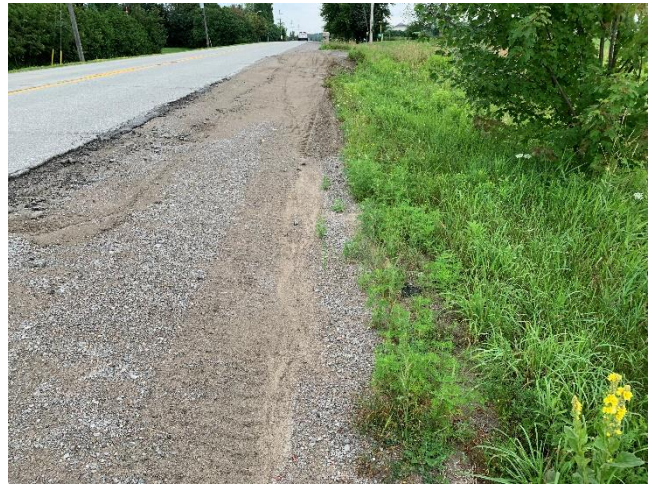
Two areas along the ROW appeared to have been disturbed and subsequently restored by parties not associated with the Project. They are assumed to have been completed by either the municipality/region (202 Cambray Road; Photo 8 - Appendix B) and/or the Ministry of Transportation (Hwy. 7, South of Concession Rd. 6, south of the community of Sunderland; Photos 15-18 – Appendix B). These restoration activities were not related to the Project.

Photo 8: Road embankment restored by the municipality/region along ROW at 202 Cambray Road, looking west (July 2021)

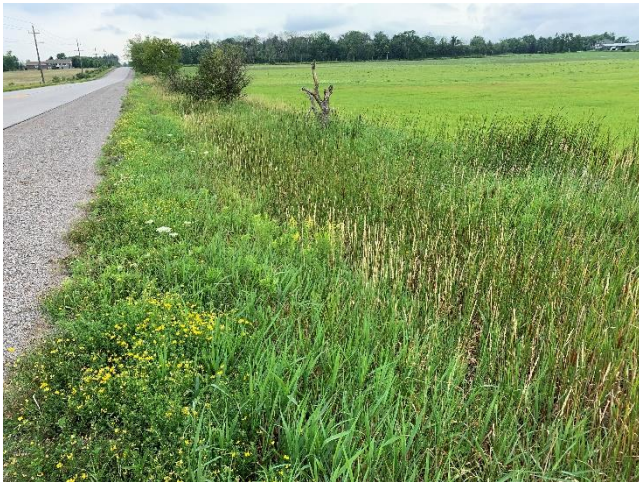
Photo 9: Stabilized entrance pit for HDD watercourse crossing at 226 Cambray Road, looking west (July 2021)

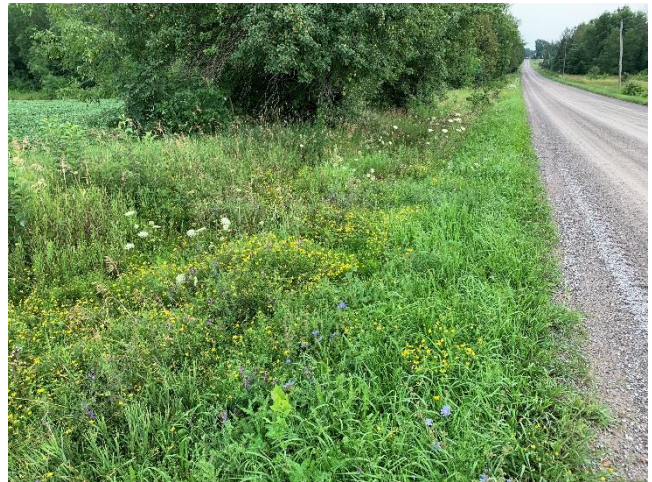
Photo 10: Well-vegetated reclaimed entrance pit for HDD wetland crossing at 139 Eden Road, looking south (July 2021)

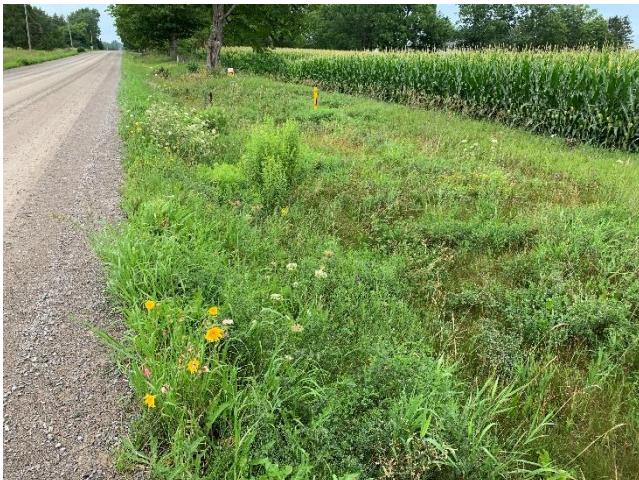
Photo 11: Stabilized road embankment at 2 Eden Road, north of Quaker Road, looking north (July 2021)

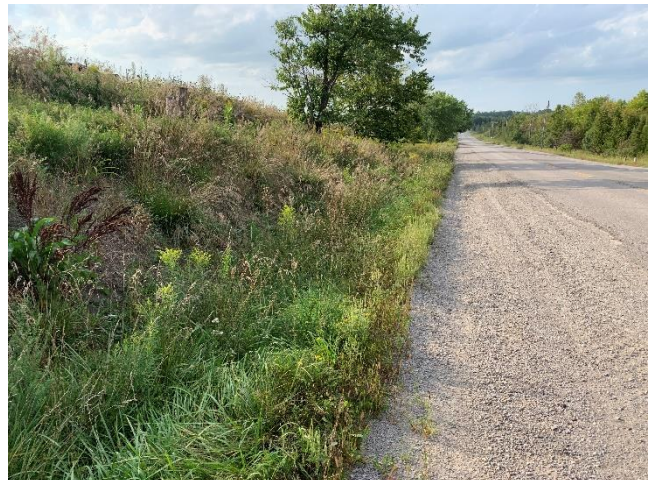
Photo 12: Reclaimed and stabilized drainage ditch in KCA Disturbed Area #2 at 15591 Simcoe Street, two years after restoration, looking south (August 2021)

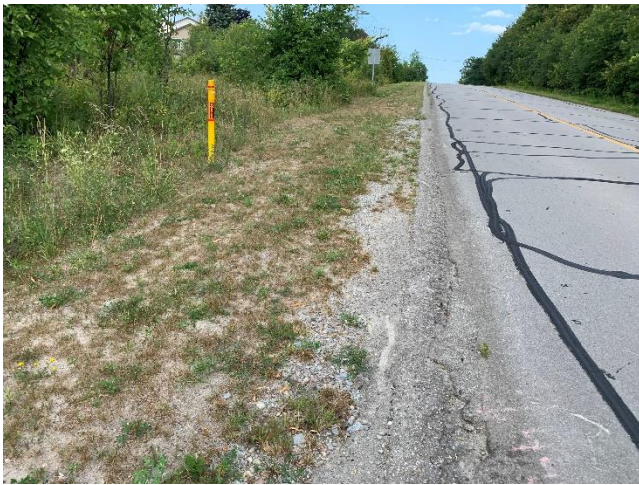
Overall, the ROW is in excellent condition, stabilized with no bare areas. There were a few small, isolated locations where vegetation was patchy and is assumed to be a result of drought conditions in 2019 and 2020; however, these areas appear stable, with no evidence of erosion and should revegetate naturally. There were no areas along the ROW which are recommended to require subsequent restoration or monitoring.

Photo 13: Reclaimed stable road embankment with some patchy vegetation establishment at 1361 Concession Road 6, looking east (August 2021)

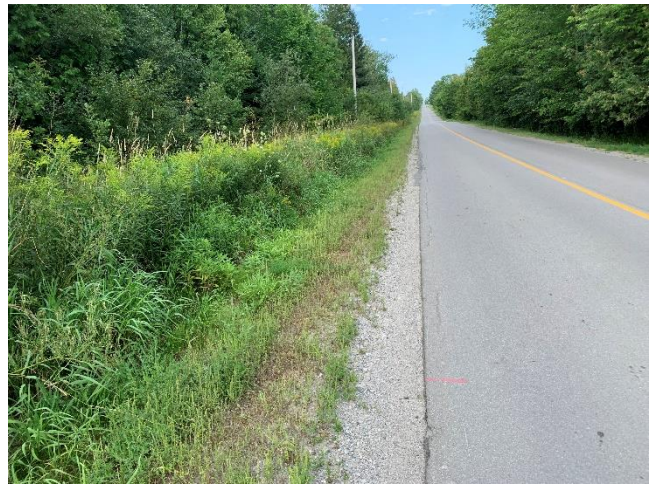
Photo 14: Reclaimed and stabilized drainage ditch in KCA Disturbed Area #3, on Concession 6, east of Sideroad 18, looking east (August 2021)

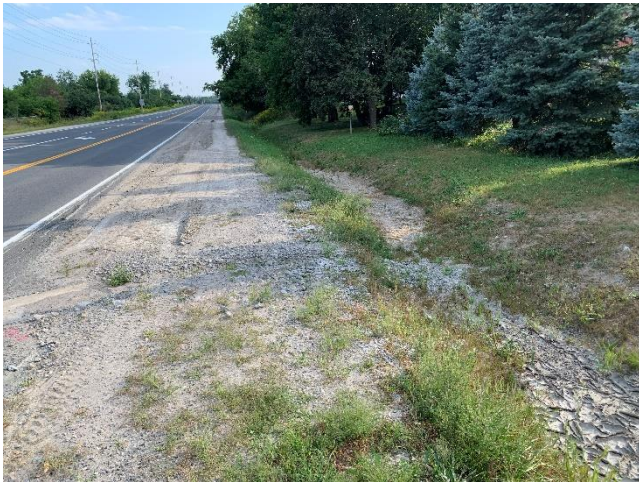
Photo 15: Reclaimed west road embankment completed by MTO at Hwy. 12 at Concession Road 6, looking south (August 2021)

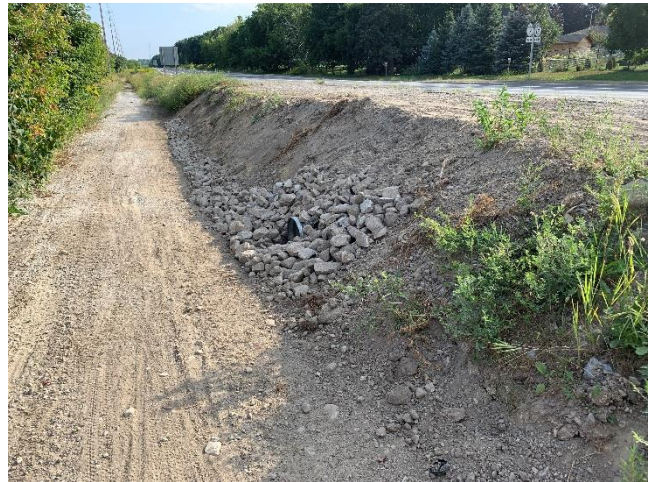
Photo 16: Reclaimed east road embankment and ATV trail completed by MTO at Hwy 12 at Concession Road 6, looking south (August 2021)

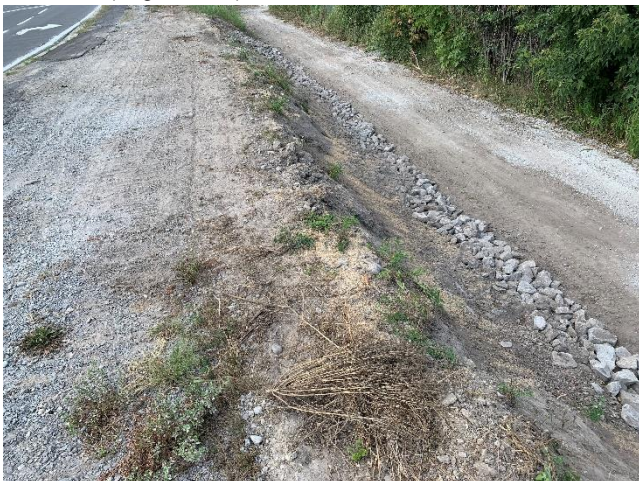
Photo 17: Reclaimed east road embankment and ATV trail completed by MTO at Hwy 12 at Concession Road 6, looking north (August 2021)

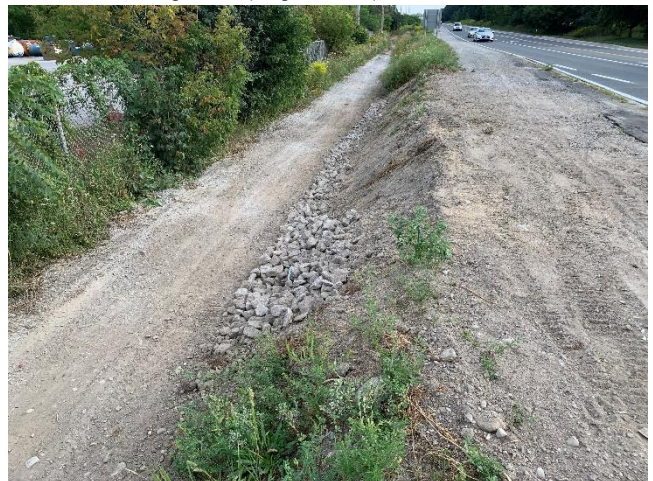
Photo 18: Reclaimed east road embankment and ATV trail completed by MTO at Hwy 12 at Concession Road 6, looking south (August 2021)
