ENBRIDGE GAS INC.

# Final Monitoring Report

Low-Carbon Energy Project (EB-2019-0294)

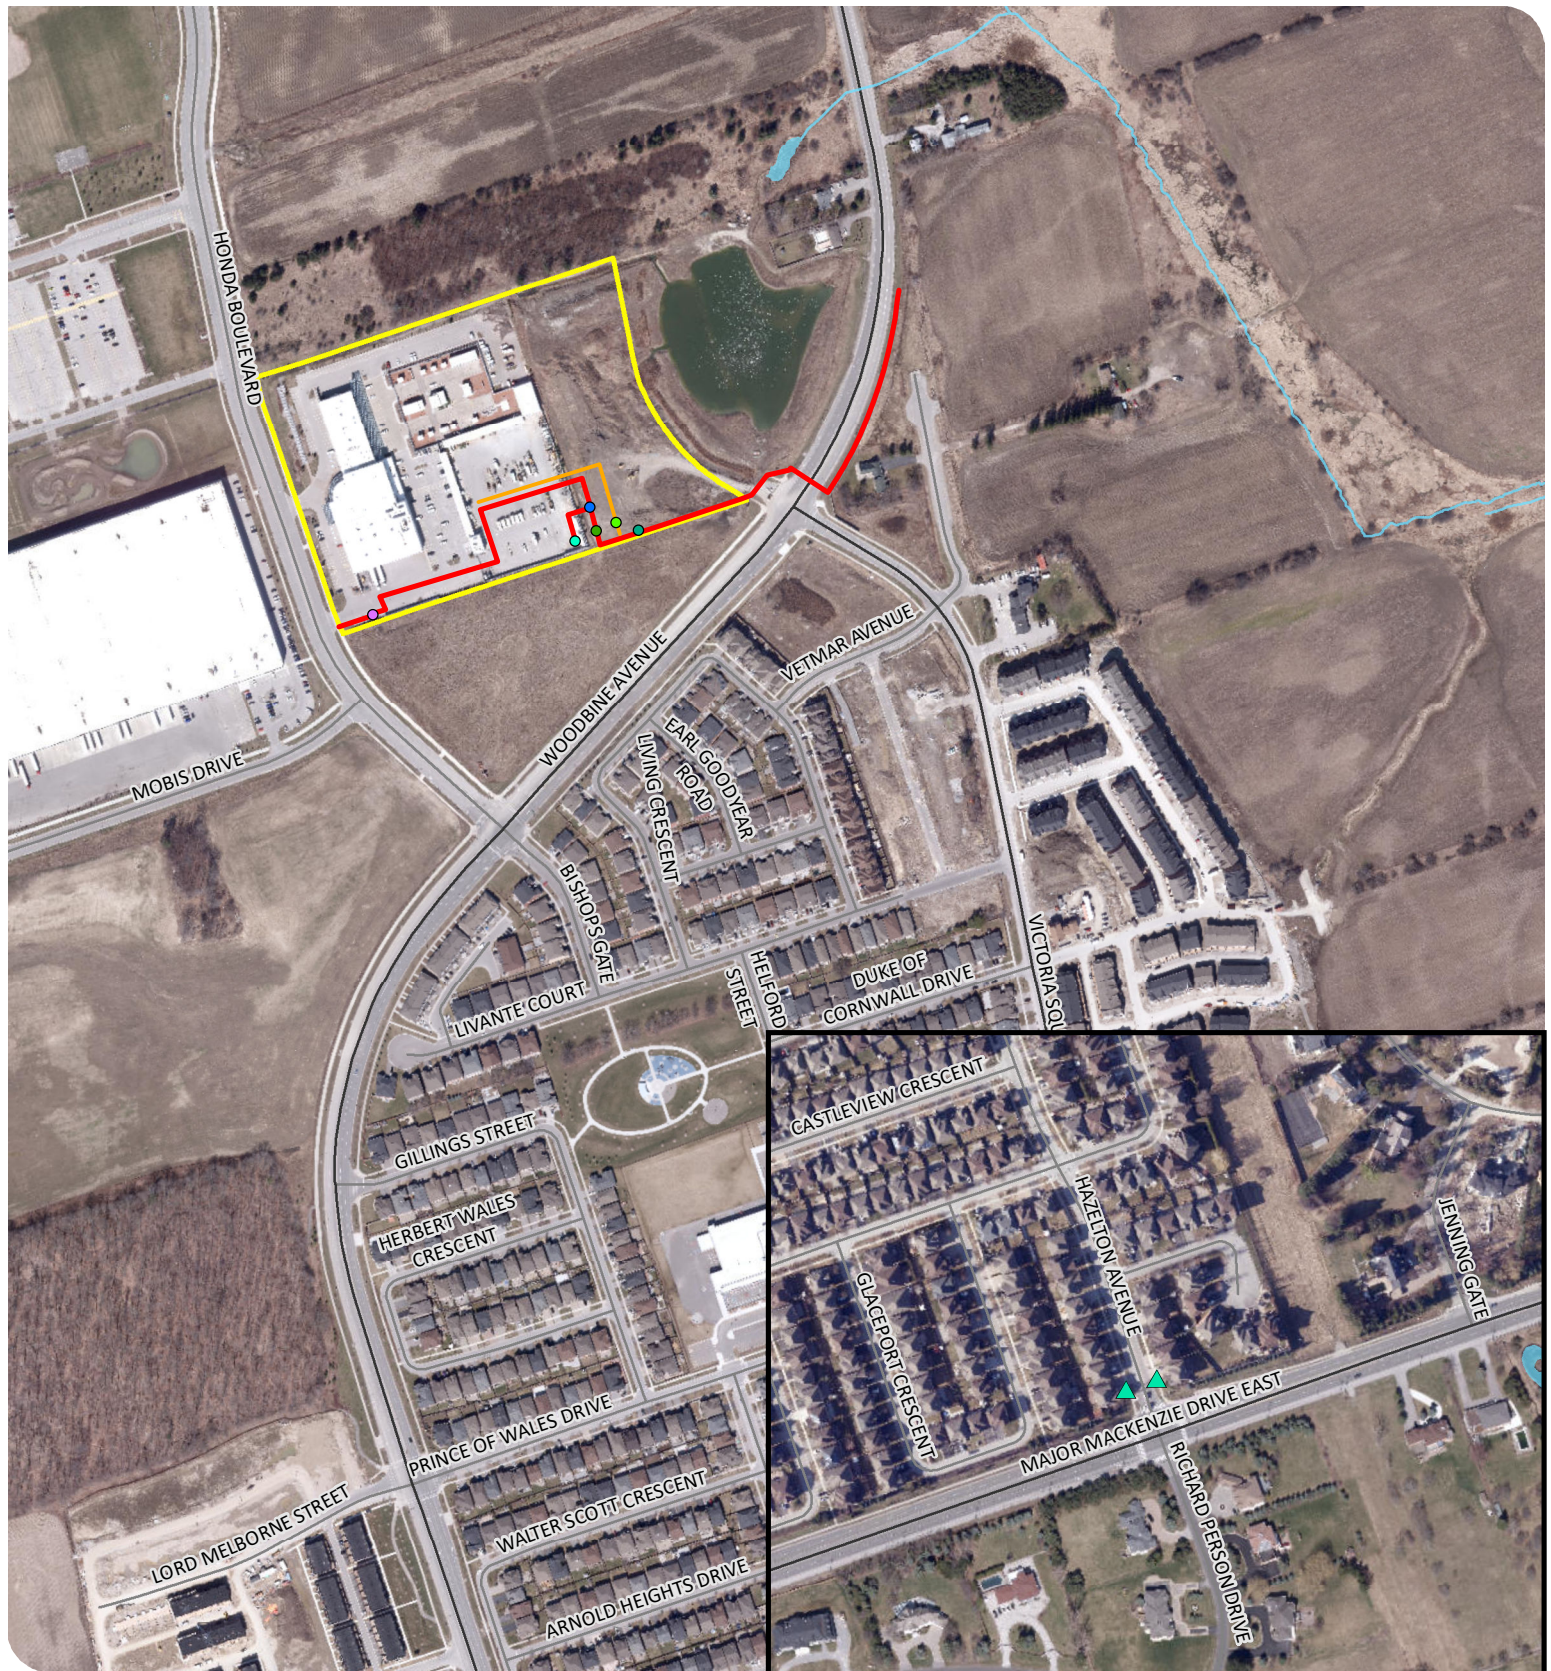
FIGURE 1

### PROJECT OVERVIEW

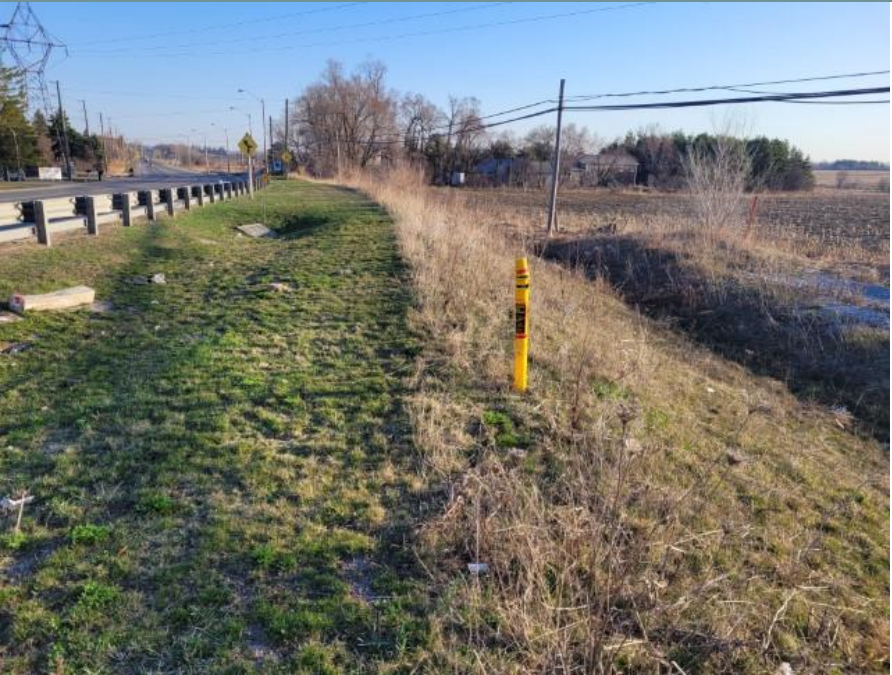
| Location | Current Condition (April 13/May 11, 2023) | Recommendations/<br>Actions | Representative Photo (April 13/May 11, 2023) | Photo # |
|---|---|---|---|---|
| Woodbine Avenue at tie-in location, east side | Area is stable and revegetated and restored to pre-construction conditions. | None required | | 1 |

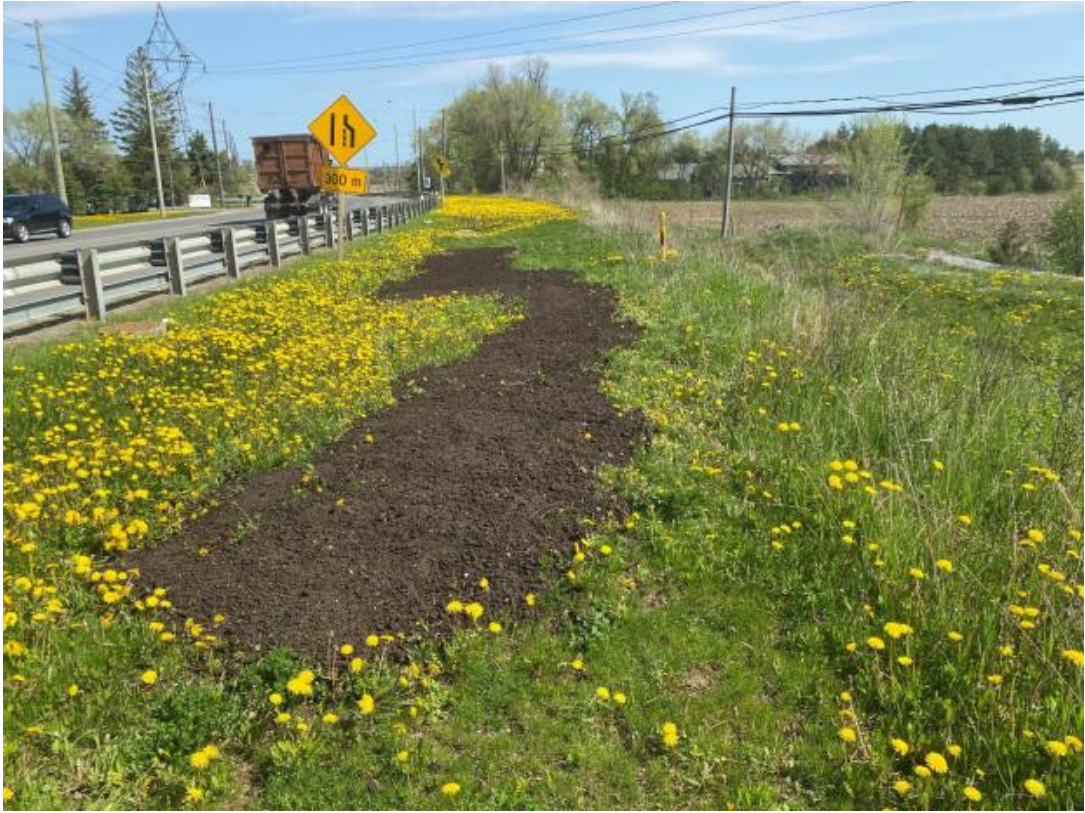
| Location | Current Condition (April 13/May 11, 2023) | Recommendations/<br>Actions | Representative Photo (April 13/May 11, 2023) | Photo # |
|---|---|---|---|---|
| Woodbine Avenue | Topsoil and seed applied. Area is stable and has been restored to pre-construction conditions. | None required | | 2 |

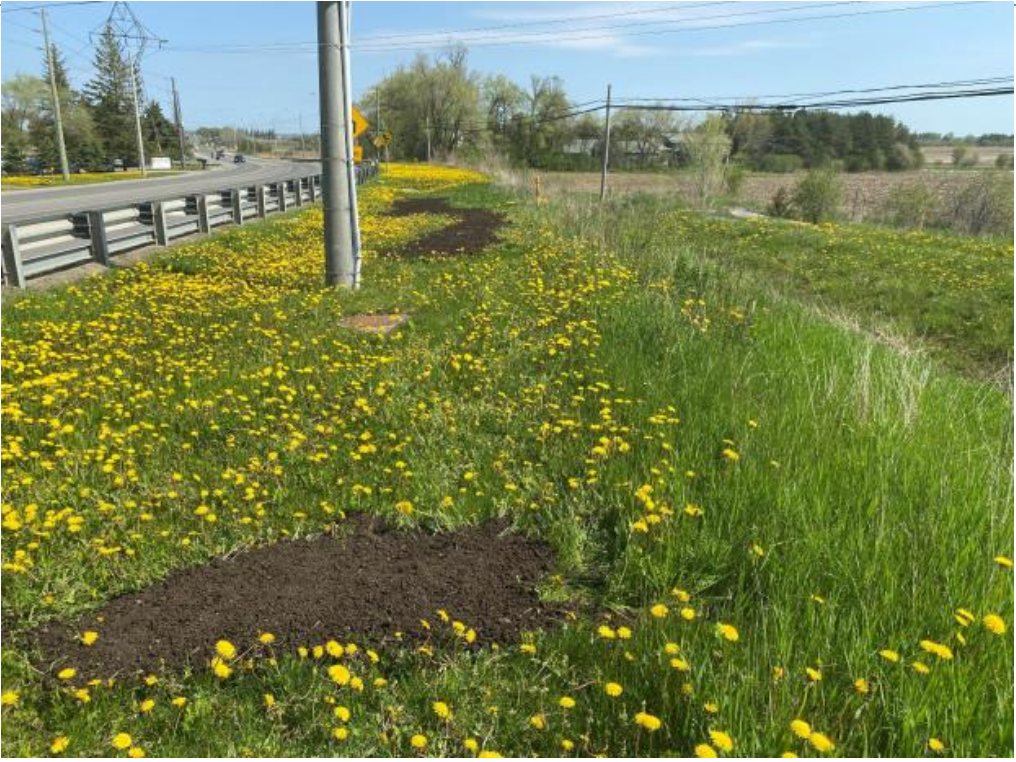
| Location | Current Condition (April 13/May 11, 2023) | Recommendations/<br>Actions | Representative Photo (April 13/May 11, 2023) | Photo # |
|---|---|---|---|---|
| Woodbine Avenue | Topsoil and seed applied. Area is stable and has been restored to pre-construction conditions. | None required | | 3 |

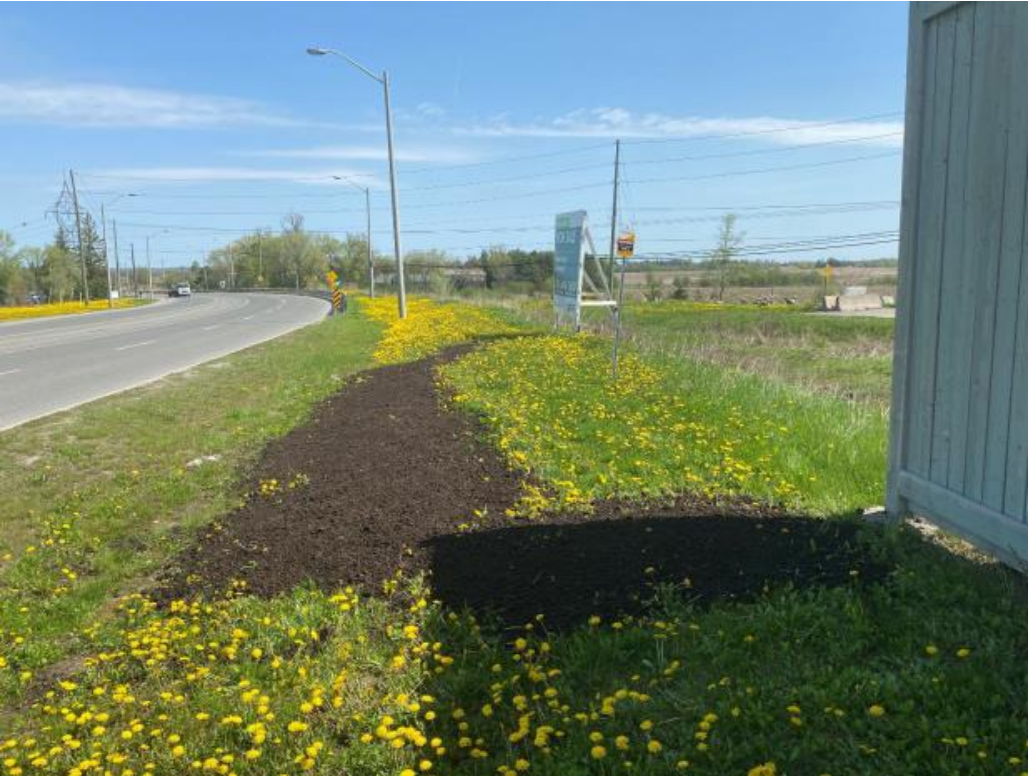
| Location | Current Condition (April 13/May 11, 2023) | Recommendations/<br>Actions | Representative Photo (April 13/May 11, 2023) | Photo # |
|---|---|---|---|---|
| Woodbine Avenue | Topsoil and seed applied. Area is stable and has been restored to pre-construction conditions. | None required | | 4 |

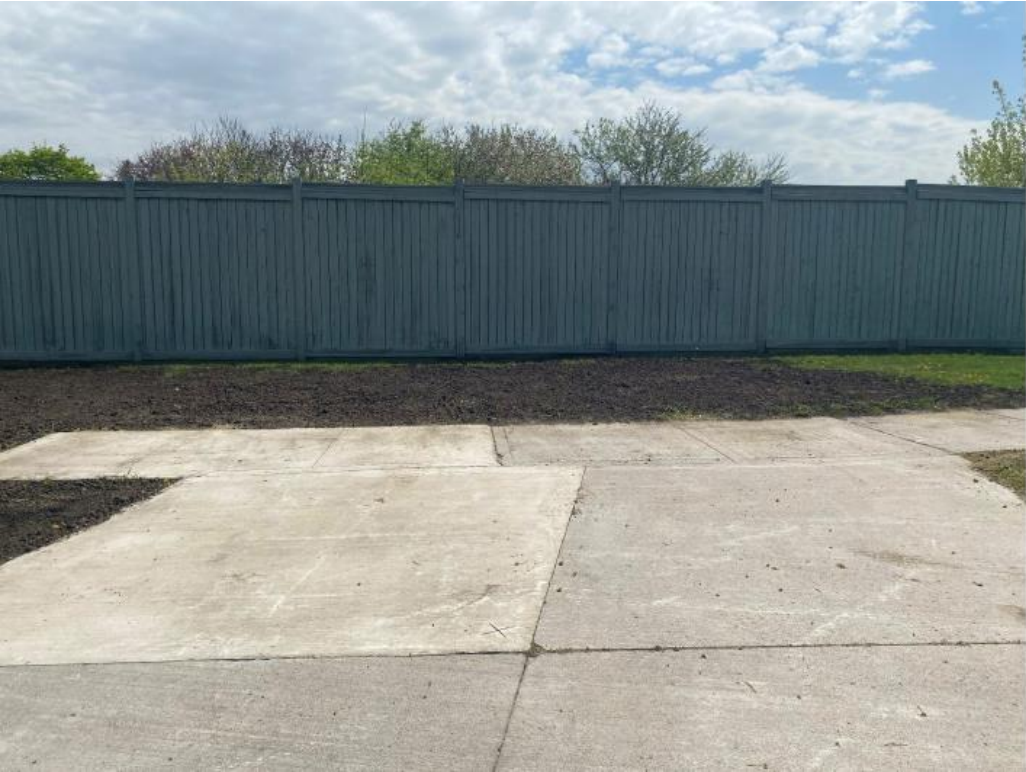
| Location | Current Condition (April 13/May 11, 2023) | Recommendations/<br>Actions | Representative Photo (April 13/May 11, 2023) | Photo # |
|---|---|---|---|---|
| Woodbine Avenue and<br>Victoria Square Boulevard | Topsoil and seed applied. Area is stable and has been restored to pre-construction conditions. | None required | | 5 |

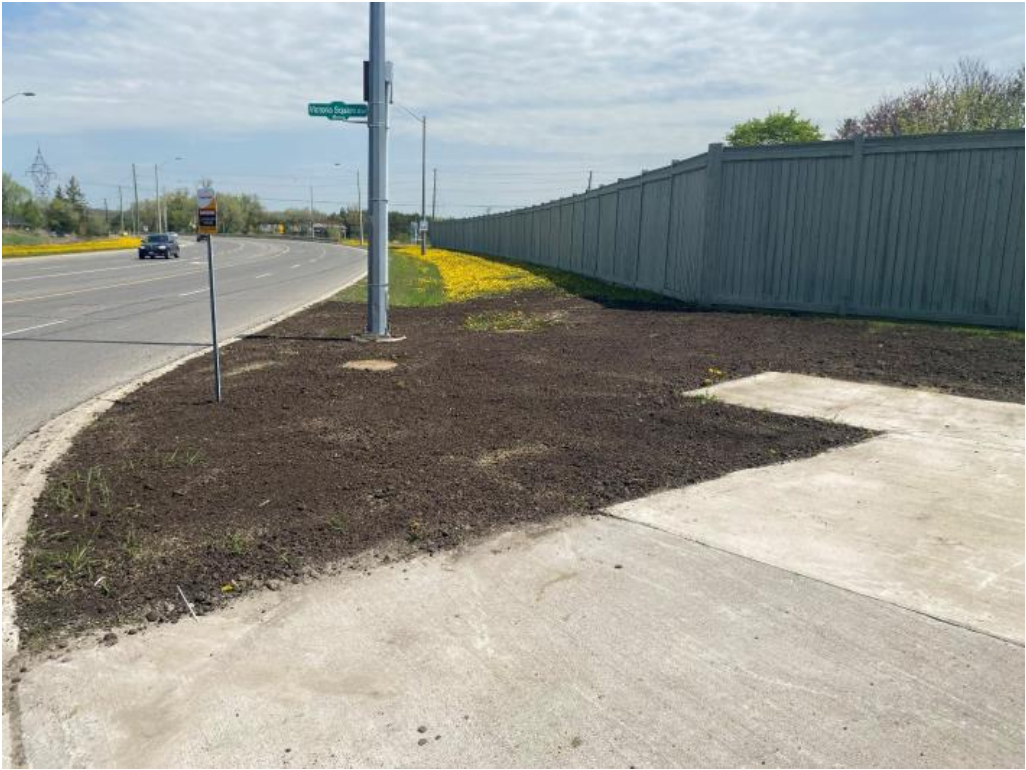
| Location | Current Condition (April 13/May 11, 2023) | Recommendations/<br>Actions | Representative Photo (April 13/May 11, 2023) | Photo # |
|---|---|---|---|---|
| Woodbine Avenue and<br>Victoria Square Boulevard | Topsoil and seed applied. Area is stable and has been restored to pre-construction conditions. | None required | | 6 |

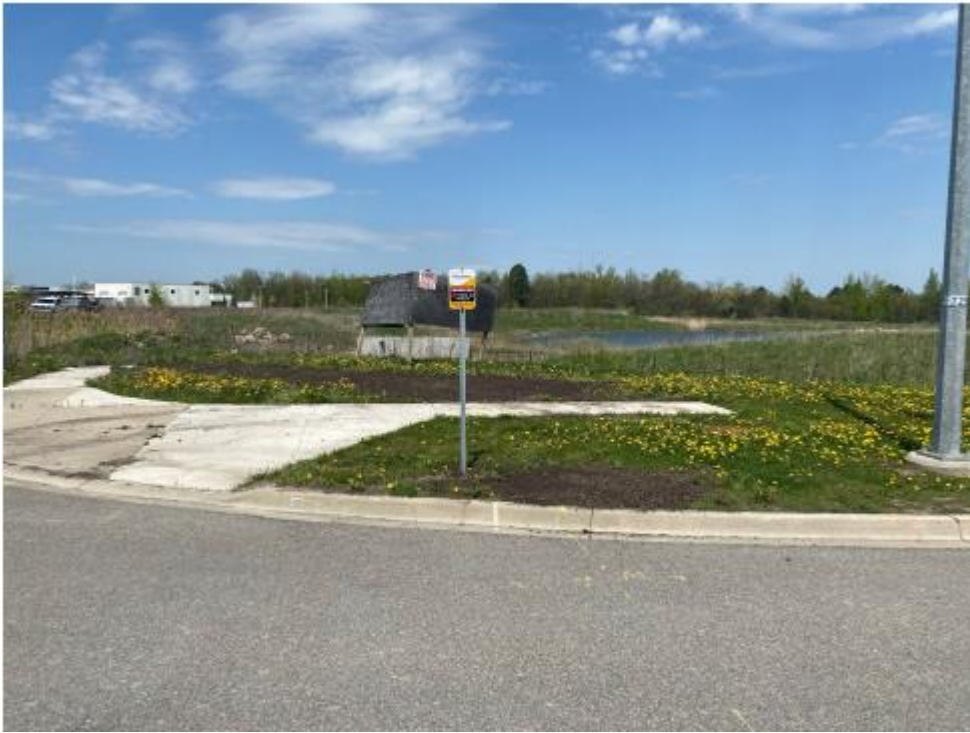
| Location | Current Condition (April 13/May 11, 2023) | Recommendations/<br>Actions | Representative Photo (April 13/May 11, 2023) | Photo # |
|---|---|---|---|---|
| Woodbine Avenue entrance to Enbridge TOC property, northwest side (drilling location) | Settlement at drilling location returned to pre-construction grade and seeded. Area is stable and has been restored to pre-construction conditions. | None required | | 7 |

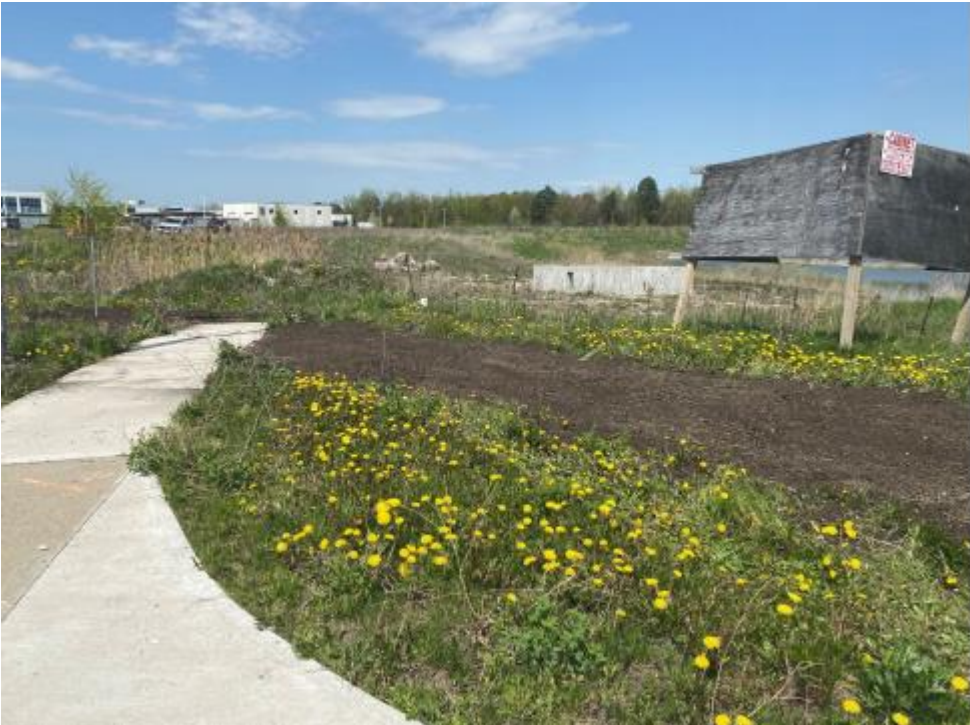
| Location | Current Condition (April 13/May 11, 2023) | Recommendations/<br>Actions | Representative Photo (April 13/May 11, 2023) | Photo # |
|---|---|---|---|---|
| Woodbine Avenue entrance to Enbridge TOC property, northwest side (drilling location) | Settlement at drilling location returned to pre-construction grade and seeded. Area is stable and has been restored to pre-construction conditions. | None required | | 8 |

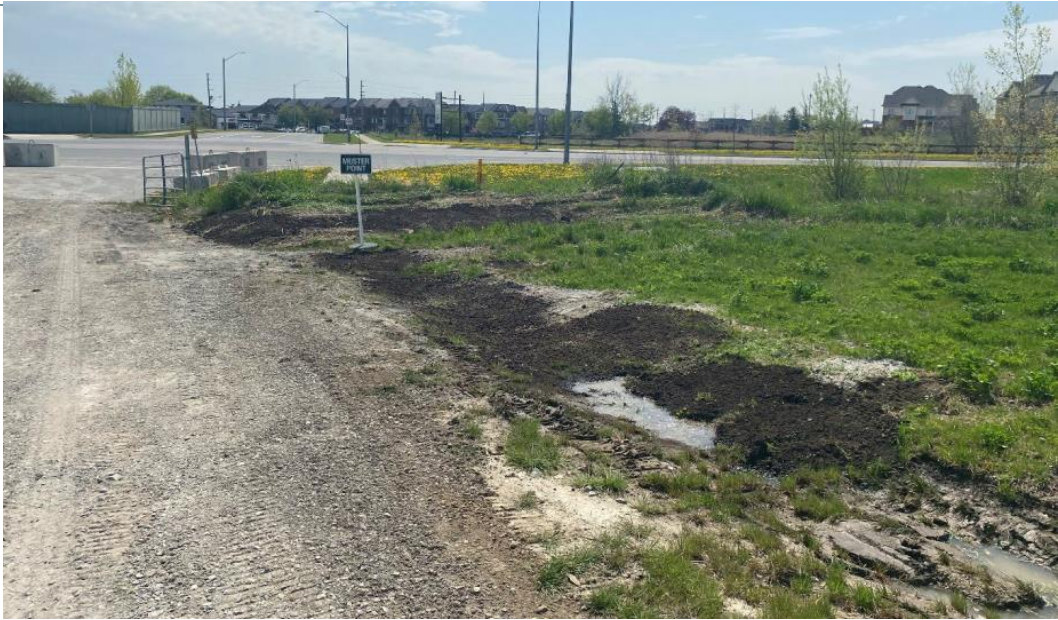
| Location | Current Condition (April 13/May 11, 2023) | Recommendations/<br>Actions | Representative Photo (April 13/May 11, 2023) | Photo # |
|---|---|---|---|---|
| Eastern portion of southern Enbridge TOC property near to Woodbine Avenue entrance | <p>Temporary erosion and sediment controls removed from site. Area is stable and topsoil and seed has been applied.</p> <p>Fill material shown in photo from snow plowing and is not related to the Project.</p> | None required | | 9 |

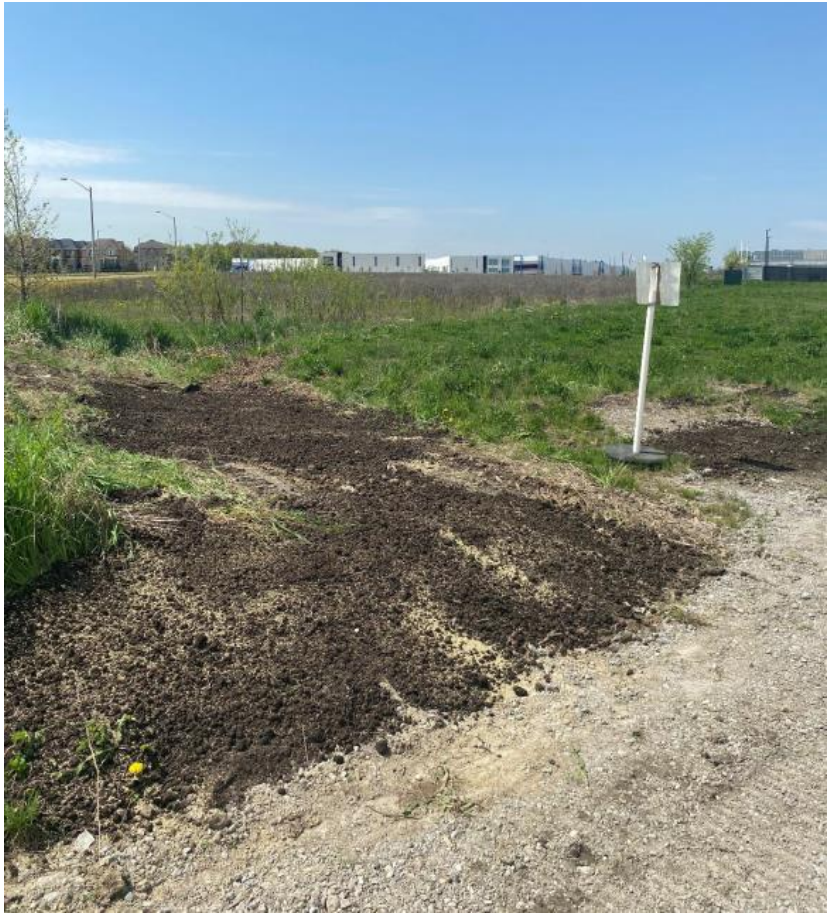
| Location | Current Condition (April 13/May 11, 2023) | Recommendations/<br>Actions | Representative Photo (April 13/May 11, 2023) | Photo # |
|---|---|---|---|---|
| Northern soil storage area, located on Enbridge TOC property | <p>Topsoil and seed applied. Area is stable and erosion and sediment controls have been removed from site.</p> | None required | | 10 |

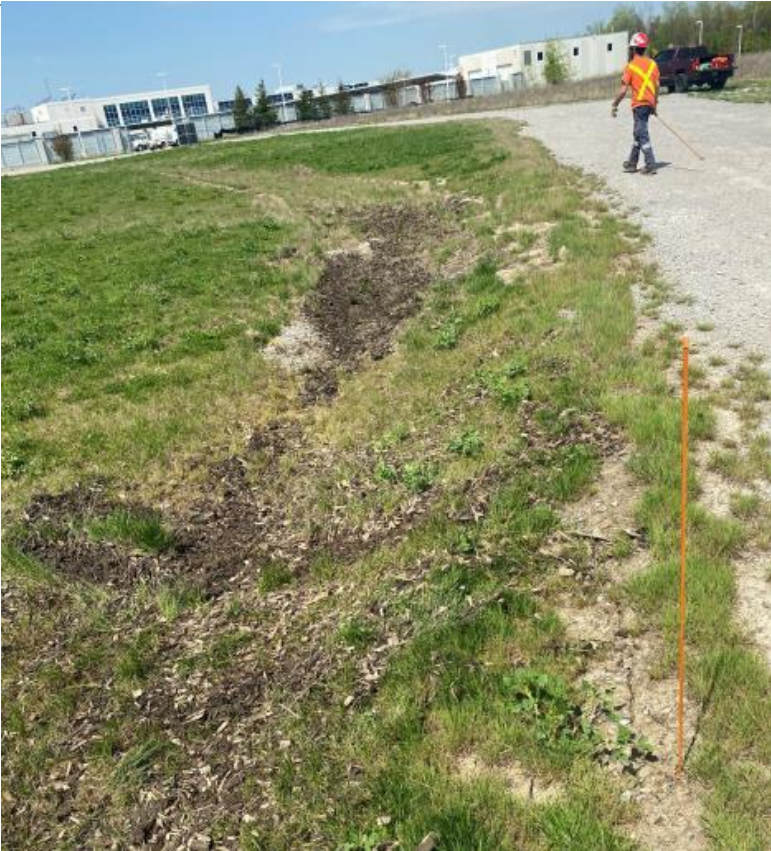
| Location | Current Condition (April 13/May 11, 2023) | Recommendations/<br>Actions | Representative Photo (April 13/May 11, 2023) | Photo # |
|---|---|---|---|---|
| Swale pathway at Enbridge TOC property | <p>No evidence of erosion.</p> <p>Area revegetated and stable and wood chips applied thinly over site in areas with tire rutting.</p> <p>Temporary erosion and sediment controls removed.</p> | None required | | 11 |

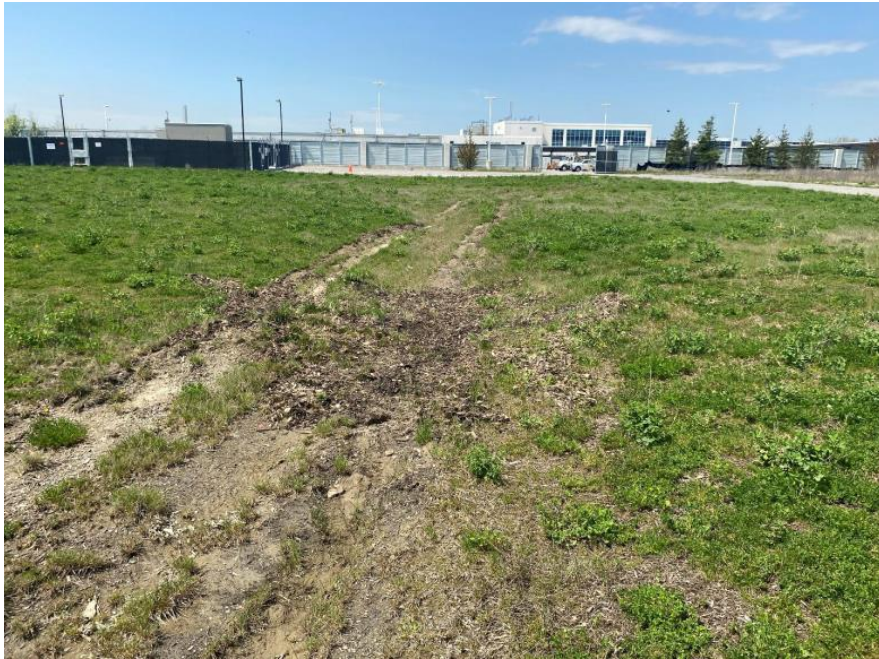
| Location | Current Condition (April 13/May 11, 2023) | Recommendations/<br>Actions | Representative Photo (April 13/May 11, 2023) | Photo # |
|---|---|---|---|---|
| Enbridge TOC property near to above-ground infrastructure | <p>Area revegetated and stable with no evidence of erosion near the roadway.</p> <p>Wood chips applied thinly over site in areas with tire rutting.</p> | None required | | 12 |

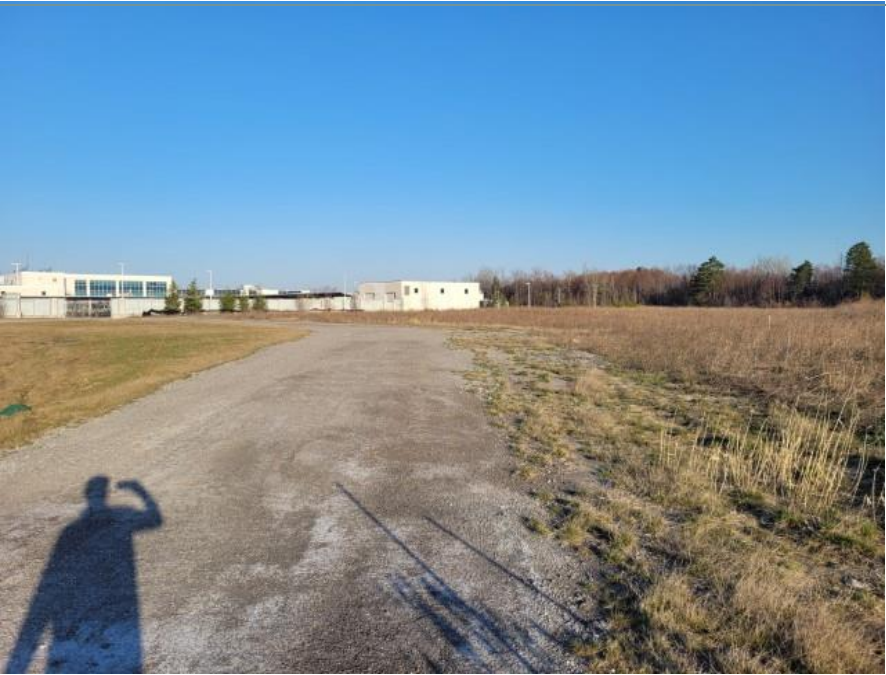
| Location | Current Condition (April 13/May 11, 2023) | Recommendations/<br>Actions | Representative Photo (April 13/May 11, 2023) | | Photo # |
|---|---|---|---|---|---|
| Enbridge TOC property access road | Area is stable with no evidence of erosion. | None required | | | 13 |
