PREPARED FOR:  
**ENBRIDGE GAS DISTRIBUTION INC.  
PIPELINE TO SERVE THE PROPOSED  
THOROLD COGEN L.P.**

TITLE  
**MITIGATION**

FIGURE NO.  
**1.0**

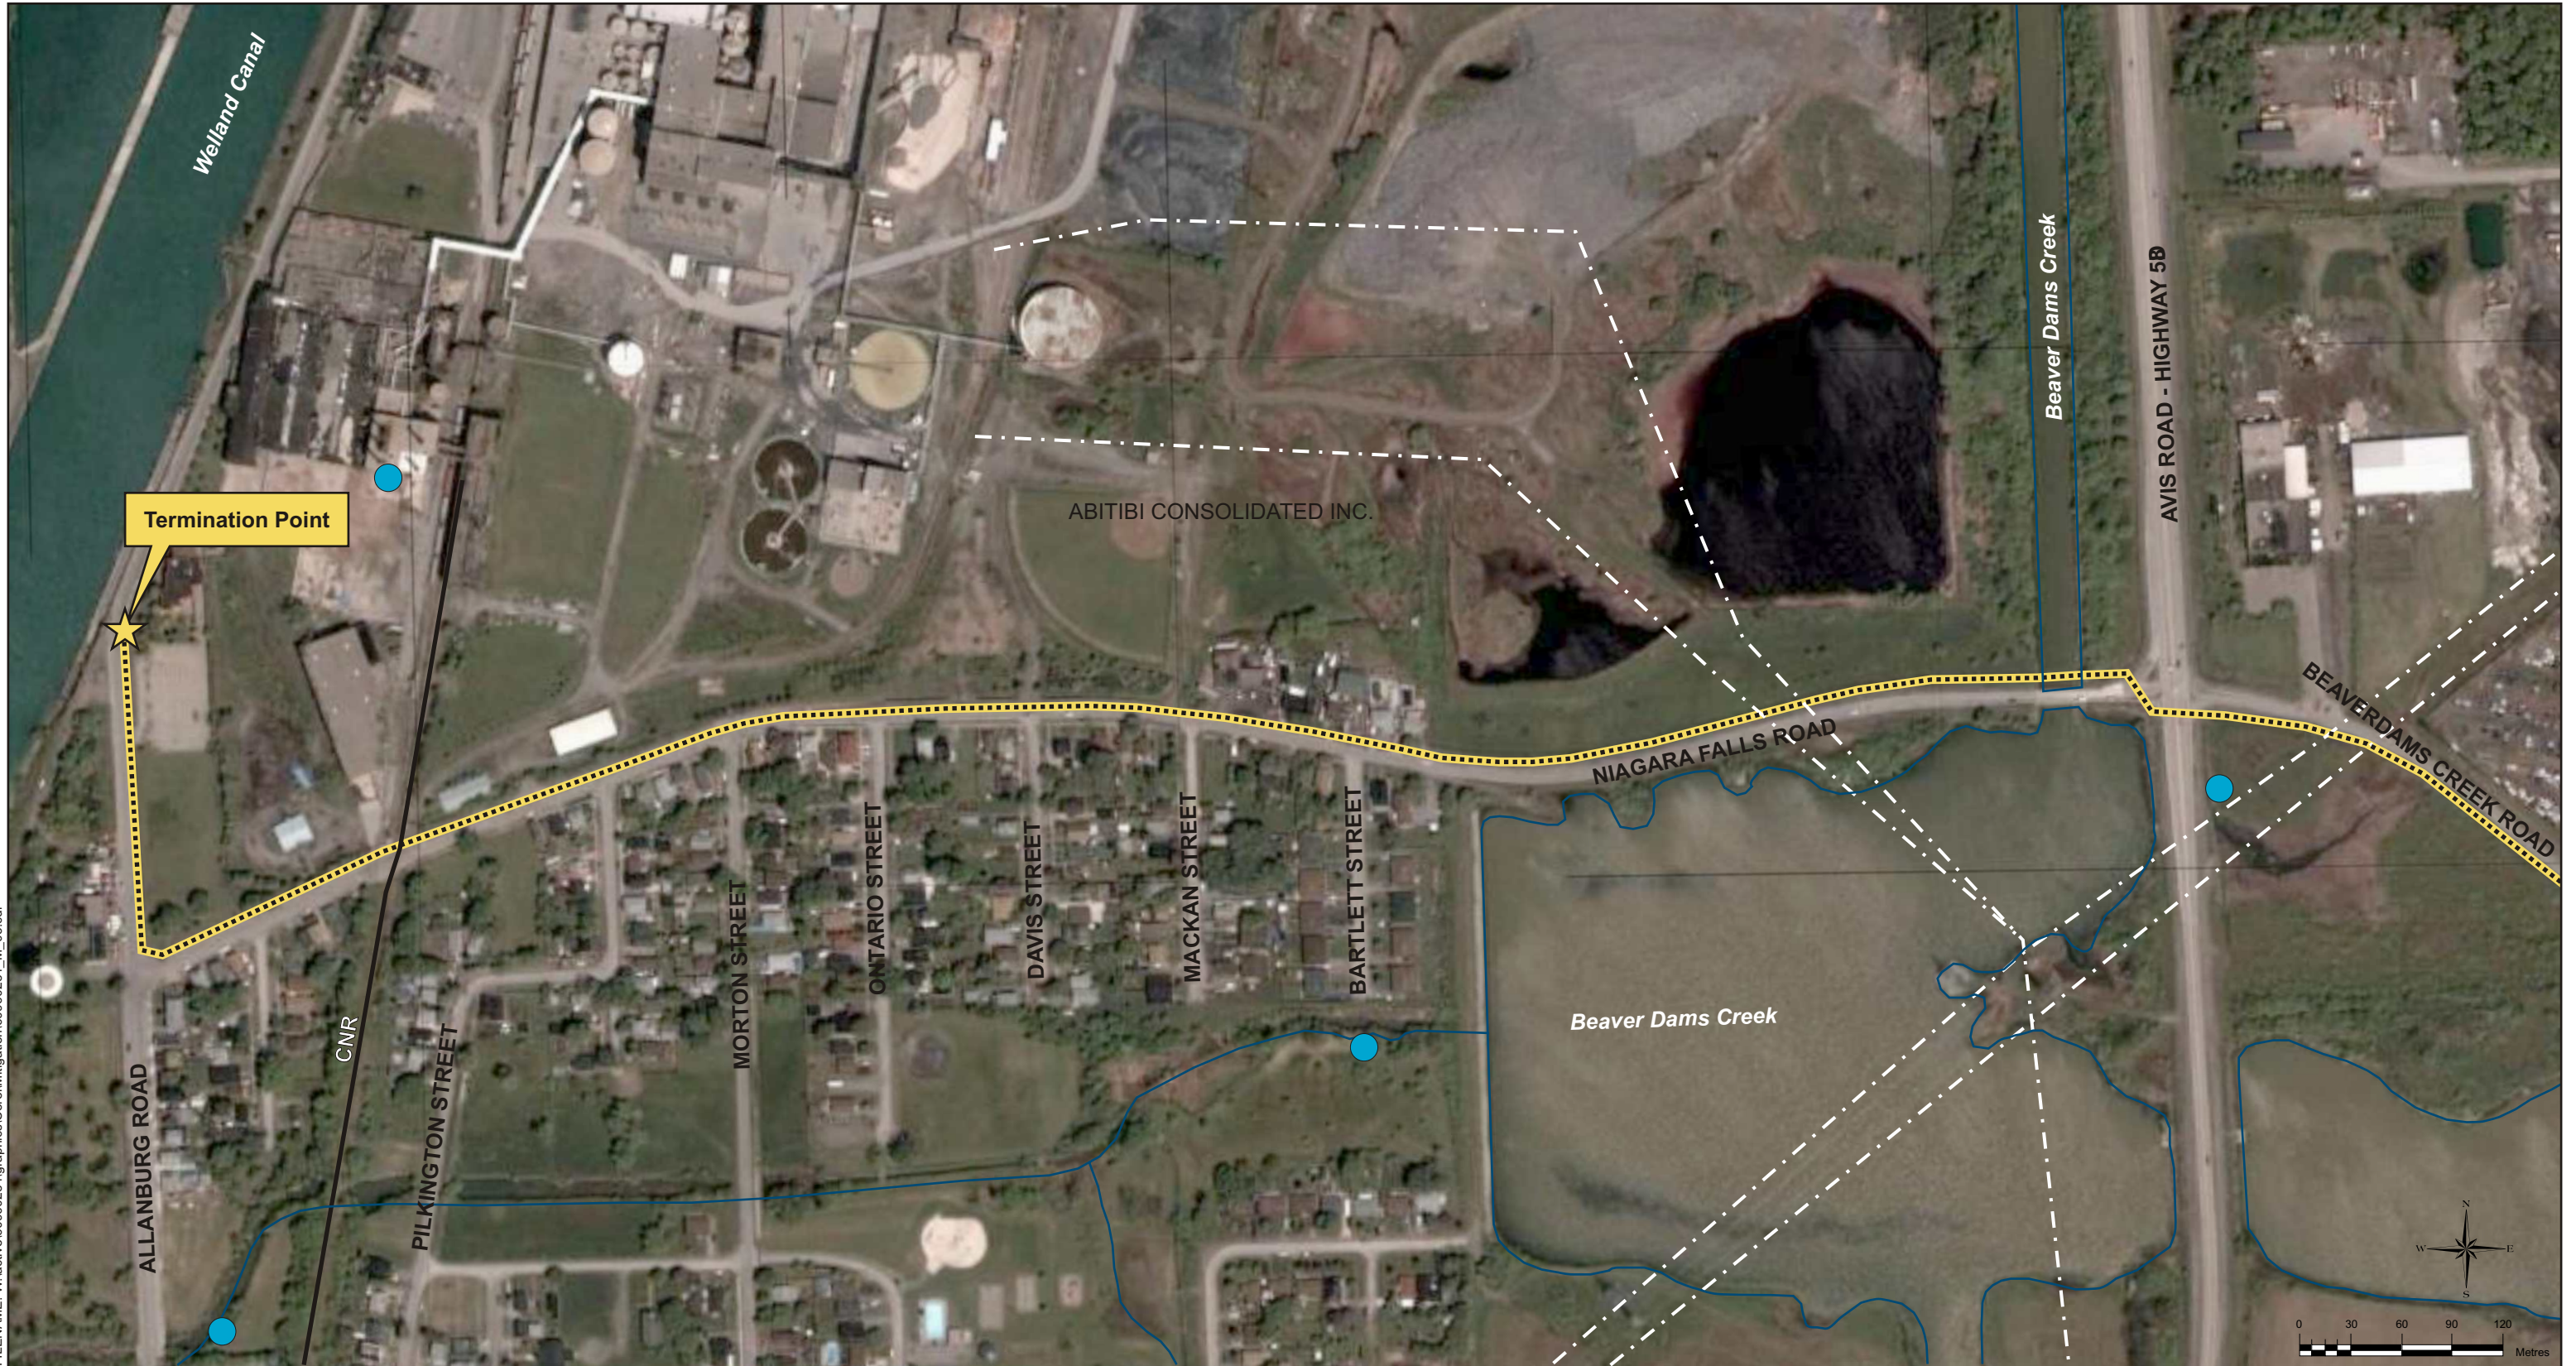
Traveling within 100 m of residences and businesses. Contact landowners prior to construction to discuss pre-construction concerns. Refer to Environmental Report Section 6.3.3 Population and Institutional Facilities.

Crossing of railway. CNR. Contact CNR to discuss construction methods and timing. Potential to encounter contaminated soils. Refer to Environmental Report Section 6.3.3 Population and Institutional Facilities.

Traveling within 100 m of a water well. Potential Disturbance to water well. Consult with landowner to determine the specific location and characteristics of their water well. Refer to Environmental Report Section 6.1.5 Hydrology.

Crossing Municipal Road. Niagara Falls Road. Contact road superintendent prior to crossing to discuss crossing timing and method. Refer to Environmental Report Section 6.3.2 Existing Linear Features.

Watercourse Crossing. Beaver Dams Creek. Inform appropriate agencies prior to commencing crossing. Refer to Environmental Report Section 6.1.5 Hydrology, and Section 6.2.1 Watercourses and Fisheries.

Crossing Provincial Highway. Highway 58 (Davis Road). Contact road superintendent and MTO prior to crossing to discuss crossing timing and method. Refer to Environmental Report Section 6.3.2 Existing Linear Features.

Under crossing of hydroelectric transmission line. Hydro One. Contact Hydro One to discuss safety and distance requirements. Refer to Environmental Report Section 6.3.2 Existing Linear Features.
