CANADIAN SEABED RESEARCH LTD.

2007 WOLFE ISLAND CABLE ROUTE SURVEY

Geophysical Survey Results

FINAL REPORT

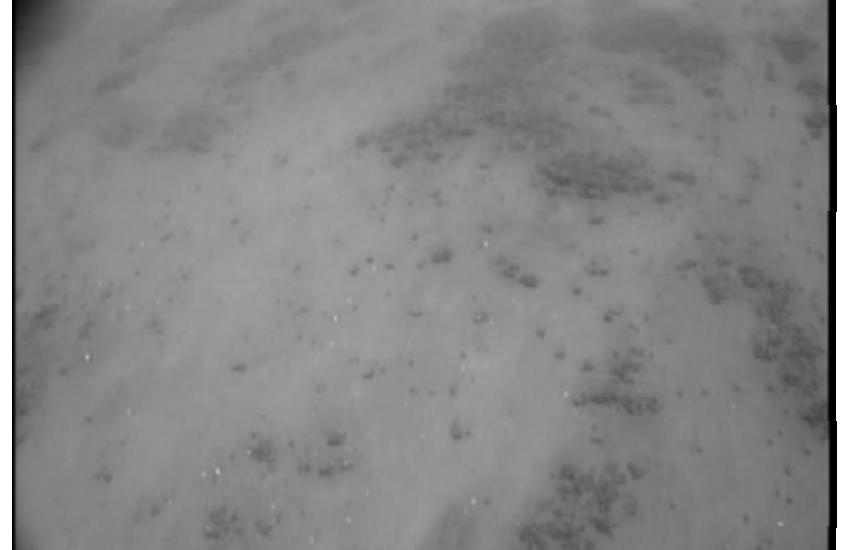
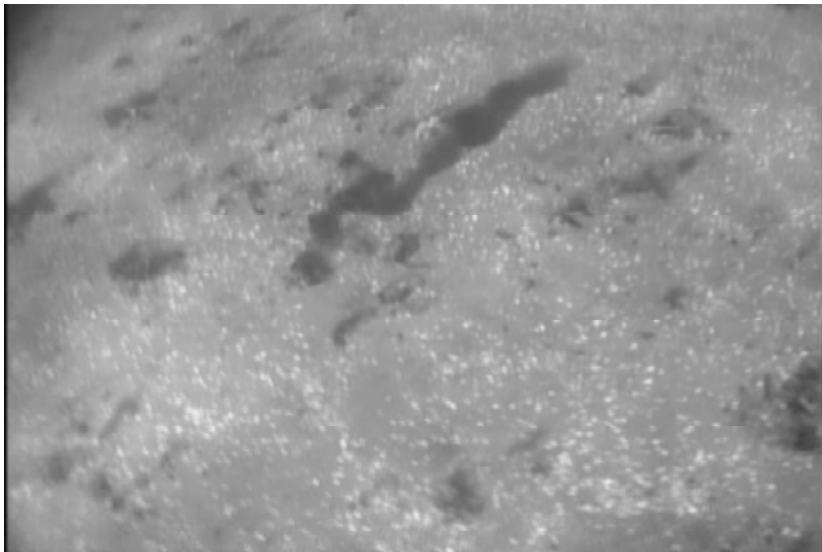
Figure 3.1 - Video still frame images of the surficial sediments present within Unit A. The images show soft clay sediments with abundant shell fragments and shell beds. Algae is also present on the lake floor, visible in the bottom two images.

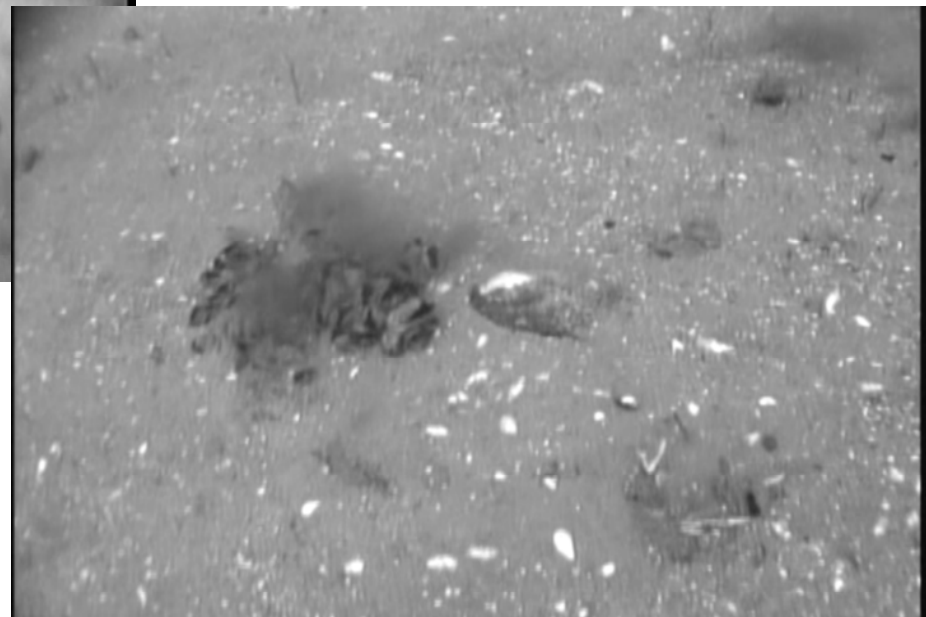
Figure 3.5 - Video still frame images of the surficial sediments present within Unit B. The images show abundant shell fragments, coarser sediments and small boulders. Due to the configuration of the drop video camera, it is not possible to accurately measure the size of features in the still frame images. Boulders identified in Unit B are typically less than 0.5 metres in size and as large as 0.75 metres.

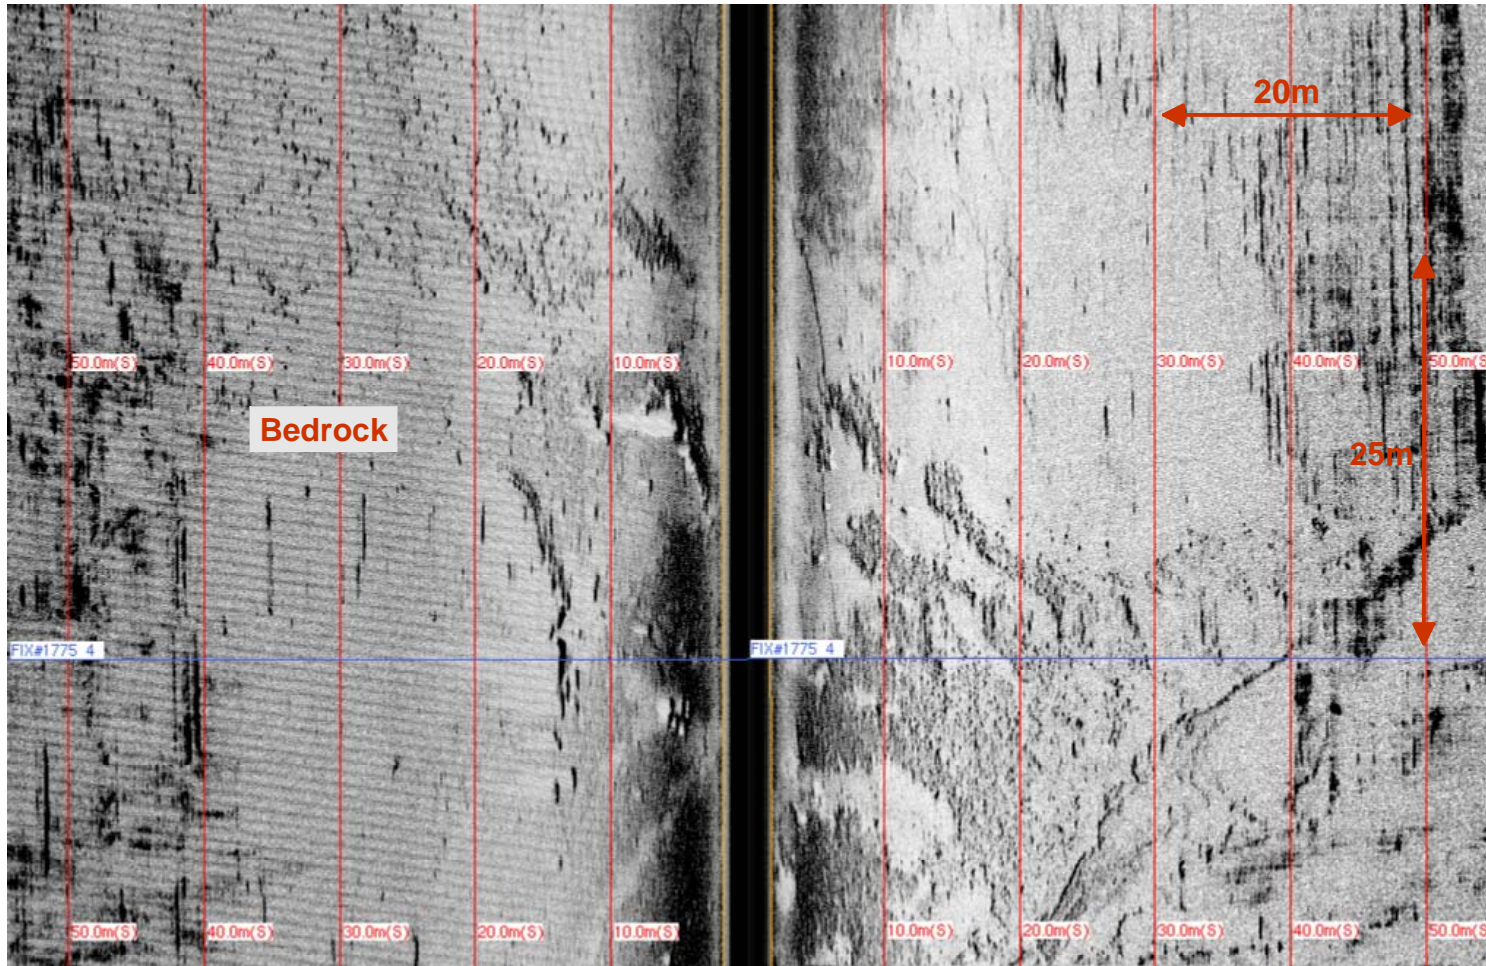
Figure 3.9 - Sidescan sonar image of bedrock where it is present at the lake floor in Sand Bay.

Bedrock was found at the lake floor near the 13 metre bathymetry contour on the bathymetric slope at the mouth of Sand Bay, and continues at the lake floor to the 1 metre bathymetry contour at the head of the Bay. Boulders are also visible resting on the bedrock surface scattered throughout Sand Bay.

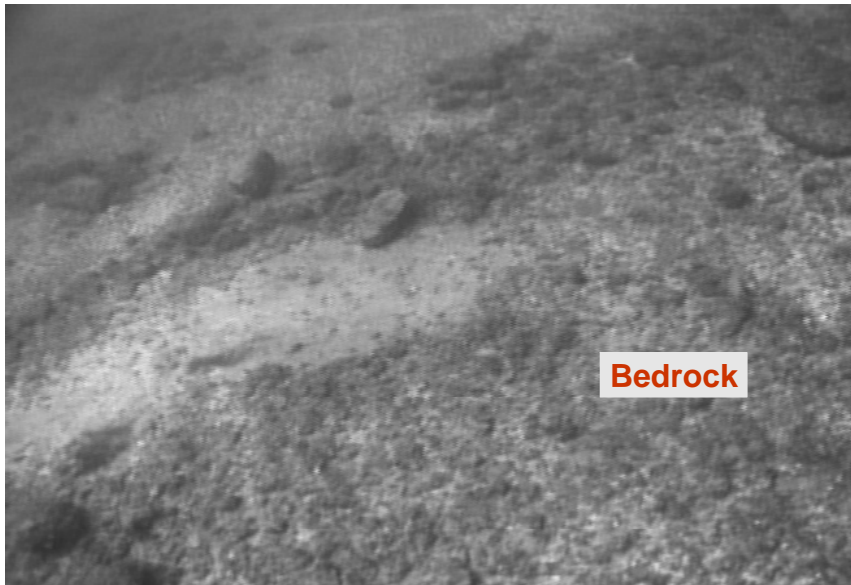
Figure 3.10 - Video still frame images of bedrock where it is present at the lake floor in Sand Bay.

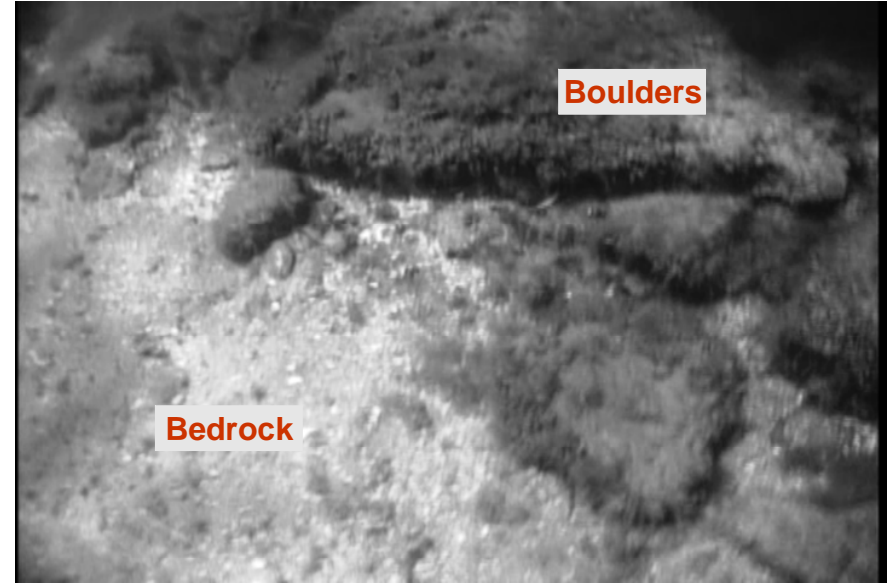
Figure 3.12 - Video still frame images of bedrock where it is present at the bedrock shoal near Wolfe Island.

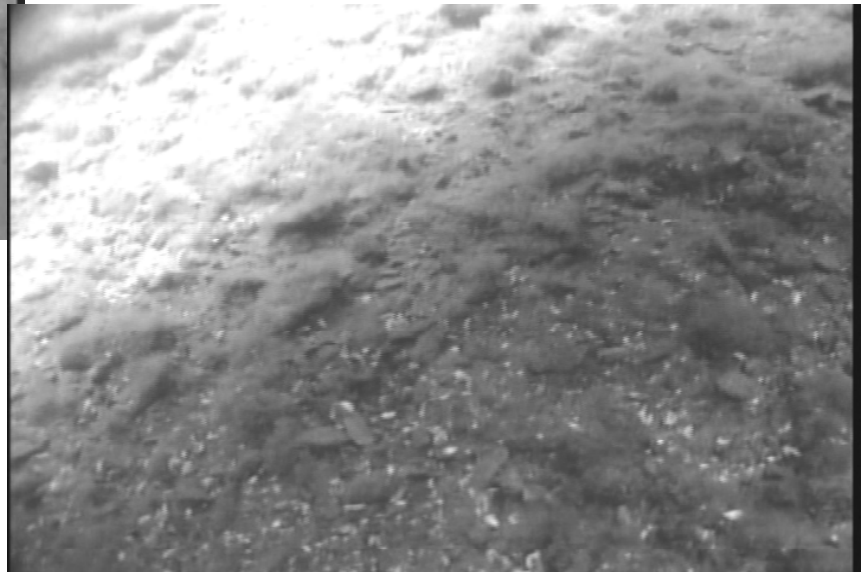
Figure 3.13 - Video still frame images of the cobble till present at the Sand Bay landfall area, (Unit E).

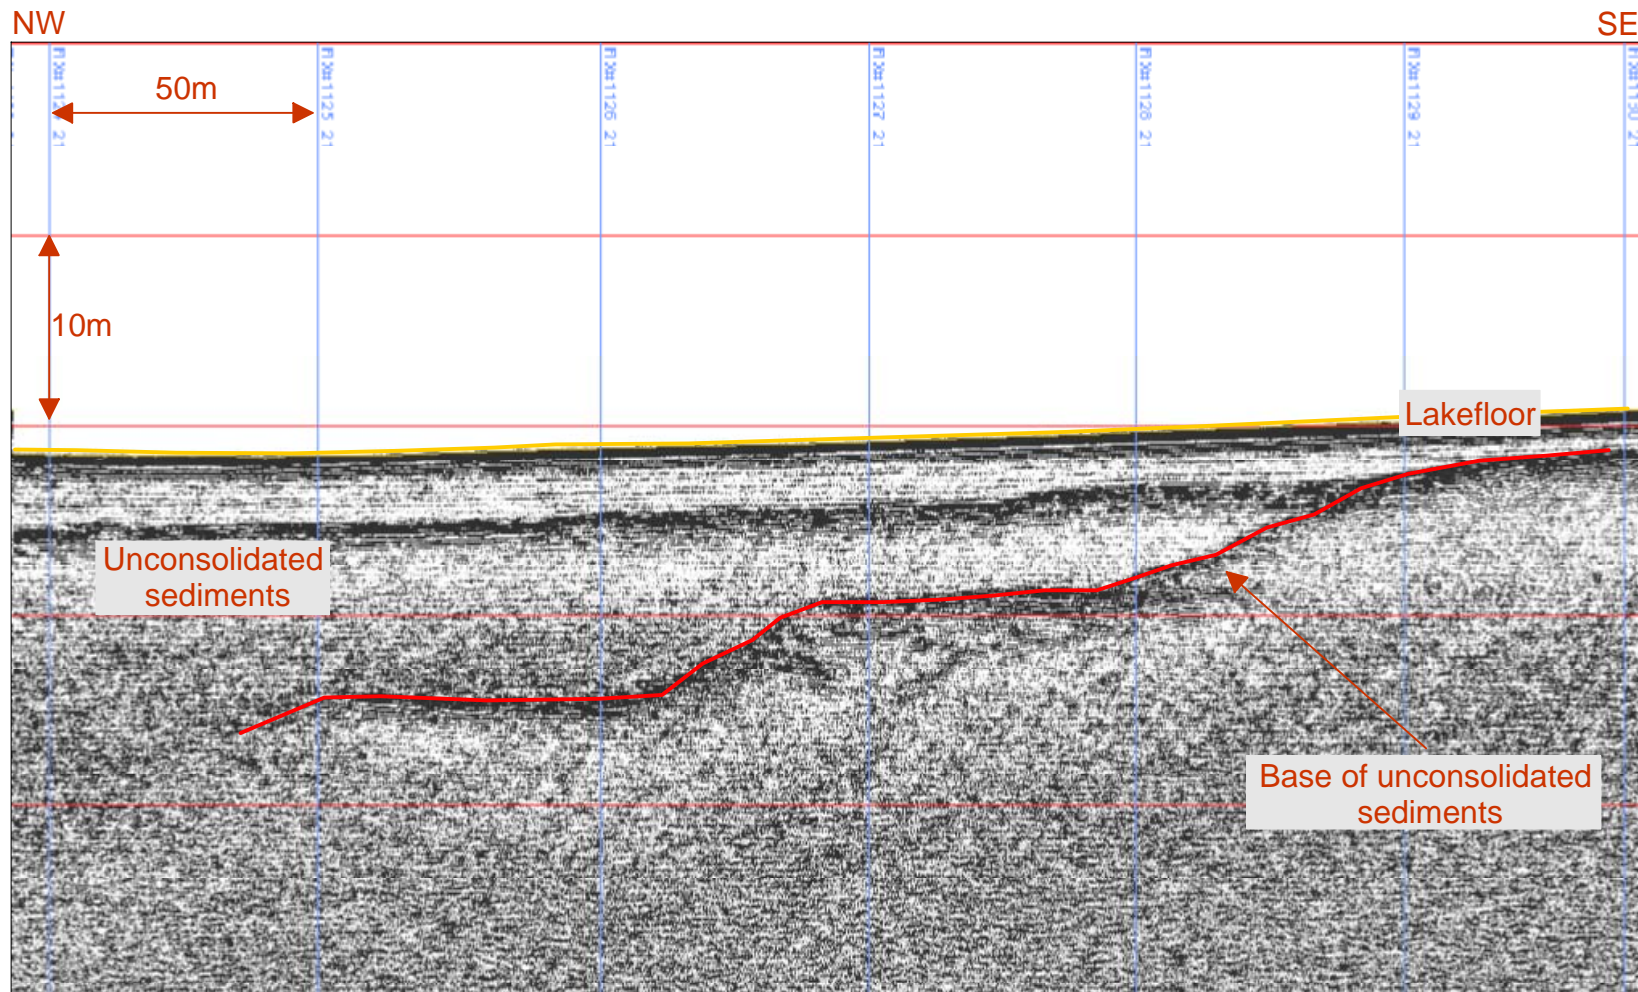
Figure 3.14 - Sub-bottom profiler image displaying thick unconsolidated sediments in the harbour channel before thinning north east of Snake Island Shoal.

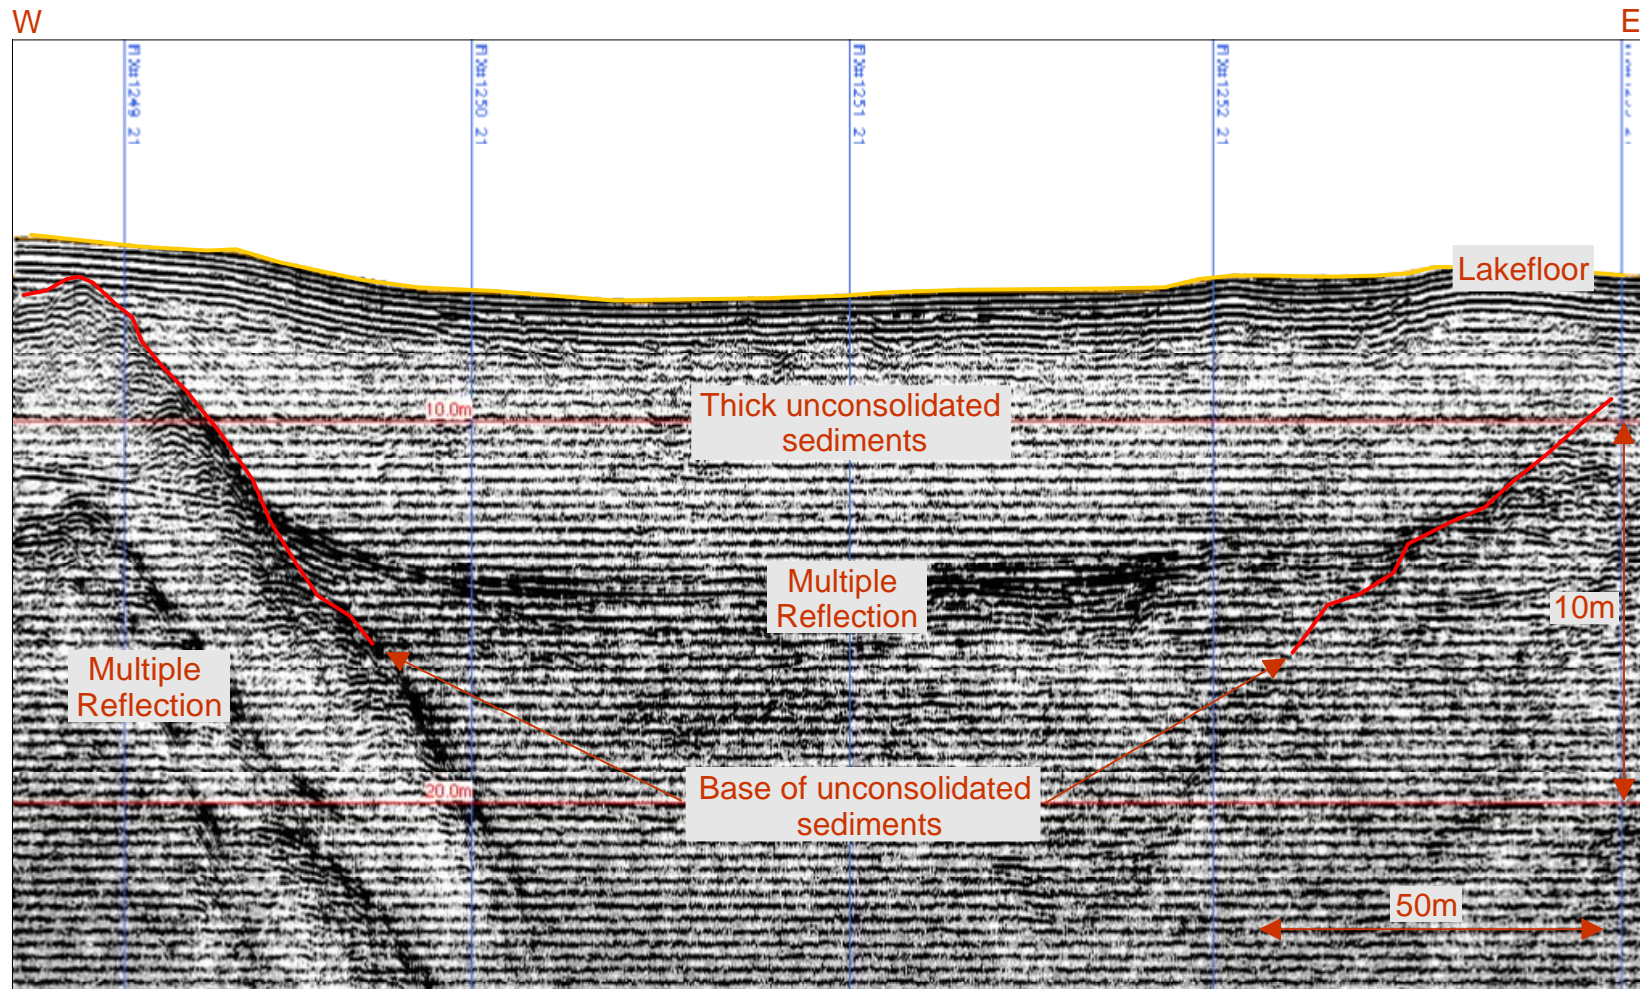
Figure 3.15 - Sub-bottom profiler image displaying thick unconsolidated sediments near the Shore of Wolfe Island.

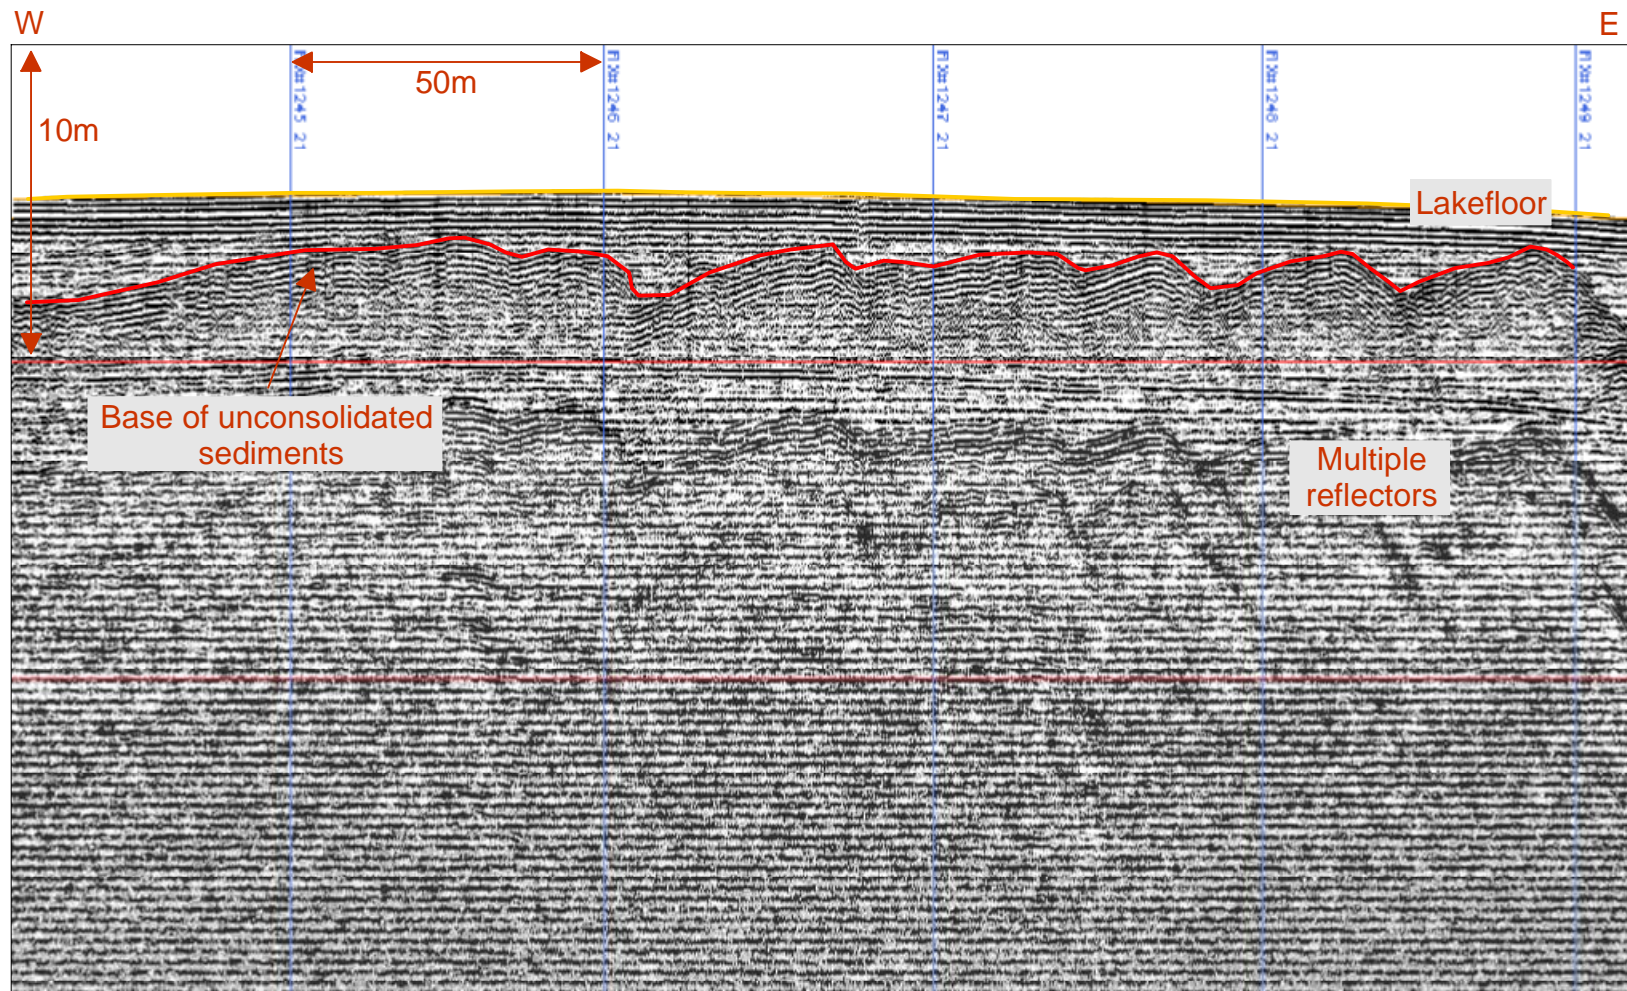
Figure 3.18 - Sub-bottom profiler image displaying the base of unconsolidated sediments reflector where it has a 'step like' appearance. It is likely that bedrock has been eroded forming the step appearance, where the height of each step is the thickness of each limestone layer.

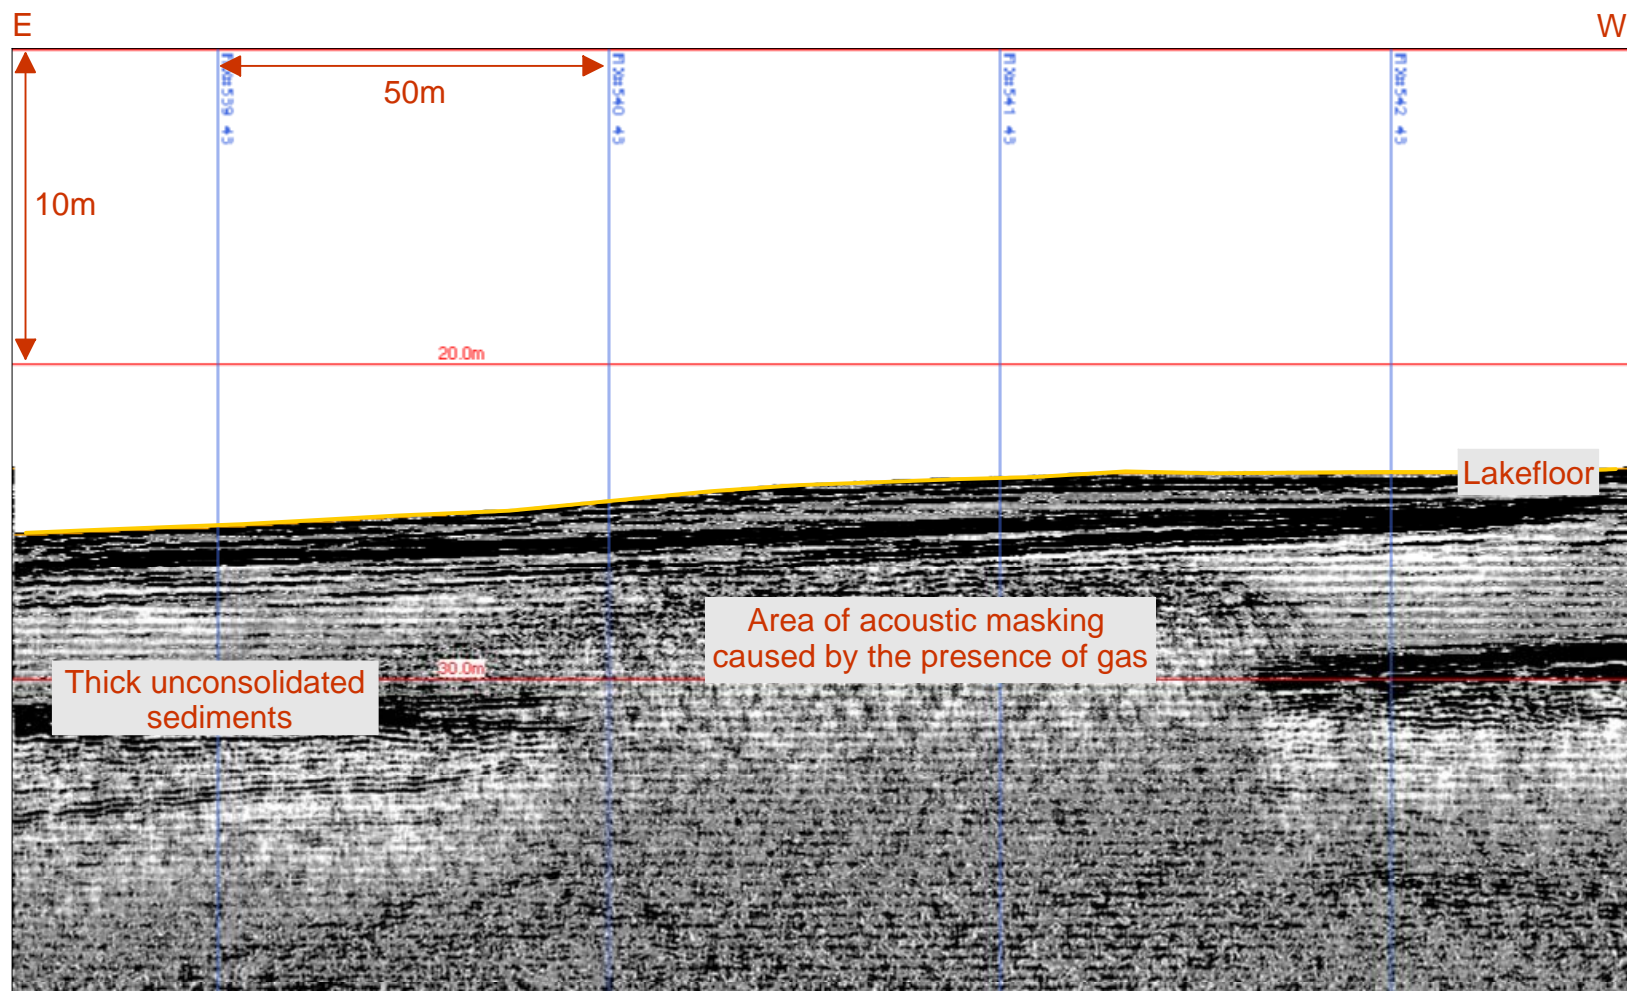
Figure 3.19 - Sub-bottom profiler image displaying acoustic masking caused by the presence of shallow gas.

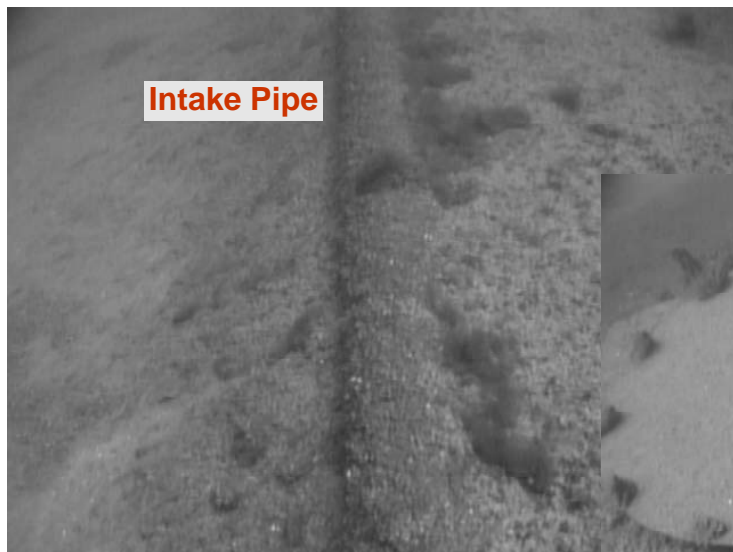
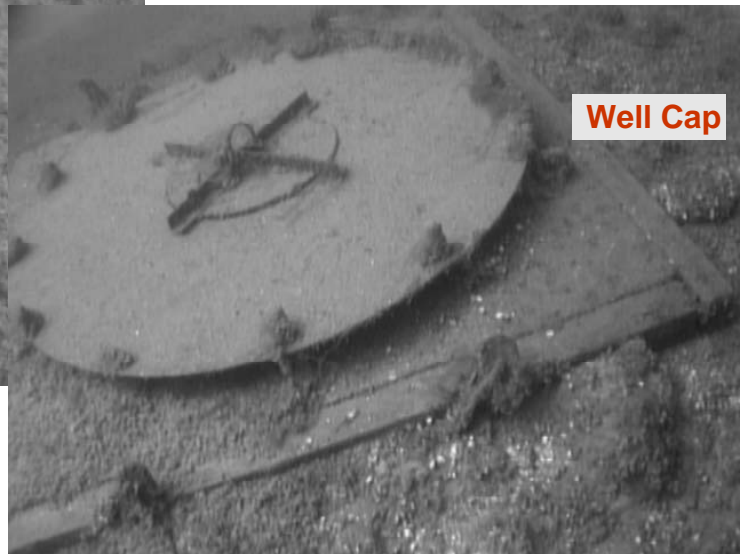
Figure 3.21 - Video still frame images of the intake pipes located east of Sand Bay. The well cap is located at the end of the western most intake pipe as shown in the top image.
