**Re: Lakeland Power Distribution Ltd
2026 IRM Interrogatory Responses
OEB File No. EB-2025-0024**

Lakeland Power Distribution Ltd.

Responses to Interrogatories from OEB, SEC and VECC

EB-2025-0024

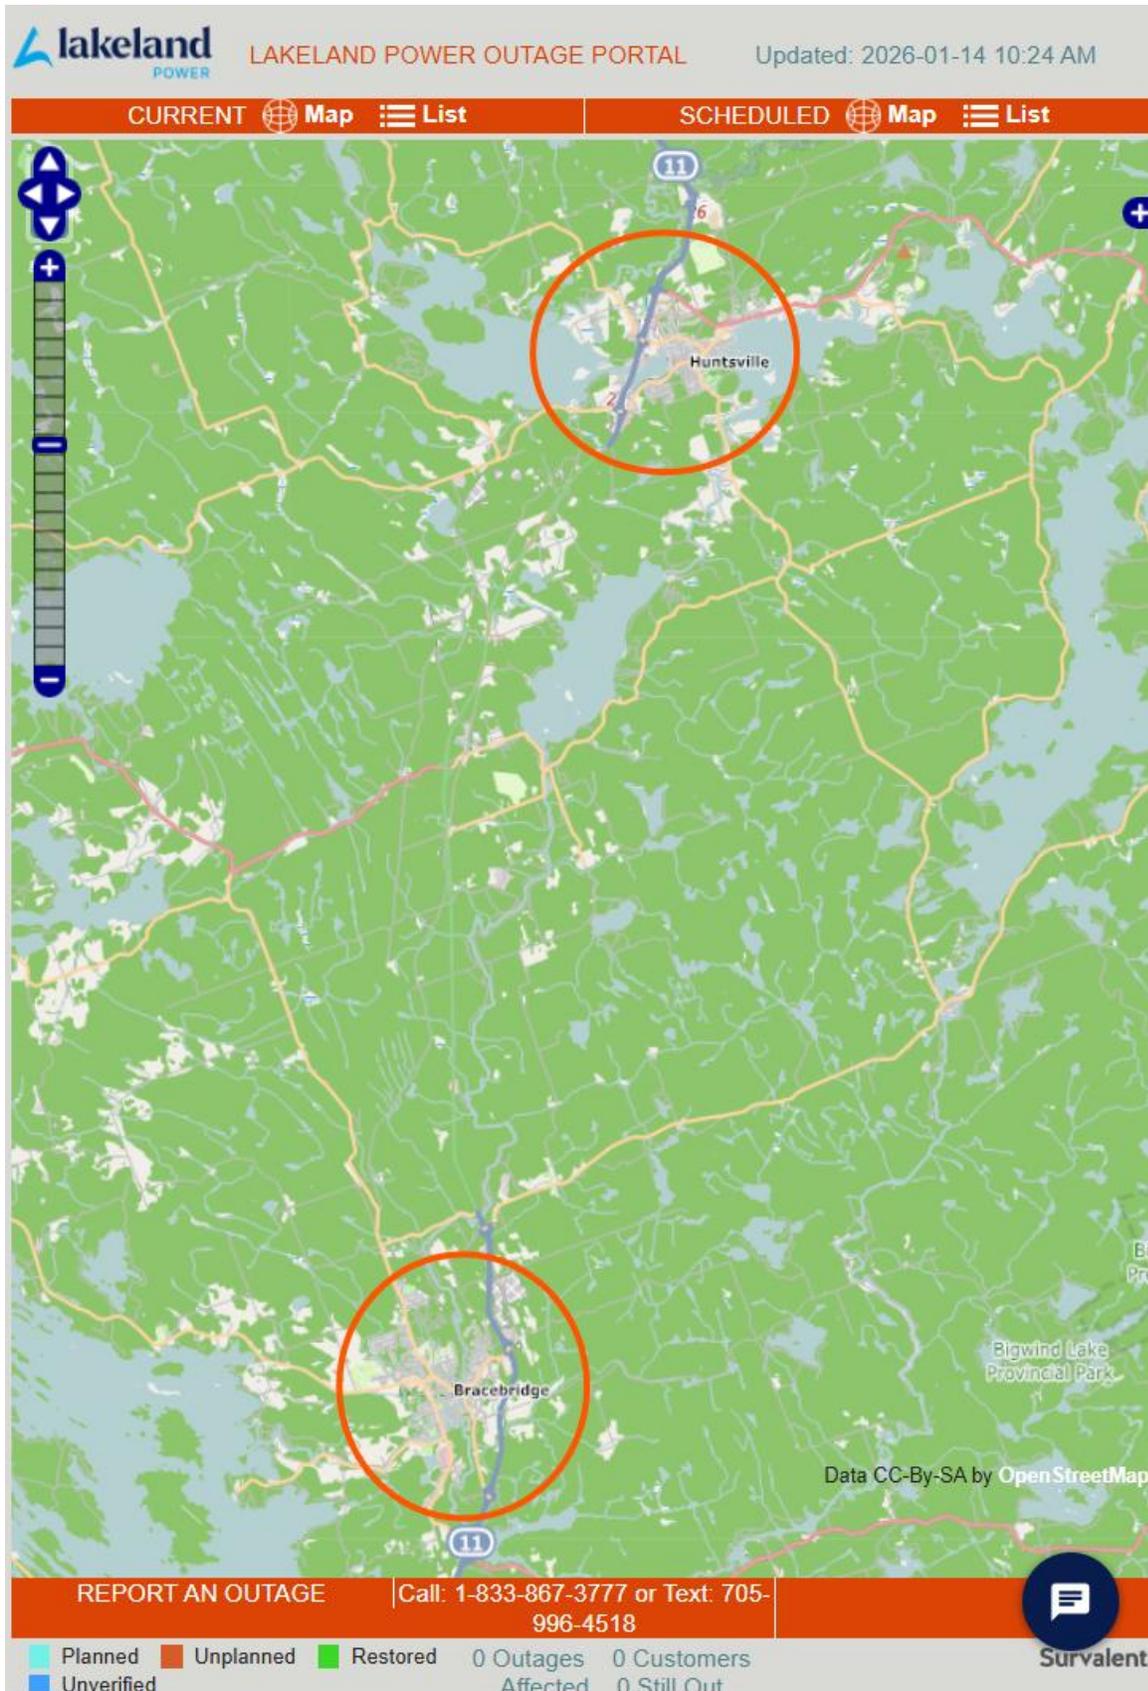
- a) A screenshot of Lakeland Power’s outage map identifying the affected areas has been provided below. 100% of Lakeland Power’s customers in Bracebridge and Huntsville were affected by the major event.

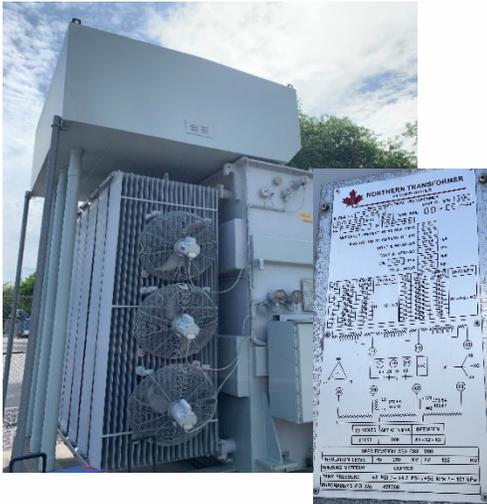
Fault Transformer and it's Nameplate:

KPC Power was called to troubleshoot the fuses blown out on the 44kV incoming pole.

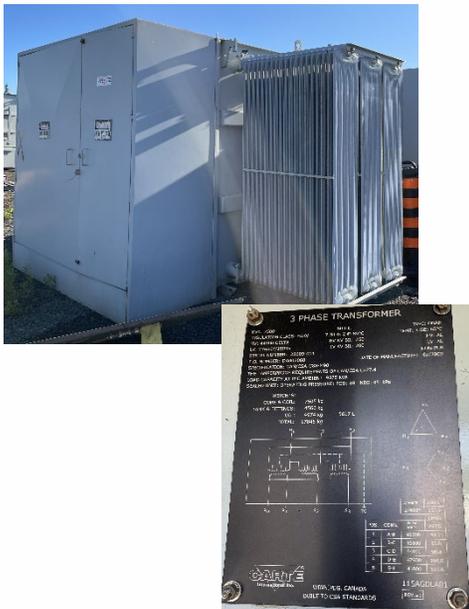
Rental Replacement Transformer and it's Nameplate:

7. KPC created a transformer switching plan and procured the materials.
8. On June 18, KPC completed temporary transformer installation.
9. During energization support on Jun.19, because of the blown PT fuses, KPC technicians conducted the Insulation Resistance test on PTs and found the failed PT ("B" phase) and removed the failed PT from cabinet.

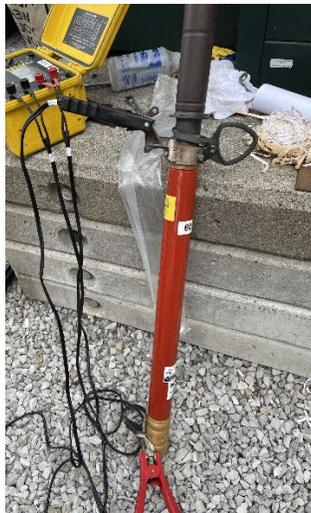
New Fuses

KPC technicians replaced the fuses and tested them with acceptable results, see Appendix 3.

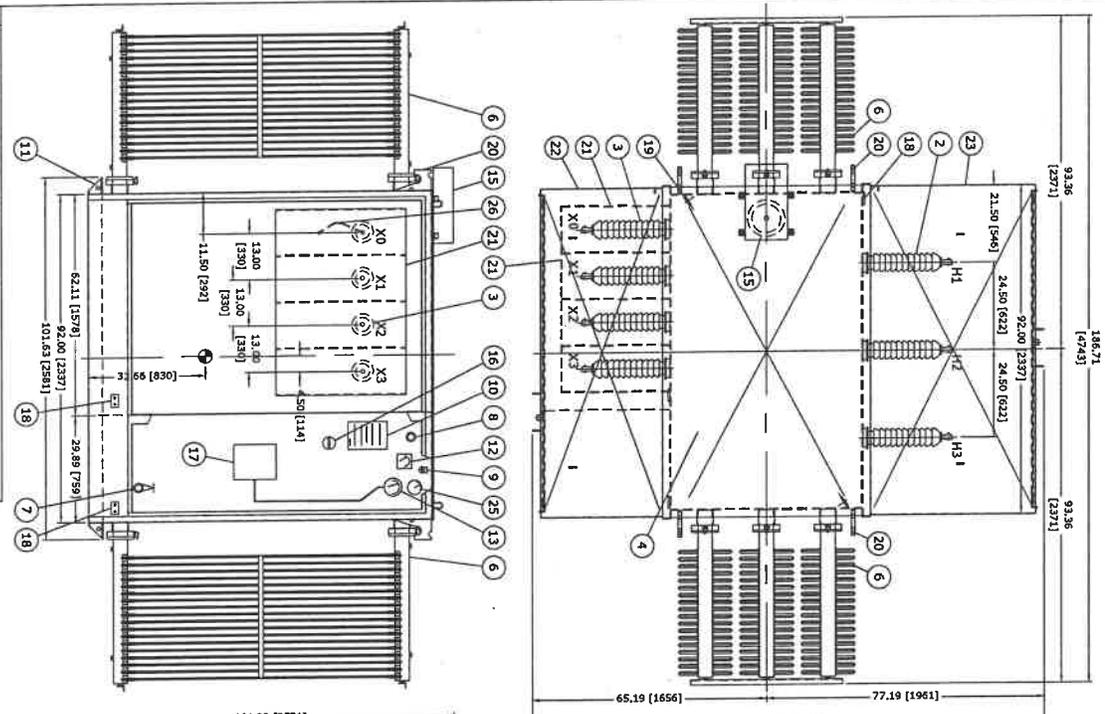
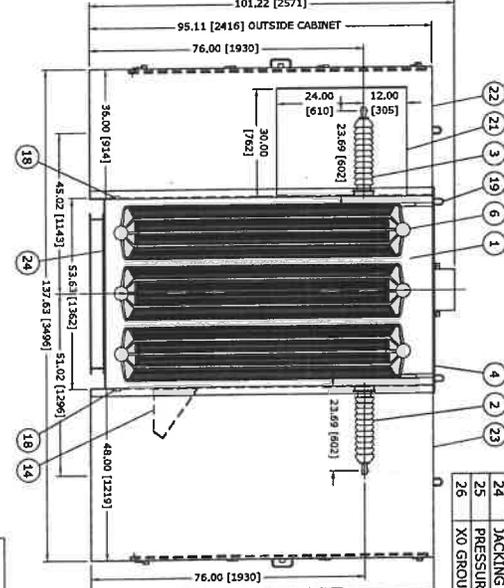
ITEM	DESCRIPTION
1	TRANSFORMER COMPARTMENT
2	PRIMARY PORCELAIN BUSHING, 46KV, 250 BIL, 208 AMP C/W 5/8" EYE
3	SECONDARY PORCELAIN BUSHING, 46KV, 250 BIL, 208 AMP, C/W 5/8" EYE
4	WELDED COVER
5	---
6	BOLT-ON RADIATORS
7	DRAIN VALVE, 1" W/SAMPLER
8	LIQUID FILL PLUG, 1"
9	PRESSURE RELIEF VALVE
10	NAMEPLATE, ALUMINUM
11	TANK SKID BASE, SUITABLE FOR SKIDDING
12	LIQUID LEVEL GAUGE
13	THERMOMETER C/W 2 CONTACTS
14	PROVISION FOR INTERMEDIATE CLASS ARRESTERS
15	LARGE PBD C/W TAMPERPROOF HOOD
16	TAP SWITCH C/W PADLOCKING FACILITIES
17	FIBREGLASS ENCLOSURE
18	3 GROUND PADS
19	COVER LIFTING LUG
20	TANK LIFTING LUG
21	INSULATING BARRIERS, C/W REMOVABLE FRONT
22	SECONDARY CABINET C/W HINGED PADLOCKABLE DOORS, BOTTOM OPENING 89"x32.5", AND 3 PENTAHED BOLTS WITH CUPWASHERS
23	C/W METAL DIVIDER PLATE AND 1/2" DOOR LOCKING BOLT FOR SECONDARY BUSHING COMPARTMENT
24	PRIMARY CABINET C/W HINGED PADLOCKABLE DOORS, BOTTOM OPENING 89"x44.5", 4 HINGES ON DOORS AND 3 PENTAHED BOLTS WITH CUPWASHER

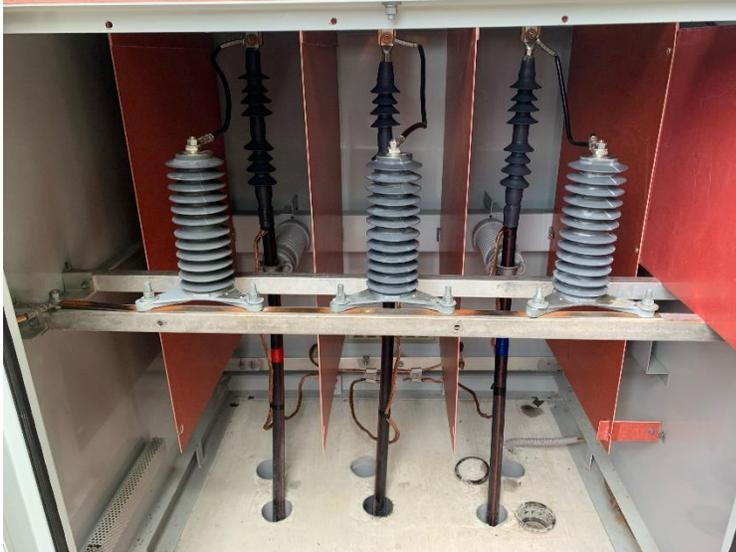
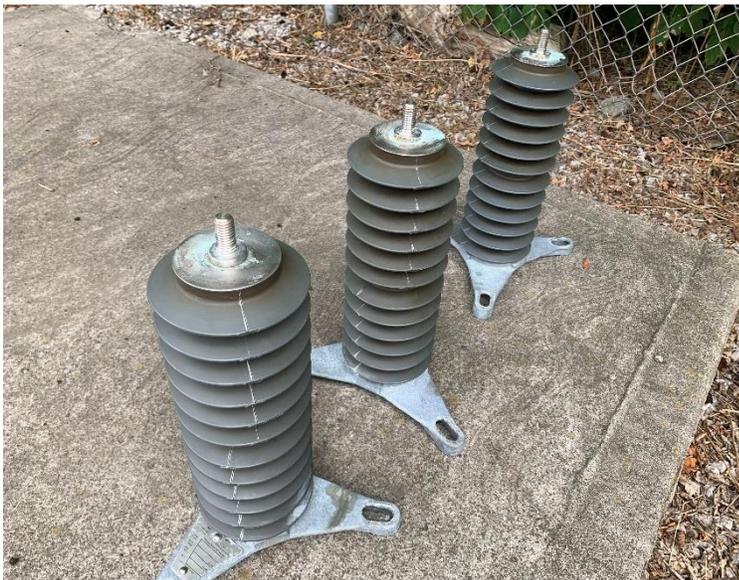
During maintenance and inspection of the Feeder 3 Surge Protection, all 3 of Feeder 3's Lightning Arresters failed Insulation Resistance testing. The three LAs were swapped out with temporary replacements.

Replace all of Feeder 3's Lightning Arresters immediately.

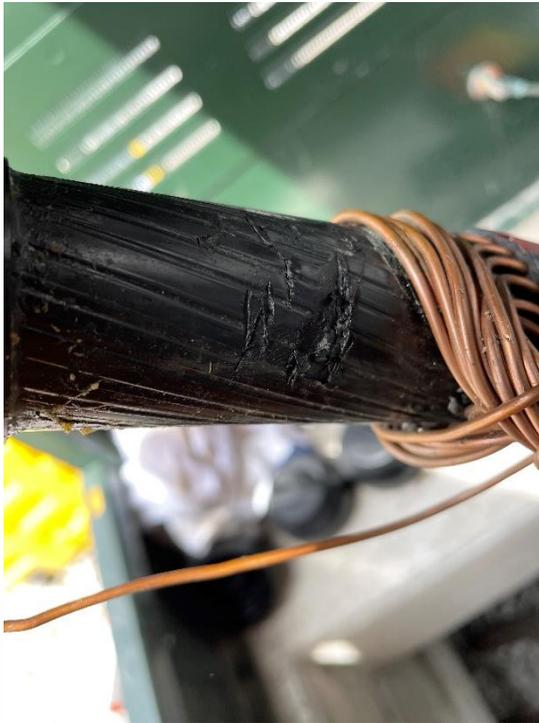
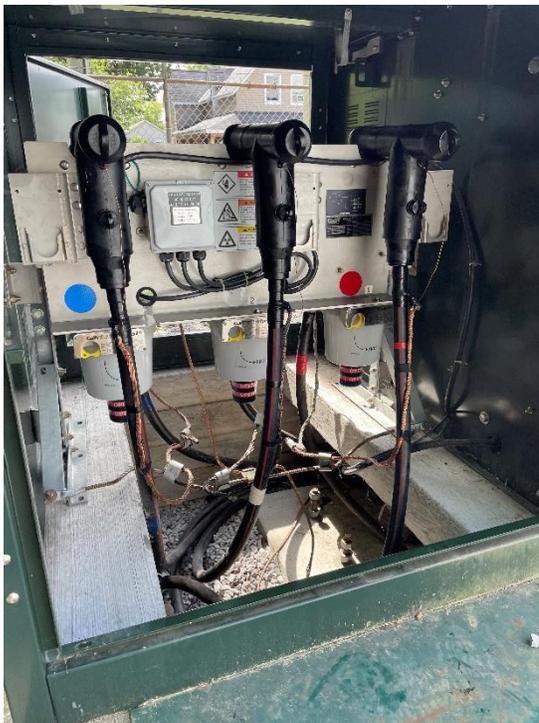
During maintenance and inspection of the Primary/Secondary Cables, KPC Technicians found damaged semi-con on all 3 phases of LR1 to Street. Rubber tape and Vinyl were applied on site.

Recommend repairing damaged semi-con on all three phases.

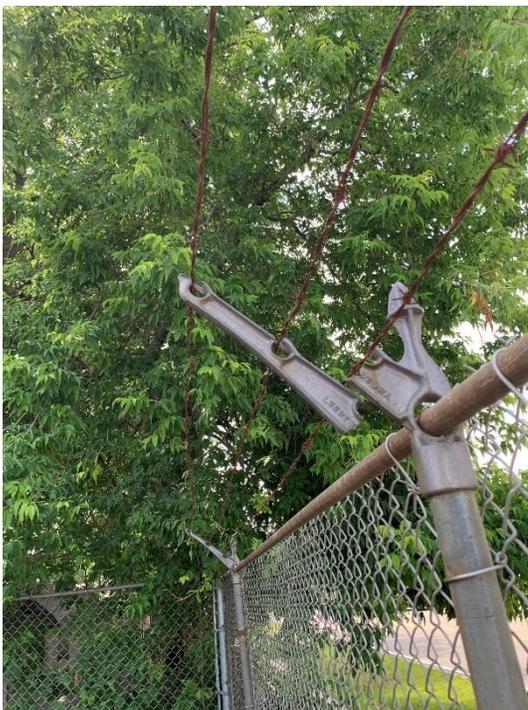
During inspection of the Main Substation Yard, it was found that the switchgear ID signs were faded, and that various barb wire were damaged.

Faded switchgear ID signs and damaged barb wire standoffs should be replaced.

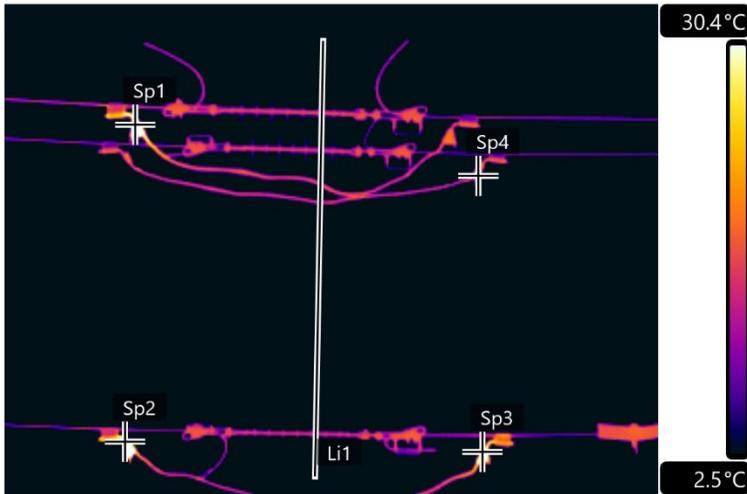
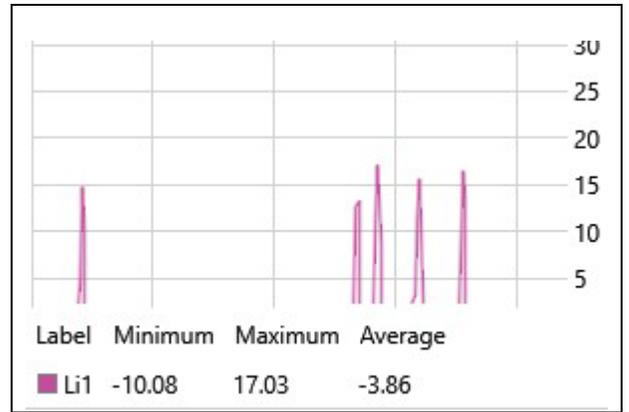
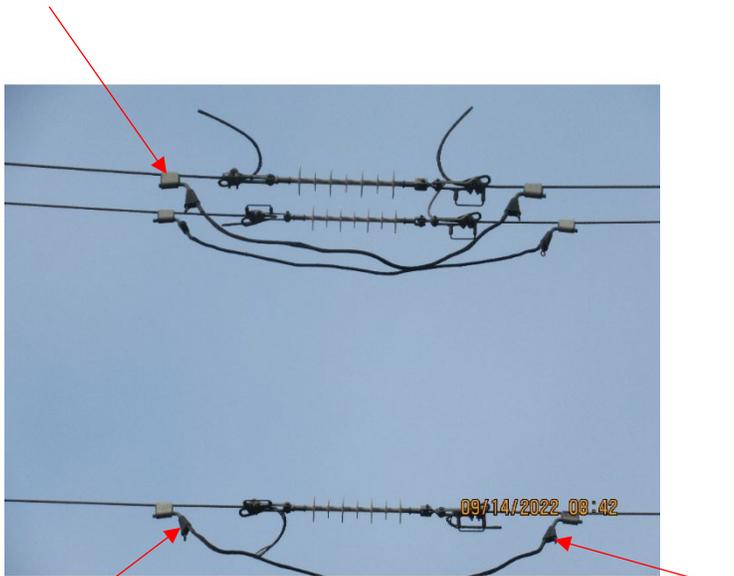
Thermal Anomaly

Image Date&Time	2022-09-14 8:43:15 AM
Image Camera Model	FLIR E75
Object Distance	6.0 m
Relative humidity	76%
Object Emissivity	0.98
Li1 Maximum	17.0 °C
Sp1	37.8 °C
Sp2	37.4 °C
Sp3	34.7 °C
Sp4	18.9 °C
Temp.Difference	18.8 °C

Client Location:	Lakeland Power – Centennial MS Substation, 109 Wellington St, Bracebridge							
Equipment location:	Centennial MS Substation, by pole 7X-657/LC-A05							
Equipment Identification:	44kV In-line Switch BRA-LLO							
Loading Amps	"A" Phase	N/A	"B" Phase	N/A	"C" Phase	N/A	Neutral	N/A
Analysis & Recommendations:								
<p>During the infrared inspection thermal variance was detected across "Blue and Red Phases" on the Ampact Wedge Connection.</p> <p>Recommendation: Replace ampact wedge connections and rescan once repairs are complete.</p>								
SEVERITY RESPONSE:	LOW	MEDIUM	HIGH	IMMEDIATE

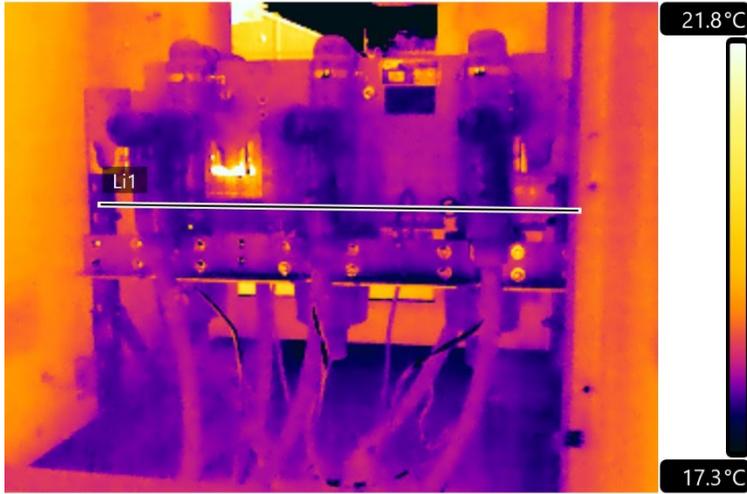
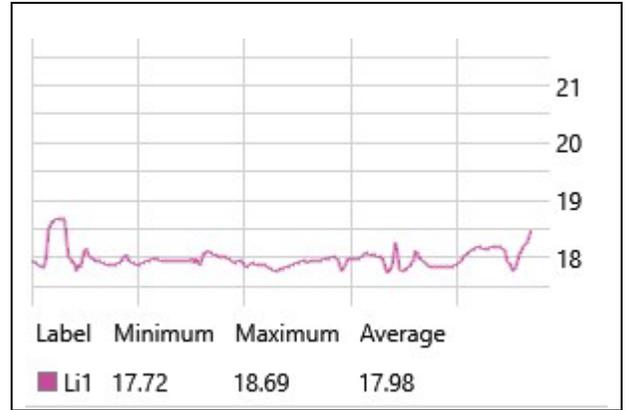
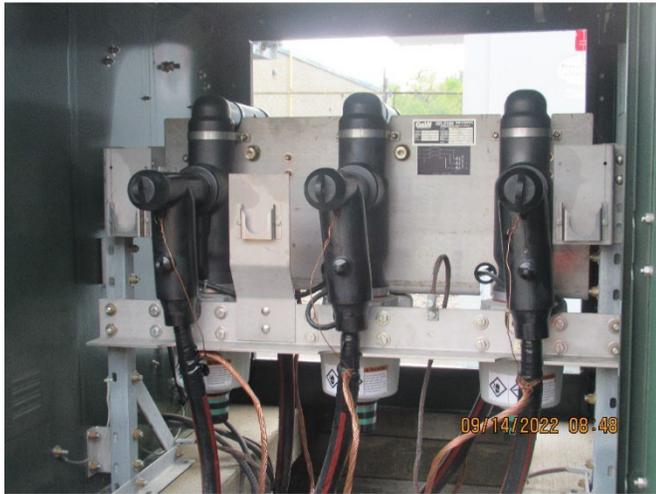
Thermal Reference Images

Image Date&Time	2022-09-14 8:49:08 AM
Image Camera Model	FLIR E75
Object Distance	2.0 m
Relative humidity	76%
Object Emissivity	0.98
Li1 Maximum	18.7 °C

Client Location:	Lakeland Power – Centennial MS Substation, 109 Wellington St, Bracebridge							
Equipment location:	Centennial MS Substation							
Equipment Identification:	27.6kV Recloser CENT-LR1, street side							
Loading Amps	"A" Phase	N/A	"B" Phase	N/A	"C" Phase	N/A	Neutral	N/A
Analysis & Recommendations:	During the infrared inspection no thermal anomalies detected. The above images are for reference only.

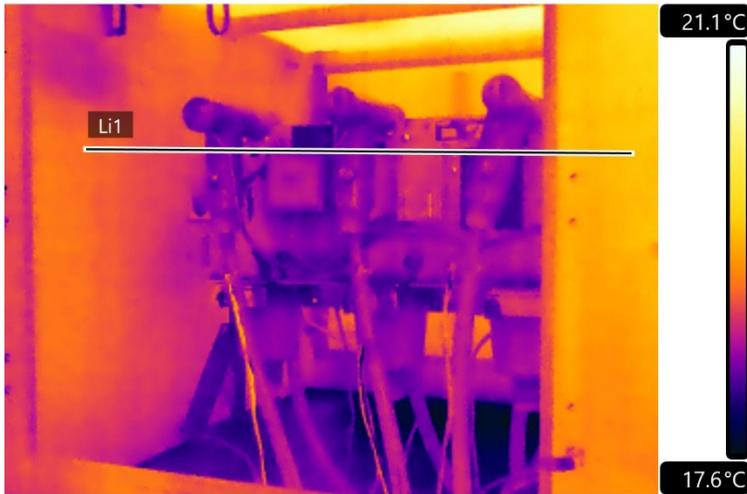
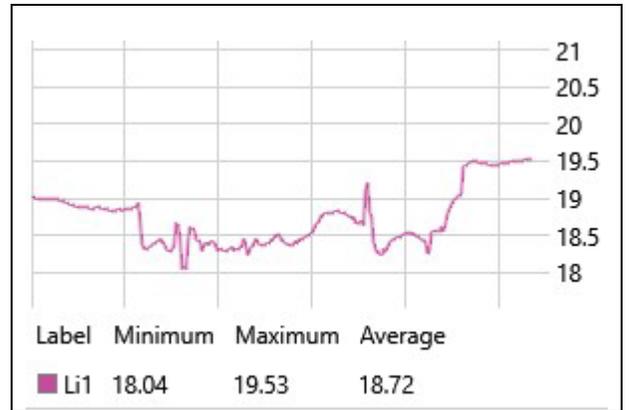
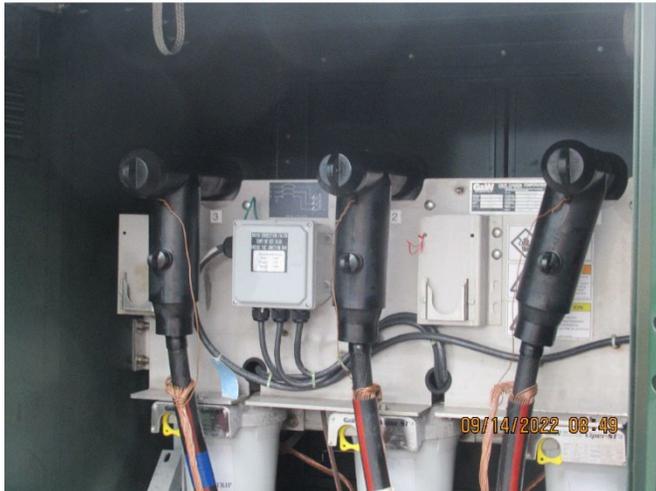
Image Date&Time	2022-09-14 8:50:54 AM
Image Camera Model	FLIR E75
Object Distance	2.0 m
Relative humidity	76%
Object Emissivity	0.98
Li1 Maximum	19.5 °C

Client Location:	Lakeland Power – Centennial MS Substation, 109 Wellington St, Bracebridge							
Equipment location:	Centennial MS Substation							
Equipment Identification:	27.6kV Recloser CENT-LR1							
Loading Amps	"A" Phase	N/A	"B" Phase	N/A	"C" Phase	N/A	Neutral	N/A
Analysis & Recommendations:								
During the infrared inspection no thermal anomalies detected. The above images are for reference only.

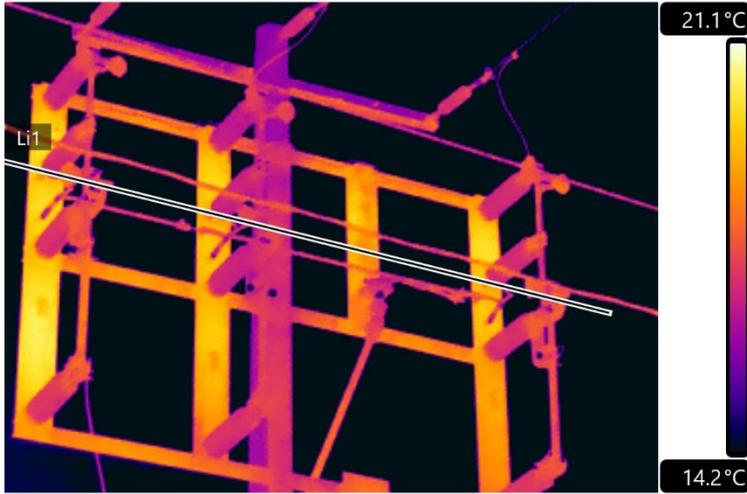
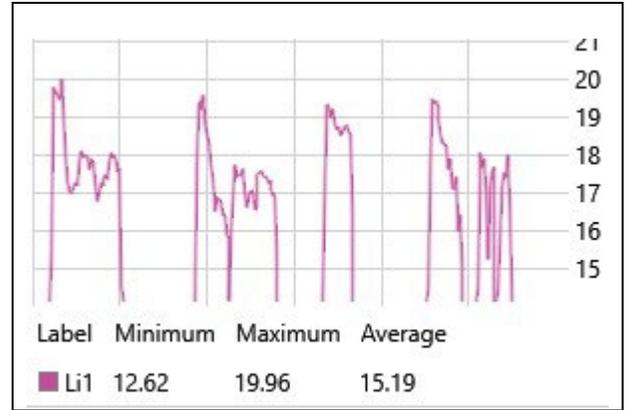
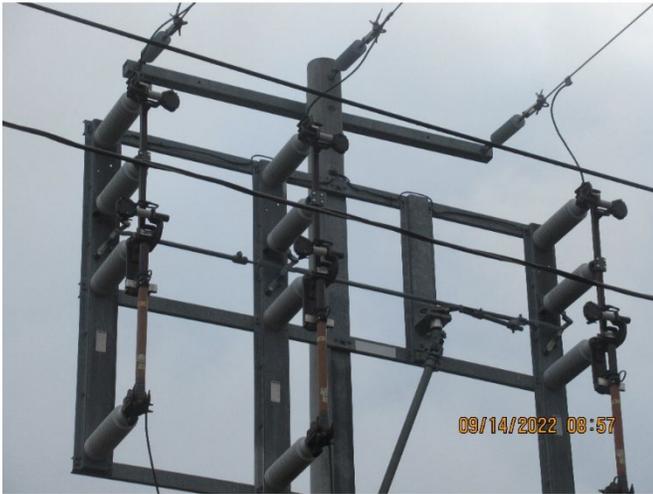
Image Date&Time	2022-09-14 8:58:07 AM
Image Camera Model	FLIR E75
Object Distance	6.0 m
Relative humidity	76%
Object Emissivity	0.98
Li1 Maximum	20.0 °C

Client Location:	Lakeland Power – Centennial MS Substation, 109 Wellington St, Bracebridge							
Equipment location:	Centennial MS Substation							
Equipment Identification:	44kV Air Breake Switch CENT-LBS							
Loading Amps	"A" Phase	N/A	"B" Phase	N/A	"C" Phase	N/A	Neutral	N/A
Analysis & Recommendations:								
During the infrared inspection no thermal anomalies detected. The above images are for reference only.

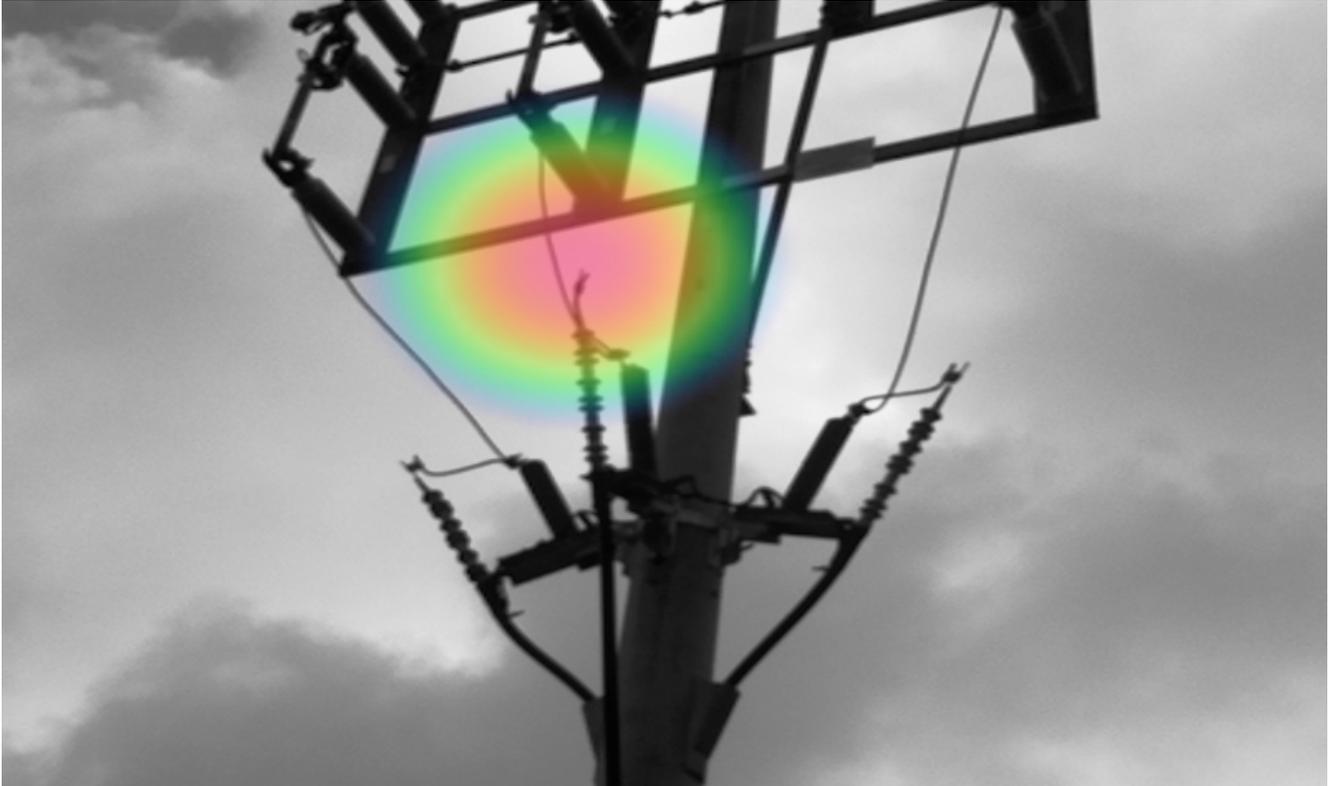
Partial Discharge Report

Snapshots	1
Minimum level	9.2 dB
Maximum level	9.2 dB
Snapshots without results	0
