March 4, 2021

Re: Enbridge Gas Inc. (Enbridge Gas)
Ontario Energy Board (OEB) File: EB-2020-0293
St. Laurent Ottawa North Replacement Project – New and Updated Evidence

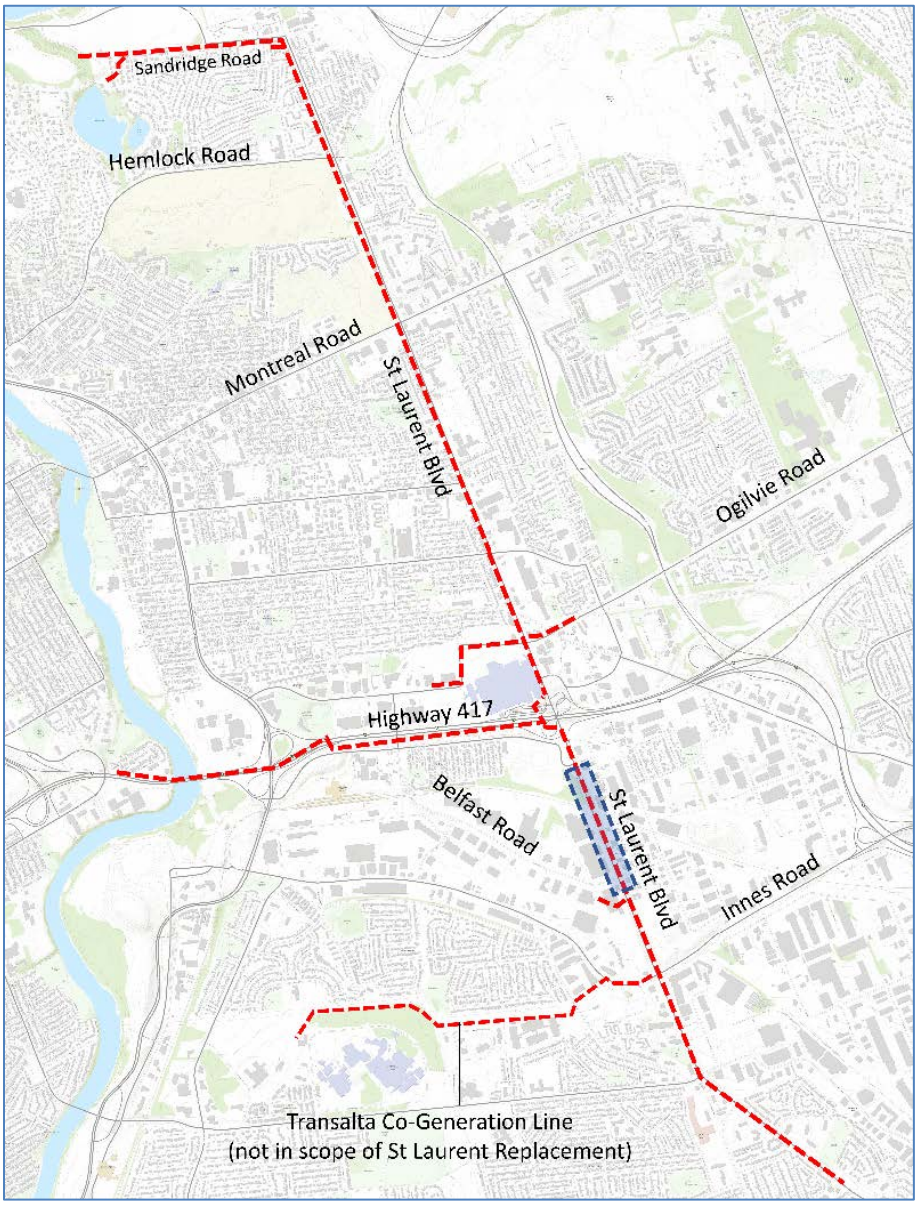
Figure 4: Location of the 2006 GPRIP Survey

27. 2006 GPRIP: The 2006 GPRIP utilized ground penetrating radar technology to identify potential corrosion defects. A portion of the St. Laurent Pipeline was surveyed using this technology. The pipeline surveyed was located just south of Tremblay Road. Figure 4 shows the location of the pipeline surveyed. As a result of the GPRIP work the Company hired Acuren Group Inc. (Acuren) to conduct an inspection of the segment of pipeline surveyed. This inspection found heavy pitting on the segment of gas main surveyed. Figure 5 shows the pitting found on /U

the gas main. The segment of the gas main exhibiting heavy pitting was cut out and replaced.

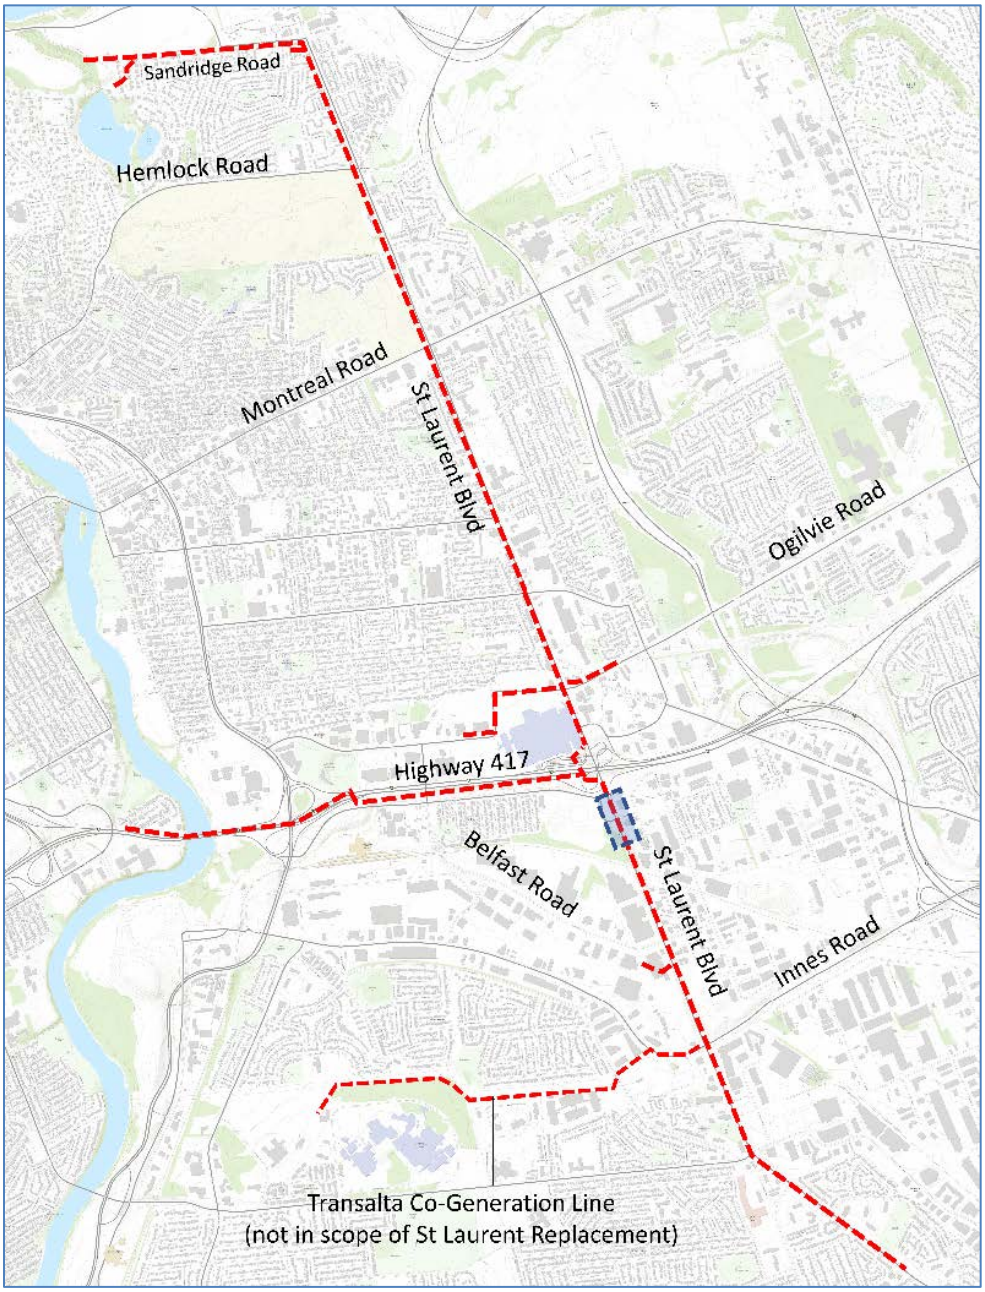
Figure 6: Location of the 2013 Main Repairs

29. 2013 Main Repairs: In 2013 several leaks were discovered on laterals near the intersection of Tremblay Road and St. Laurent Boulevard. These leaks were directly related to field applied coatings, failed installation welds and poor internal fusion. Enbridge Gas hired Acuren to conduct an inspection of the gas main in order to determine the condition of the pipeline. Figure 6 provides a map of the location of the leaks. Figure 7 provides examples of failed installation welds and poor internal fusion. These issues are all common to installation practices of the 1950's and 1960's. Attachment 3 sets out Acuren's report /U

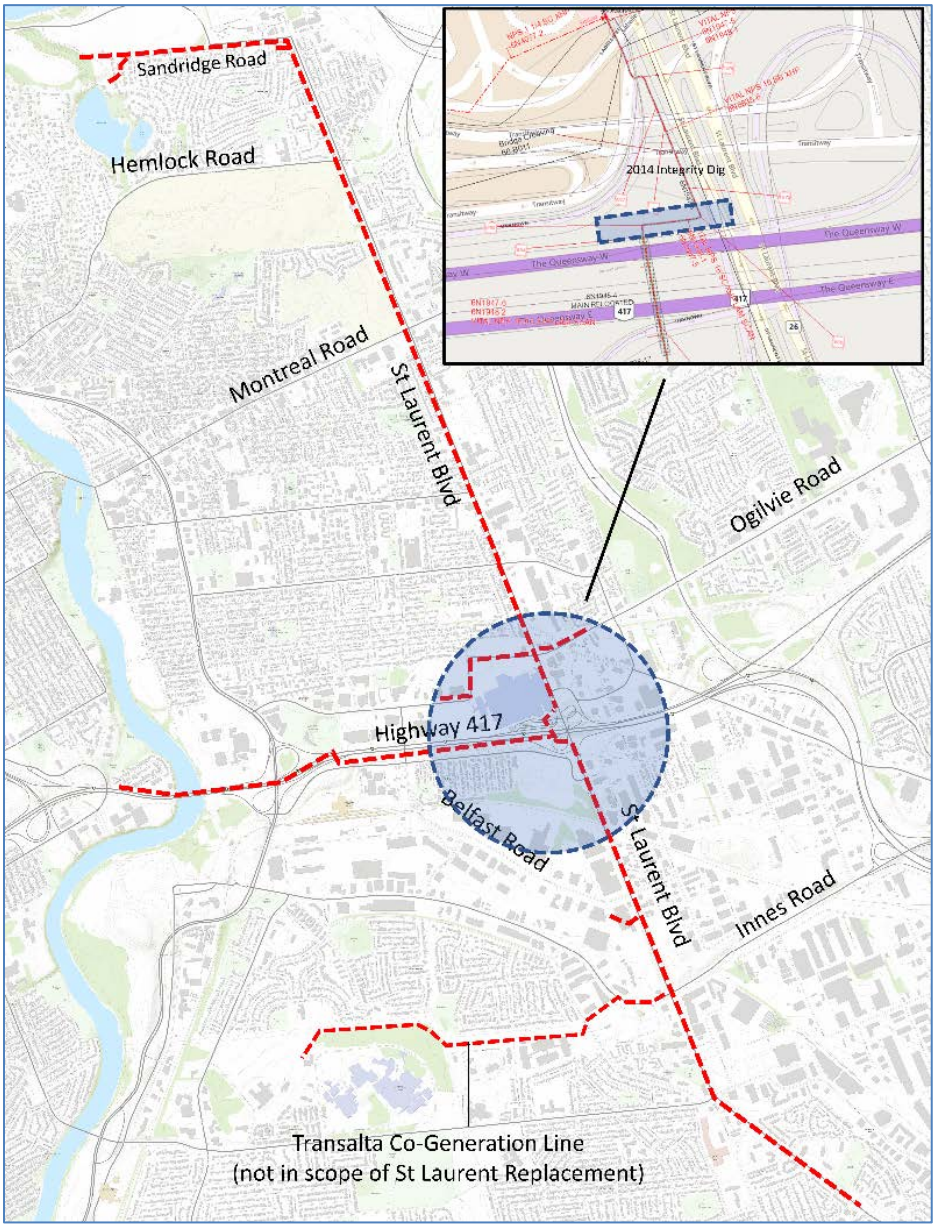
Figure 8: Location of the 2014 Integrity Dig

32. 2014 Integrity Dig: In early 2014 Enbridge Gas was contacted by a third-party hydro-vac excavator performing work for another contractor. The work being performed by the hydro-vac excavator was unrelated to any Enbridge Gas work. The third-party indicated that they had noticed a number of gouges and dents on the NPS 16 XHP ST gas main at St. Laurent Boulevard and Highway 417. Figure 8 shows the location of the 2014 Integrity Dig. Figure 9 shows examples of damage to the gas main. Upon inspection it was determined that the gas main was damaged due to third-party excavation at some point in time after the initial installation of the gas main. Enbridge Gas hired Acuren to conduct an inspection of the gas main in order to determine the condition of the pipeline. Acuren's reports are set out at Attachment 4 and Attachment 5 to this Exhibit. These reports indicated there were: /U

were repaired using sleeves. One feature was a smooth plain dent with no metal loss, linear indication or other stress concentrator, and was therefore assessed as acceptable to be recoated and left in service. Six features were assessed as acceptable to recoat after grinding to repair the feature.

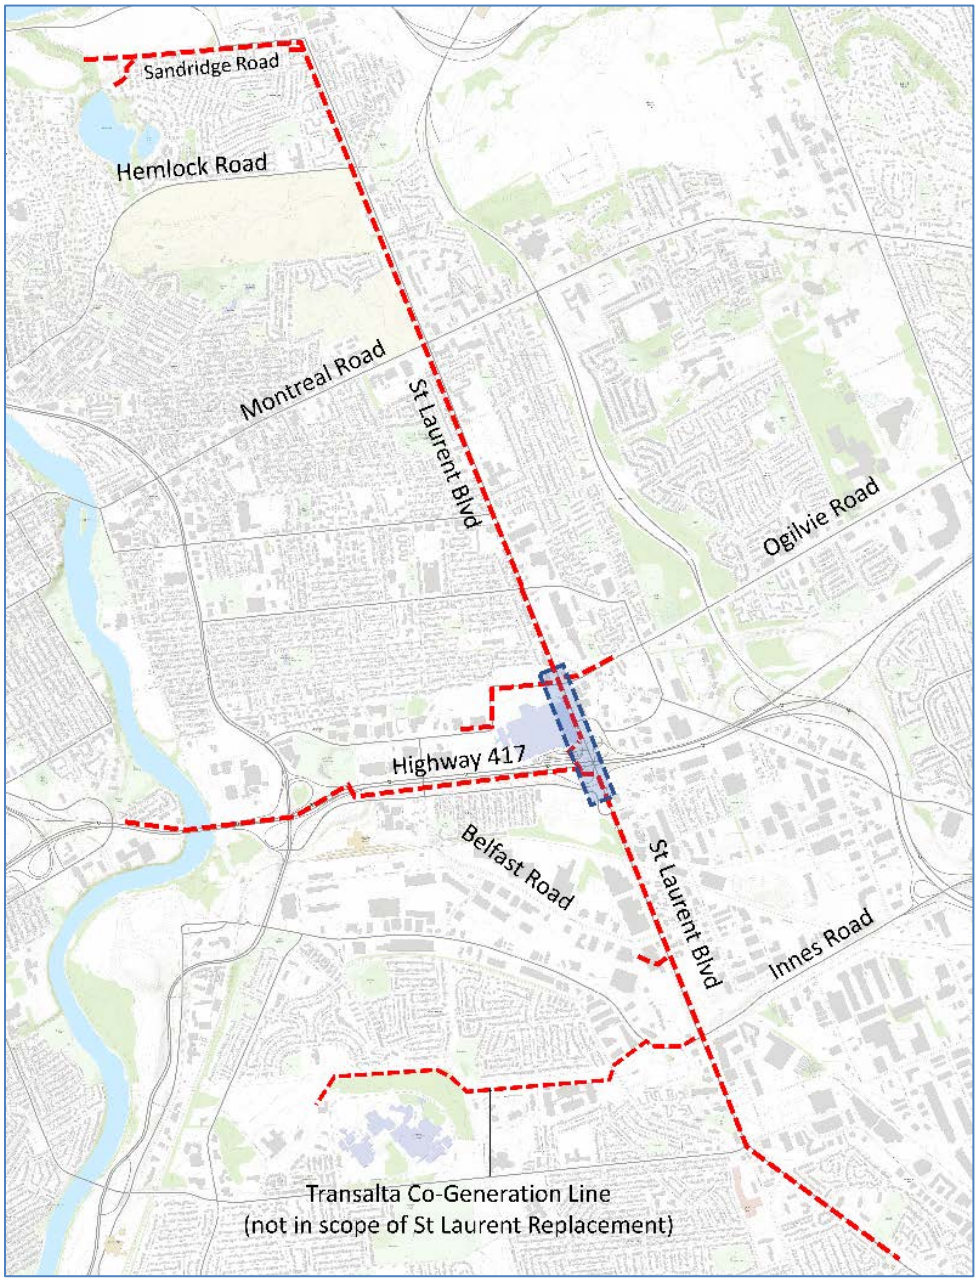
Figure 10: Location of the 2016 NPS 16 Bridge Crossing Inspection

35. 2016 Bridge Inspection: As part of Enbridge Gas's regular bridge crossing inspection program, a visual inspection was completed on the pipeline crossing the OC Transitway Bus Corridor just north of Highway 417 along St. Laurent Boulevard. Severe corrosion was identified at the north and south end of the NPS 16 XHP main where the pipeline surfaces. At both of these locations, a pipeline anchor is installed and it is unclear whether the pipeline or anchor sleeves are corroding. Figure 10 shows the location of the 2016 NPS 16 Bridge Crossing Inspection. Figure 11 shows pictures of the bridge crossing at the north and south ends of the bridge where the pipeline comes out of the ground. Attachment 6 sets out the bridge crossing inspection report and additional pictures showing the condition of the pipeline /U

36. Corrosion concerns along the pipeline are described in greater detail below. At this location, the corrosion to the above ground pipeline and/or pipeline anchor could be accelerated due to environmental conditions, such as road salt accumulating around the pipeline and pipeline anchor at ground level. This area of concern will continue to be monitored in accordance with Enbridge Gas's bridge crossing inspection program until the pipeline can be replaced.

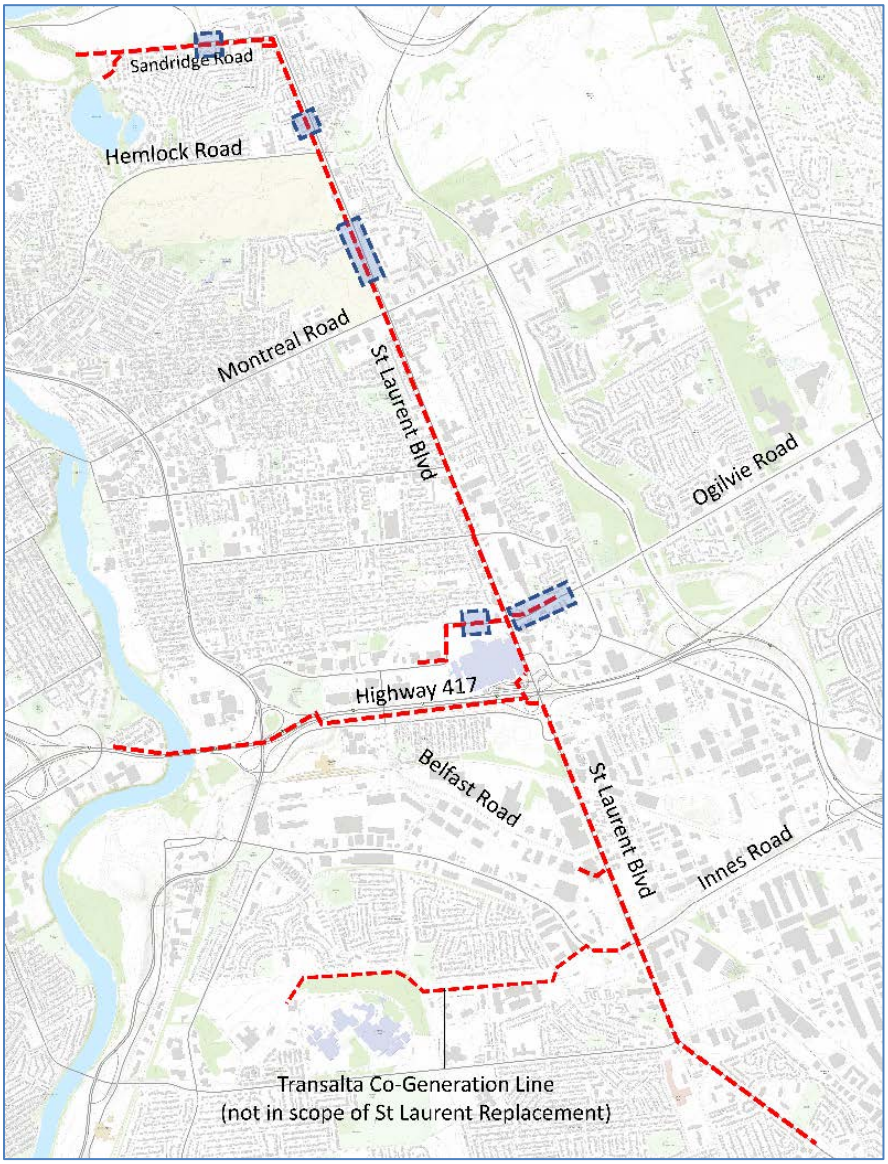
Figure 12: Location of Depth of Cover Issues Per 2017 Survey

37. 2017 Survey: In 2017 Enbridge Gas hired G-Tel Engineering (G-Tel) to complete a Depth of Cover survey. The entirety of the St. Laurent Pipeline was surveyed to identify areas of concern with shallow depth of cover. Figure 12 shows where shallow depth of cover issues were discovered, and Table 4 summarizes the extent of the shallow cover. Attachment 7 provides the results of the survey work completed by G-Tel

38. Natural gas pipelines are installed to meet or exceed applicable minimum regulatory requirements at the time of construction. In some instances, cover over a pipeline may be altered due to excavation activities, erosion, construction, flooding, ground subsidence or other environmental factors or human intervention. Over time low or no depth of cover can increase the risk of third-party damages

(constructors believing there is more cover than what is actually there). In addition, in areas where a pipeline is installed under roads, weight transfer from large vehicles and heavy equipment moving over a pipeline can also increase the risk of damages. Depth of cover also plays an important role in ensuring the safety and integrity of compression couplings that were used to mechanically join pipe sections together.

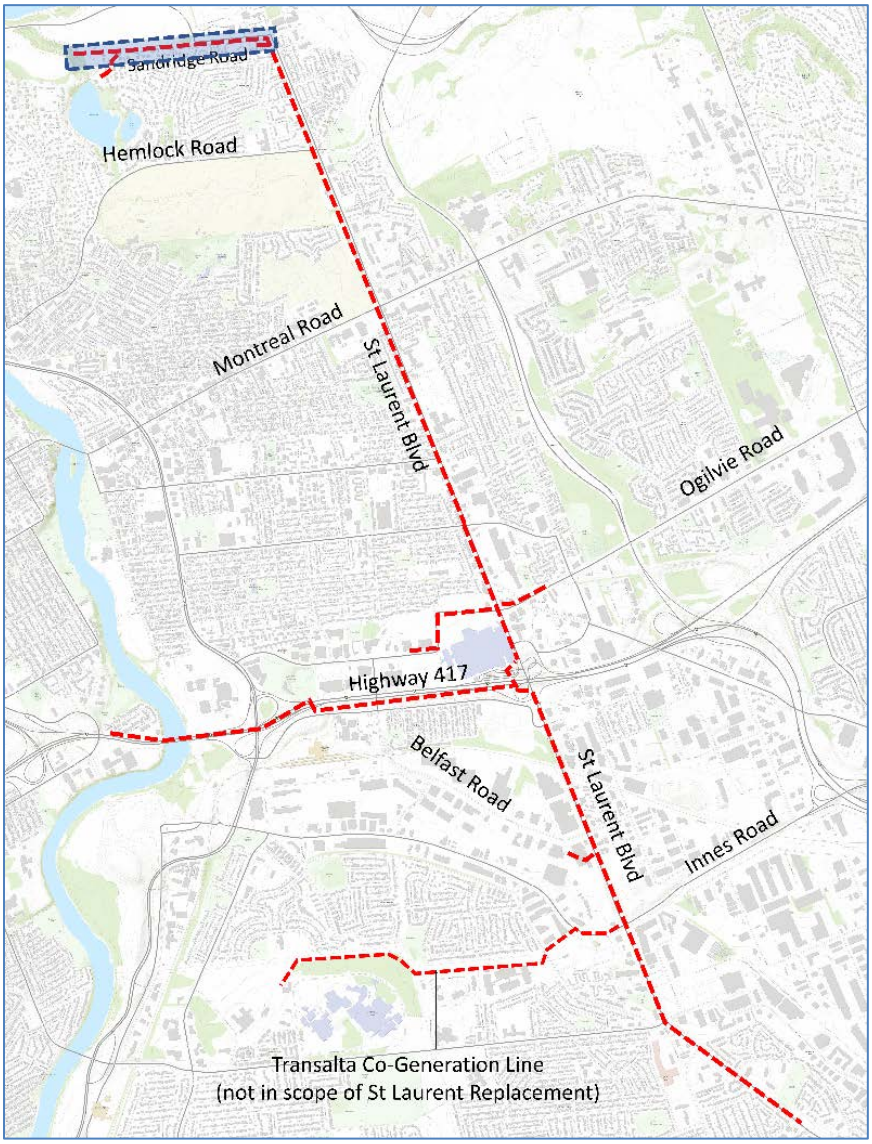
Figure 13: NPS 12 XHP ST Main on Sandridge Road
(Between Hillsdale Road and St. Laurent Boulevard)

43. The segments of the St. Laurent Pipeline exhibiting areas of shallow cover that were identified as part of the 2018 Inspection are listed in Table 5.

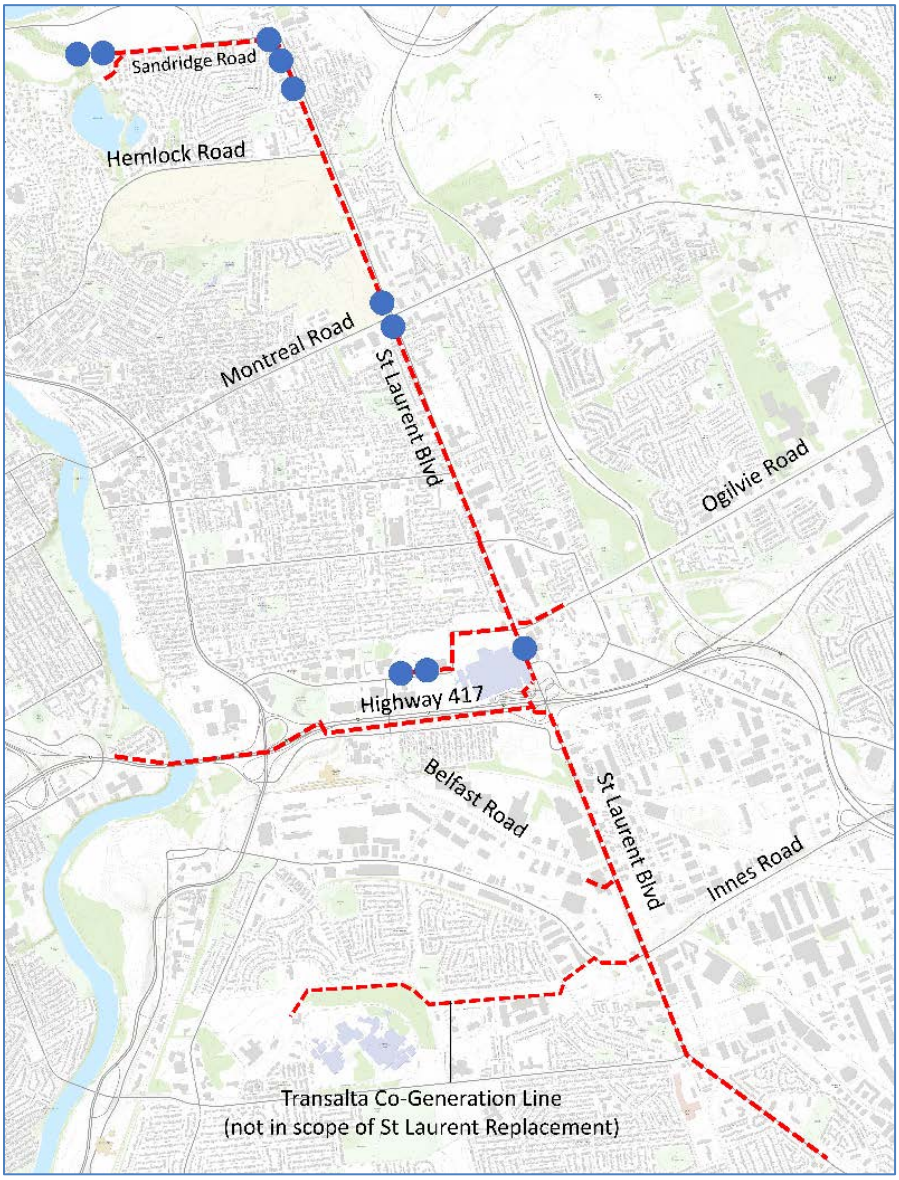
Figure 15: Compression Couplings on the St. Laurent Pipeline

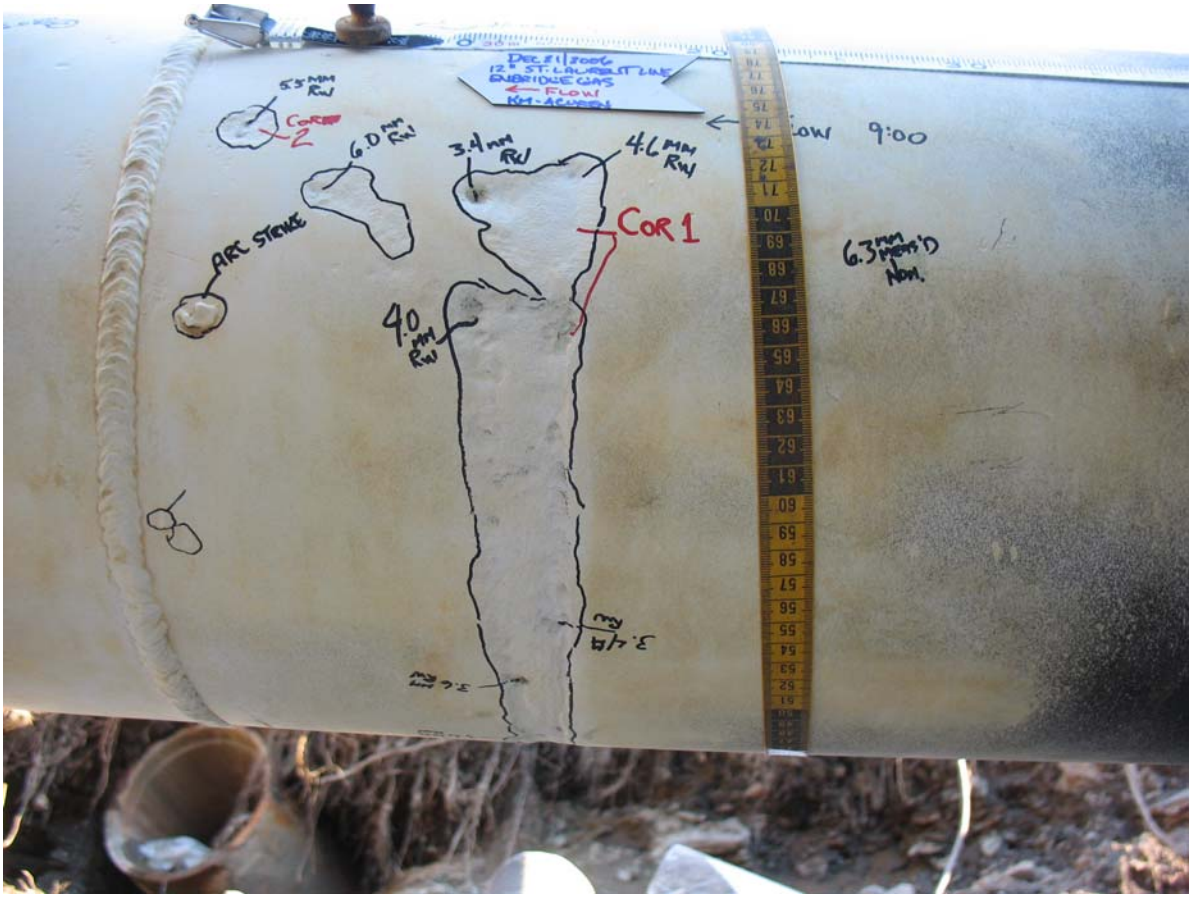
02 - Corrosion 1 0.9mm remaining wall thickness
12 St. Laurent RR Xing

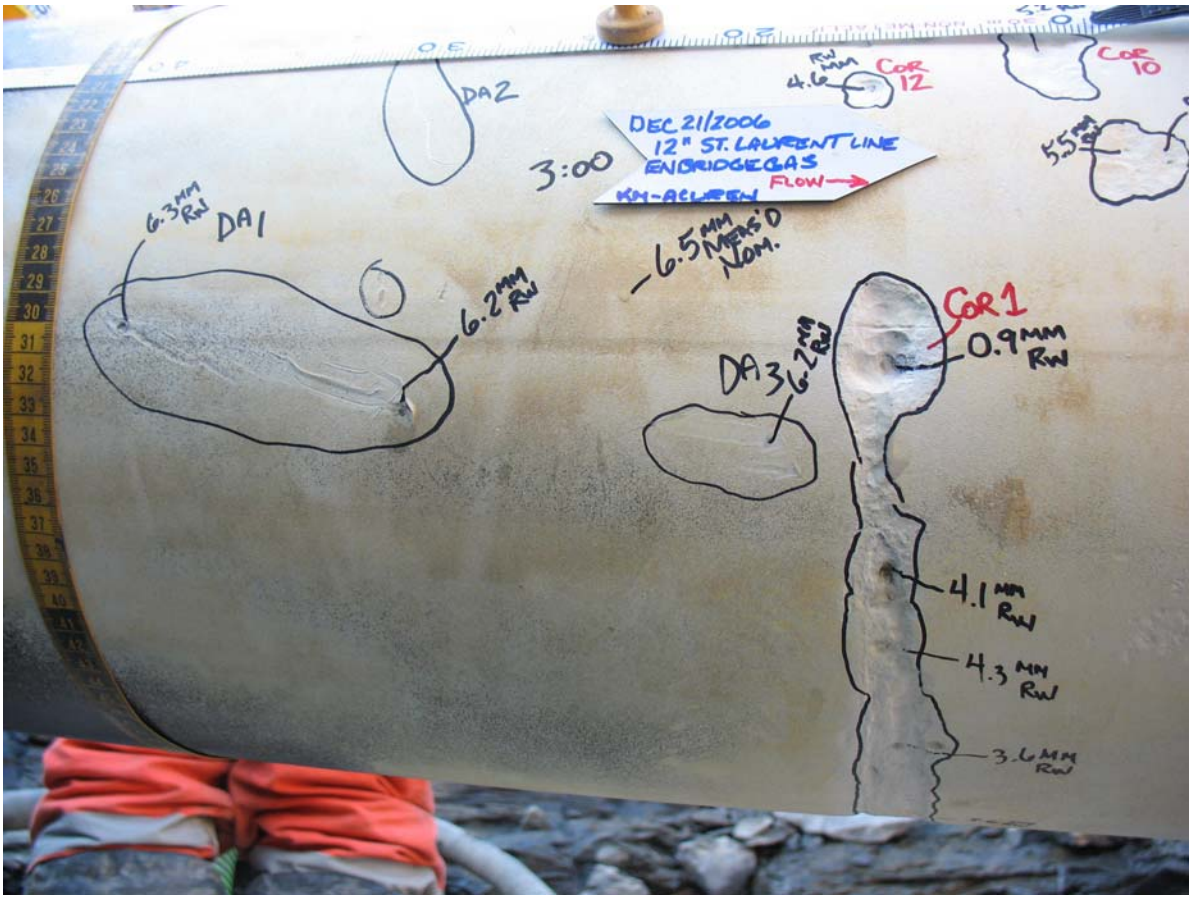
10 - Dent found to be 2mm deep
12 St. Laurent RR Xing

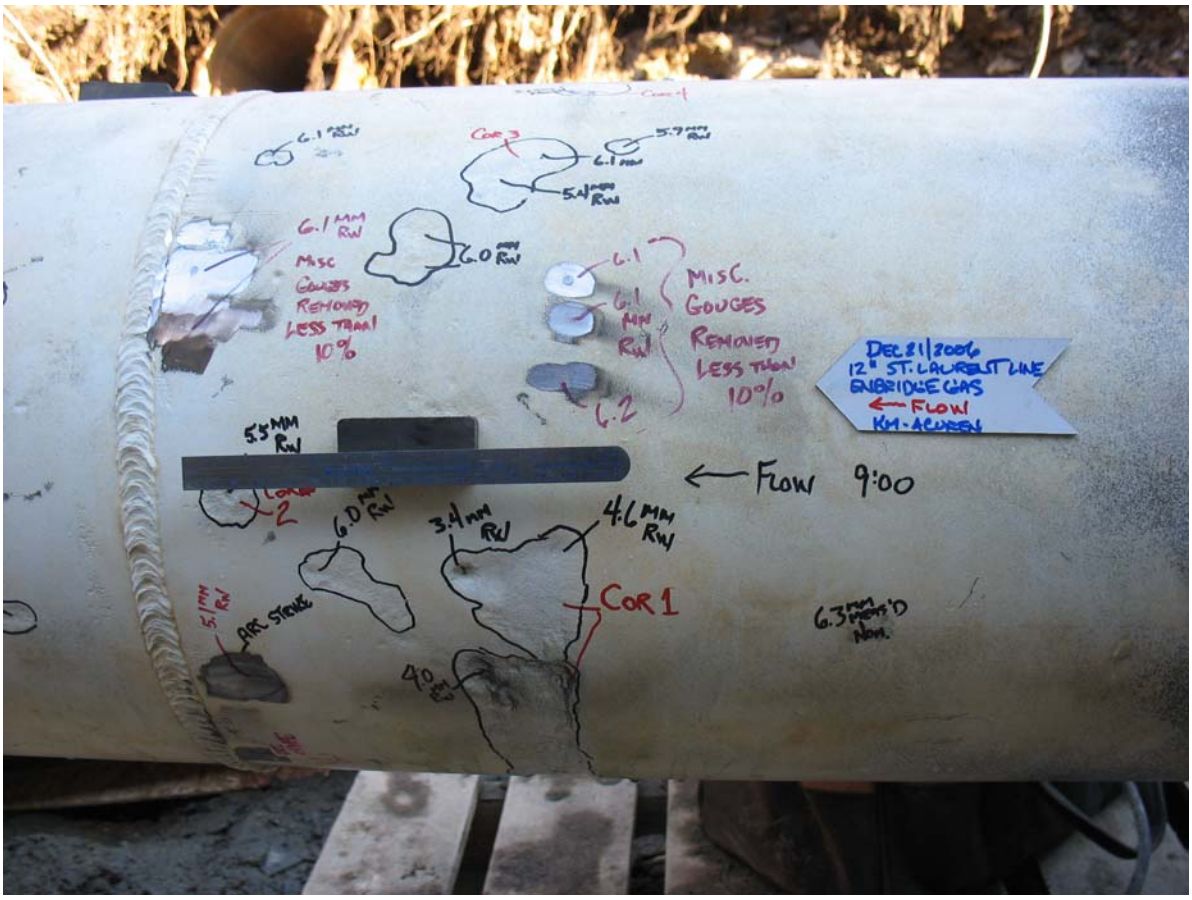
17 - Grind repair multiple arc strike and scrape locations

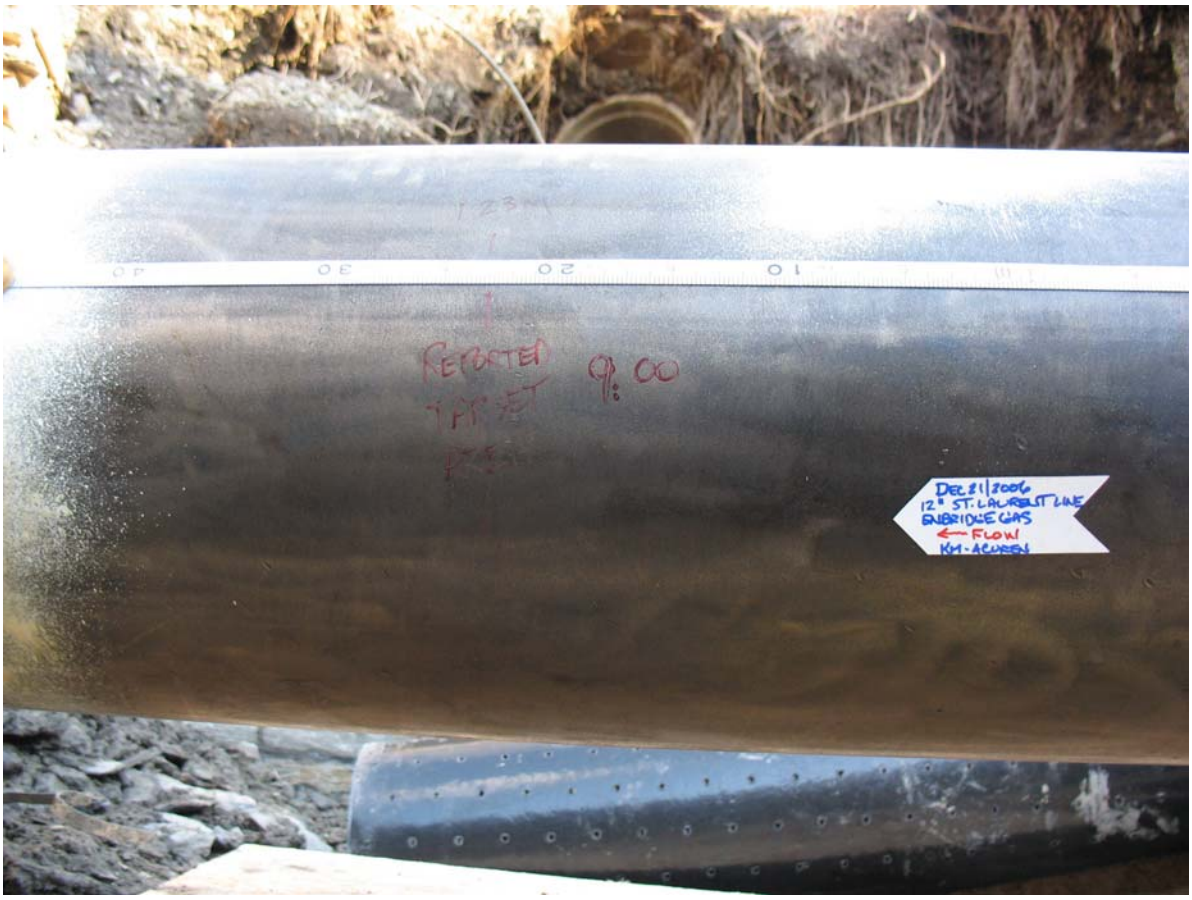
19 - Reported target area

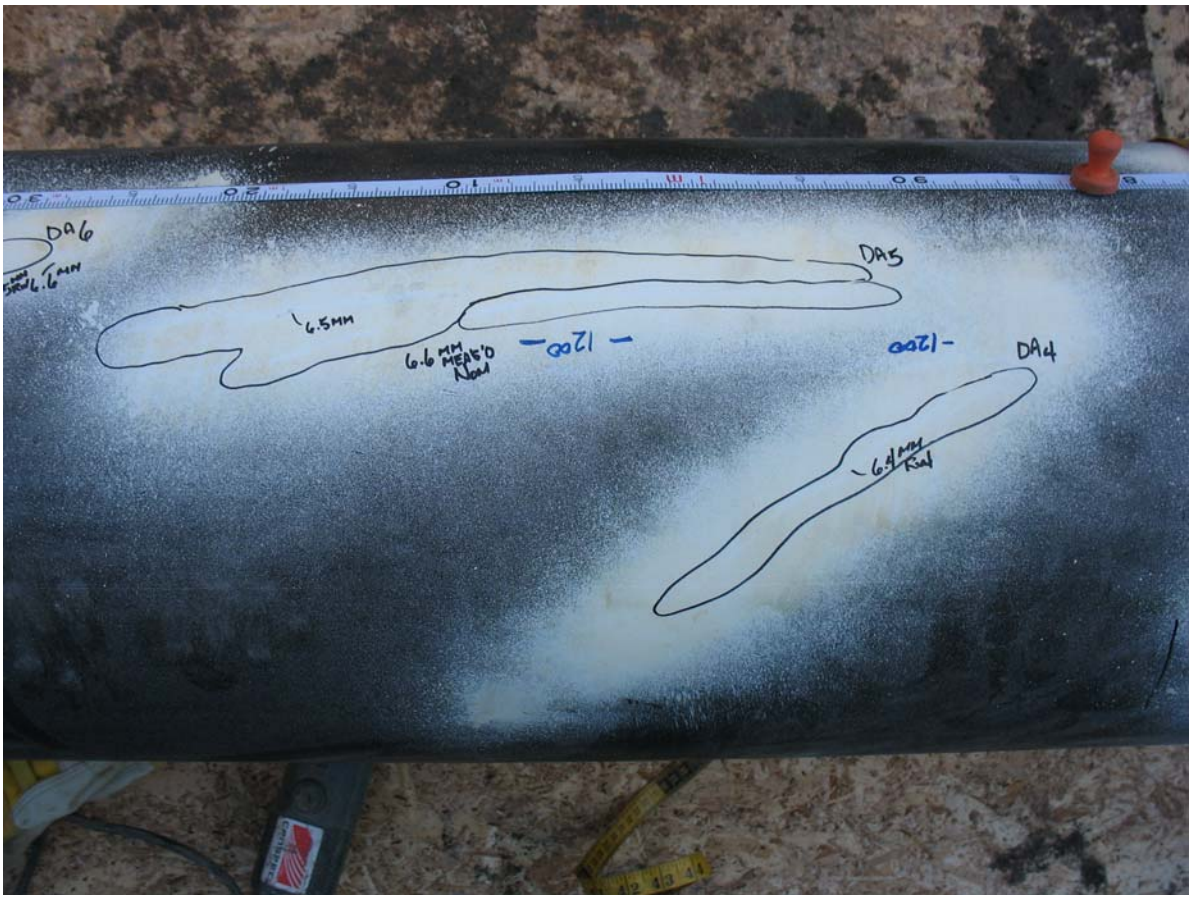
21 - General NDE areas

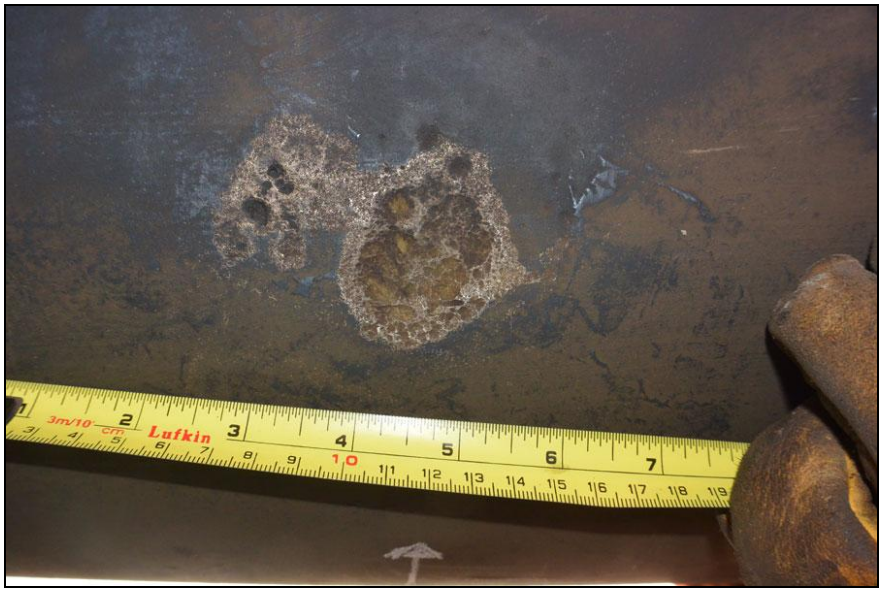
Photo 6:

More corrosion area

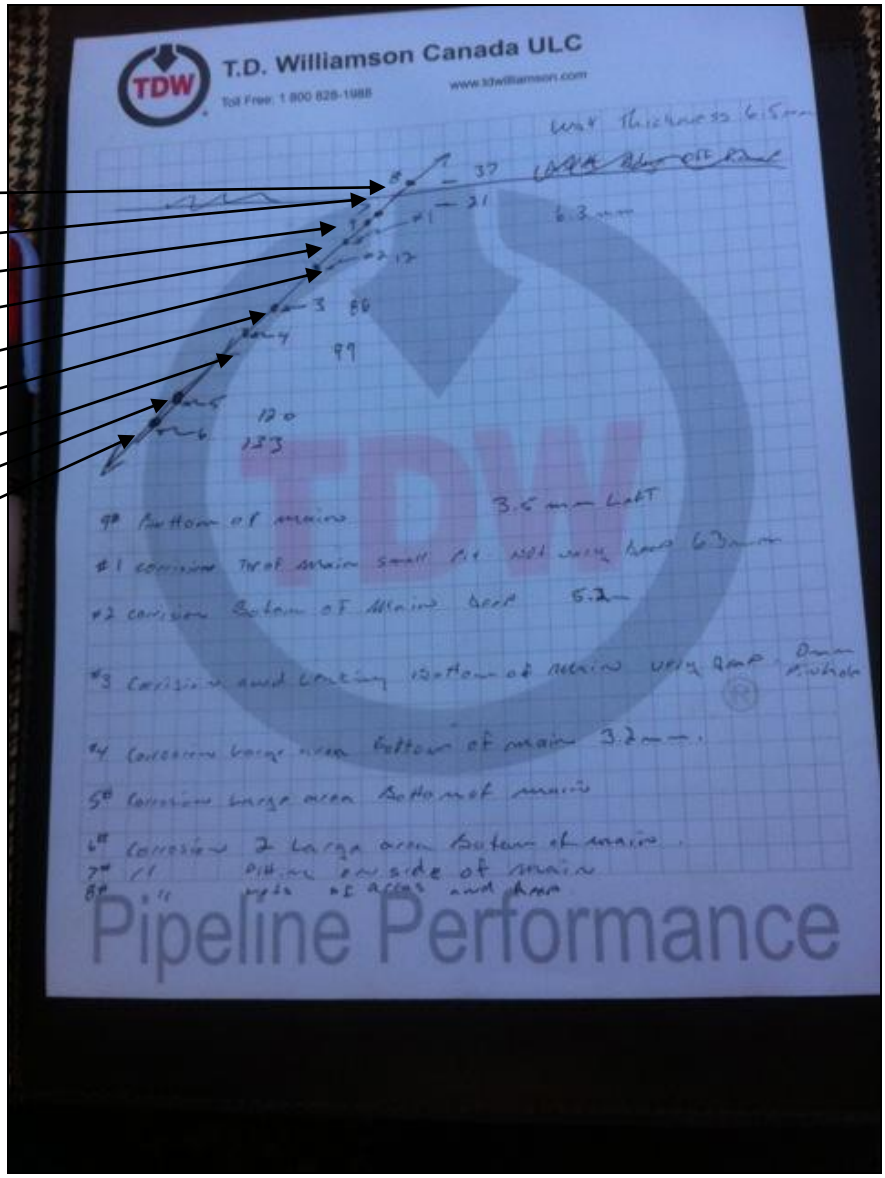
Photo 8:

Locations where some wall thickness remaining inside pits.

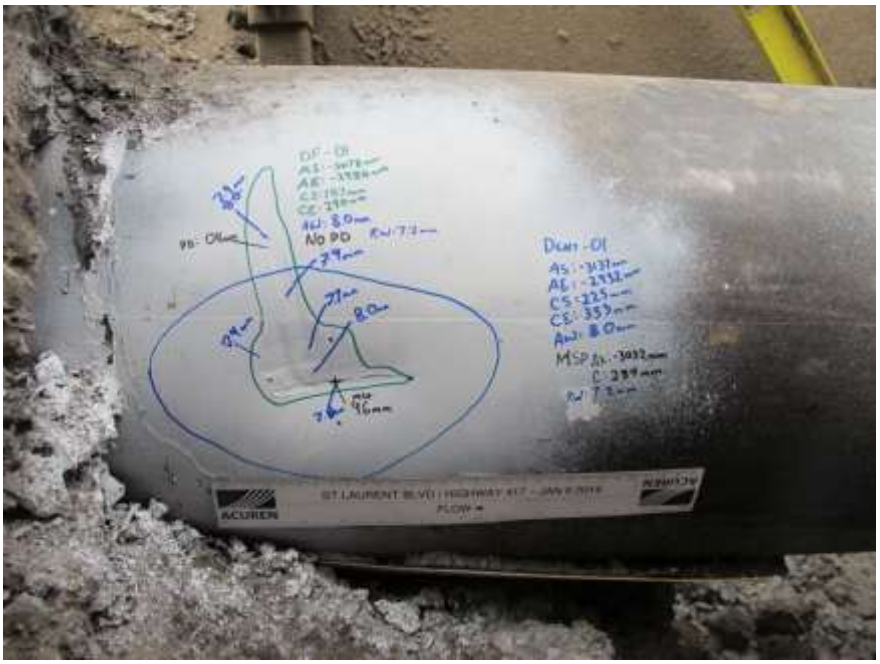
View of Dent 01 (D-01) and Intersecting Damage Feature 01 (DF-01).

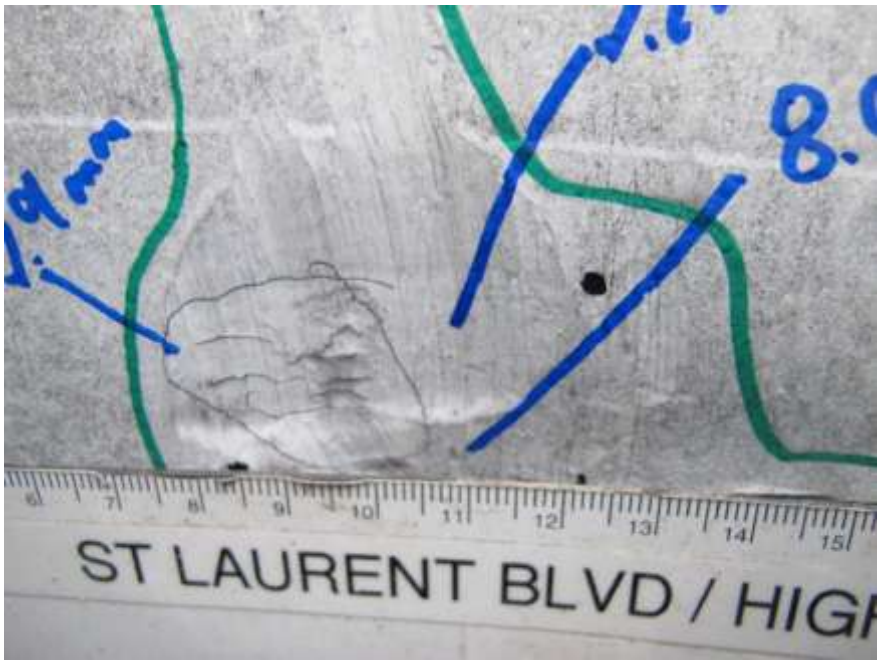
View of linier indications located within Damage Feature 01 (DF-01)

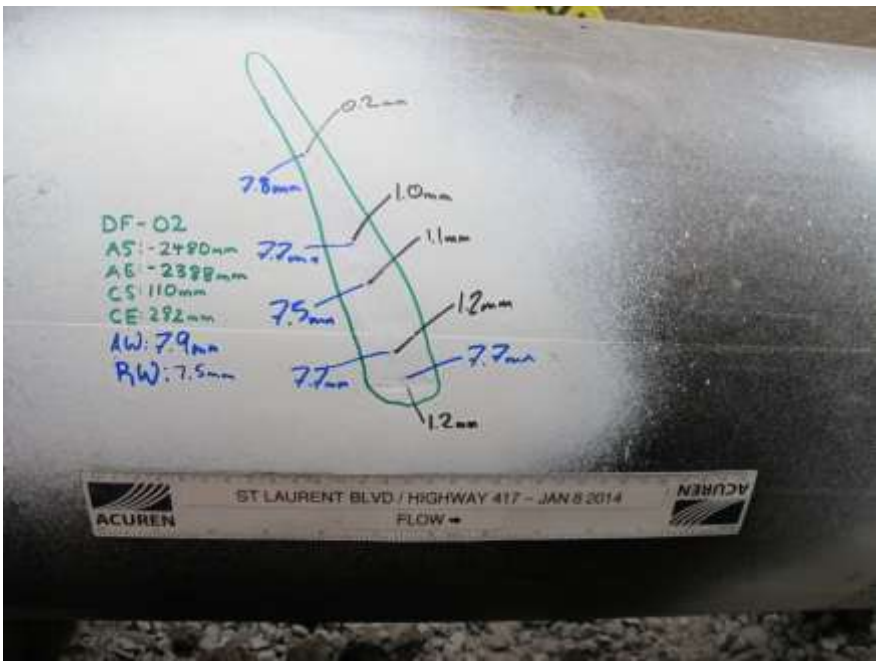
View of Damage Feature 02 (DF-02).

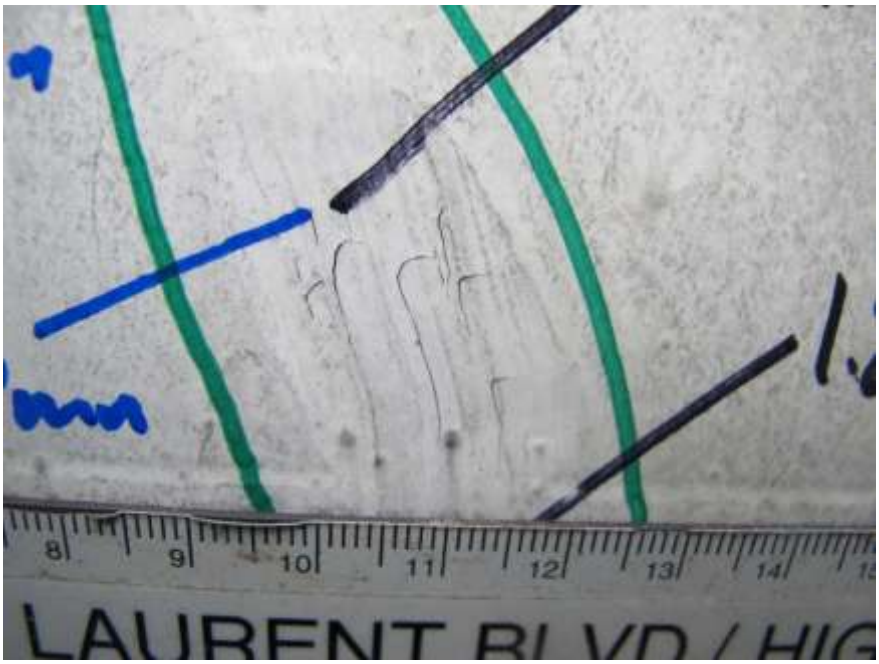
View of linier indications located within Damage Feature 02 (DF-02)

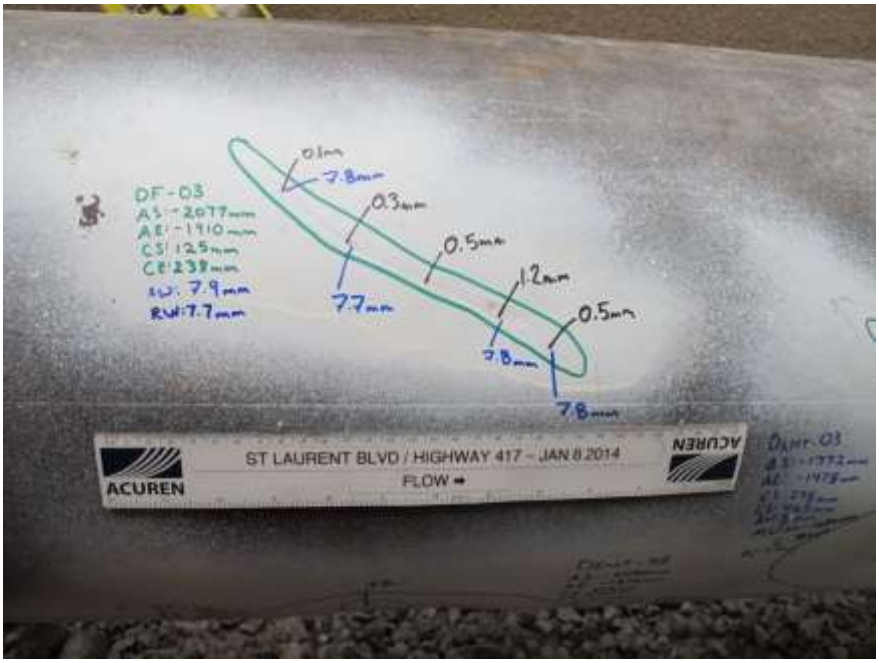
View of Damage Feature 03 (DF-03).

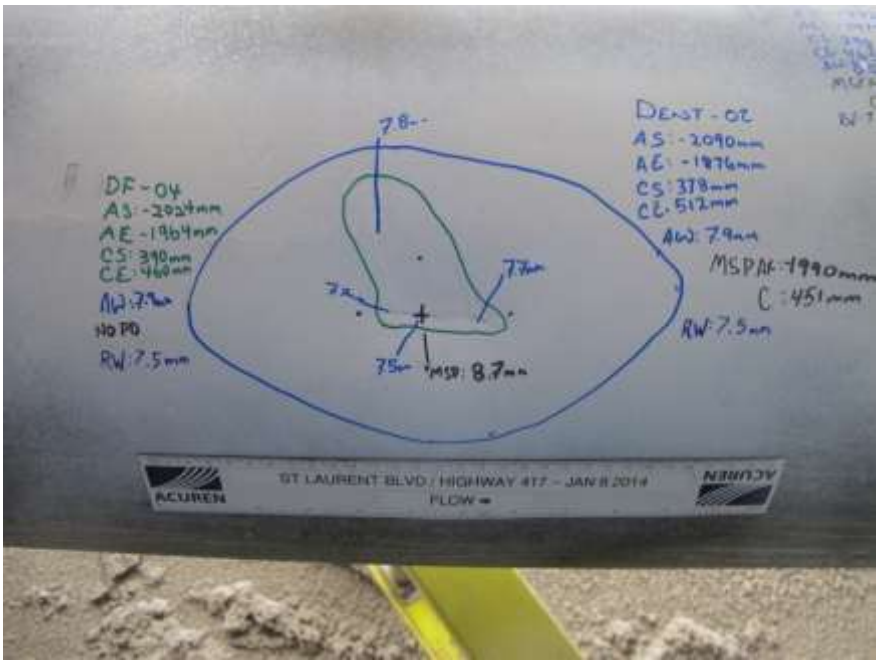
View of Dent 02 (D-02) and intersecting Damage Feature 04 (DF-04).

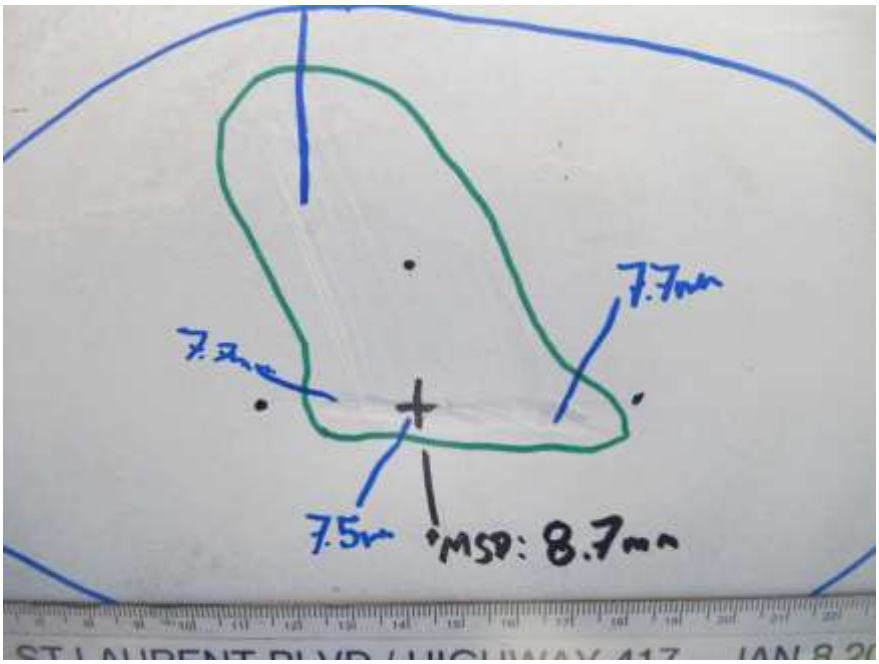
Closer view of Damage Feature 04 (DF-04)

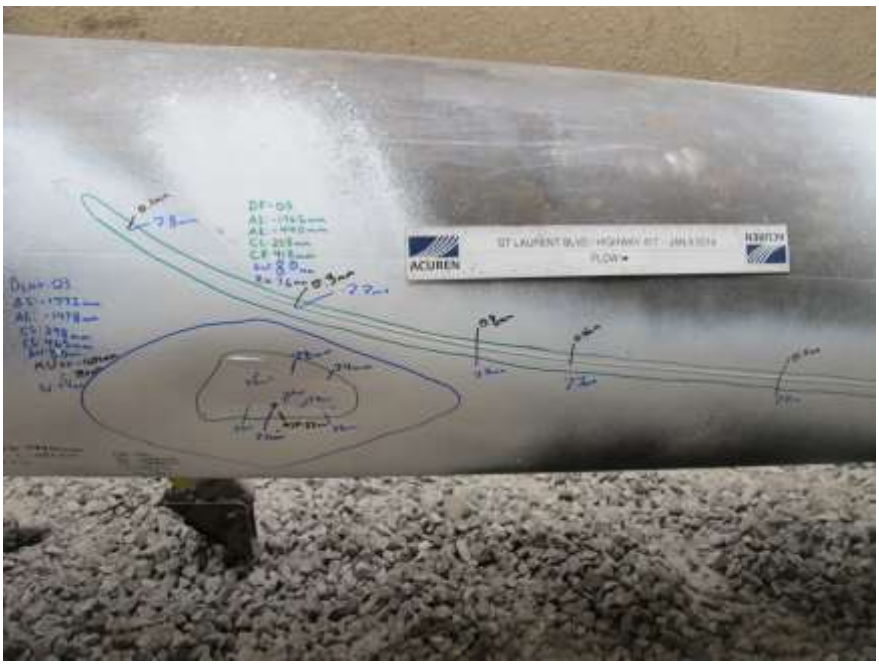
View of Damage Feature 05 (DF-05).

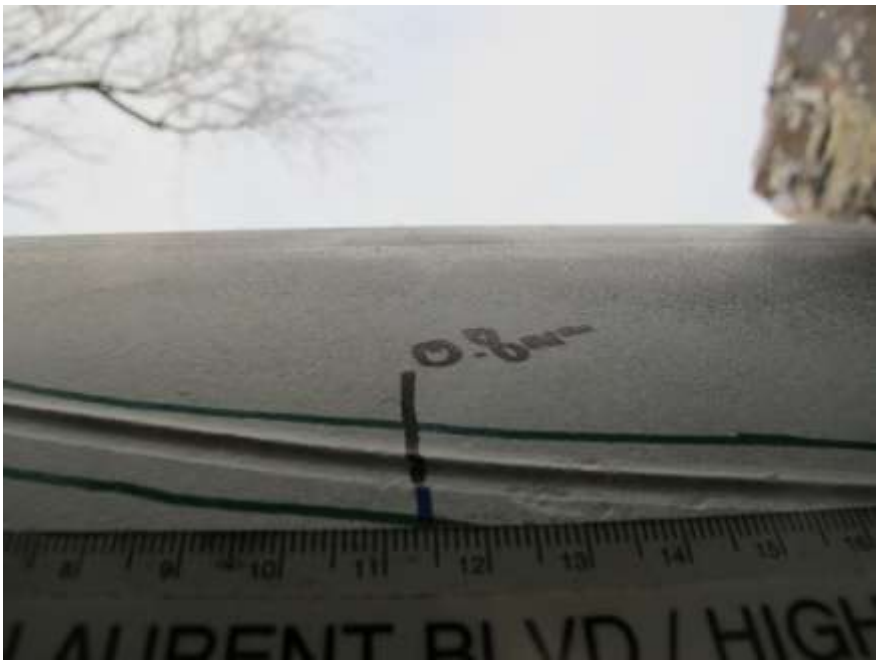
Closer view of Damage Feature 05 (DF-05) showing edge profile of damage feature.

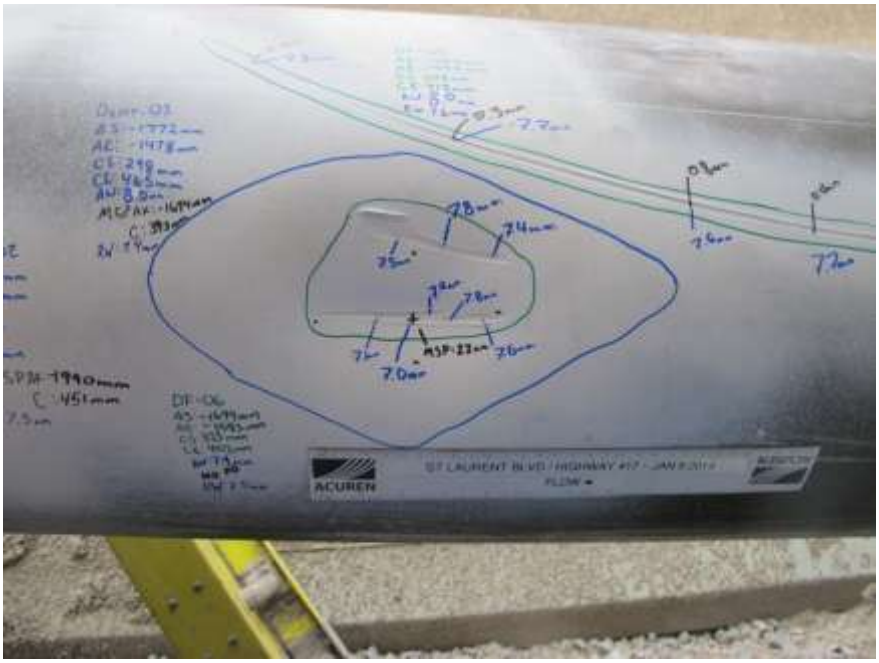
View of Dent 03 (D-03) and intersecting Damage Feature 06 (DF-06).

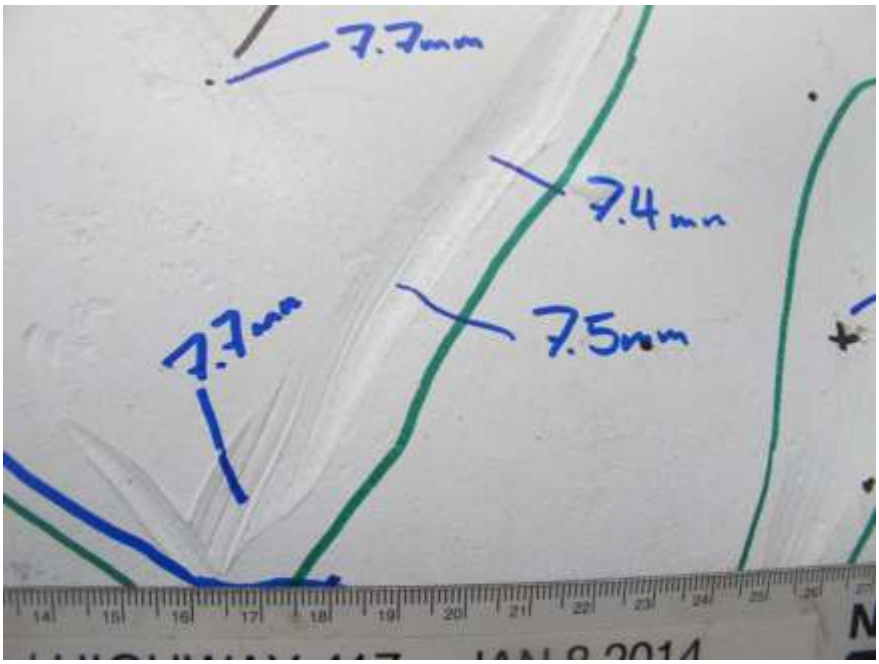
Closer view of Damage Feature 07 (DF-07).
