March 4, 2021

Re: Enbridge Gas Inc. (Enbridge Gas)
Ontario Energy Board (OEB) File: EB-2020-0293
St. Laurent Ottawa North Replacement Project – New and Updated Evidence

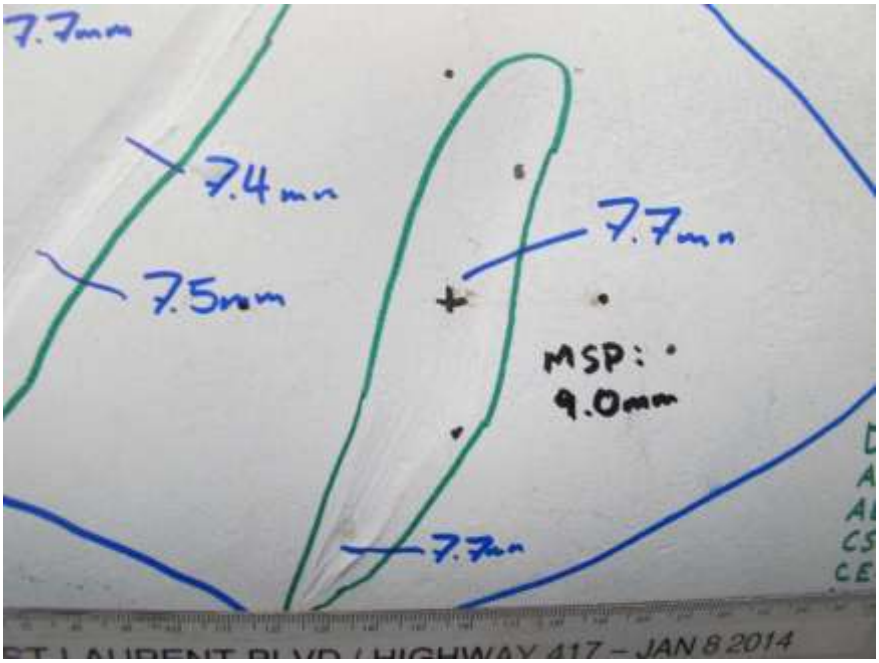
Closer view of Damage Feature 08 (DF-08).

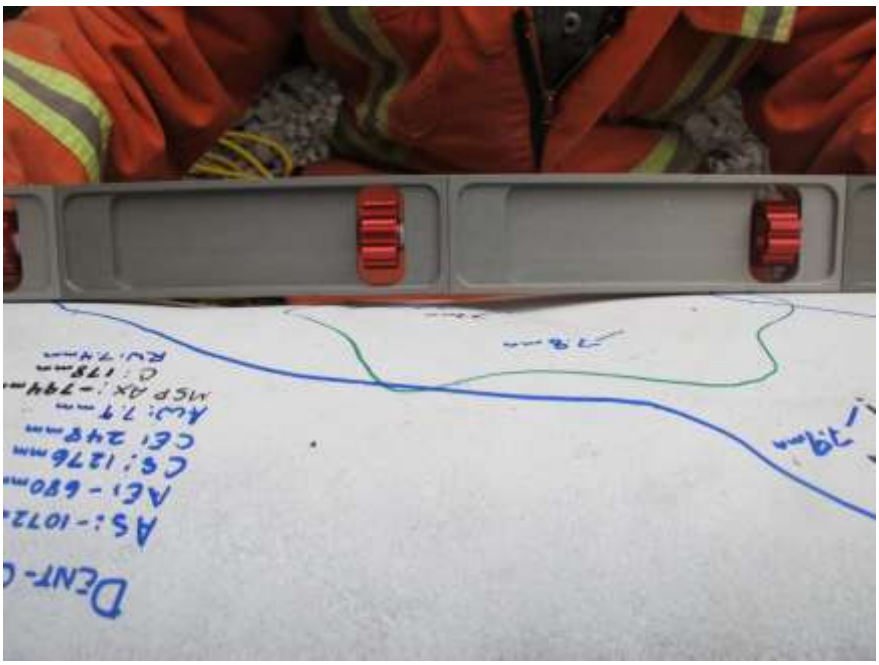
Photo 27:

Continued view of dent profile of Dent 04 (D-04).

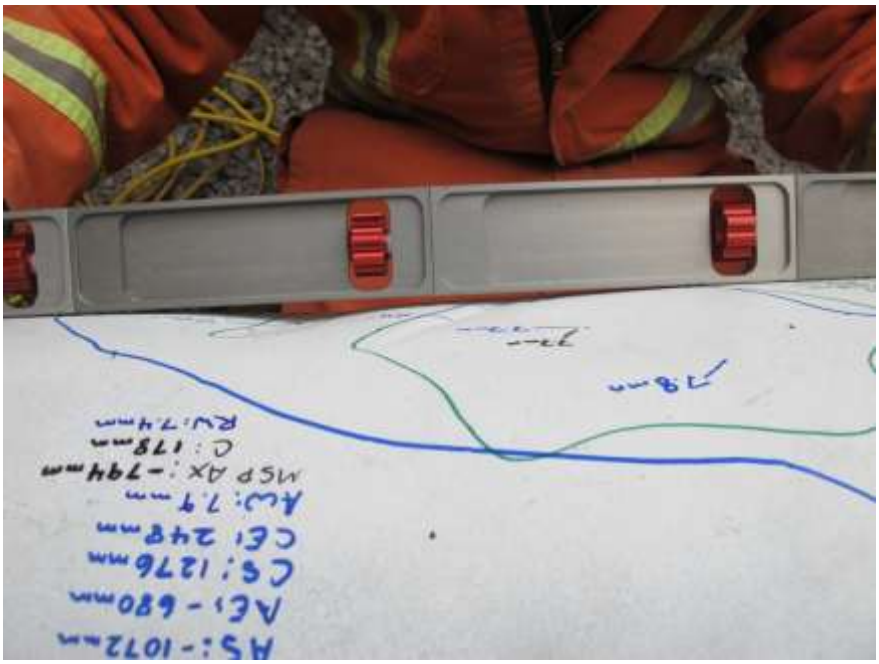
Photo 28:

Continued view of dent profile of Dent 04 (D-04).

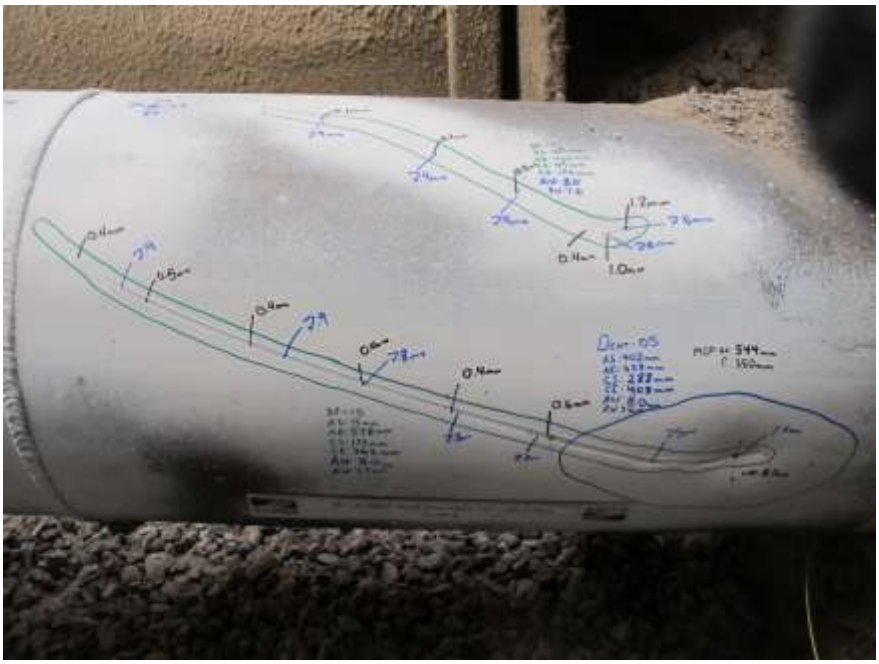
View of Dent 05 (D-05) and intersecting Damage Features 10 (DF-10).

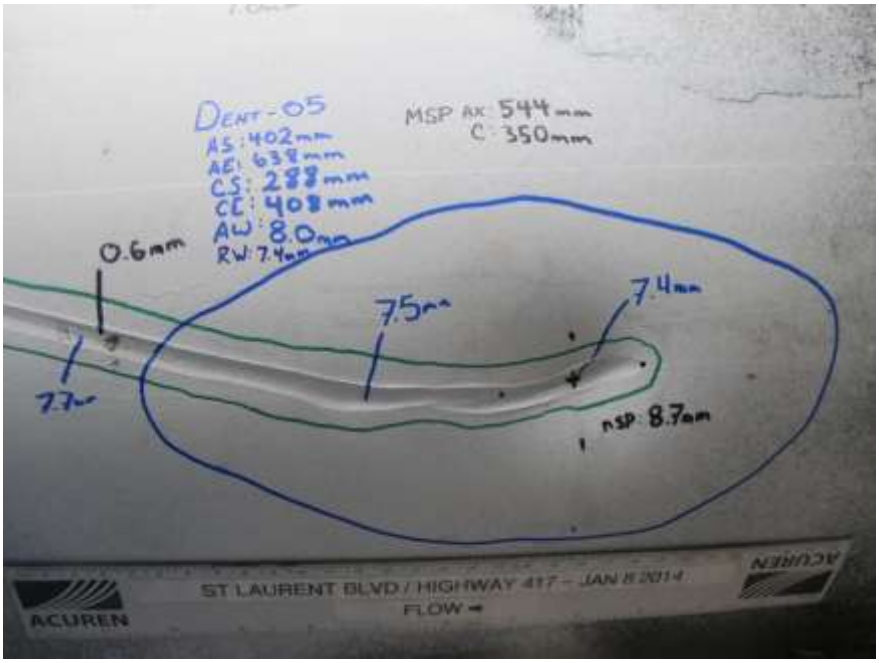
Photo 31:

View of Dent 05 (D-05)

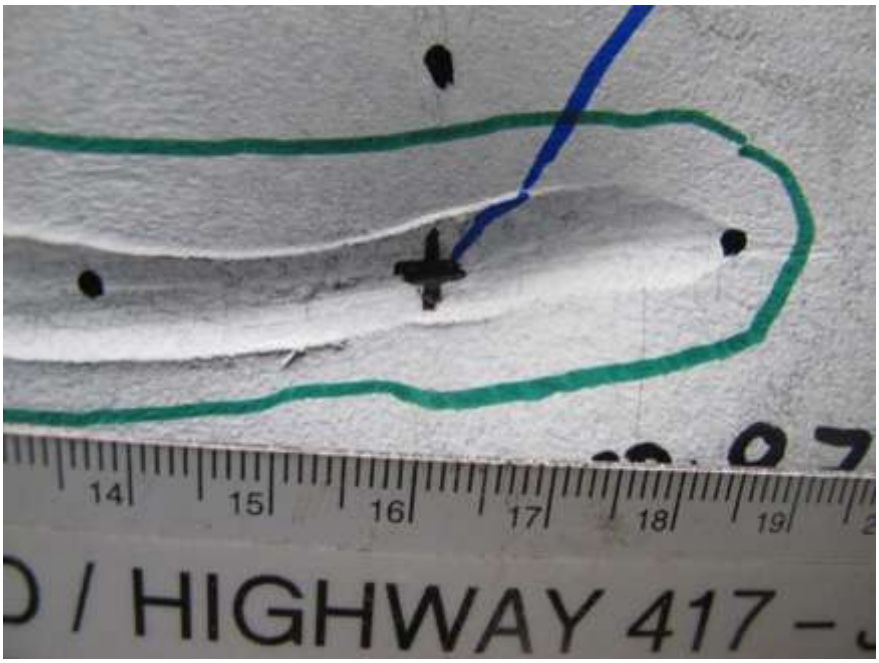
Closer view of Damage Feature 10 (DF-10) showing the edge profile of the damage feature.

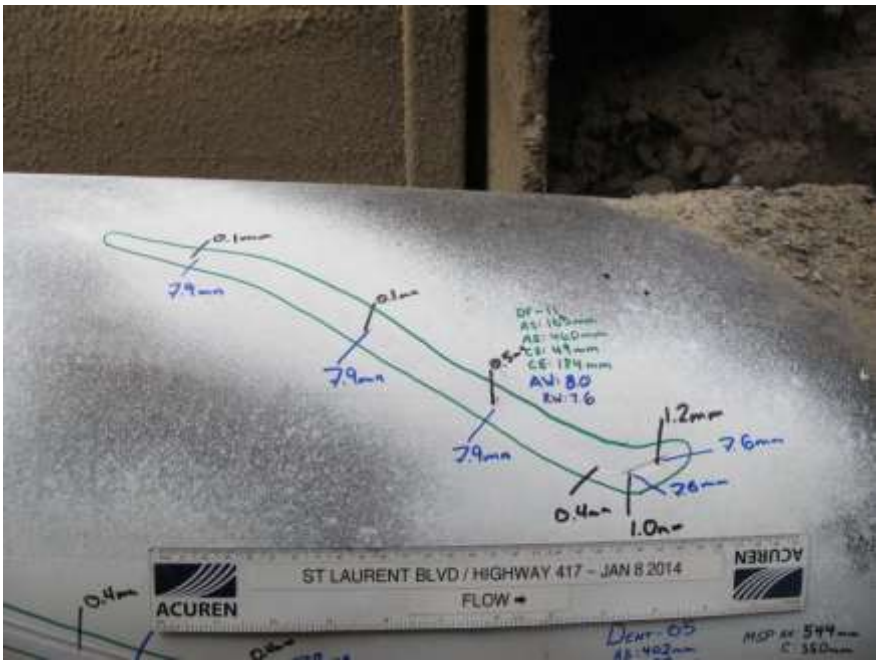
View of Damage Feature 11 (DF-11)

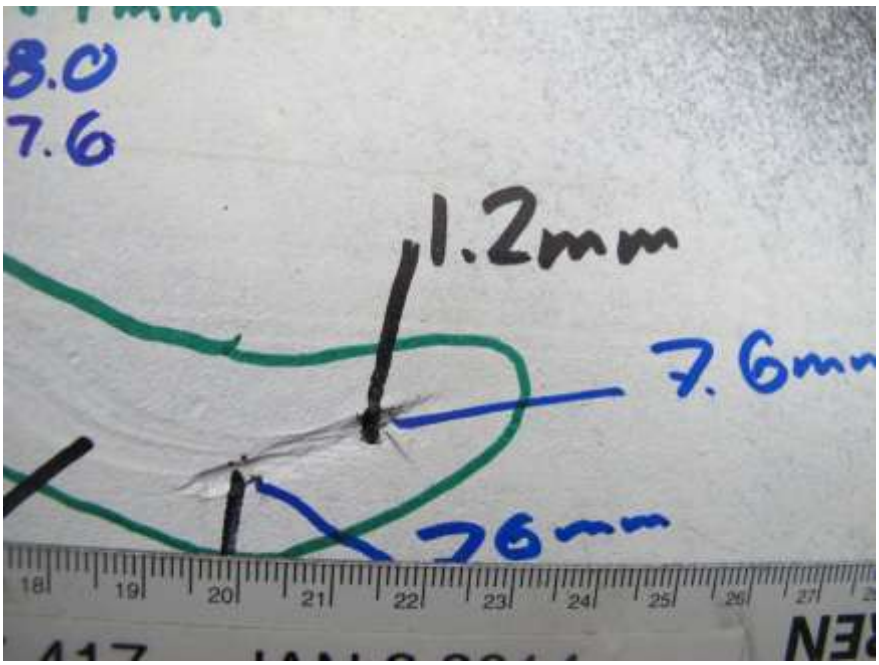
Closer view of Damage Feature 11 (DF-11)

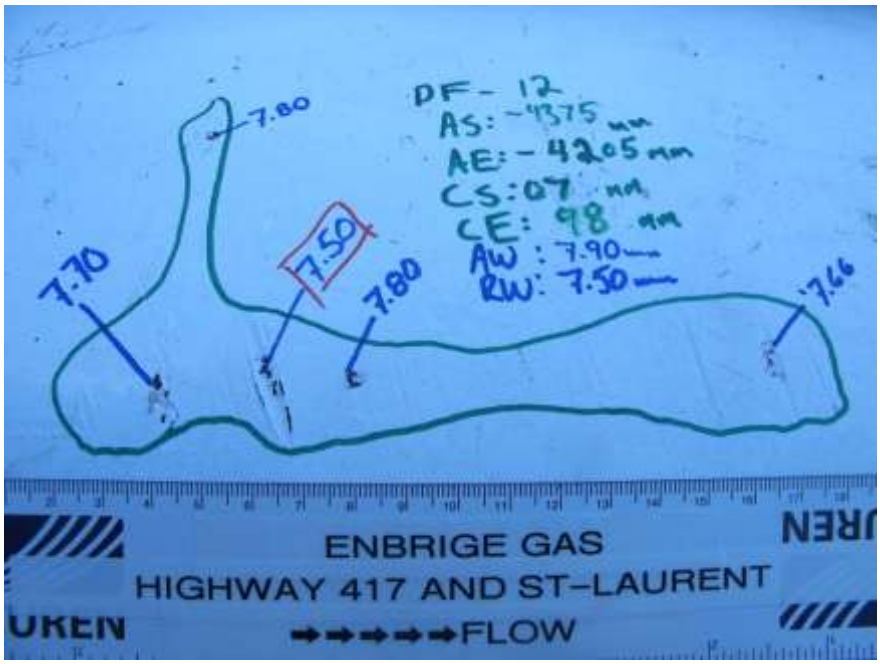
View of damage feature DF-12.

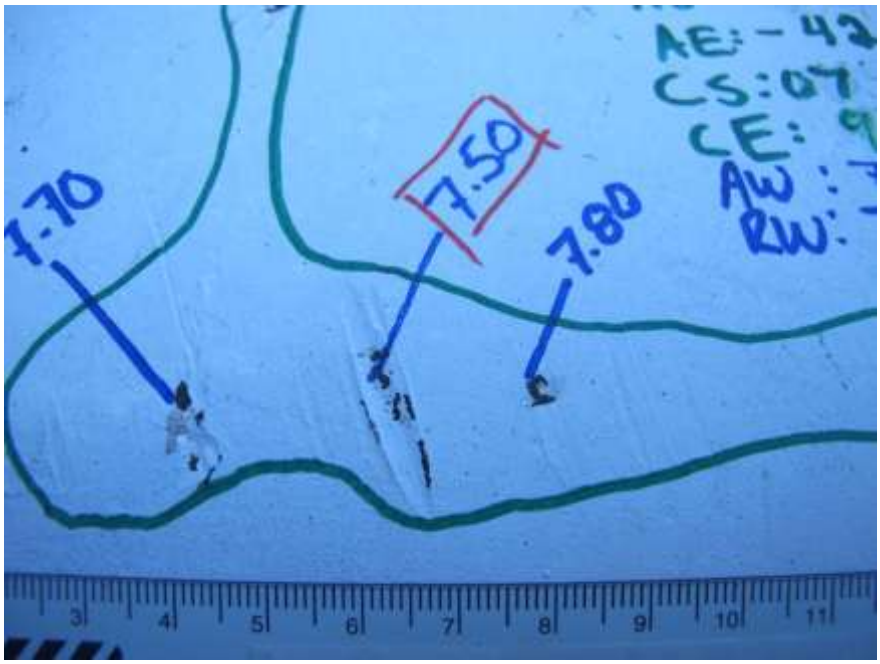
Photo 15:

Closer view of DF-12.

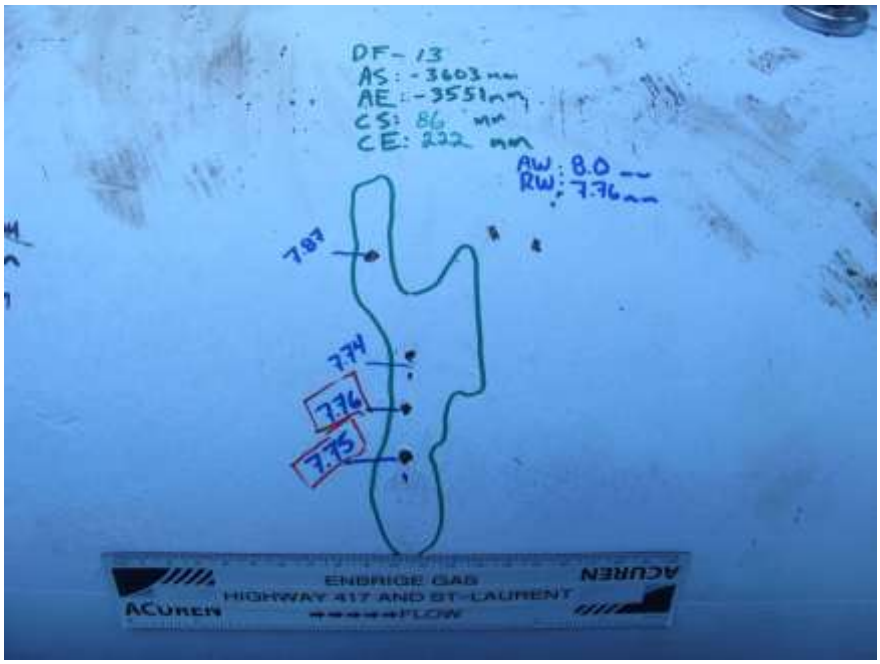
View of damage feature DF-13.

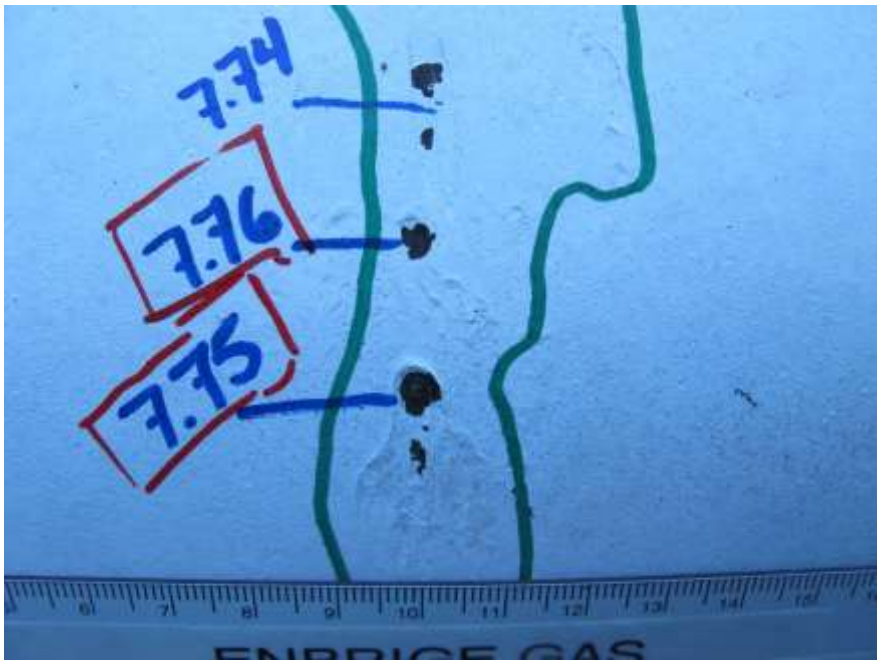
Photo 17:

Closer view of DF-13.

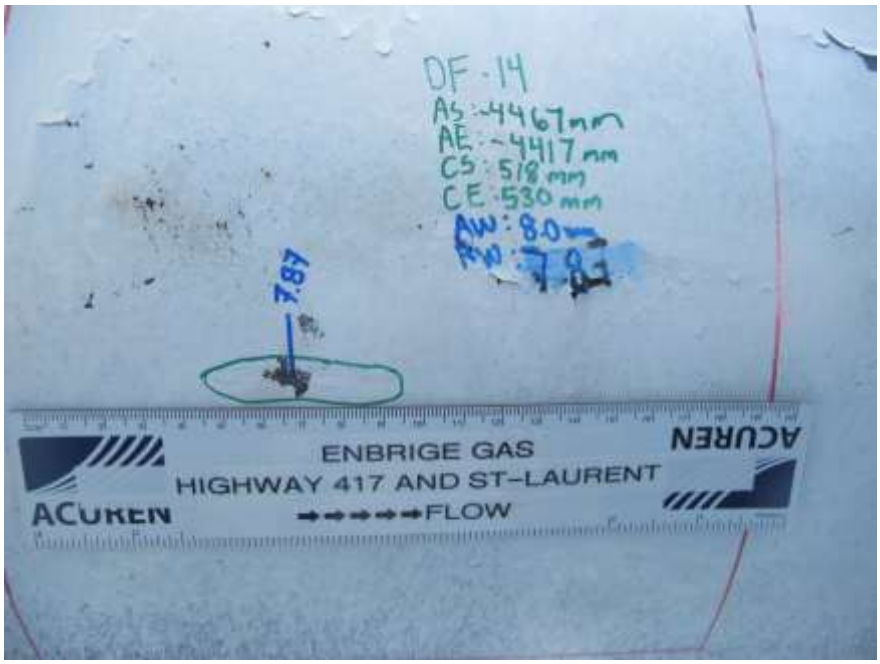
View of damage feature DF-14.

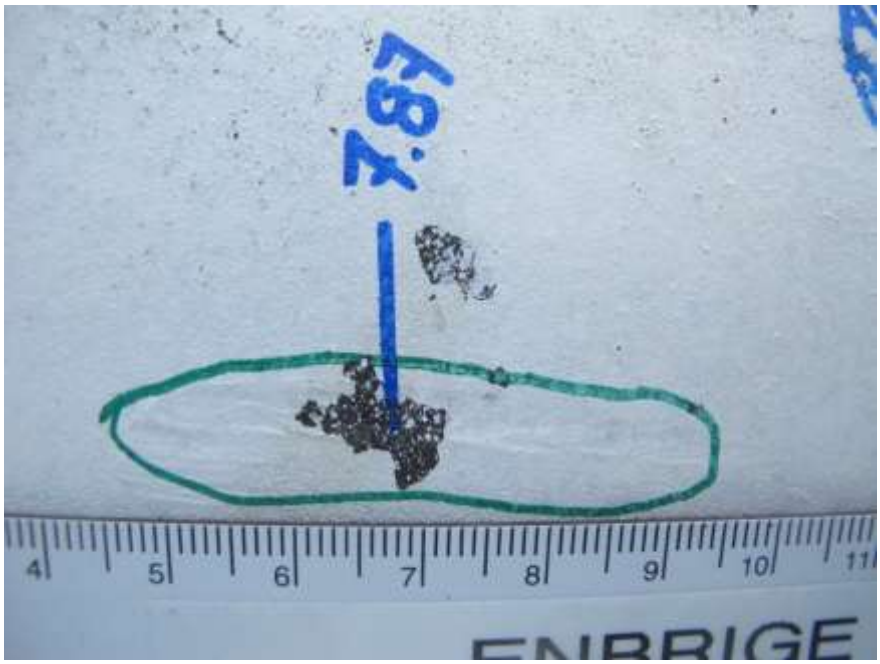
Photo 19:

Closer view of DF-14.

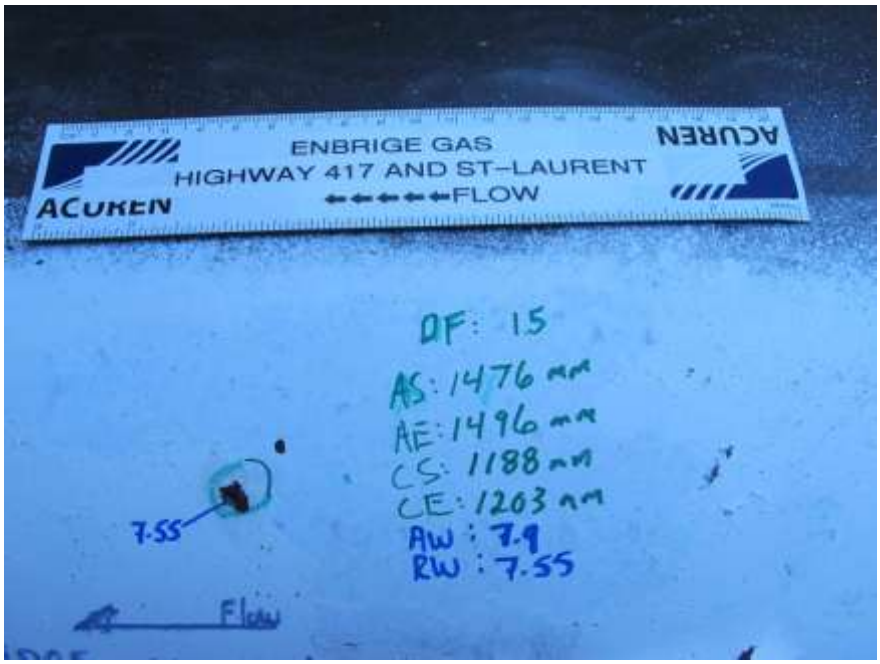
View of damage feature DF-15.

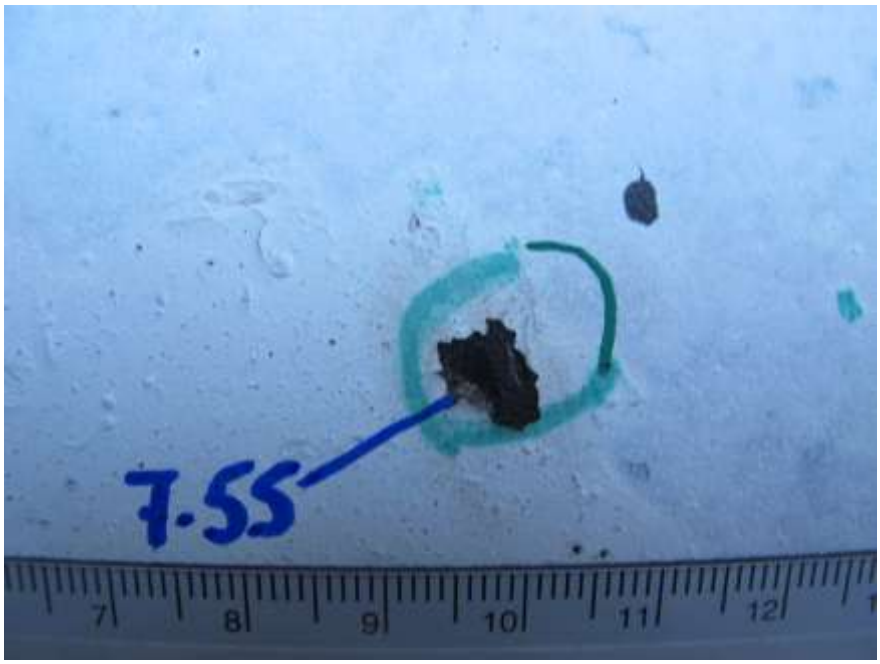
Photo 21:

Closer view of DF-15.

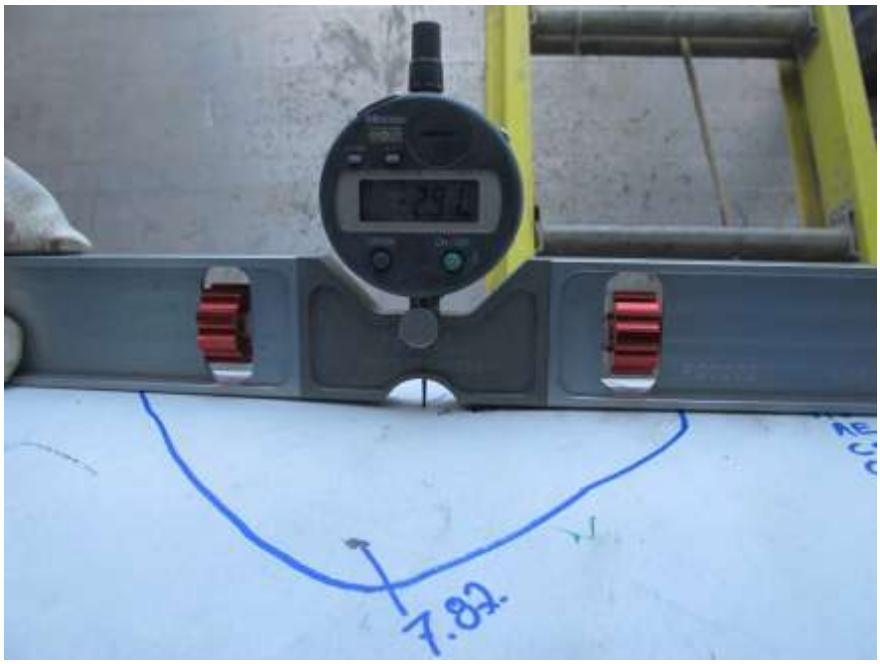
Photo 23:

View of dent depth (2.91 mm) for feature D-06.

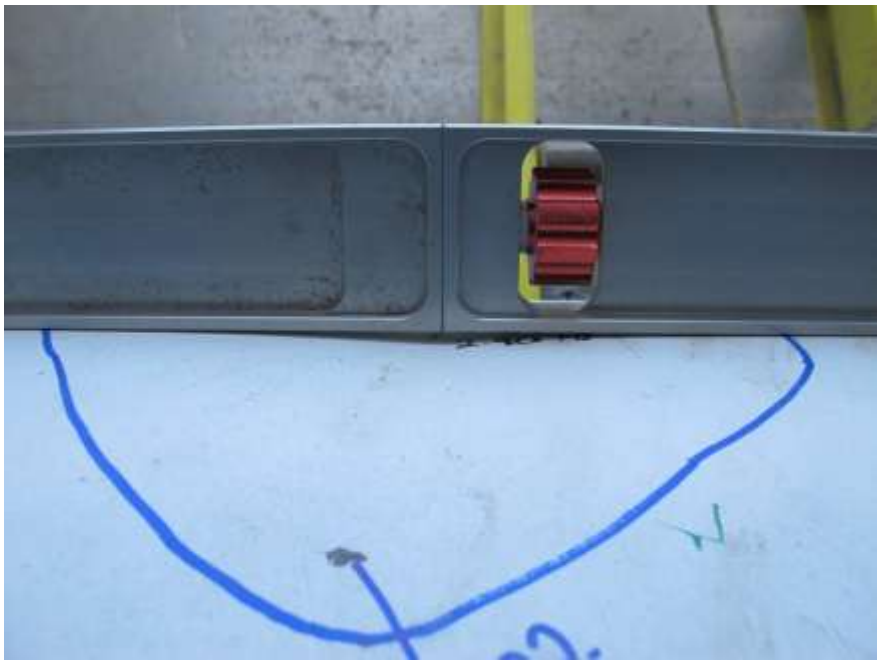
Photo 24:

View of dent D-06 profile.

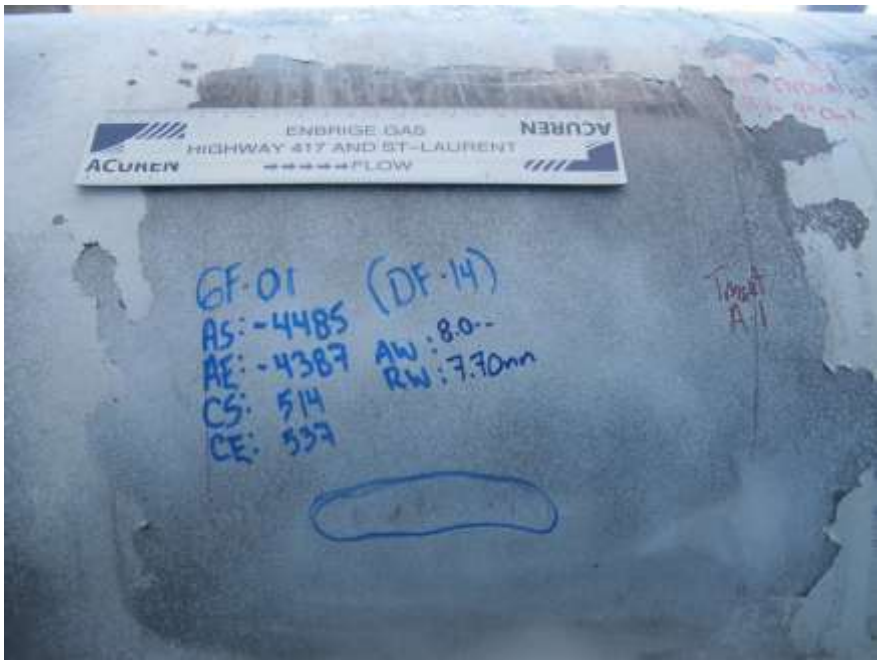
Photo 25:

View of grid feature GF-01.

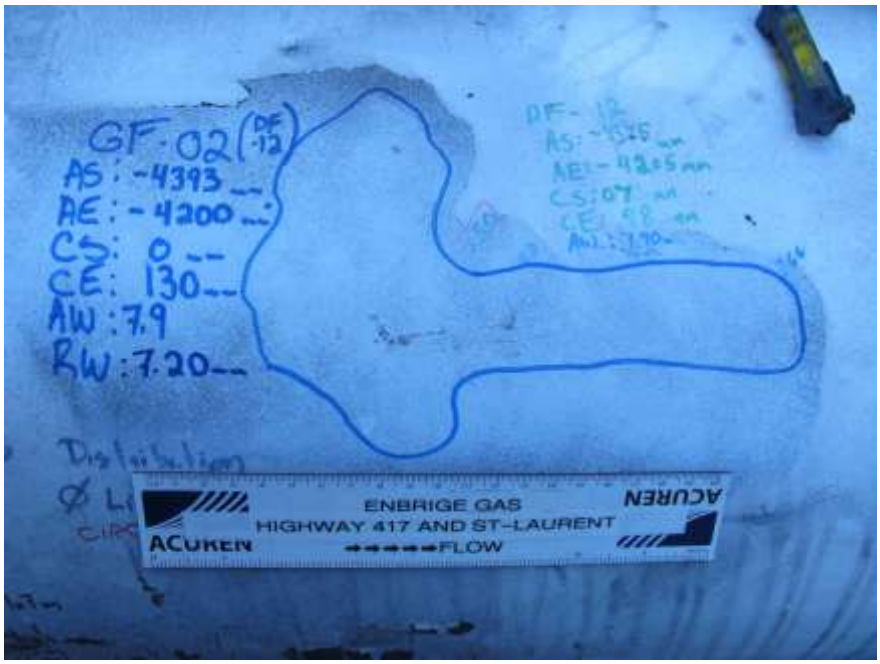
Photo 26:

View of grind feature GF-02.

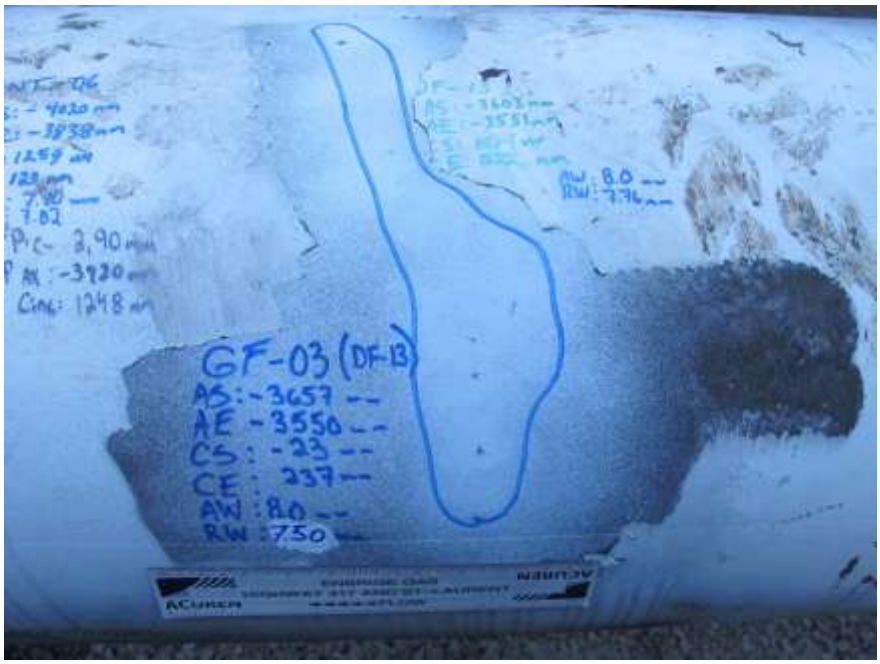
Photo 27:

View of grind feature GF-03.

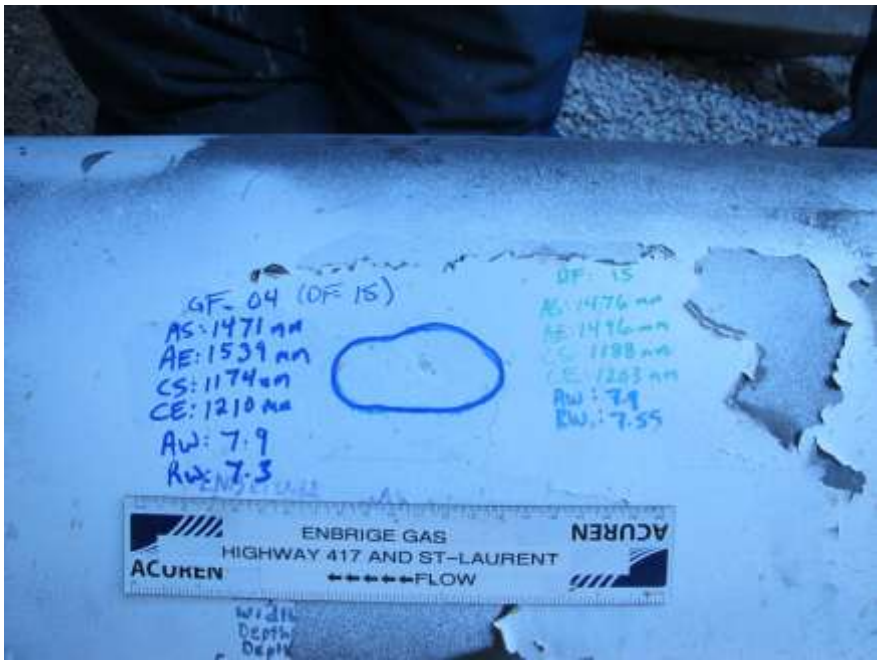
Photo 28:

View of grind feature GF-04.

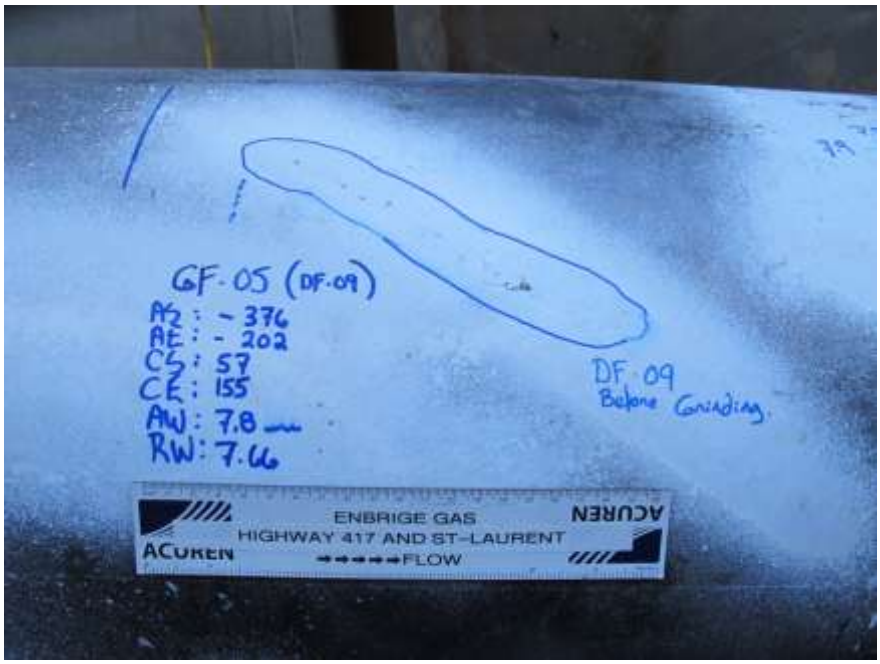
Photo 29:

View of grind feature GF-05.

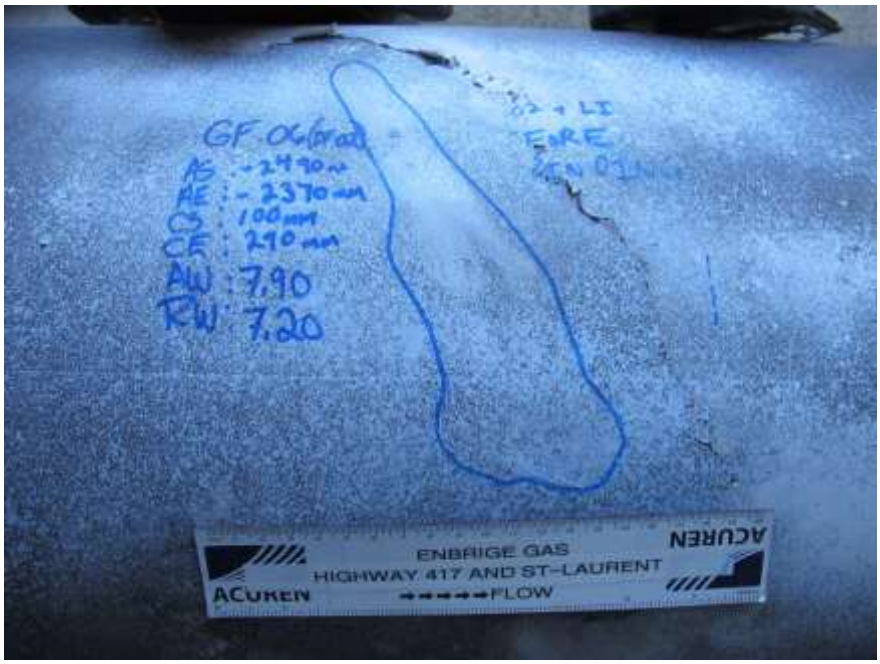
Photo 30:

View of grind feature GF-06.

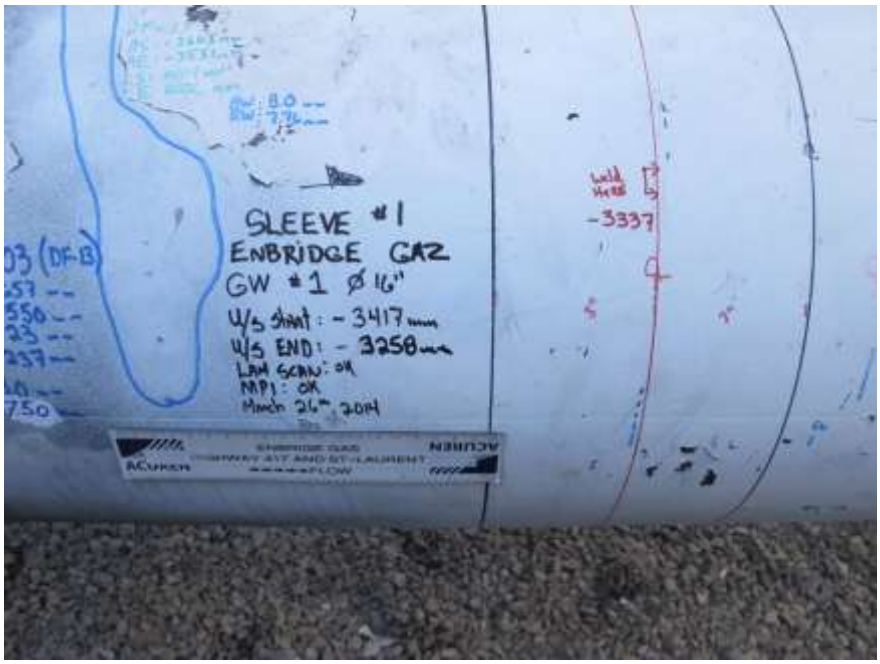
Photo 33:

View of upstream landing for sleeve 01.

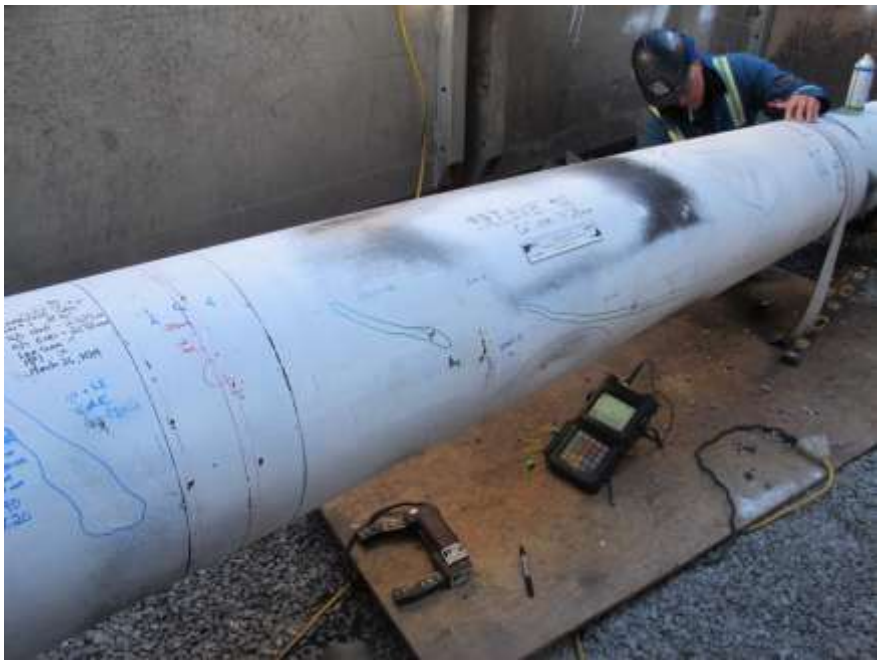
Photo 36:

Overview of sleeve landing sleeve 02.

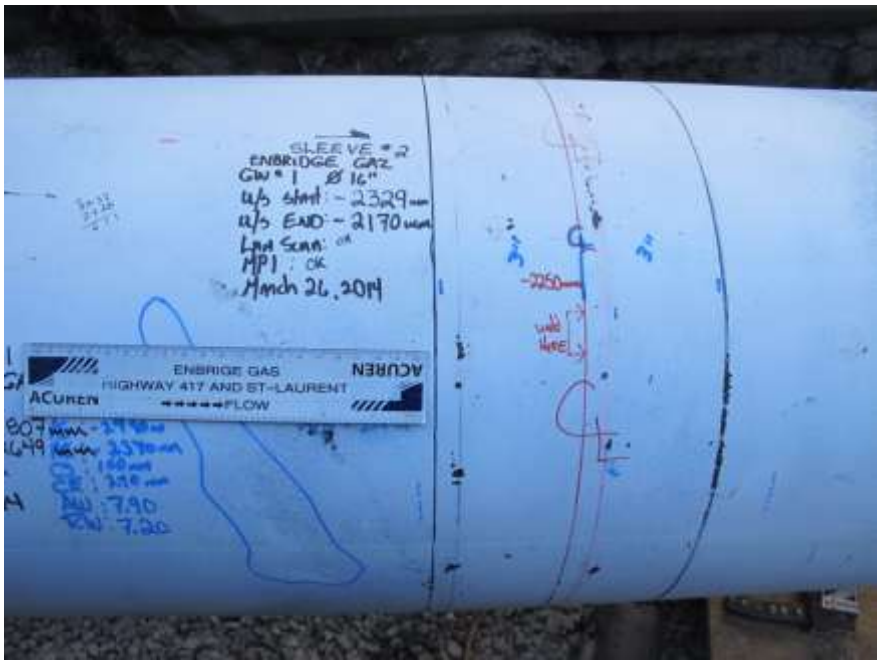
Photo 37:

View of upstream landing for sleeve 02.

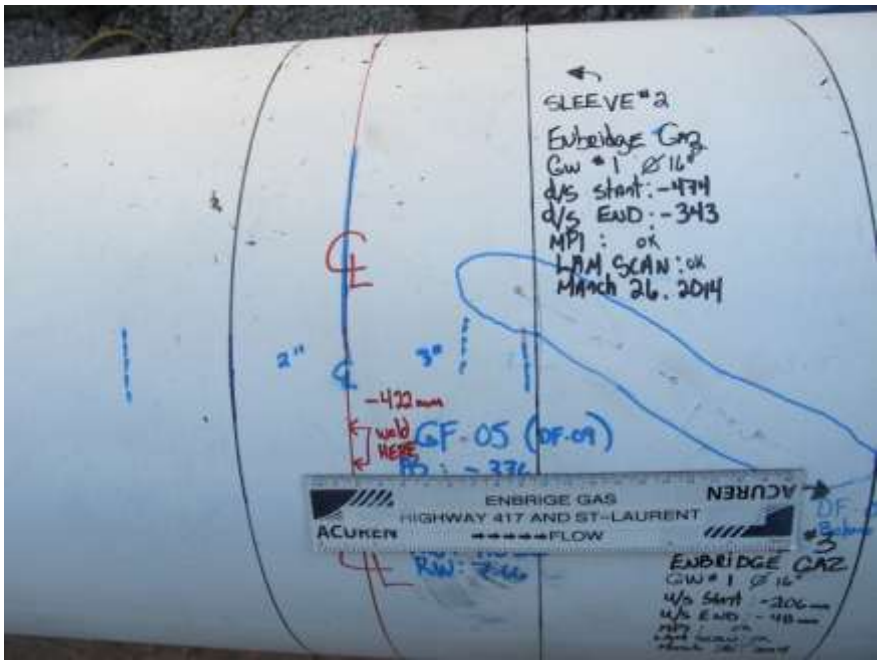
Photo 38:

View of downstream landing for sleeve 02.

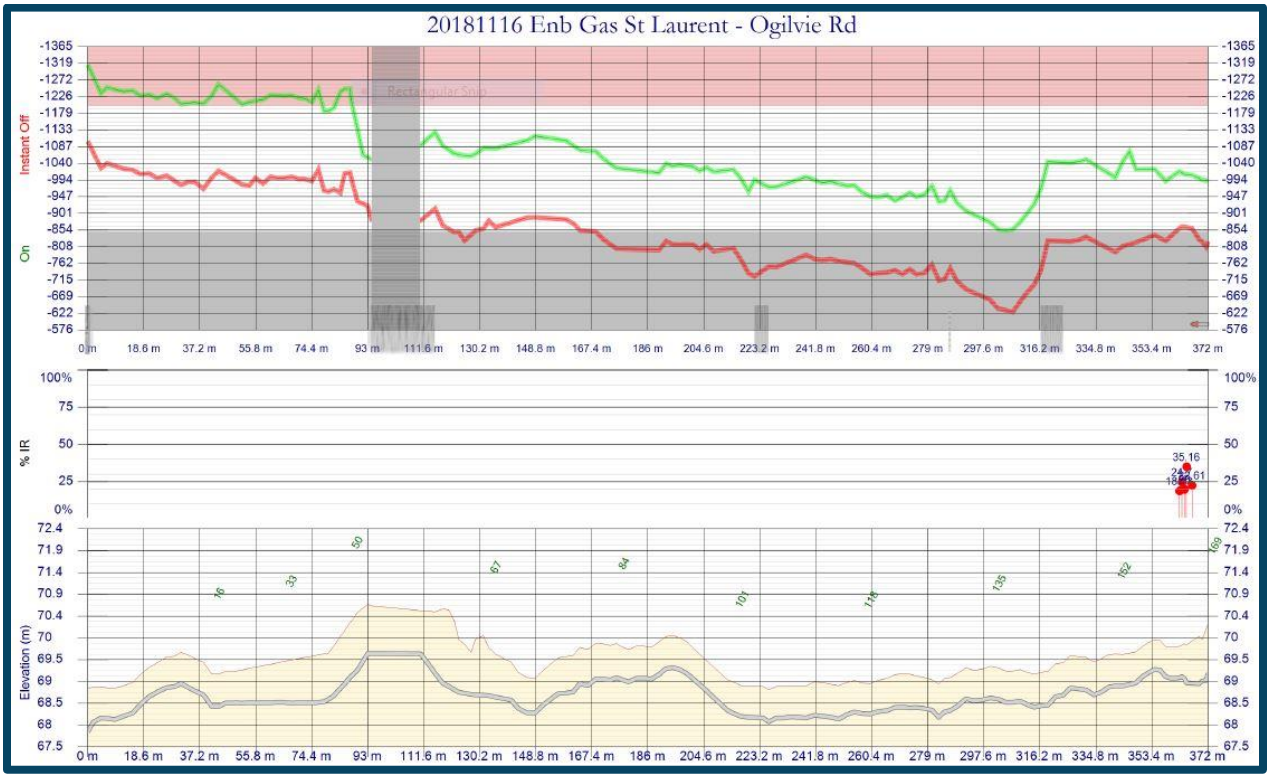
Figure 3.3.6: Ogilvie Rd. CP CIPS Profile

The CP CIPS data indicated that the level of cathodic protection did not satisfy -850mV/CSE NACE SP0169-2013 instant-off criterion in three areas of Ogilvie Rd location. It should be noted that the results of this survey present the CP levels at the time of the survey and could change over time. CP CIPS is recommended to be performed regularly to confirm level of cathodic protection on the entire line.
