Re: Enbridge Gas Inc. ("Enbridge Gas")
Ontario Energy Board ("OEB") File No. EB-2022-0003
NPS 20 Waterfront Relocation Project – Interrogatory Responses

Answer to Interrogatory from
OEB Staff ("STAFF")

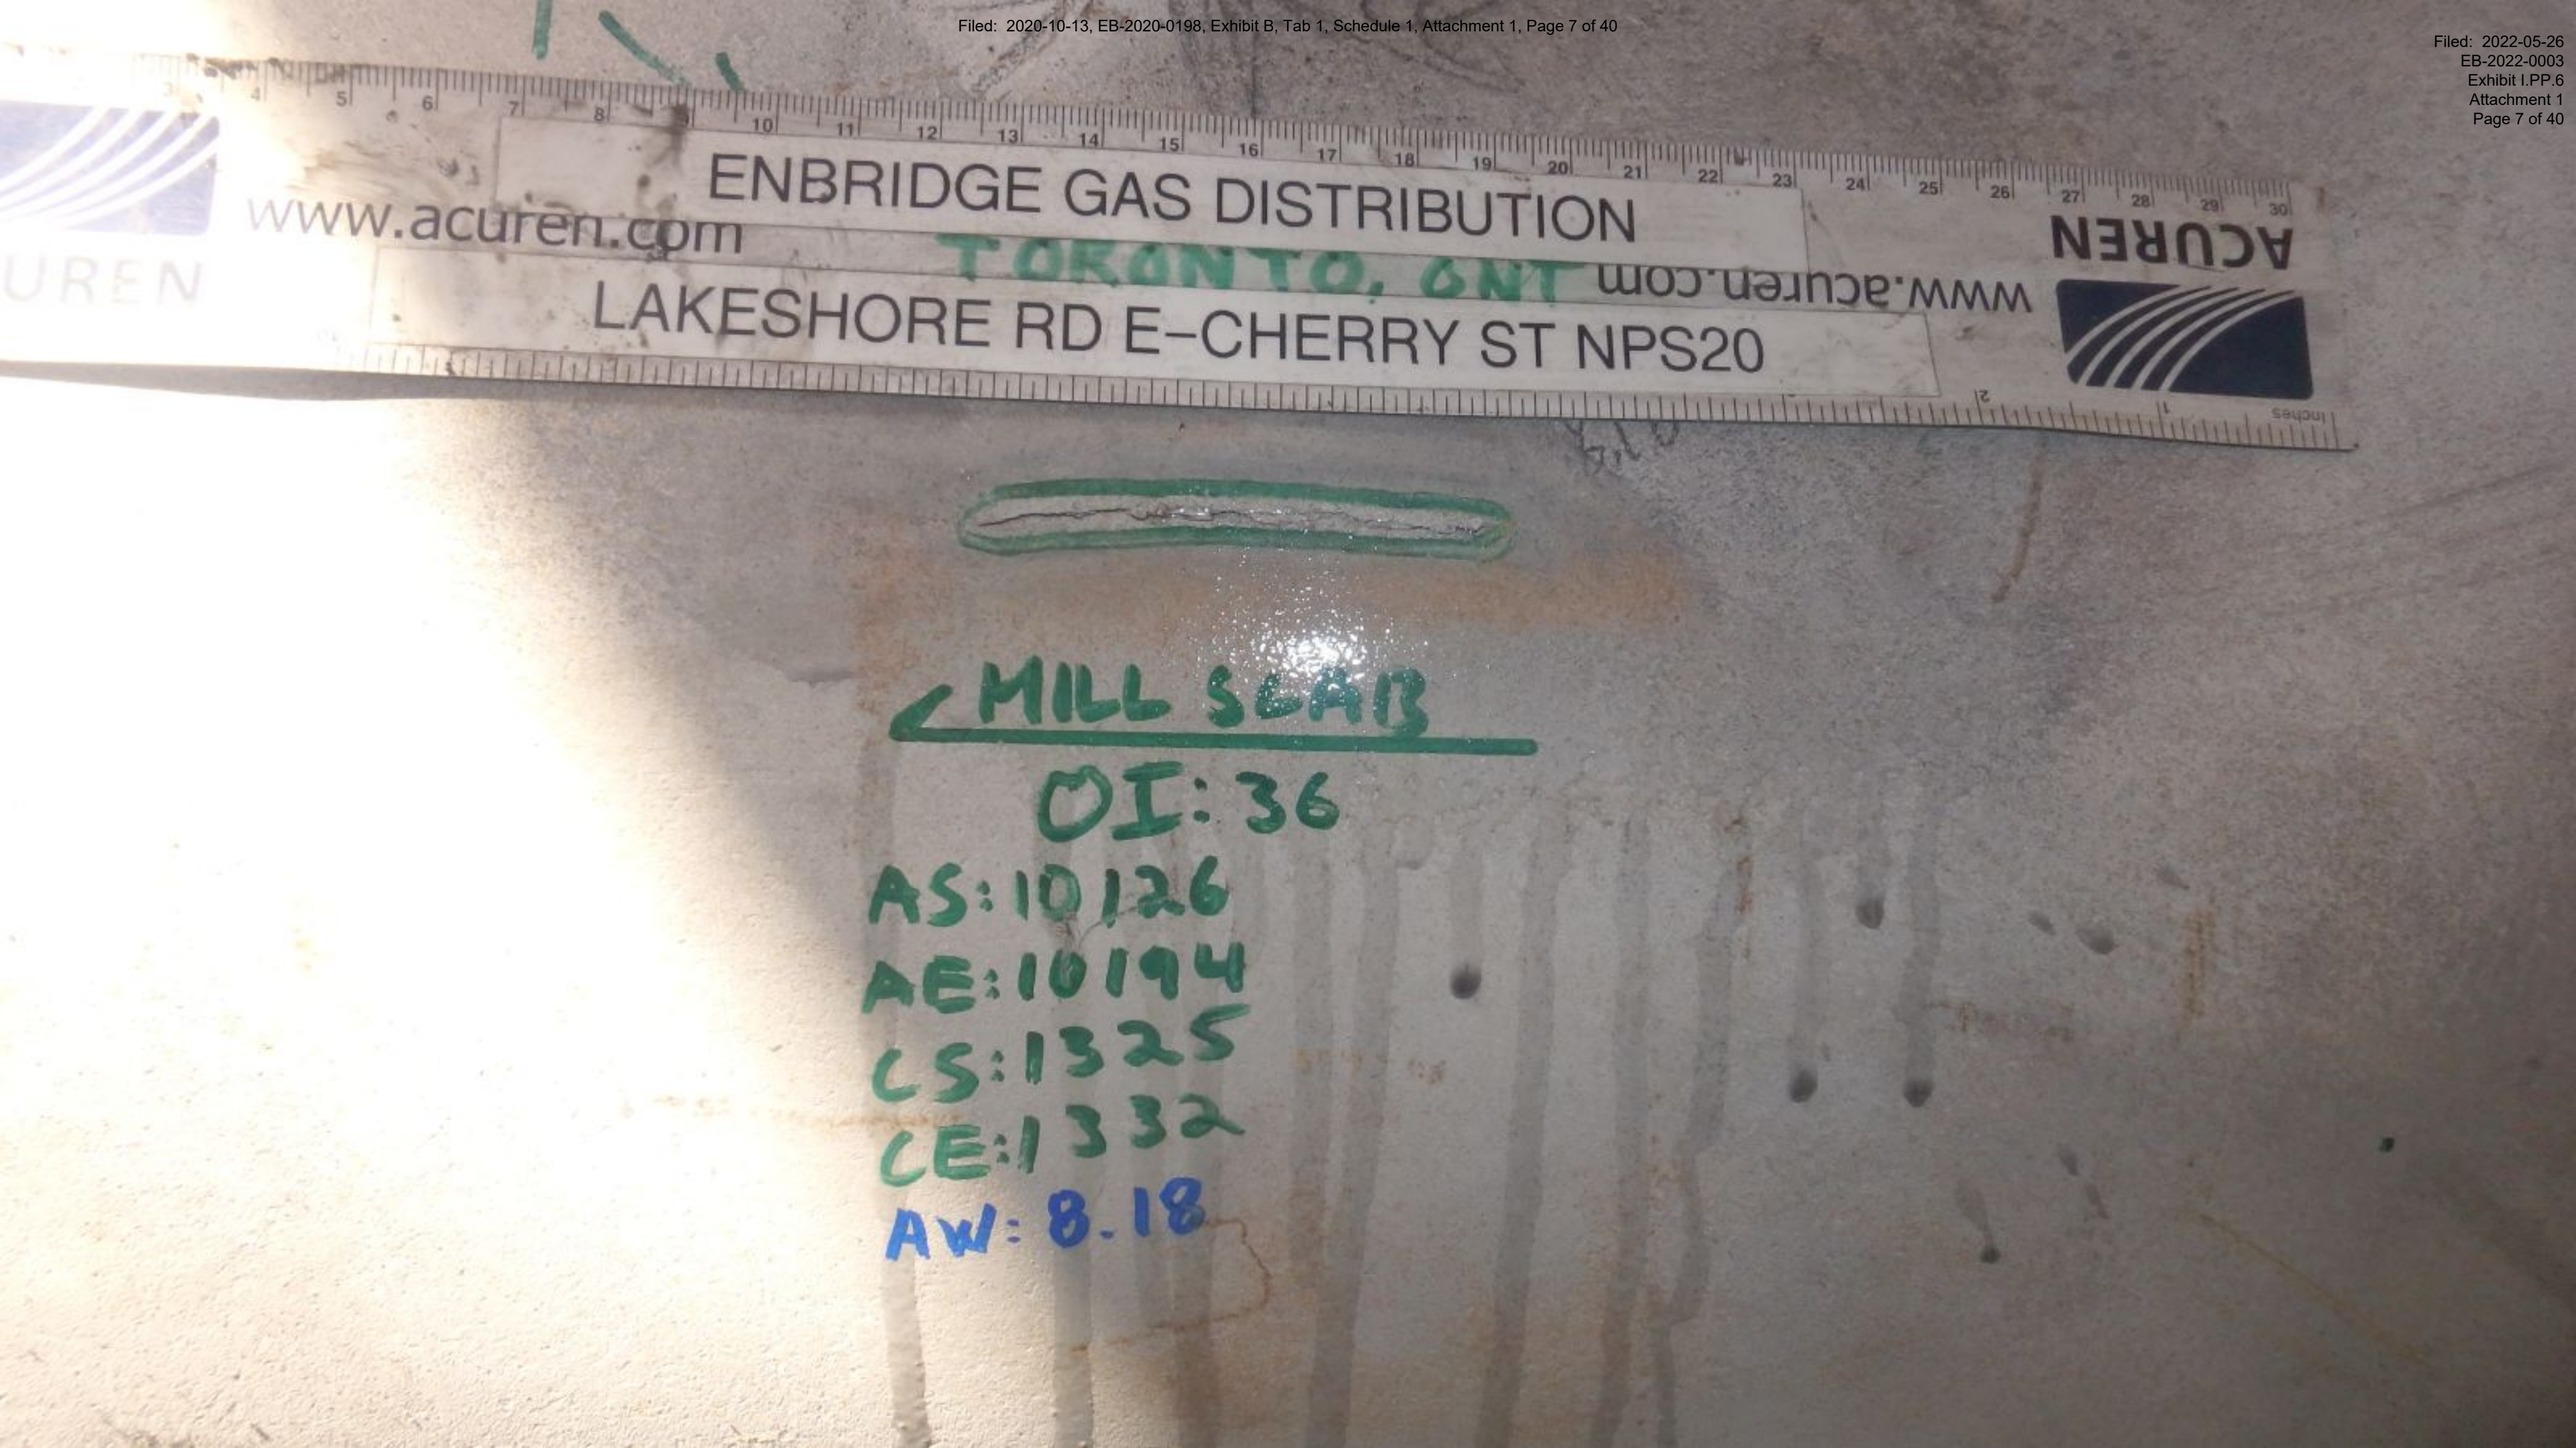
ENBRIDGE GAS DISTRIBUTION
TORONTO, ONT
LAKESHORE RD E-CHERRY ST NPS20
www.acuren.com
ACUREN
MILL SCAB
OI: 36
AS: 10126
AE: 10194
CS: 1325
CE: 1332
AW: 8.18

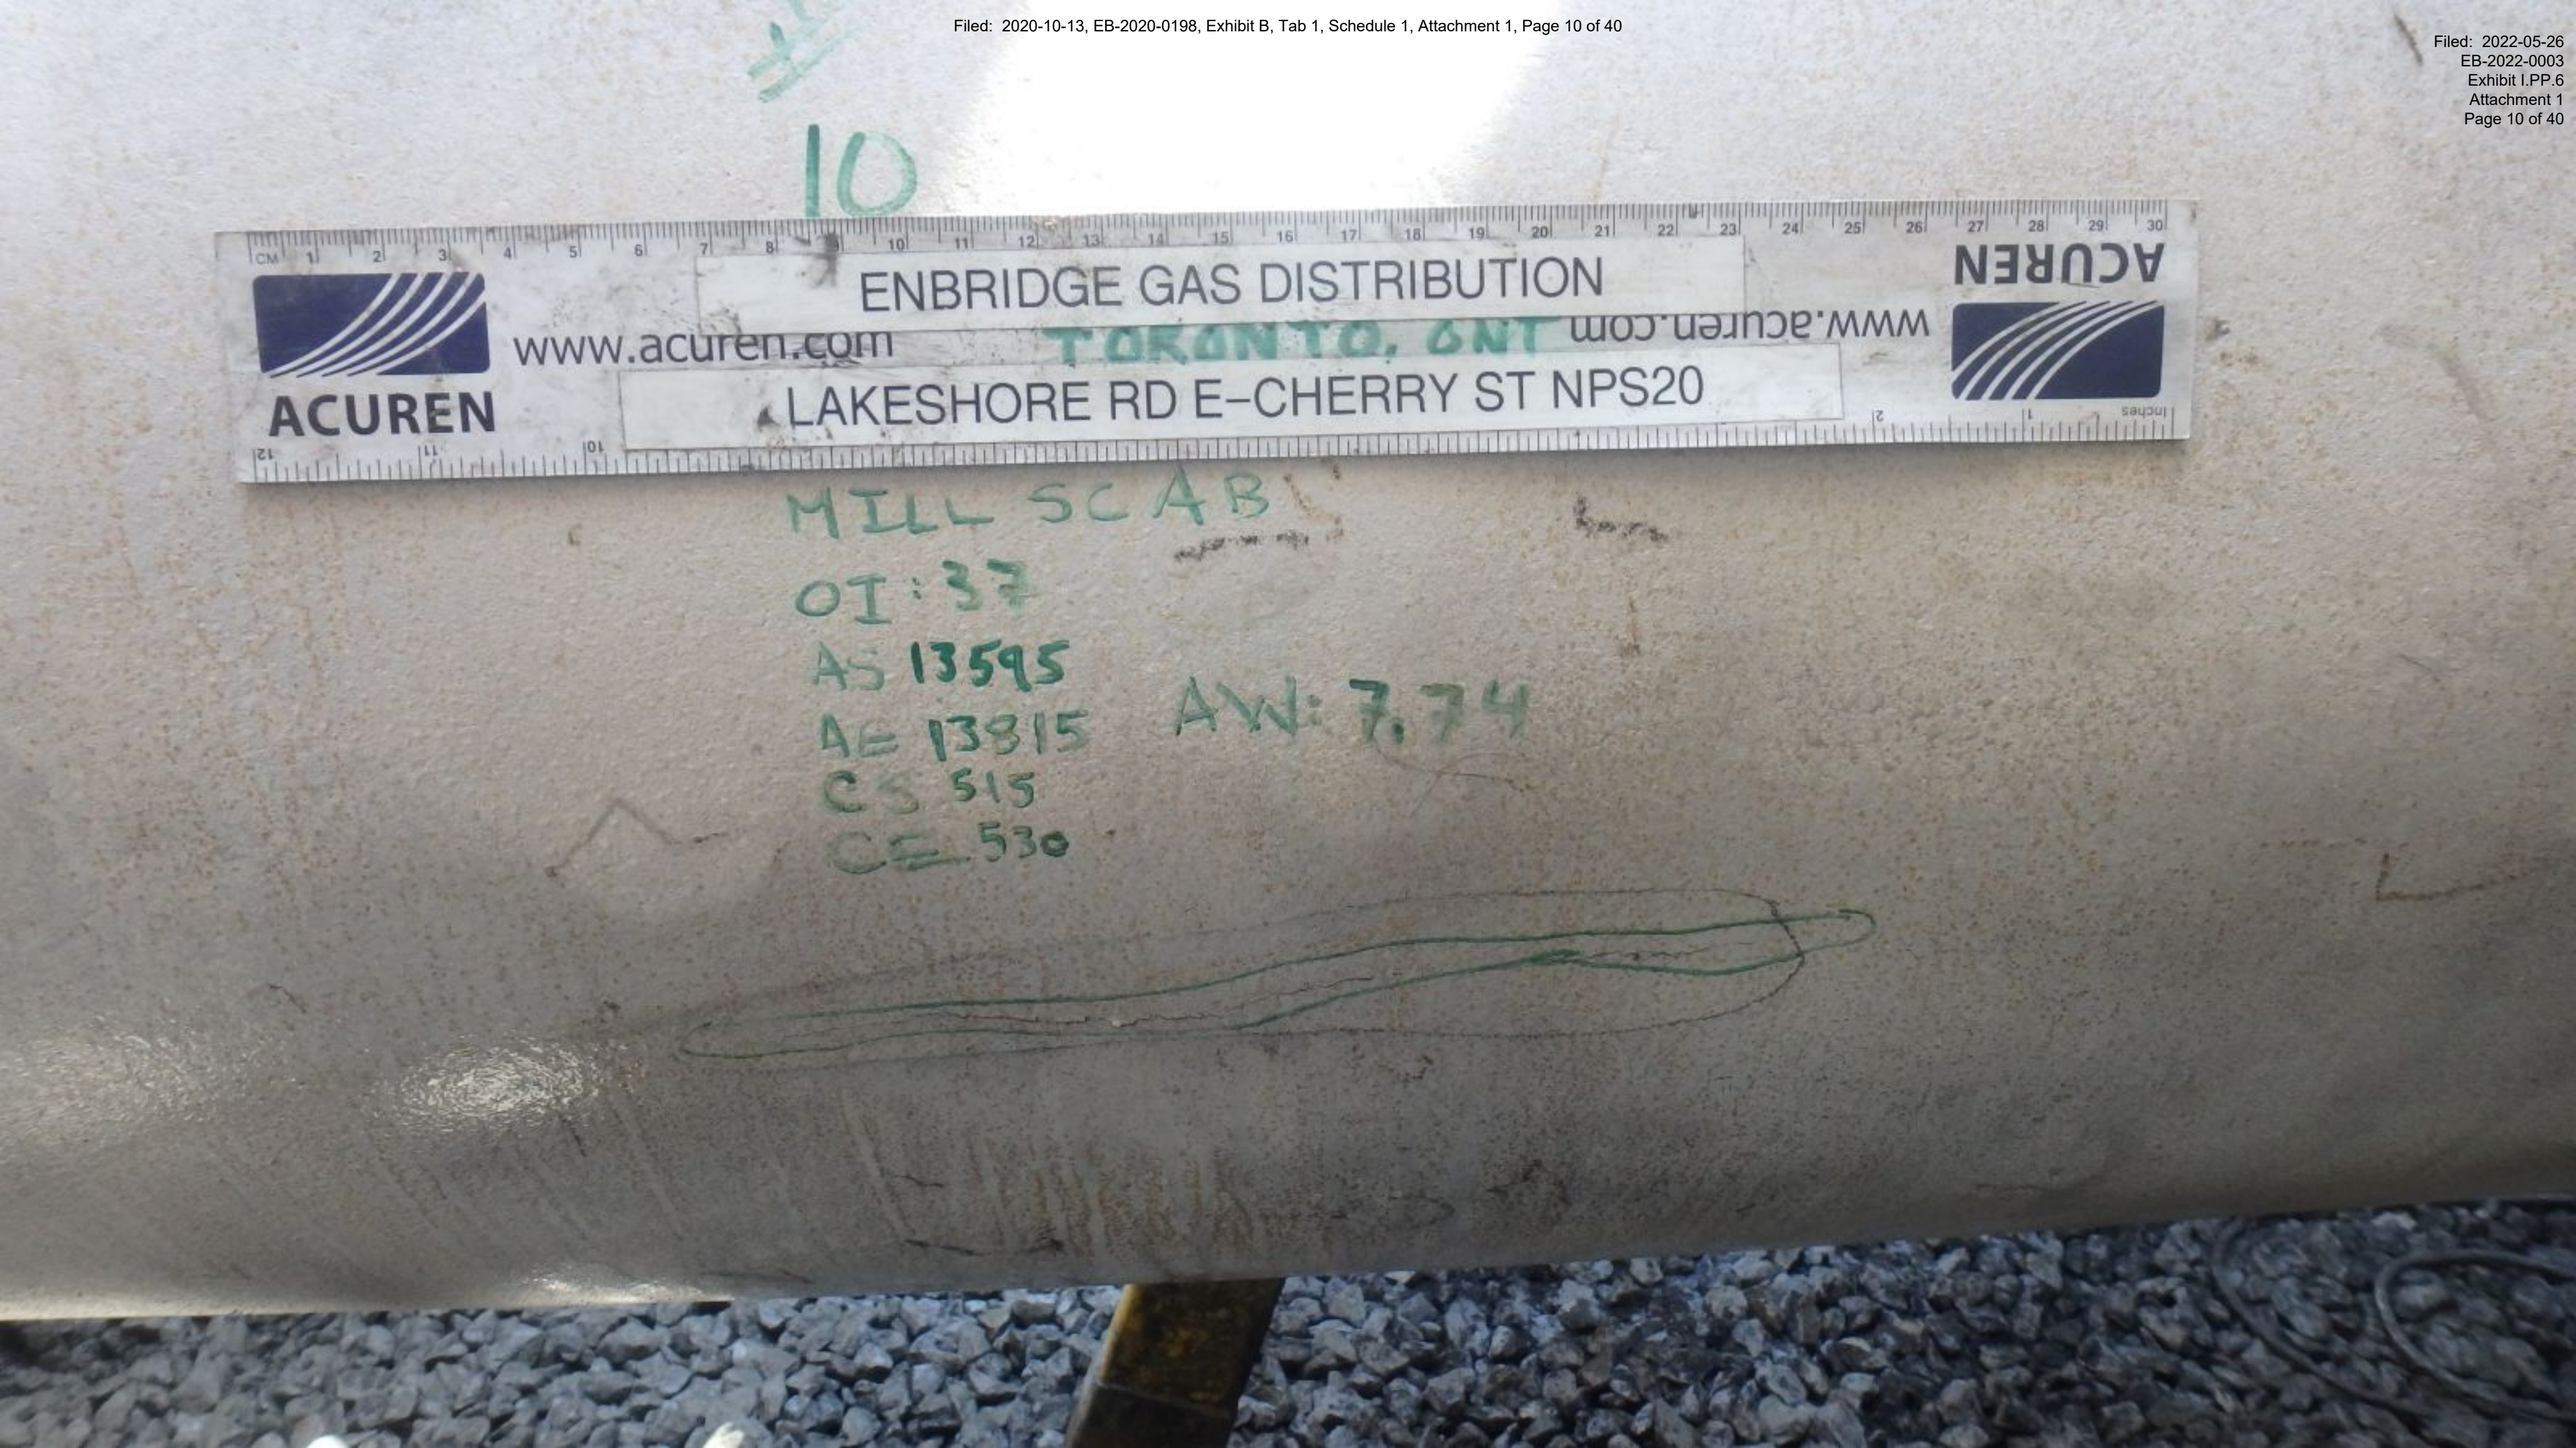
10
ENBRIDGE GAS DISTRIBUTION
ACUREN
www.acuren.com
TORONTO, ONT
LAKESHORE RD E-CHERRY ST NPS20
MILL SCAB
OI: 37
AS 13595
AE 13315
AW: 7.74
CS 515
CE 530

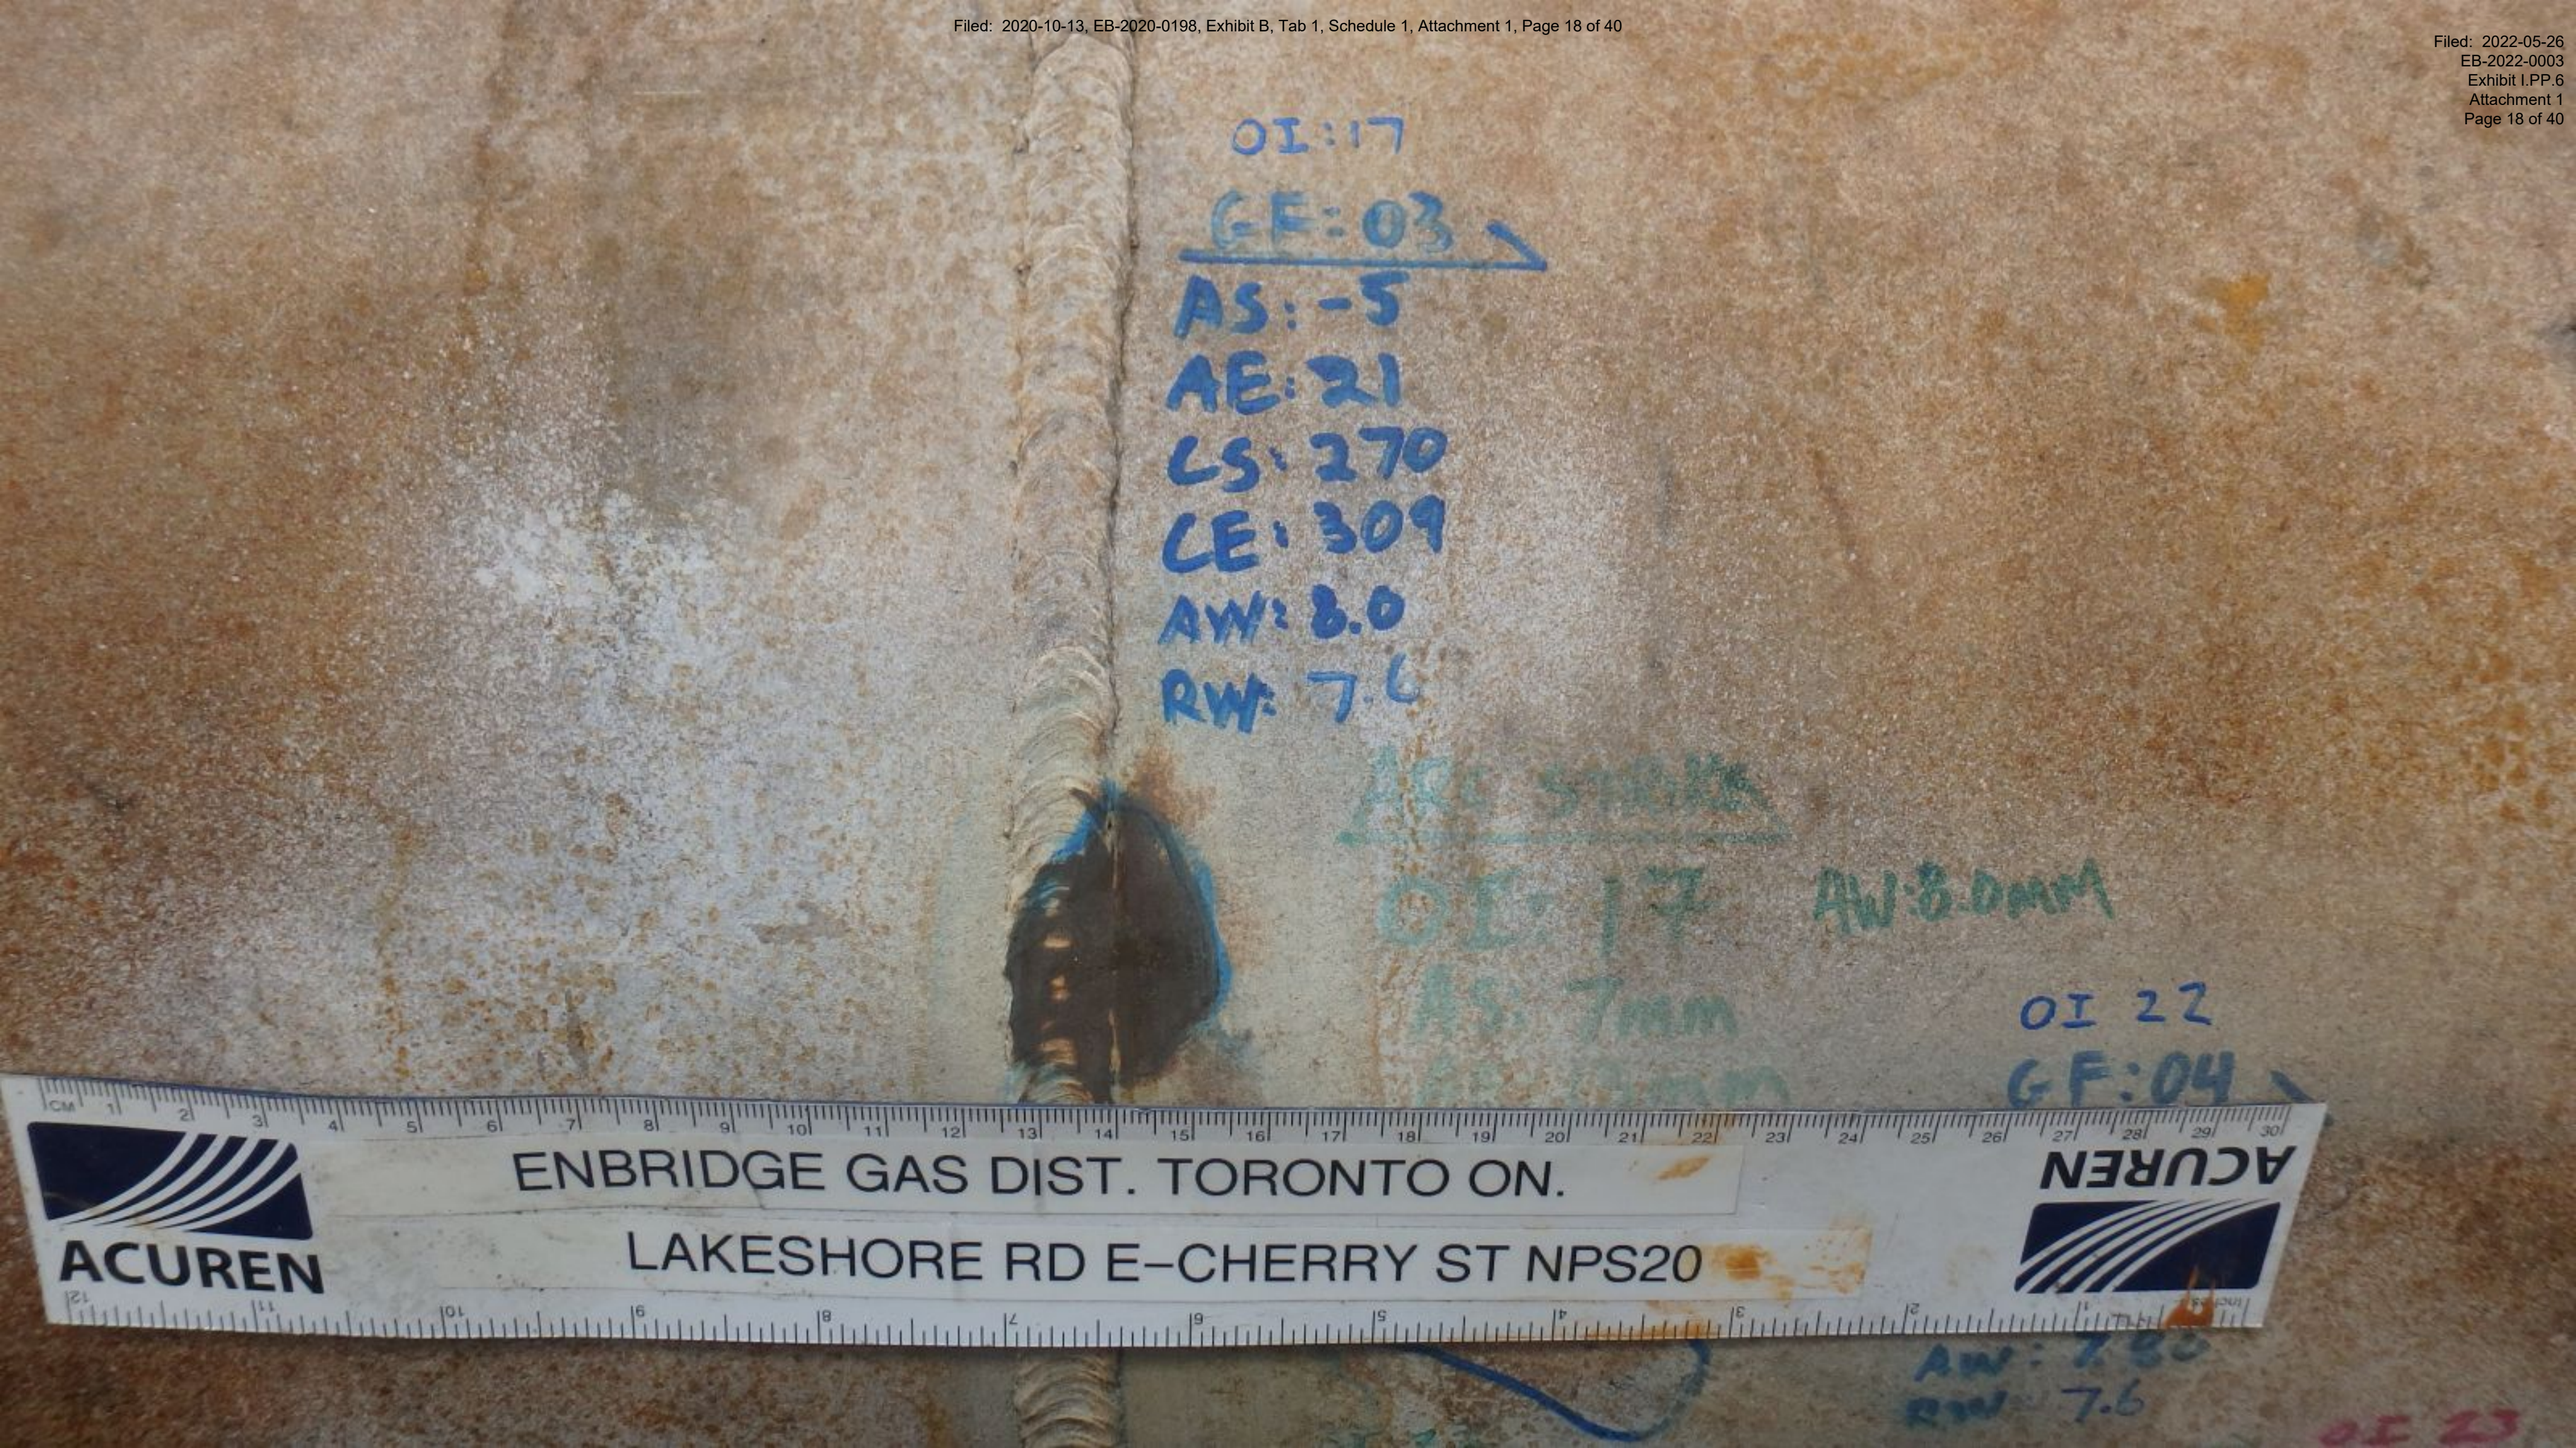
OI:17
GF:03
AS:-5
AE:21
CS:270
CE:309
AW:8.0
RW:7.6
OI:17
AS:7mm
AW:8.0mm
OI 22
GF:04
ENBRIDGE GAS DIST. TORONTO ON.
LAKESHORE RD E-CHERRY ST NPS20
ACUREN
ACUREN
AW:7.8
RW:7.6

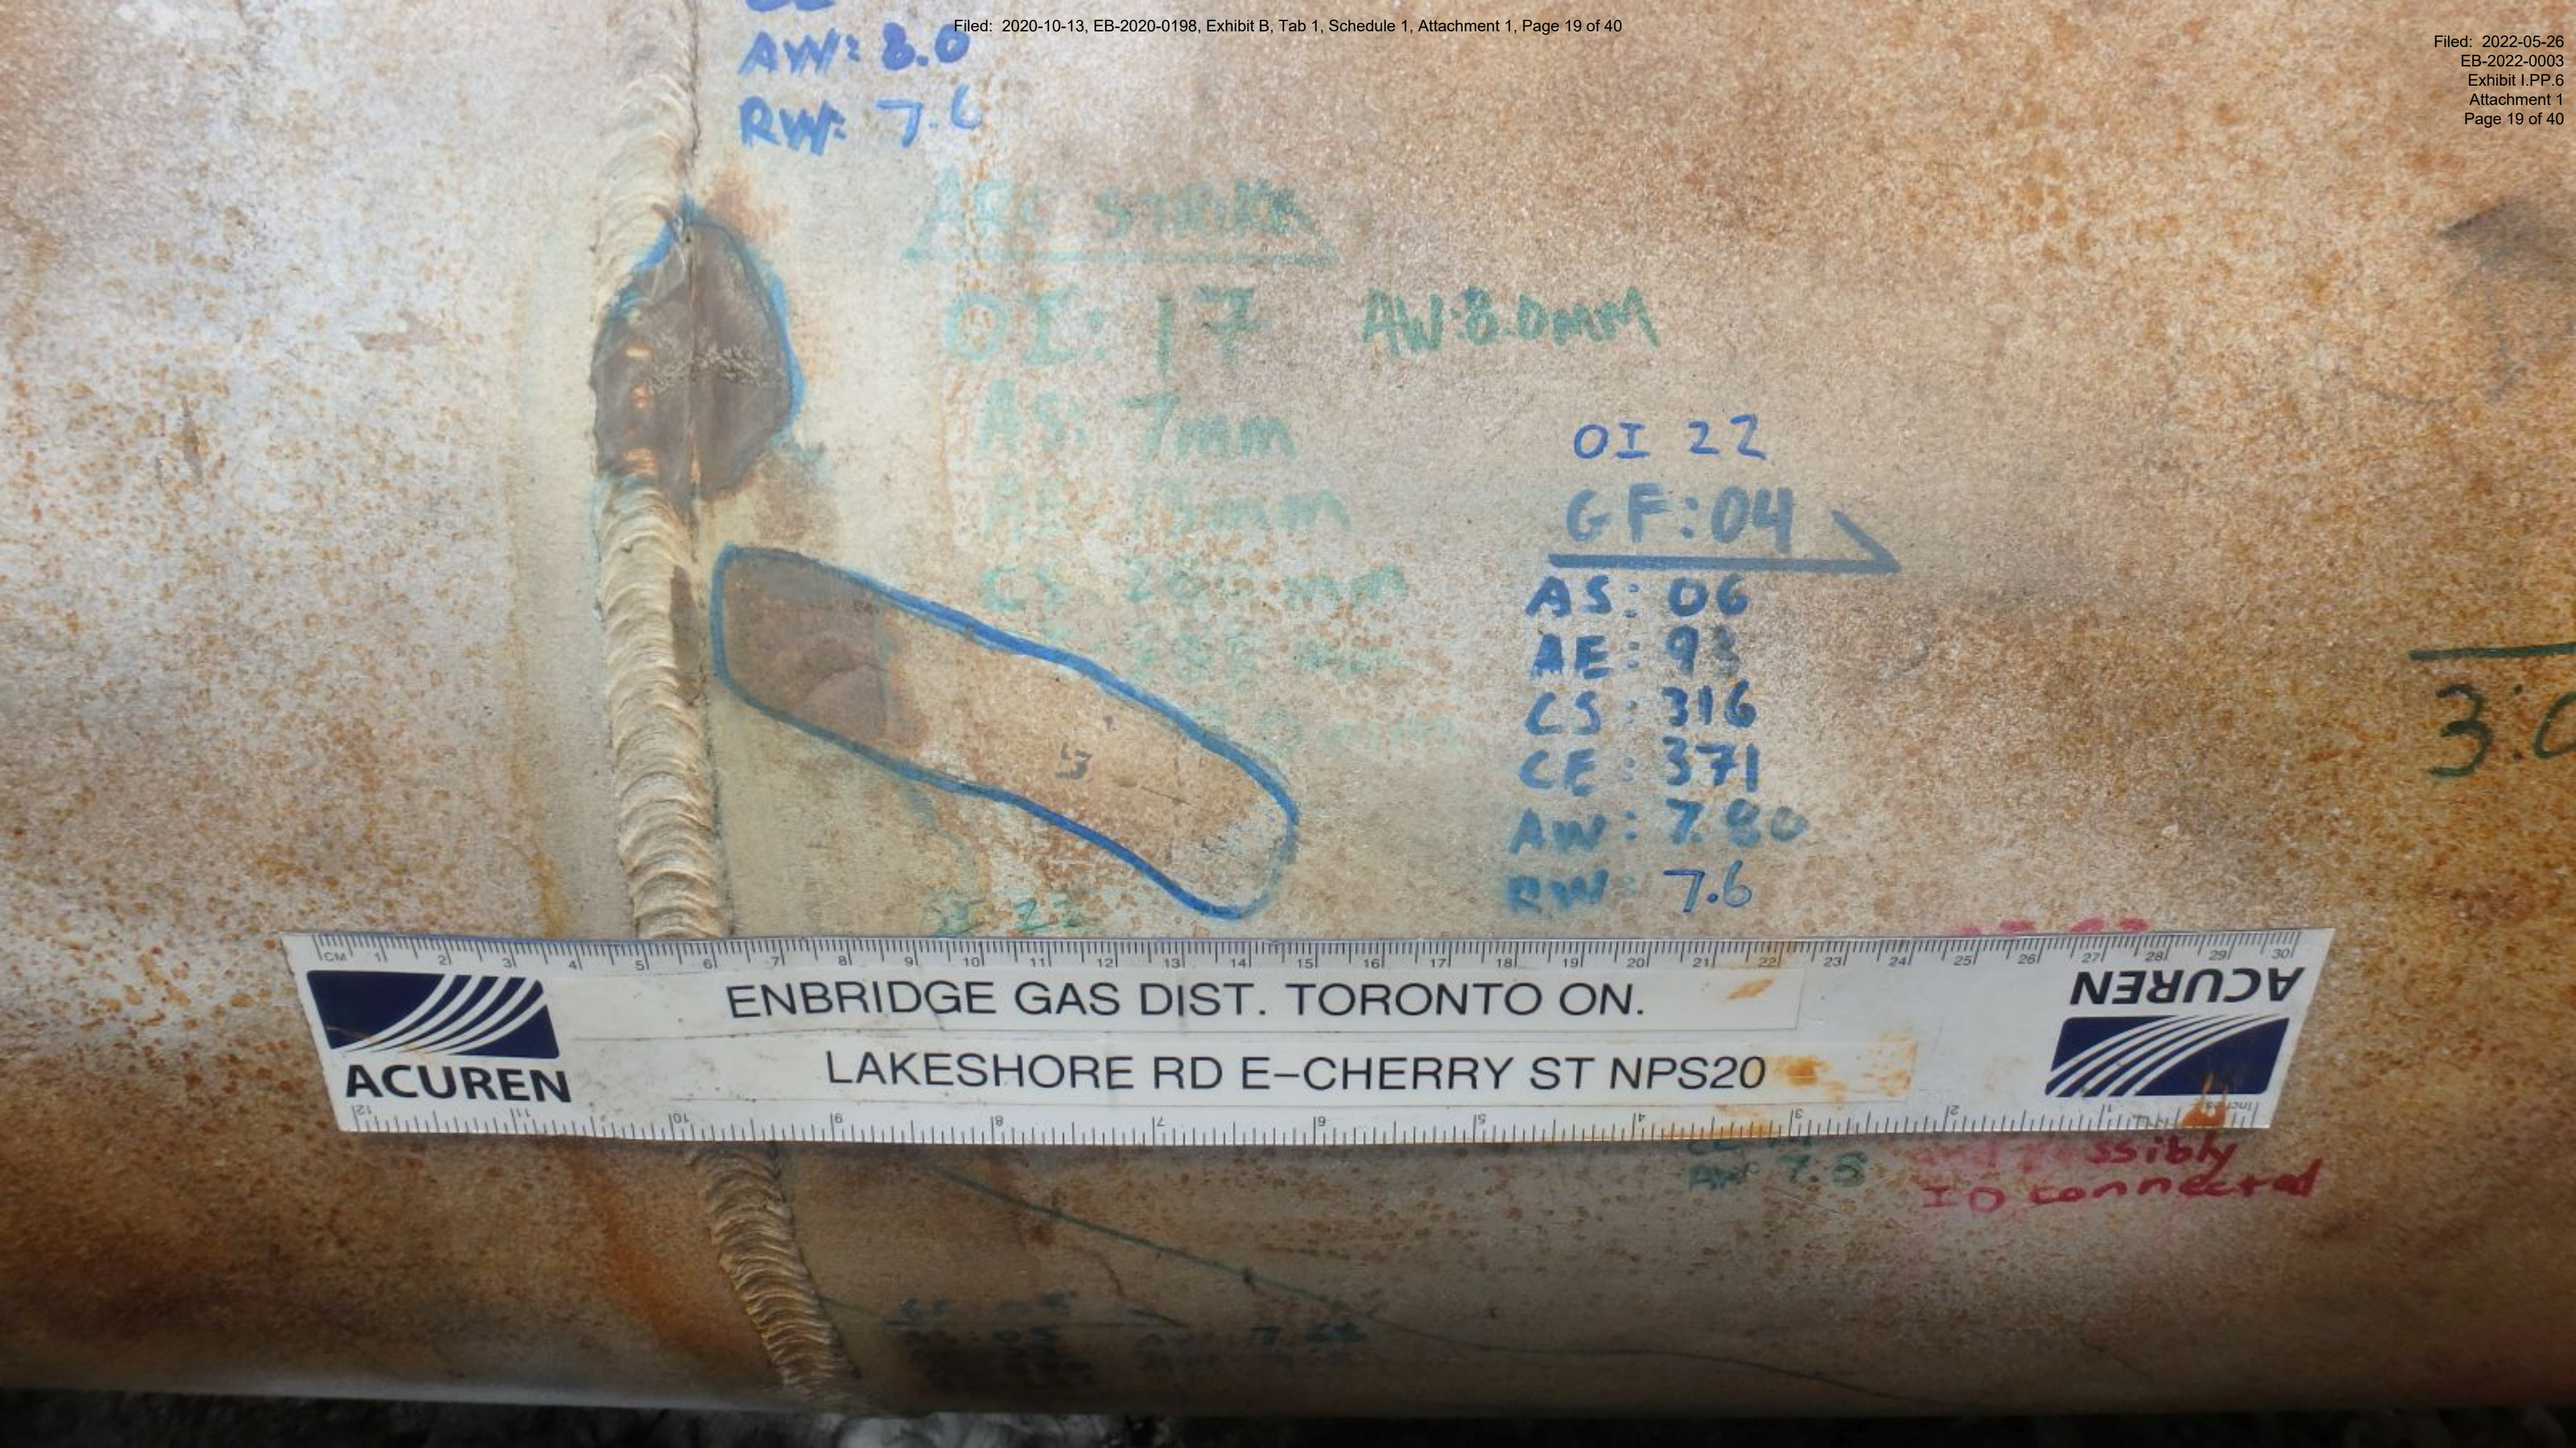
AW: 8.0
RW: 7.6
OI: 17
AW: 8.0mm
AS: 7mm
OI 22
GF: 04
AS: 06
AE: 93
CS: 316
CE: 371
AW: 7.80
RW: 7.6
ENBRIDGE GAS DIST. TORONTO ON.
LAKESHORE RD E–CHERRY ST NPS20
ACUREN
RW 7.5

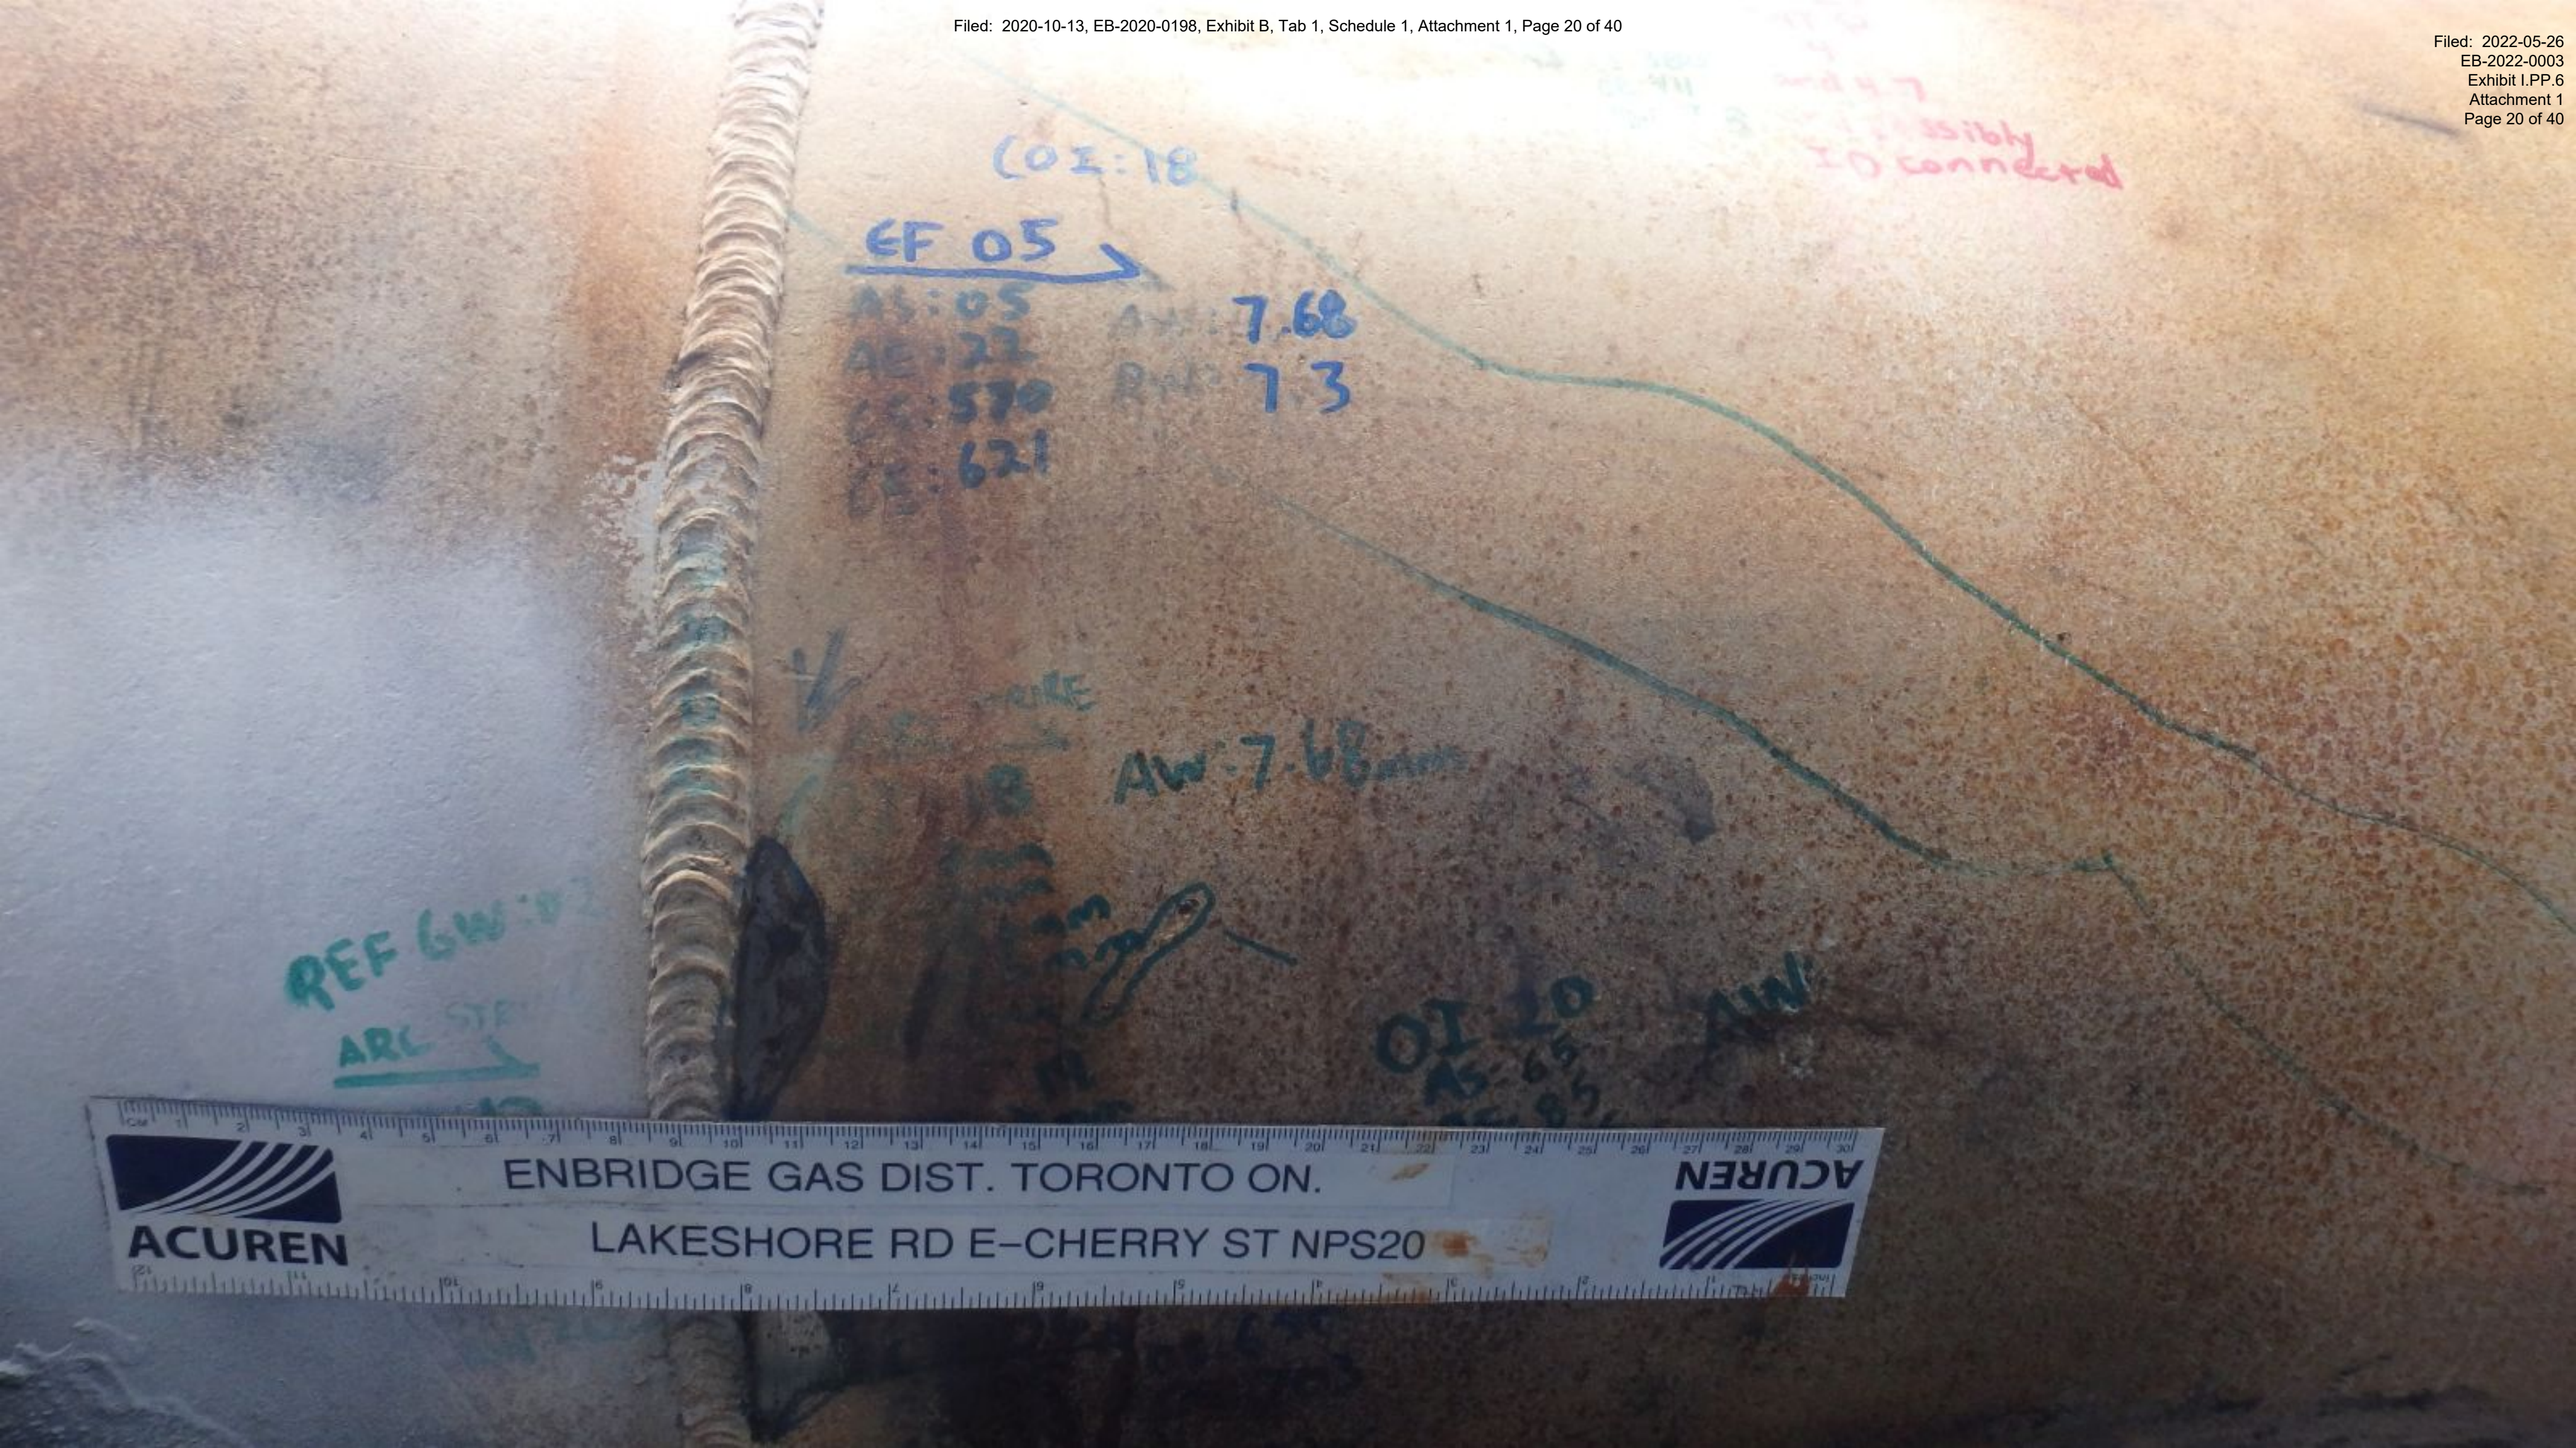
COI: 18
EF 05
AS: 05
AE: 22
CS: 570
CE: 621
AW: 7.68
AW: 7.68
REF GW
ARC
OI 20
AW
ENBRIDGE GAS DIST. TORONTO ON.
LAKESHORE RD E-CHERRY ST NPS20
ACUREN
ACUREN

ENBRIDGE GAS DIST. TORONTO ON.
LAKESHORE RD E-CHERRY ST NPS20
ACUREN
7.68
0=19
CE 06
AS:05
AE:30
CS:650
CE:703
7.68 RW 7.6

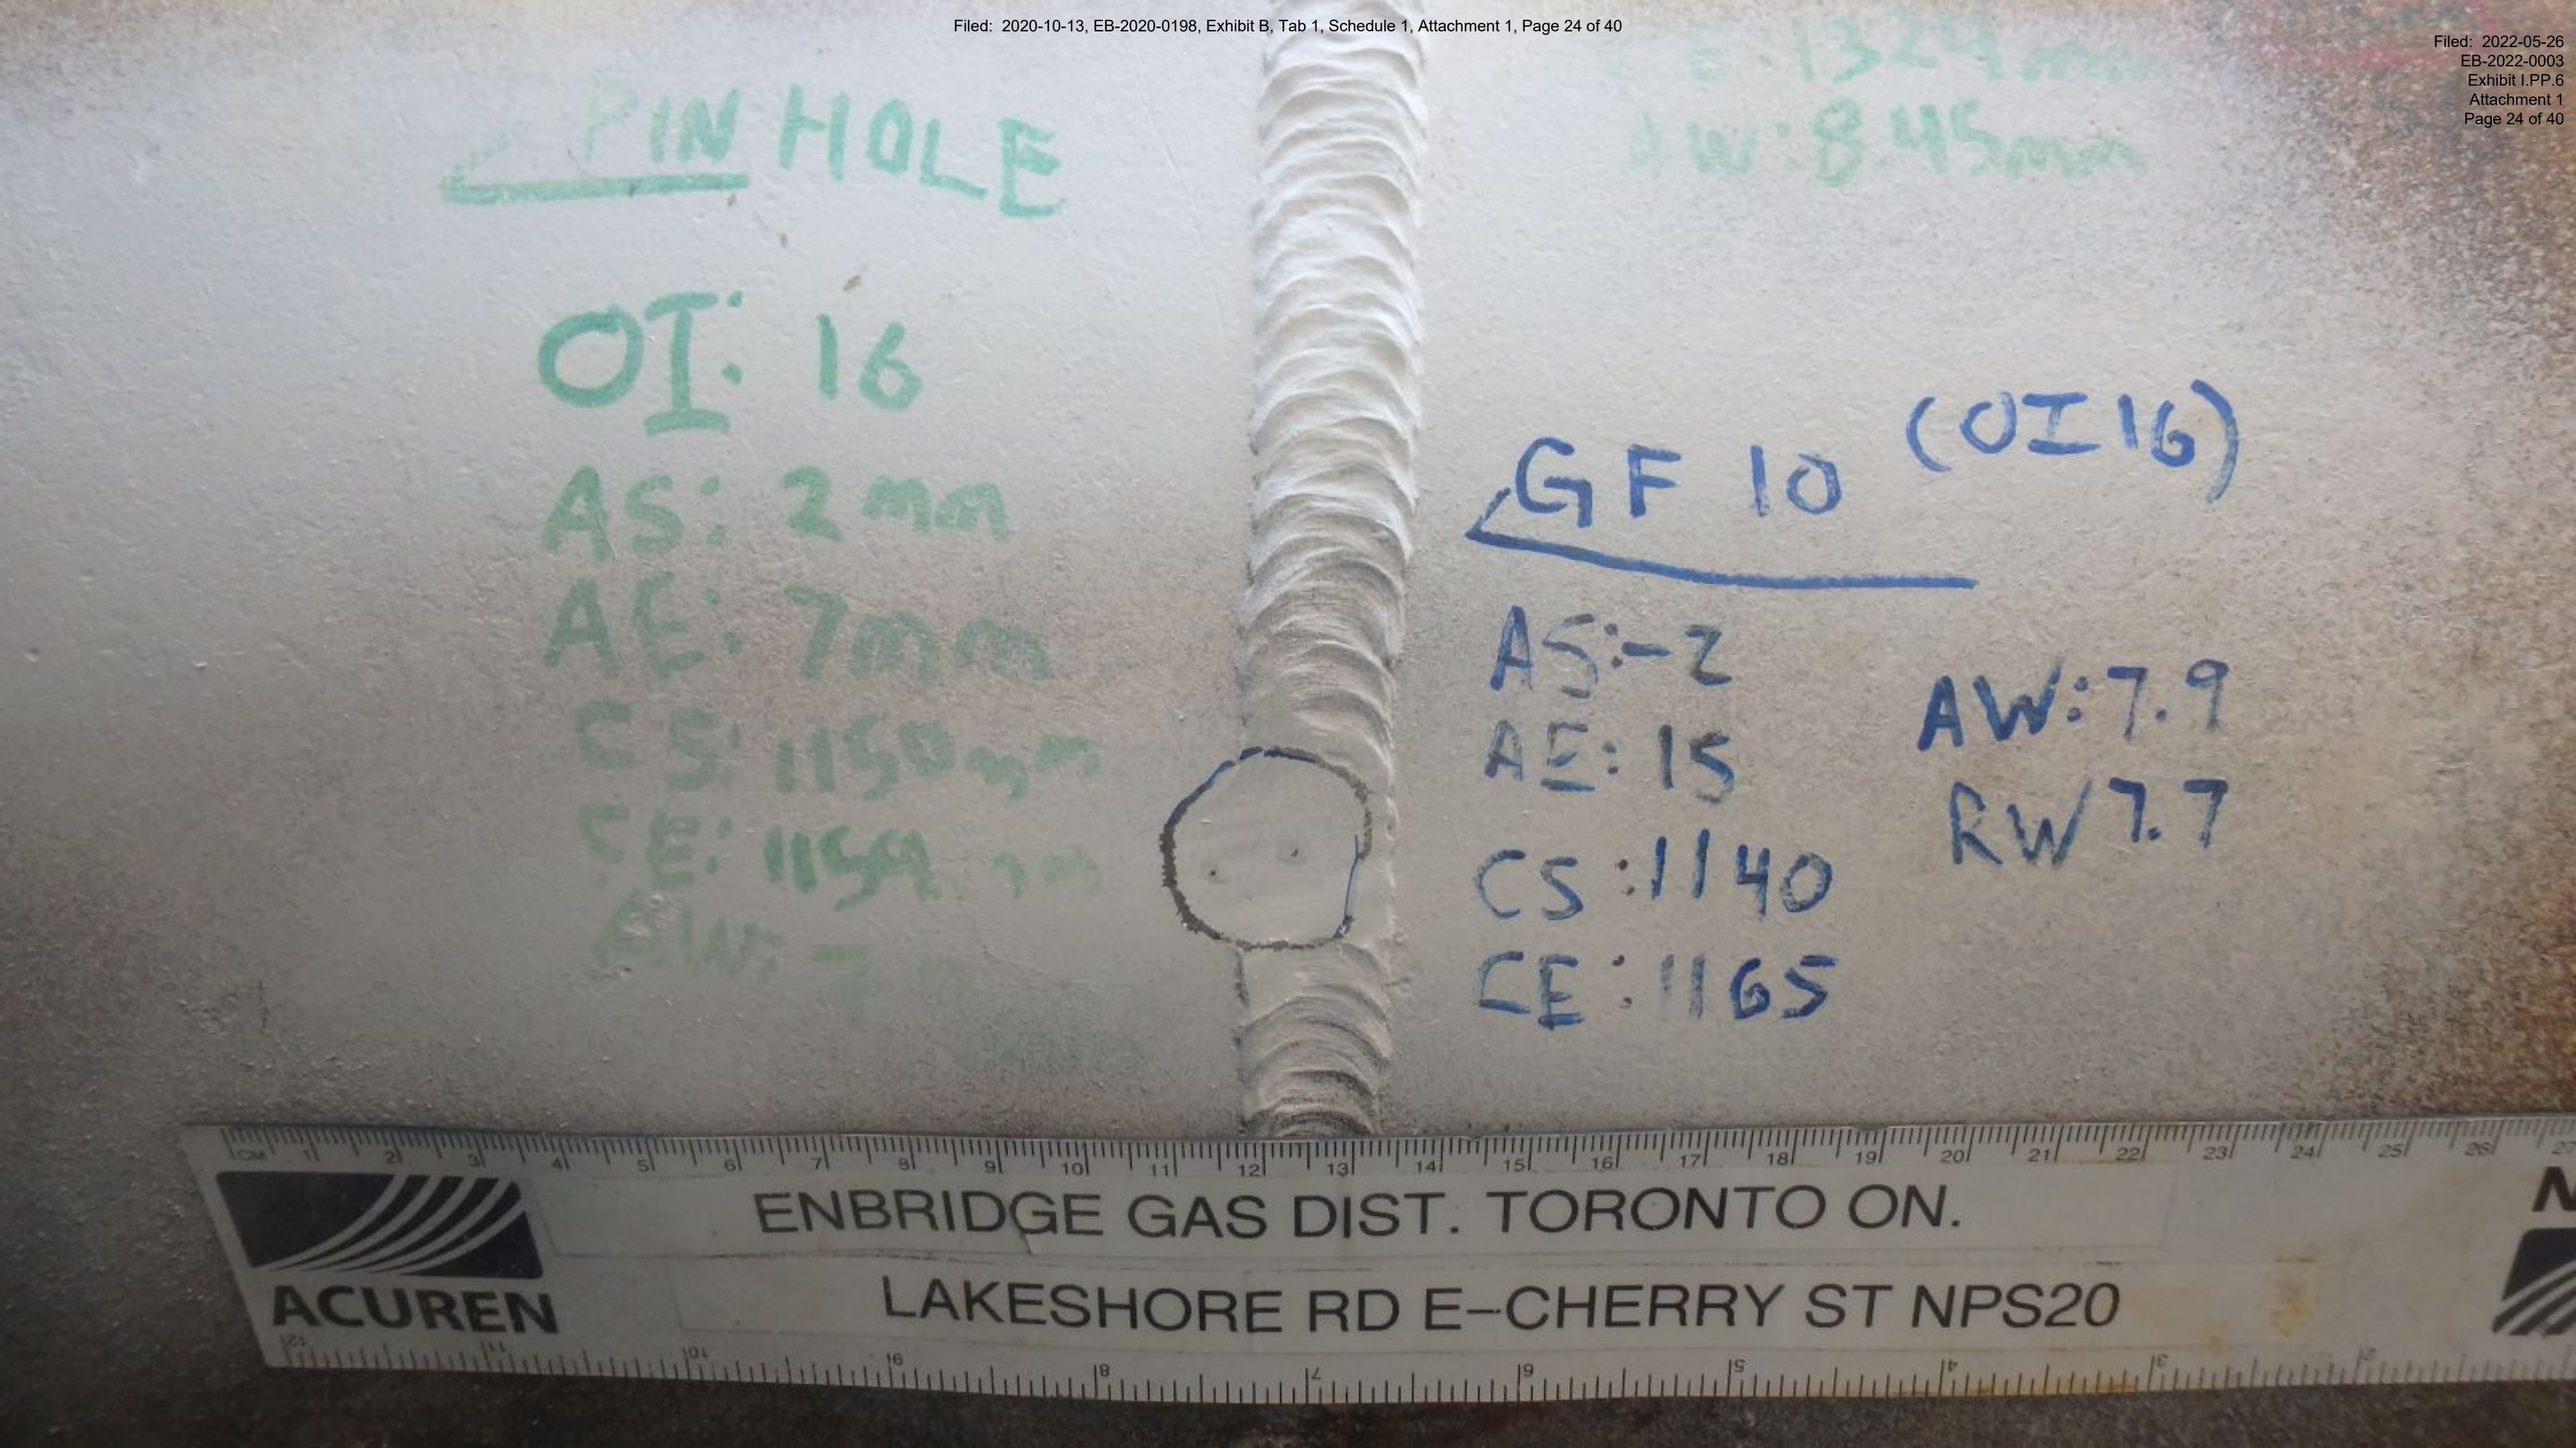
PIN HOLE
OI: 16
AS: 2 mm
AE: 7mm
CS: 1150
CE: 1154
GF 10 (OI 16)
AS: -2
AE: 15
CS: 1140
CE: 1165
AW: 7.9
RW 7.7
ENBRIDGE GAS DIST. TORONTO ON.
LAKESHORE RD E–CHERRY ST NPS20
ACUREN
