Re: Enbridge Gas Inc. ("Enbridge Gas")
Ontario Energy Board ("OEB") File No. EB-2022-0003
NPS 20 Waterfront Relocation Project – Interrogatory Responses

Answer to Interrogatory from
OEB Staff ("STAFF")

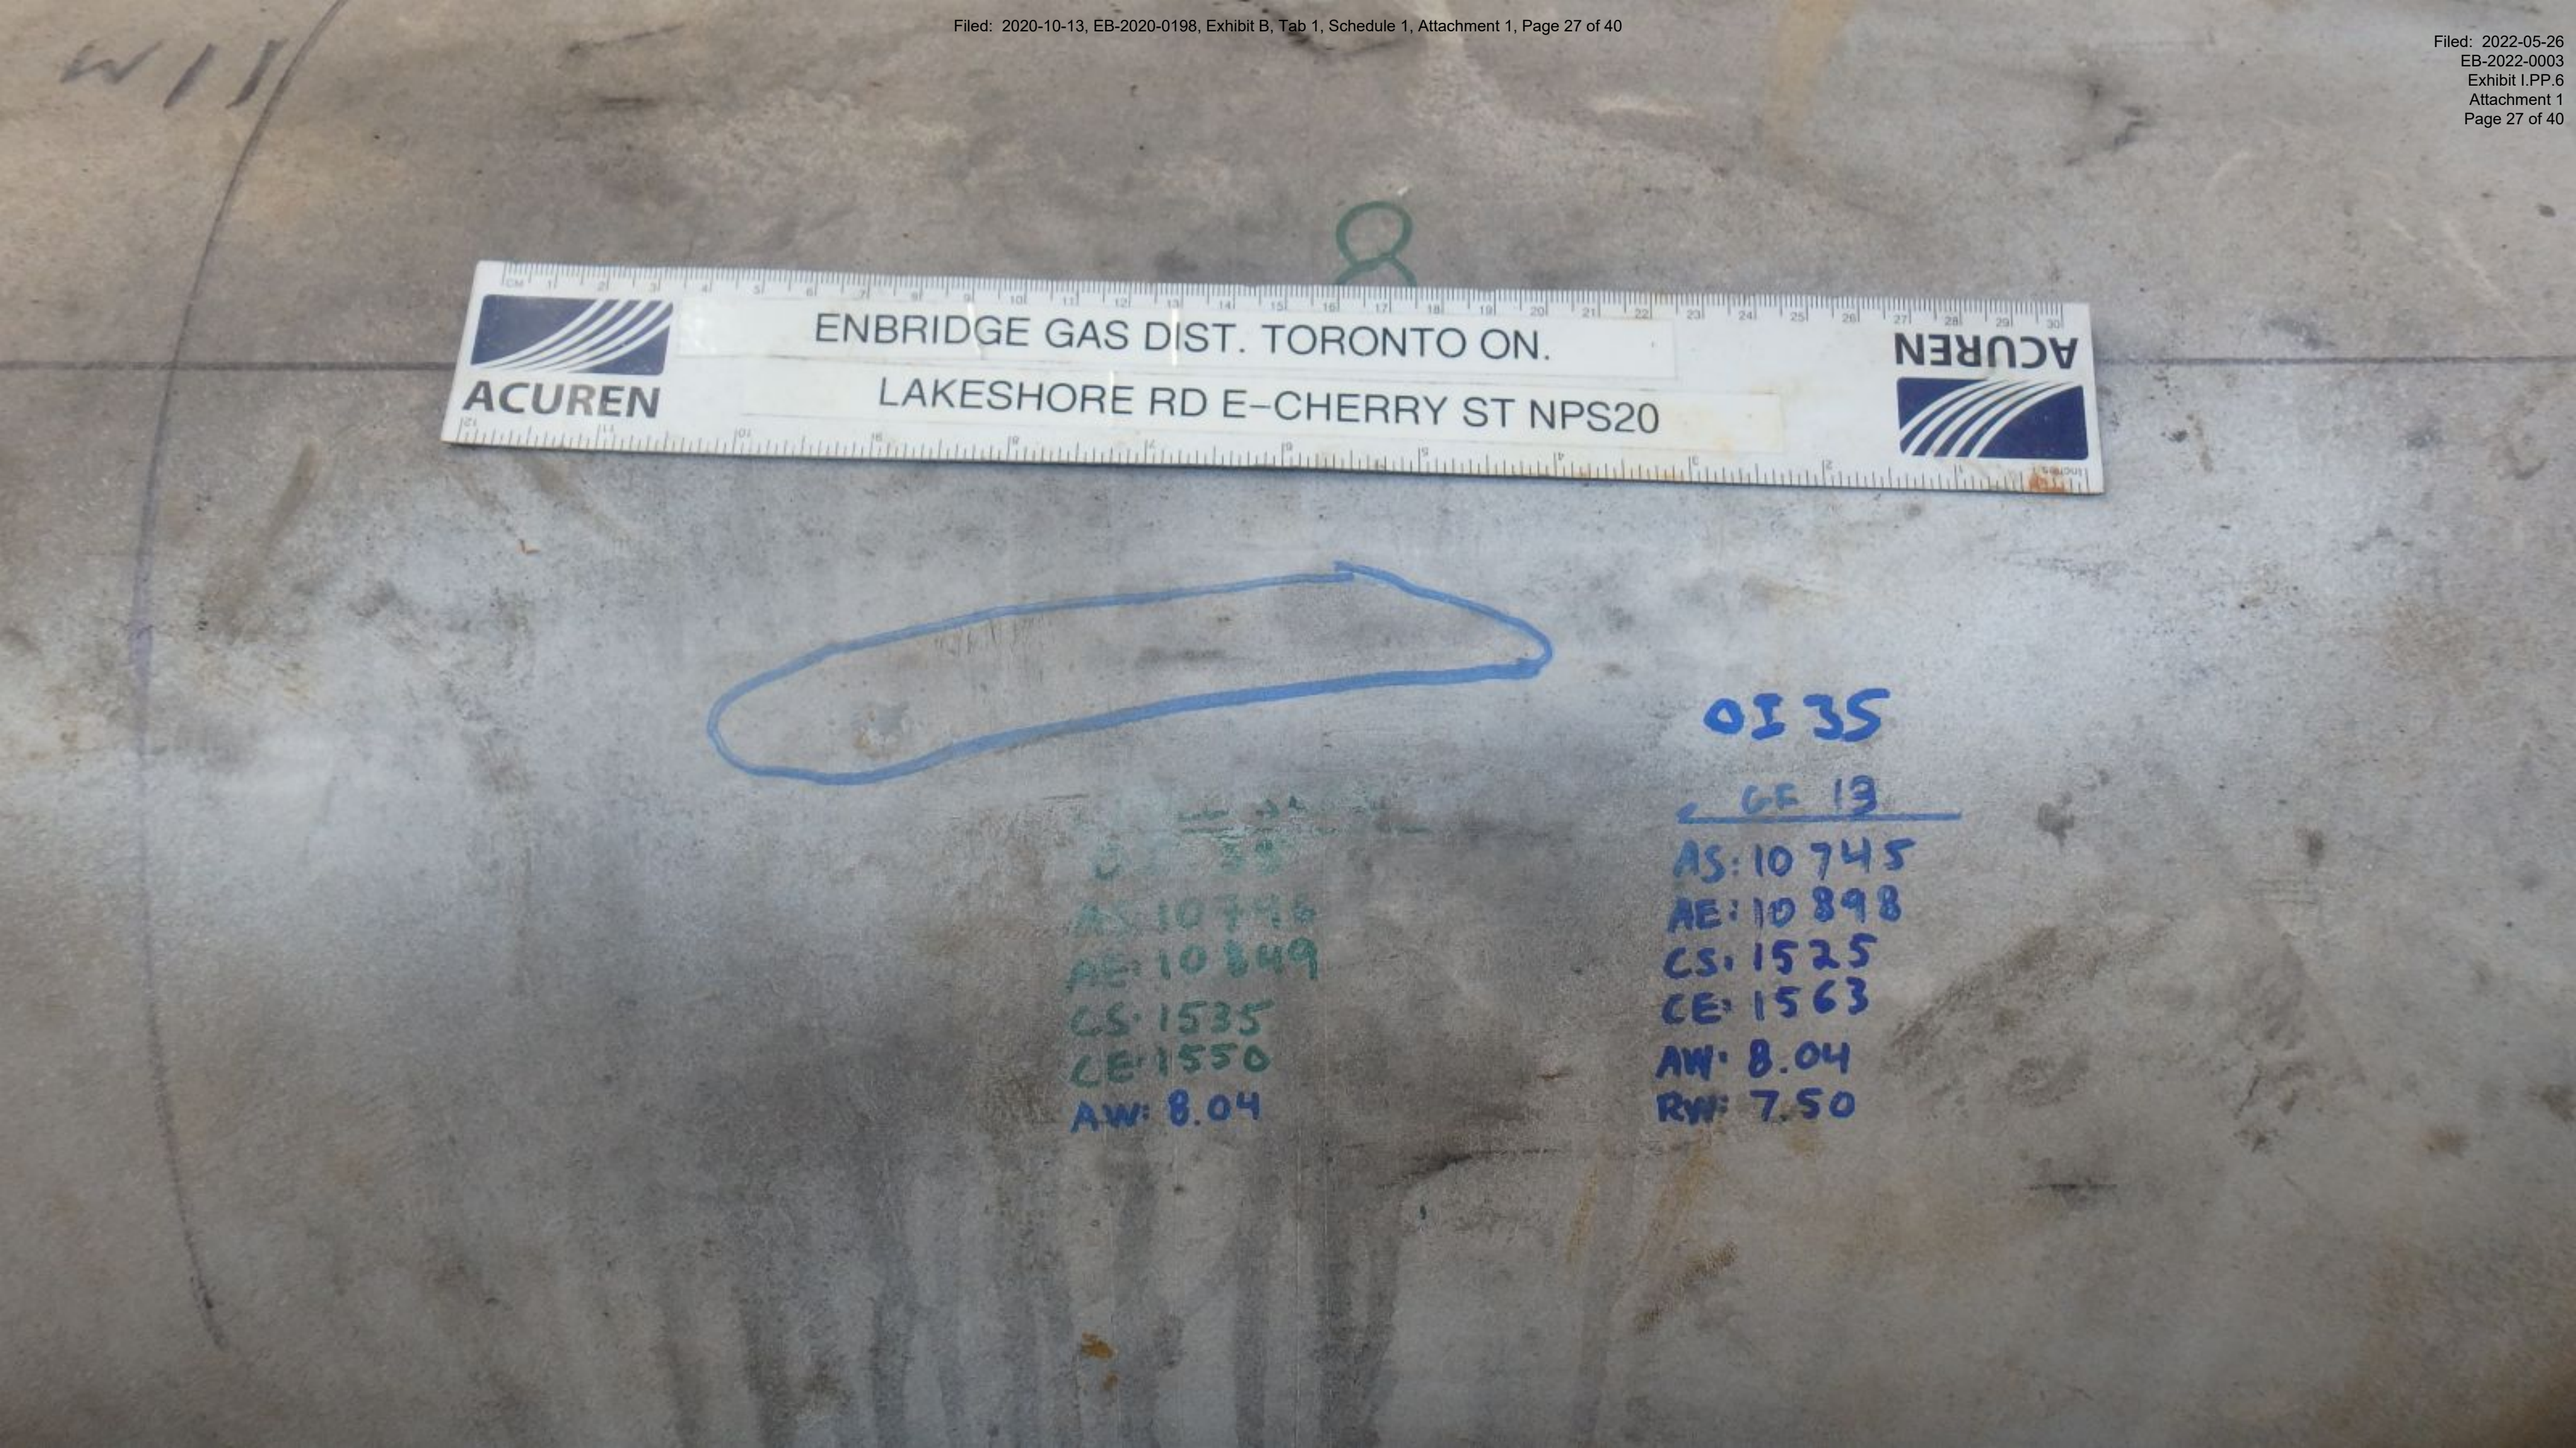
ENBRIDGE GAS DIST. TORONTO ON.
LAKESHORE RD E–CHERRY ST NPS20
ACUREN
ACUREN
OI 35
CE 13
AS: 10745
AE: 10898
CS: 1525
CE: 1563
AW: 8.04
RW: 7.50
AS: 10746
AE: 10849
CS: 1535
CE: 1550
AW: 8.04

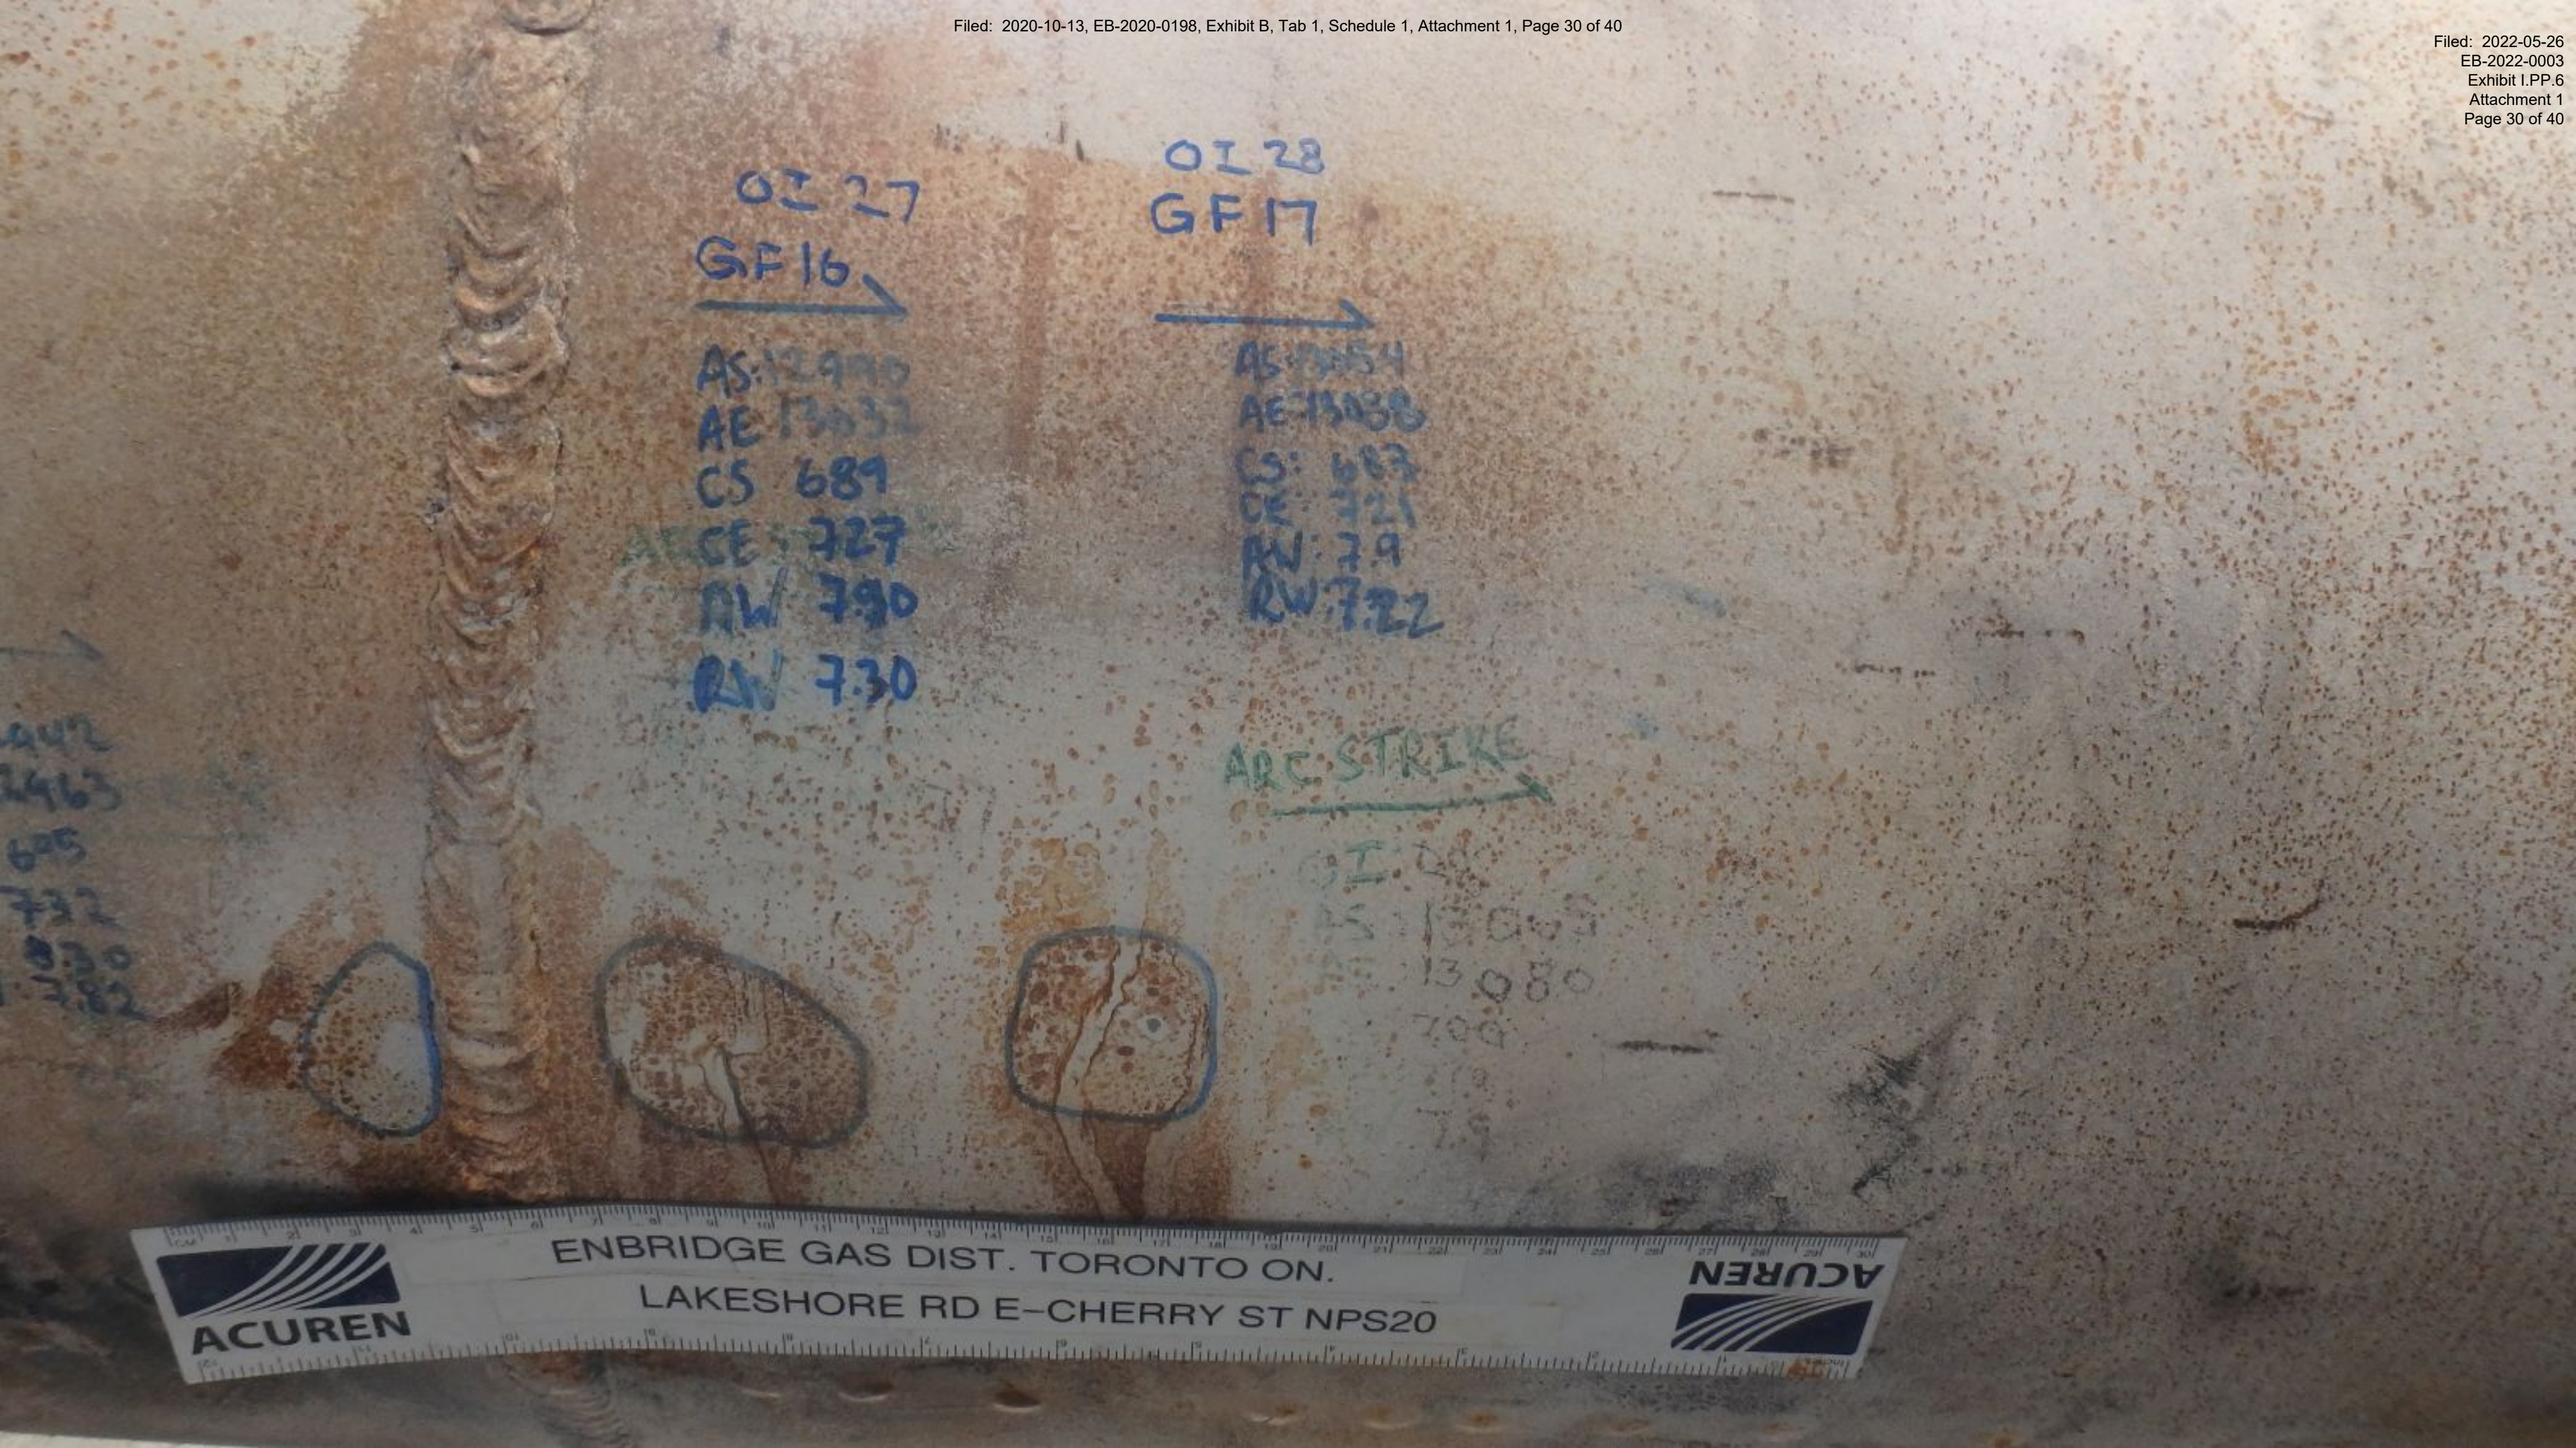
OI 27
GF16
AS:12980
AE 13632
CS 689
CE 727
AW 790
RW 730
OI 28
GF17
AS 13854
AE 13838
CS: 687
CE: 721
AW 79
RW 722
ARC STRIKE
ENBRIDGE GAS DIST. TORONTO ON.
LAKESHORE RD E-CHERRY ST NPS20
ACUREN
ACUREN

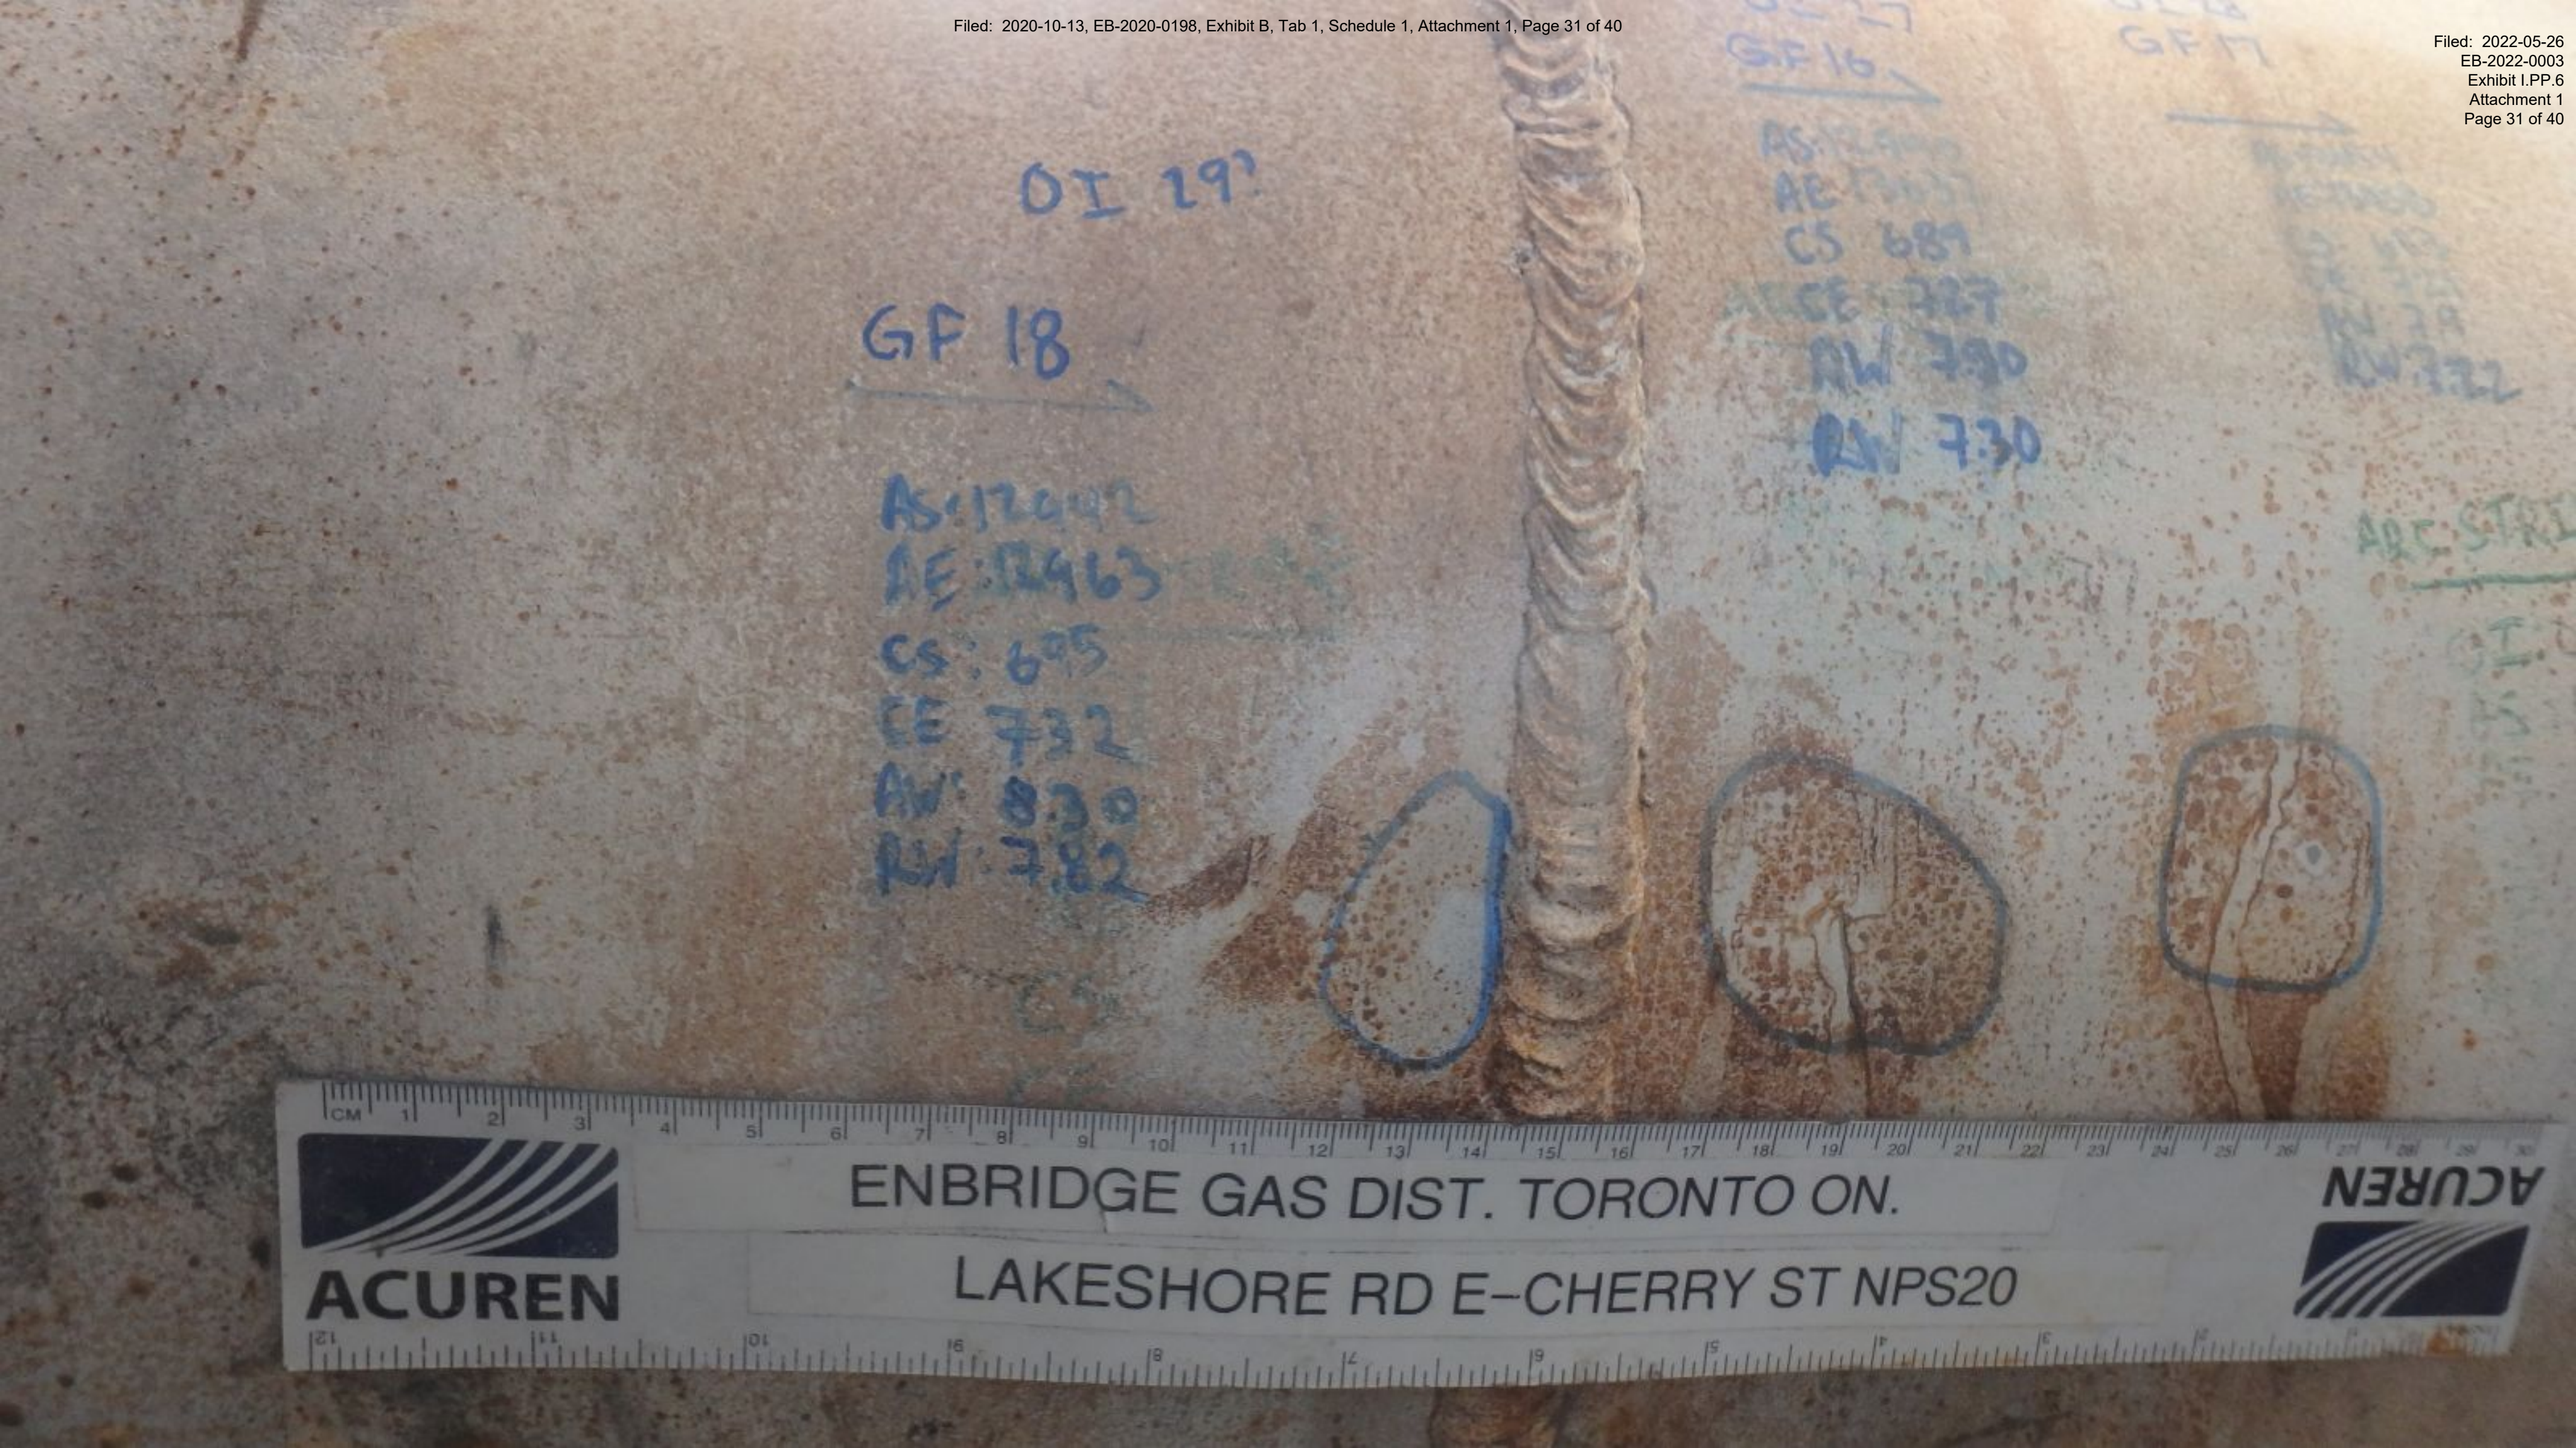
DI 19
GF 18
AS:12492
AE:12463
CS: 695
CE 732
AW: 830
RW: 782
GF 16
CS 689
RW 730
RW 722
ENBRIDGE GAS DIST. TORONTO ON.
LAKESHORE RD E-CHERRY ST NPS20
ACUREN

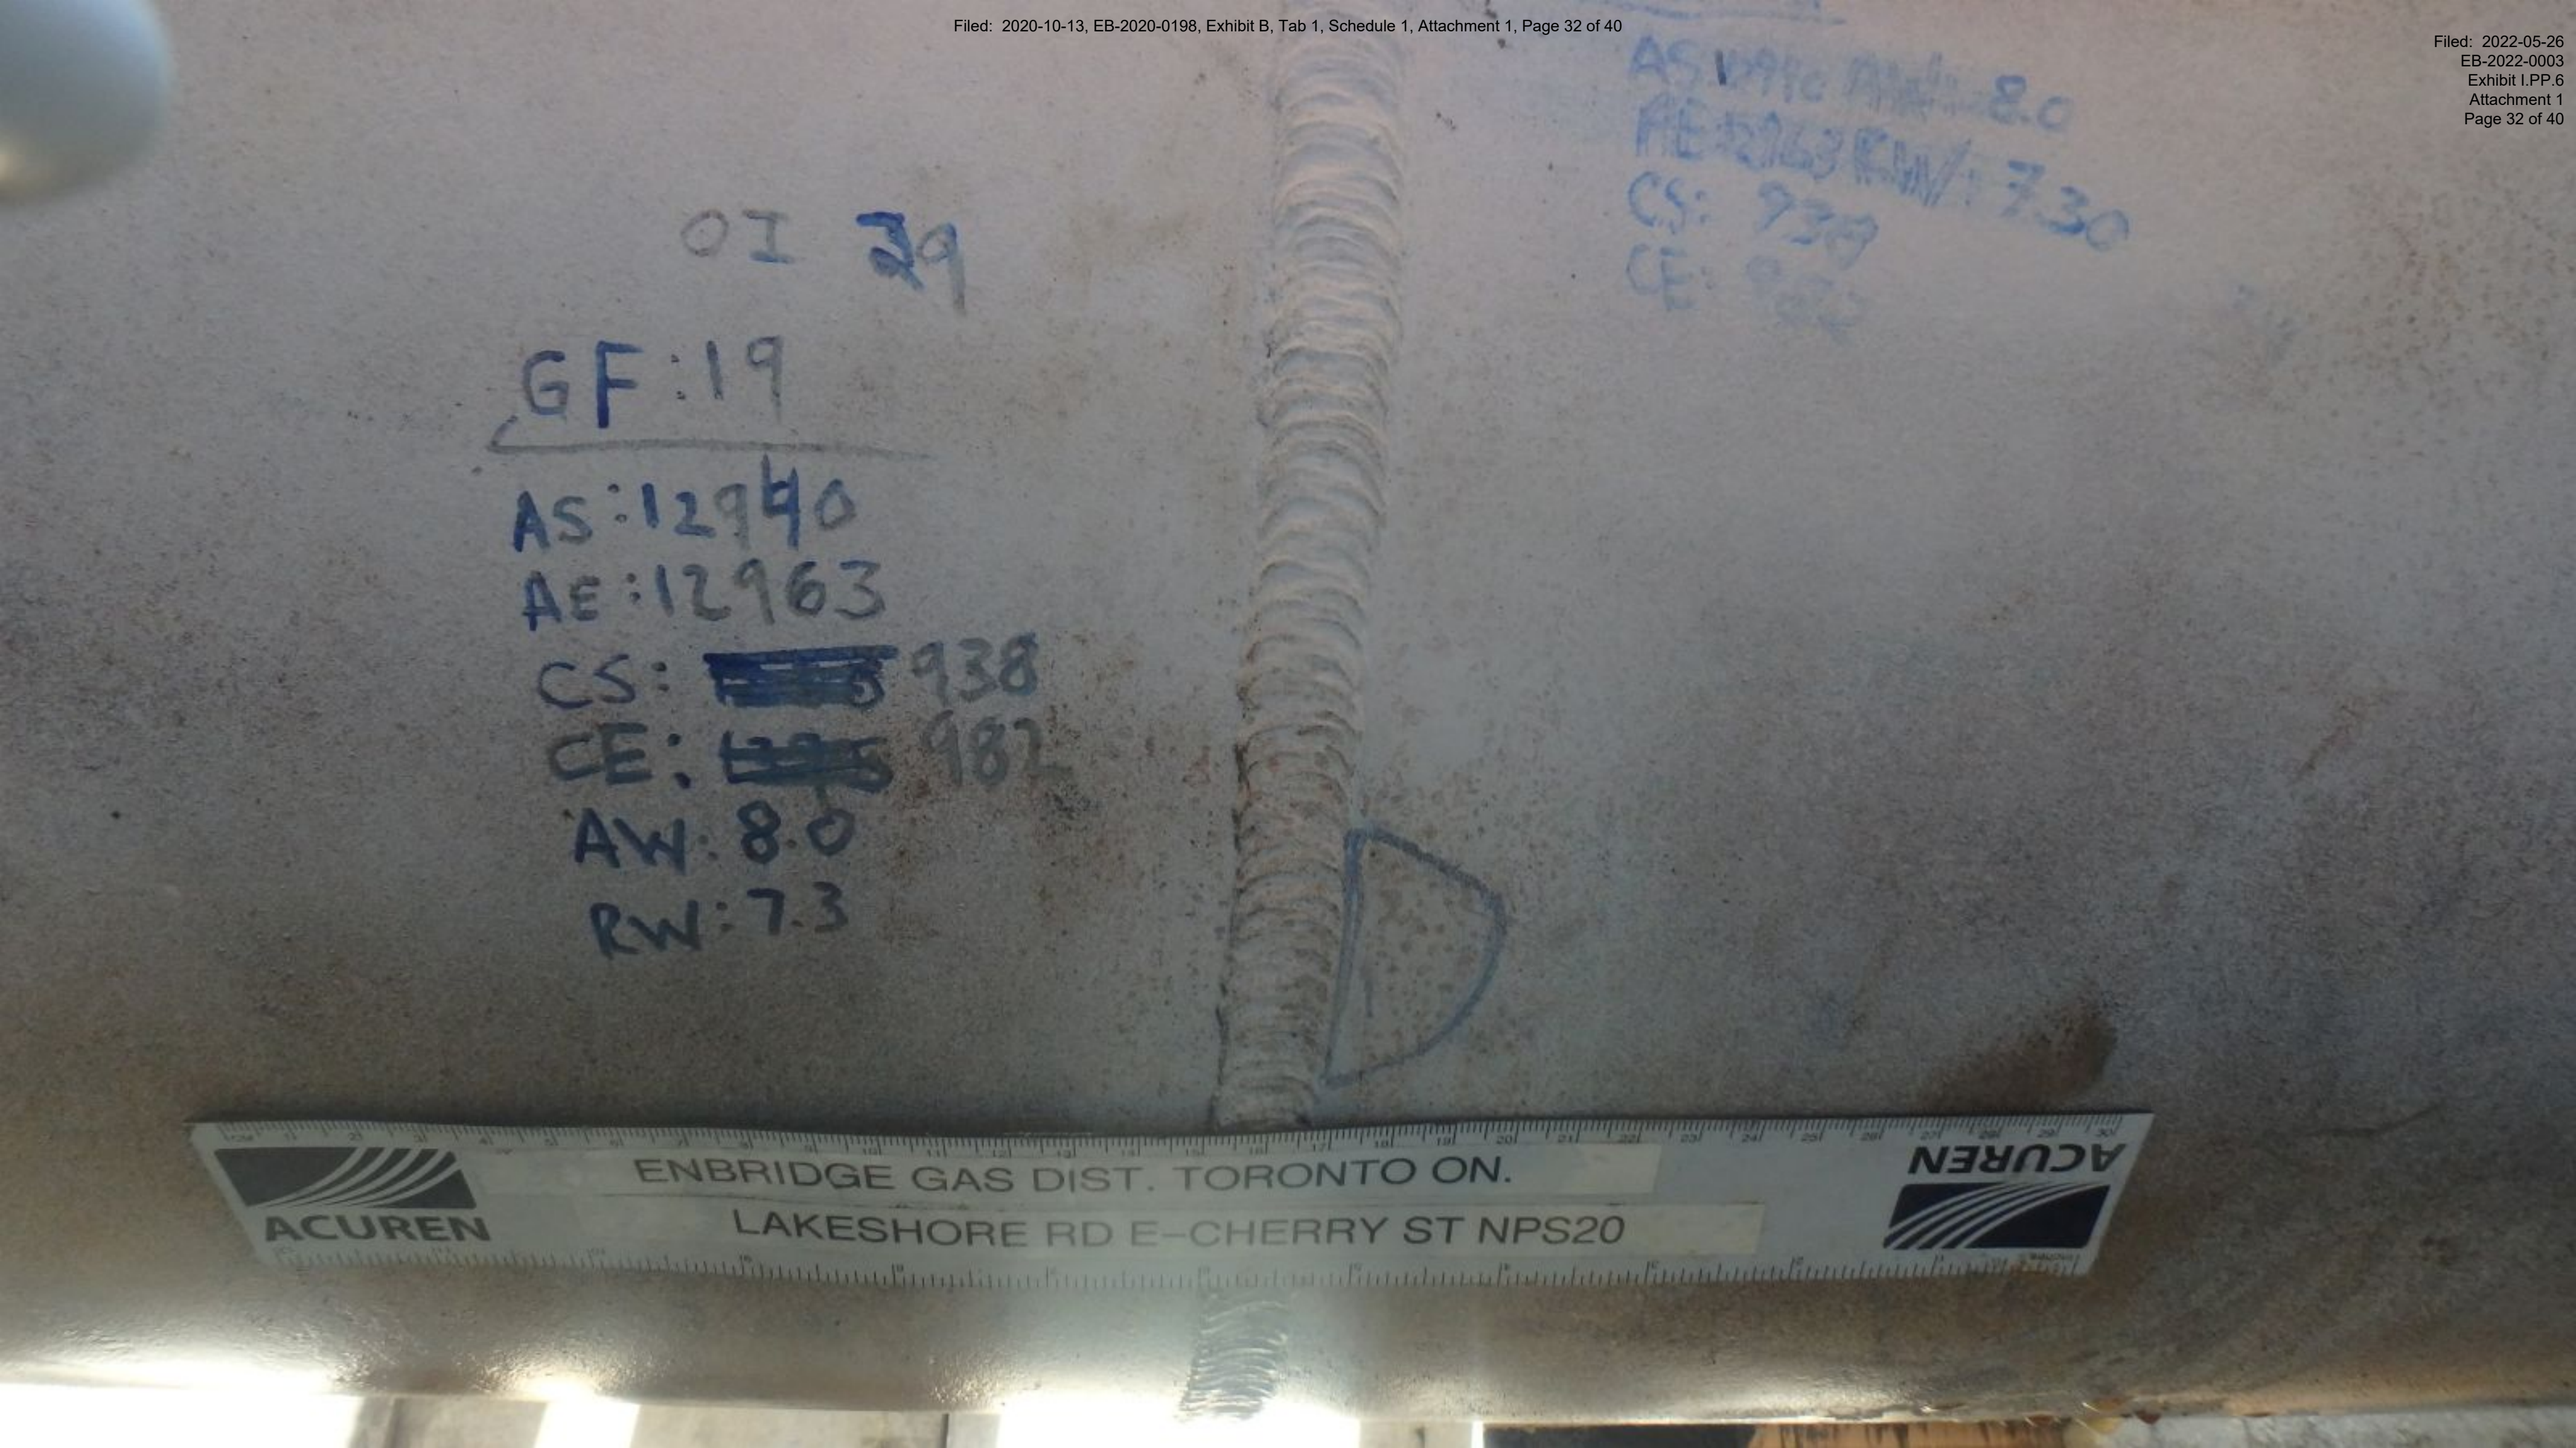
OI 29
GF:19
AS:12940
AE:12963
CS: 938
CE: 982
AW: 8.0
RW: 7.3
ACUREN
ENBRIDGE GAS DIST. TORONTO ON.
LAKESHORE RD E-CHERRY ST NPS20
ACUREN

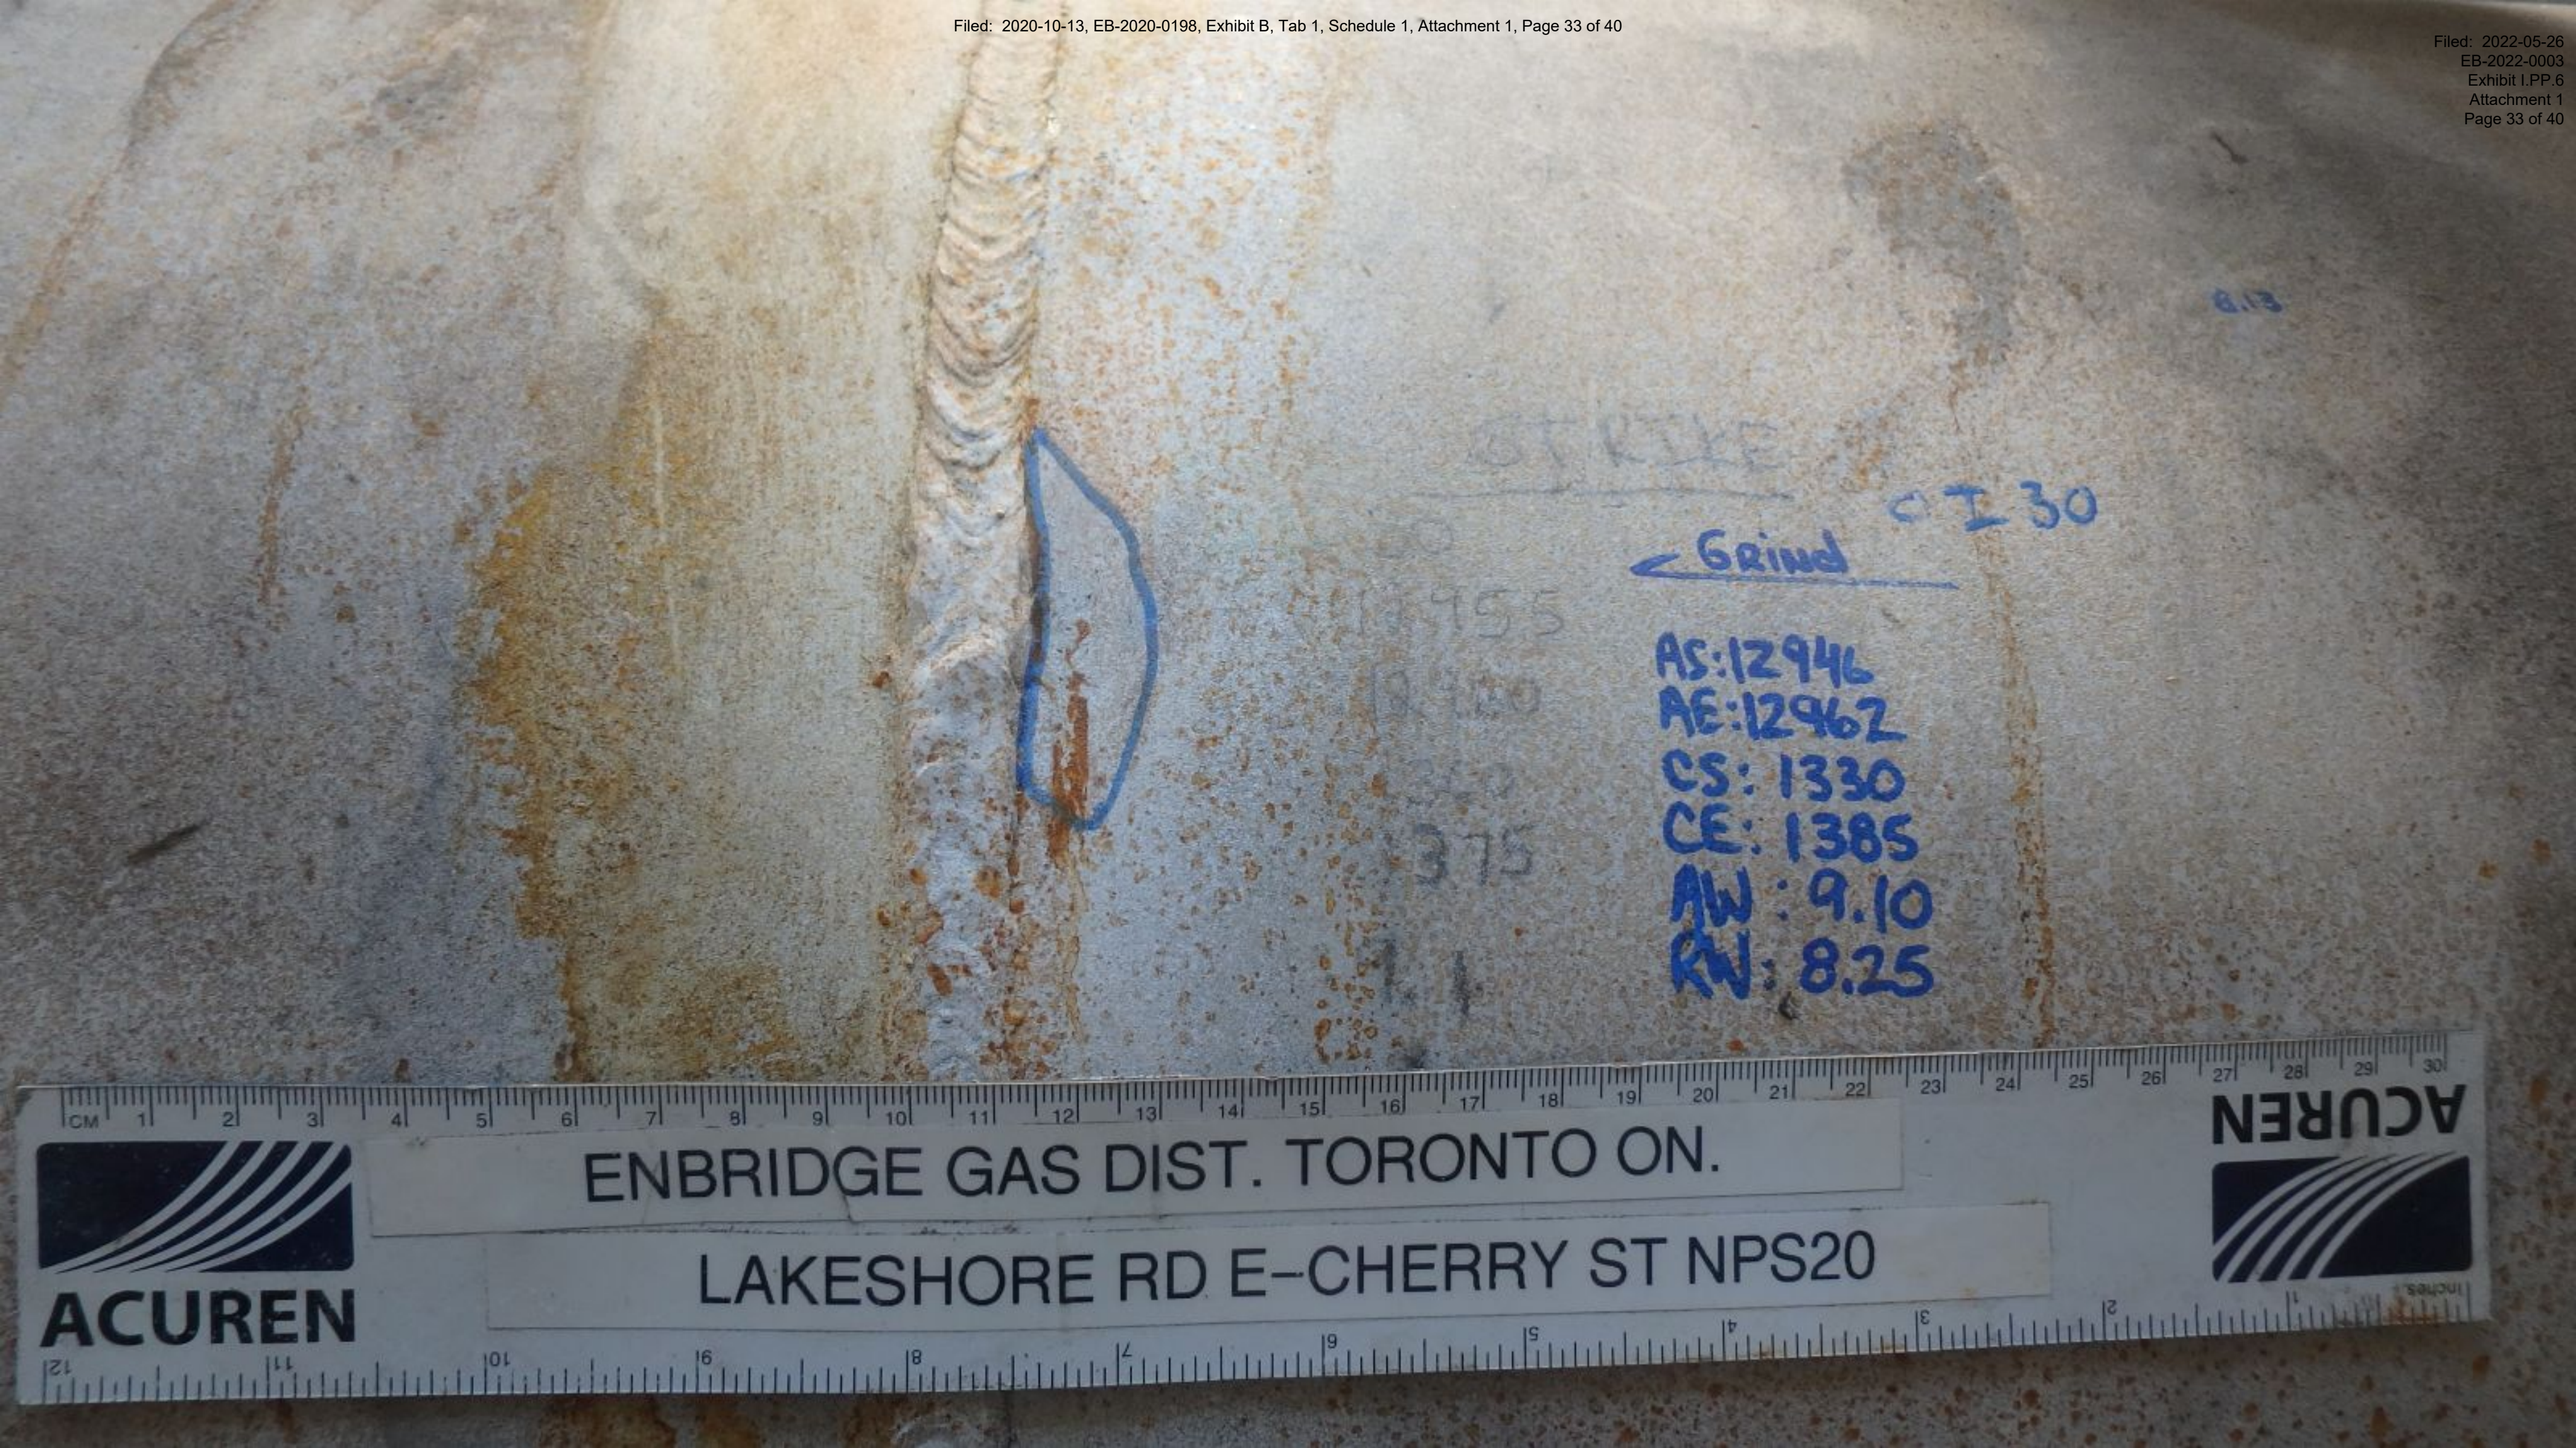
8.13
STRIKE
CI 30
Grind
AS:12946
AE:12962
CS: 1330
CE: 1385
AW : 9.10
RW: 8.25
ENBRIDGE GAS DIST. TORONTO ON.
LAKESHORE RD E-CHERRY ST NPS20
ACUREN
ACUREN

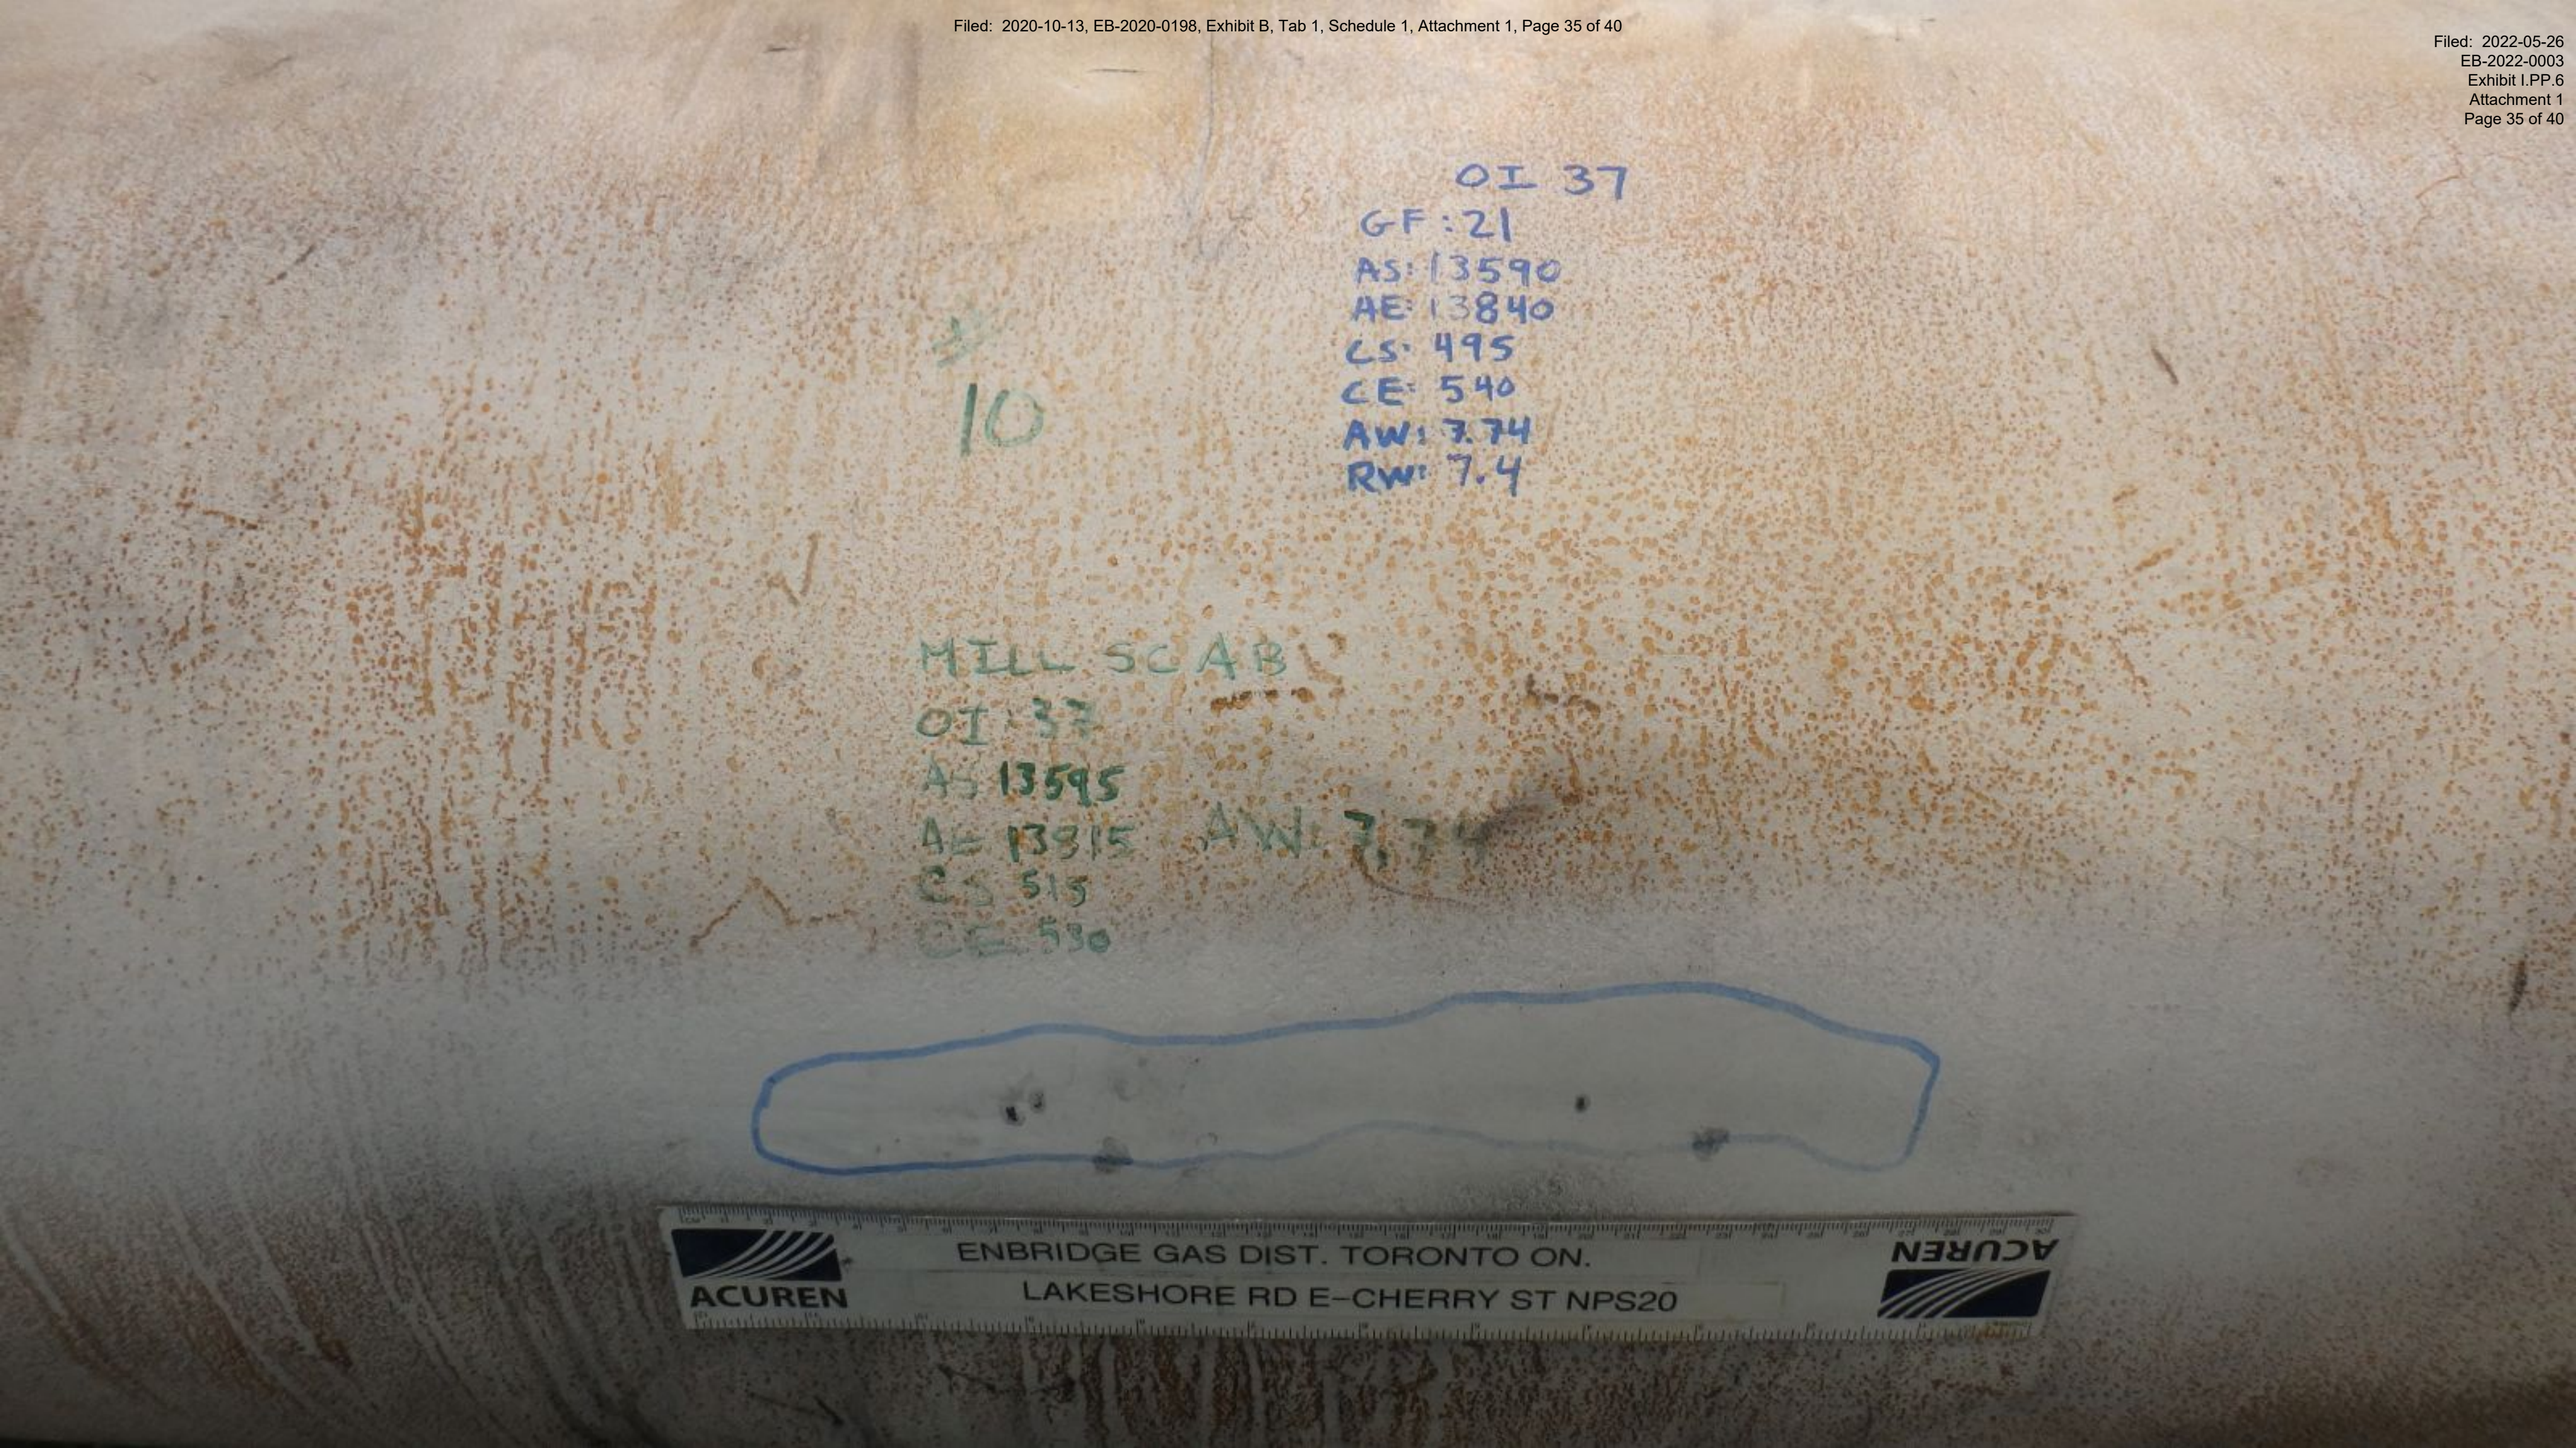
OI-37	Mill scab	N/A	2.00	13595	13815	220	515	530	15	N/A	N/A	7.74	No	Removed by grinding (Grind Depth 0.34)
COR1	External Corrosion	N/A	2.00	-134	-123	11	1266	1325	59	1.56	7.25	7.25	No	left as is
COR2	External Corrosion	N/A	2.00	355	427	72	1518	1567	49	1.63	6.50	8.28	No	left as is
COR3	External Corrosion	N/A	2.00	1155	1270	115	1250	1350	100	1.38	6.20	7.70	No	left as is
COR4	External Corrosion	N/A	2.00	775	790	15	690	700	10	0.95	7.10	8.00	No	left as is
COR5	External Corrosion	N/A	2.00	1215	1250	35	625	690	65	0.95	6.80	7.80	No	left as is

OI 37
GF: 21
AS: 13590
AE: 13840
CS: 495
CE: 540
AW: 7.74
RW: 7.4
10
MILL SCAB
OI: 37
AS: 13595
AE: 13915
CS 515
CE 530
AW: 7.74
ENBRIDGE GAS DIST. TORONTO ON.
LAKESHORE RD E-CHERRY ST NPS20
ACUREN
ACUREN

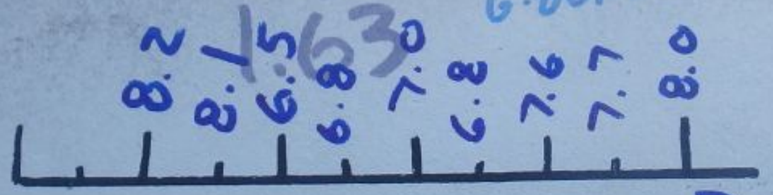
COR 02
WT PROFILE

COR: 02
AS: 355mm
AE: 427 mm
CS: 1518mm
CE: 1567mm
AW: 8.28 mm
RW: 6.50mm
