Re: Enbridge Gas Inc. ("Enbridge Gas")
Ontario Energy Board ("OEB") File No. EB-2022-0003
NPS 20 Waterfront Relocation Project – Interrogatory Responses

Answer to Interrogatory from
OEB Staff ("STAFF")

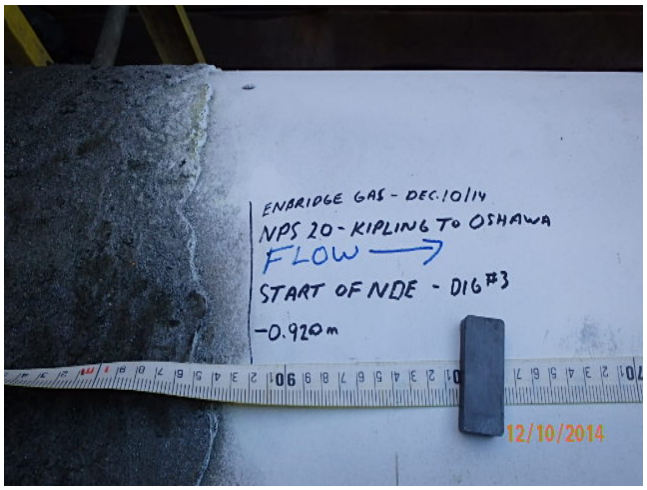
ILI feature cluster

The ILI corrosion features, A016, 17, 18 and 19, have been combined into one large cluster since they were in close proximity. The cluster measured 350 mm and 254 mm wide. A river bottom grid was used as a guide to measure the remaining wall thicknesses throughout the feature with a UT instrument. The lowest reading for wall thickness was 3.15 mm remaining wall. Magnetic particle inspection was performed on the NDE area, and three manufacturing defects were discovered. The features were removed with light buffing, which did not exceed 10% wall loss. A moldable clock spring was placed on the pipe for preventative measures. The dimensions and location of the clock spring are not present in this report because the information was not provided to us, however picture of the clock spring are present.

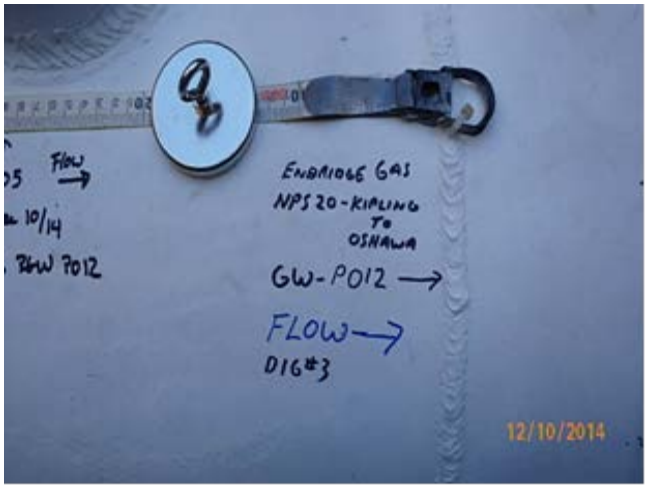
MFG feature 1

INSPECTION RESULTS: Damage features 1 & 2 (crack-like indications) were found by Magnetic Particle Inspection (see Photograph #1 below) on top section of pipe (U/S of GW P012). These two areas were buffed out (see Photograph #2 below) with less than 10 % wall loss.

CRK-01 and CRK-02 were found on joint PO12 while CRK-03 was on joint PO11. Alll Features were buffed out witth less than 10% wall loss. All Grind features measurement after buffing are shown above.

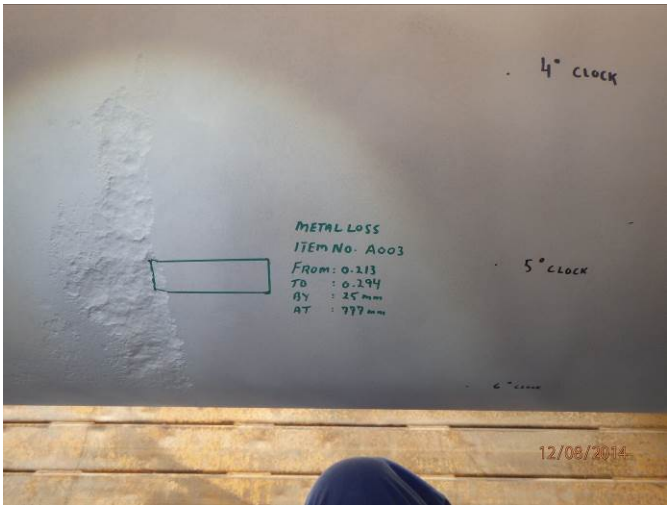
ILI A003

Two External Corrosion features, one linear indication and three arc strike were located on the exposed and blasted section of pipe. Feature EML-001 corresponded to ILI feature A003 with a length of 268 mm, width of 353 mm and a maximum depth of 5.1 mm (65%) while as found feature EML-002 is 60 mm long, 227 mm wide and 0.93 mm deep (11.8%). 100% magnetic particle inspection was performed on the entire section of exposed pipe. The MPI detected a small linear indication that had a maximum depth of 0.2 mm. Three arc strike indications were found beside Girth weld P008. A composite sleeve (clock spring) was installed over top of the anomalies that were detected for remediation purposes.

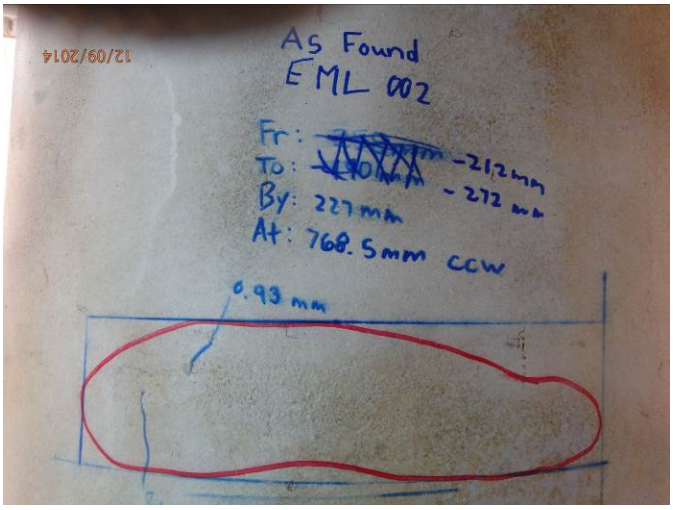
Damage Grind Feature-01

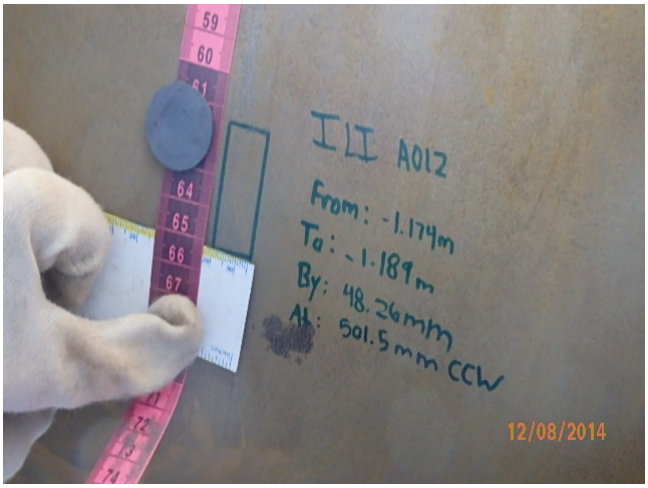
ILI Feature – A012

The predicted measurements for the ILI features differ from the as found features. For feature EML-01, the ILI values were 2 mm longer and 26 mm wider than the as found feature. However the depth of the as found feature is 1.31 mm deeper than the ILI value. The as found feature for EML-02 is 9 mm longer and 13 mm wider than the ILI values, and the ILI is 0.8 mm deeper than the as found feature. Crack-like manufacturing defects were located on the original pipe exposure; due to our findings, more of the pipe was exposed for a total length of 13.704 m. A total of 40 crack-like manufacturing defects were found with magnetic particle inspection. These indications were buffed out and removed completely. After the removal of the indications the areas were inspected with ultrasonic inspection for remaining wall thickness. None of the areas that were buffed exceeded 10% wall loss.

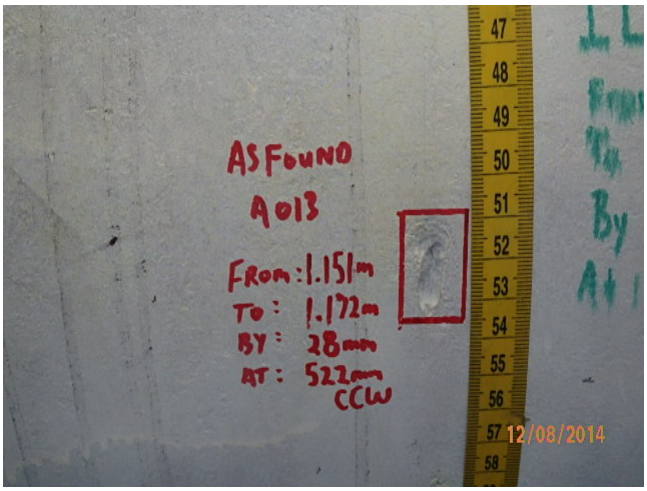
A013 Deepest point – 3.28mm

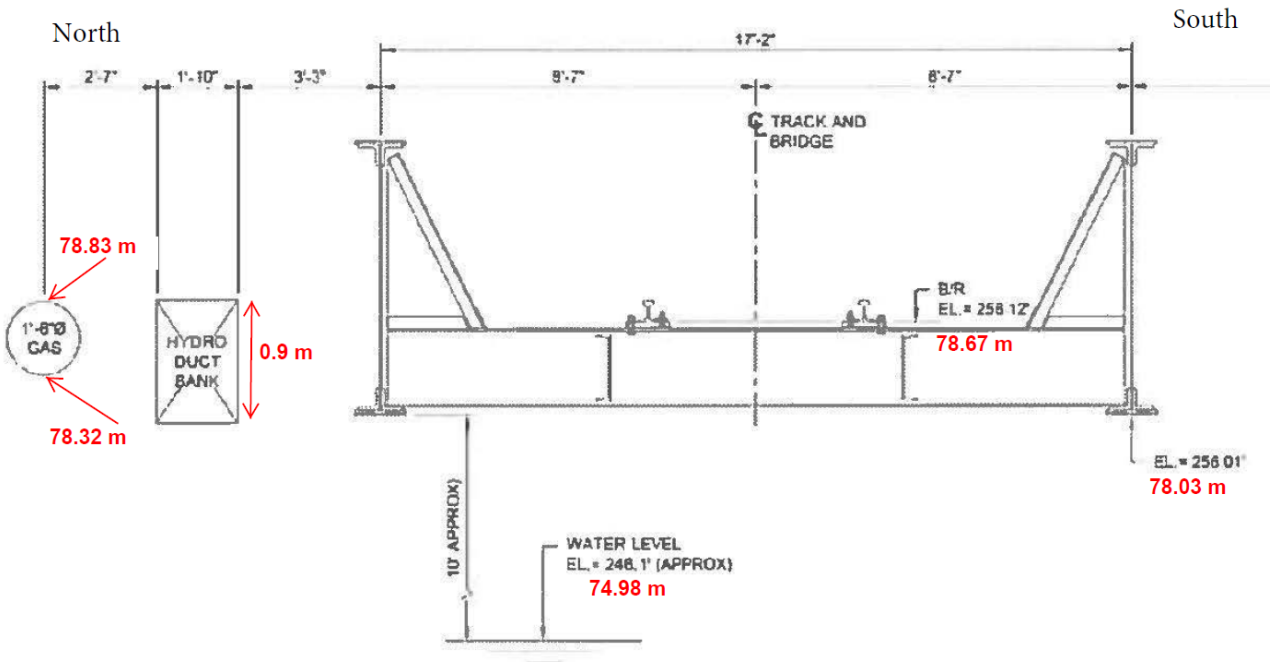
Figure 3. Bridge cross-section (AECOM 2016)

Bridge and pipe elevations were estimated based on AECOM preliminary drawings dated November 1, 2016 (**Figure 3**). According to these drawings the pipe invert has an elevation of approximately 78.32 m, the bottom of the hydro utility duct has an elevation of 77.97 m.
