INTERIM ENVIRONMENTAL MONITORING REPORT
**Innes Road Pipeline Replacement
Project**

EB-2012-0438 EB-2014-0017

Prepared by Dillon Consulting Limited

June 2015 – 13-8395

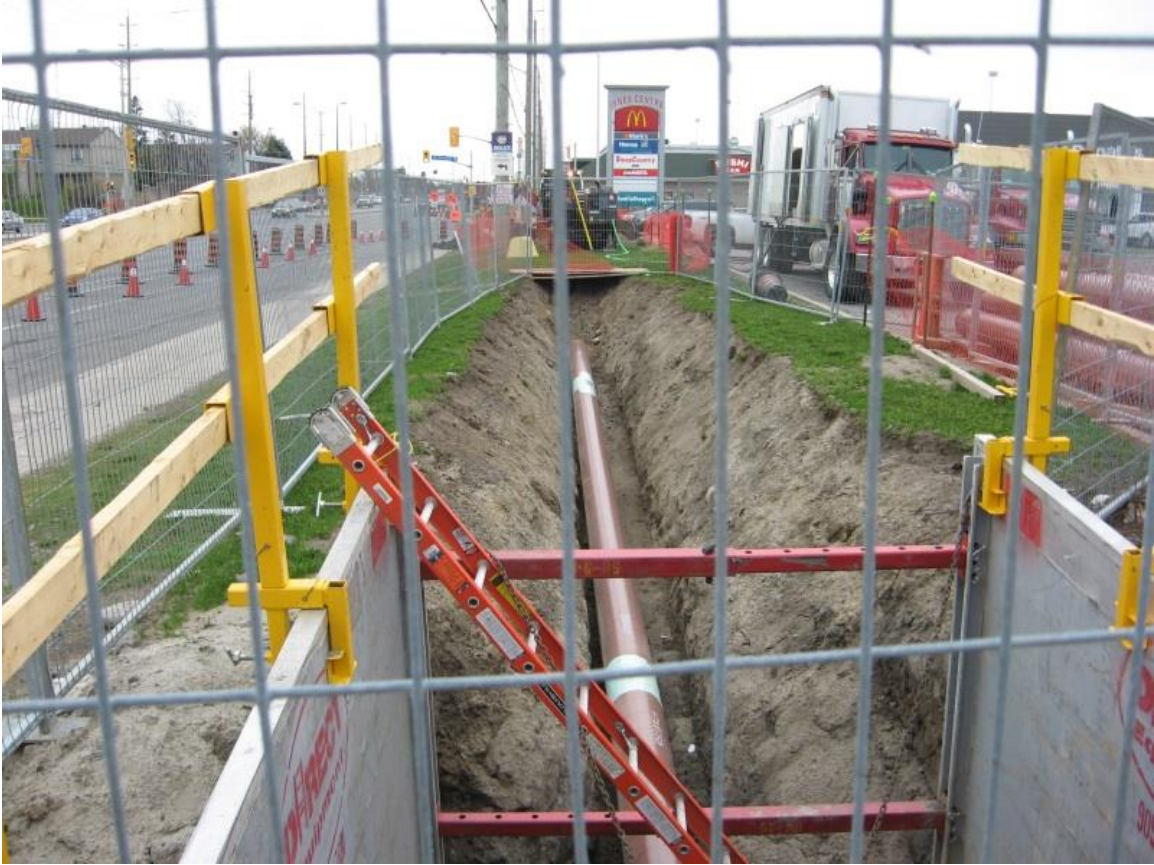
LOCATION #B4

Vegetation	Adjacent to ESSO Station	B4	Bare patch of grass adjacent to the sidewalk	<ul style="list-style-type: none"> Increased soil erosion potential Poor aesthetics 	<ul style="list-style-type: none"> Over-seed bare patches with fresh seed and water (Summer 2015) Hydro-seeding recommended
Trench Subsidence	Adjacent to ESSO Station	B5	Soil under sidewalk subsiding	<ul style="list-style-type: none"> Sidewalk collapse Minor hazard 	<ul style="list-style-type: none"> Repair as appropriate (Summer 2015) Over-seed bare patches with fresh seed and water (Summer 2015) Periodic visual inspection is recommended
Vegetation	Adjacent to Costco parking	B6	One dead ornamental tree (species unknown)	<ul style="list-style-type: none"> Loss of urban tree canopy Poor aesthetics 	<ul style="list-style-type: none"> Replace dead tree (Summer 2015)
Vegetation	Adjacent to Costco parking	B7	One pine tree has been cut down	<ul style="list-style-type: none"> Loss of urban tree canopy Poor aesthetics 	<ul style="list-style-type: none"> Replace cut tree (Summer 2015)
