**Re: Enbridge Gas Distribution Inc. (“Enbridge”)  
EB-2016-0054 – Seaton Land Development Pipeline Project  
Conditions of Approval – Post Construction Report - Correction**

**Enbridge Gas Distribution Inc.  
Interim Post-construction  
Environmental Monitoring Report  
Pipeline to Serve the Seaton Land  
Development  
EB -2016-0054**

# PRE-CONSTRUCTION AND POST- CONSTRUCTION PROPERTY CONDITION ASSESSMENTS

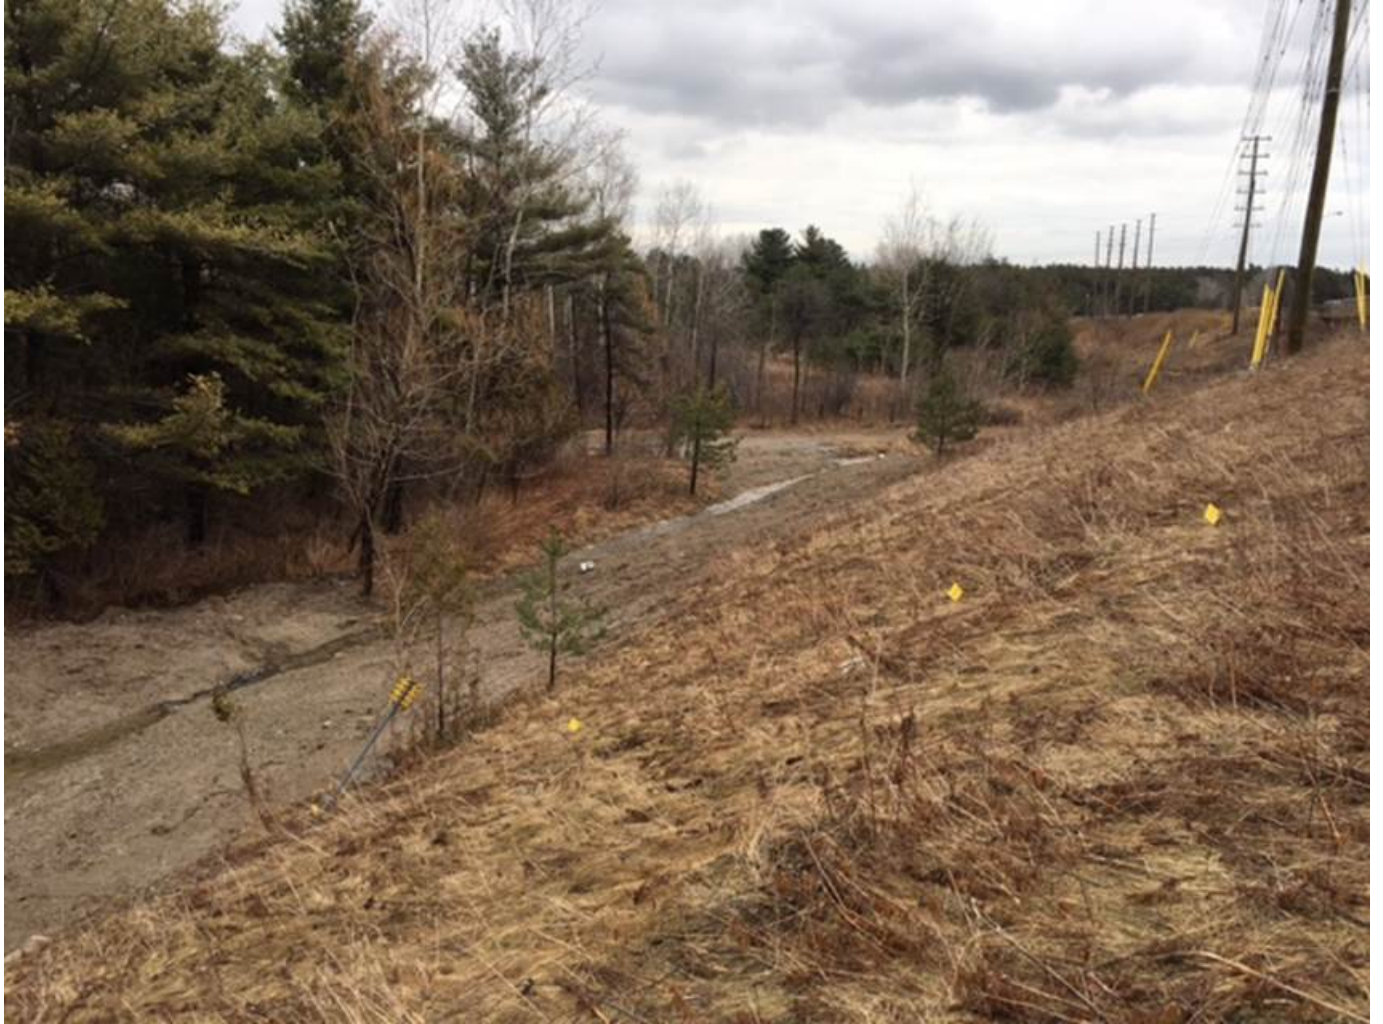
<b>Photo #</b>	<b>Location</b>	<b>Current Condition</b>	<b>Action</b>
<b>Photo 1</b>	Taunton Rd and Sideline 16 tie-in pit (looking North)	In complete. Drainage resembles pre-construction condition.	Further seeding required.
<b>Photo 2</b>	Taunton Rd and Sideline 16 tie-in pit (looking North- East)	In complete. Drainage resembles pre-construction condition.	Further seeding required.
<b>Photo 3</b>	Regulator Station east of Brock Rd (looking north-west).	In complete. Construction was finished in December.	Requires grading and seeding
<b>Photo 4</b>	Regulator Station east of Brock Rd (looking East).	In complete. Construction was finished in December.	Requires grading and seeding
<b>Photo 5</b>	West of Brock Rd (looking east).	Complete.	Follow up required assessing vegetation growth.
<b>Photo 6</b>	East side of Urfe Creek (looking west).	Complete. The Creek was seeded and straw was placed over top as a temporary over-winter ESC measure.	Follow up required assessing vegetation growth.

Photo 1: Taunton Rd and Sideline 16 tie-in pit (looking north)

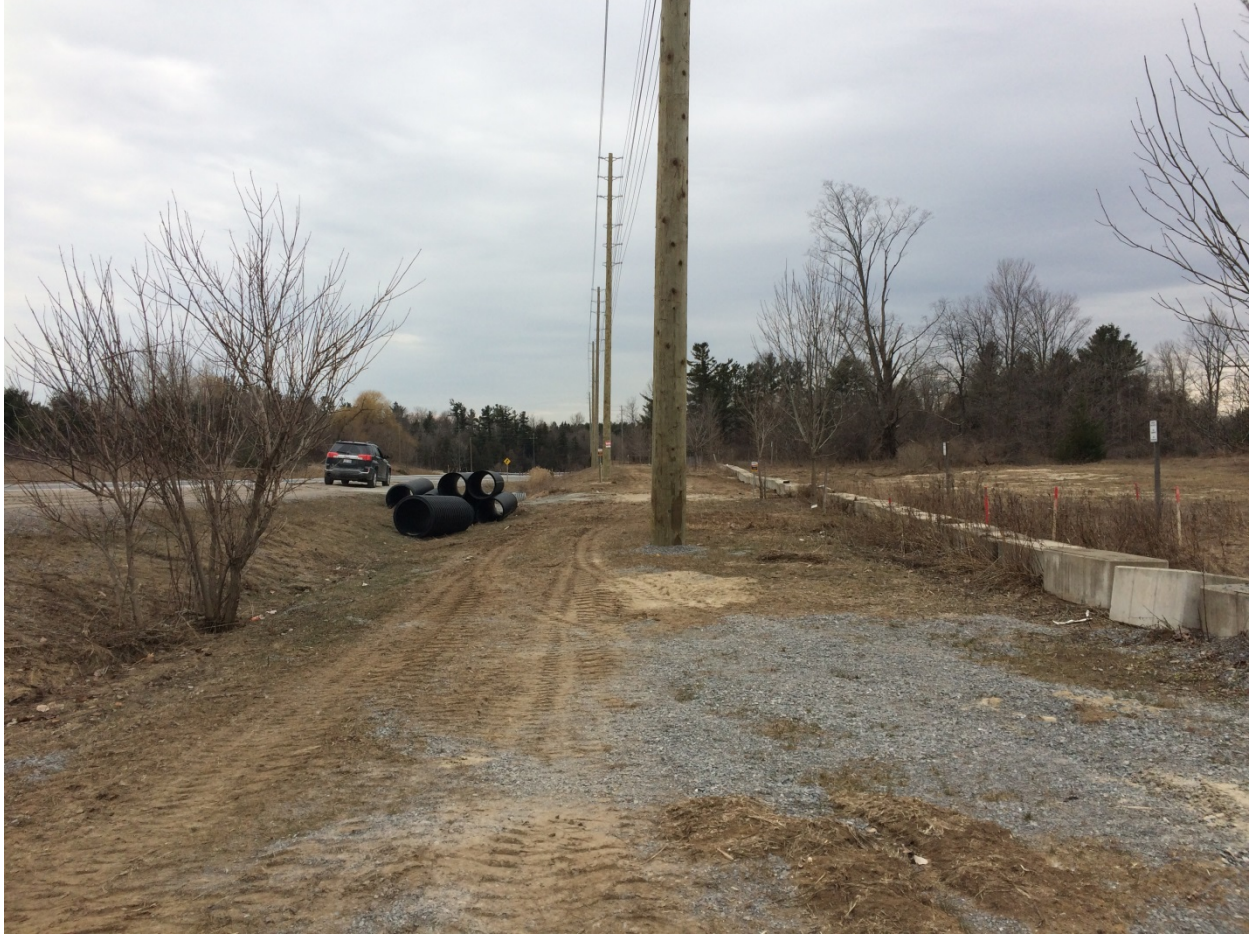
<b>Photo 7</b>	West side of Urfe creek (looking east)	Complete. The Creek was seeded and straw was placed over top as a temporary over-winter ESC measure. Area was shared by other utility companies as a staging area.	Follow up required assessing vegetation growth.
<b>Photo 8</b>	West side of Urfe Creek (looking west)	Complete. The Creek was seeded and straw was placed over top as a temporary over-winter ESC measure. Area was shared by other utility companies as a staging area.	Follow up required assessing vegetation growth.
<b>Photo 9</b>	East side of Ganatsekiagon creek (looking west).	Complete. The Creek was seeded and straw was placed over top as a temporary over-winter ESC measure.	Follow up required assessing vegetation growth.
<b>Photo 10</b>	West side of Ganatsekiagon Creek	Complete. The Creek was seeded and straw was	Follow up required assessing vegetation

Photo 7: West side of Urfe creek (looking east)

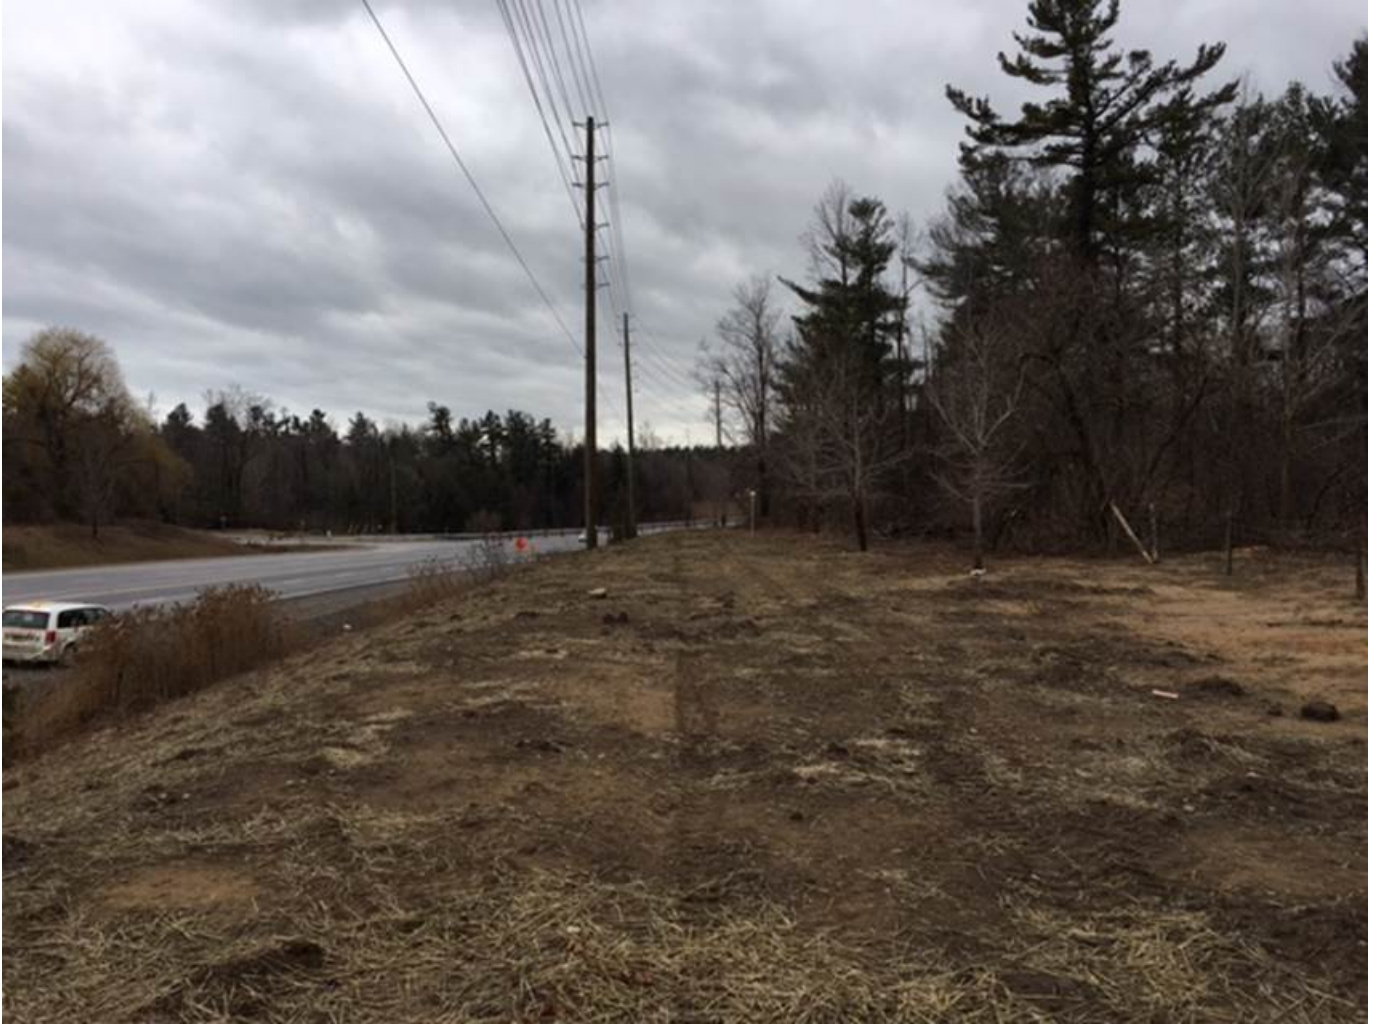
Photo 8: West side of Urfe Creek (looking west)

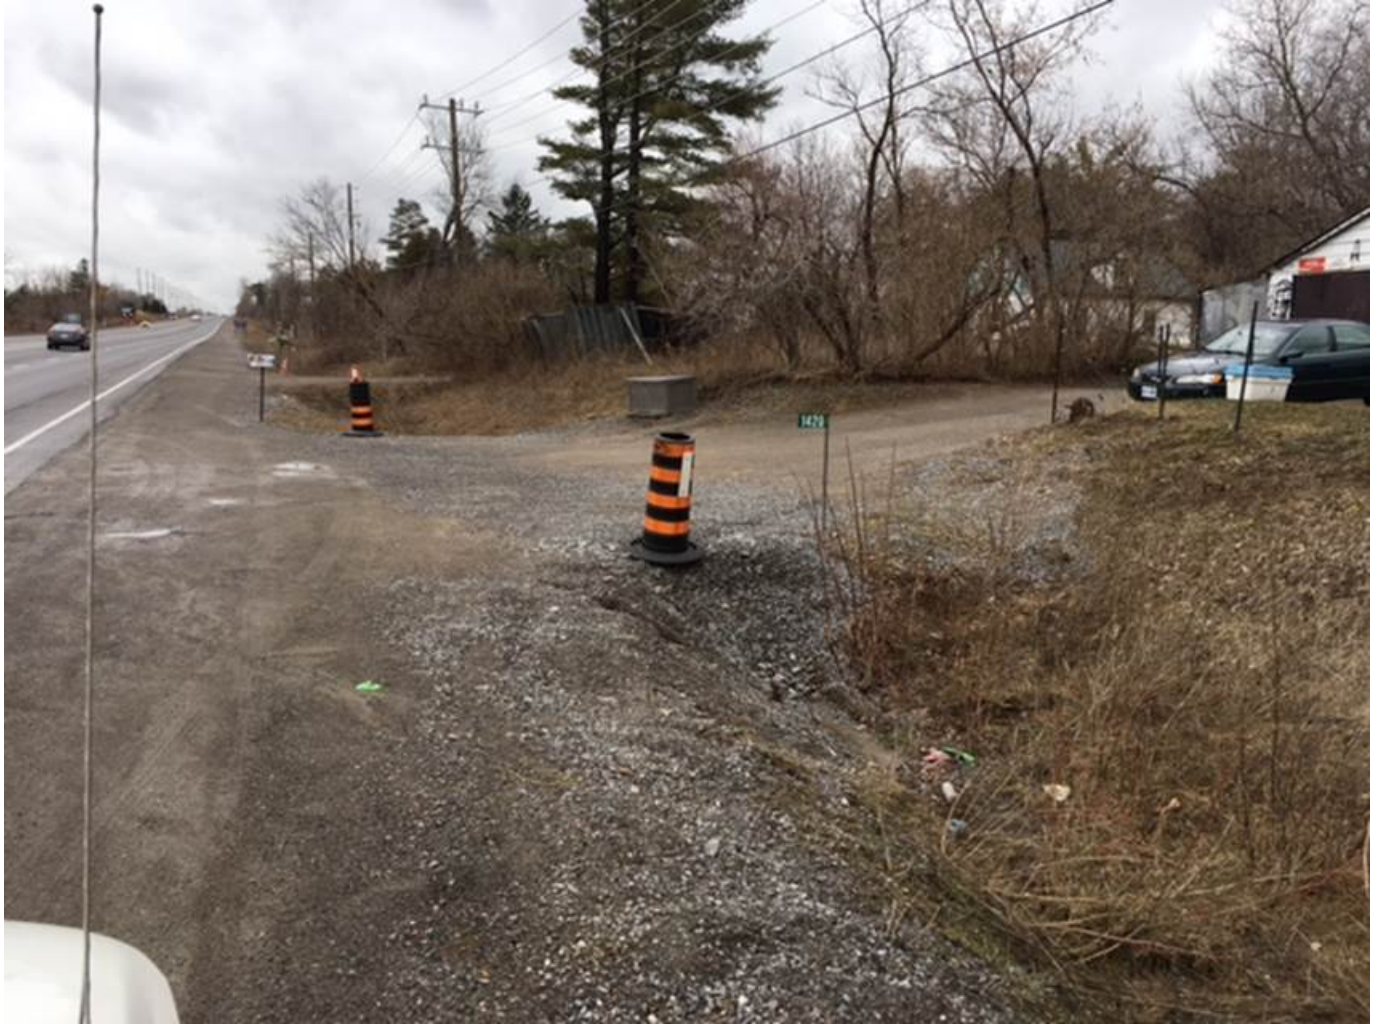
(looking east).	placed over top as a temporary over-winter ESC measure.	growth.
<b>Photo 11</b>	West of Ganatsekiagon Creek (looking east). Hydro corridor crossing.	Complete. The Creek was seeded and straw was placed over top as a temporary over-winter ESC measure.	Follow up required assessing vegetation growth.
<b>Photo 12:</b>	1420 Taunton Rd west of the Hydro corridor crossing (looking west).	In complete.	Further clean-up will be required in the spring.
<b>Photo 13</b>	Trans Norther Pipeline Inc. utility crossing west of 1420 Taunton Rd (looking east).	Complete. The area was seeded and straw was placed over top as a temporary over-winter ESC measure.	Follow up required assessing vegetation growth.
<b>Photo 14</b>	Trans Northern Pipeline Inc. utility crossing west of 1420 Taunton Rd (looking east)	Complete. The area was seeded and straw was placed over top as a temporary over-winter ESC measure.	Follow up required assessing vegetation growth.

Photo 11: West of Ganatsekiagon Creek looking east. Hydro corridor crossing.

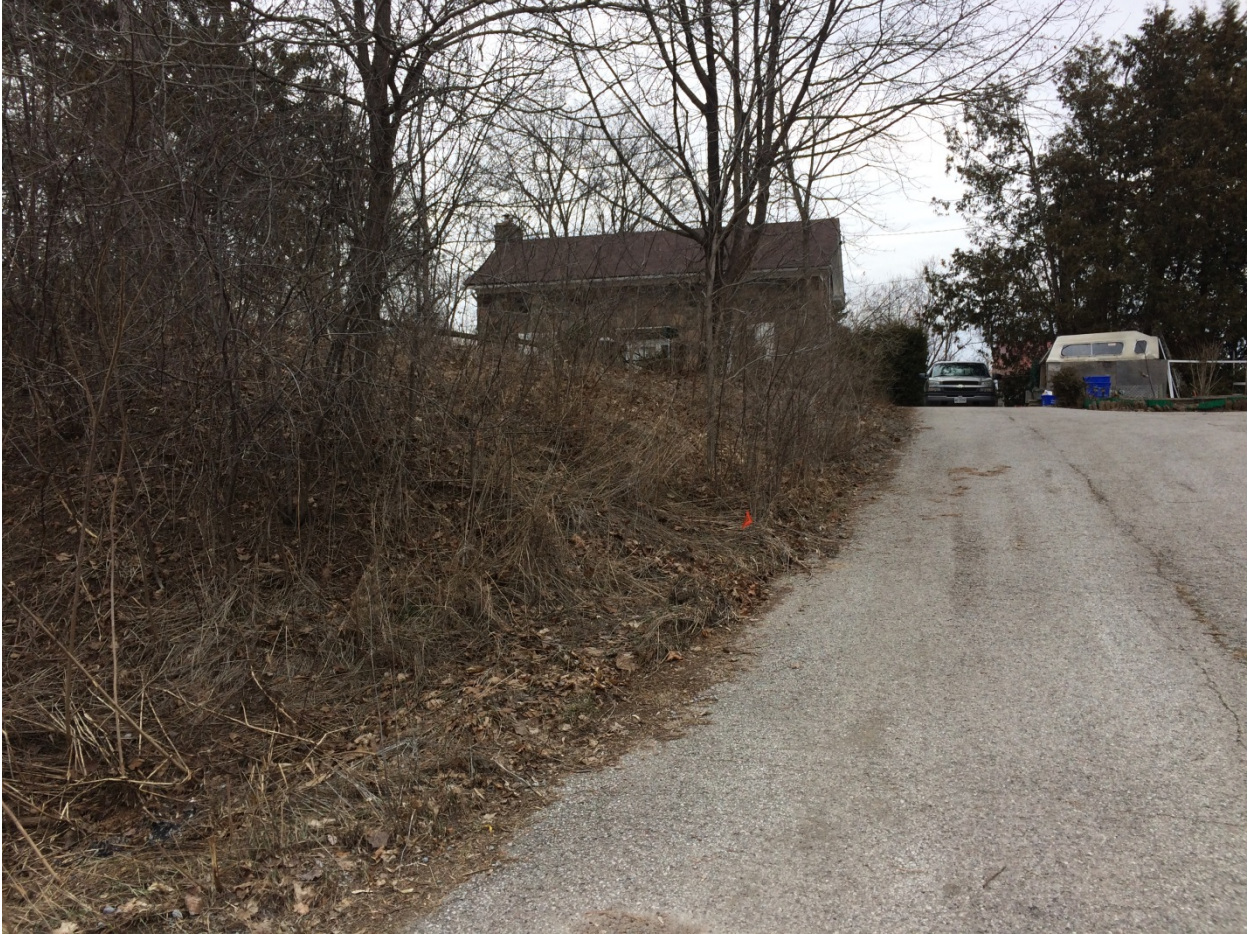
<b>Photo 15</b>	Heritage building at 1290 Taunton Rd (looking west)	Complete. No impacts were recorded during construction. Please see Appendix D	No further Action required.
<b>Photo 16</b>	Heritage building at 1290 Taunton Rd (looking north)	Complete. No impacts were recorded during construction. Please see Appendix D	No further Action required.
<b>Photo 17</b>	West of 1290 Taunton Rd (looking east)	In complete. Construction was finished in December.	Requires grading and seeding
<b>Photo 18</b>	West of 1290 Taunton Rd (looking west)	In complete. Construction was finished in December.	Requires grading and seeding
<b>Photo 19</b>	Sideline 24 and Taunton Rd (looking west)	In Complete. Construction was finished in December.	Requires grading and seeding

Photo 15: Heritage building at 1290 Taunton Rd (looking west)

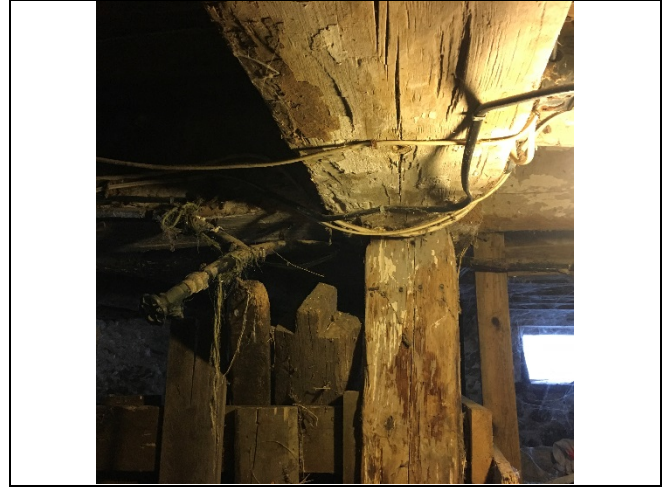
Photo 32: The wood post and floor joist appear to be consistent with the pre-construction assessment.

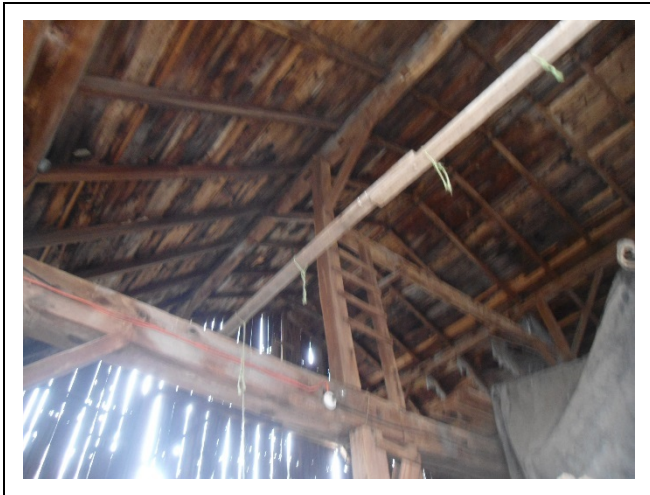
Photo 33: E17 - View of the first floor wood roof frame structure

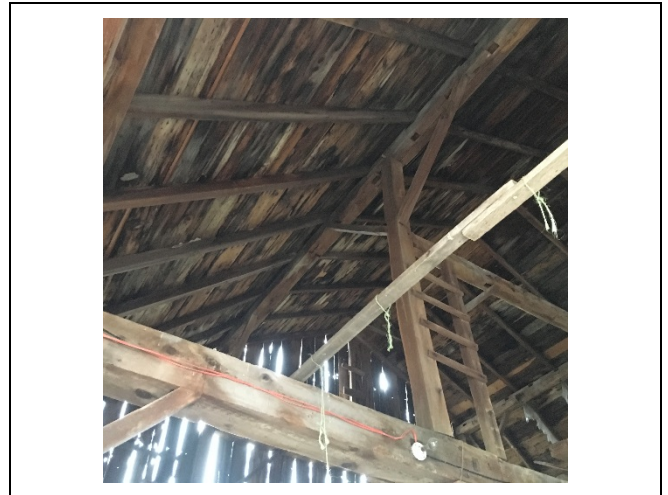
Photo 34: The first floor wood roof frame structure appears to be consistent with the pre-construction assessment

E-15	Superstructure	Basement - Floor Wood Framing Structure	View of the floor joists in the basement (See Photograph 29).	The condition of the floor joists appear to be similar to the pre-construction assessment.(See Photograph 30).	
E-16	Superstructure	Basement - Floor Wood Framing Structure	View of the wood post and floor joists in the basement (See Photograph 31).	The condition of the wood post and floor joist appear to be consistent with the initial assessment (See Photograph 32).	
E-17	Superstructure	First Floor - Wood Roof Framing Structure	View of the first floor wood roof frame structure (See Photograph 33).	The condition of the wood roof frame structure appears to be similar with the pre-construction assessment (See Photograph 34).
