## **CONDITION ASSESSMENT FOR ENWIN UTILITIES' 27.6 kV ASSETS**

### EXECUTIVE SUMMARY

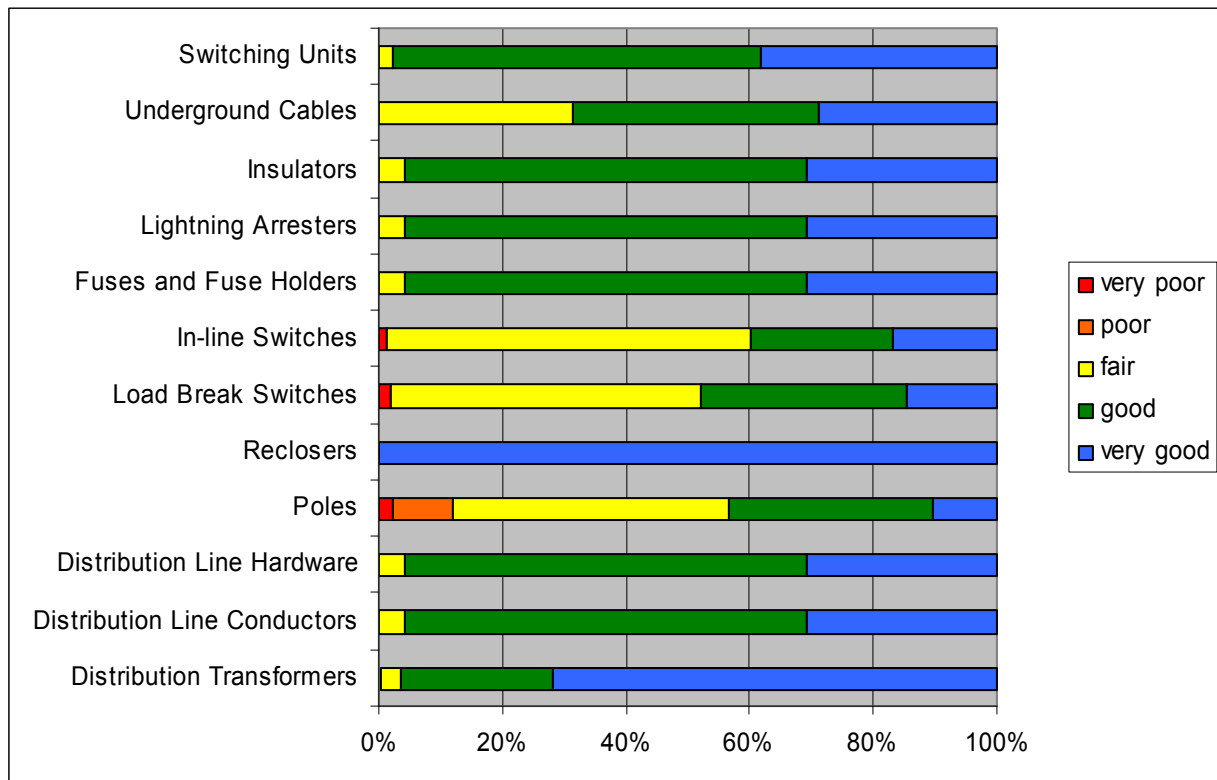
The overall asset condition at ENWIN Utilities is good. The health index results are shown in the following figure. They show that the assets are generally in good condition. Approximately 15% of the poles are in poor condition and need to be replaced. In addition there are a few switches in need of replacement.

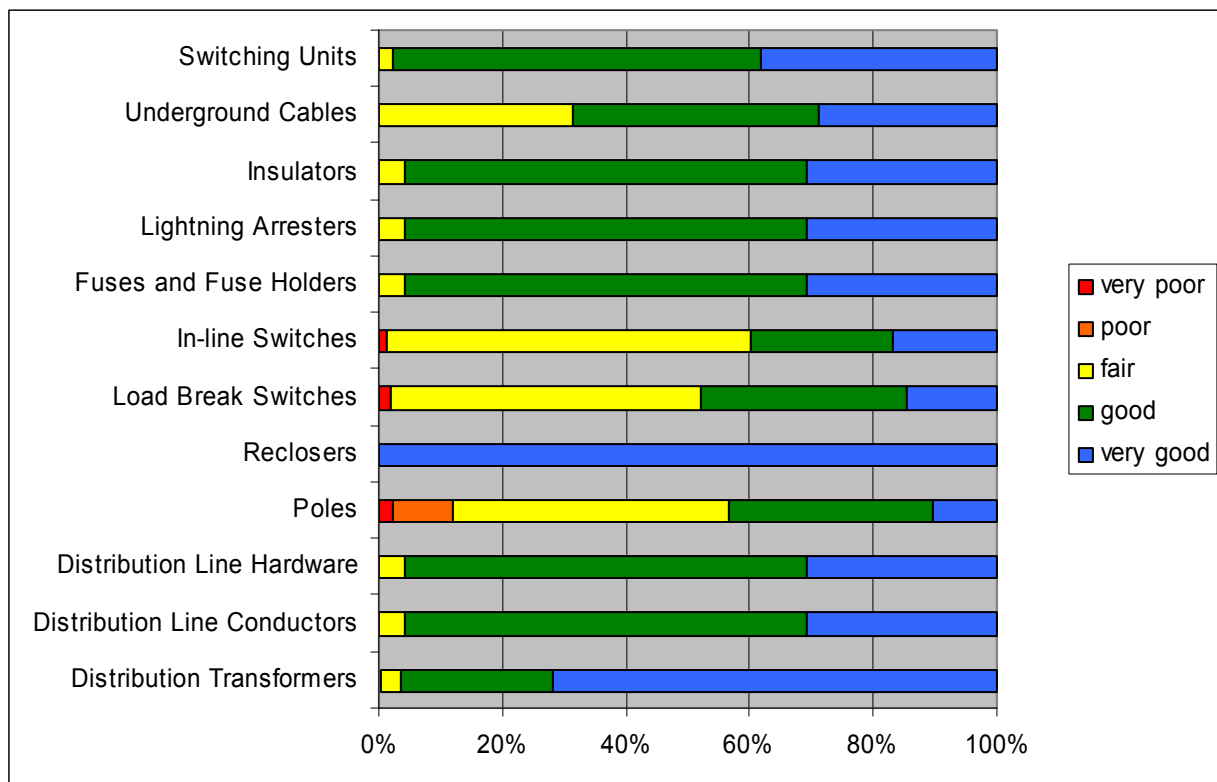
1. The overall asset condition at ENWIN Utilities is very good. The Health Index results are shown in the following figure. They show that the assets are generally in good condition. Approximately 15% of the poles are in poor condition and need to be replaced. In addition there are a few switches in need of replacement.

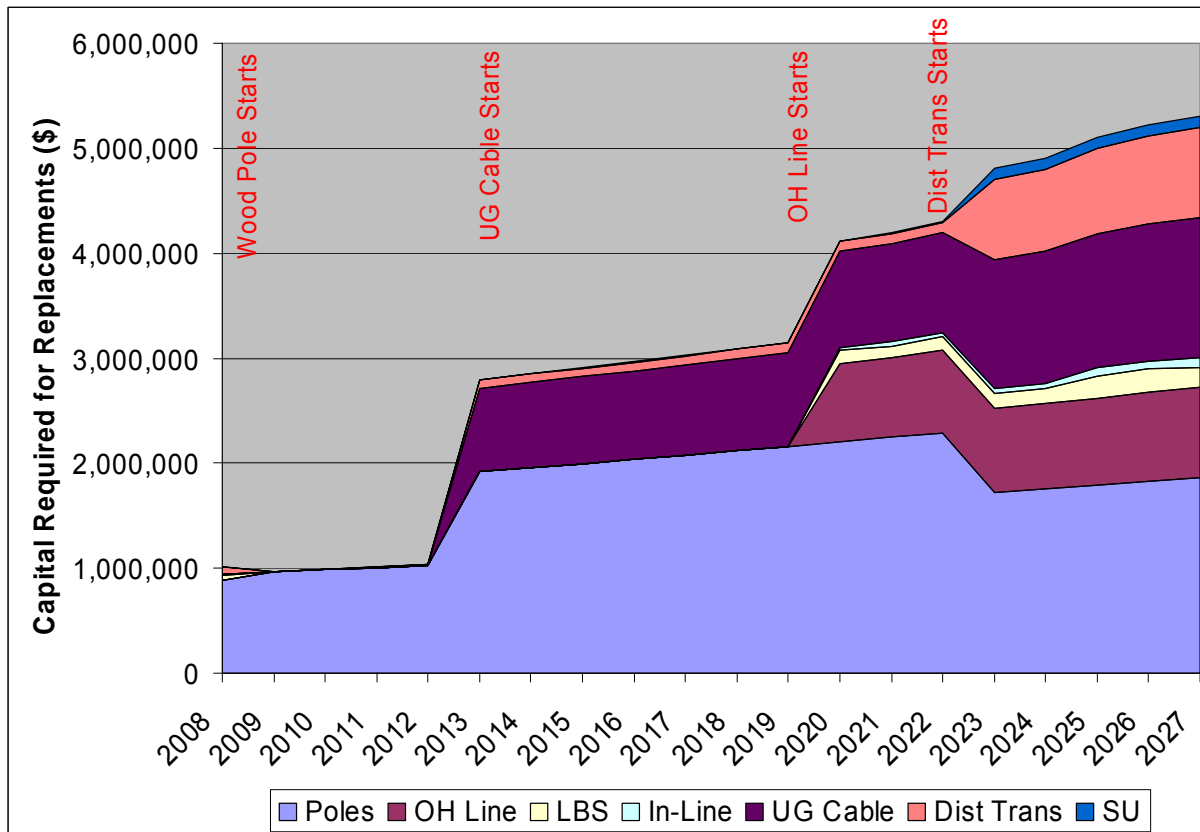
4. Overall spending on maintenance is at the low end of the range of best practices in the industry, at \$44 in O&M per year per customer and \$90 in capital replacement per year per customer. Recent capital replacement programs have reduced overtime and maintenance costs, but capital spending may need to be increased in the future to maintain the system in the present good condition. At the present time, capital spending is only 83% of the annual depreciation. The following figure shows the recommended plan.

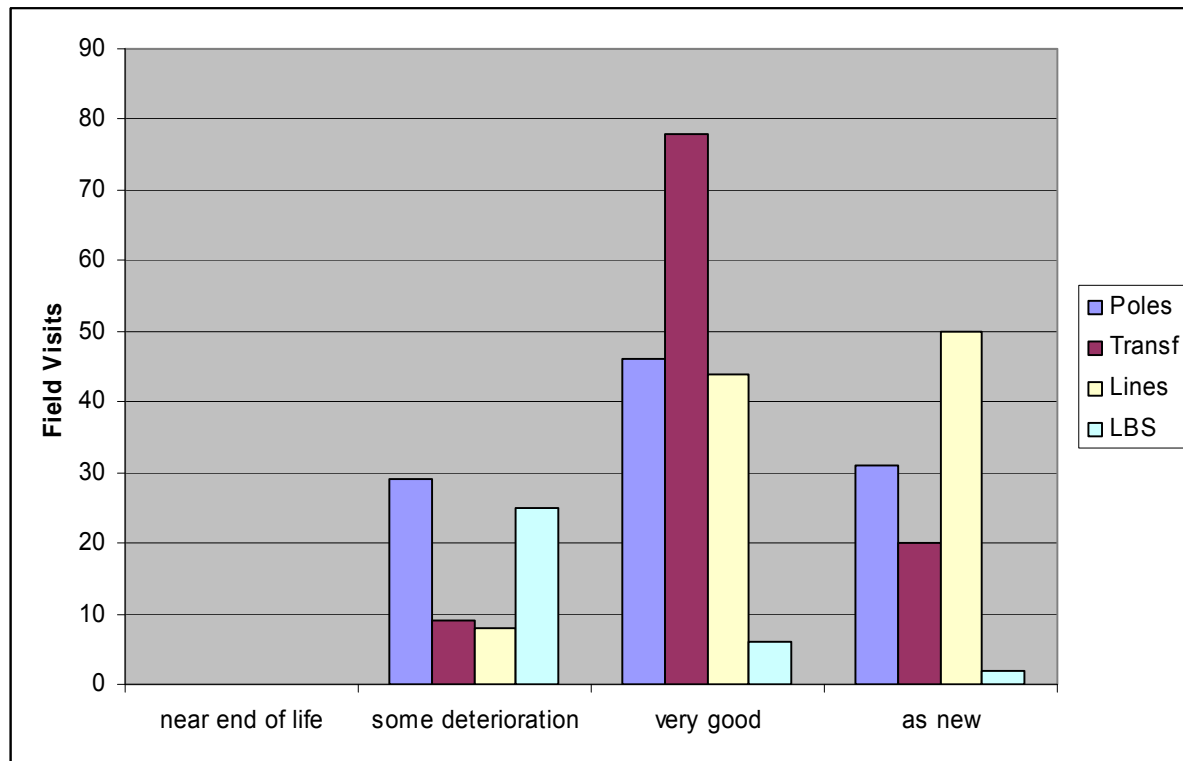
**Figure 1 Results of Field Visits**

The following figure summarizes the results of the field visits. This figure cannot be used to draw conclusions about the condition of the equipment because a visual inspection is often a poor indicator when used alone.

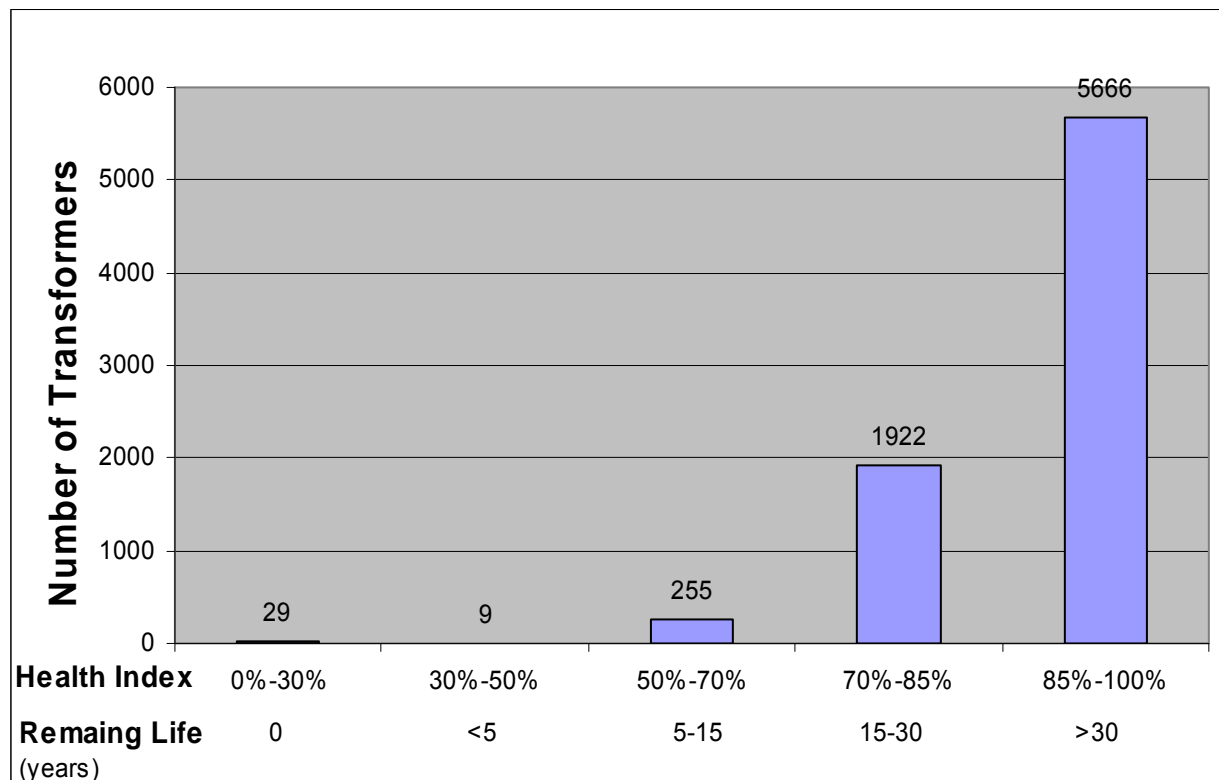
**Figure 2 Distribution Transformer Health Index Results**

The good condition of distribution transformers indicated by the health index has been confirmed by the interviews with staff and the visual inspections. Many replacements have been made due to load growth and voltage upgrading.

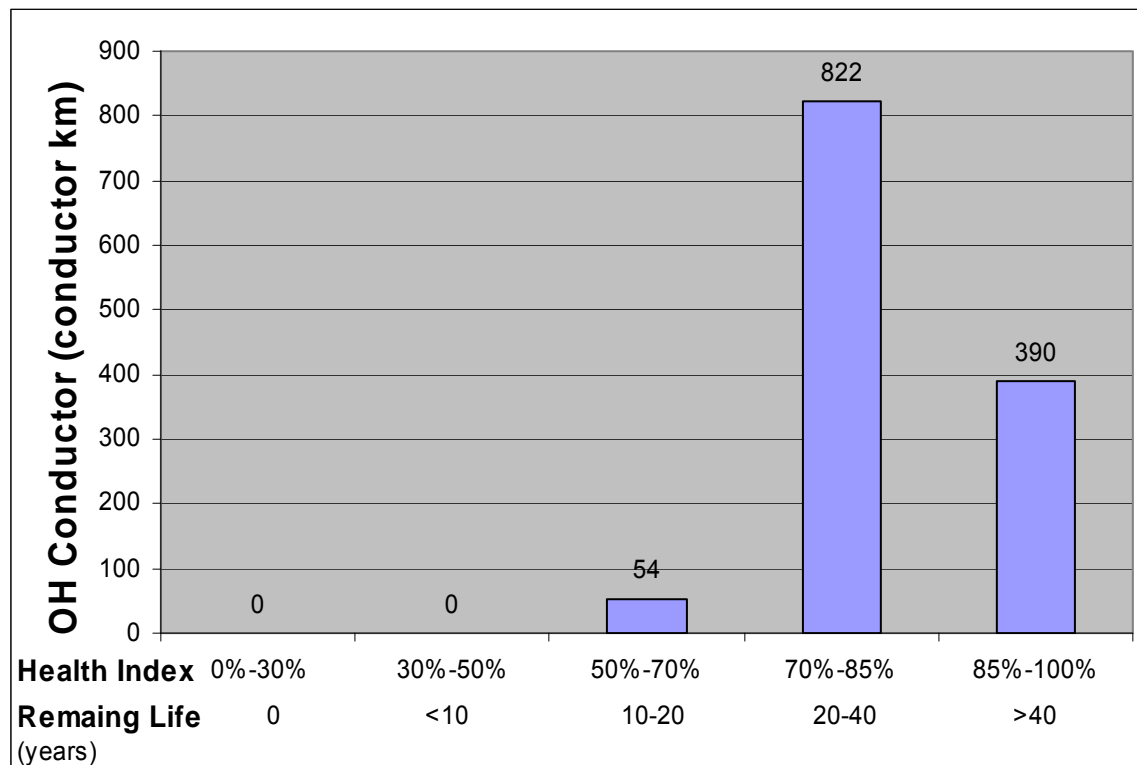
**Figure 3 OH Conductor Health Index Results**

The good condition indicated by the health index for overhead conductor has been confirmed by the interviews with staff. There have been very few problems experienced, even with very old copper conductor.

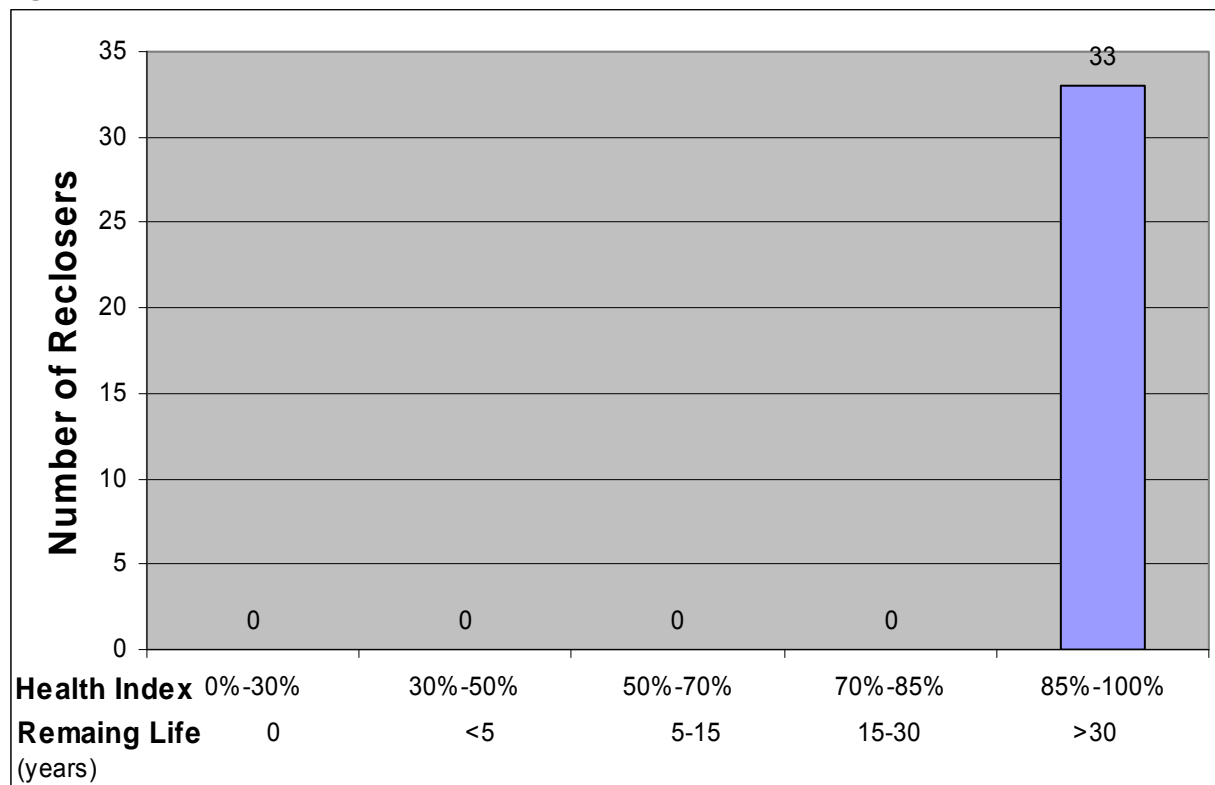
**Figure 5 Recloser Health Index Results**

The excellent condition of reclosers indicated by the health index has been confirmed by interviews with staff and visual inspection. Reclosers have only been installed in recent years in an effort to improve reliability. There have been some failures with units from a specific manufacturer, but these issues are being addressed under warranty with the manufacturer. They are not indicative of the overall condition of the reclosers.

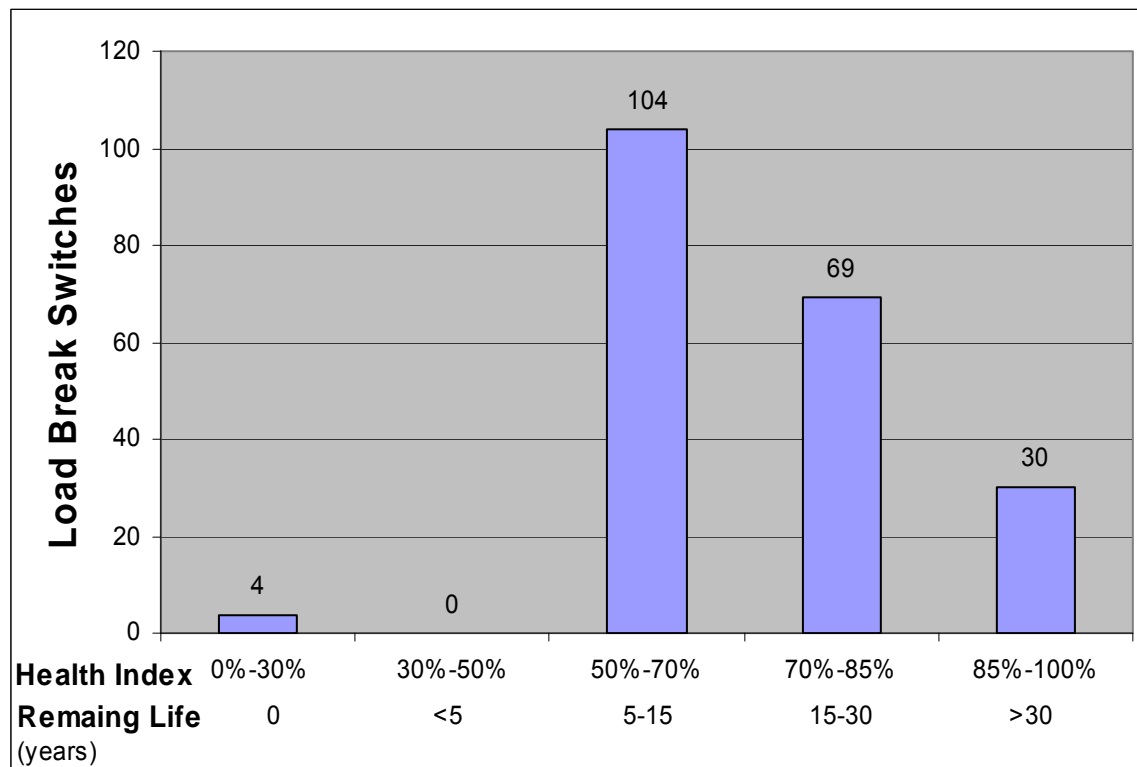
**Figure 6 Load Break Switch Health Index Results**

The generally good condition of load break switches indicated by the health index has been conformed by interviews with staff. The switches are operated annually as part of the scheduled maintenance program and any deficiencies are repaired.

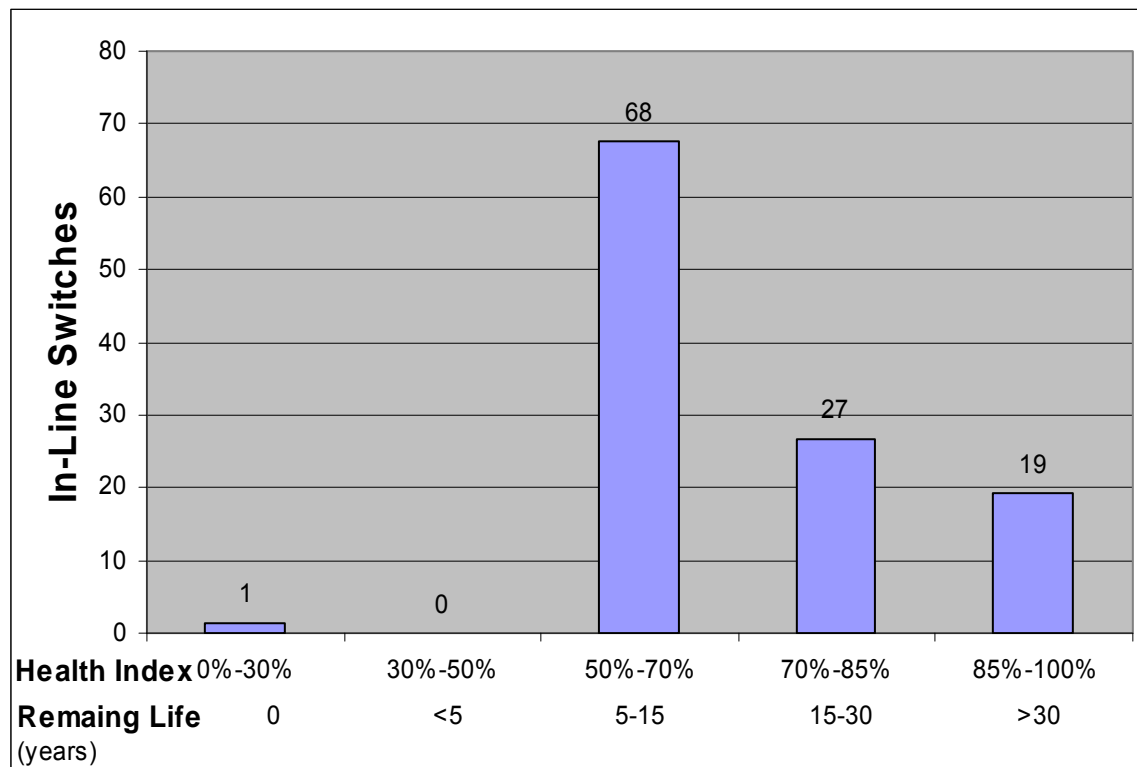
**Figure 7 In-line Switch Health Index Results**

The good condition of in-line switches indicated by the health index has been confirmed by interviews with staff. There have been problems with some designs in the past, but these have been replaced with better designs.

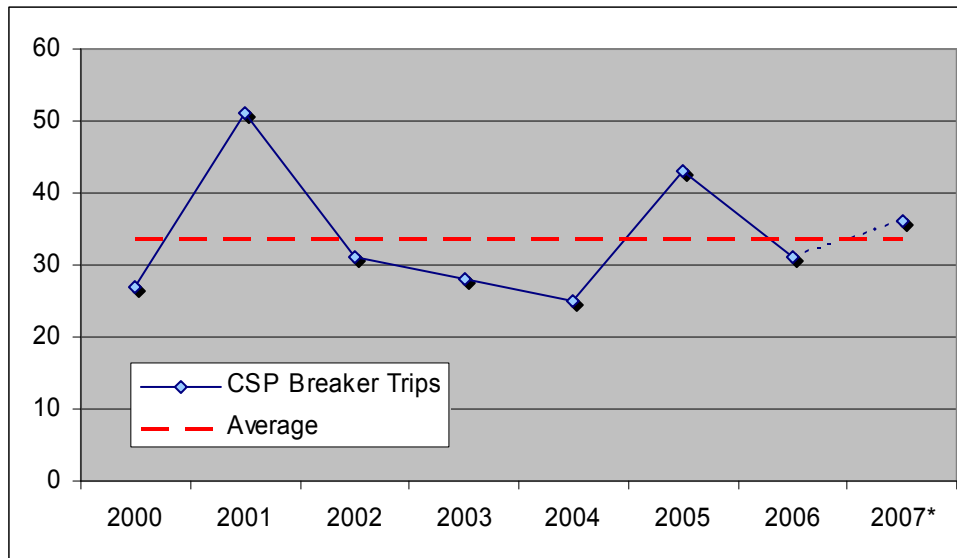
**Figure 11 Trend in CSP Transformer Breaker Trips**

The trend in secondary breaker trips in completely self protected (CSP) transformers is shown in Figure 11. There is no increasing trend, indicating that the secondary breakers of the CSP transformers are not reaching end of life. There are 2454 CSP transformers installed on the system with an average operation rate of 33.7 per year, which is 1.3%. This operation rate is typical of the industry and also does not indicate end of life.

These reliability and failure rate figures are consistent with the generally good condition found in the health index calculation.

CSP transformers have been known to have problems with the secondary breaker tripping at too low a load level and causing an unnecessary outage. One of the staff interviews mentioned this issue. There is a potential for this problem to increase as the transformers age. The rate at which customer interruptions are caused by this should be monitored. If the rate becomes unacceptable then a planned replacement program may be necessary. At the present time only the monitoring of the interruption rate is recommended as there is no evidence to show that the rate is unacceptably high at the present time (see Figure 11).

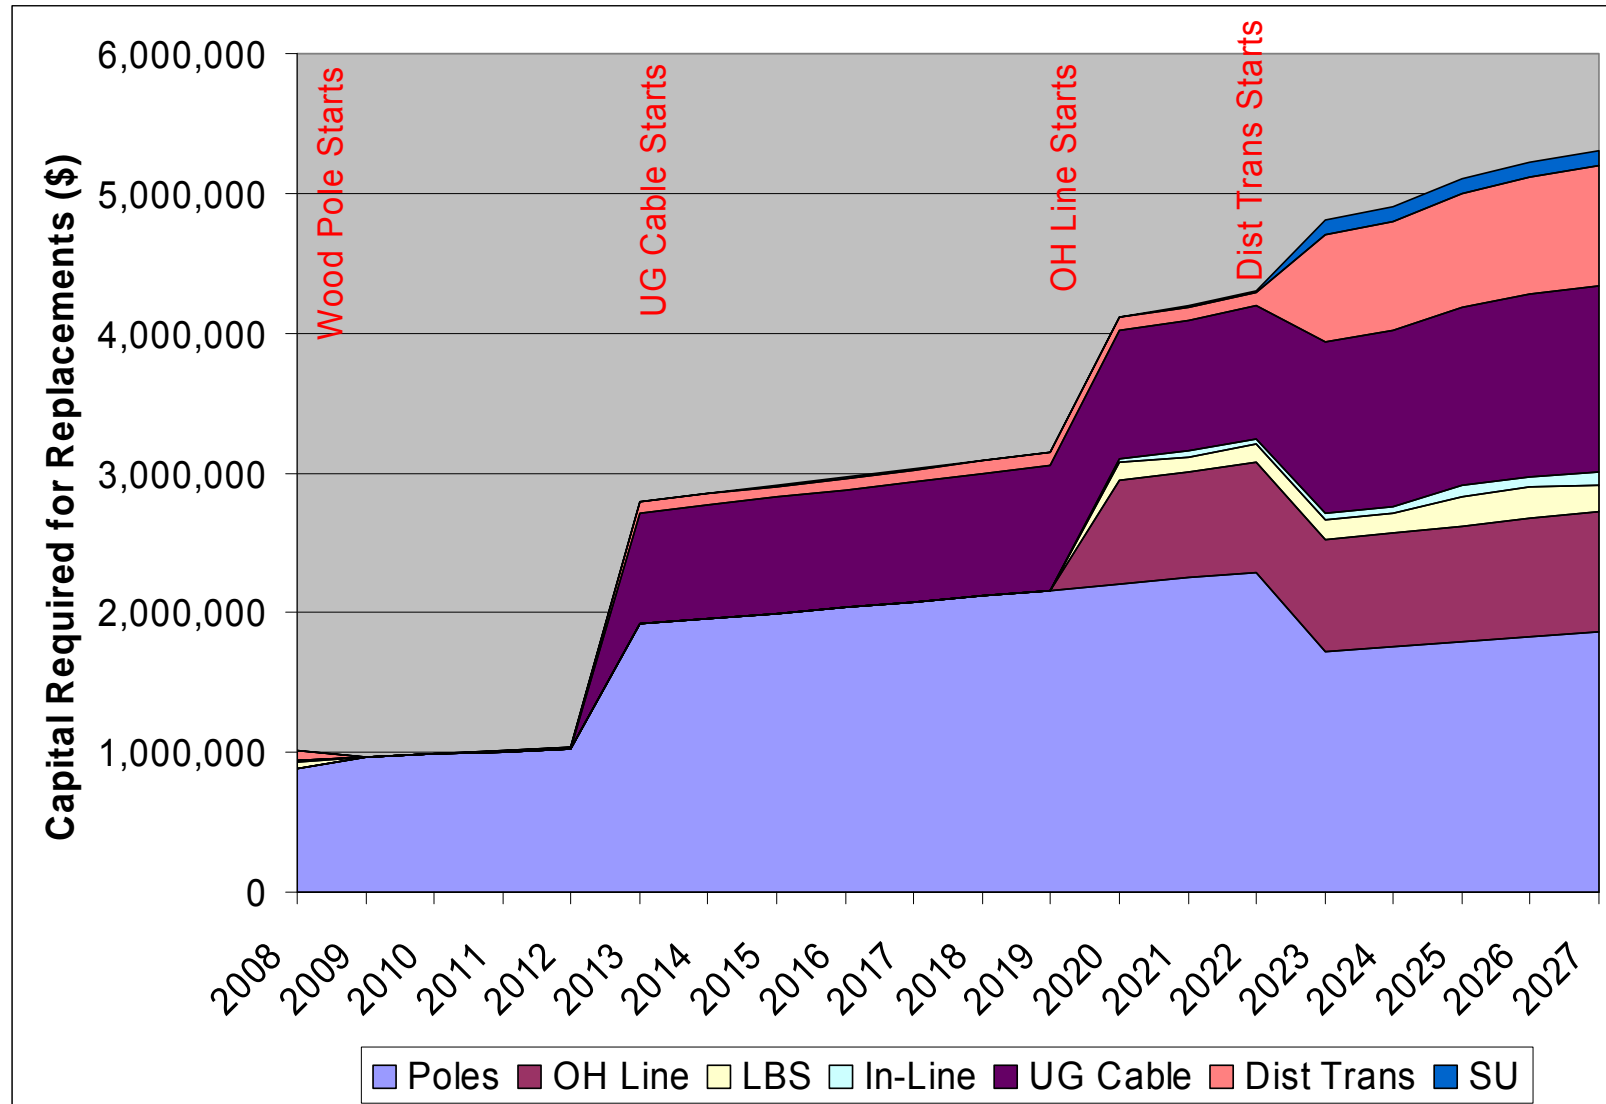
**Figure 12 Estimated Capital Plan for Power System Equipment Aging Only**

Another factor that can increase the capital requirement in any one year is the cost efficiency of replacing many components at once. Rather than replace individual conductors, insulators and hardware based on their condition, it is often cost effective to rebuild an entire line section all at once. This means that some components will be replaced before their end of life, but that the overall long-term cost will be minimized. This plan has been made assuming this efficient replacement strategy. The "OH Line" in Figure 11 includes conductor, insulators and hardware.

It is difficult to compare the plan in Figure 11 with the present capital spending of \$6.1 million because the latter number includes the 4.16 kV and replacements for reasons other than end of life.
