**Re: Enbridge Gas Inc. (“Enbridge Gas”)
Ontario Energy Board (“Board”) File No.: EB-2019-0006
St. Laurent Pipeline Project (“Project”)**

St. Laurent Pipeline Project:
Post-Construction Report
EB-2019-0006

Company: Enbridge Gas Inc.

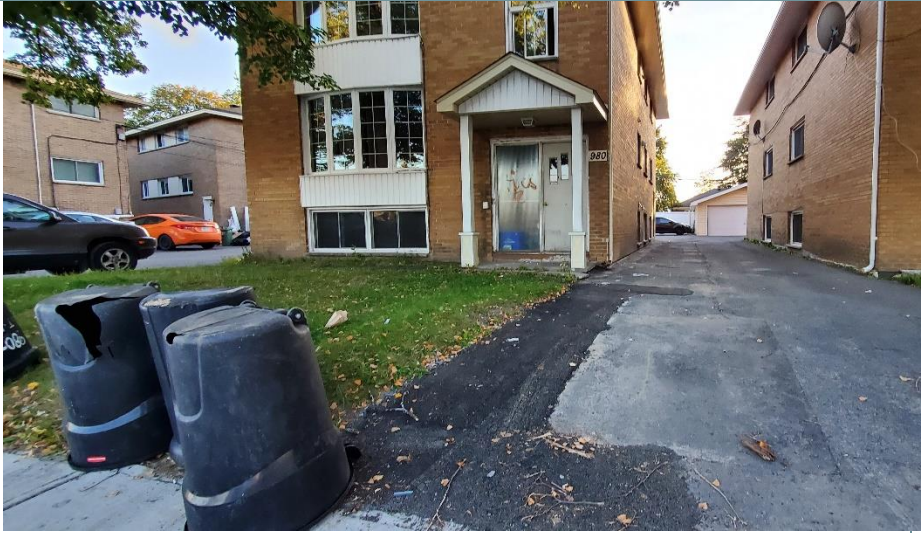
<p>Facing west at front yard of 980 St. Laurent Boulevard from southbound St. Laurent Boulevard sidewalk.</p> <p>Upgraded service connection area.</p>	<p>Reclaimed</p>	<p>None required.</p>

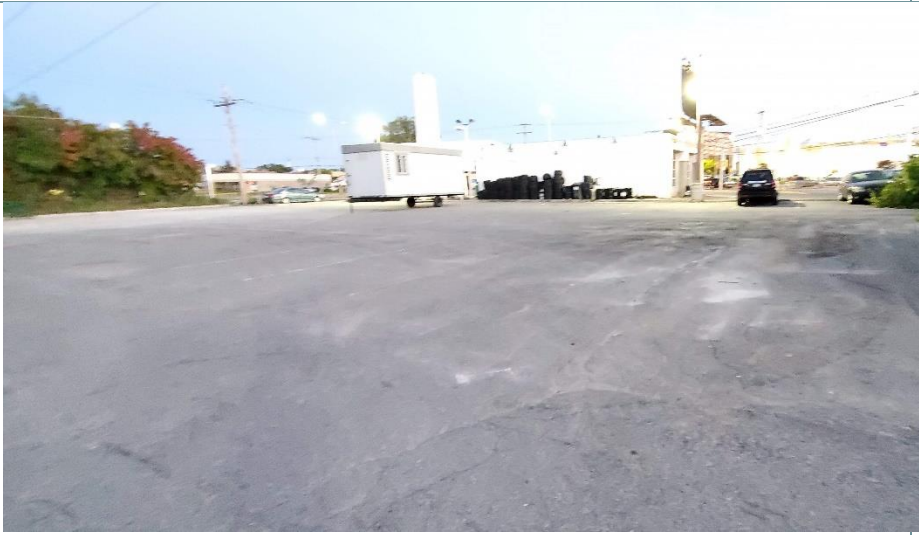
<p>Facing southeast within shared business/commercial parking lot located adjacent to and north of Carlsbad Auto Service (1057 Cyrville Road).</p> <p>Past equipment staging area as well as sand and gravel storage area.</p>	<p>Reclaimed</p>	<p>None required.</p>

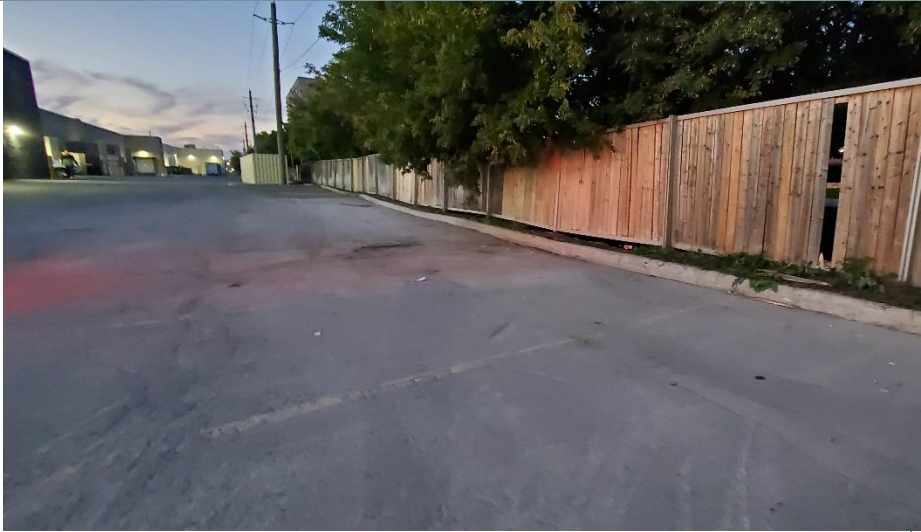
<p>Facing northwest within shared business/commercial parking lot located adjacent to and north of Carlsbad Auto Service (1057 Cyrville Road).</p> <p>Past equipment staging area as well as sand and gravel storage area.</p>	<p>Reclaimed</p>	<p>None required.</p>

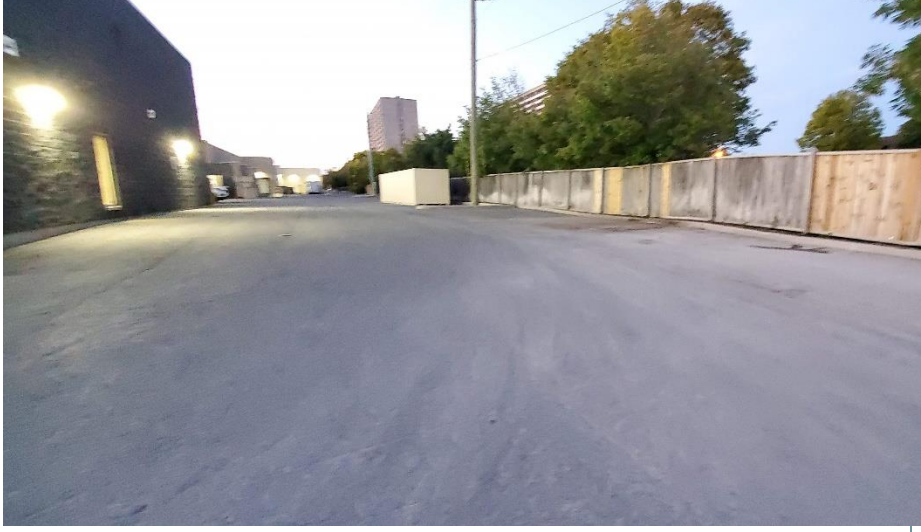
<p>Facing north within shared business/commercial parking lot located adjacent to and north of Carlsbad Auto Service (1057 Cyrville Road).</p> <p>Past equipment staging area as well as sand and gravel storage area.</p>	<p>Reclaimed</p>	<p>None required.</p>
