DILLON
CONSULTING

IMPERIAL OIL LIMITED

Post-Construction (Interim) Report

Waterdown to Finch Project (EB-2019-0007)

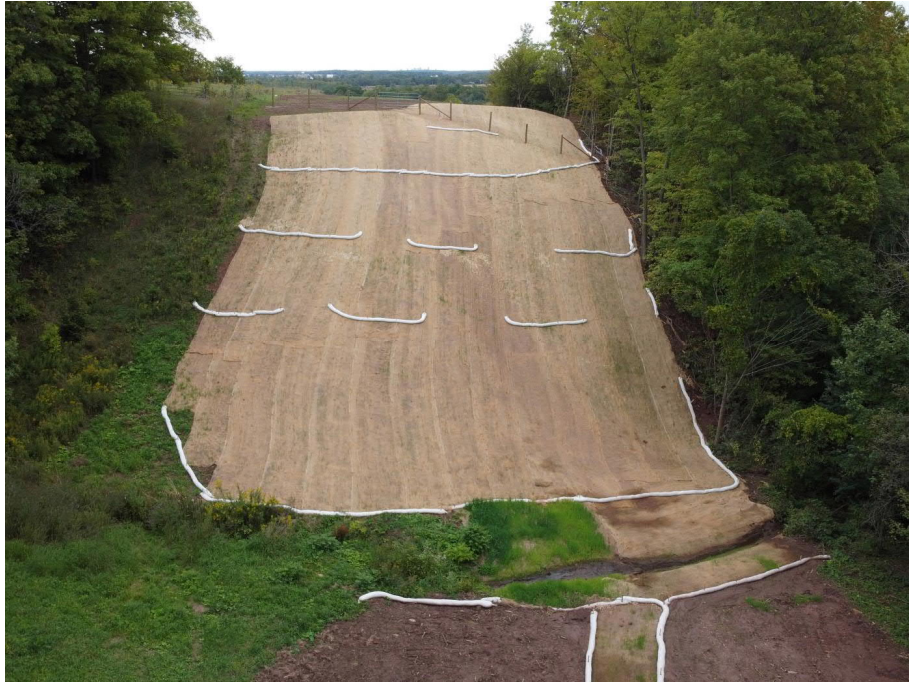
controls were implemented and these areas were restored to pre-construction conditions following construction. Photo 1 in Appendix B shows an example of steep slope erosion control measures implemented during restoration.

Photo 1: Steep slope restoration at KP 10+530, view facing northeast.

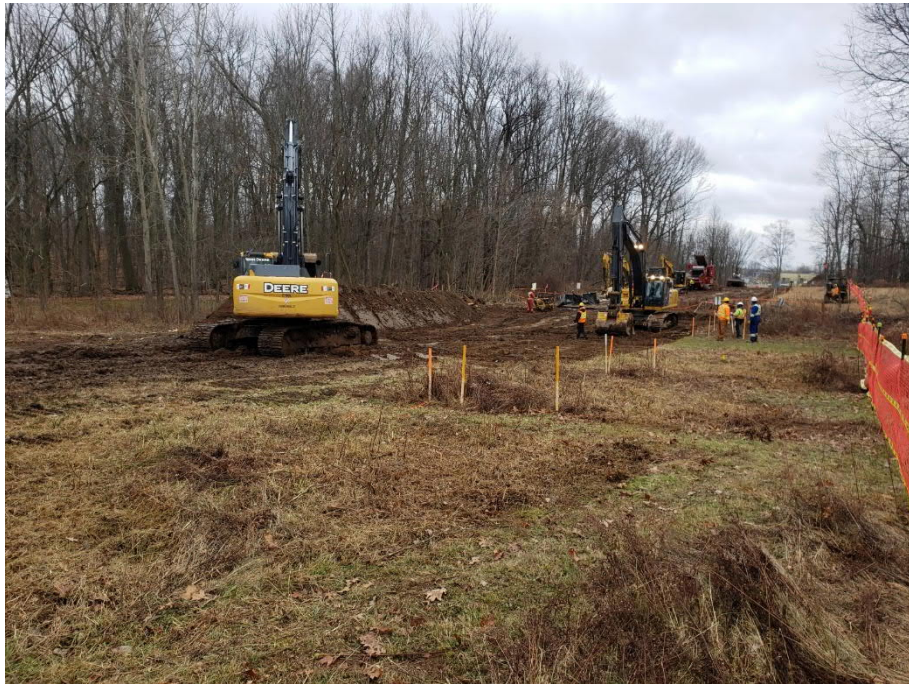
Photo 2 in Appendix B shows an example of topsoil stripping activities in progress along the construction ROW.

Photo 2: Topsoil stripping activities at KP 0+150, view facing southwest.

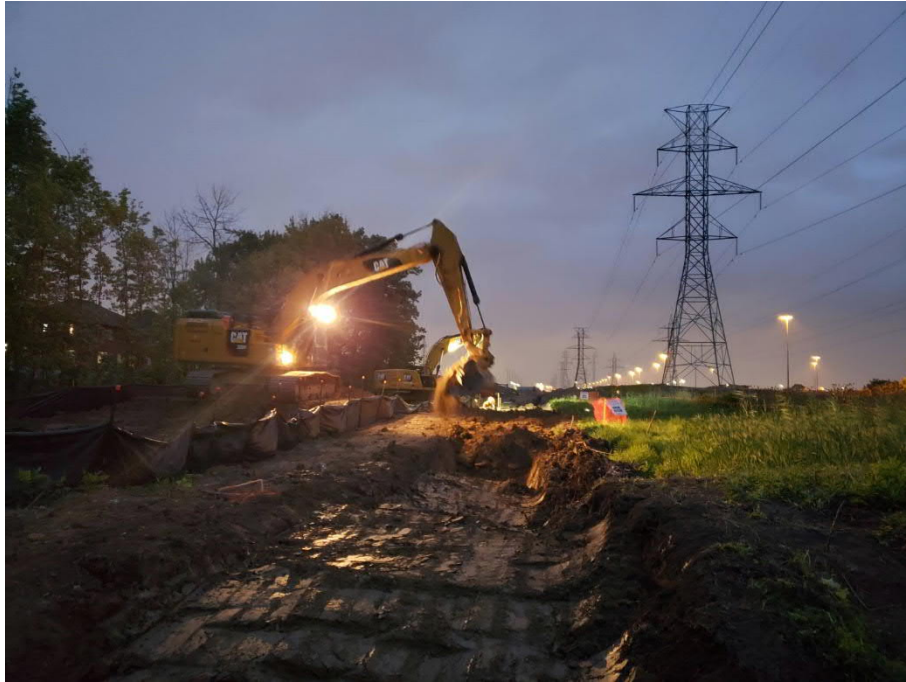
Photo 3: Wetland crossing during backfilling (WT_8.1), view facing northeast.

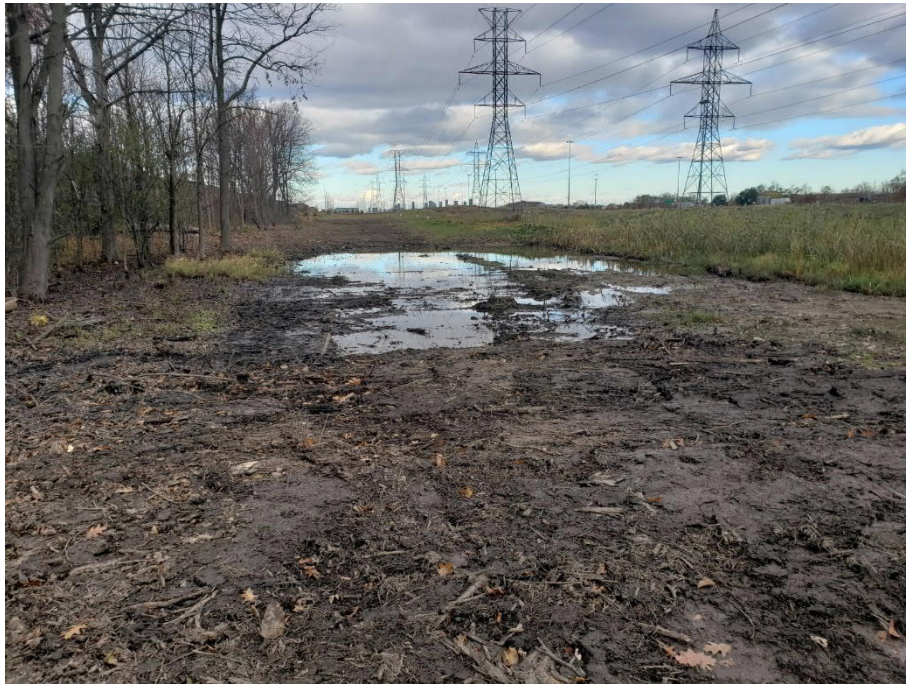
Photo 4: Wetland crossing restored following construction (WT_8.1), view facing northeast.

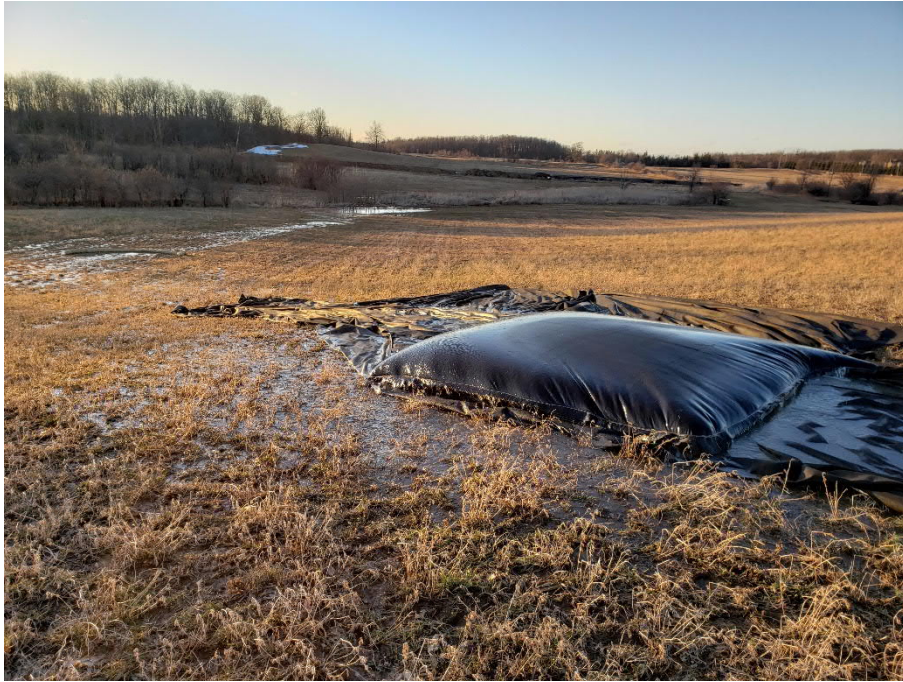
Measures were implemented to avoid erosion and sedimentation during dewatering, including dewatering into a filter bag in a well-vegetated upland area, and ensuring the discharge location was a minimum of 30 m away from watercourses. All dewatering locations were reviewed and approved by the Environmental Inspector. Photo 5 in Appendix B shows an example of dewatering mitigation that was implemented during construction.

Photo 5: Silt bag used during dewatering at KP 8+630 to prevent erosion and sedimentation, view facing northwest.

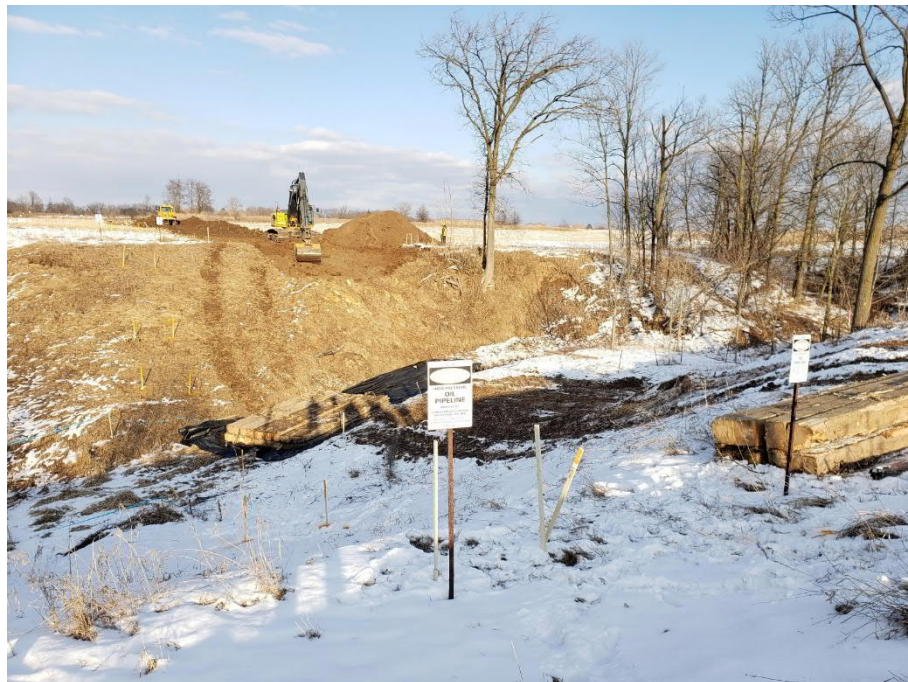
Photo 6: Open-cut watercourse crossing (WC_9.1), pre-construction, view facing east.

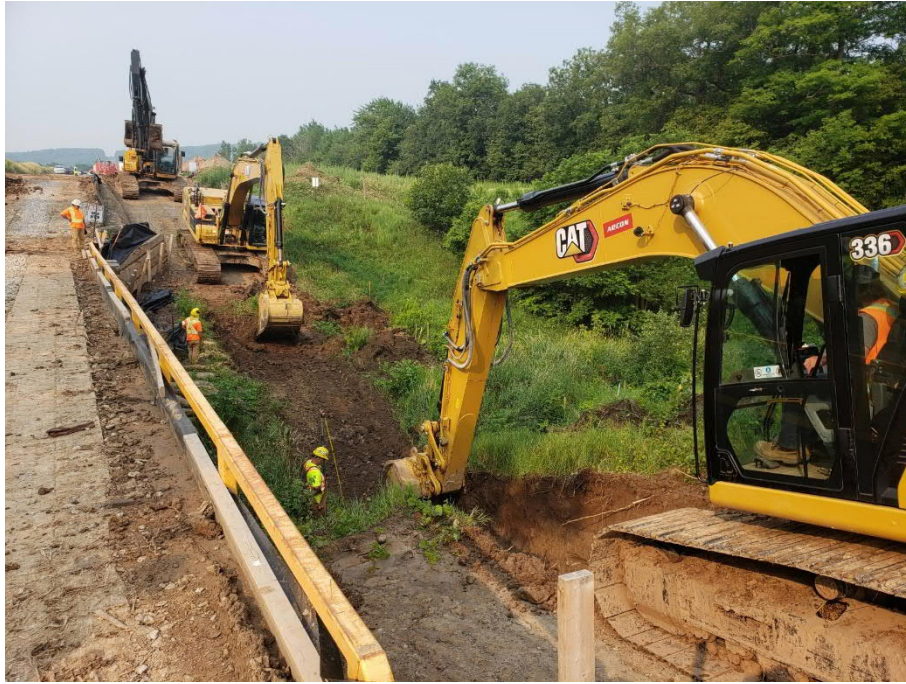
Photo 7: Open-cut watercourse crossing (WC_9.1), excavation during construction, view facing northeast.

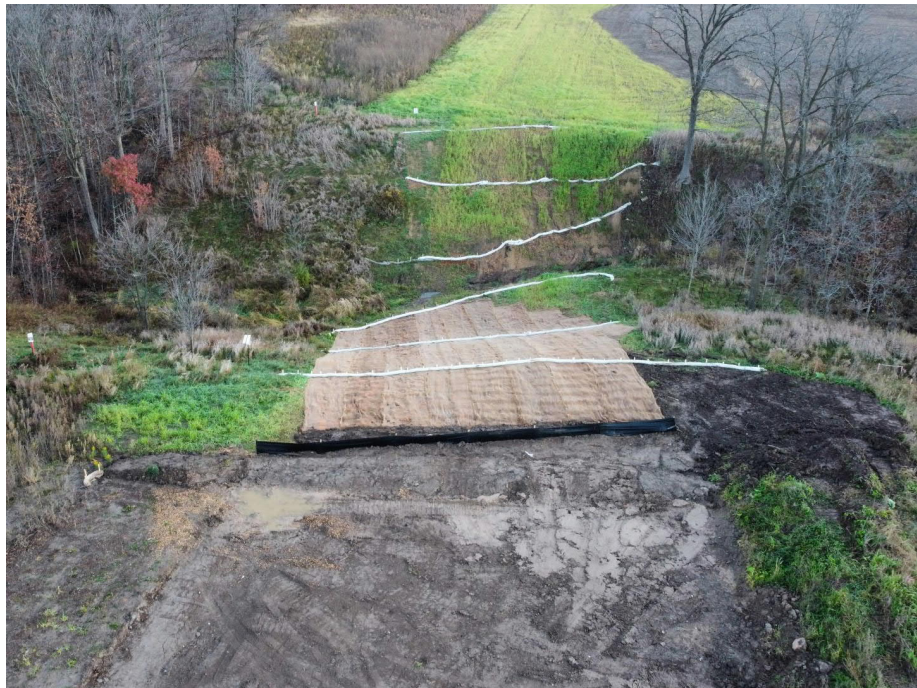
Photo 6, Photo 7, and Photo 8 in Appendix B show an open-cut watercourse crossing before, during, and after construction, respectively.

Photo 8: Open-cut watercourse crossing (WC_9.1), restored after construction, view facing northeast.

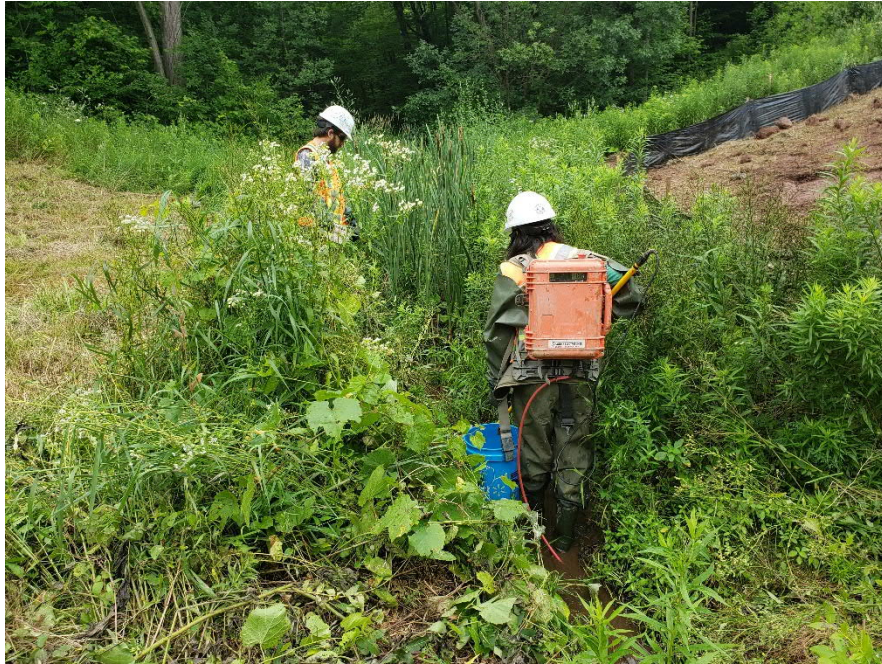
Fish salvage was conducted at three isolated pipeline crossings (Bronte Creek Tributary 2Ba, Bronte Creek Tributary 2Bc, and Bronte Creek Tributary 2B). Results of fish salvage activities are summarized in Table 3. A total of 17 fish were salvaged while conducting fish salvages at isolated pipeline crossings. No species at risk or species of special status were observed. A total of three fish mortalities were observed (Eastern blacknose dace). As per the license to collect fish issued to Dillon Consulting Limited, a written report outlining methods used, the number and species of fish salvaged and their fate was submitted to the Ministry of Natural Resources and Forestry on December 15, 2021. A fish salvage photo (Photo 9) is provided in Appendix B.

Photo 9: Fish salvage in process at Bronte Creek Tributary 2Ba.

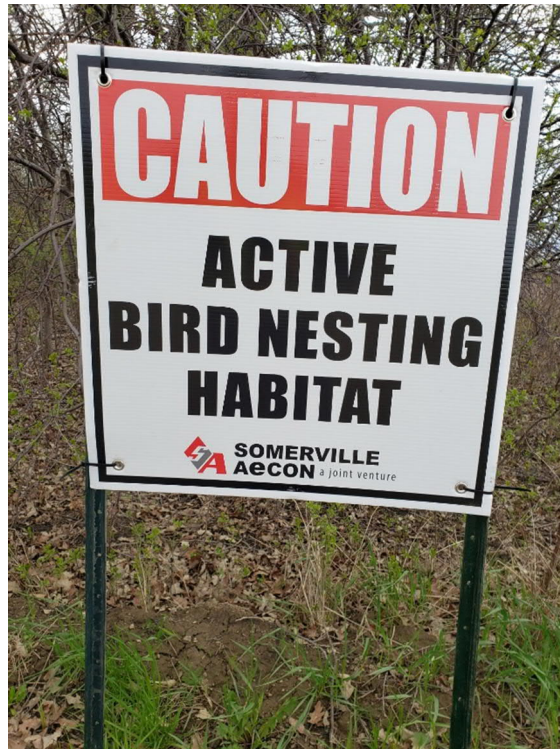
In accordance with the EPP, bird nest sweeps were conducted by a biologist prior to vegetation clearing during the period of May 15 to August 31. In order to avoid disruption to nesting birds, clearing was conducted outside of this period in several areas along the ROW. When nests were identified, mitigation measures were implemented until the nest had fledged. This typically involved establishing a “no go” buffer (e.g., 30 m) around the nest to prevent disruption to the nesting bird. Photo 10 in Appendix B shows an example of nesting bird signage used during construction.

Photo 10: Example of nesting bird signage used during construction.

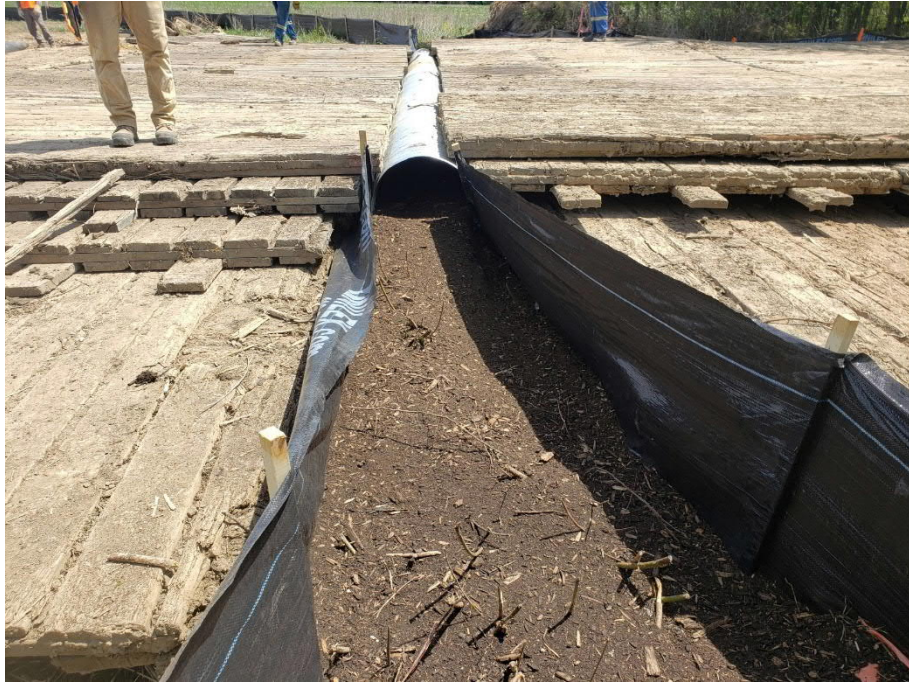
Photo 11: Jefferson Salamander culvert crossing at KP 8+045, view facing north.

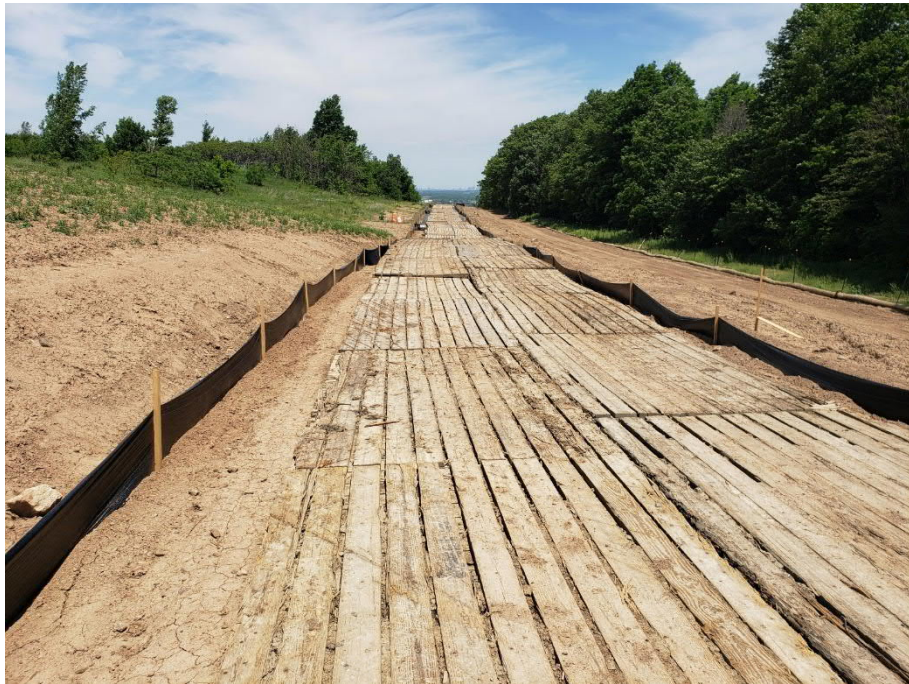
Photo 12: Jefferson Salamander mitigation at KP 9+450, view facing northeast.

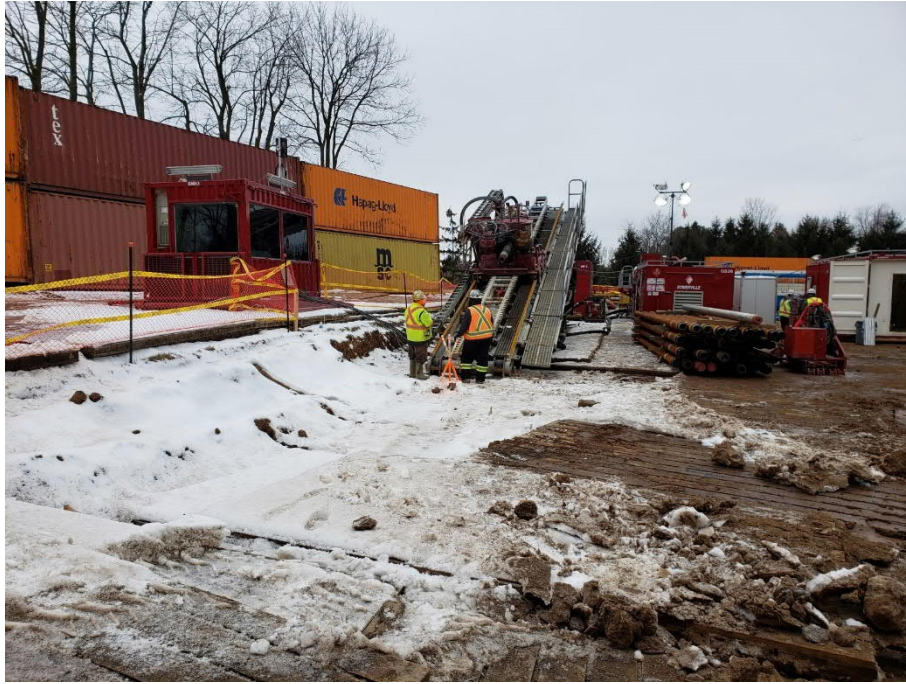
Photo 13: Sound wall constructed of sea cans at the Robson Road HDD.

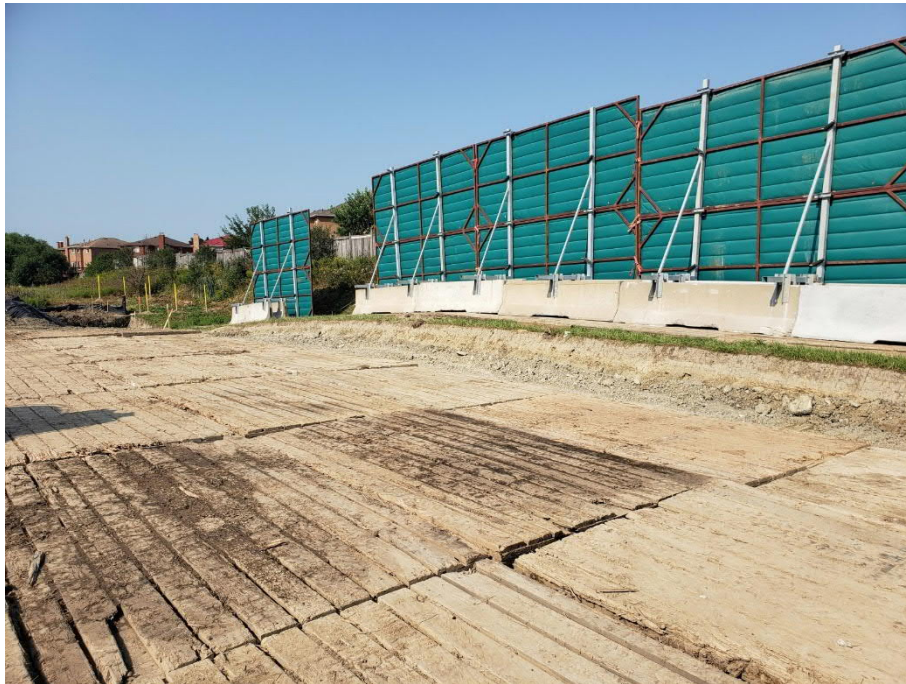
Photo 13 and Photo 14 in Appendix B show examples of noise abatement mitigation used during HDD.

Photo 14: Engineered sound wall installed at the Mavis Road HDD.

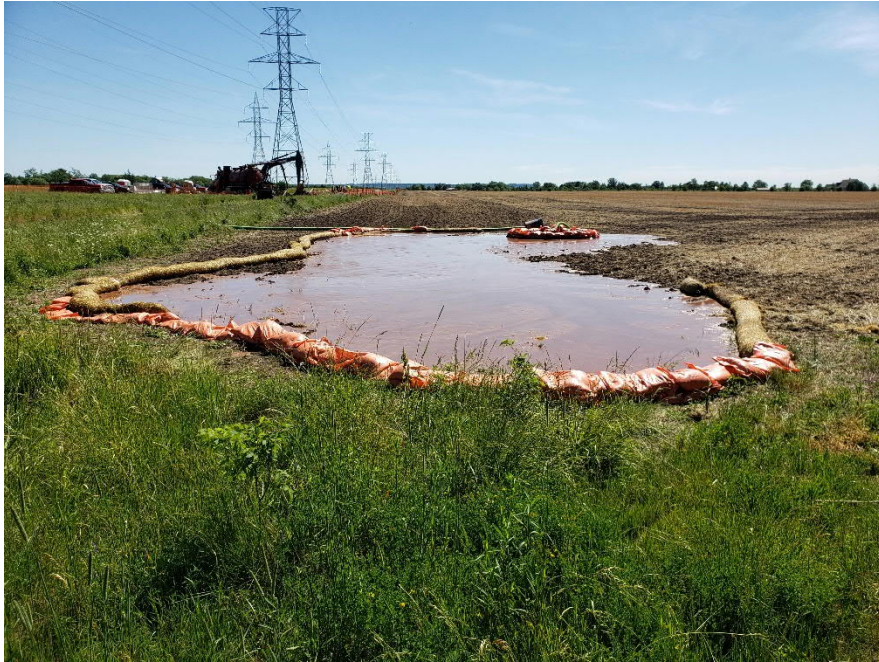
When inadvertent returns (IRs) occurred during HDD/HDB activities, drilling activities were halted and the appropriate notifications were completed. Where fluid released was >100 L off site or >25 L on site, notification was made to the MECP's Spills Action Centre (SAC) and any potentially impacted municipality or agency, as directed by the SAC. Depending on the volume of the fluids observed, berms, silt fence and/or hay bales were erected to prevent further migration of drilling fluids from the location. Clean-up work was performed using hand tools to the maximum extent possible. Larger IRs required mechanical equipment, such as a vacuum truck, to be used for clean-up activities. Disturbed areas were restored to pre-construction site conditions. An example of an IR contained and after clean-up is shown in Photo 15 and Photo 16 in Appendix B.

Photo 15: Inadvertent return at KP 21+985 contained using sediment control measures, facing southwest.

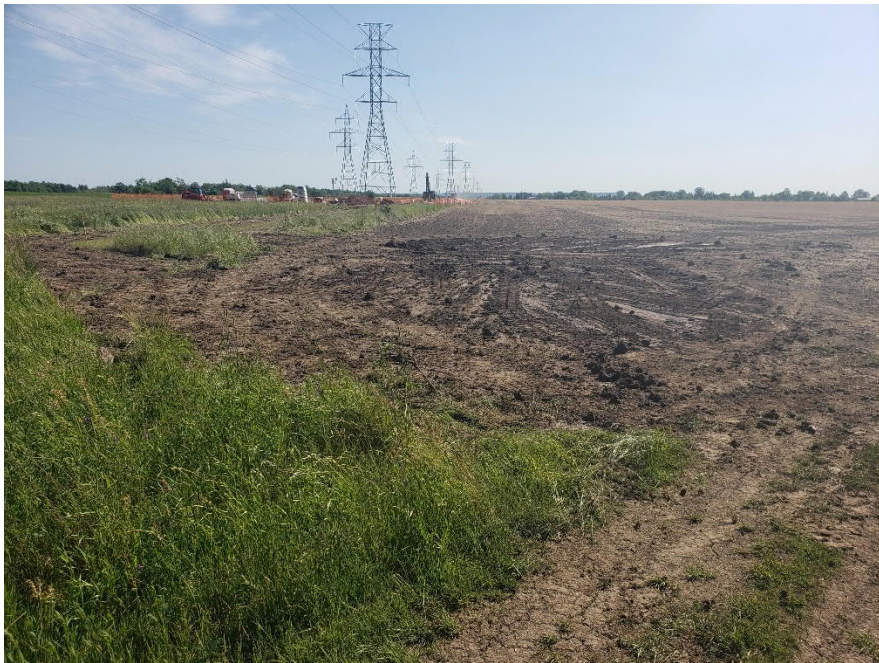
Photo 16: Inadvertent return at KP 21+985 following clean-up, facing southwest.

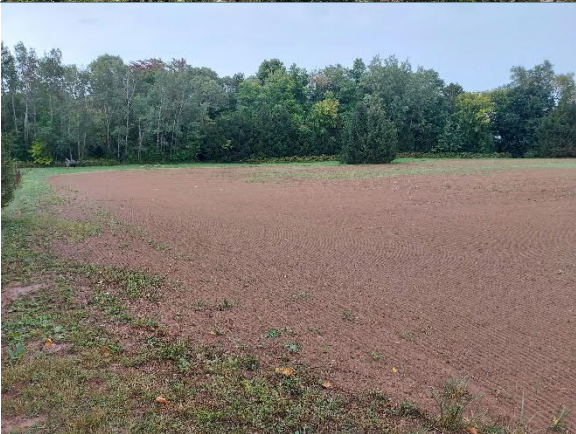
WTFN0038	Reduced crop density at KP 7.4.	Y	Confirm revegetation success in 2023.

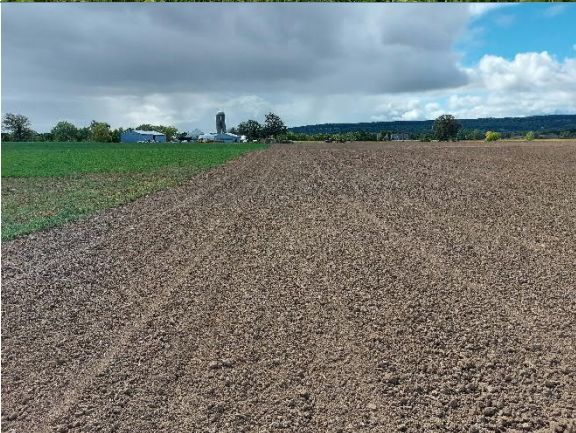
WTFN1017	The ROW is mostly bare soil.	Y	Confirm revegetation success in 2023.

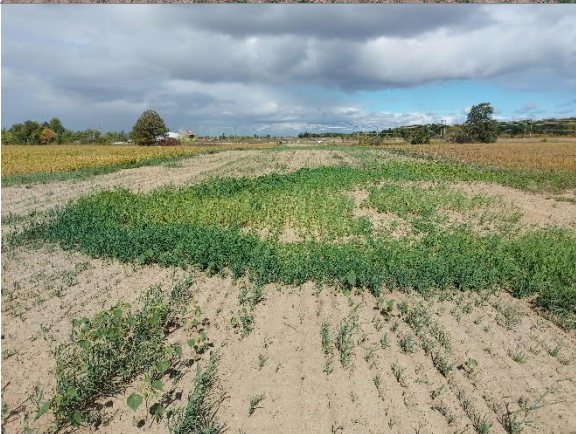
WTFN1022	The ROW is mostly bare soil.	Y	Confirm revegetation success in 2023.

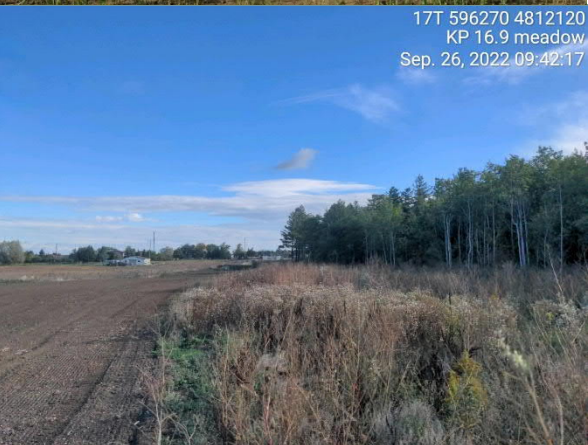
WTFN1032	The ROW is mostly bare soil. Small areas of higher weed abundance (Annual Ragweed and Bull Thistle) observed.	Y	Confirm revegetation success in 2023.

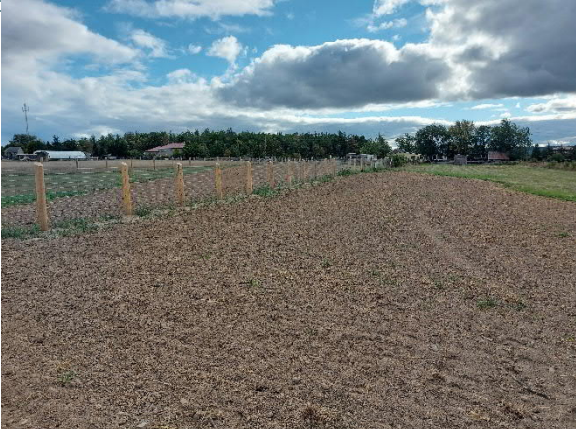
WTFN1035	Site restoring, but higher abundance of weeds (Field Mustard and Annual Ragweed) abundance observed on-ROW.	Y	Site to be re-assessed in 2023. Control weeds as needed.

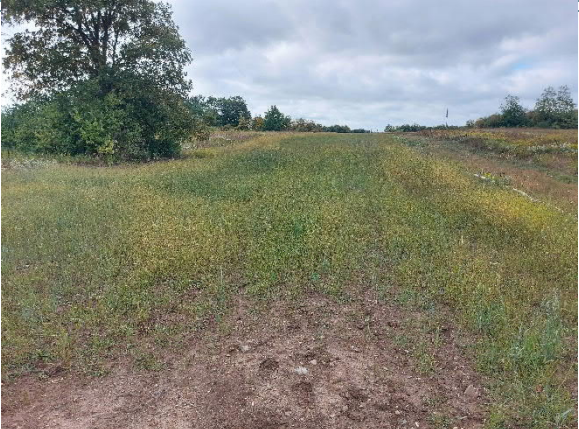
WTFN1045	The ROW is mostly bare soil. Areas of higher weed abundance (Annual Ragweed) observed on-ROW.	Y	Site to be reassessed in 2023.

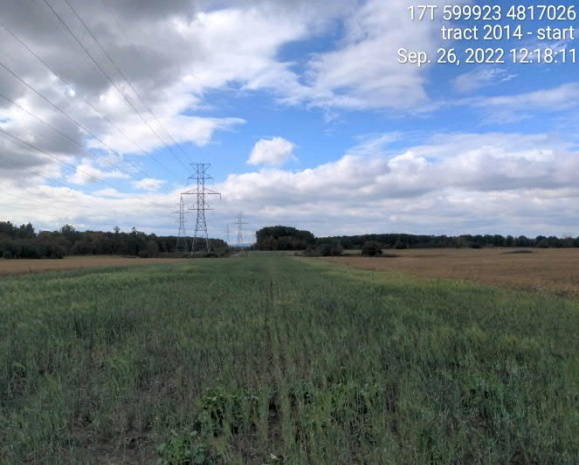
<p>17T 599923 4817026 tract 2014 - start Sep. 26, 2022 12:18:11</p>
WTFN2015	Crops are establishing, some weeds observed.	Y	Confirm revegetation success in 2023.

Location (Tract No.)	Site Condition	Additional Work Recommended (Y/N)	Comments/Recommendations	Representative Photo (Date)
WTFN2014	Crops are establishing, some weeds observed.	Y	Confirm revegetation success in 2023.

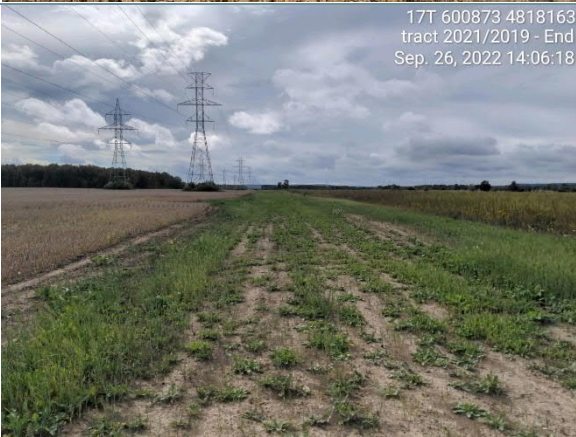
<p>17T 600873 4818163 tract 2021/2019 - End Sep. 26, 2022 14:06:18</p>
WTFN2021	Cover crop planted, some bare areas observed.	Y	Confirm revegetation success in 2023.

<p>17T 600302 4817494 tract 2017a/2018 - KP23.67 Crop Establishment Sep. 26, 2022 13:41:28</p>
WTFN2019	Cover crop planted, some bare areas observed.	Y	Confirm revegetation success in 2023.

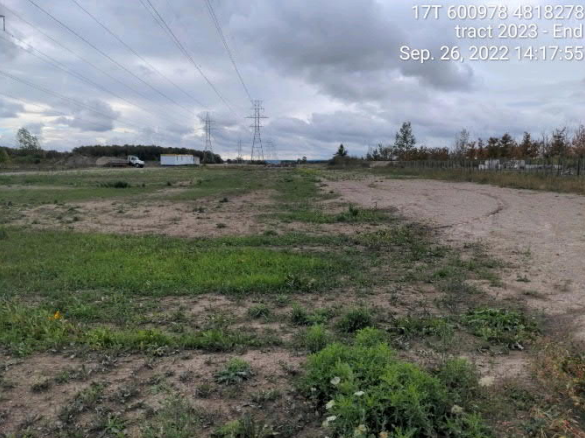
Location (Tract No.)	Site Condition	Additional Work Recommended (Y/N)	Comments/Recommendations	Representative Photo (Date)
WTFN2023	ROW is unseeded and there are large patches of Canada Thistle.	Y	Site to be re-assessed in 2023. Control weeds and seed if required.

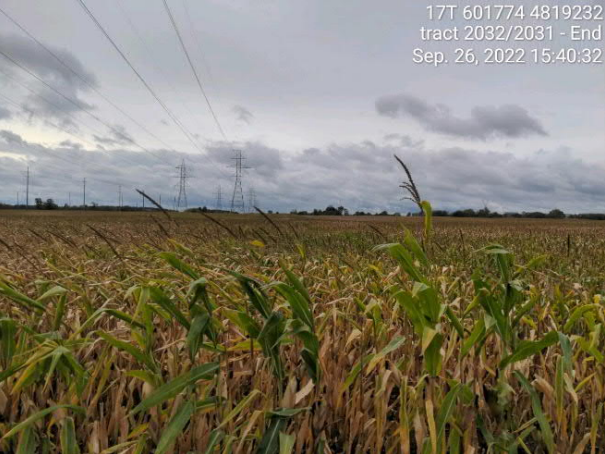
Location (Tract No.)	Site Condition	Additional Work Recommended (Y/N)	Comments/Recommendations	Representative Photo (Date)
WTFN2031	Site restored.	N	No issues documented at the time of inspection.

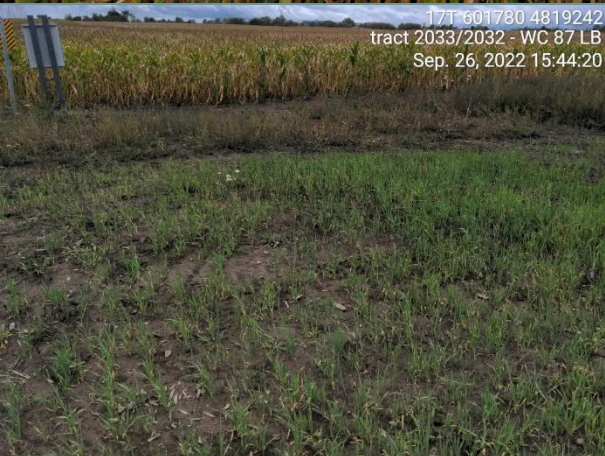
WTFN2032	Crop density on-ROW less than off-ROW.	Y	Confirm revegetation success in 2023.

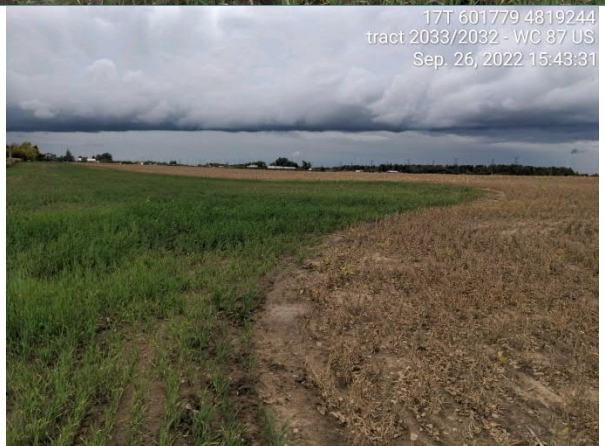
WTFN2033	Crop density on-ROW less than off-ROW.	Y	Confirm revegetation success in 2023.

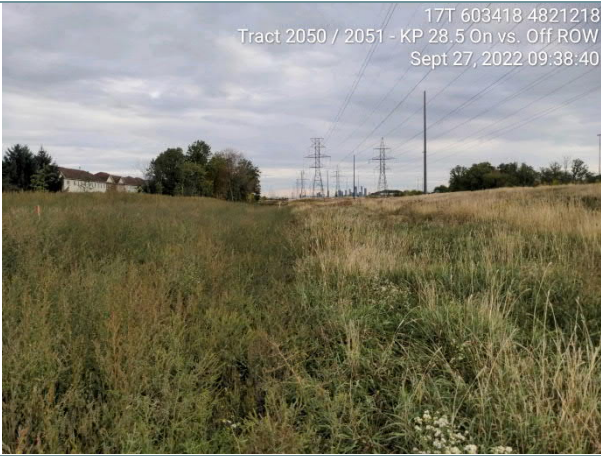
WTFN2051	Site restored, some bare areas observed.	Y	Confirm revegetation success in 2023.

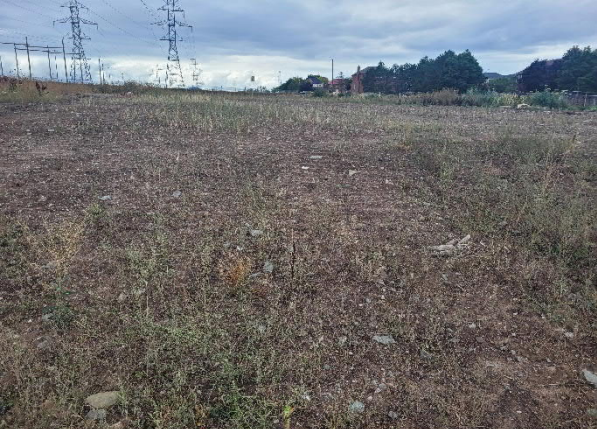
Location (Tract No.)	Site Condition	Additional Work Recommended (Y/N)	Comments/Recommendations	Representative Photo (Date)
WTFN3003A	Bare soil observed.	Y	Confirm revegetation success in 2023.

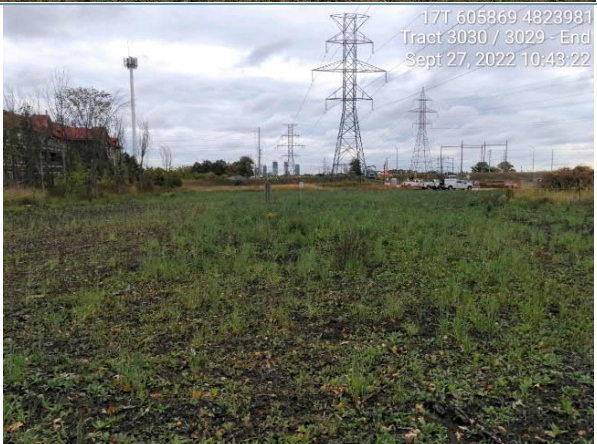
WTFN3030	Oats cover crop applied.	Y	Confirm revegetation success in 2023.

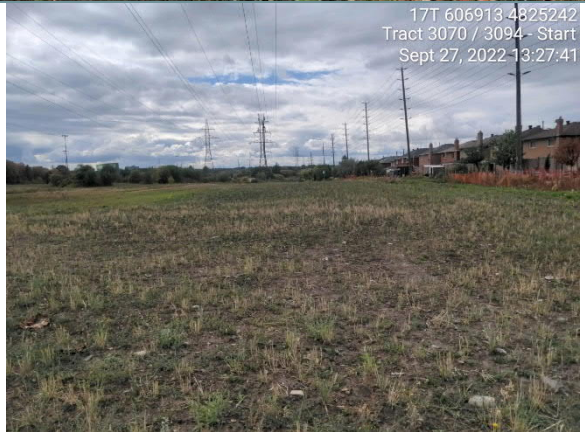
WTFN3070	Site seeded, with sections of bare soil on ROW.	Y	Confirm revegetation success in 2023.

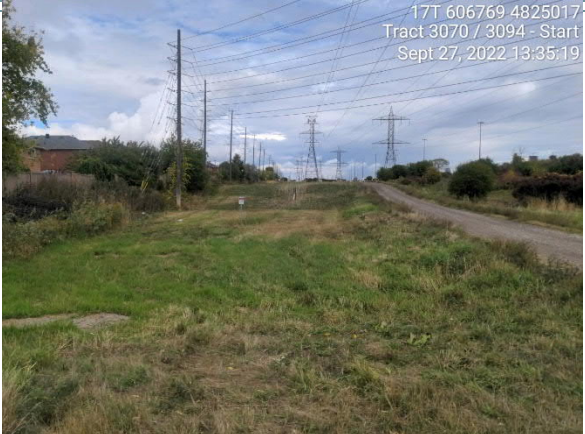
Location (Tract No.)	Site Condition	Additional Work Recommended (Y/N)	Comments/Recommendations	Representative Photo (Date)
WTFN3094	Site seeded, with sections of bare soil on ROW.	Y	Confirm revegetation success in 2023.

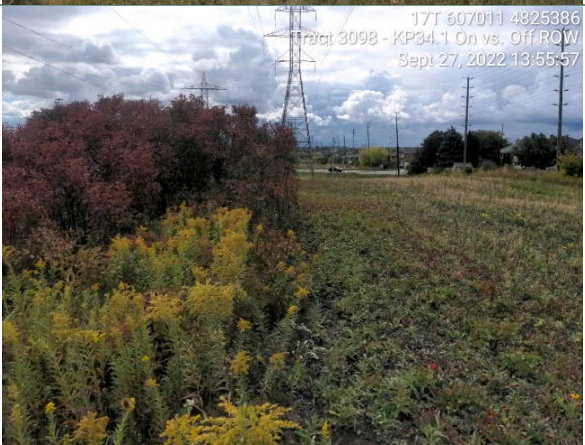
WTFN3098	Site restored, with sections of bare soil on ROW.	Y	Confirm revegetation success in 2023.

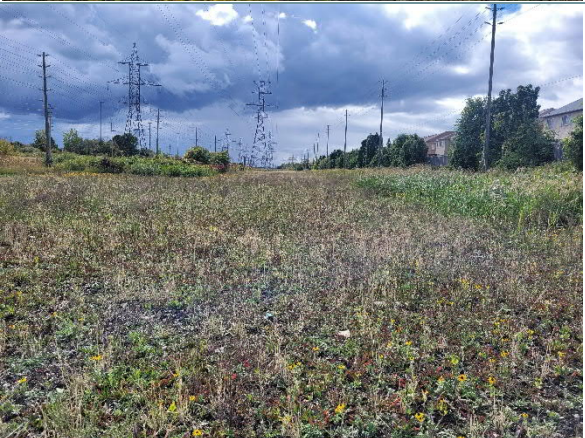
WTFN3145	Site restored.	N	No issues documented at the time of inspection.

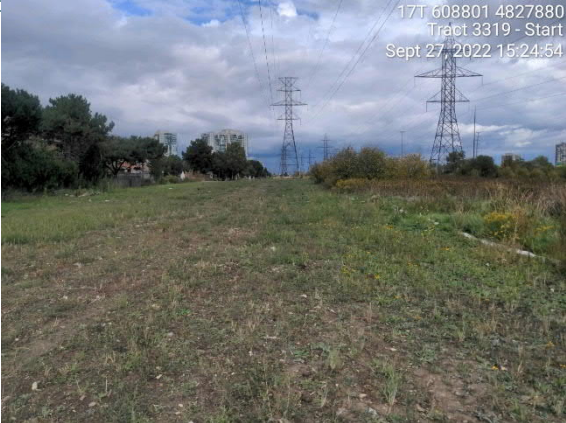
Location (Tract No.)	Site Condition	Additional Work Recommended (Y/N)	Comments/Recommendations	Representative Photo (Date)
WTFN3319	There is more bare soil on-ROW compared to off-ROW.	Y	Site to be re-assessed in 2023.

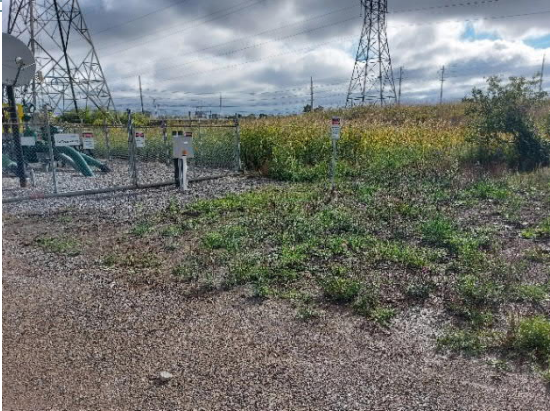
Location (Tract No.)	Site Condition	Additional Work Recommended (Y/N)	Comments/Recommendations	Representative Photo (Date)
WTFN4001	Areas of bare ground, higher weed density (Canada Thistle, Purple Loosestrife) and higher surface stone density observed. Non-biodegradable ESC measures require removal.	Y	Site to be re-assessed in 2023. Control weeds and seed if required. Non-biodegradable ESC measures require removal.

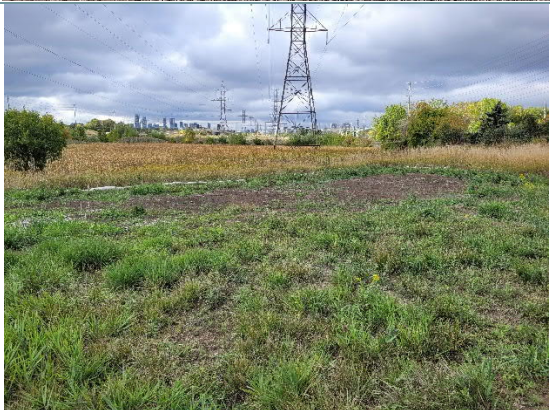
WTFN4009A	Bare soil on site.	Y	Site to be re-assessed in 2023. Seed if required.

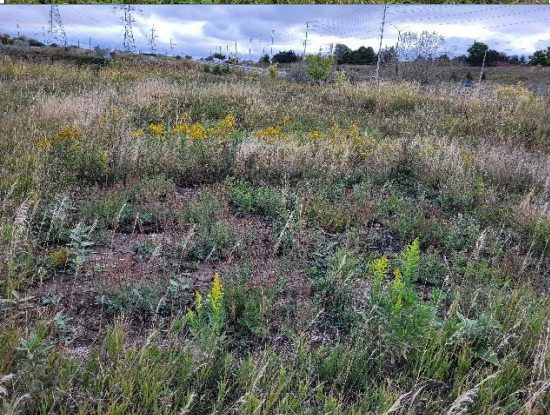
WTFN4011	Bare soil on site.	Y	Site to be re-assessed in 2023. Seed if required.

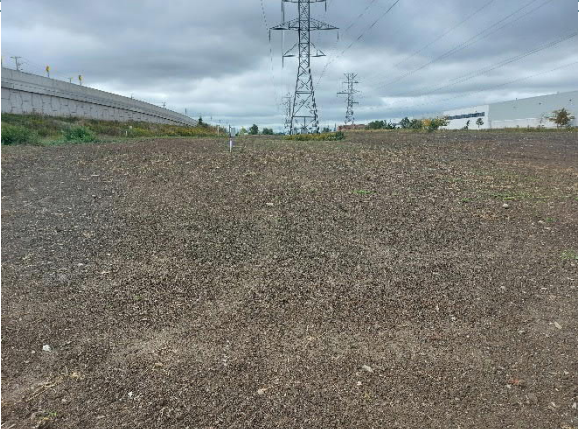
Location (Tract No.)	Site Condition	Additional Work Recommended (Y/N)	Comments/Recommendations	Representative Photo (Date)
WTFN4030	The ROW is mostly bare soil. Higher abundance of weeds (Canada Thistle) observed around edge of disturbed area.	Y	Confirm revegetation success in 2023.

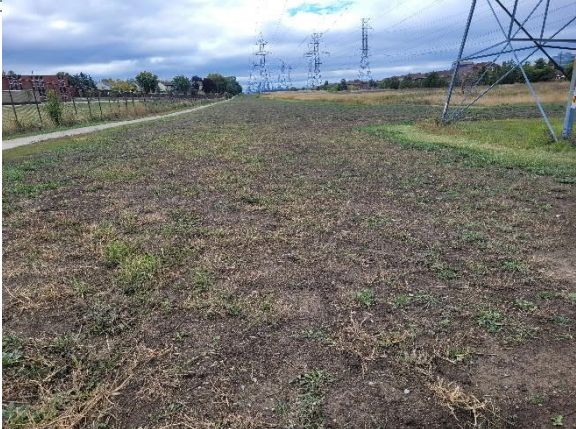
Location (Tract No.)	Site Condition	Additional Work Recommended (Y/N)	Comments/Recommendations	Representative Photo (Date)
WTFN4049	Vegetation on the west is not as well-established compared to the east side.	Y	Site to be re-assessed in 2023. Seed if required.

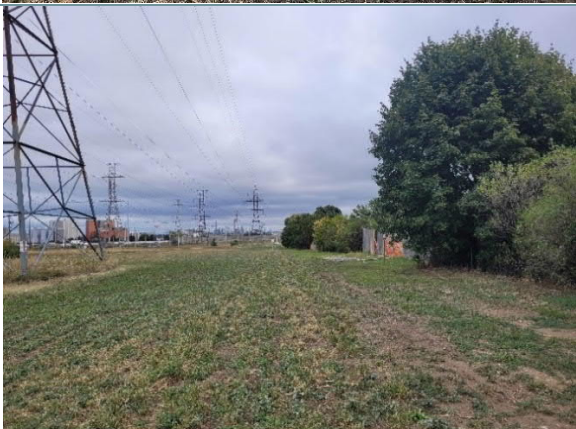
WTFN4052	Site restored.	N	No issues documented at the time of inspection.

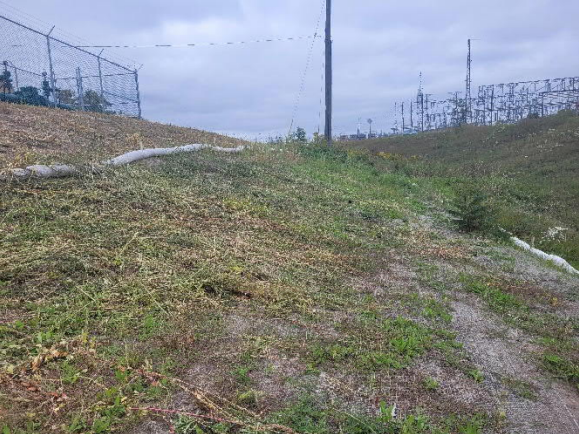
Location (Tract No.)	Site Condition	Additional Work Recommended (Y/N)	Comments/Recommendations	Representative Photo (Date)
WTFN4072	Site restored, some bare areas observed.	Y	Site to be re-assessed in 2023. Seed if required.

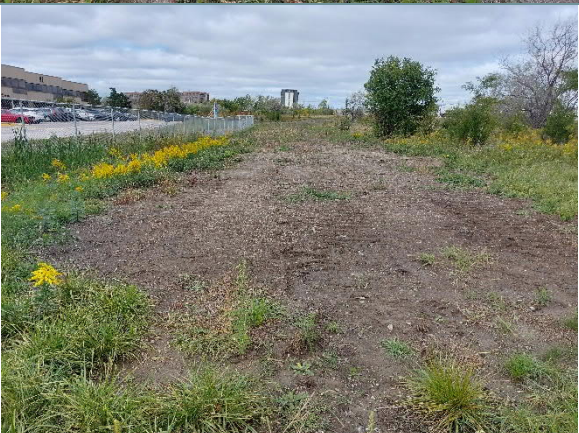
WTFN4082	The ROW is mostly bare soil.	Y	Confirm revegetation success in 2023.

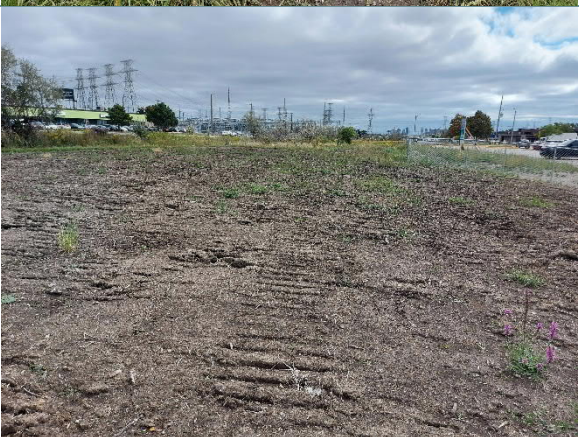
WTFN4083	The ROW is mostly bare soil.	Y	Confirm revegetation success in 2023.

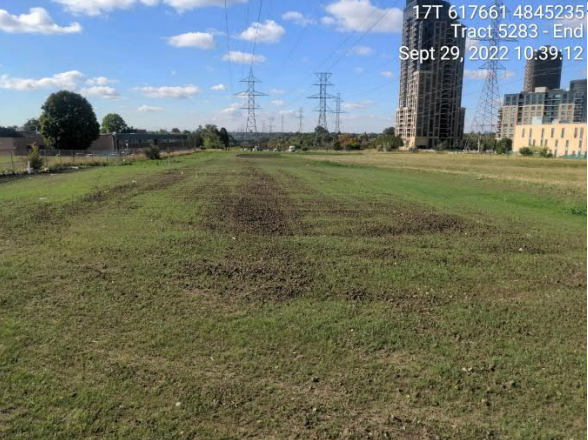
<p>17T 617661 4845235 Tract 5283 - End Sept 29, 2022 10:39:12</p>
WTFN5292	Bare ground observed in naturalized areas of parcel.	Y	Confirm revegetation success in 2023. Seed if required.

Location (Tract No.)	Site Condition	Additional Work Recommended (Y/N)	Comments/Recommendations	Representative Photo (Date)
WTFN5283	Site restored, areas of bare soil observed.	Y	Confirm revegetation success in 2023. Seed if required.

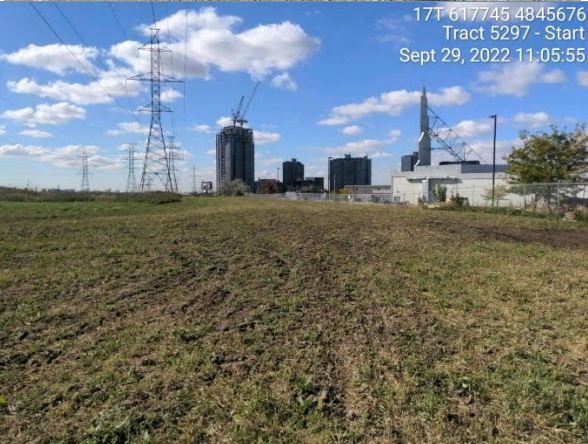
<p>17T 617745 4845676 Tract 5297 - Start Sept 29, 2022 11:05:55</p>

WTFN5297	Site restored, areas of bare soil observed. Cover crop planted.	Y	Confirm revegetation success in 2023. Seed if required.

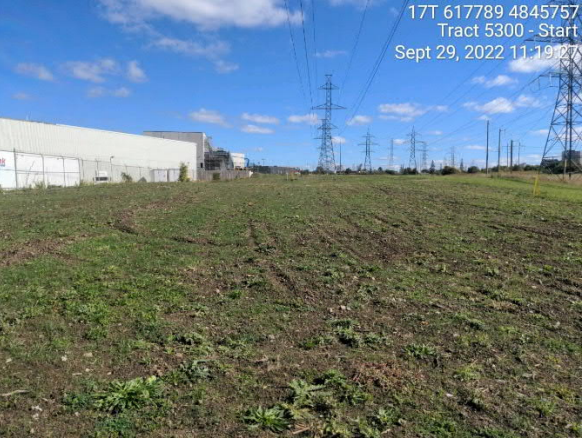
<p>17T 617789 4845757 Tract 5300 - Start Sept 29, 2022 11:19:27</p>
WTFN5311	Site restored. Single area of bare ground observed at west end of parcel.	Y	Confirm revegetation success in 2023. Seed if required.

Location (Tract No.)	Site Condition	Additional Work Recommended (Y/N)	Comments/Recommendations	Representative Photo (Date)
WTFN5300	Site restored, areas of bare soil observed.	Y	Confirm revegetation success in 2023. Seed if required.

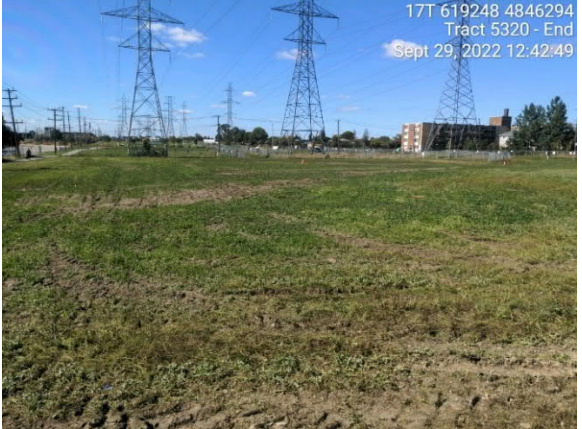
<p>17T 619248 4846294 Tract 5320 - End Sept 29, 2022 12:42:49</p>

WTFN5320	Site restored, areas of bare soil observed.	Y	Confirm revegetation success in 2023. Seed if required.

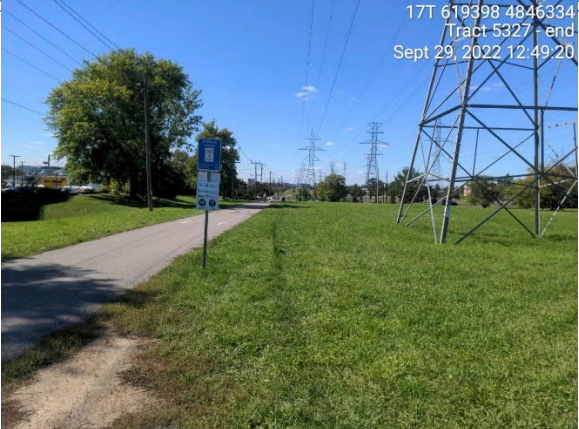
Location (Tract No.)	Site Condition	Additional Work Recommended (Y/N)	Comments/Recommendations	Representative Photo (Date)
WTFN5327	Site restored.	N	No issues documented at the time of inspection.
