# EB-2023-0144 – Hydro One Networks Inc. – Chapleau Public Utilities Corporation – Observation Report

## HYDRO ONE'S OBSERVATION REPORT ON OPERATION OF CHAPLEAU PUBLIC UTILITIES CORPORATION (EB-2023-0144)

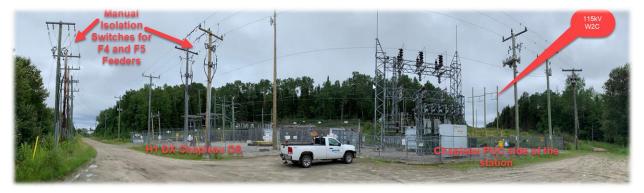
The biggest risk to the supply of power in Chapleau is the failure of station equipment – specifically the two transformers located inside the station. The CPUC station is located next to Hydro One's Distribution station. The relatively small customer base and the desire to mitigate rate impacts are likely why a large investment to renew the station has not been executed in the past.

Panorama View of Hydro One & Chapleau Stations

Given the above reasons, Hydro One believes that a large-scale investment to address the station assets' age and safety related deficiencies will be required within the next few years. Planning for this should begin immediately such that the Town's reliability and quality of service do not deteriorate.
