**Re: Imperial Oil Incorporate ("Imperial")
Ontario Energy Board ("OEB") File No. EB-2019-0007
Waterdown to Finch Project ("Project")**

Final Monitoring Report

Waterdown to Finch Project (EB-2019-0007)

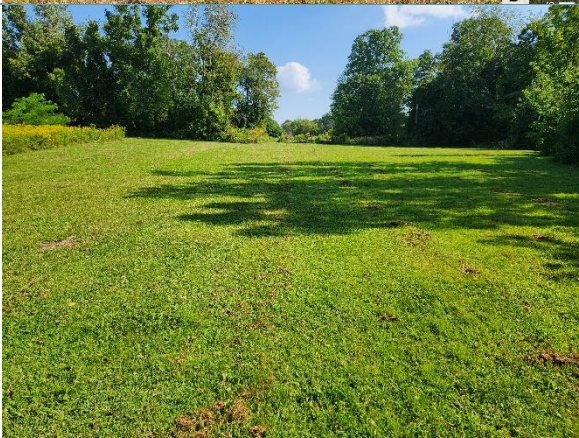
WTFN0002	Site restored.	N	No issues documented at the time of inspection.

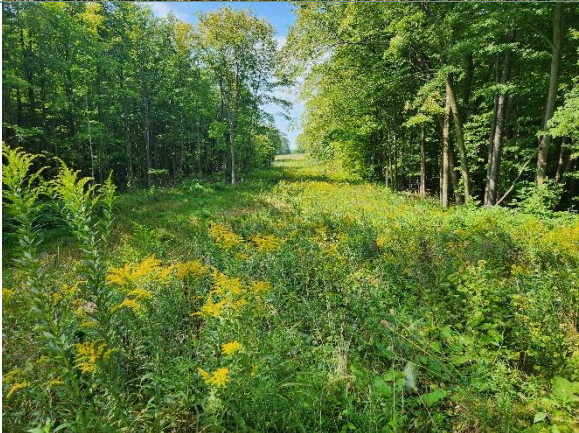
WTFN0012	Site restored, but a small area with wood chips inside wetland boundaries is slowing revegetation.	Y	Remove wood chips.

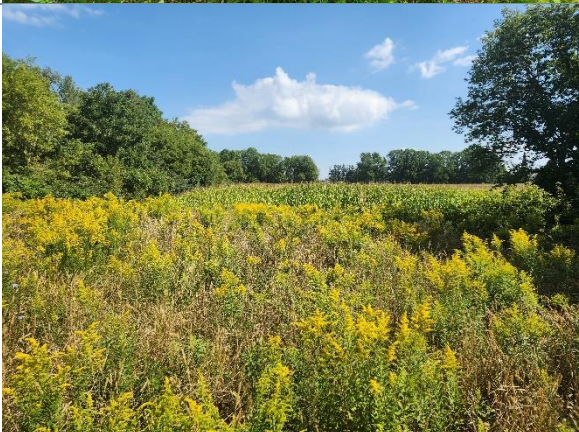
WTFN0013	Site Restored.	N	No issues documented at the time of inspection.

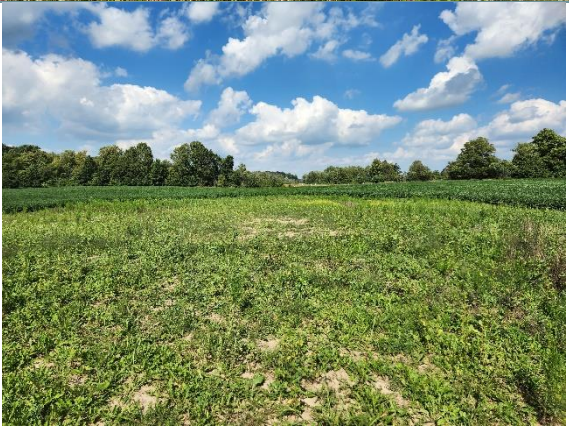
WTFN0038	Area of bare soil at KP7.475 (not planted with crop by land owner)	Y	Site to be re-assessed in 2024.

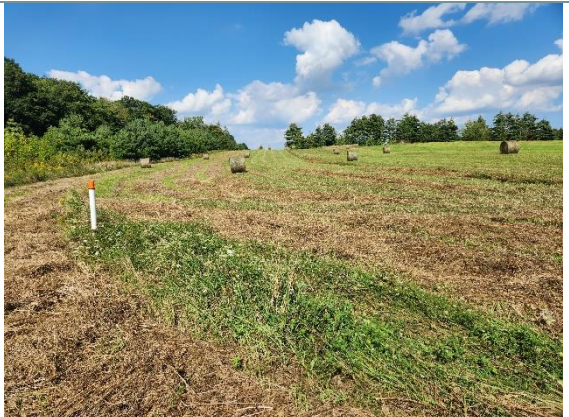
WTFN0039	Site restored.	N	No issues documented at the time of inspection.

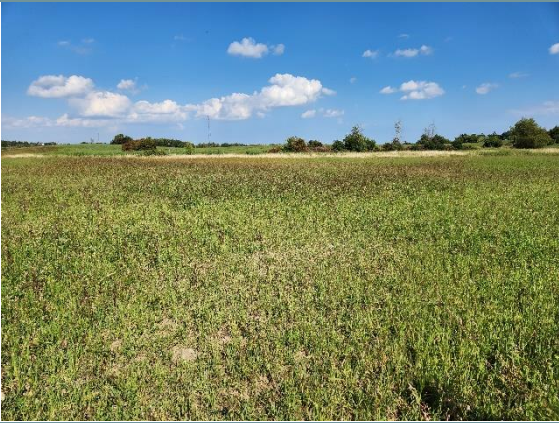
WTFN0041	Areas of bare soil and higher weed density (Annual Ragweed) than adjacent lands observed.	Y	Control weeds and seed as needed.

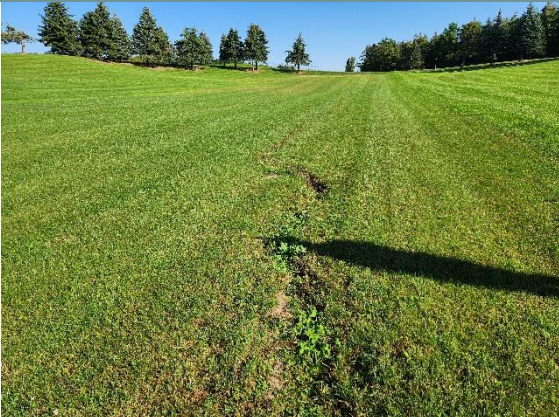
WTFN0045	Area of bare soil at KP9.275. Rutting and drilling present in the ROW.	Y	Site to be re-assessed in 2024. Seed bare area as needed. Further assess and repair erosion/rutting.

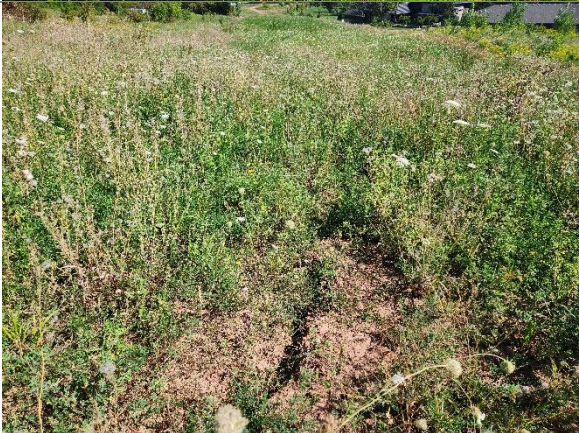
WTFN1000	Minor rill in ROW observed. Higher density of weeds (White Sweet-clover) than adjacent lands observed.	Y	Control weeds as needed. Further assess and repair erosion.

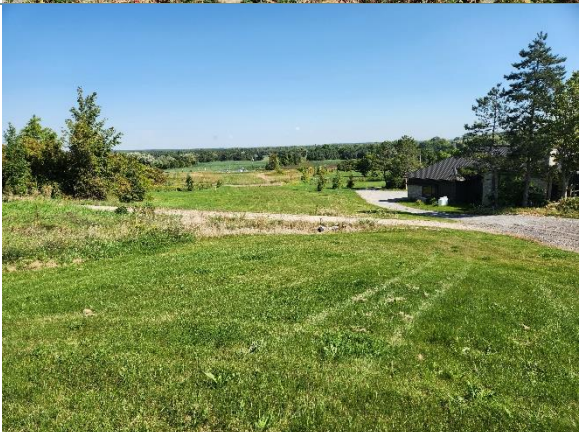
WTFN1001	Site restored.	N	No issues documented at the time of inspection.

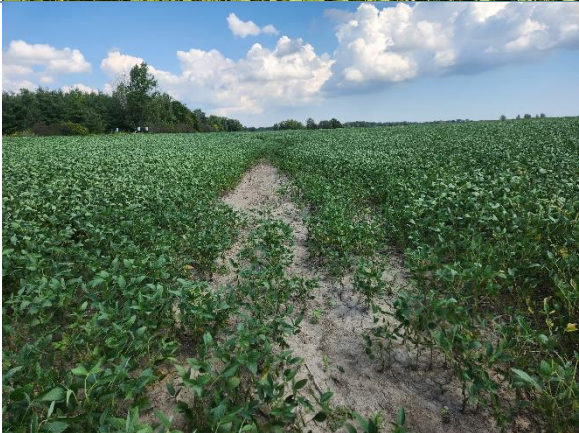
WTFN1004	Higher weed density (Annual Ragweed) in ROW than adjacent lands. Areas of bare soil and soil cracking observed along flow path of surface water at KP11.64.	Y	Site to be re-assessed in 2024. Seed and control weeds as needed. Repair area impacted by water pooling.

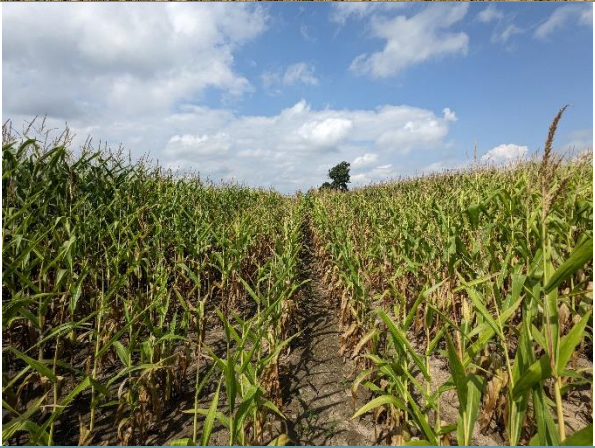
WTFN1026	Site restored, but small patch of stunted crop growth observed in ROW at KP16.	Y	Site to be re-assessed in 2024.

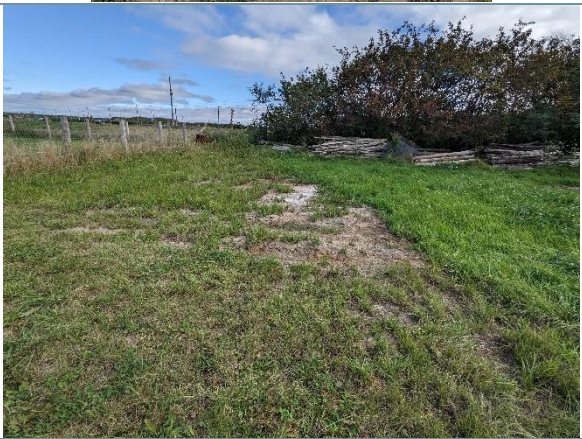
WTFN1033	Site restored, but small areas of bare soil and water pooling at KP17.4.	Y	Seed as needed. Repair area impacted by water pooling.

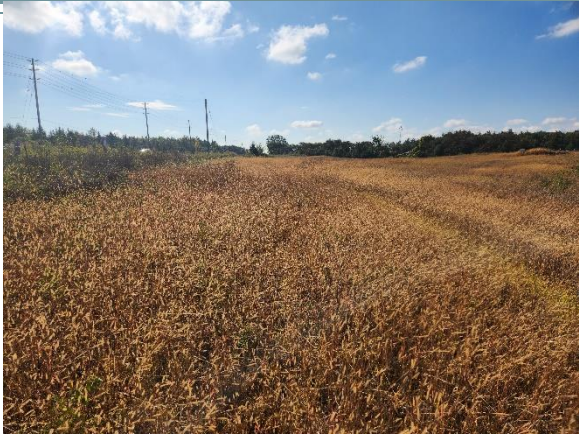
Location (Tract No.)	Site Condition	Additional Work Recommended (Y/N)	Comments/Recommendations	Representative Photo (Sept. 2023)
WTFN1035	Site restored.	N	No issues documented at the time of inspection.

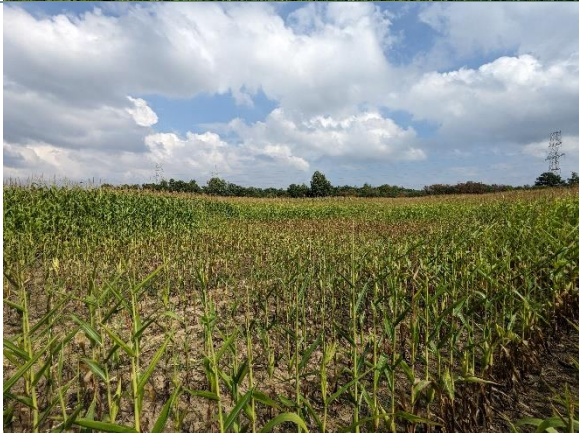
WTFN1043	Site restored, but area of low crop health and height at KP18.4.	Y	Site to be re-assessed in 2024.

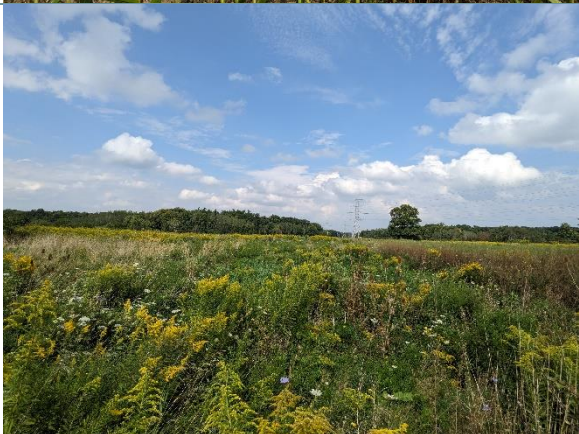
WTFN1044	Site restored.	N	No issues documented at the time of inspection.

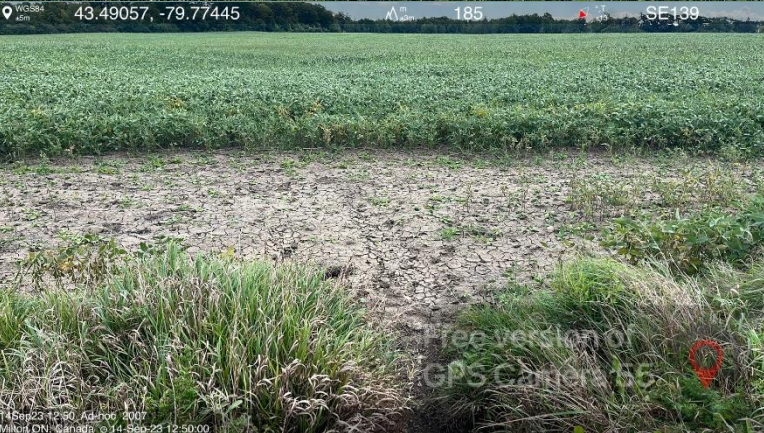
<p>A GPS photo showing a field of green crops under a blue sky with scattered clouds. In the background, several high-voltage power lines with towers are visible. The photo includes a red location pin and a 'Free version of GPS Camera 5.0' watermark.</p>
WTFN2007	Areas of bare soil, cracked soil at KP21.5. Low crop height and health observed between KP21.8 and KP21.9. Drainage issues related to rutting of ground at KP 22.7.	Y	Site to be re-assessed in 2024. Seed as needed. Repair area impacted by rutting and drainage issues.

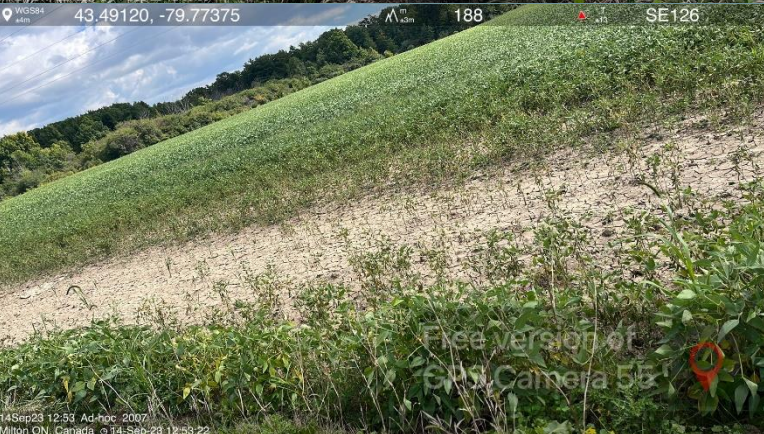
WTFN2014	Areas of bare soil. Drainage issues due to rutting of ground at KP 22.7.	Y	Site to be re-assessed in 2024. Seed as needed. Repair area impacted by rutting and drainage issues.

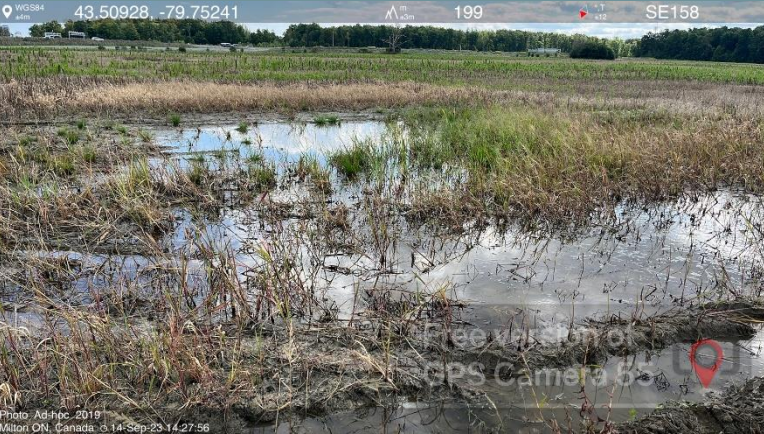
Location (Tract No.)	Site Condition	Additional Work Recommended (Y/N)	Comments/Recommendations	Representative Photo (Sept. 2023)
WTFN2019	Wet areas observed. Ponding observed at KP 23.6.	N	Ponding and drainage issues consistent with pre-construction conditions, site resolved.

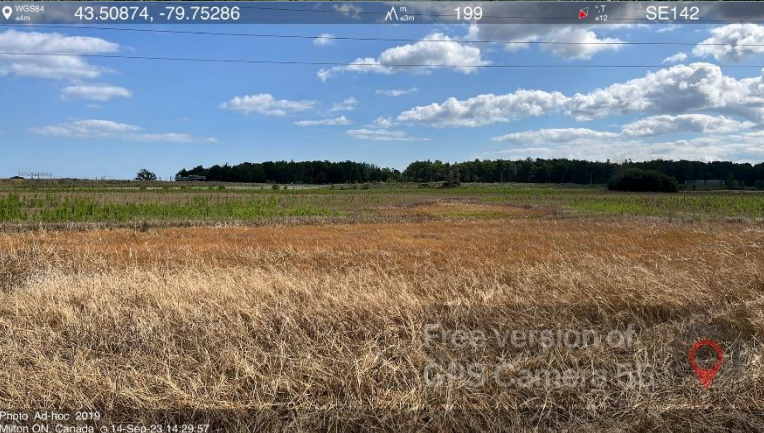
<p>A photograph showing a wetland area with a small pond surrounded by tall reeds and grasses. The water is still, reflecting the sky. The photo includes a GPS overlay at the top with coordinates 43.50928, -79.75241 and a location marker SE158.</p>
WTFN2021	Wet areas observed at KP24.5 and KP24.4.	N	Wet areas observed at KP24.5 and KP24.4 consistent with pre-construction conditions, site resolved.

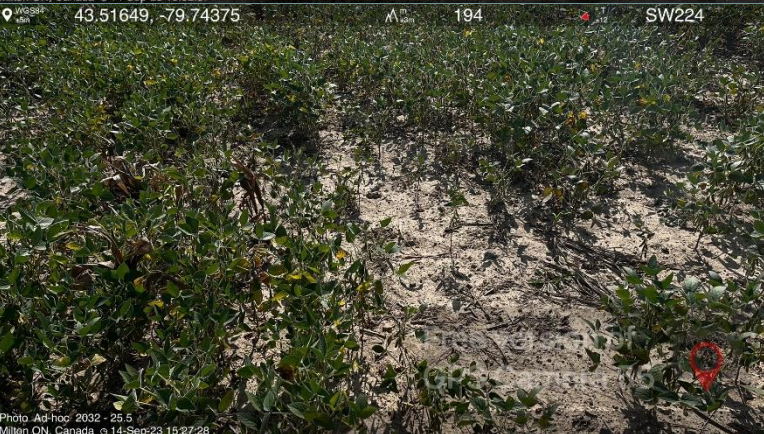
<p>A photograph showing a large area of bare, light-colored soil in a field. In the background, there are green fields and several tall metal power line towers under a blue sky with scattered white clouds. The photo includes a GPS overlay at the top with coordinates 43.51078, -79.75008 and a red location pin.</p>
WTFN2030A	Crop establishment issue in soy field between KP25.5 and KP25.6.	Y	Site to be re-assessed in 2024.

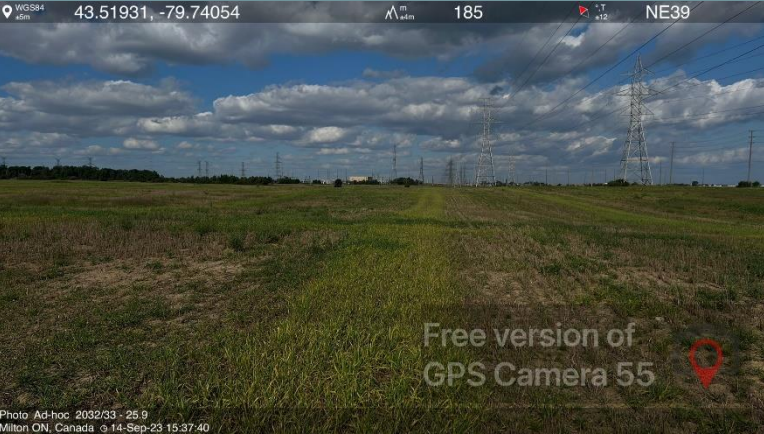
Location (Tract No.)	Site Condition	Additional Work Recommended (Y/N)	Comments/Recommendations	Representative Photo (Sept. 2023)
WTFN2031	Crop establishment issue in soy field observed at KP25.5 & 25.6.	Y	Site to be re-assessed in 2024.

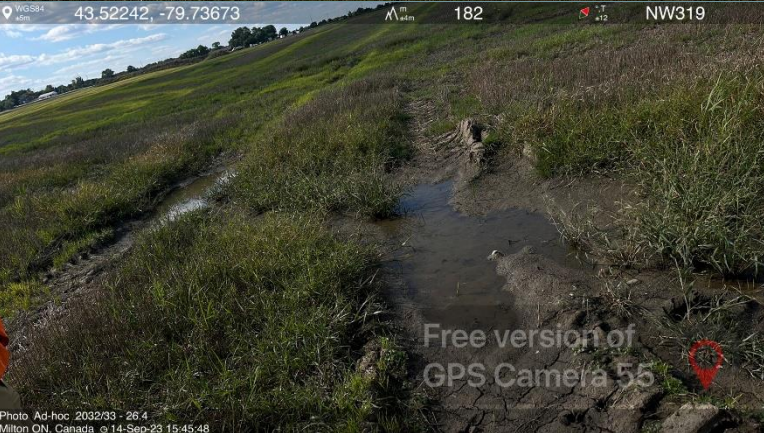
<p>A photograph showing a soybean field with sparse and uneven crop growth. The sky is blue with scattered white clouds. In the background, several high-voltage power lines are visible against the horizon. The photo includes a red location pin and a watermark for 'Free version of GPS Camera 55'.</p>
WTFN2032	Drainage issue observed at KP26.4. Crop establishment issue in soy field observed at KP25.5 & 25.6.	Y	Site to be re-assessed in 2024. Drainage issue consistent with pre-construction conditions.

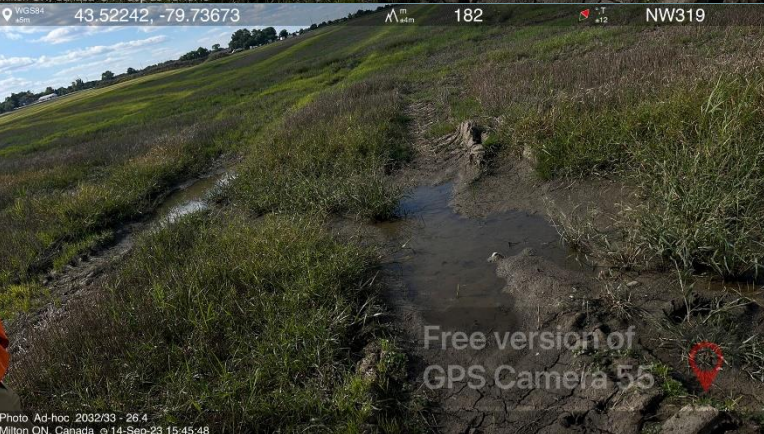
WTFN2033	Site restored, but drainage issue observed at KP26.4.	N	Drainage issue consistent with pre-construction conditions, site resolved.

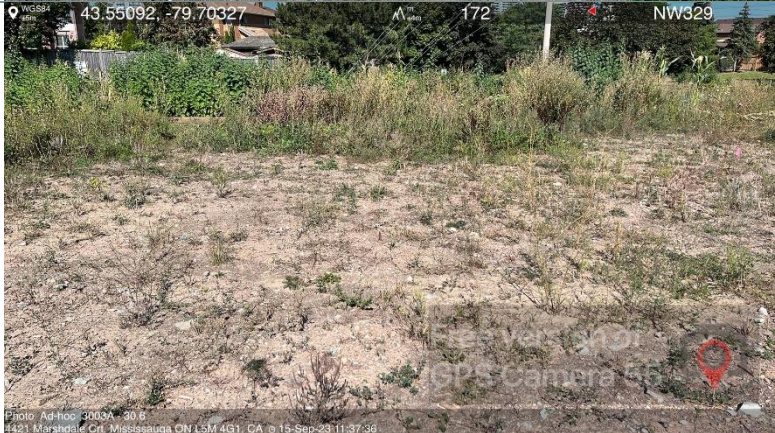
<p>A photograph showing a dirt road or path leading through a field. In the background, several high-voltage power lines are visible against a clear blue sky. The photo includes a GPS overlay at the top with coordinates 43.54717, -79.70759, elevation 173, and location SW228.</p>
WTFN3003A	Areas of bare soil between KP30.5 and KP30.7.	Y	Seed and control weeds as needed.

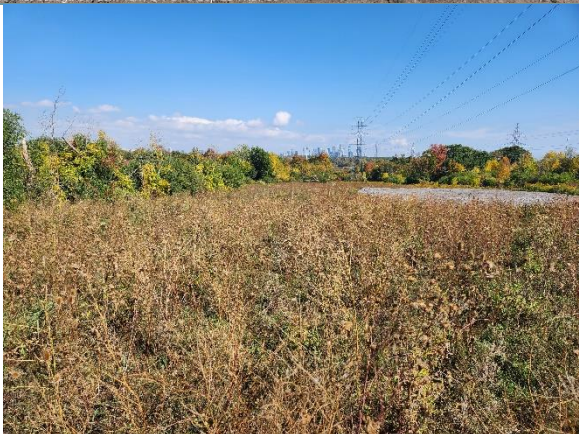
<p>A photograph of a field with sparse vegetation and several patches of bare, light-colored soil. The photo includes a GPS overlay at the top with coordinates 43.55092, -79.70327, elevation 172, and location NW329.</p>
WTFN3029	Site Restored, with small bare patch at KP31.46.	Y	Seed bare area as needed.

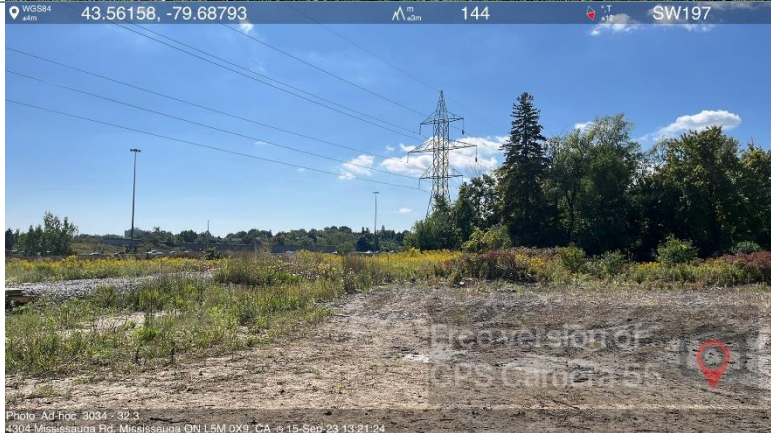
<p>A photograph showing a field of sunflowers in the foreground, with a line of trees and several high-voltage power line towers in the background under a clear blue sky. The photo includes a GPS overlay at the top with coordinates 43.55963, -79.69230 and a SW205 marker.</p>
WTFN3034	Site restored. Hydro One workspace, gravel pad, and debris pile observed.	N	No issues documented at the time of inspection.

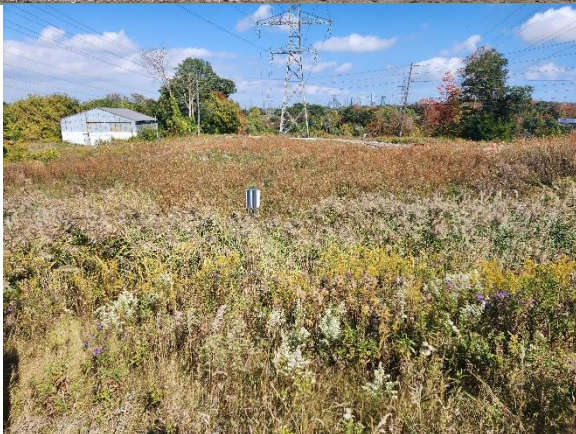
<p>A photograph of a cleared, gravel-covered area with sparse vegetation. In the background, there are trees and a power line tower. The photo includes a GPS overlay at the top with coordinates 43.56158, -79.68793 and a SW197 marker.</p>
WTFN3064	Higher weed density (Annual Ragweed) than adjacent lands observed.	Y	Control weeds as needed.

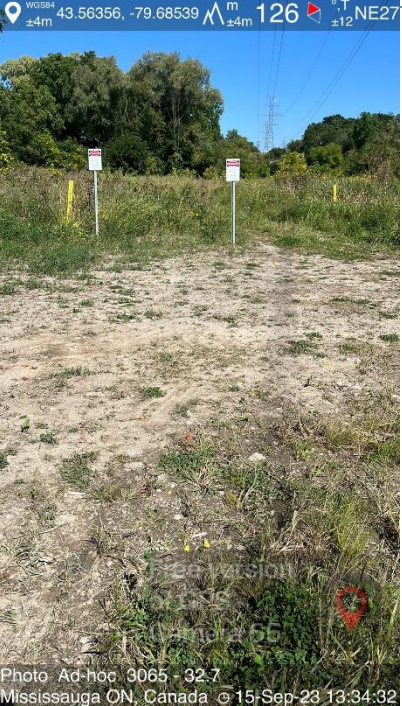
Location (Tract No.)	Site Condition	Additional Work Recommended (Y/N)	Comments/Recommendations	Representative Photo (Sept. 2023)
WTFN3065	Site restored, but some areas of bare soil at KP 32.7. Hill has sparse vegetation but well-established native seed mix.	Y	Site to be reassessed in 2024. Seed as needed.

<p>GPS photo showing site WTFN3065. The image displays a dirt path with sparse vegetation and some bare soil. A red location pin is visible in the bottom right corner of the photo. The photo metadata includes coordinates 43.56356, -79.68539, elevation 126m, and a bearing of NE27. The photo was taken on 15-Sep-23 at 13:34:32.</p>
WTFN3070	Site has been restored.	N	No issues documented at the time of inspection.

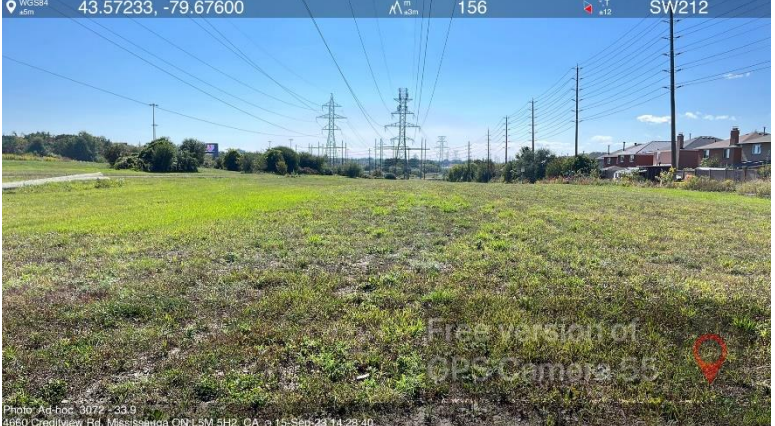
WTFN3072	Areas of sparse vegetation.	Y	Seed as needed.

<p>GPS photo showing site WTFN3072. The image displays a field with sparse vegetation. The photo metadata includes coordinates 43.57233, -79.67600, elevation 156m, and a bearing of SW212. The photo was taken on 15-Sep-23 at 14:28:40.</p>

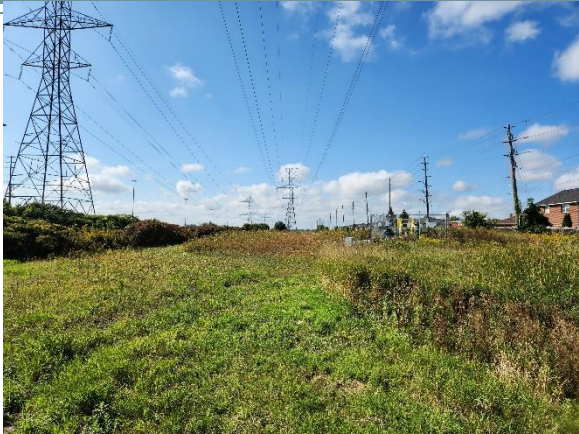
Location (Tract No.)	Site Condition	Additional Work Recommended (Y/N)	Comments/Recommendations	Representative Photo (Sept. 2023)
WTFN3098	Site restored.	N	No issues documented at the time of inspection.

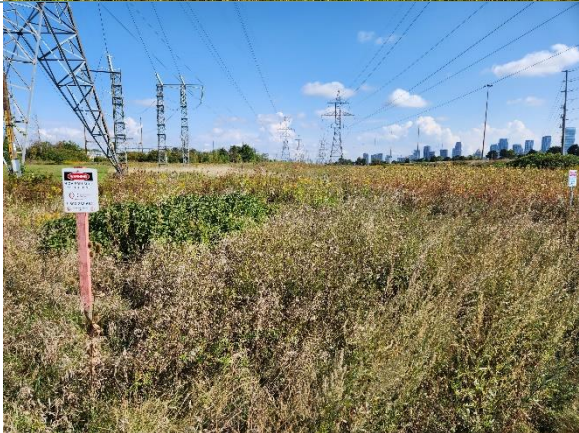
WTFN3145	Site restored.	N	No issues documented at the time of inspection.

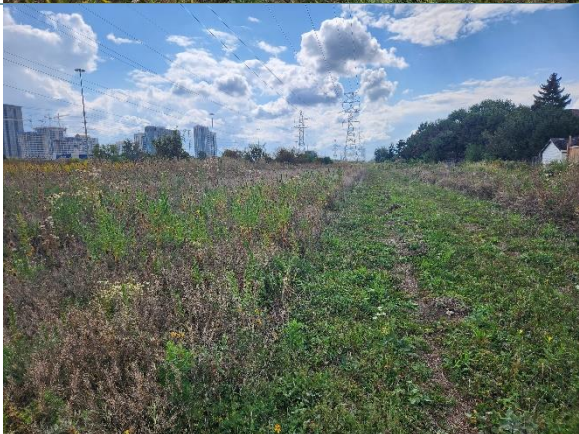
WTFN3319	Higher weed density (Thistle species) than adjacent land.	Y	Control weeds as needed.

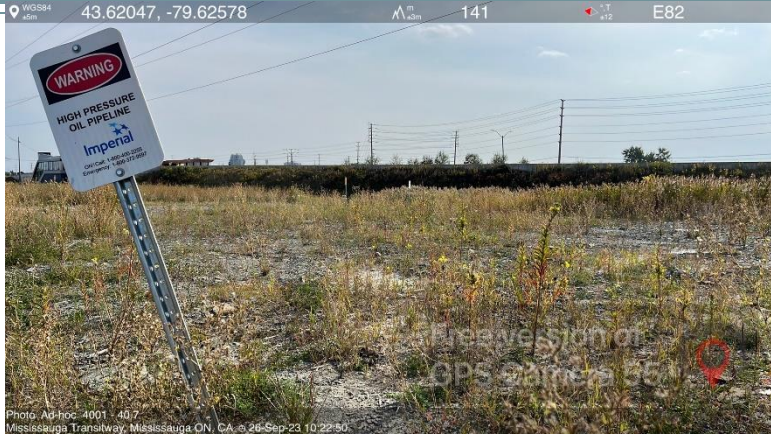
Location (Tract No.)	Site Condition	Additional Work Recommended (Y/N)	Comments/Recommendations	Representative Photo (Sept. 2023)
WTFN4001	Site restored, but area of bare soil at KP40.45-40.8.	Y	Seed as needed.

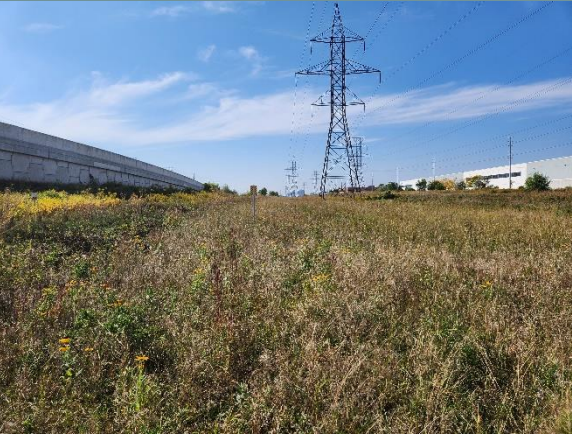
Location (Tract No.)	Site Condition	Additional Work Recommended (Y/N)	Comments/Recommendations	Representative Photo (Sept. 2023)
WTFN4030	Areas of bare soil. Minor rill observed at KP 42.7.	Y	Site to be reassessed in 2024. Seed as needed. Repair areas impacted by erosion.

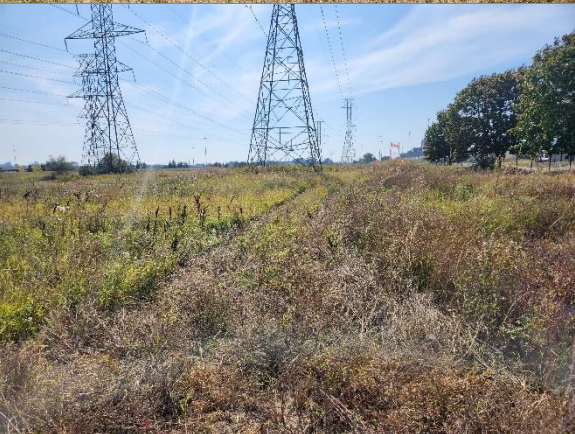
WTFN4071	Higher weed density (Thistle species) than adjacent lands. Area of bare soil at KP47.6	Y	Seed and control weeds as needed.

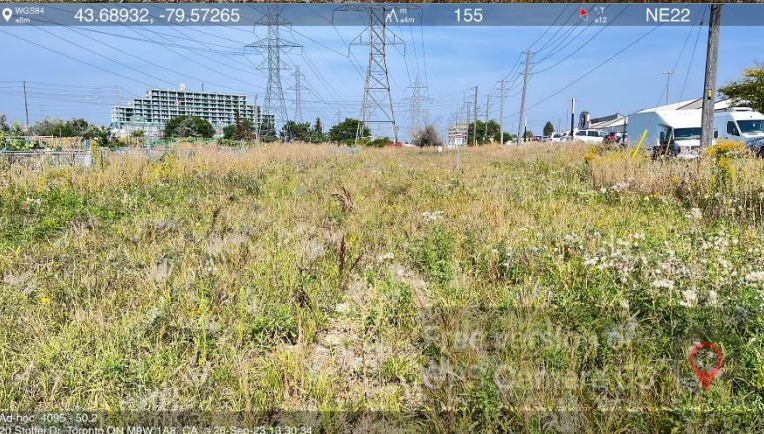
WTFN4095	Site restored, but some bare patches at KP50.2.	Y	Seed as needed.

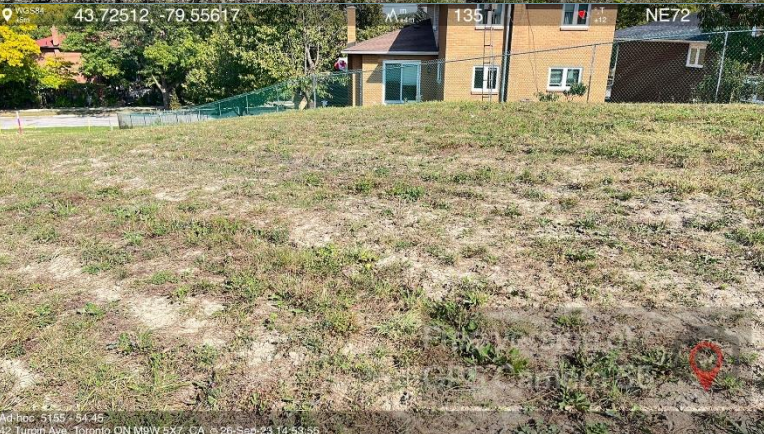
WTFN5155	Sparse vegetation, site was observed to be mowed.	Y	Site to be reassessed in 2024. Seed as needed.
