**Re: 2009 Cost of Service Rate Application  
EB-2008-0227**

### EXECUTIVE SUMMARY

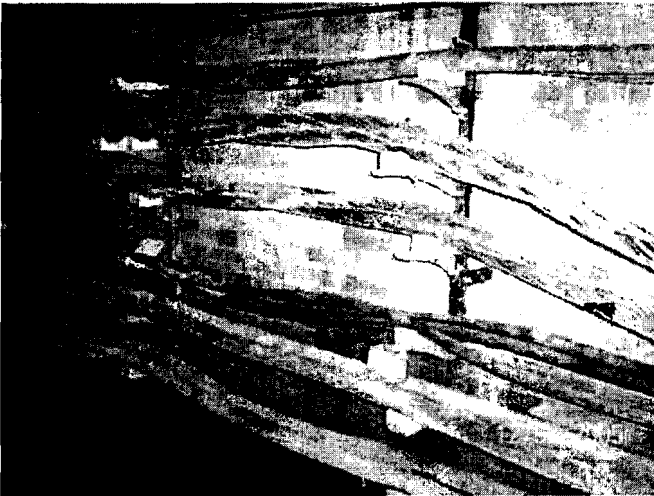
South Wall (East to West)
