Festival Hydro Inc. Substation Condition Assessments Seaforth, Ontario Report

Festival Hydro Inc. has retained Costello Utility Consultants to assist with a comprehensive review of the two substations (Chalk DS and Welsh DS) in Seaforth Ontario and to provide a recommendation on the merits of replacement of these assets or to invest in a voltage conversion program to ultimately phase these stations out of service.

Appendix B – Site Photos

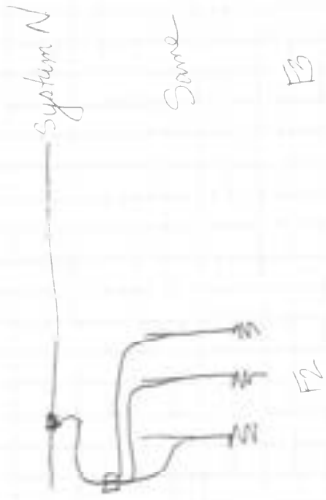
Riser Poles

Old T-bar/bare fence within 8' of str fence
Outside grid?

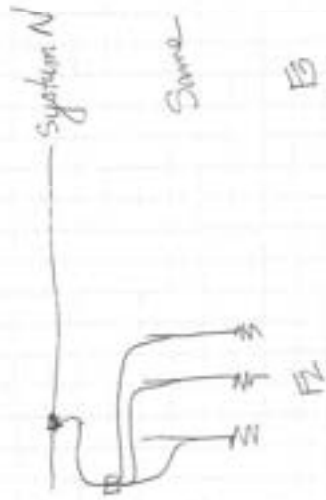
Poles

1. T-bar/bolt fence within 8' of str fence
inside yard?

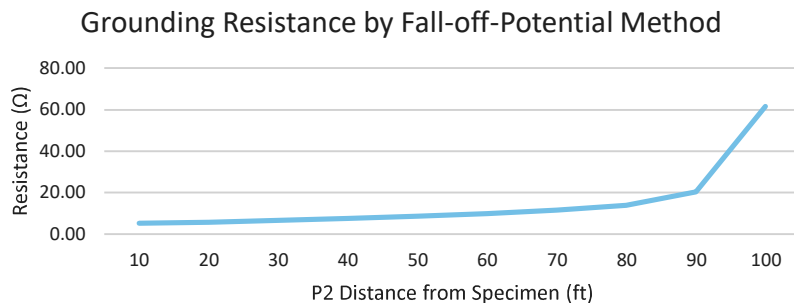
Electrical Tests

Distance of C2 from Specimen (ft)	Distance of P2 from Specimen (ft)	Resistance (Ω)
100	10	5.32
100	20	5.88
100	30	6.70
100	40	7.60
100	50	8.72
100	60	9.92
100	70	11.70
100	80	14.00
100	90	20.50
100	100	61.50

Results Satisfactory OK
