Burlington **hydro** inc.

# Appendix L

## Fleet Management Plan

Fleet Management Plan

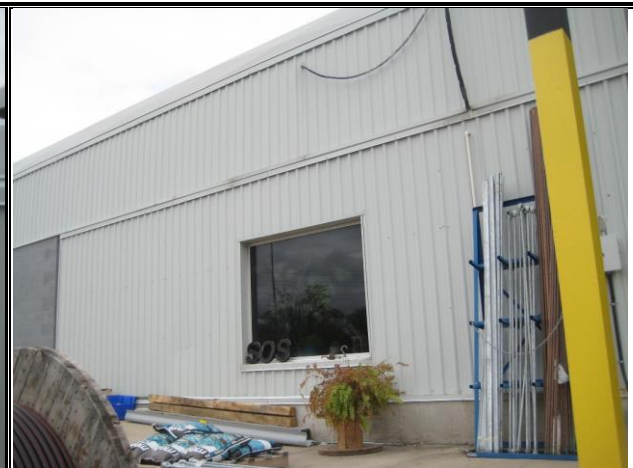
**Photo #46: Service Centre Metal Cladding**

The corrugated metal siding is in good condition. However, we noticed that the paint is starting to fade at the metal cladding in the office building. This is not impacting the cladding structurally at this time as the metal has not started to corrode. You may wish to repaint the metal cladding as the finish continues to age and wear. We included an allowance for painting in the Capital Expenditures.

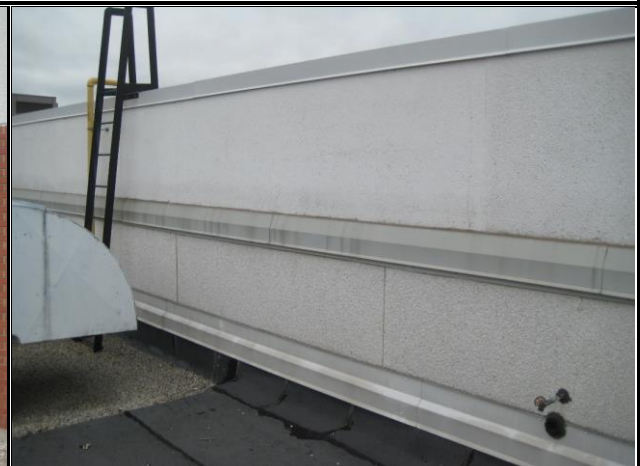
**Photo #54: Exposed Aggregate Panels at Office Original Building**

The composite panels are generally in good to fair condition. However, the cladding is stained and it has cracked at some locations. We recommend repairing cracked areas and recoat the panels. We included a repair allowance in the Capital Expenditures.

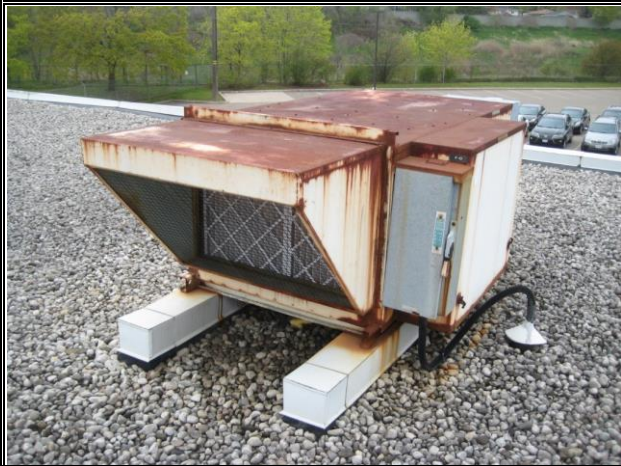
**Photo #72: Decommissioned Roof Top Unit**

The most northern service centre roof top unit is reportedly decommissioned. The remaining units appeared to be in good to fair working condition. The older roof top units may contain R-22 refrigerant which has been phased out through federal legislation. Compatible refrigerants are available on the market, depending on the unit. We recommend that you discuss this with the service contractor to determine if you will be able to continue servicing the units or if premature replacement will be required due to the refrigerant.

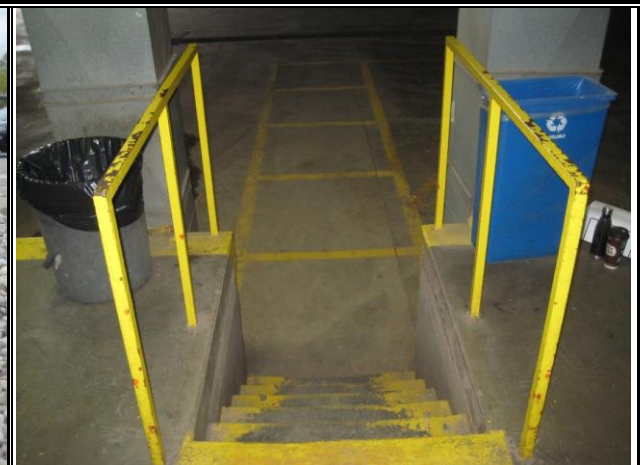
**Photo #118: Service Centre Metal Railings**

Description
<p>There are various types of guardrails throughout the property. The guardrails are located at the front and secondary entrances, at the exterior concrete stairs and in the service centre.</p> <p>Main Entrance – Prefinished aluminum picket-style railings.</p> <p>Secondary Entrance – Painted Metal railings.</p> <p>Interior Stairs – Painted Metal Railings.</p> <p>At Concrete Steps in Parking Lot - Painted Metal Railings.</p>
Observations and Recommendations
<p>The metal railings are in good to fair condition. Some of the guardrails have started to corrode due to exposure to de-icing salts. We recommend cleaning, priming and painting as part of the building maintenance.</p> <p>At end of service life, we recommend replacement with prefinished aluminum which has lower maintenance requirements (not painting needed, more corrosion resistant).</p>
